Expertise

Protocol number: 46104756
Order No. / Reference: 26482361
Inspection date: 23 Jun 2026

Manufacturer: Opel

Model: Mokka 1.2 DI Turbo Automatik Ultimate

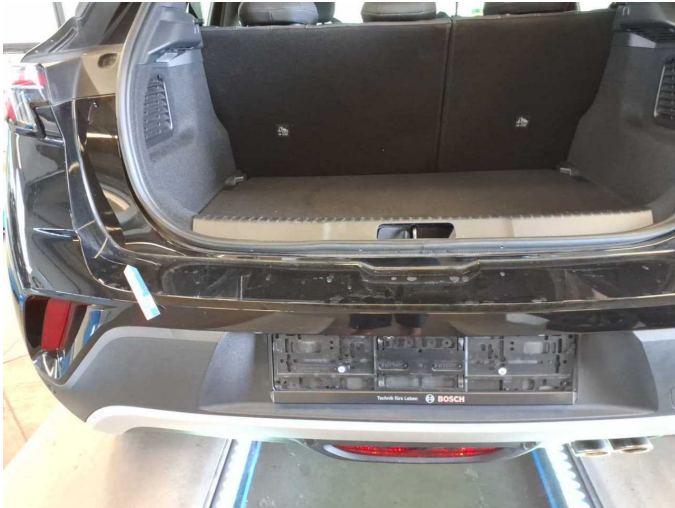
No.	Component group	Description
1	Rear bumper	Rear bumper - Scratch(es) - Smart repair

Damage 1: Rear bumper: Rear bumper - Scratch(es) - Smart repair

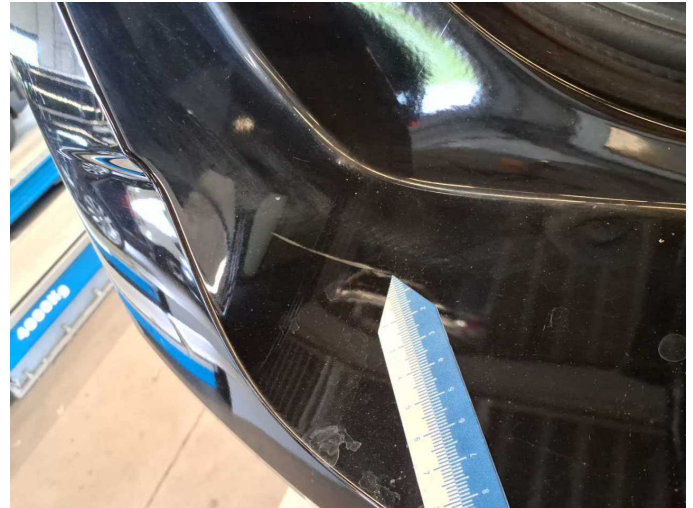
Damage 1: Rear bumper: Rear bumper - Scratch(es) - Smart repair

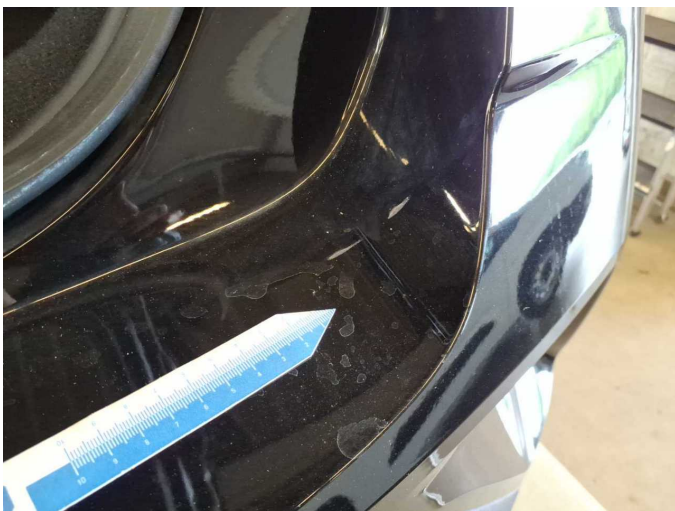
Damage 1: Rear bumper: Rear bumper - Scratch(es) - Smart repair

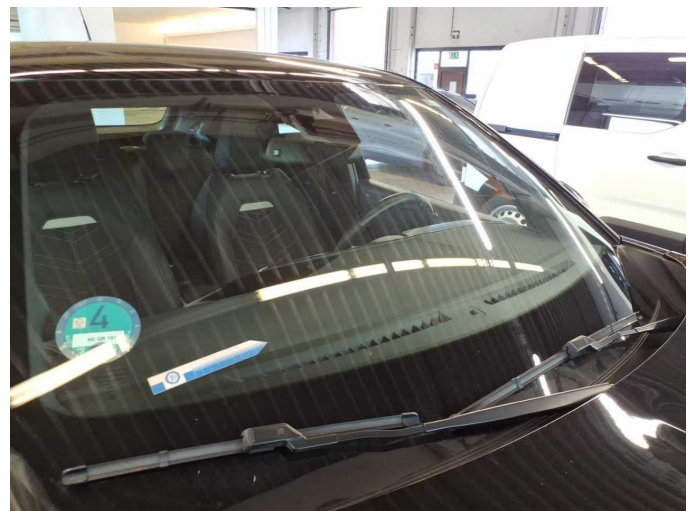
No.	Component group	Description
1	Vehicle glazing	Windscreen - Stone chips
2	Bonnet	Bonnet - Stone chips
3	Door - front right side	Door edge - Scratch(es)

Wear and tear 1: Vehicle glazing: Windscreen - Stone chips

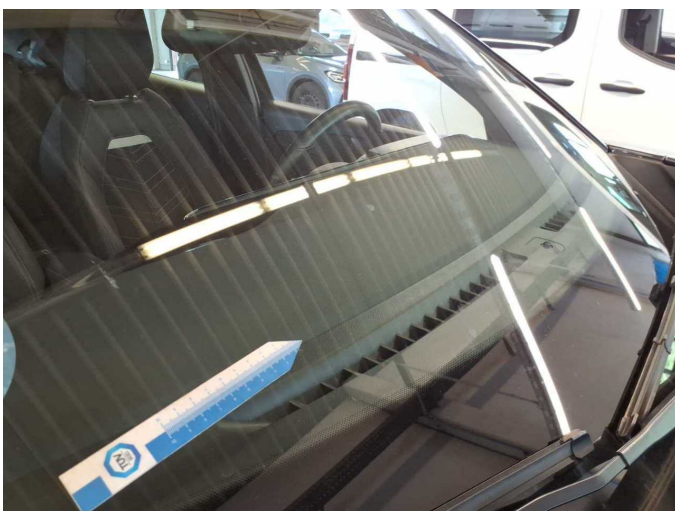
Wear and tear 1: Vehicle glazing: Windscreen - Stone chips

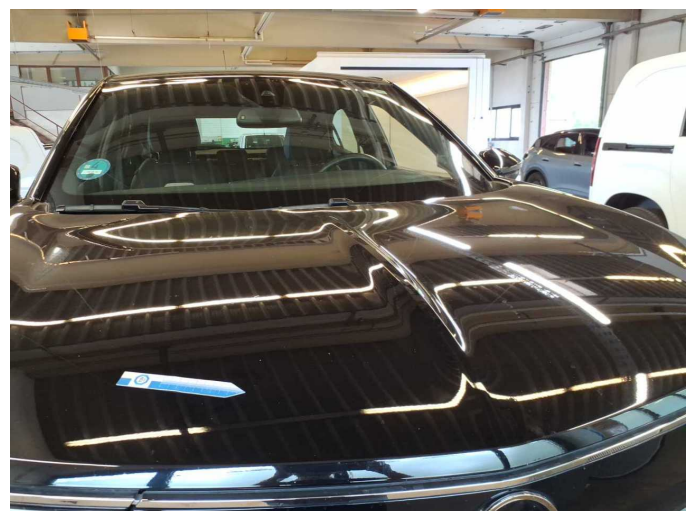
Wear and tear 2: Bonnet: Bonnet - Stone chips

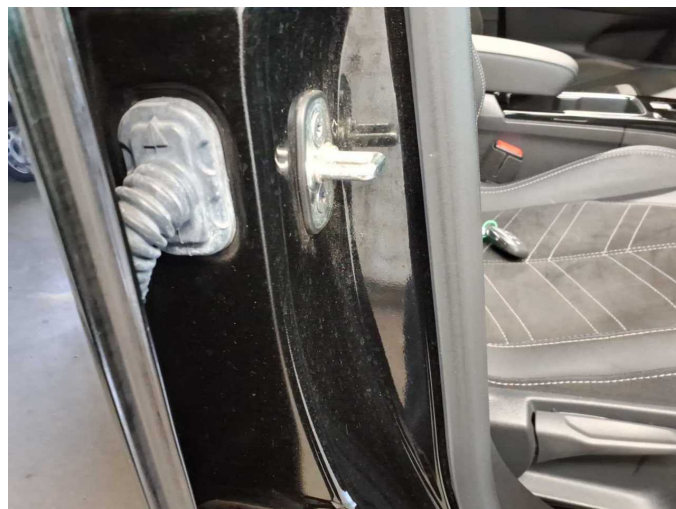
Wear and tear 3: Door - front right side: Door edge - Scratch(es)

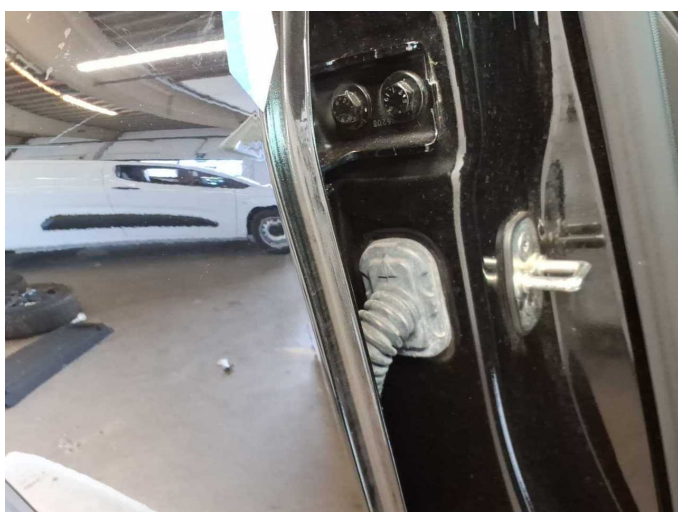
Wear and tear 3: Door - front right side: Door edge - Scratch(es)
