## Expertise

Protocol number: 46108141  
Order No. / Reference: 26472955  
Inspection date: 23 Jun 2026

Manufacturer: Peugeot

Model: 208 BlueHDi 100 GT Pack

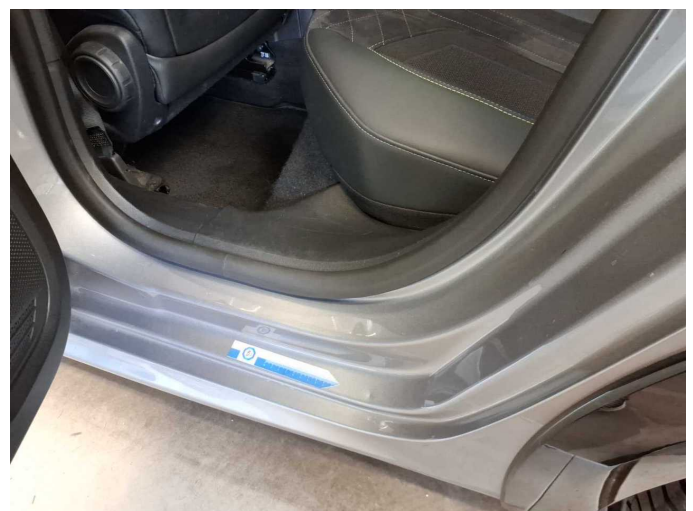
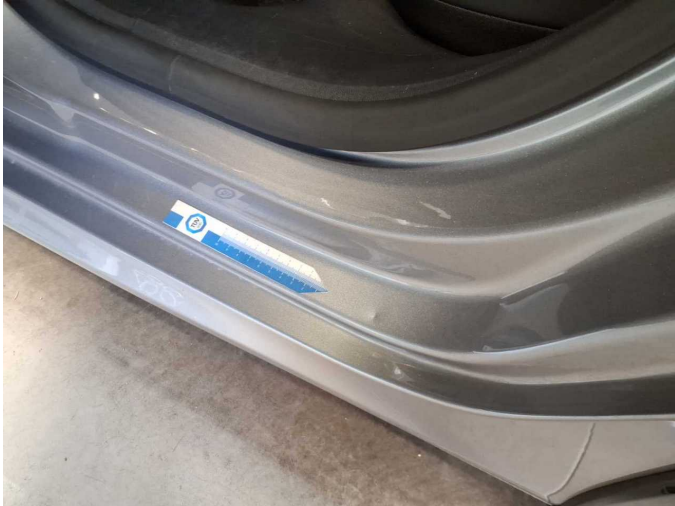
Damage 1: Side panel - rear left side: Sill - dent(s) - Smart repair

**Damage 1:** Side panel - rear left side: Sill - dent(s) - Smart repair

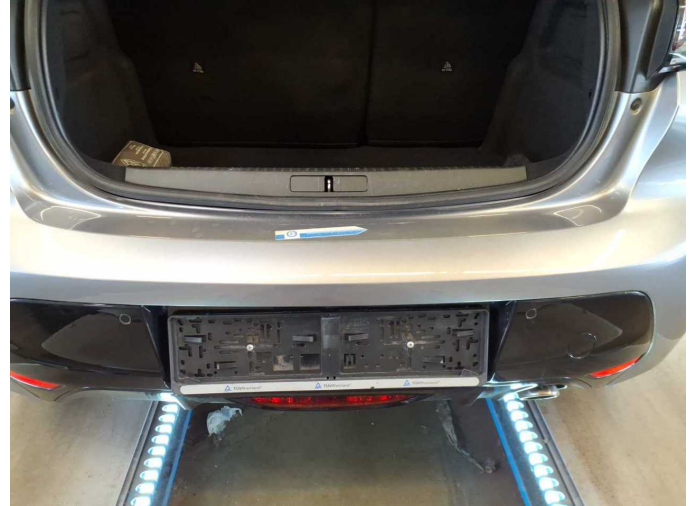
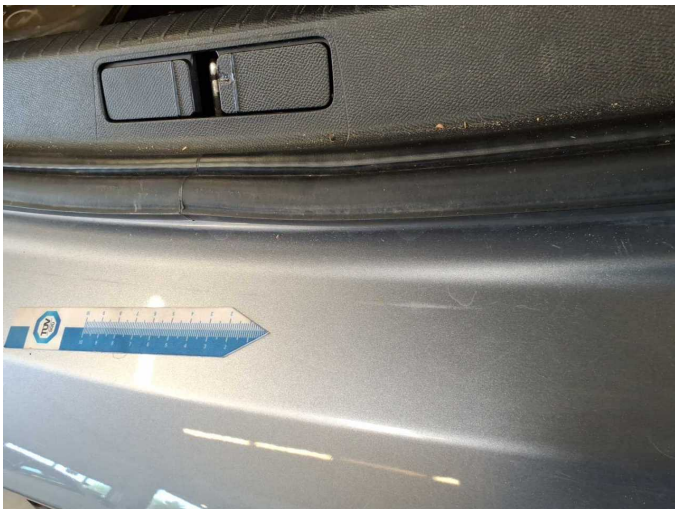
**Damage 2:** Rear bumper: Rear bumper - Scratch(es) - Smart repair

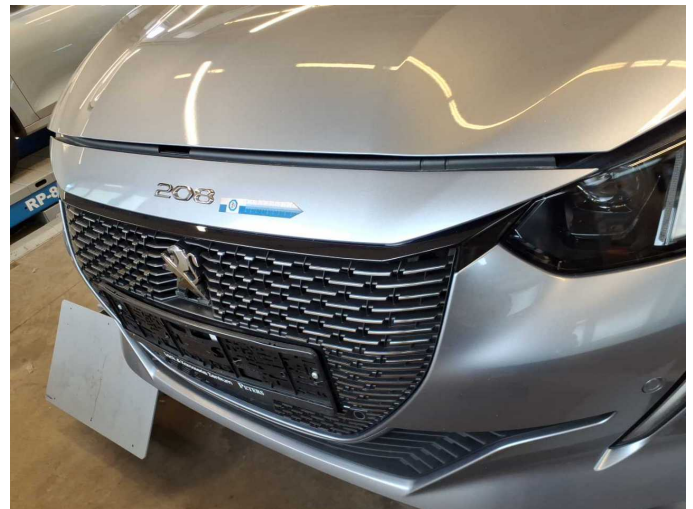
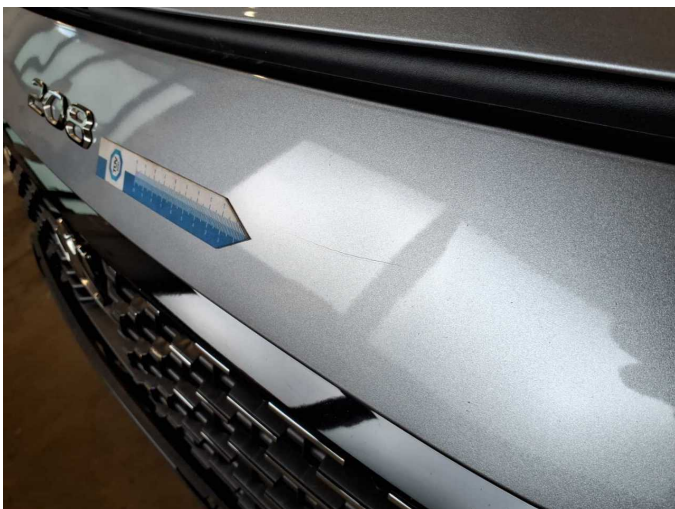
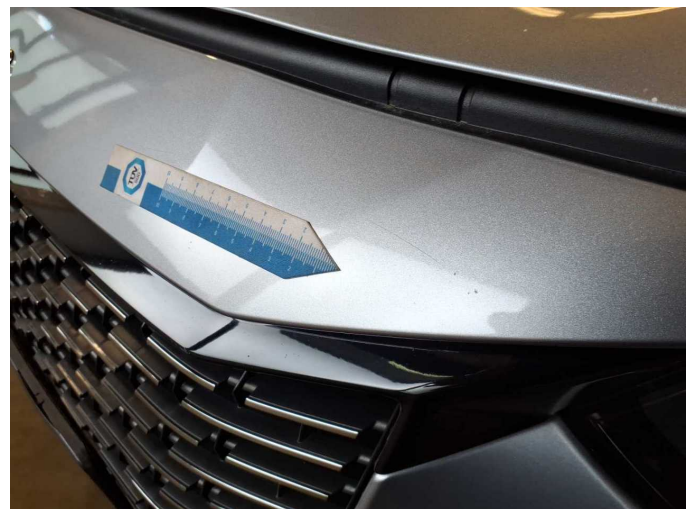
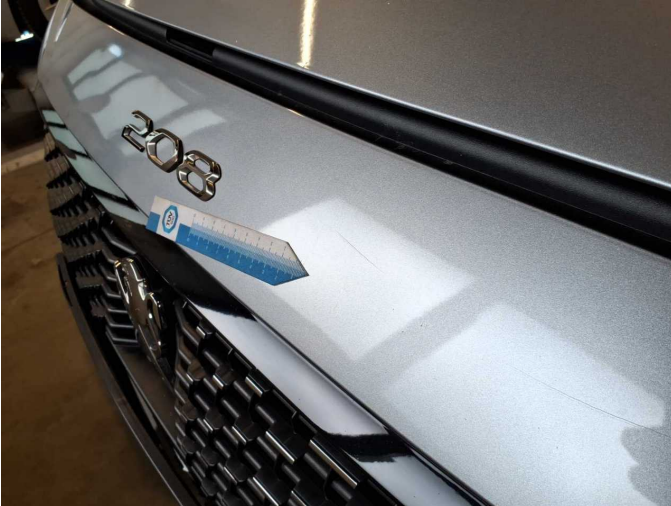
**Damage 3:** Front bumper: Front bumper - Scratch(es) - Smart repair

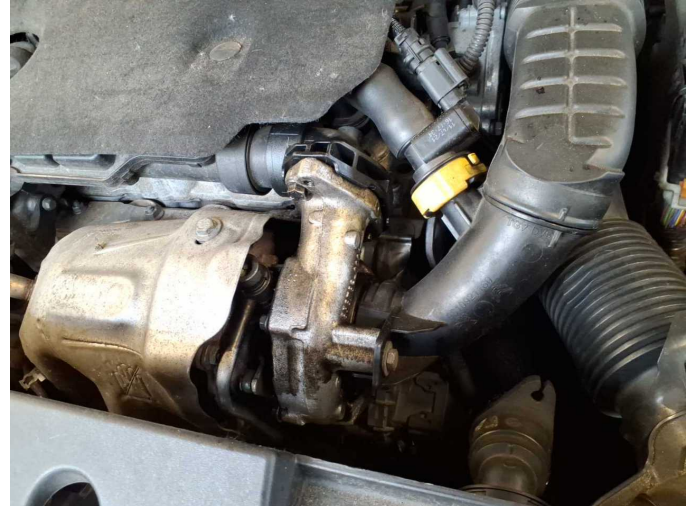
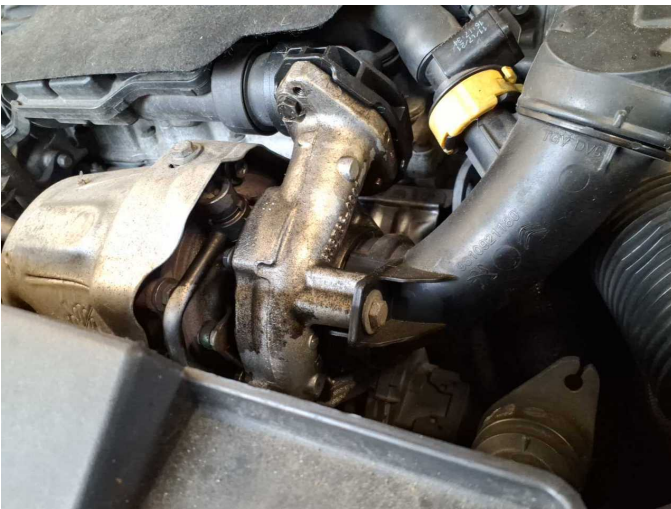
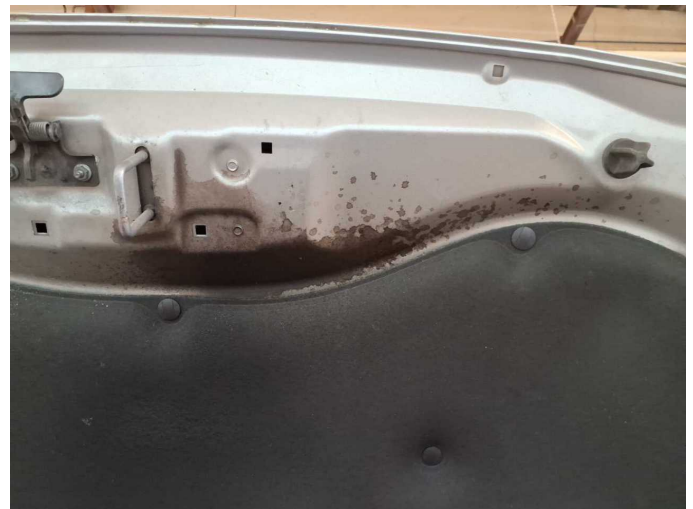
**Damage 4:** Engine: Engine (Mehrkosten möglich) - Leaking - Diagnosed and repair if necessary

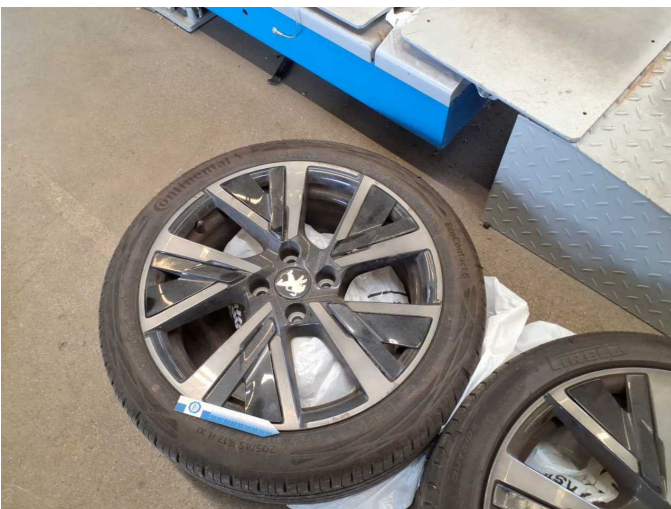
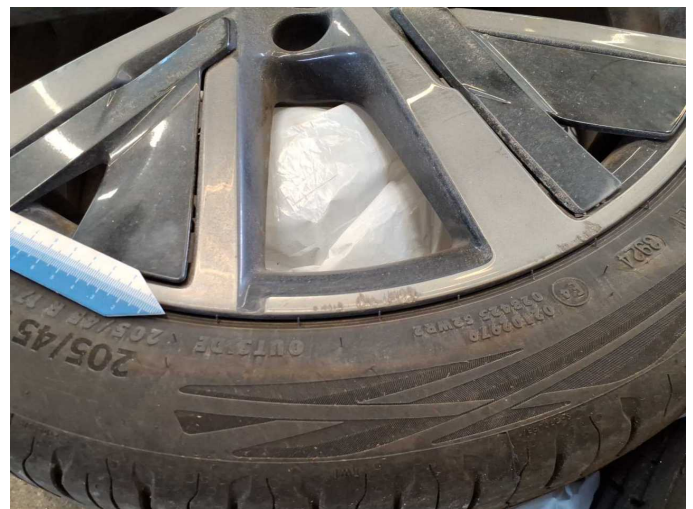
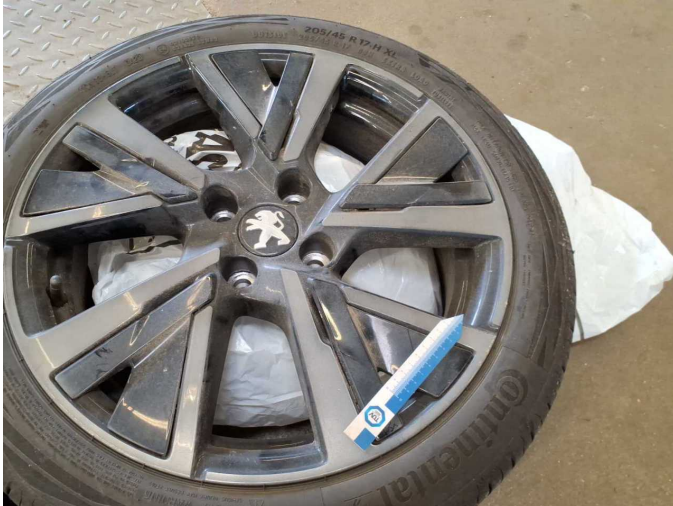
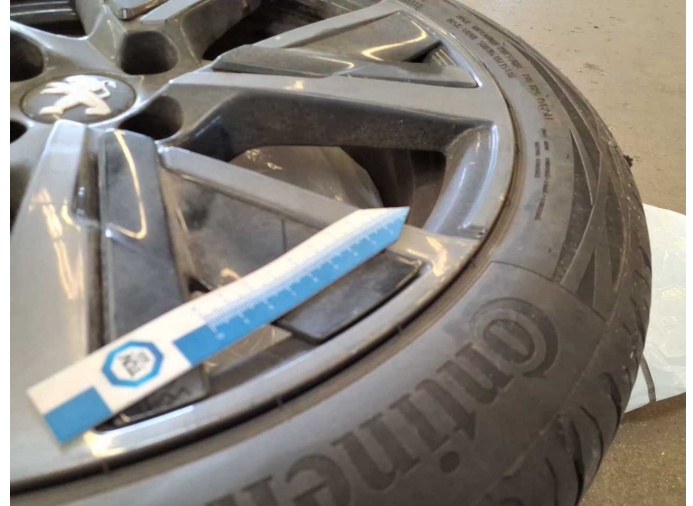
**Damage 6:** 2nd wheel set: 2 alloy rims - Scratched - Loss in value

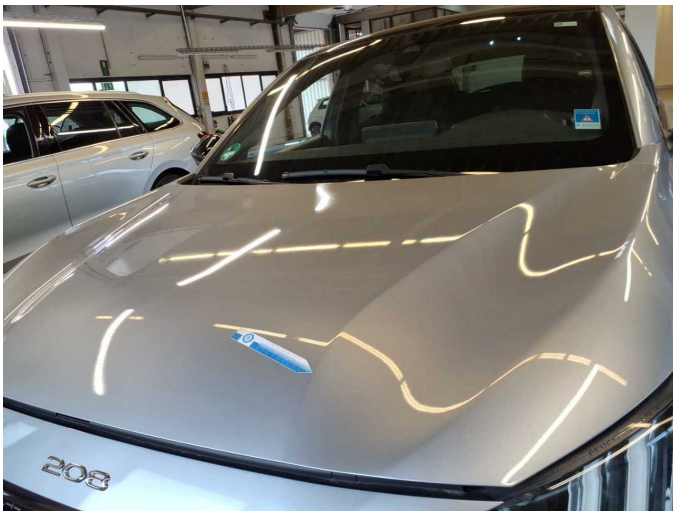
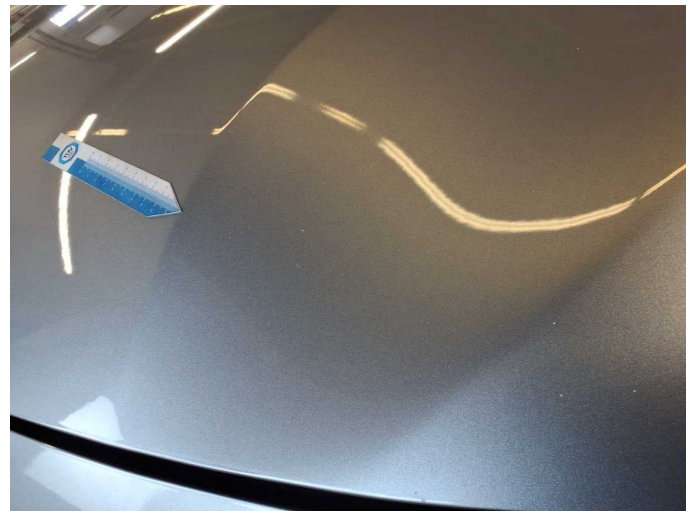
**Wear and tear 1:** Bonnet: Bonnet - Stone chips - No deduction

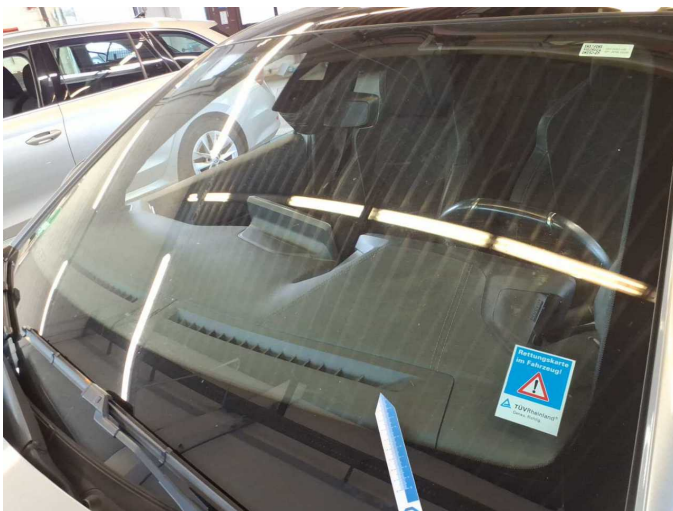
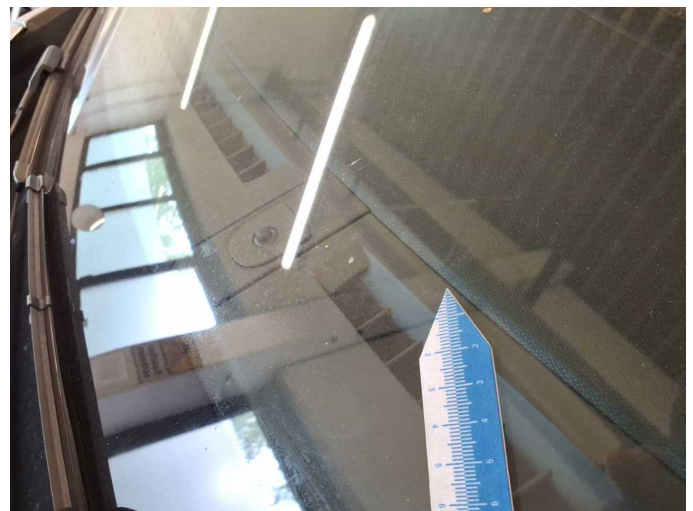
**Wear and tear 3:** Vehicle glazing: Windscreen - Stone chips - No deduction

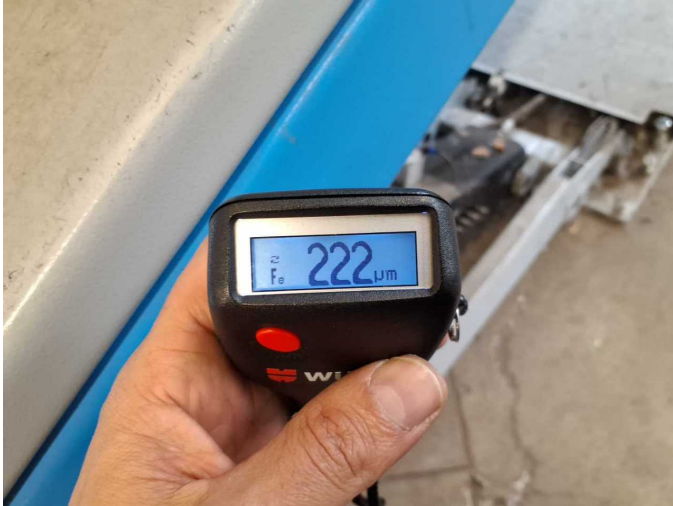
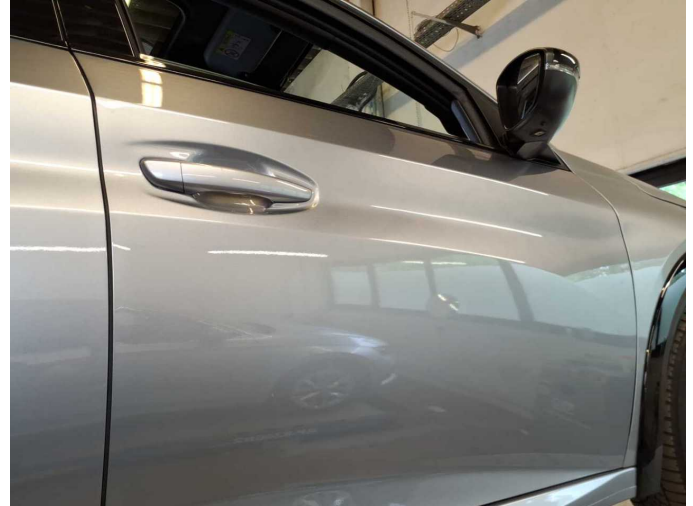
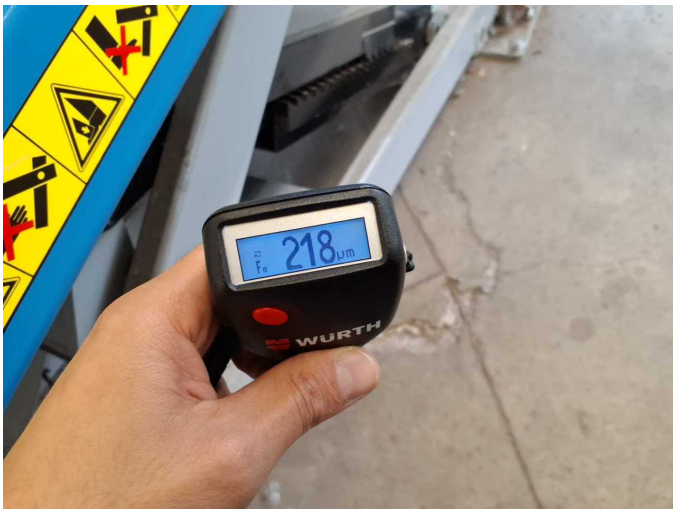
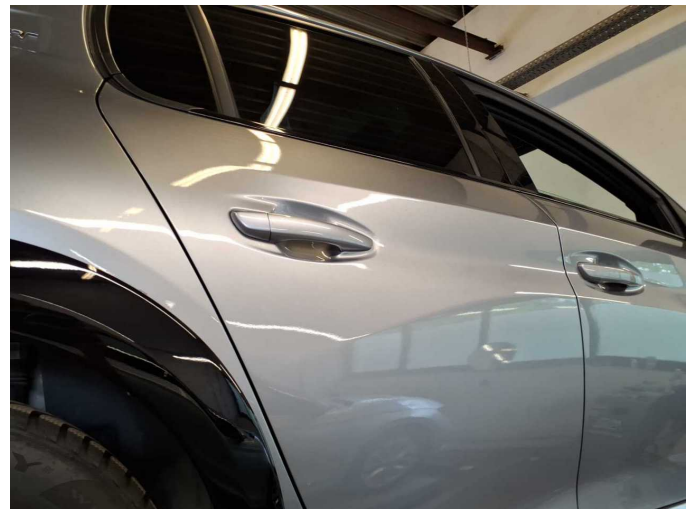
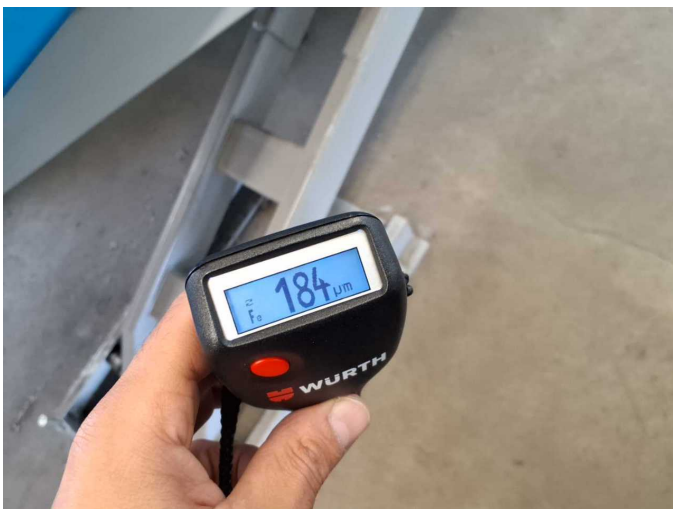
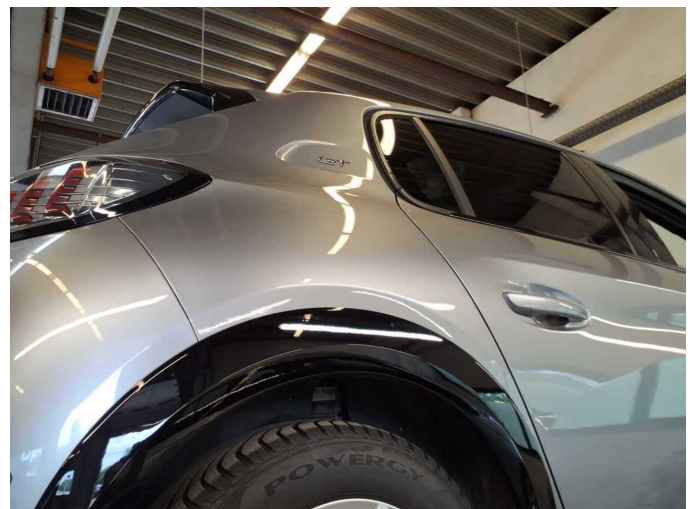
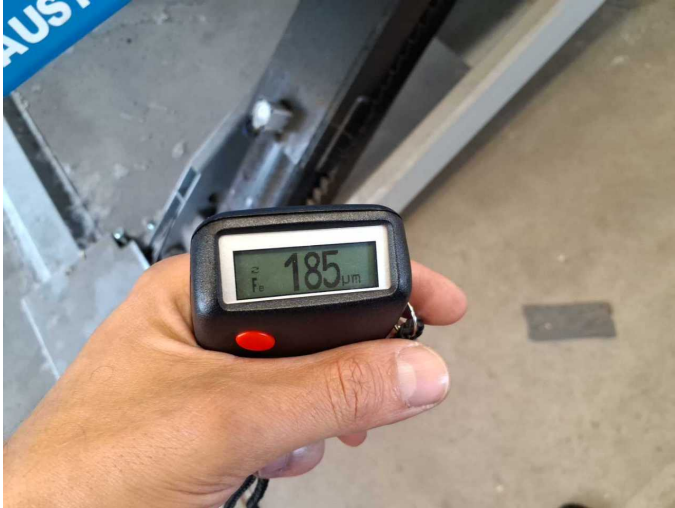
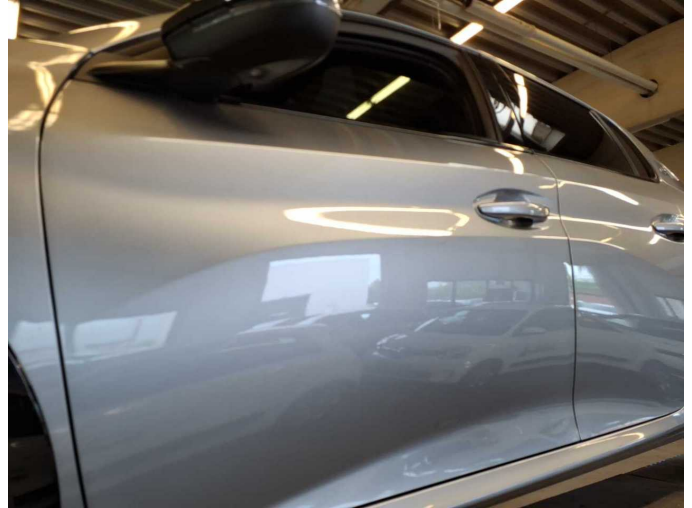
Side panel - rear right side	184 µm	Door - rear right side	218 µm
Door - front left side	185 µm	Door - front right side	222 µm

**Repainting 1:** Side panel - rear right side, Door - rear right side, Door - front left side, Door - front right side
