Expertise

Protocol number: 45850775
Order No. / Reference: 26529557
Inspection date: 8 Jun 2026

Model: Focus Turnier 1.5 EcoBlue Start-Stopp-System Aut. TITANIUM

VIN: WF0PXXGCHPPL83330

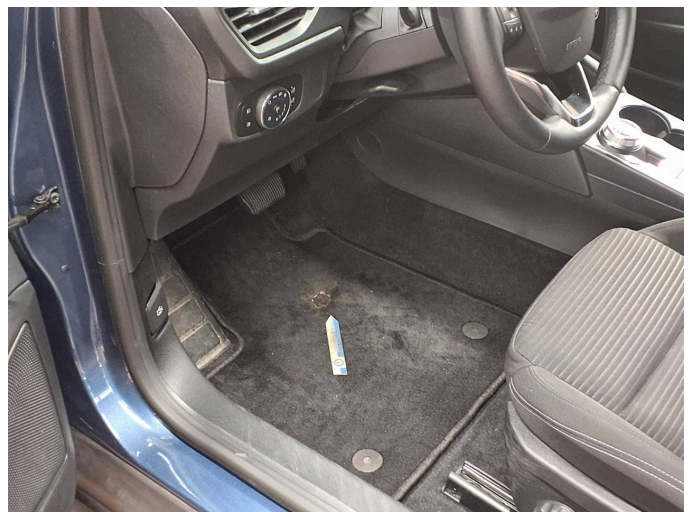
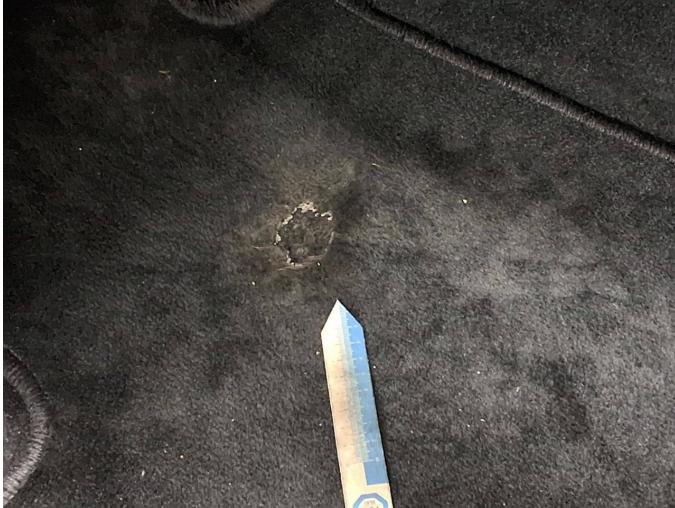
Damage 1: Trim / covers: Floor mats - Holes - Replace

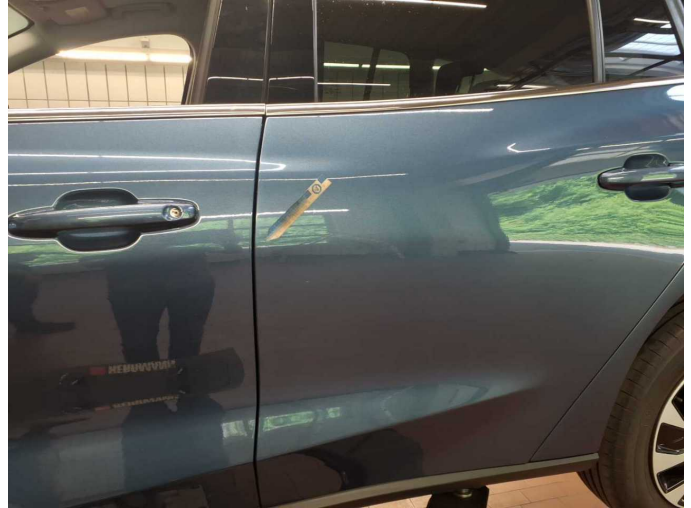
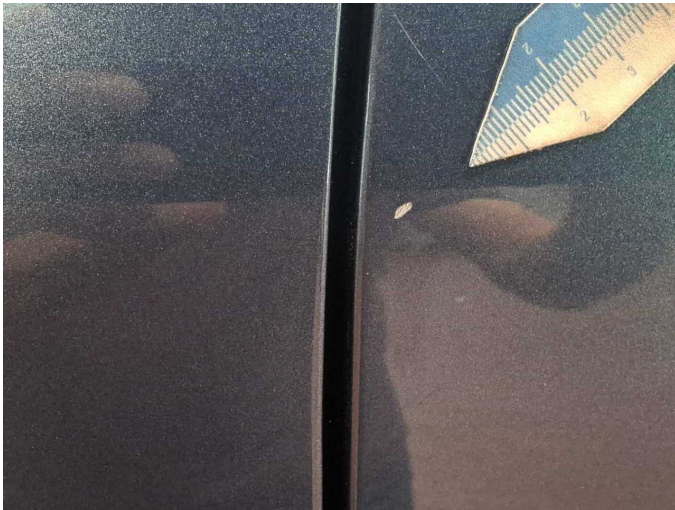
Damage 2: Door - rear left side: Door - Scratch(es) - Smart repair

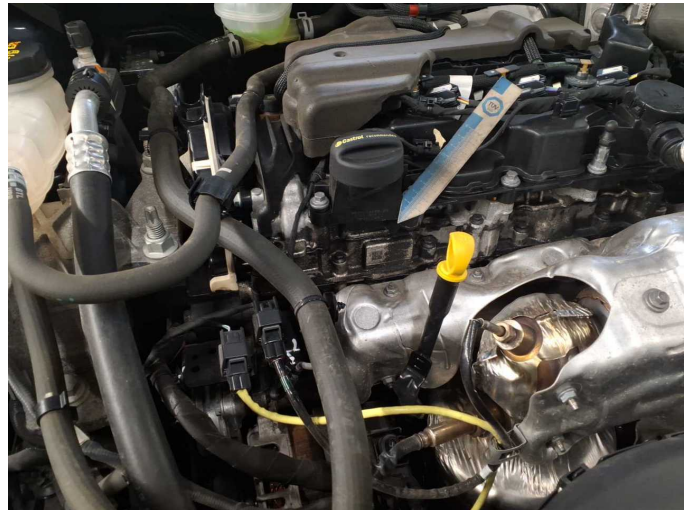
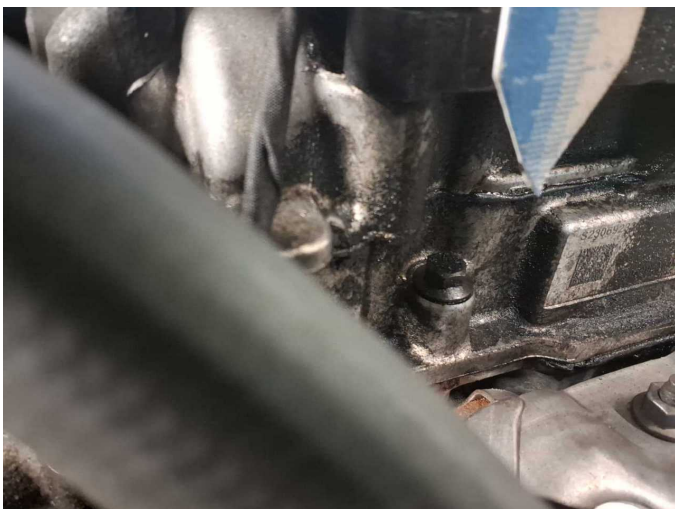
Damage 3: Engine: Engine (Ölverlust) - Leaking - Perform diagnosis

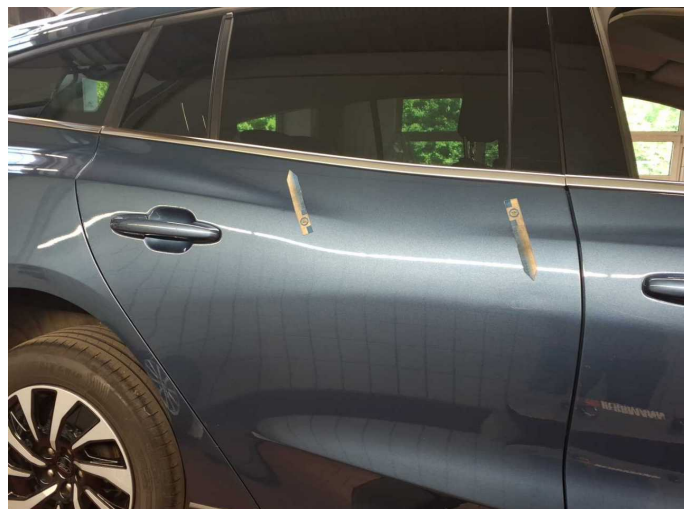
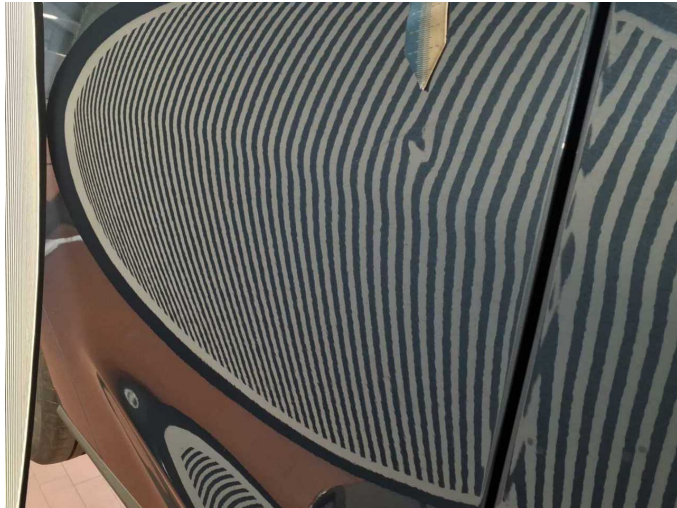
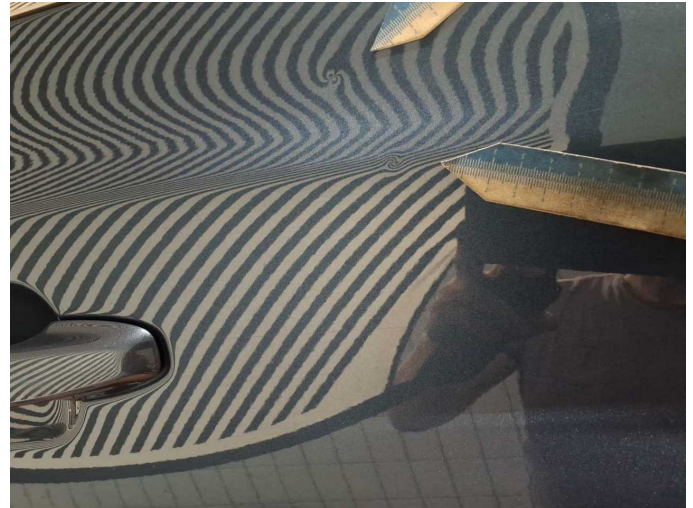
Damage 4: Door - rear right side: Door - dent(s) - Smart repair

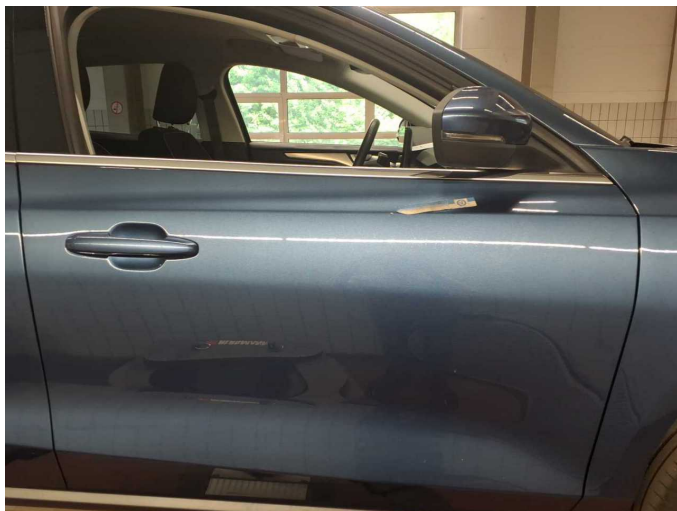
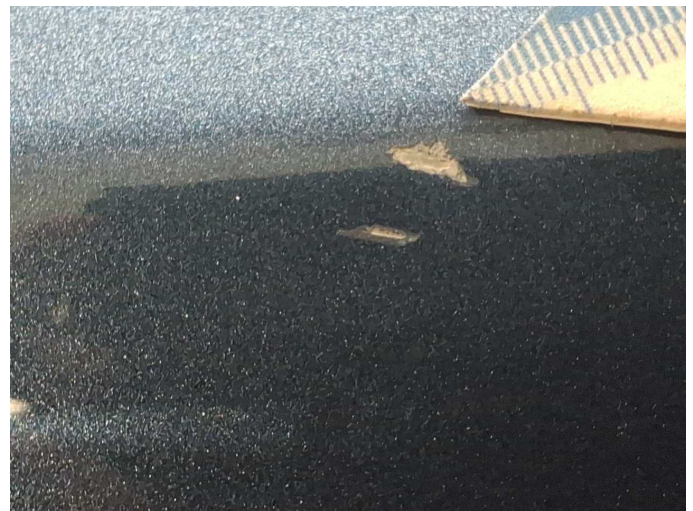
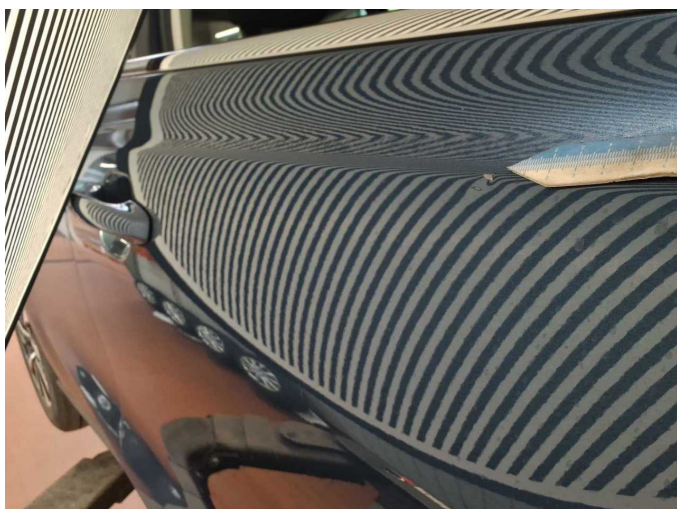
Damage 5: Door - front right side: Door - Dent / paintcoat damage - Smart repair

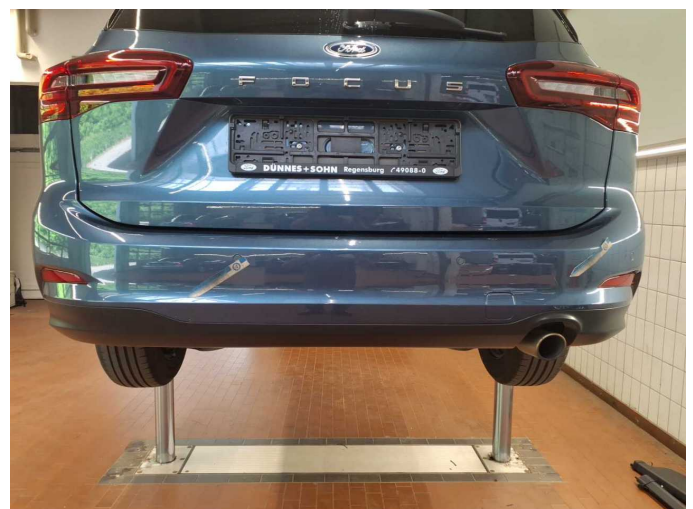
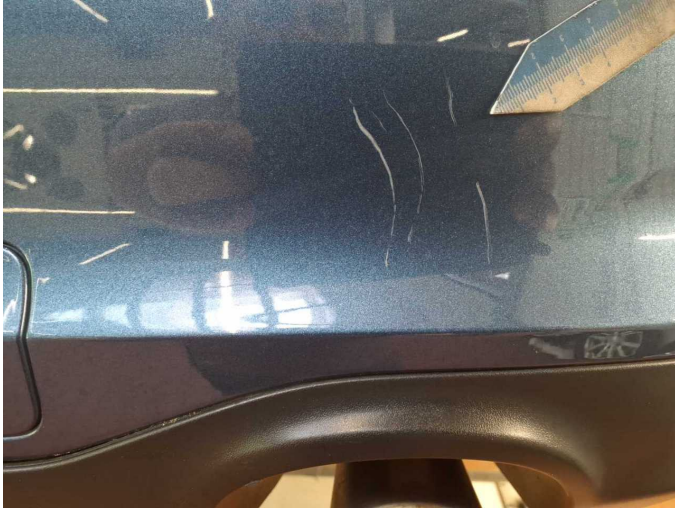
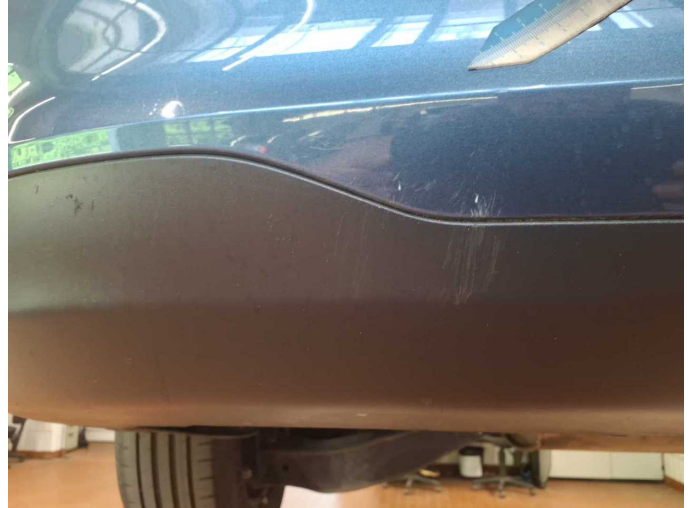
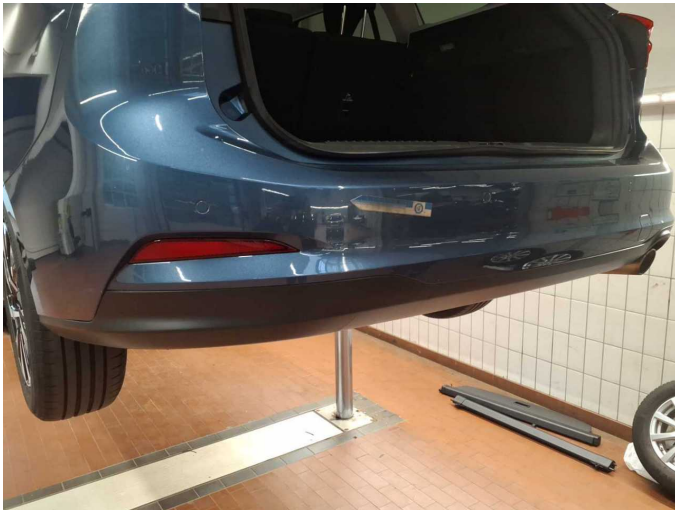
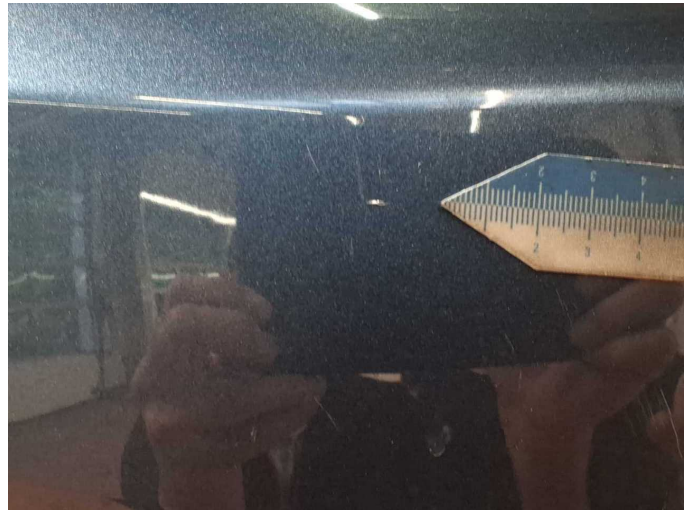
Damage 6: Rear bumper: Rear bumper - Scratch(es) - Paint

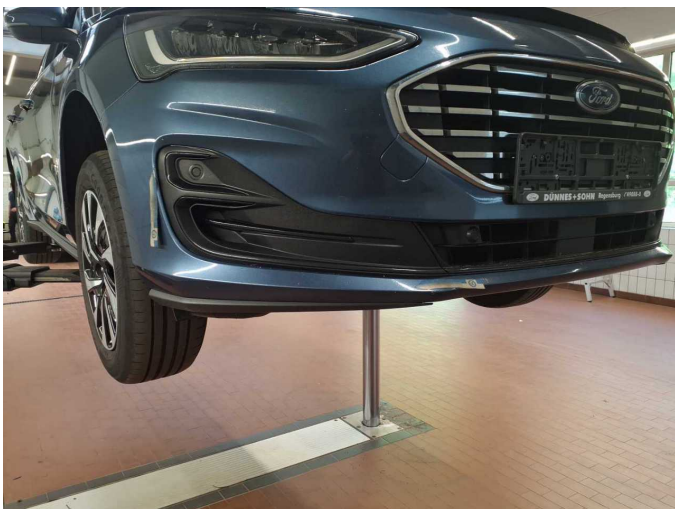
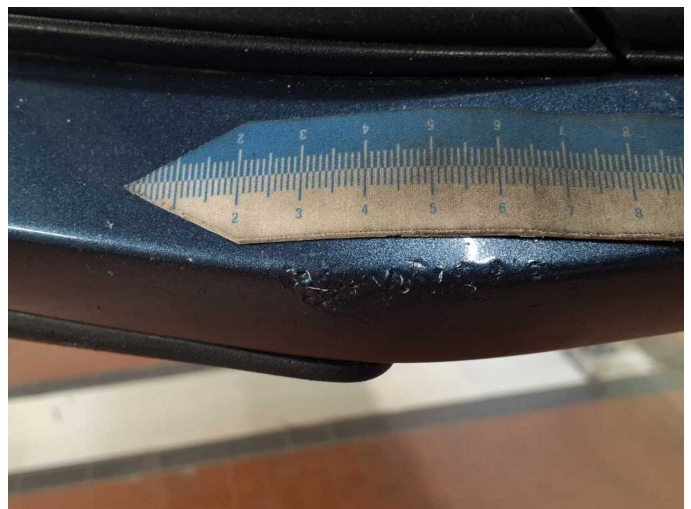
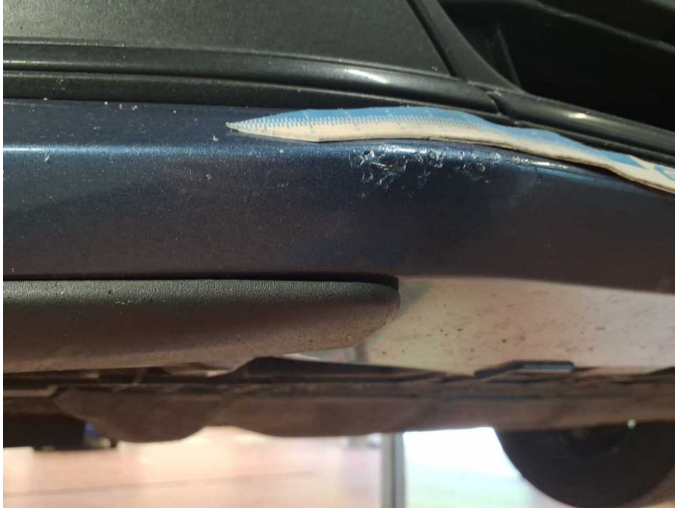
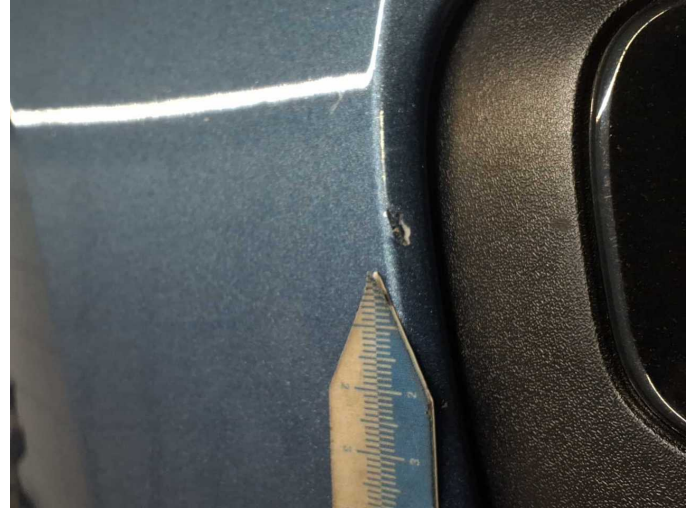
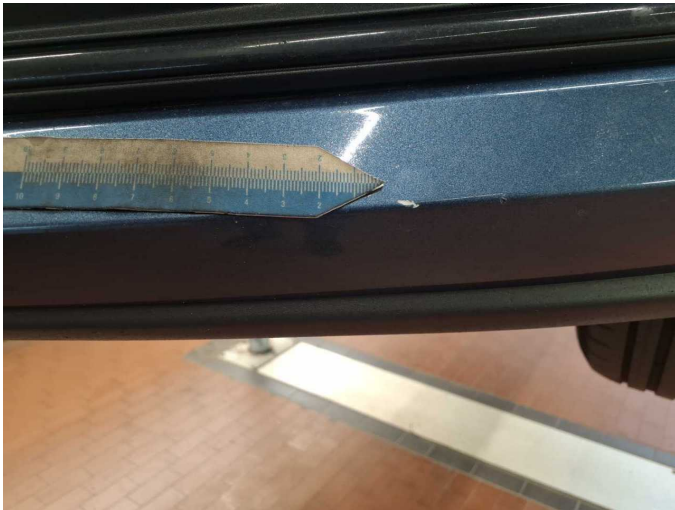
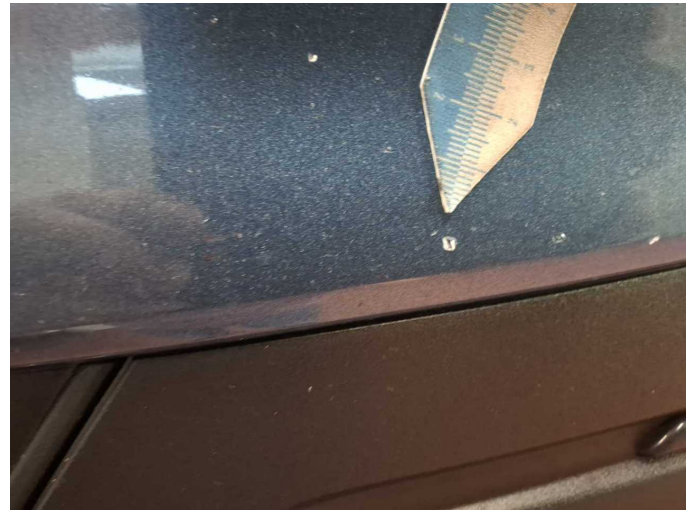
Damage 7: Front bumper: Front bumper - Scratch(es) - Paint

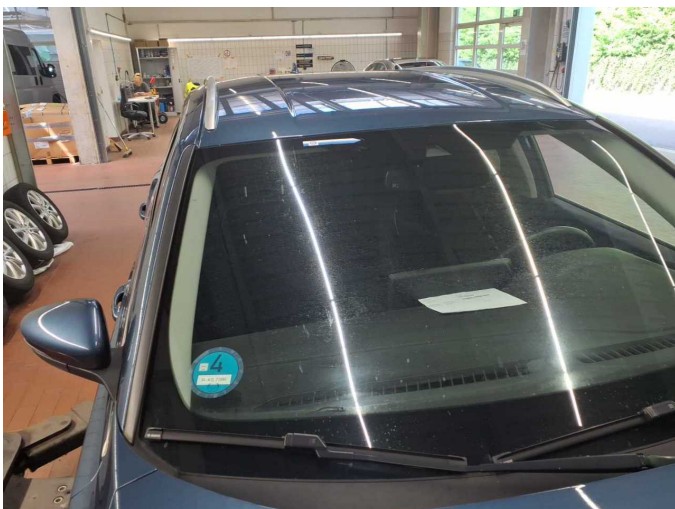
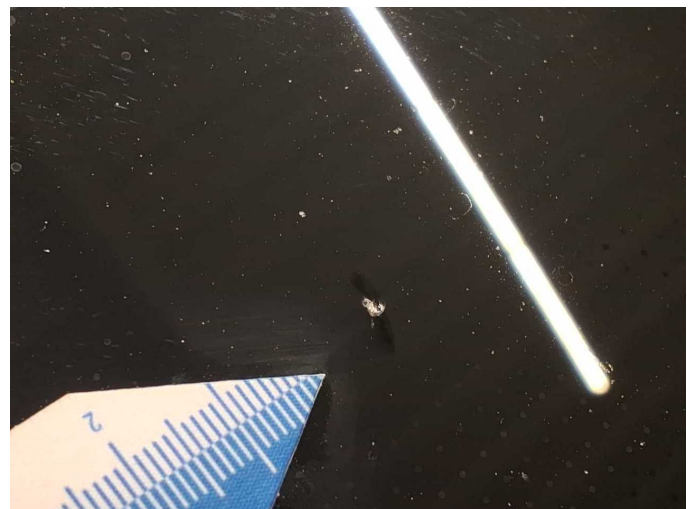
Damage 8: Vehicle glazing: Windscreen with lane departure assistant - Stone chips - Replace

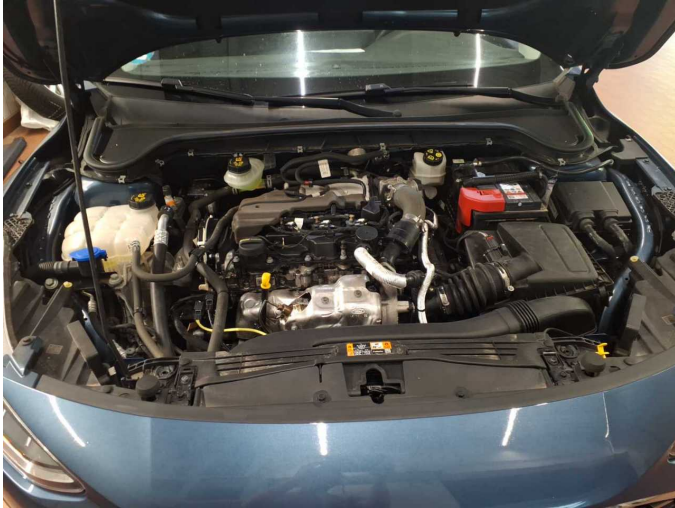
Engine - Engine cover

Missing part 1: Engine: Engine cover - Missing - Replace
