Expertise

Protocol number: 46364660  
Order No. / Reference: 26649500  
Inspection date: 7 Jul 2026

Manufacturer: Mercedes-Benz

Model: Vito 114 CDI Kompakt HA Aut. BASE

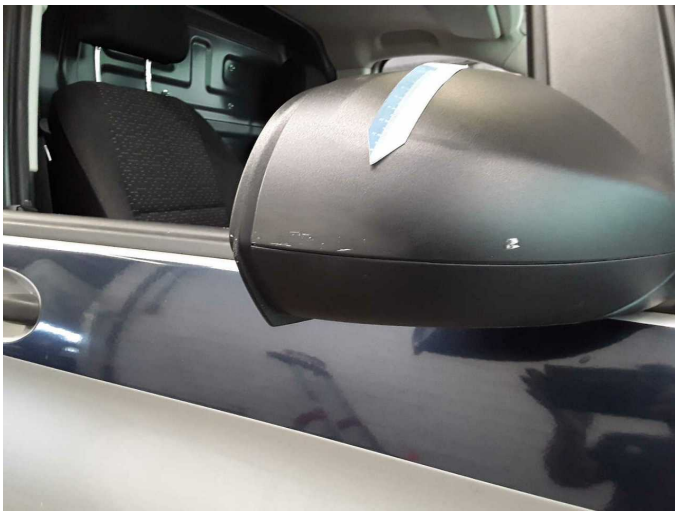
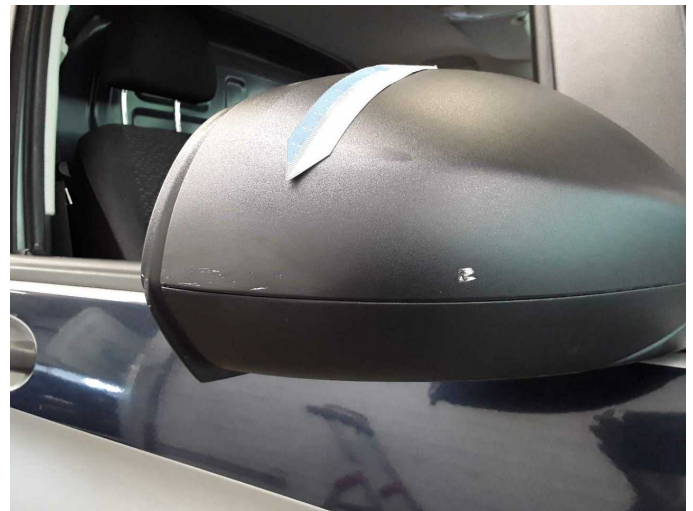
| No. | Component group | Description |
|---|---|---|
| 2 | Wing mirror - right side | Cap - Scratch(es) - Smart repair |

**Damage 2:** Wing mirror - right side: Cap - Scratch(es) - Smart repair

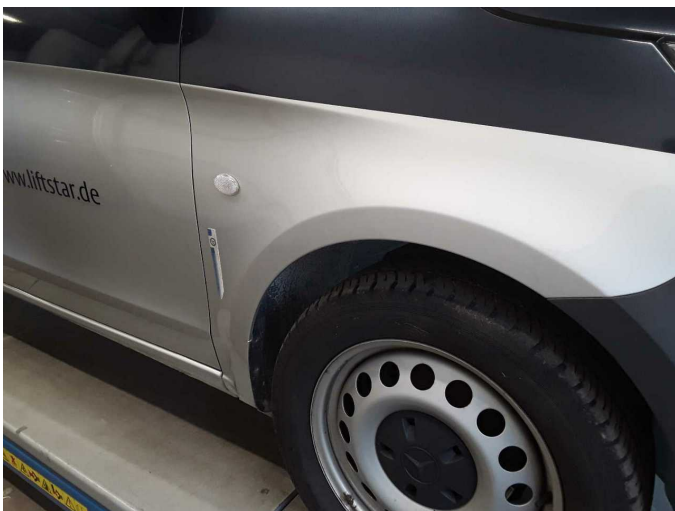
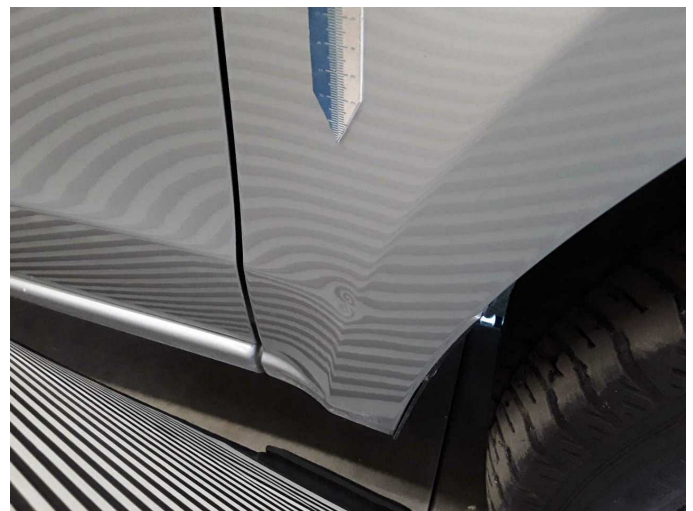
| No. | Component group | Description |
|---|---|---|
| 3 | Mudguard - right side | Mudguard - right side - dent(s) - Smooth repair work |

**Damage 3:** Mudguard - right side: Mudguard - right side - dent(s) - Smooth repair work

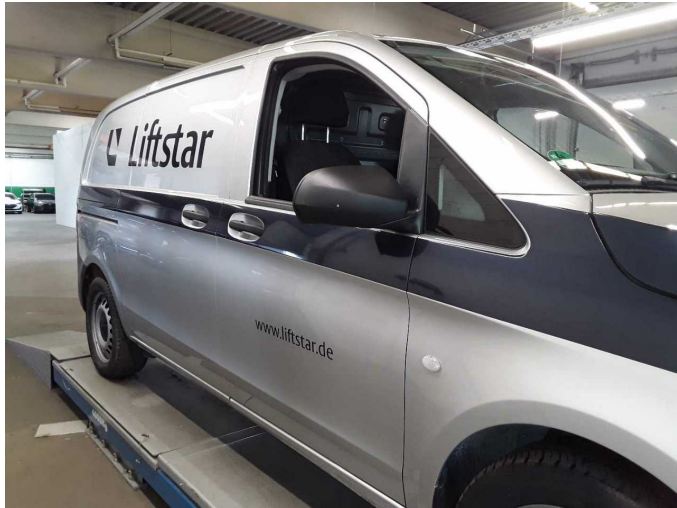
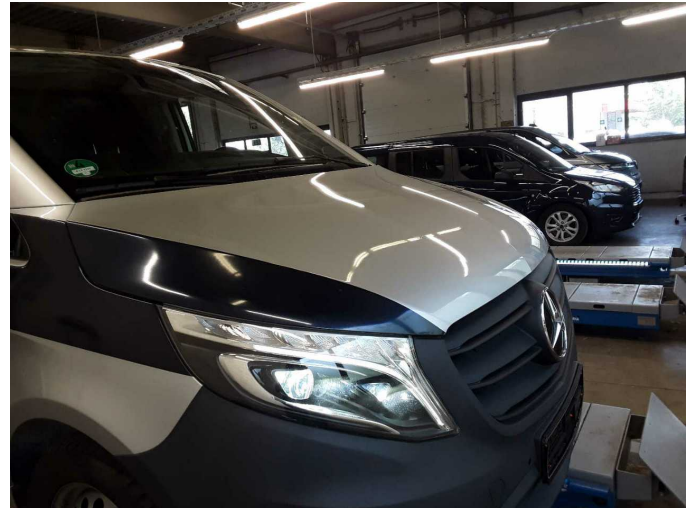
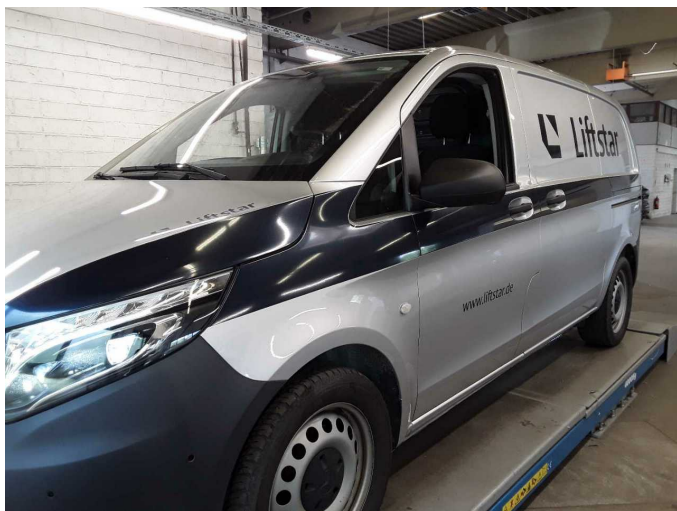
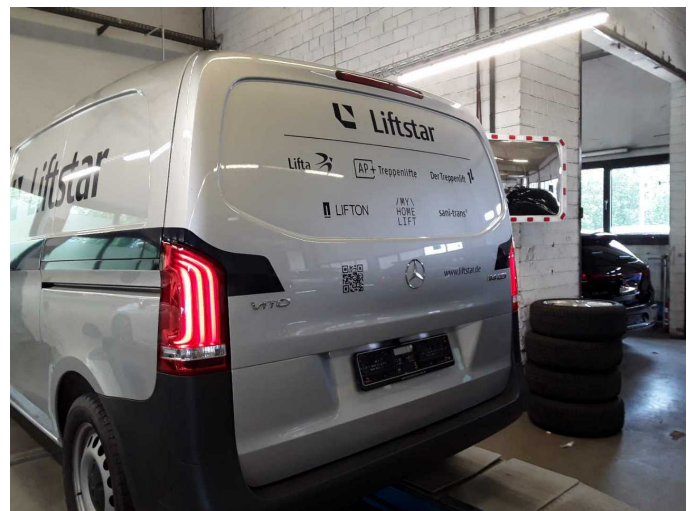
| No. | Component group | Description |
|---|---|---|
| 4 | Body | Body - Glued / labelled - No deduction |

**Damage 4:** Body: Body - Glued / labelled - No deduction

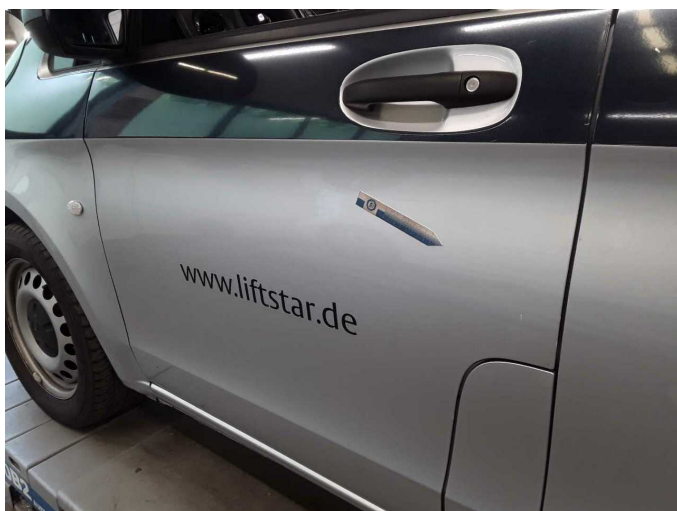
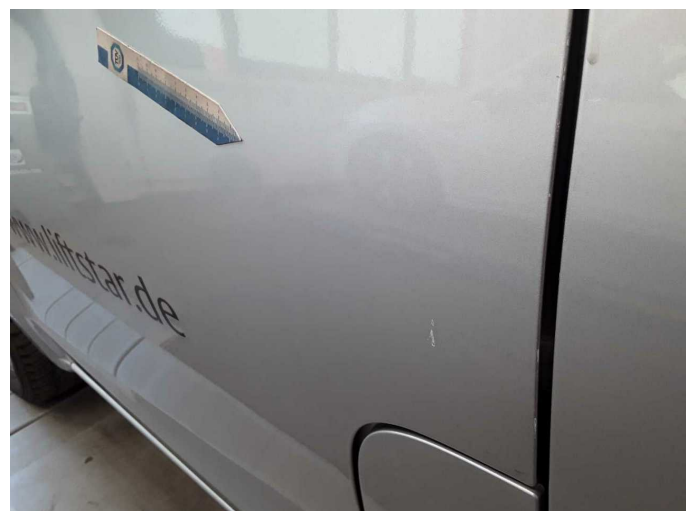
| No. | Component group | Description |
|---|---|---|
| 5 | Door - front left side | Door - Scratch(es) - Paint |

**Damage 5:** Door - front left side: Door - Scratch(es) - Paint

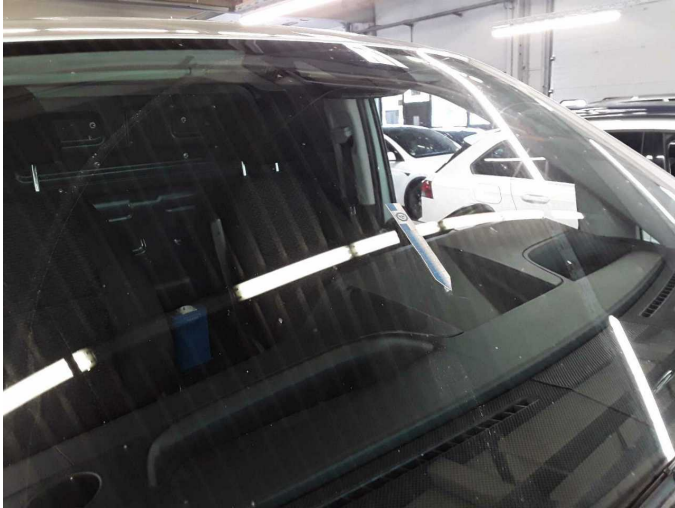
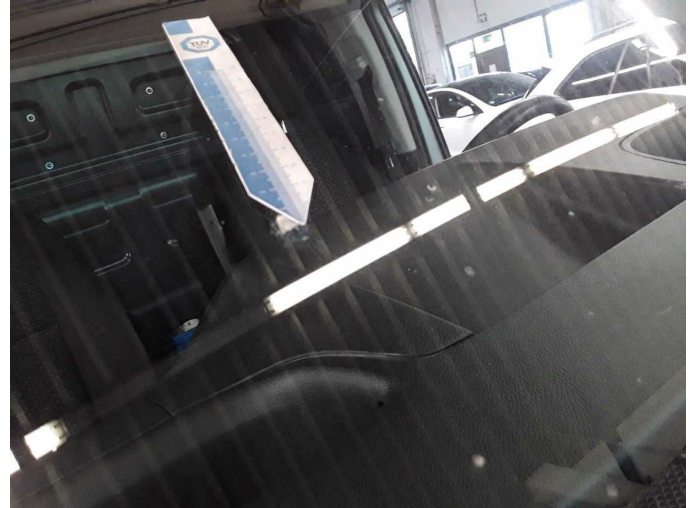
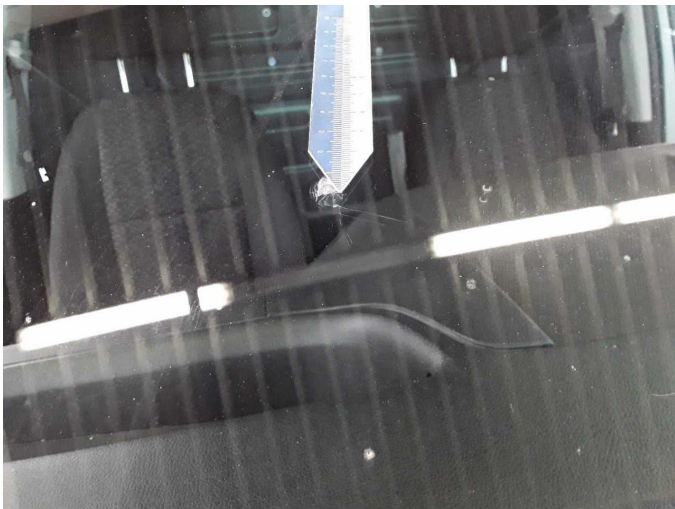
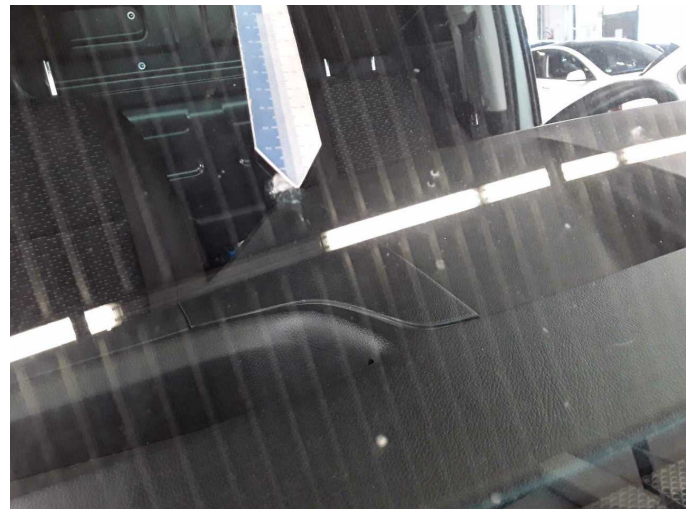
| No. | Component group | Description |
|---|---|---|
| 6 | Vehicle glazing | Windscreen (Rissbildung) - Stone chips - repair according to calculation |

**Damage 6:** Vehicle glazing: Windscreen (Rissbildung) - Stone chips - repair according to calculation
