Expertise

Protocol number: 46531055  
Order No. / Reference: 26606820  
Inspection date: 14 Jul 2026

Manufacturer: Opel

Model: Crossland 1.5 Diesel GS

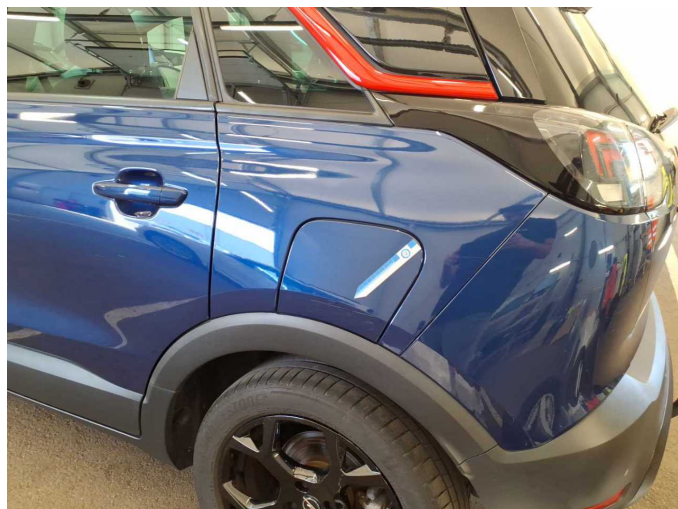
| No. | Component group | Description |
|---|---|---|
| 1 | Fuel system | Tank cap - Scratch(es) - Smart repair |

**Damage 1:** Fuel system: Tank cap - Scratch(es) - Smart repair

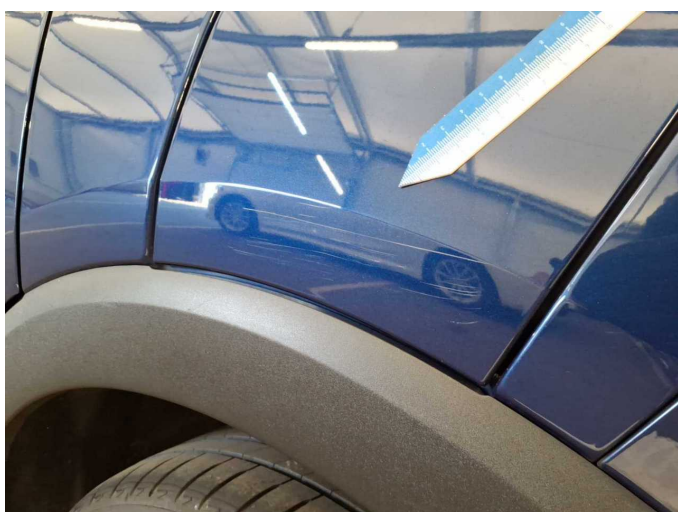
**Damage 1:** Fuel system: Tank cap - Scratch(es) - Smart repair

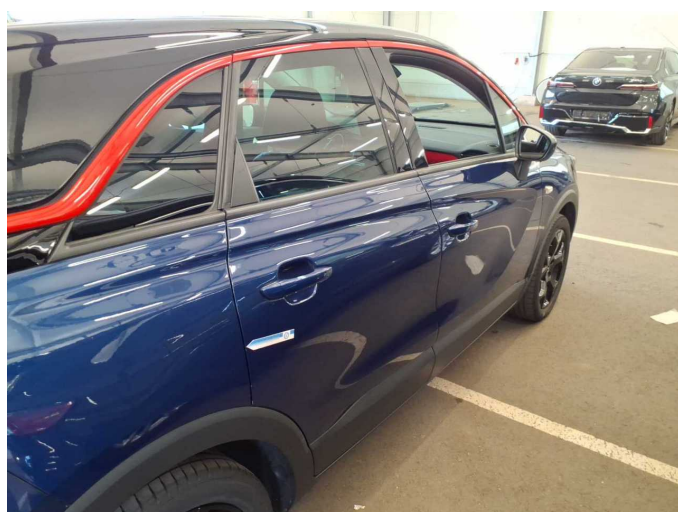
| No. | Component group | Description |
|---|---|---|
| 2 | Door - rear right side | Door edge - Scratch(es) - Smart repair |

**Damage 2:** Door - rear right side: Door edge - Scratch(es) - Smart repair

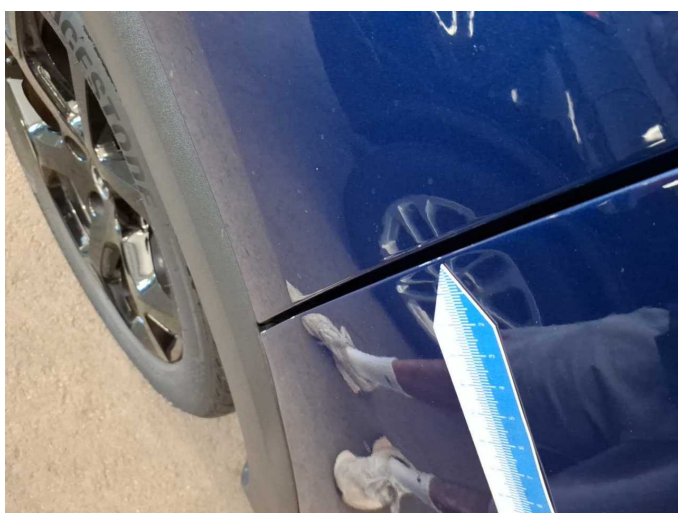
**Damage 2:** Door - rear right side: Door edge - Scratch(es) - Smart repair

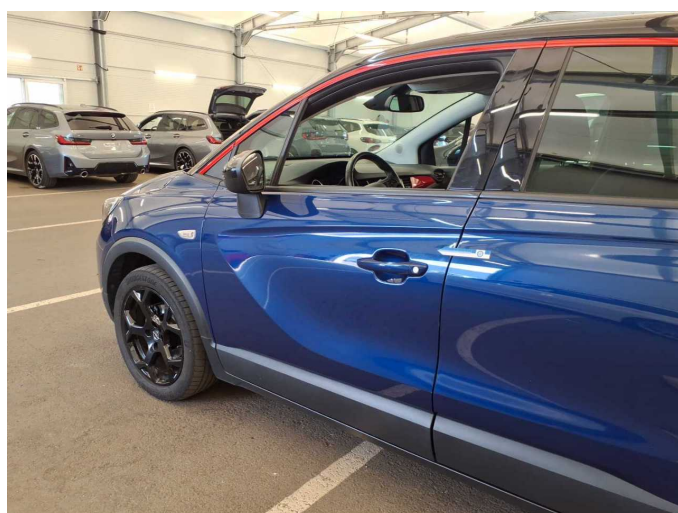
| No. | Component group | Description |
|---|---|---|
| 3 | Door - front left side | Door - Scratch(es) - Smart repair |

**Damage 3:** Door - front left side: Door - Scratch(es) - Smart repair

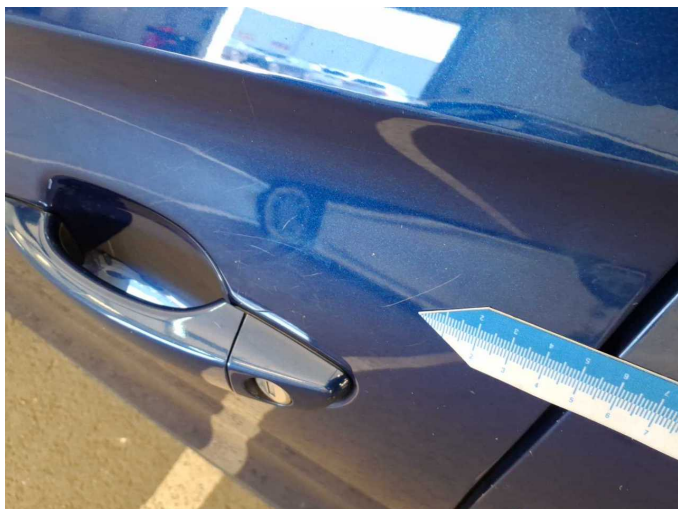
**Damage 3:** Door - front left side: Door - Scratch(es) - Smart repair

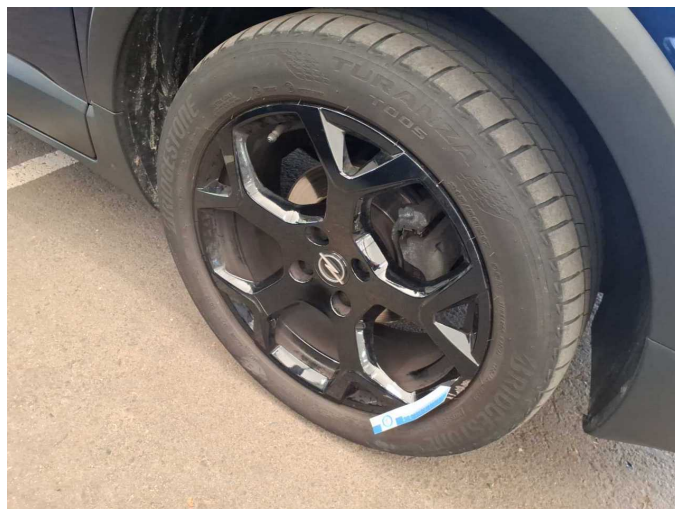
| No. | Component group | Description |
|---|---|---|
| 4 | Wheel / tyres | Alloy rim - front right side (Mit Materialabtrag) - Scratched - Replace |

**Damage 4:** Wheel / tyres: Alloy rim - front right side (Mit Materialabtrag) - Scratched - Replace

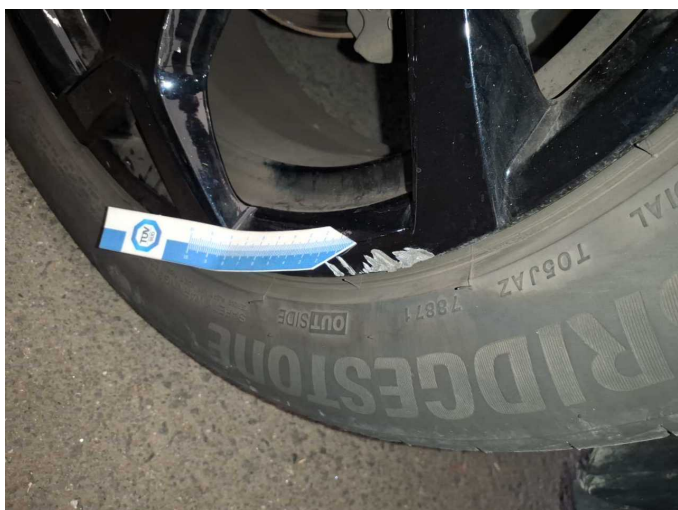
**Damage 4:** Wheel / tyres: Alloy rim - front right side (Mit Materialabtrag) - Scratched - Replace

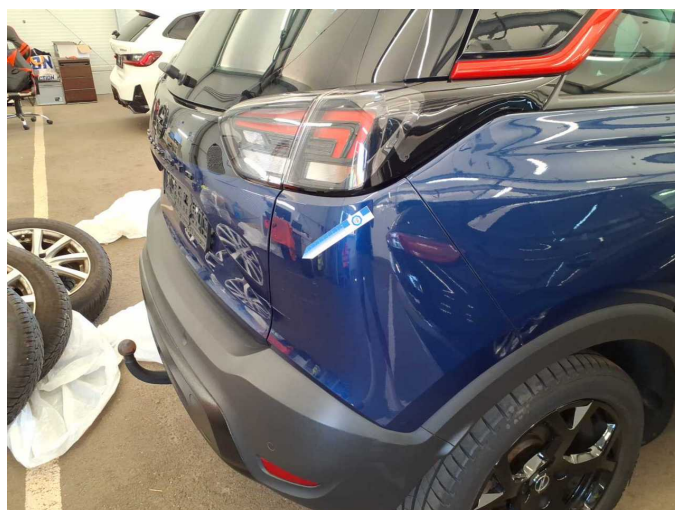
| No. | Component group | Description |
|---|---|---|
| 5 | Rear bumper | Bumper - rear right side - Scratched - Paint |

**Damage 5:** Rear bumper: Bumper - rear right side - Scratched - Paint

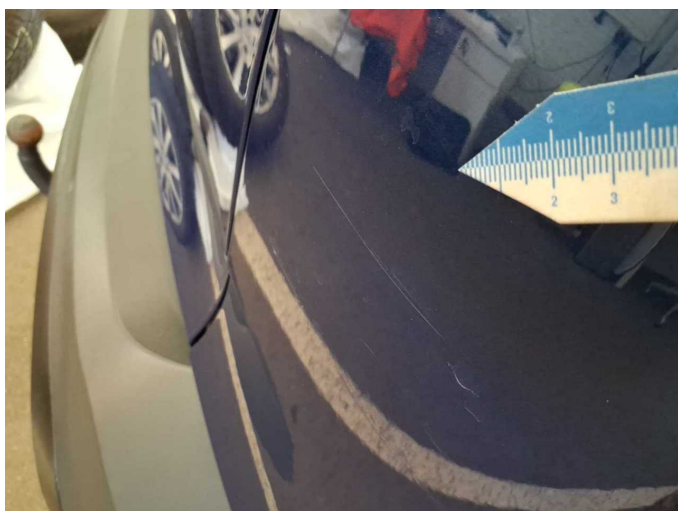
**Damage 5:** Rear bumper: Bumper - rear right side - Scratched - Paint

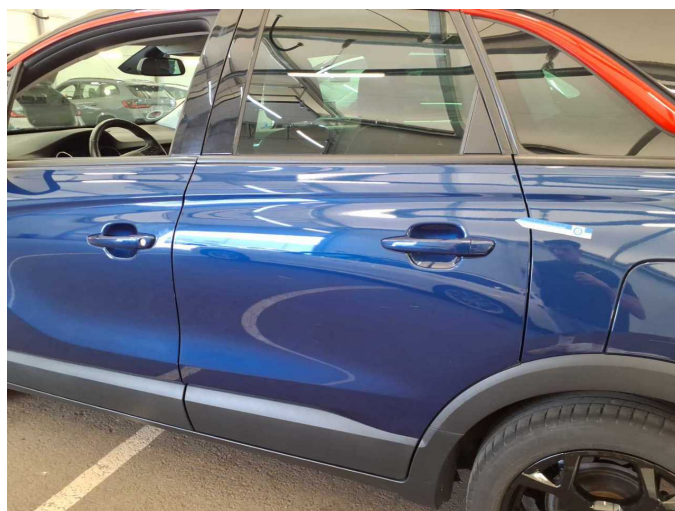
| No. | Component group | Description |
|---|---|---|
| 6 | Door - rear left side | Door - Scratch(es) - Paint |

**Damage 6:** Door - rear left side: Door - Scratch(es) - Paint

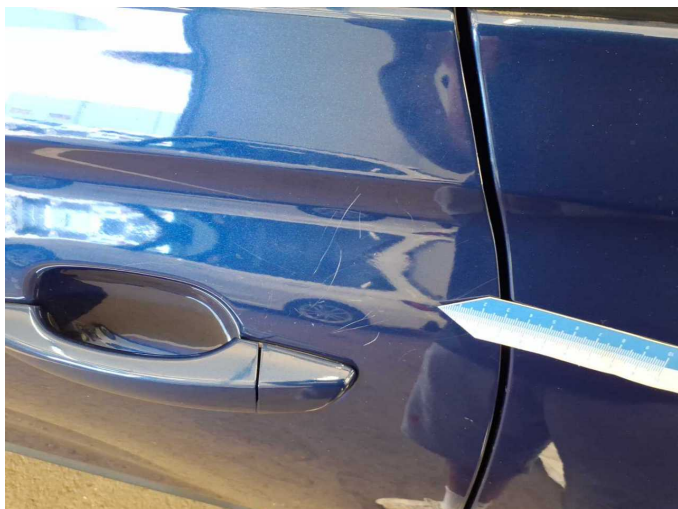
**Damage 6:** Door - rear left side: Door - Scratch(es) - Paint

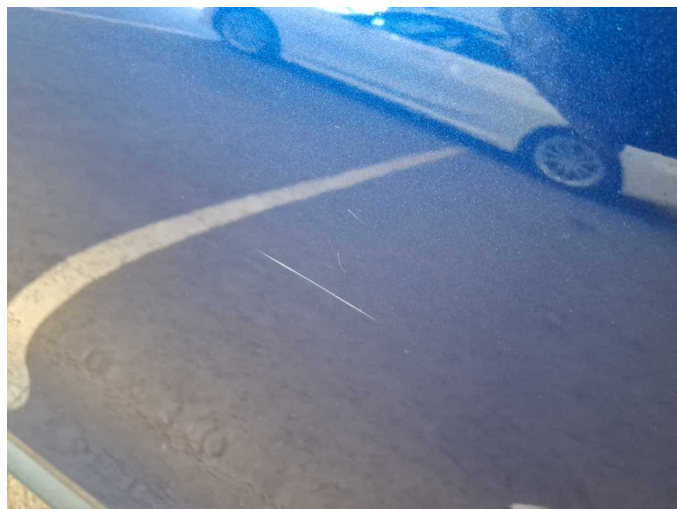
**Damage 6:** Door - rear left side: Door - Scratch(es) - Paint

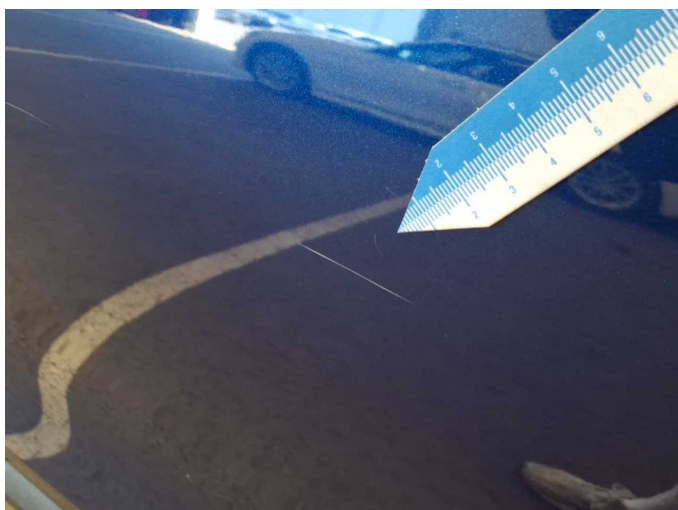
**Damage 6:** Door - rear left side: Door - Scratch(es) - Paint

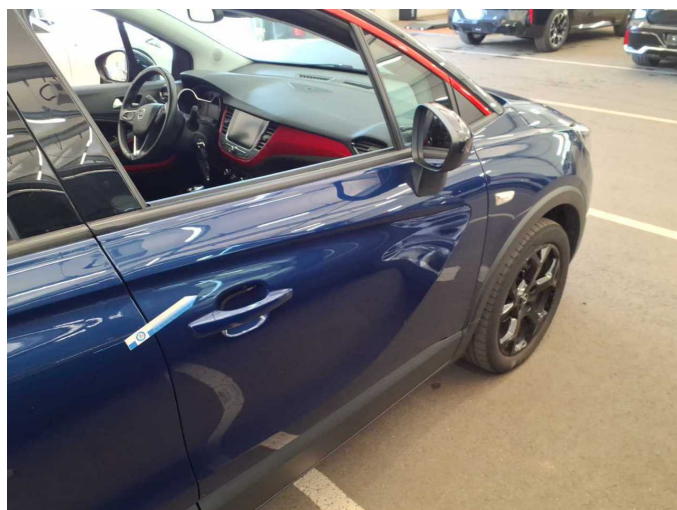
| No. | Component group | Description |
|---|---|---|
| 7 | Door - front right side | Door - Scratched - Repair and paint |

**Damage 7:** Door - front right side: Door - Scratched - Repair and paint

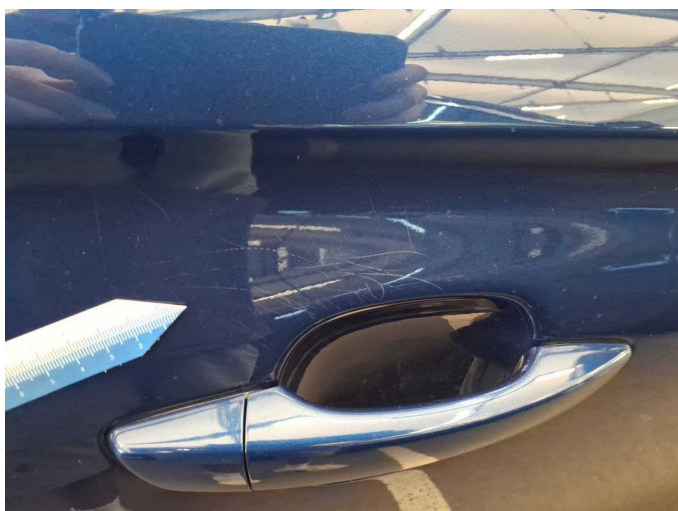
**Damage 7:** Door - front right side: Door - Scratched - Repair and paint

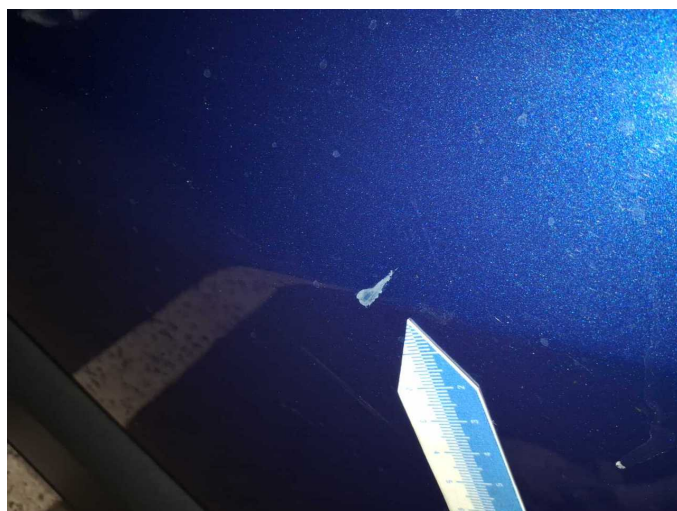
**Damage 7:** Door - front right side: Door - Scratched - Repair and paint

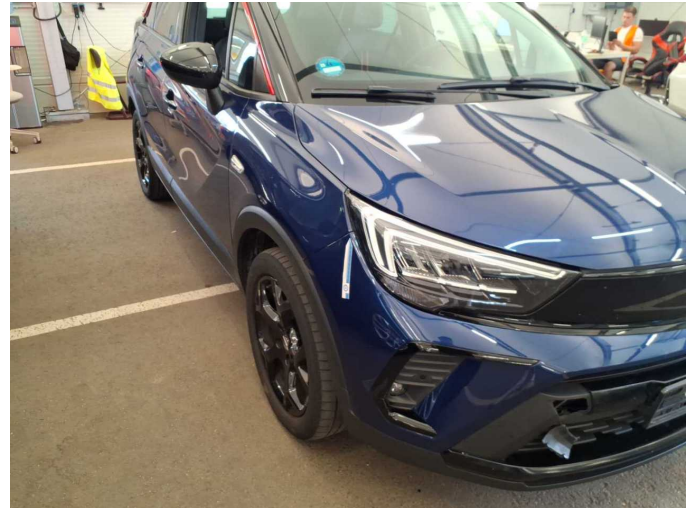
1 Front

**Accident 1:** Front

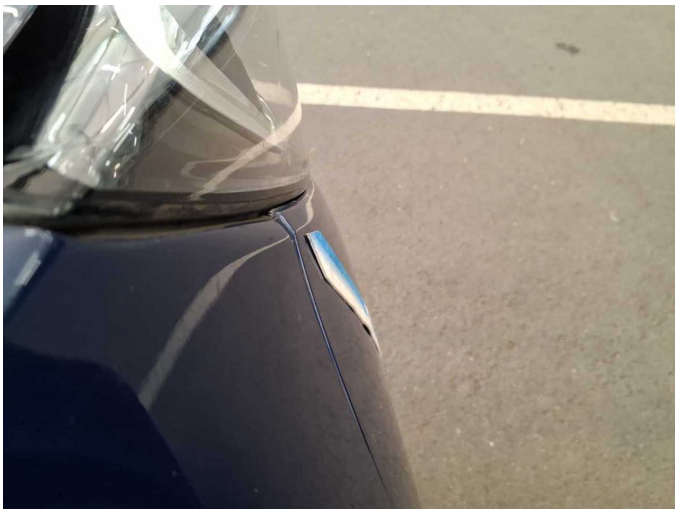
**Accident 1:** Front

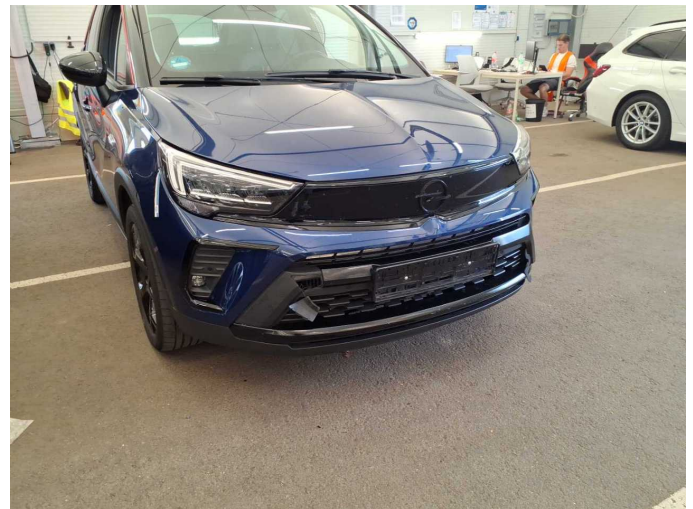
**Accident 1:** Front

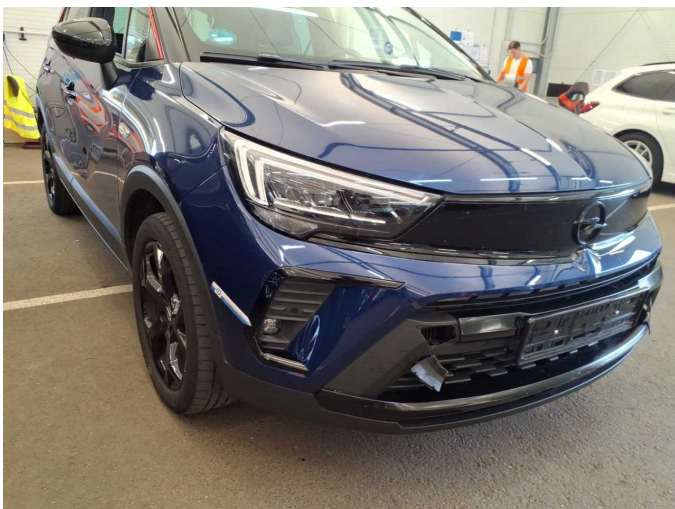
**Accident 1:** Front

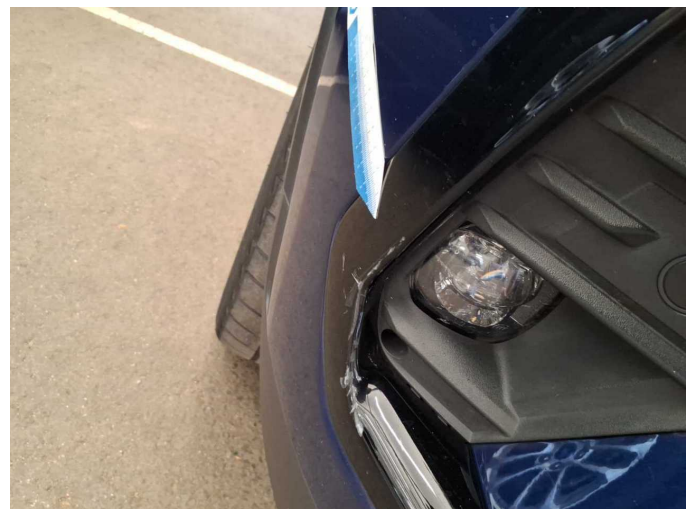
**Accident 1:** Front

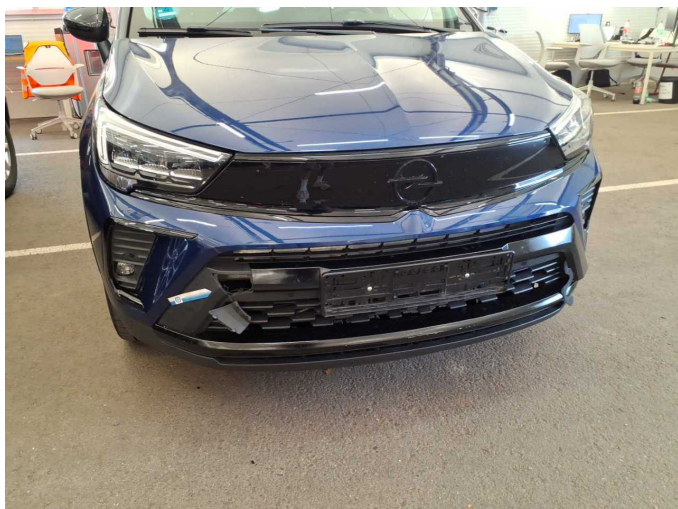
**Accident 1: Front**

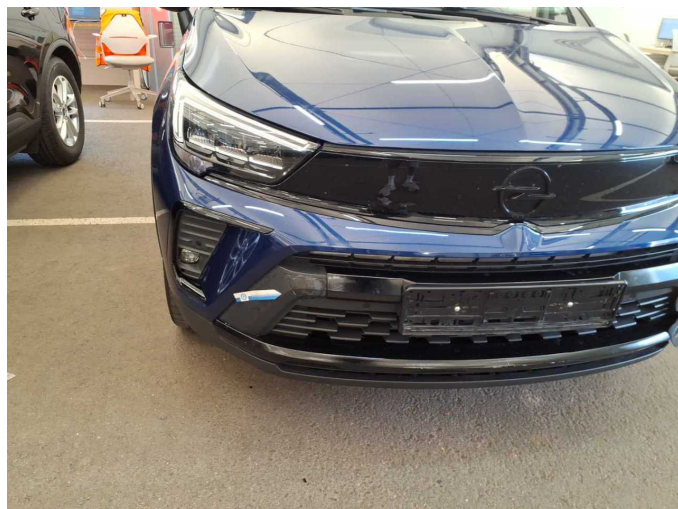
**Accident 1: Front**

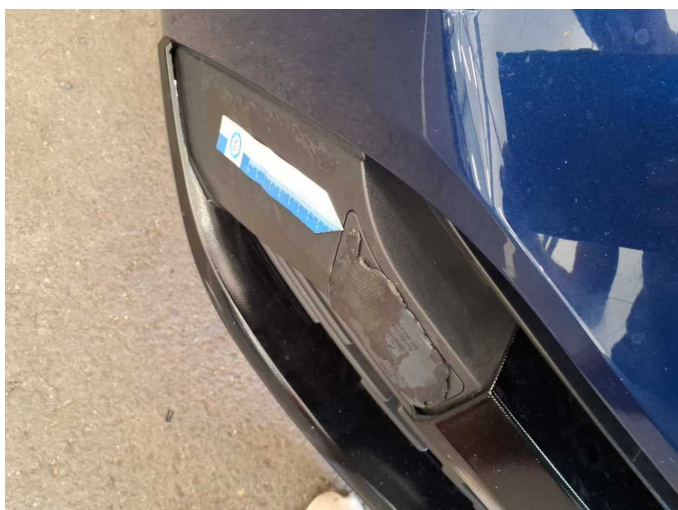
**Accident 1: Front**

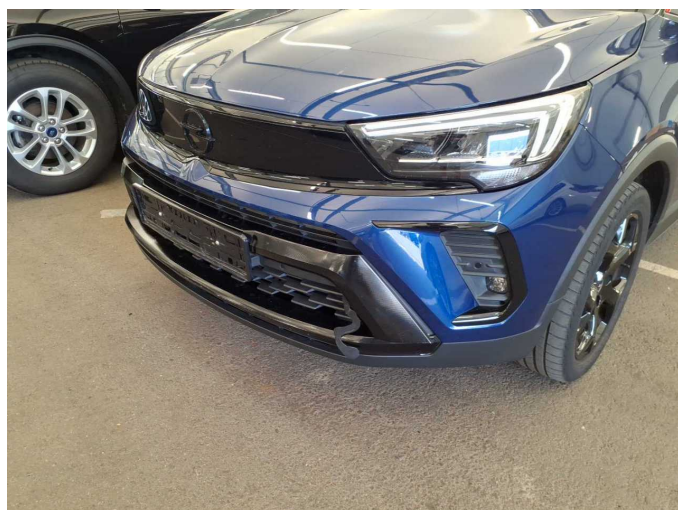
**Accident 1: Front**

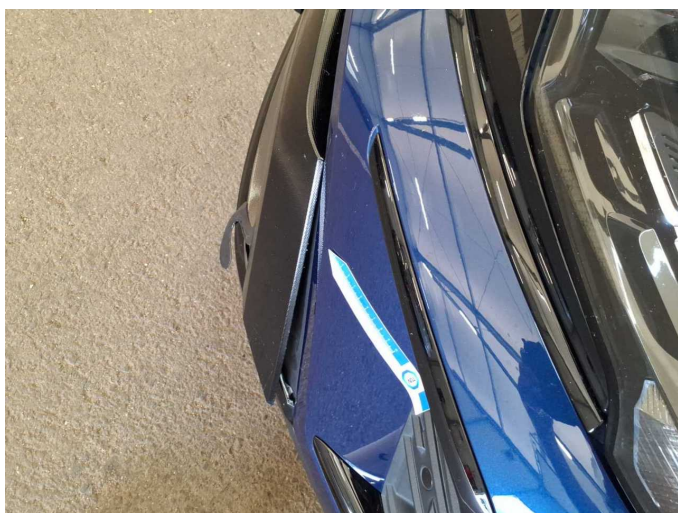
**Accident 1: Front**

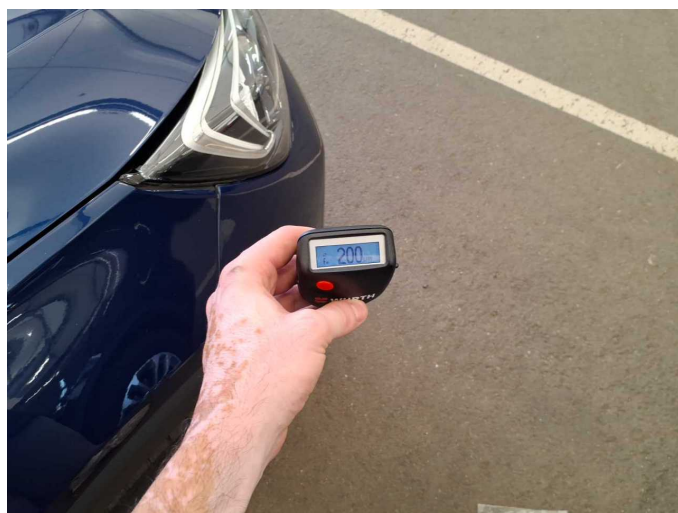
- Mudguard - right side, Professionally carried out, Invoice of repair done Non-existent
- Side panel - rear right side, Professionally carried out, Invoice of repair done Non-existent
- Door - rear right side, Professionally carried out, Invoice of repair done Non-existent
- Door - front right side, Professionally carried out, Invoice of repair done Non-existent

| Mudguard - right side | 200 µm | Side panel - rear right side | 173 µm |

**Repainting 1: Mudguard - right side**

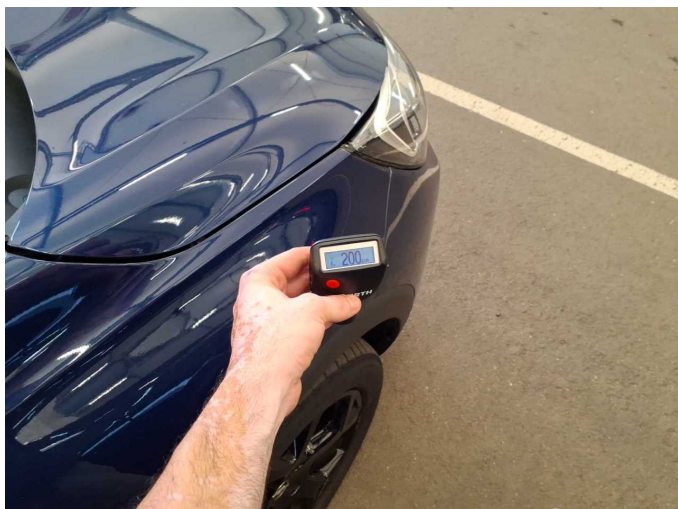
**Repainting 1:** Mudguard - right side

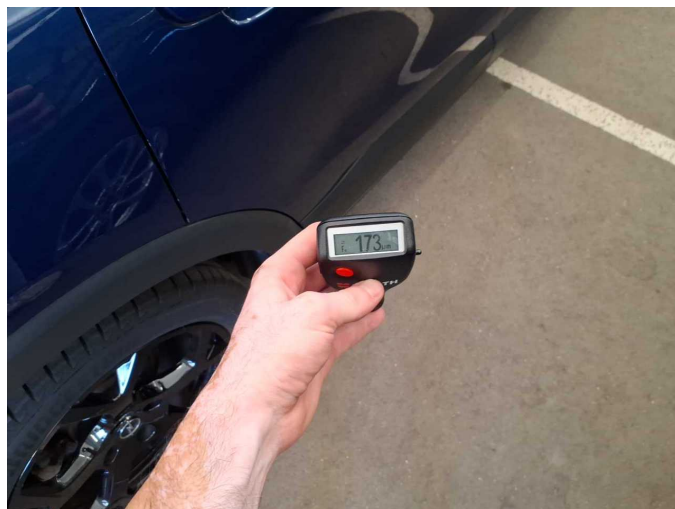
**Repainting 2:** Side panel - rear right side

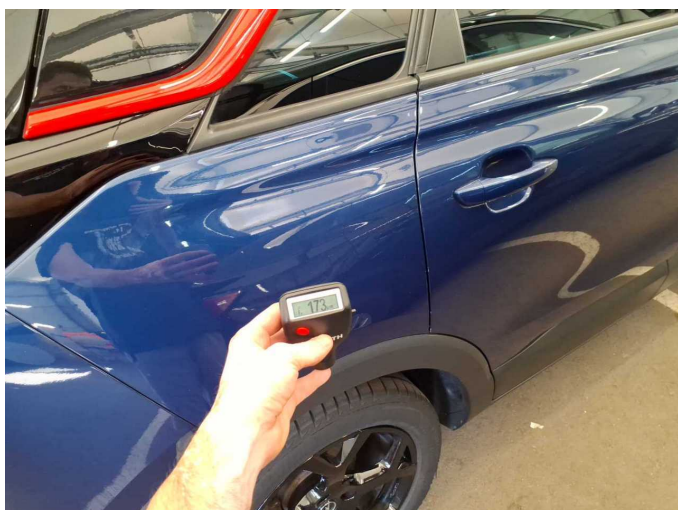
**Repainting 2:** Side panel - rear right side

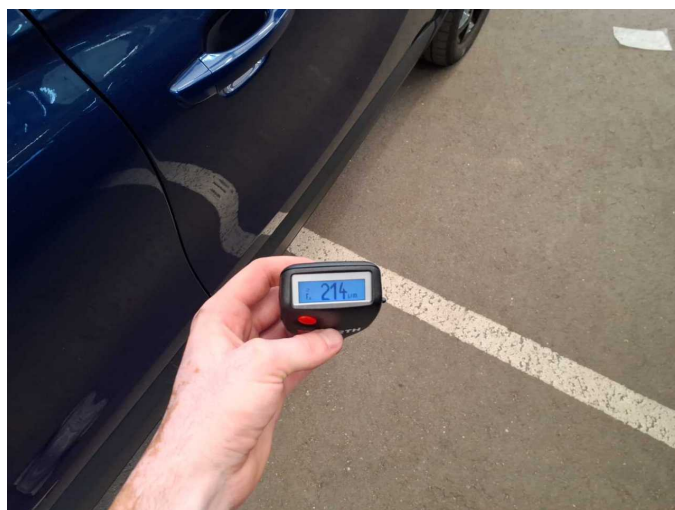
| Door - rear right side | 214 µm | Door - front right side | 193 µm |

**Repainting 3:** Door - rear right side

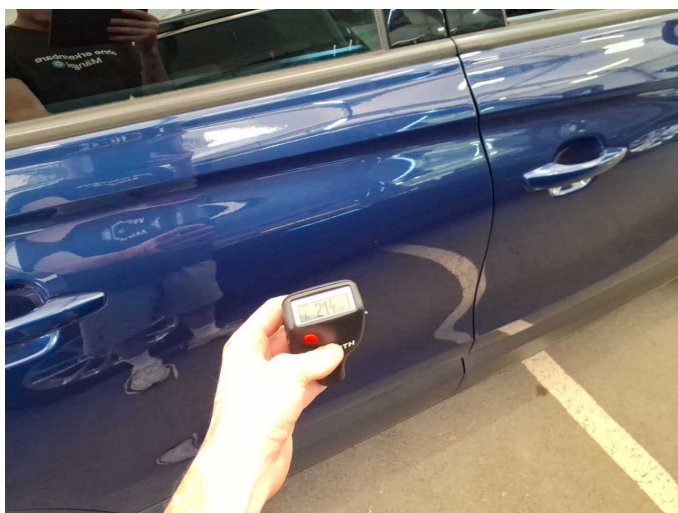
**Repainting 3:** Door - rear right side

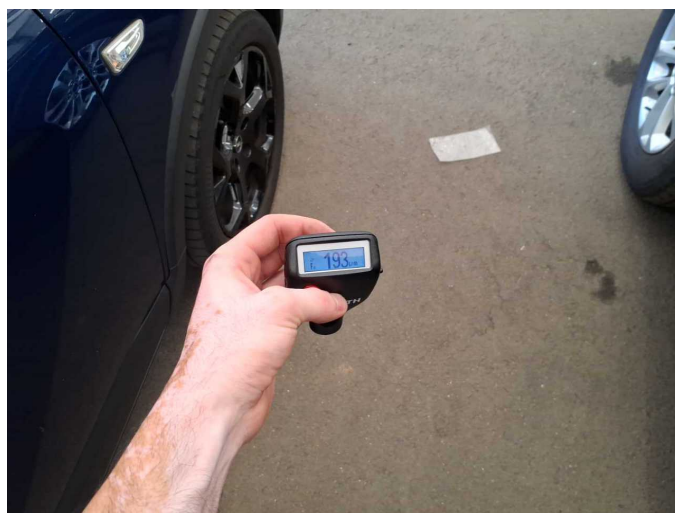
**Repainting 4:** Door - front right side

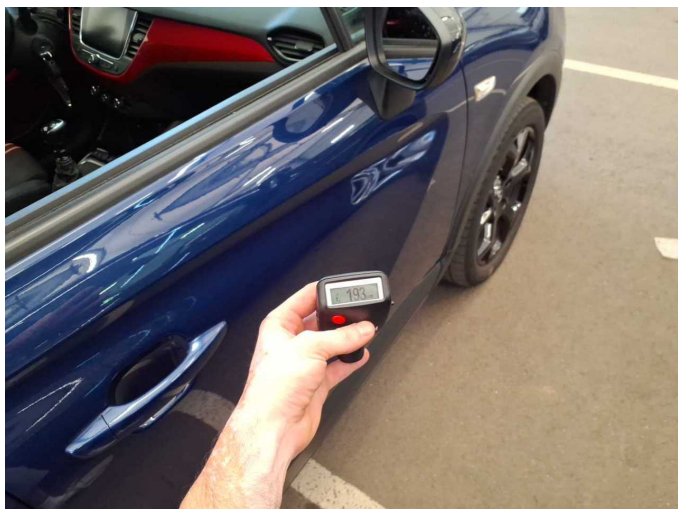
**Repainting 4:** Door - front right side
