## Expertise

Protocol number: 45860139  
Order No. / Reference: 26307658  
Inspection date: 9 Jun 2026

Manufacturer: Opel

Model: Astra Sports Tourer 1.2 Turbo Automatik GS

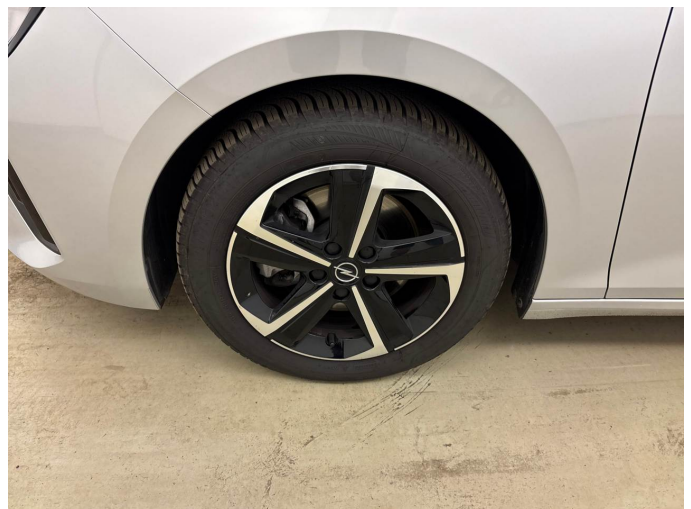
Figure 12: Mounted tyres

Mounted tyres				
#	Tyre size	Type of tyre	Manufacturer	Tread depth
1)	205/55 R16 94V	All-season tyres on Light alloy	Goodyear	7mm / 7mm
2)	205/55 R16 94V	All-season tyres on Light alloy	Goodyear	7mm / 7mm
Replacement				
Typ	Tyre size	Type of tyre	Manufacturer	Tread depth
	Tirefit	Expiration date 08/2029

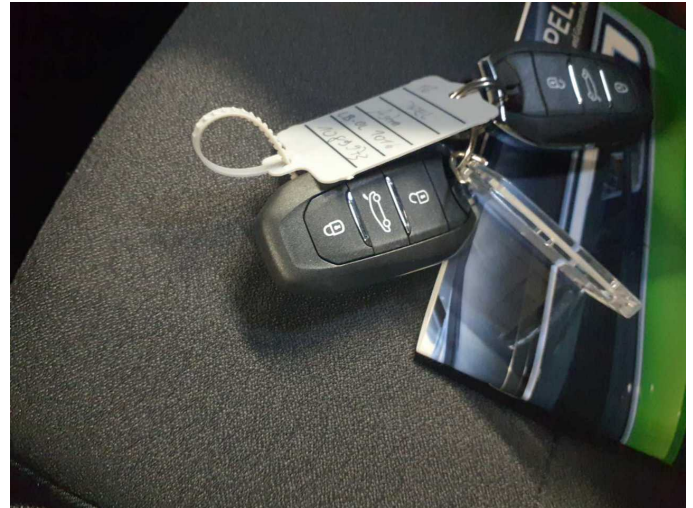
No.	Component group	Description
1	Equipment	Vehicle key (Batterie) - Non-operational - Replace

Damage 1: Equipment: Vehicle key (Batterie) - Non-operational - Replace
