## Expertise

Protocol number: 45793122  
Order No. / Reference: 26153222  
Inspection date: 2 Jun 2026

Model: 319 CDI Sprinter 4x4 Standard 9G-TRONIC PRO

VIN: W1V3MBTZ7TP849554

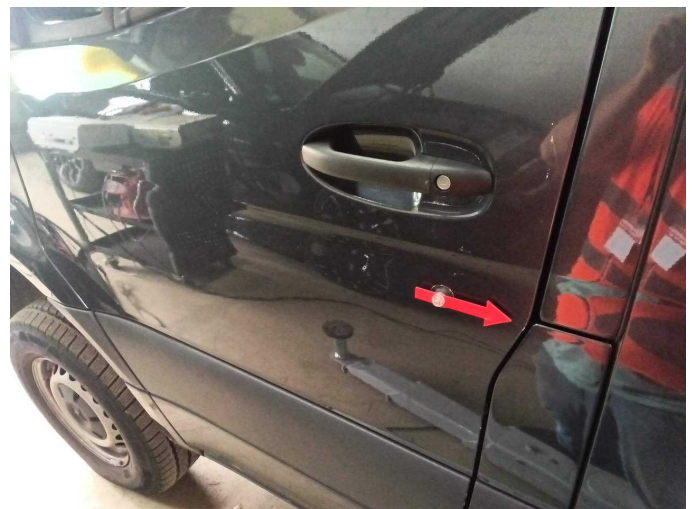
Damage 1: Door - front left side: Door edge - Scratch(es) - Smart repair

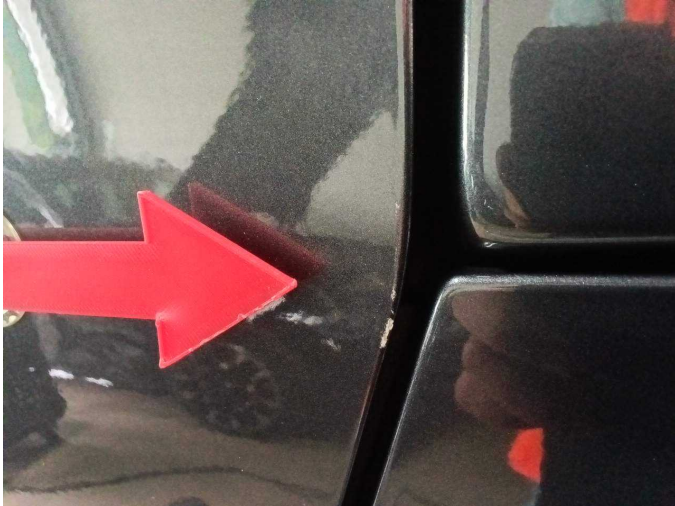
**Damage 1:** Door - front left side: Door edge - Scratch(es) - Smart repair

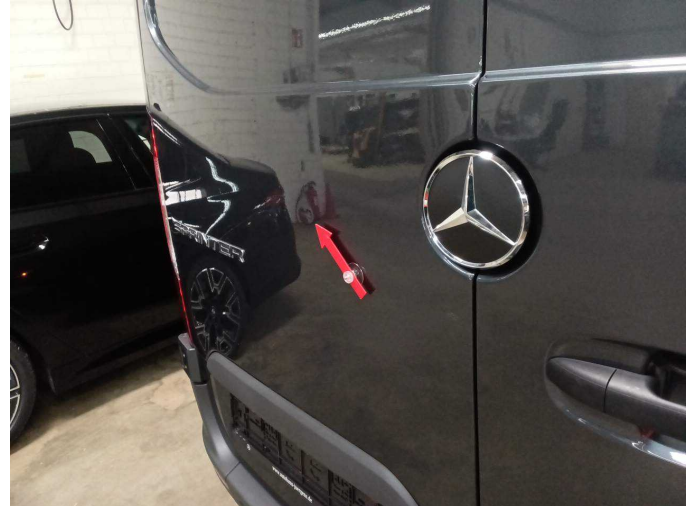
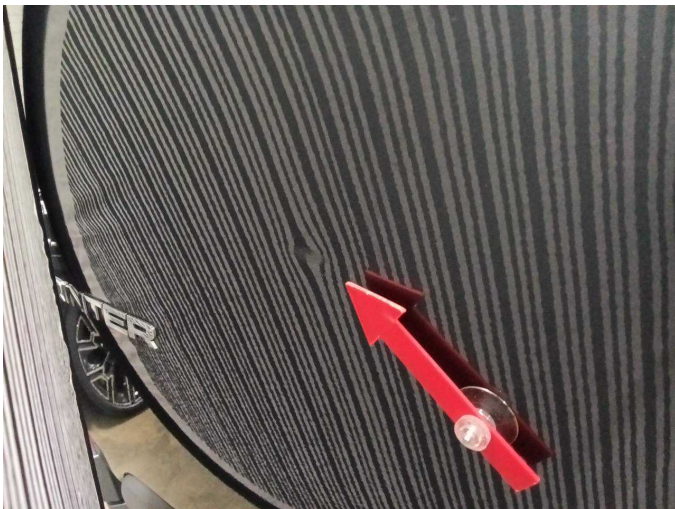
**Damage 2:** Boot lid / rear door: Rear door - left side - dent(s) - Smart repair

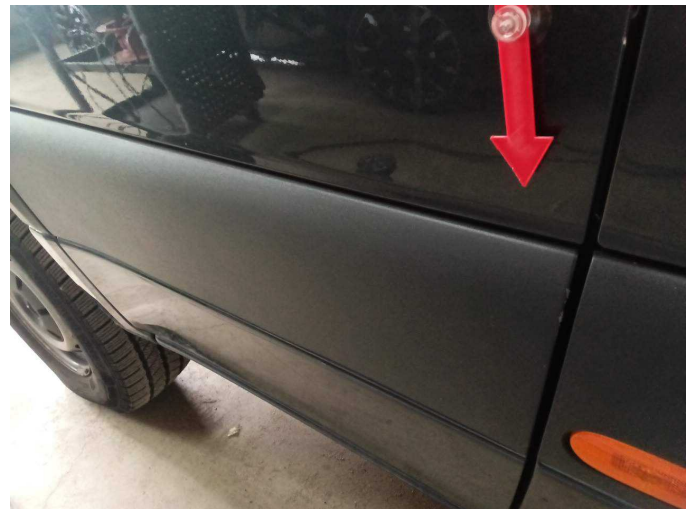
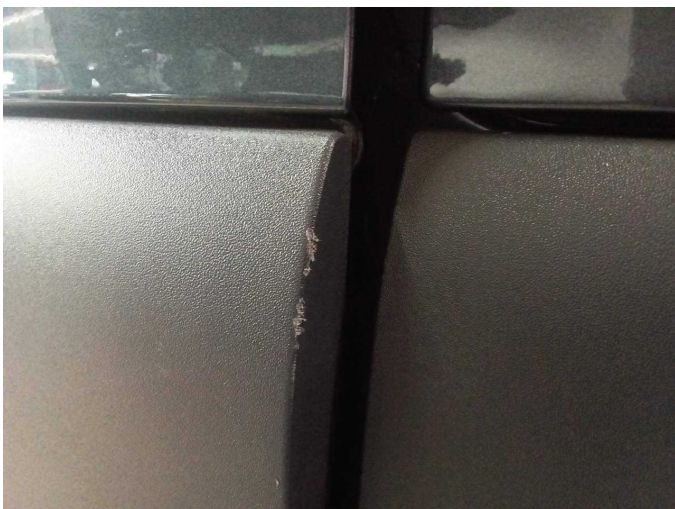
**Damage 3:** Door - front left side: Brightware - lower - Scratched - Replace

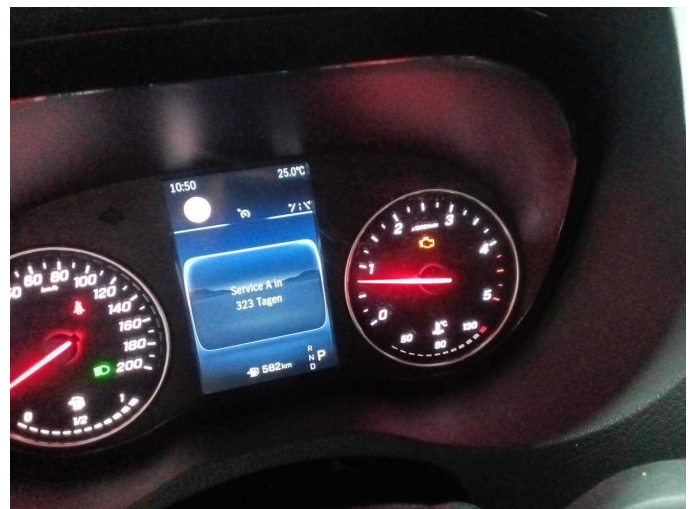
Documents submitted	At the time of the inspection, the vehicle registration certificate Part 2 (title) was available, but the vehicle registration certificate Part 1 (document) was not. (Copy)
VIN comparison	The vehicle identification number (VIN) was read from the vehicle and its conformity with the submitted documents was confirmed by the undersigned during the inspection.
Inspection	The inspection conditions were sufficient for the assessment of the vehicle. Lifting equipment and/or a pit were available for examining the vehicle.
Test drive	No test drive/shunting maneuver was carried out during the inspection of the vehicle.
Engine function test	An engine test run was performed, problem has been detected This is due to the following reason.: Motorkontrolle aktiv

**Damage 4:** Instrument panel: Indicator light (Motorkontrolle) - on - Perform diagnosis

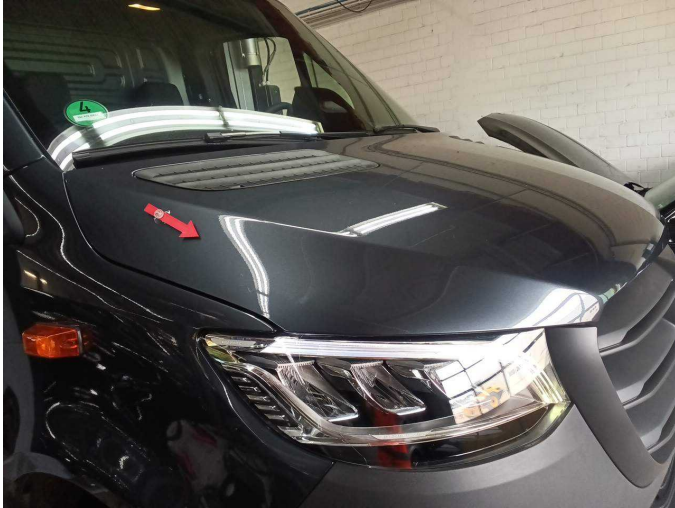
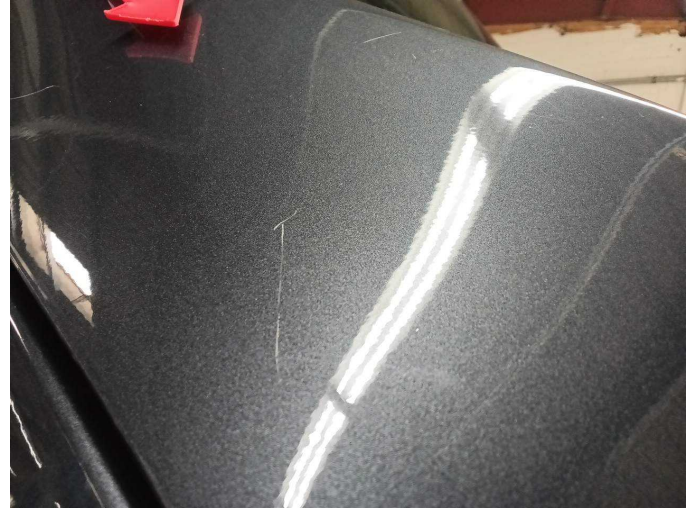
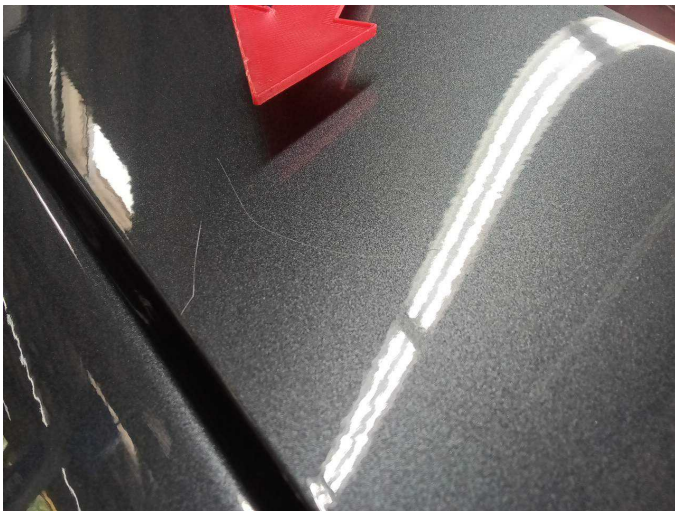
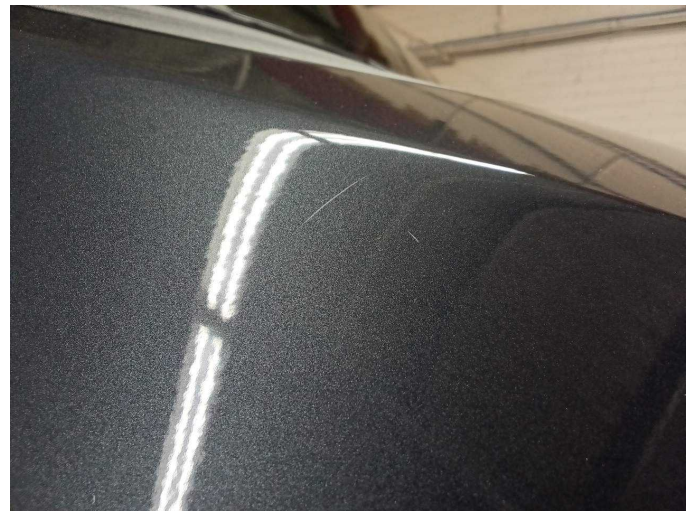
**Damage 5:** Bonnet: Bonnet - Scratch(es) - Paint

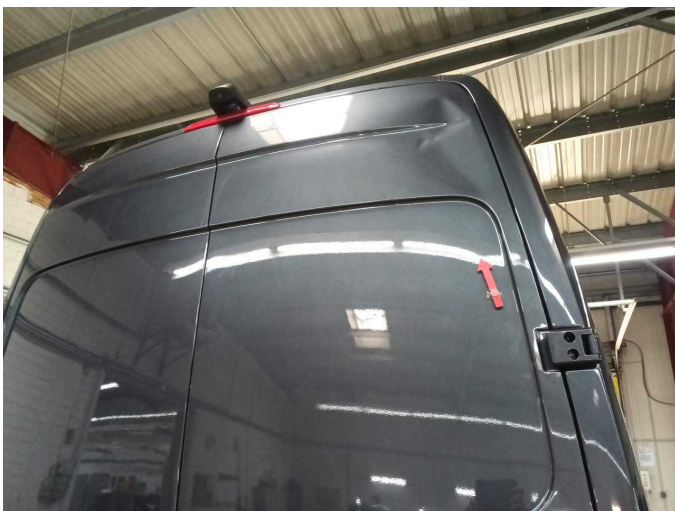
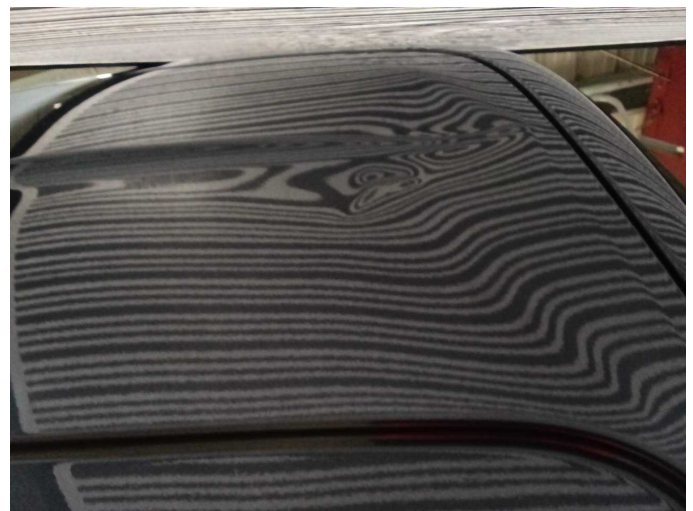
**Damage 6:** Boot lid / rear door: Rear door - right side - Dent / paintcoat damage - Repair and paint

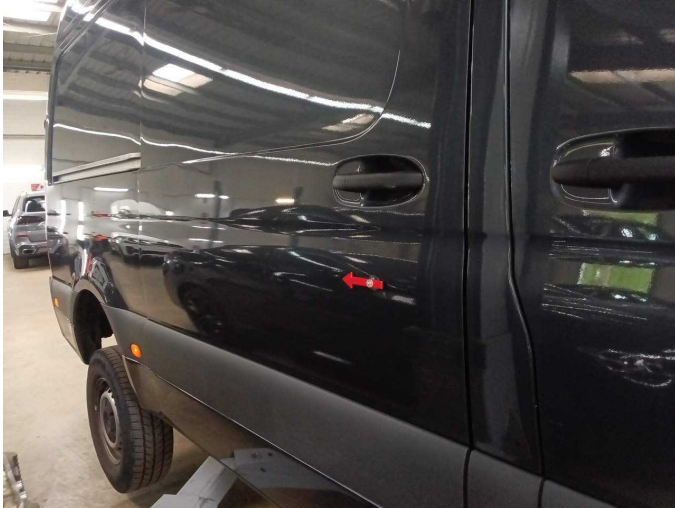
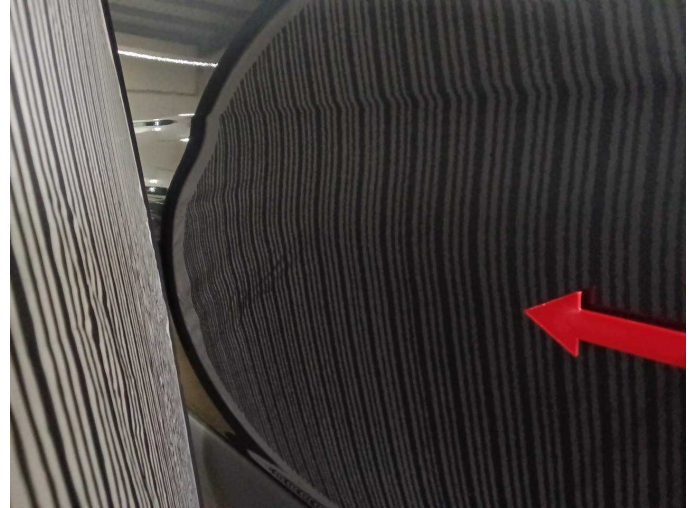
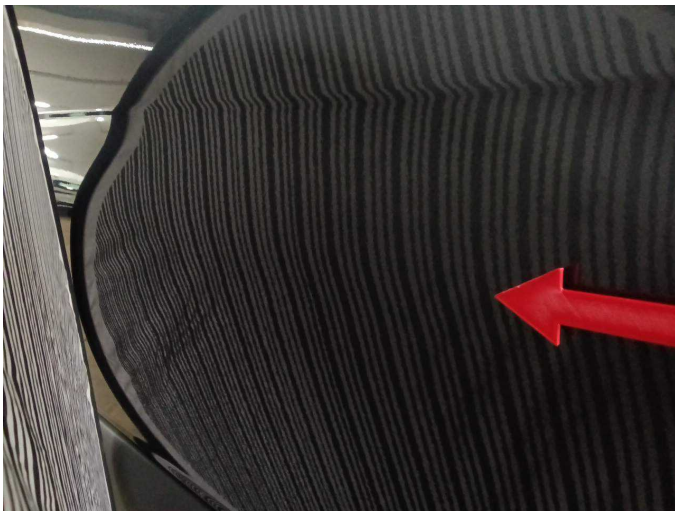
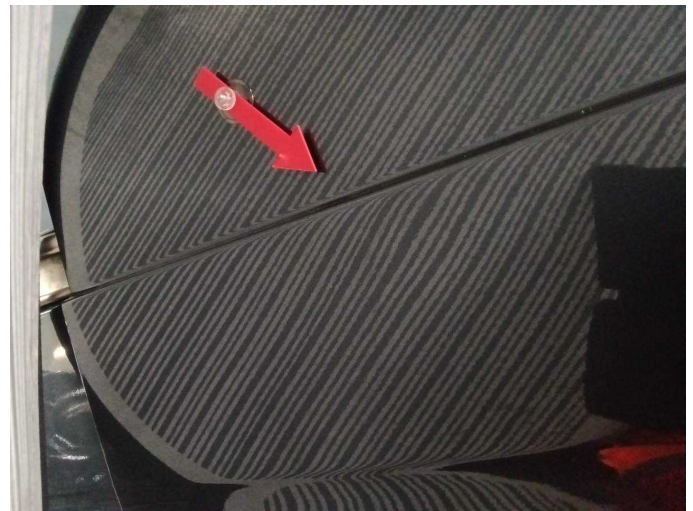
**Wear and tear 8:** Sliding door, right: Sliding door - dent(s) - No deduction

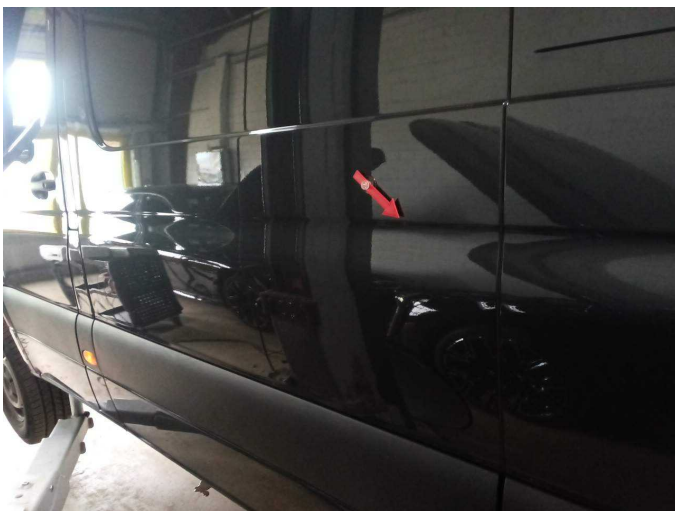
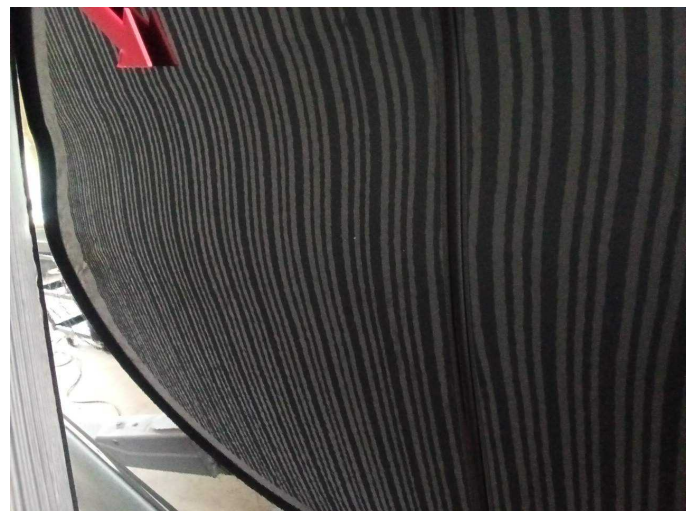
**Wear and tear 9:** Side panel - rear left side: Side panel - dent(s) - No deduction

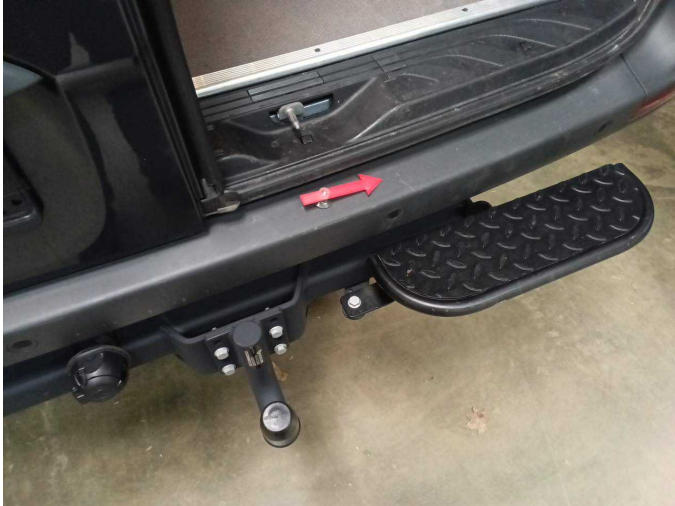
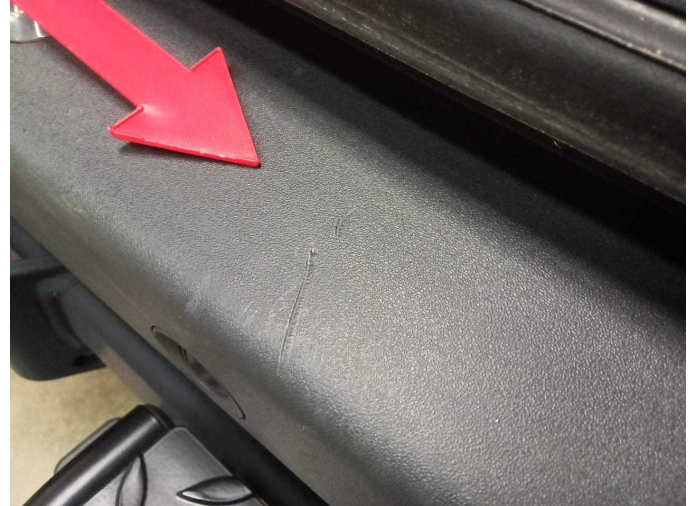
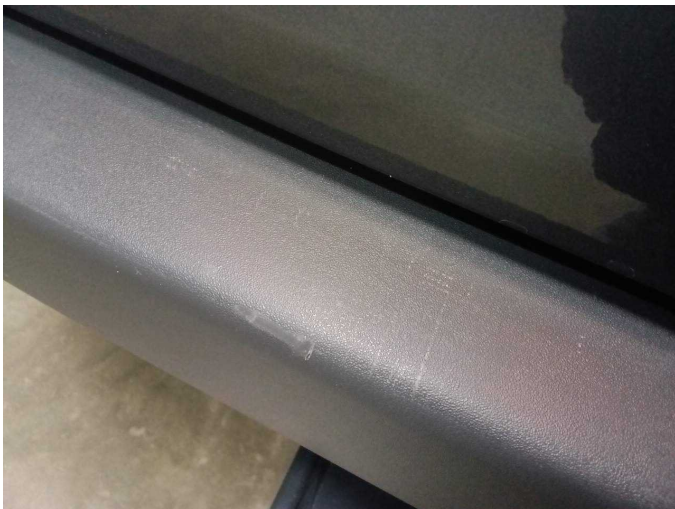
**Wear and tear 10:** Rear bumper: Rear bumper (Verlade- / Einstiegsbereich) - Scratched - No deduction
