## Expertise

Protocol number: 45791234  
Order No. / Reference: 26442348  
Inspection date: 3 Jun 2026

Model: Octavia Combi 2.0 TDI Tour

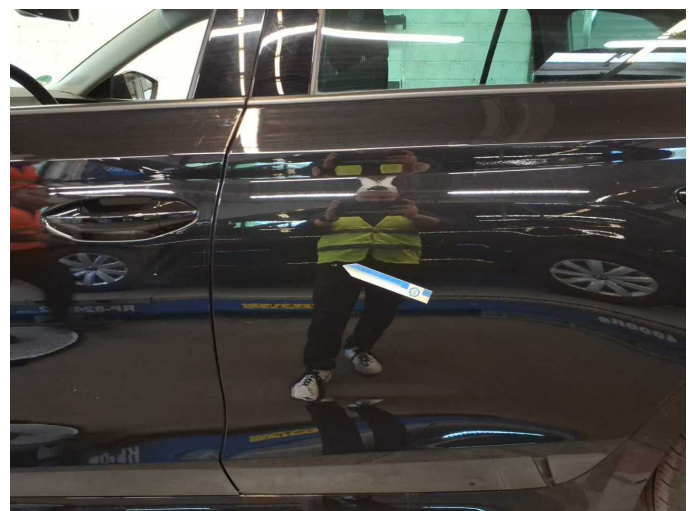
Damage 2: Door - rear left side: Door - Scratch(es) - Smart repair

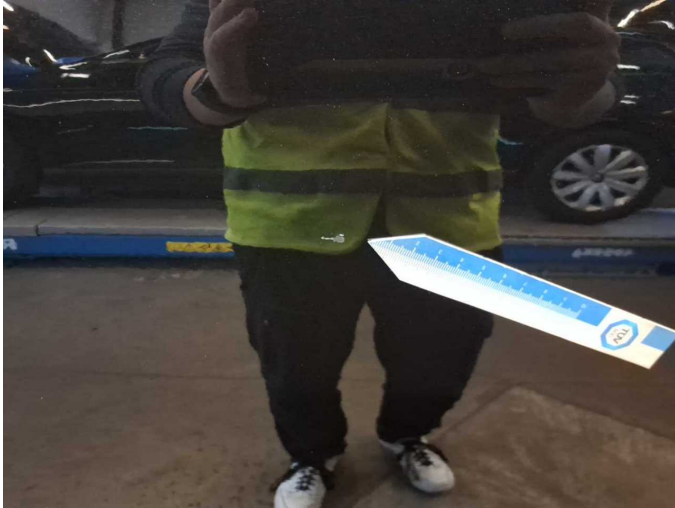
**Damage 2:** Door - rear left side: Door - Scratch(es) - Smart repair

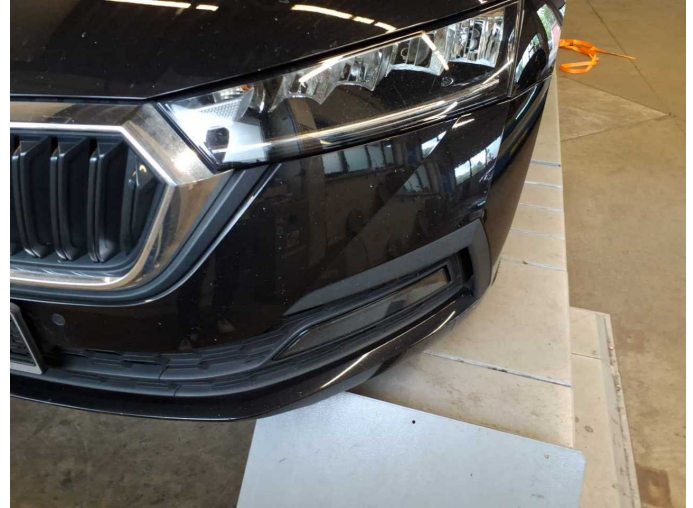
**Damage 3:** Front bumper: Front bumper - Stone chips - Paint

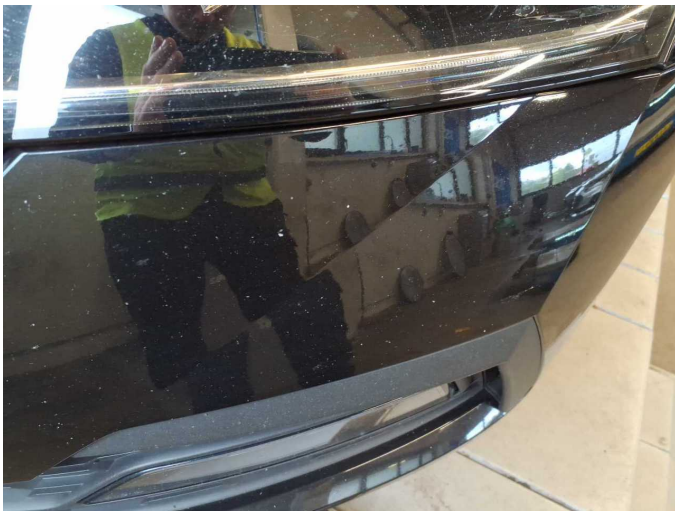
**Damage 3:** Front bumper: Front bumper - Stone chips - Paint

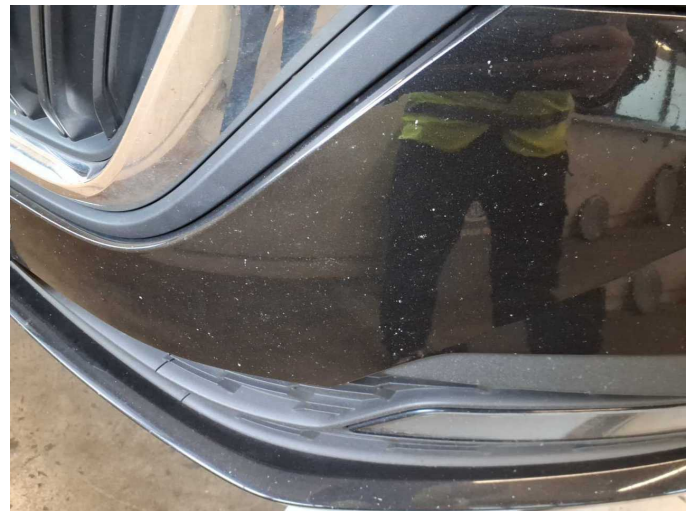
**Damage 3:** Front bumper: Front bumper - Stone chips - Paint

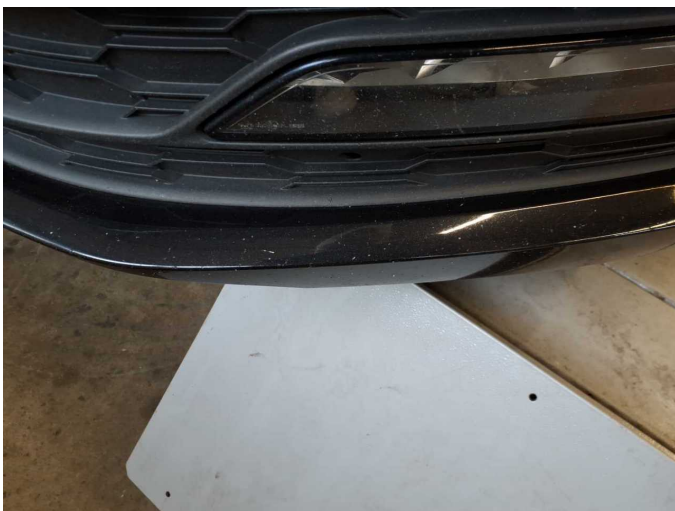
**Damage 3:** Front bumper: Front bumper - Stone chips - Paint

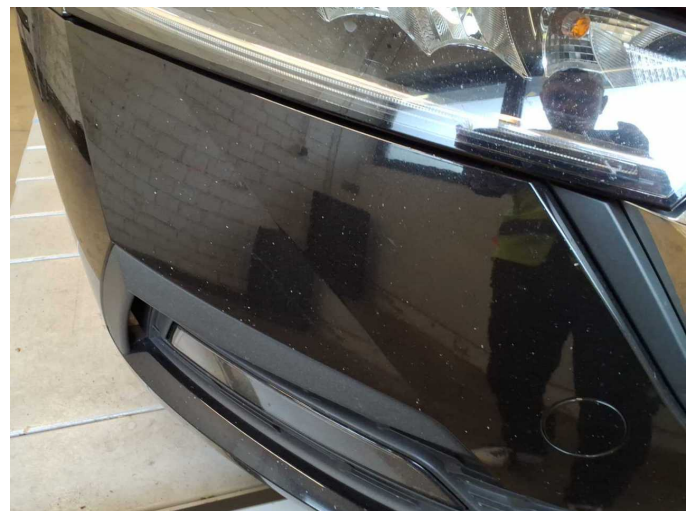
**Damage 3:** Front bumper: Front bumper - Stone chips - Paint

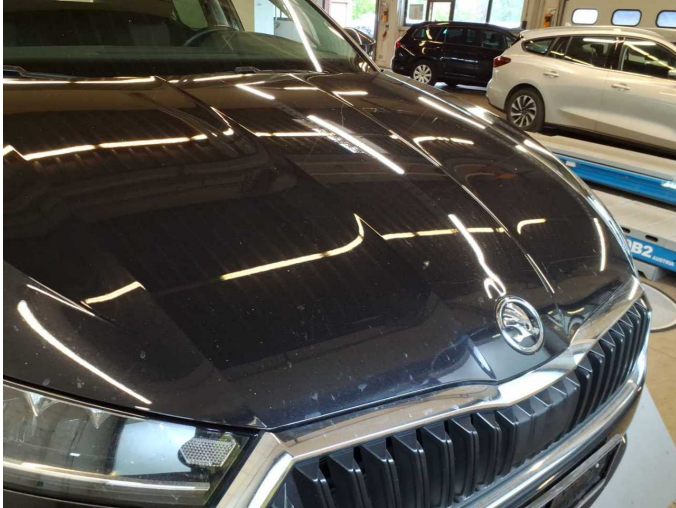
**Damage 4:** Bonnet: Bonnet - Stone chips - Paint

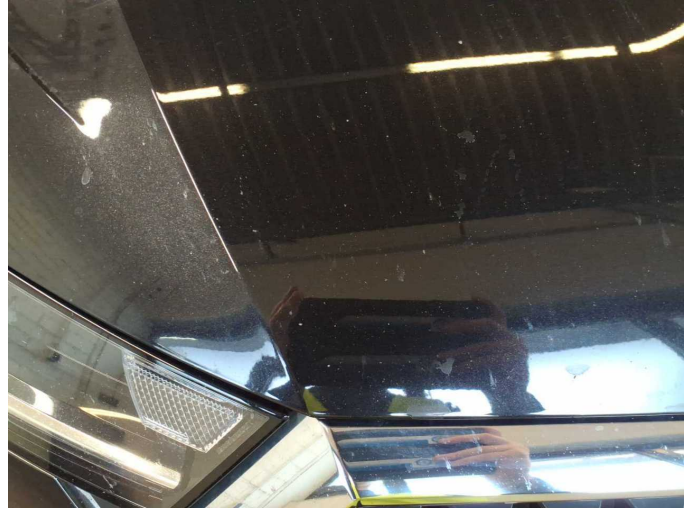
**Damage 4:** Bonnet: Bonnet - Stone chips - Paint

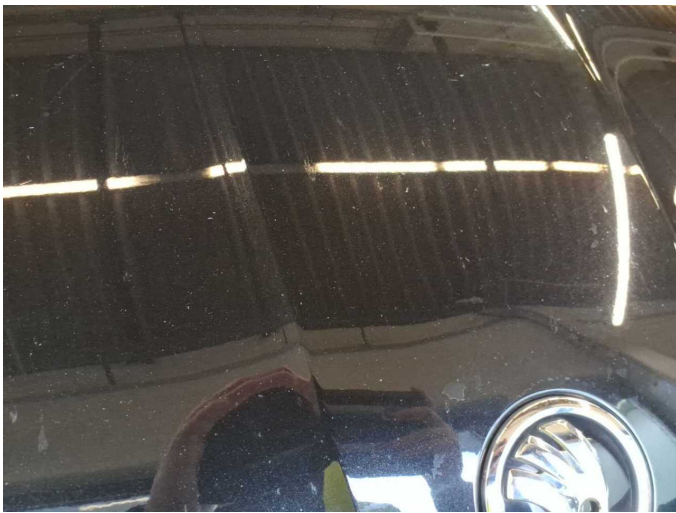
**Damage 4:** Bonnet: Bonnet - Stone chips - Paint

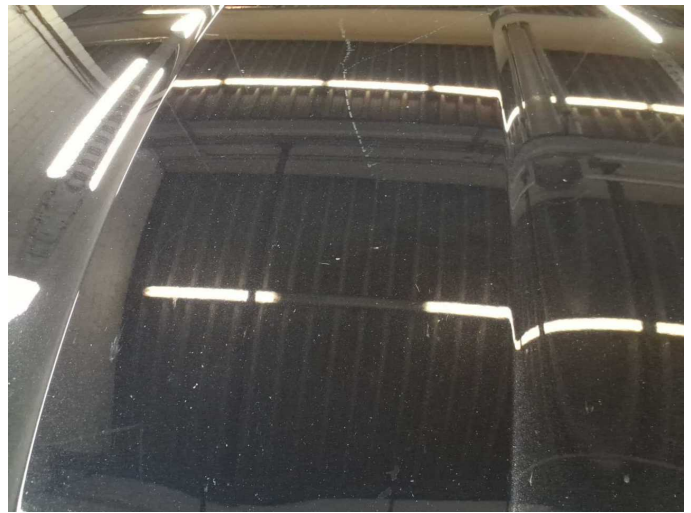
**Damage 4:** Bonnet: Bonnet - Stone chips - Paint

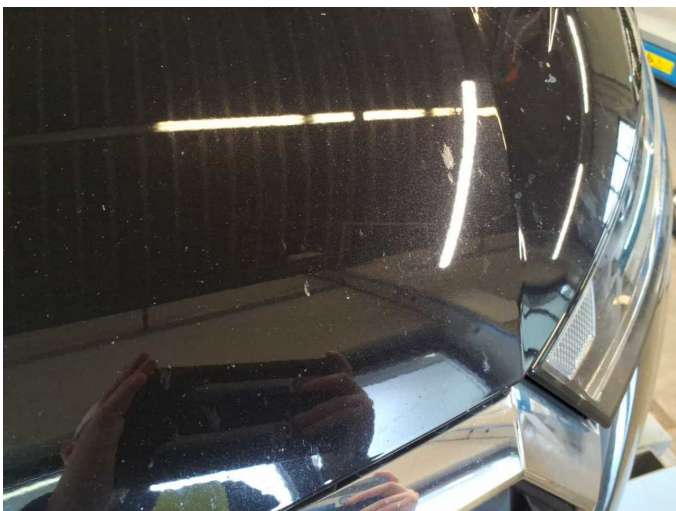
**Damage 4:** Bonnet: Bonnet - Stone chips - Paint

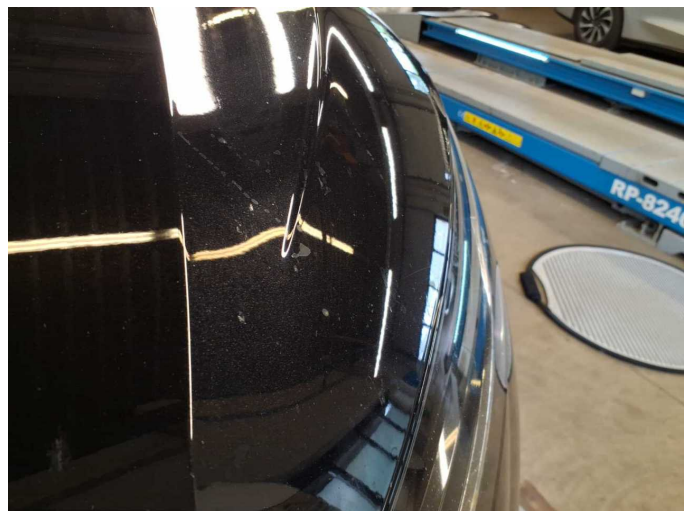
**Damage 4:** Bonnet: Bonnet - Stone chips - Paint

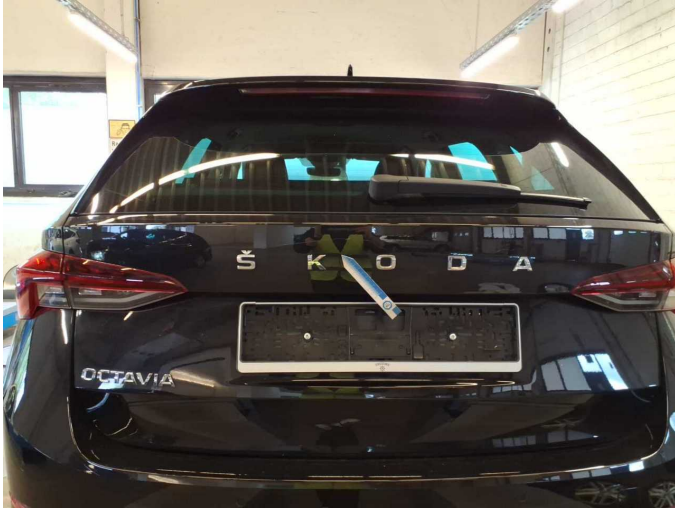
**Damage 5:** Boot lid / rear door: Boot lid - Scratch(es) - Paint

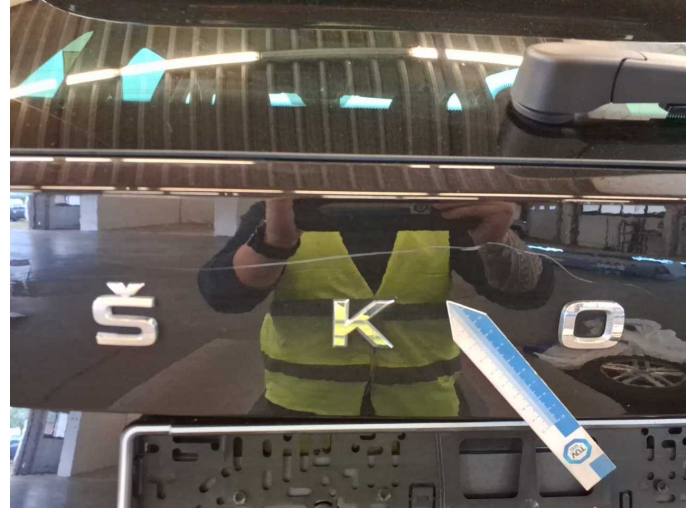
**Damage 5:** Boot lid / rear door: Boot lid - Scratch(es) - Paint

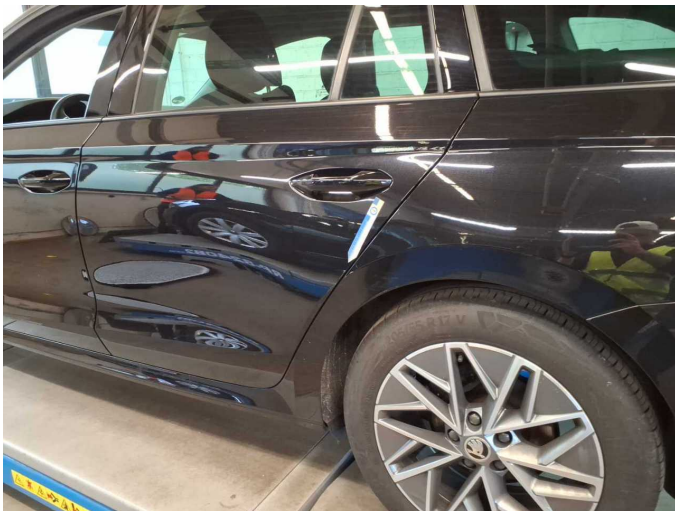
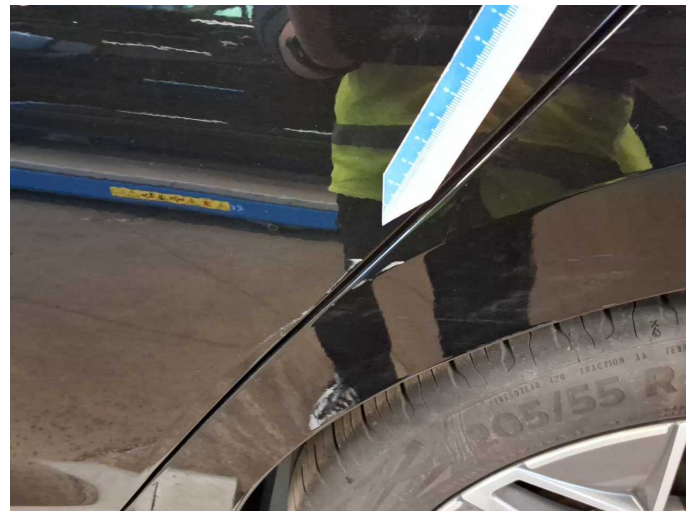
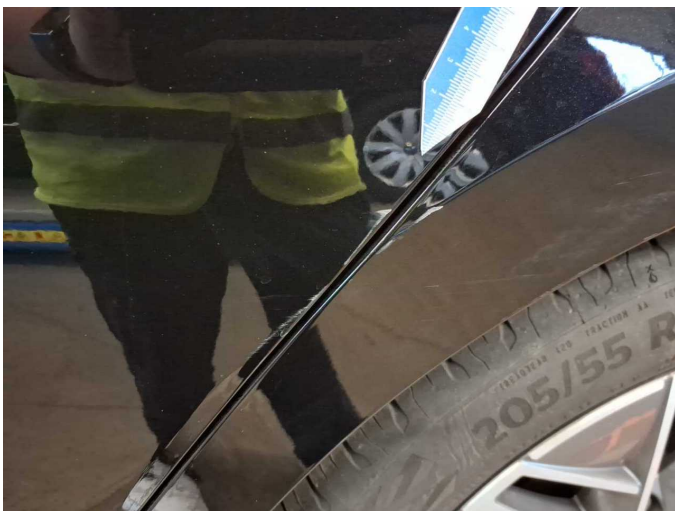
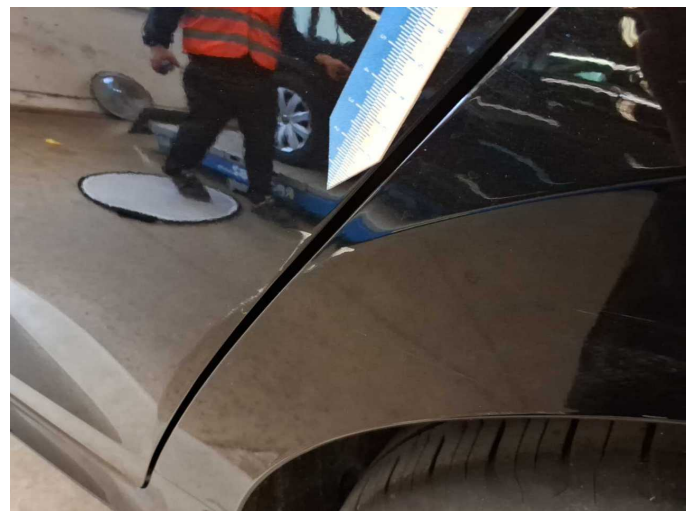
**Accident 1:** Side - left
