Expertise

Protocol number: 46348402
Order No. / Reference: 26185565
Inspection date: 2 Jul 2026

Model: Vito 116 CDI Lang HA PRO

VIN: W1VVLBEZ0T4560820

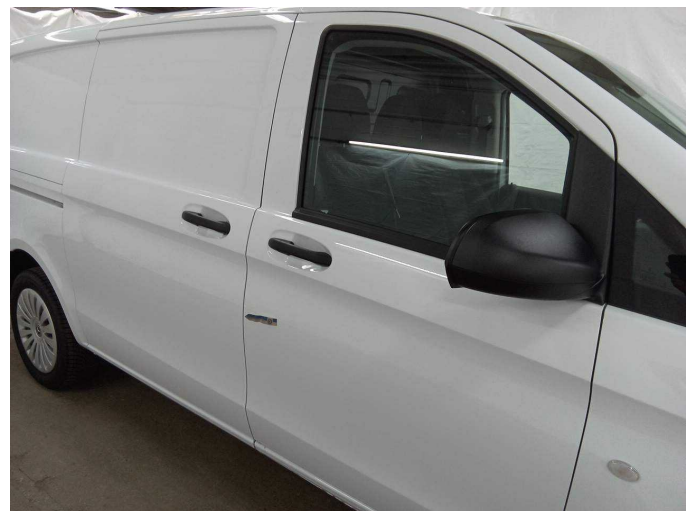
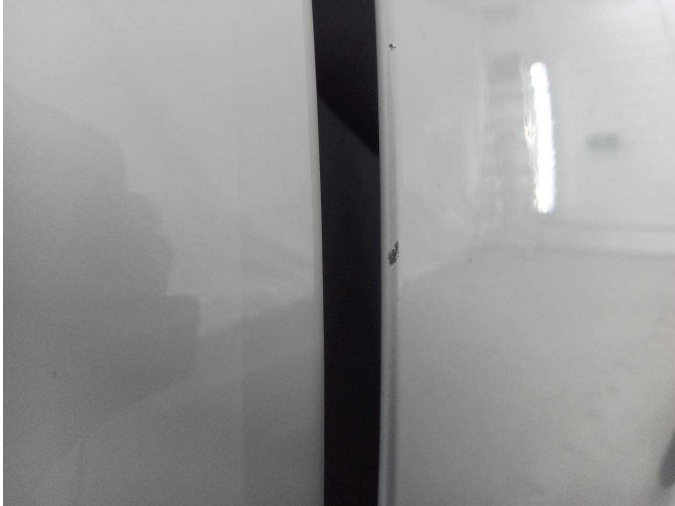
Damage 1: Door - front right side: Door edge - Scratch(es) - Smart repair

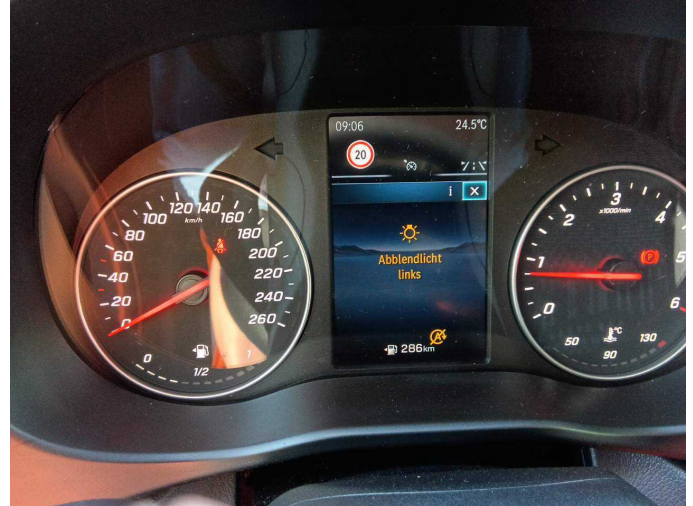
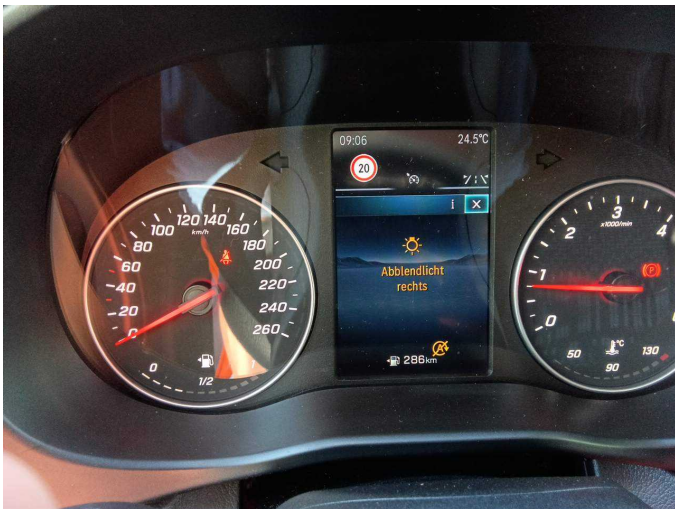
Damage 2: Electrical system: Lighting system (Abblendlicht links) - Functional / admissibility - Perform diagnosis

Damage 2: Electrical system: Lighting system (Abblendlicht rechts) - Functional / admissibility - Perform diagnosis

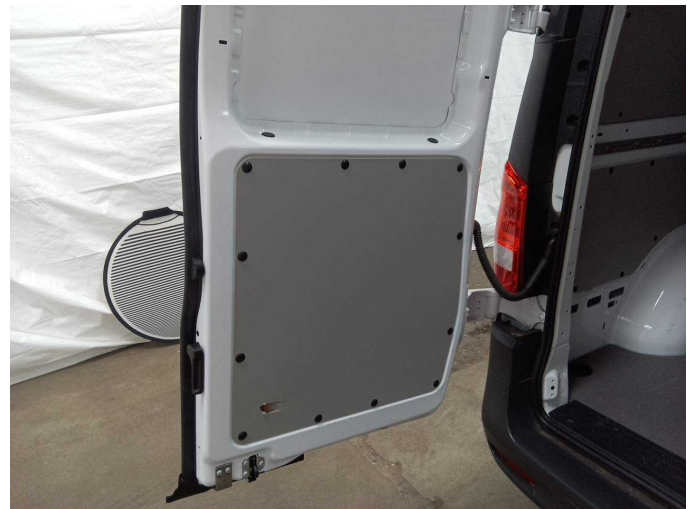
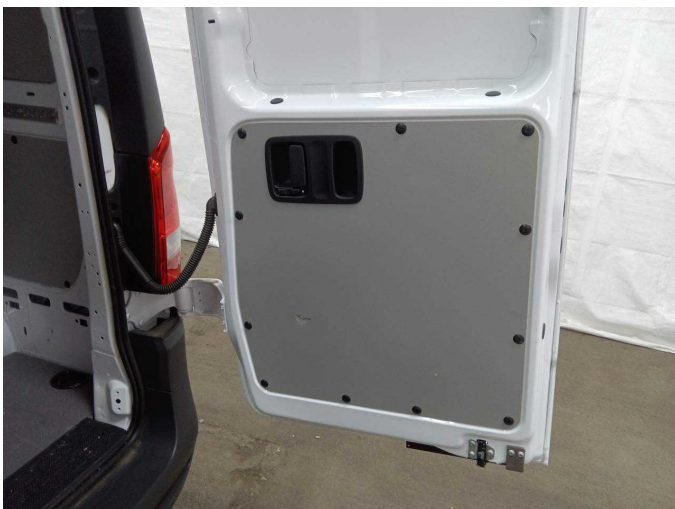
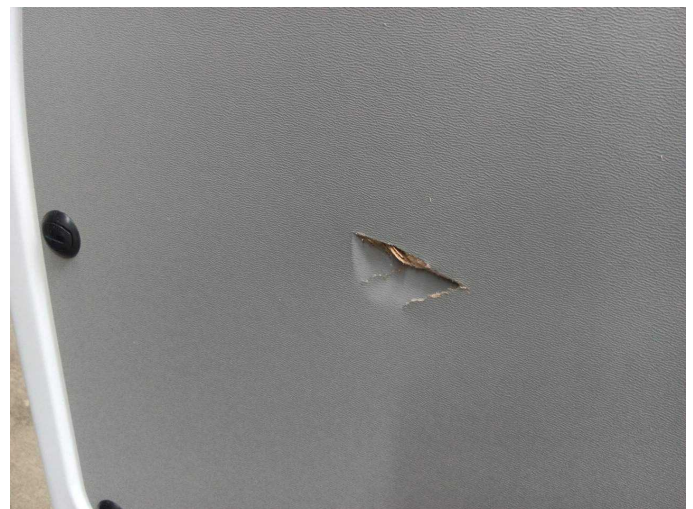
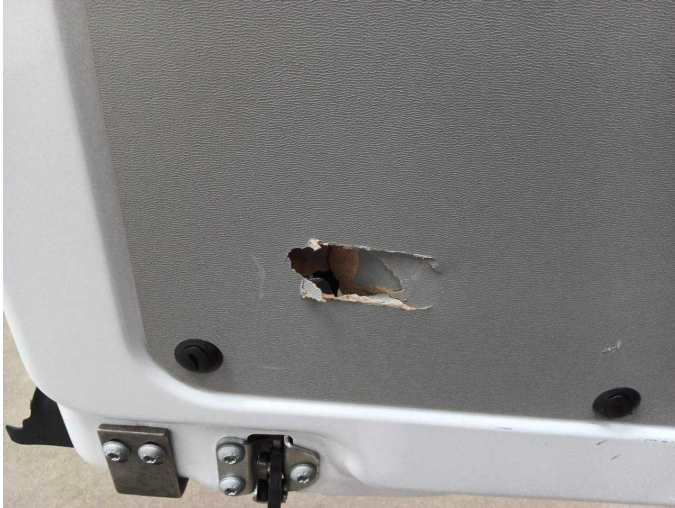
Damage 3: Trim / covers: Boot lid - interior trim - Holes - Replace

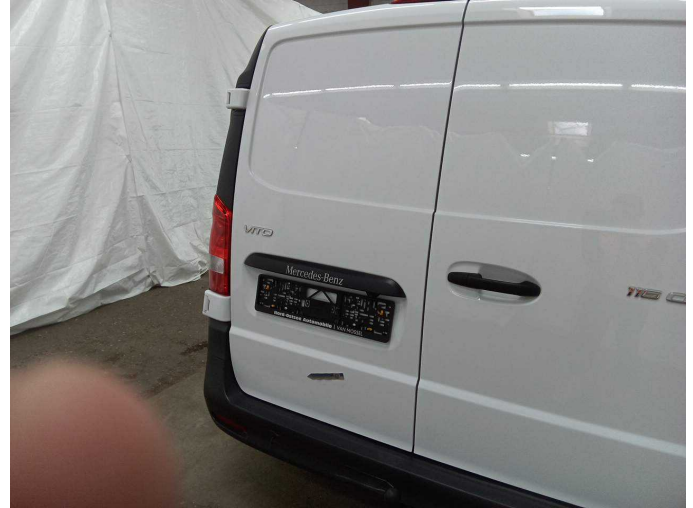
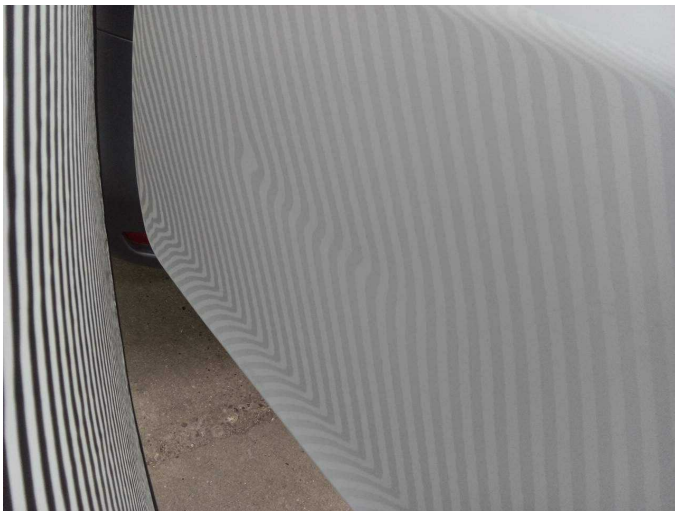
Damage 4: Boot lid / rear door: Rear door - left side (10 cm lang) - dent(s) - Smooth repair work

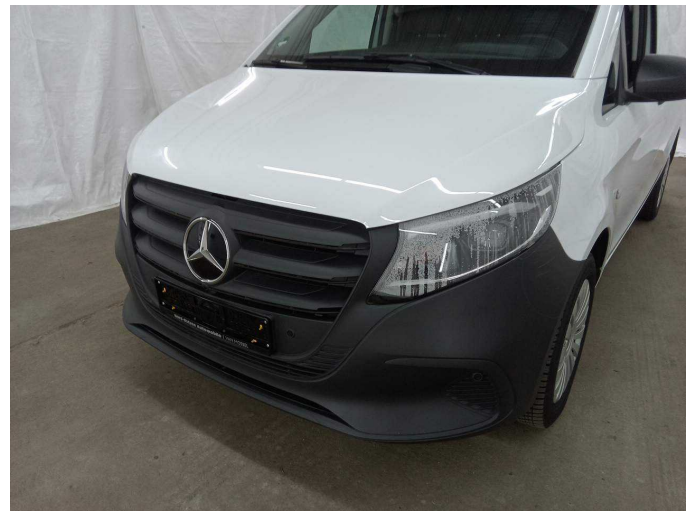
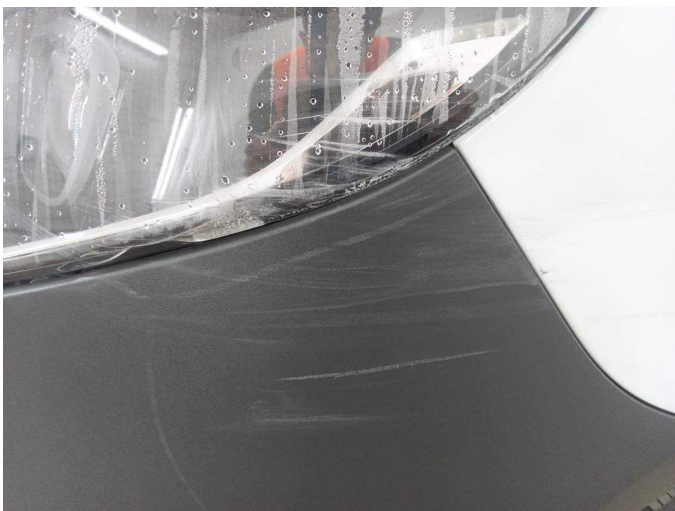
Damage 5: Front bumper: Front bumper - Scratch(es) - Loss in value

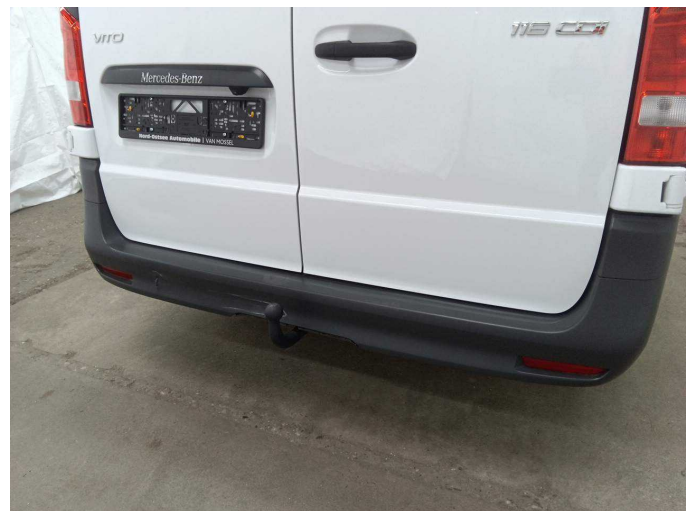
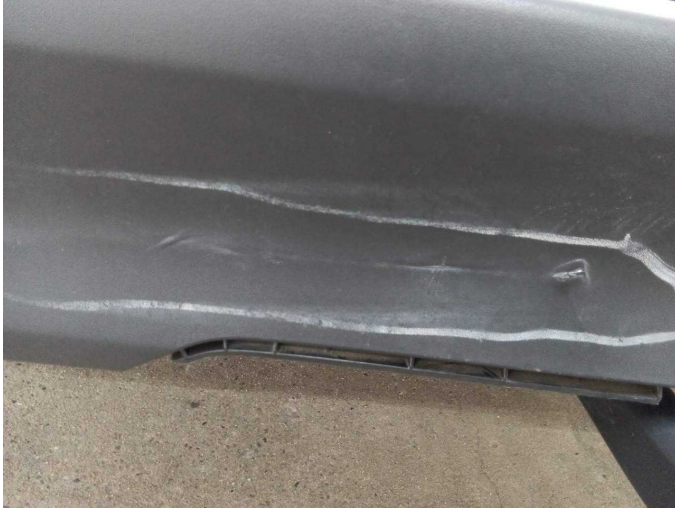
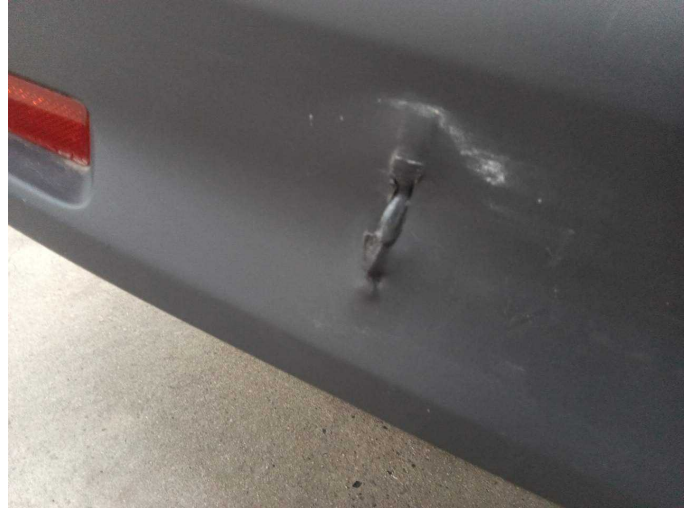
Damage 6: Rear bumper: Rear bumper - Broken / torn - Replace

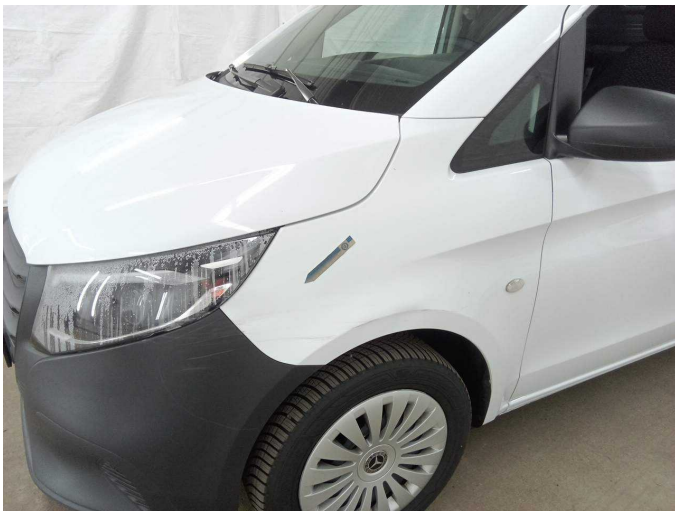
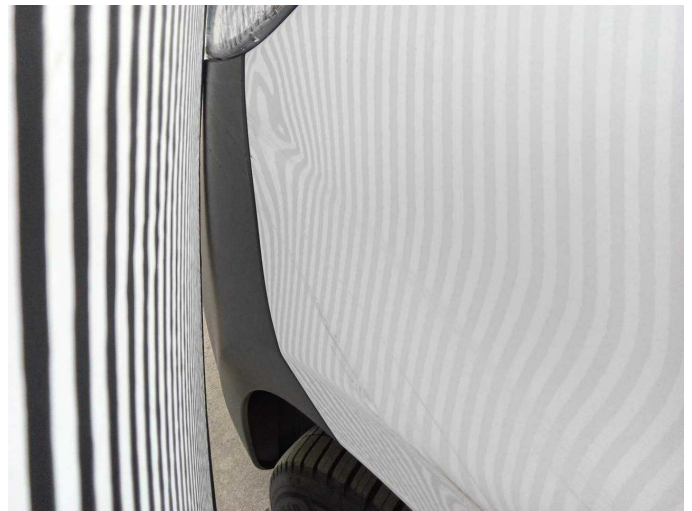
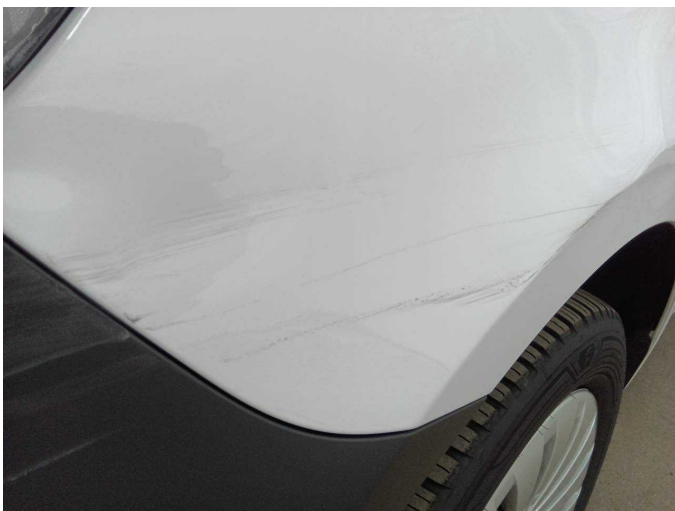
Damage 7: Mudguard - left side: Mudguard - left side - Dent / paintcoat damage - Repair and paint

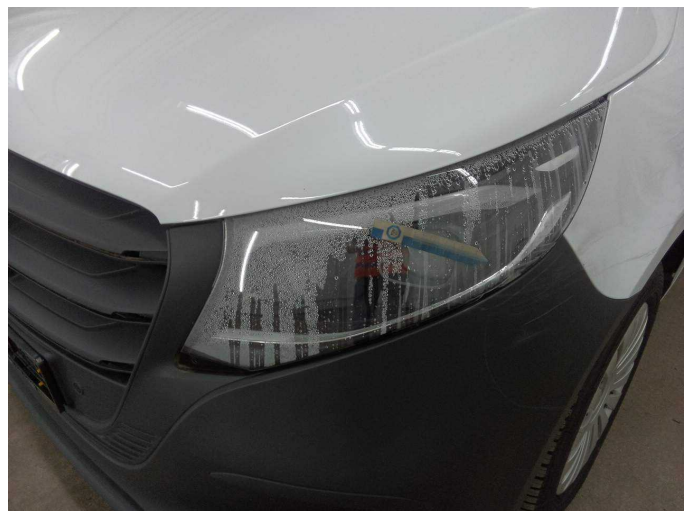
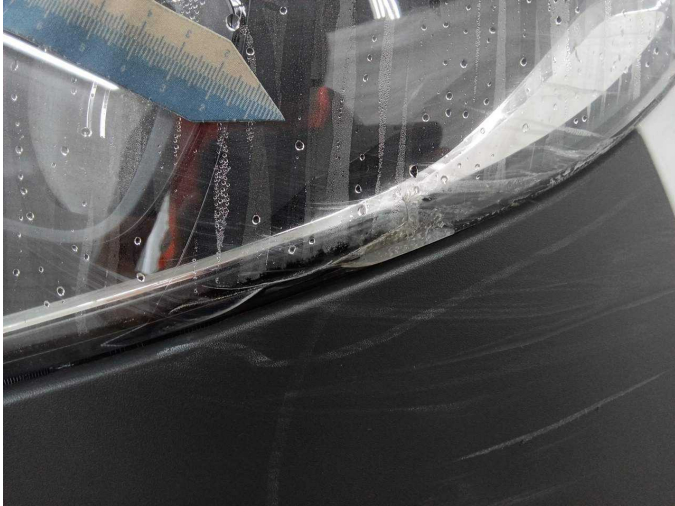
Damage 8: Headlight: Headlight - left side - Broken / torn - Replace

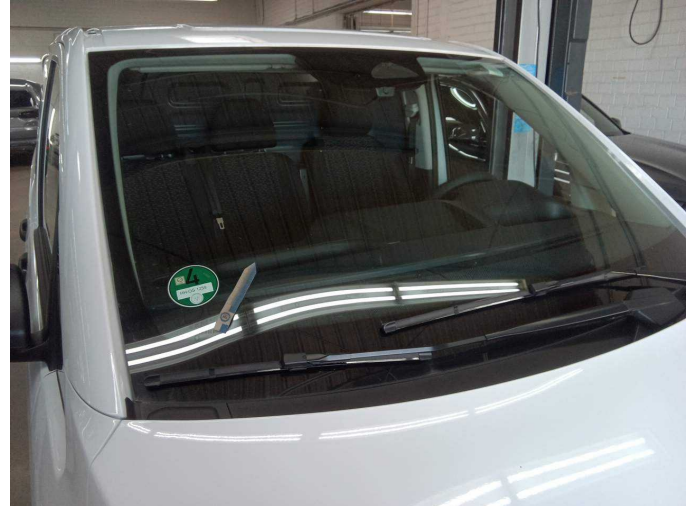
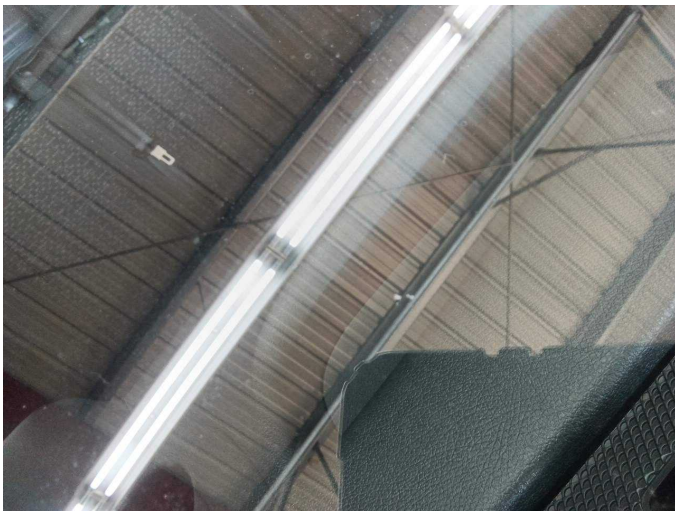
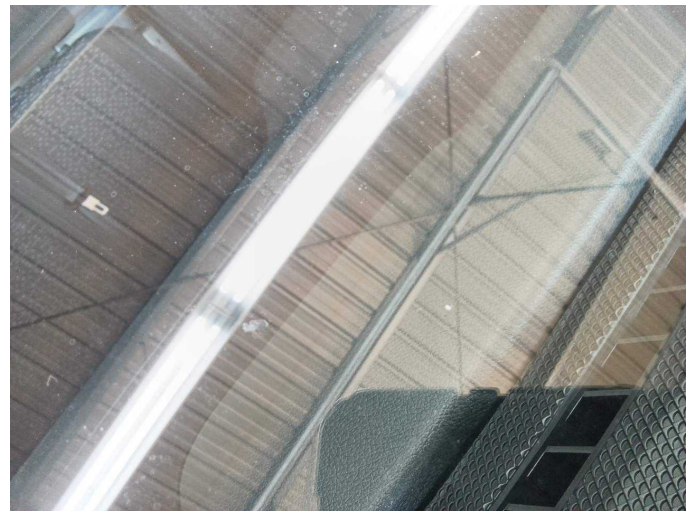
Wear and tear 1: Vehicle glazing: Windscreen - Stone chips - No deduction

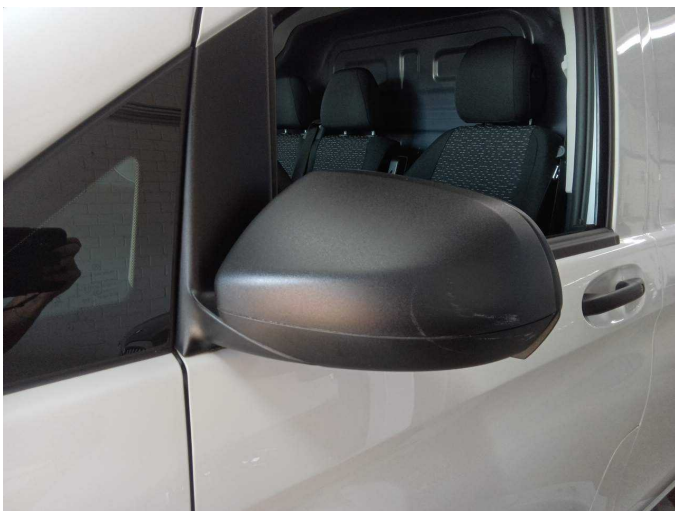
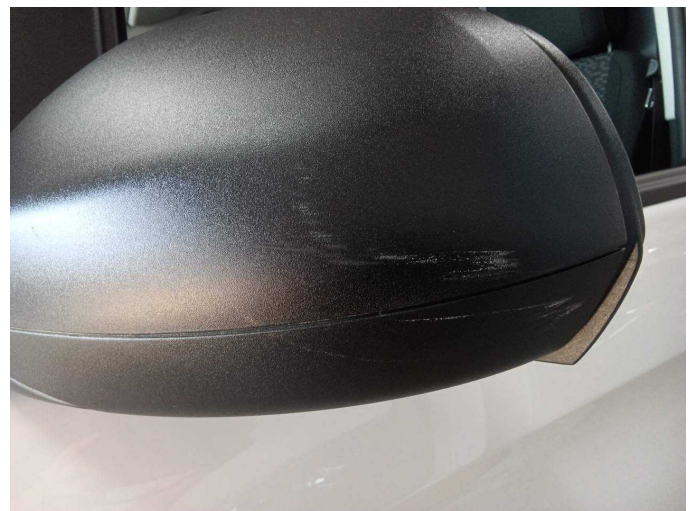
Wear and tear 2: Wing mirror - left side: Cap - Scratch(es) - No deduction
