Expertise

Protocol number: 45992677
Order No. / Reference: 26484777
Inspection date: 17 Jun 2026

Manufacturer: Opel

Model: Insignia Sports Tourer 1.5 Diesel Business Edition

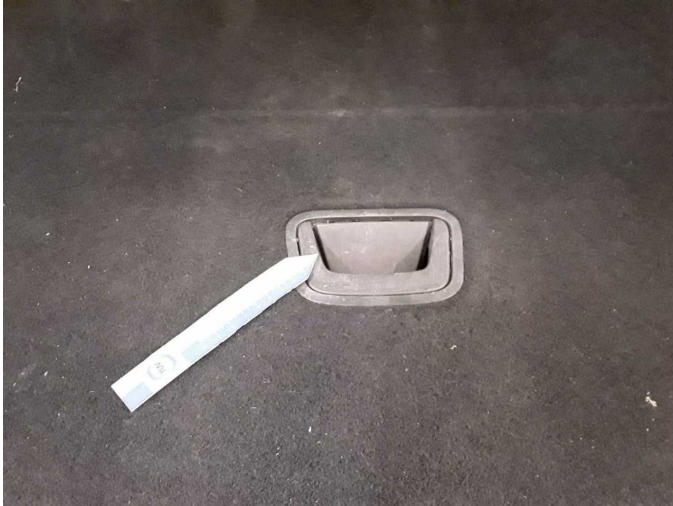
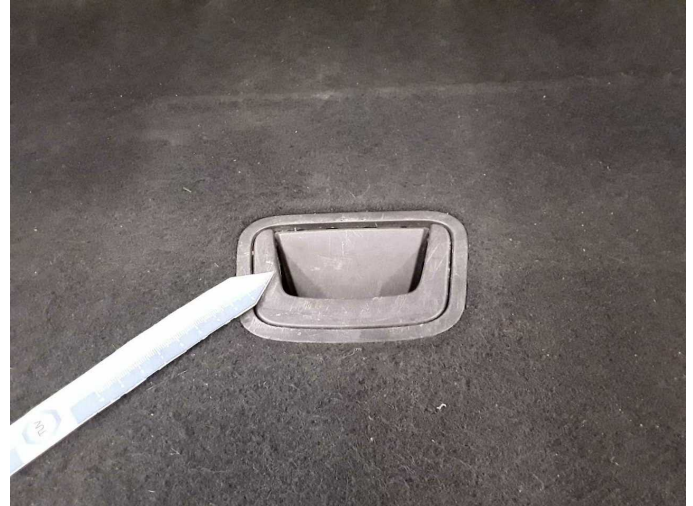
Damage 1: Interior: Cargo area floor (Halterung) - Damaged - Replace

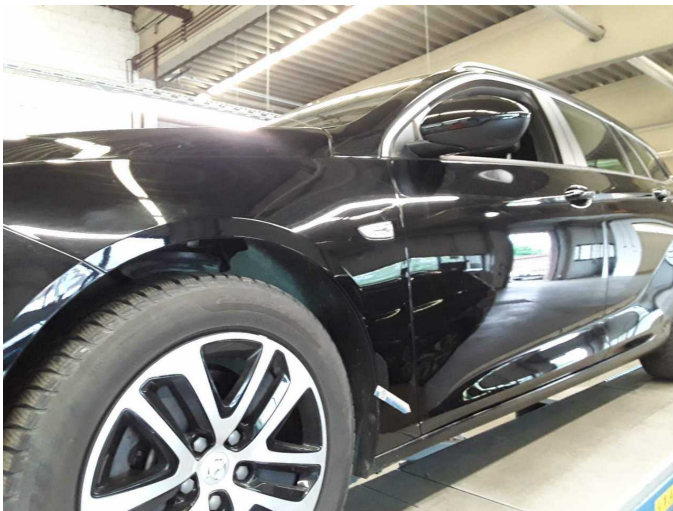
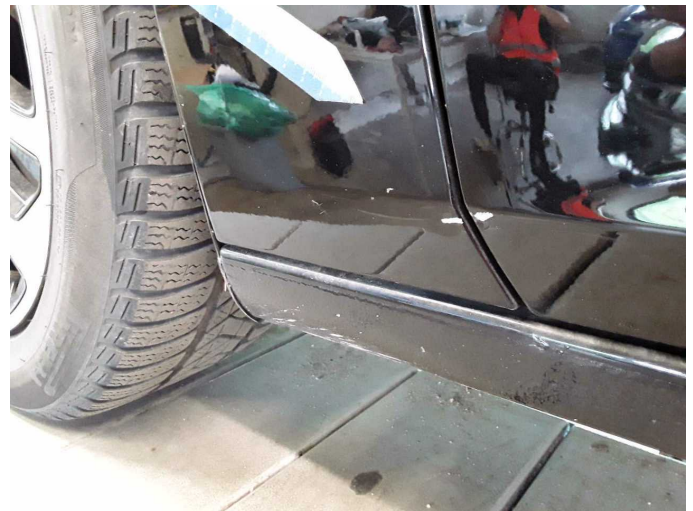
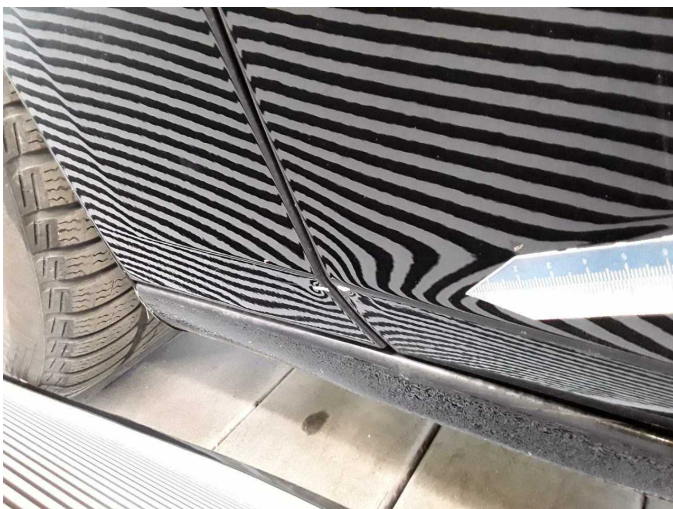
Damage 2: Mudguard - left side: Mudguard - left side - Scratch(es) - Smart repair

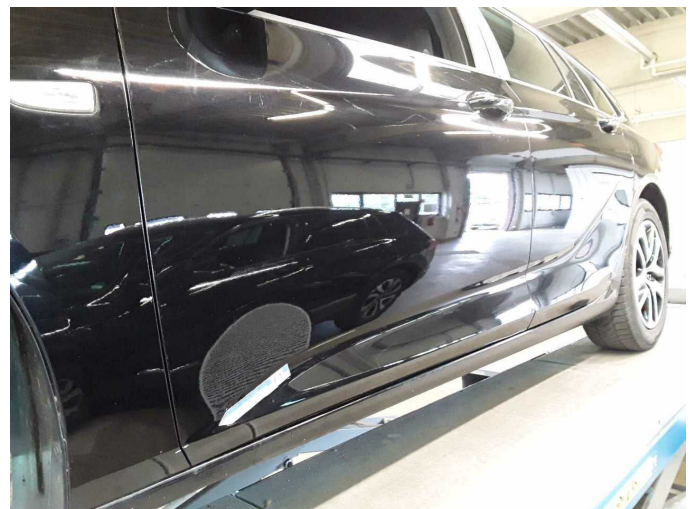
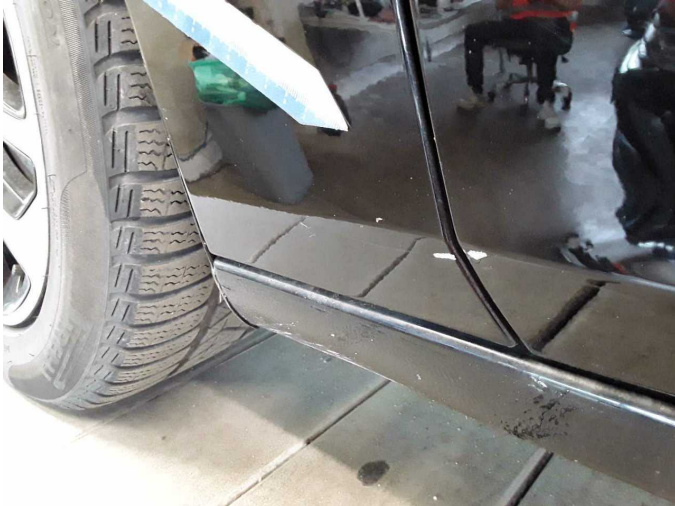
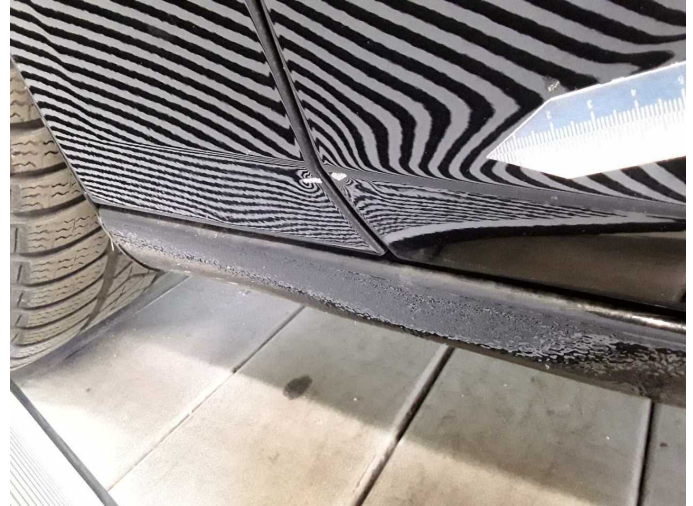
Damage 3: Door - front left side: Door - Scratch(es) - Smart repair

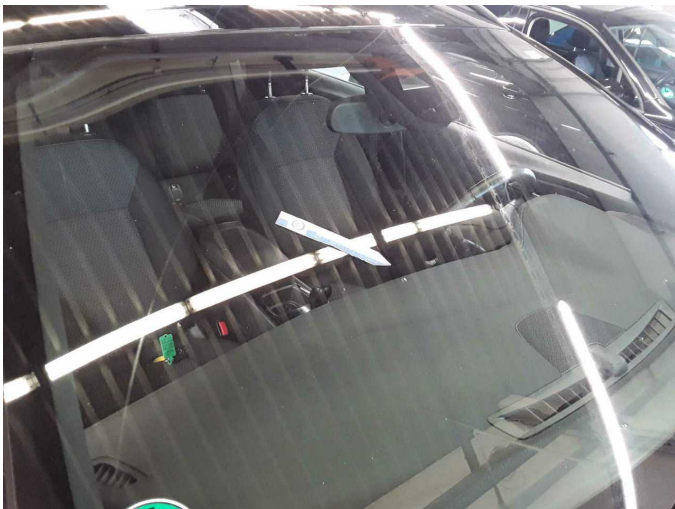
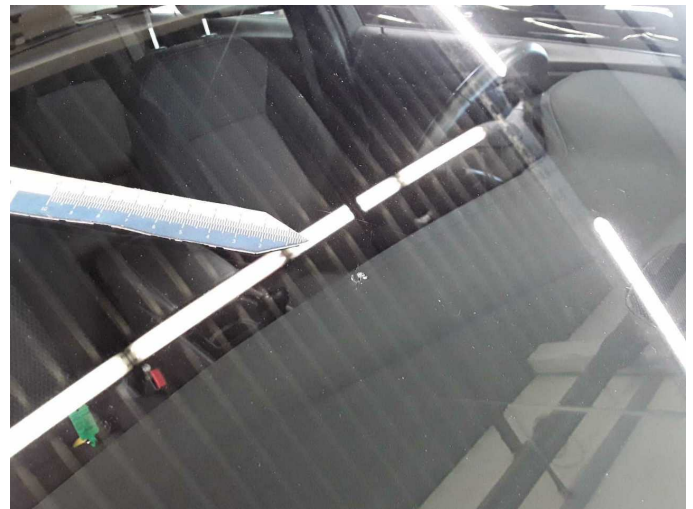
Damage 4: Vehicle glazing: Windscreen (Rissbildung) - Stone chips - Smart repair

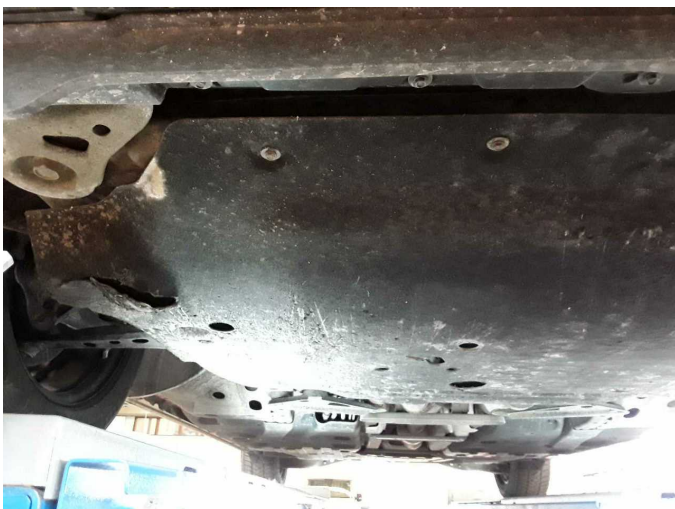
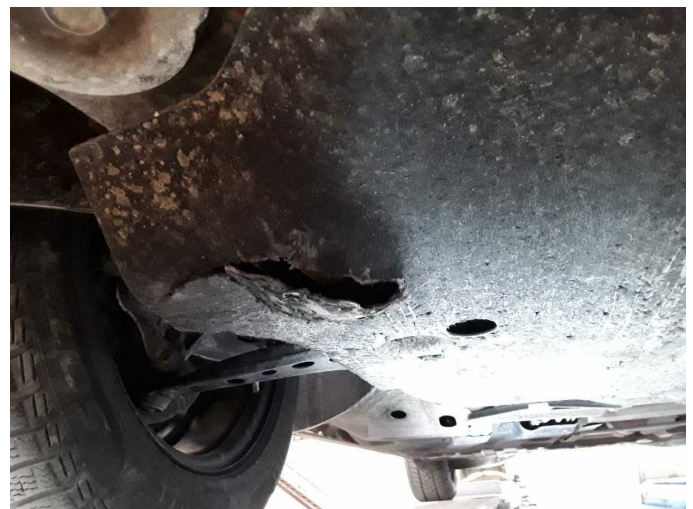
Damage 5: Body: Underbody panelling - Damaged - Replace

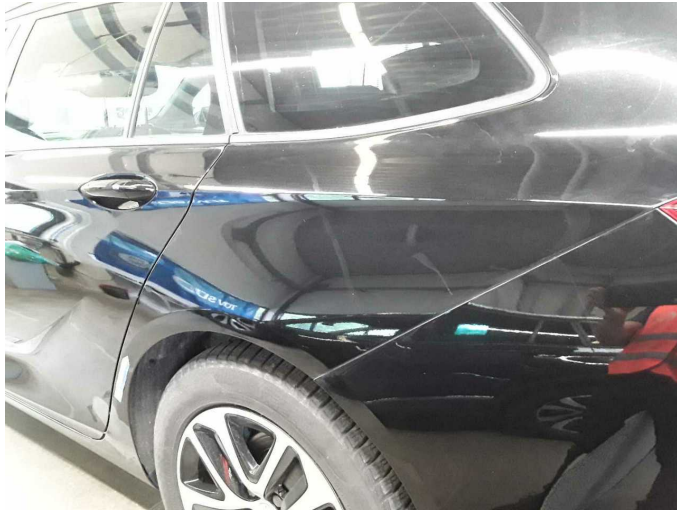
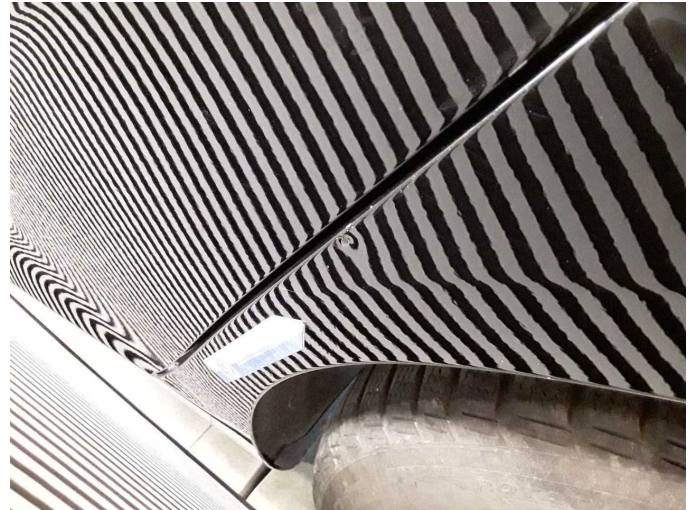
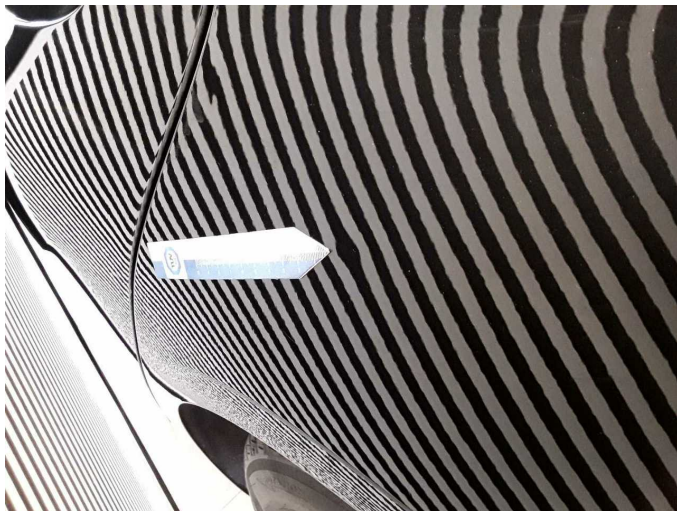
Damage 6: Side panel - rear left side: Side panel - Dent / paintcoat damage - Repair and paint

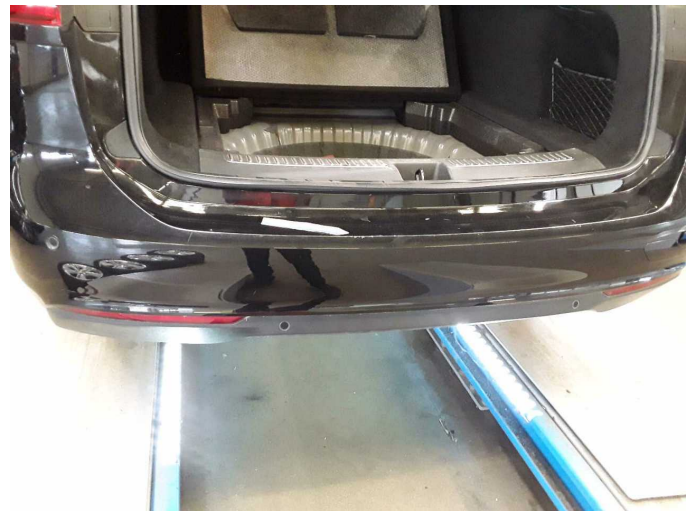
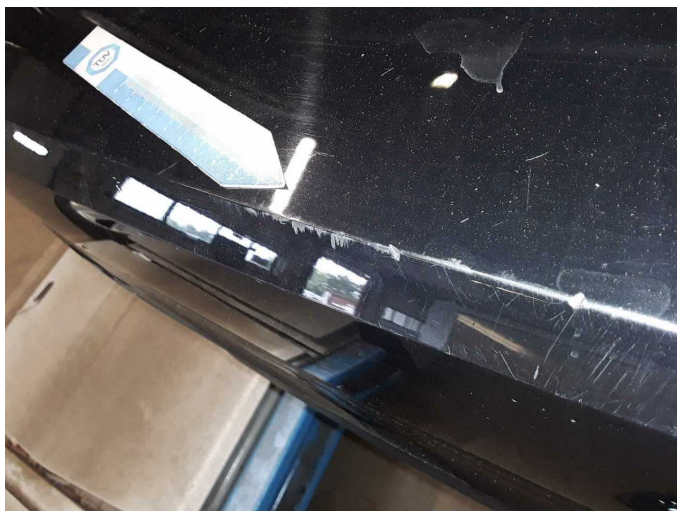
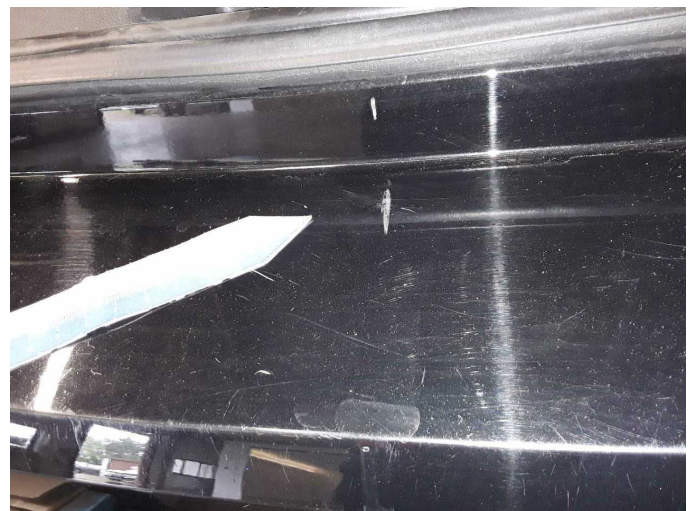
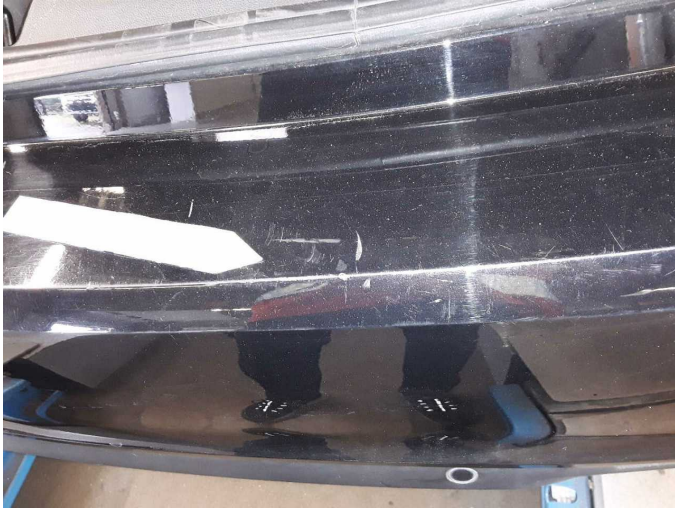
Damage 7: Rear bumper: Rear bumper - Scratch(es) - Paint

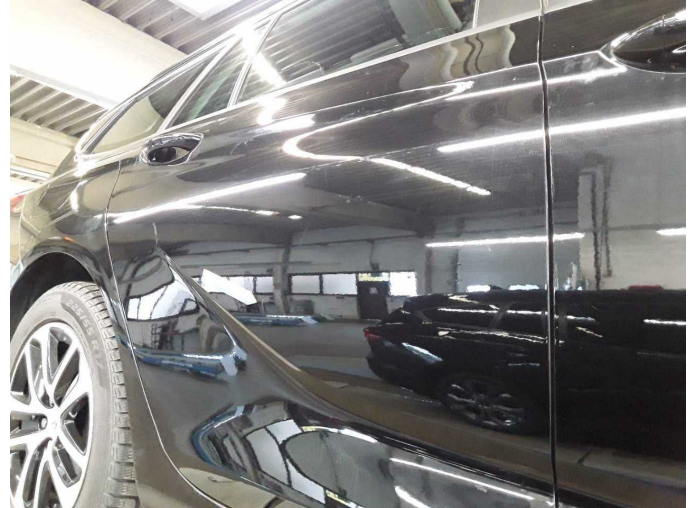
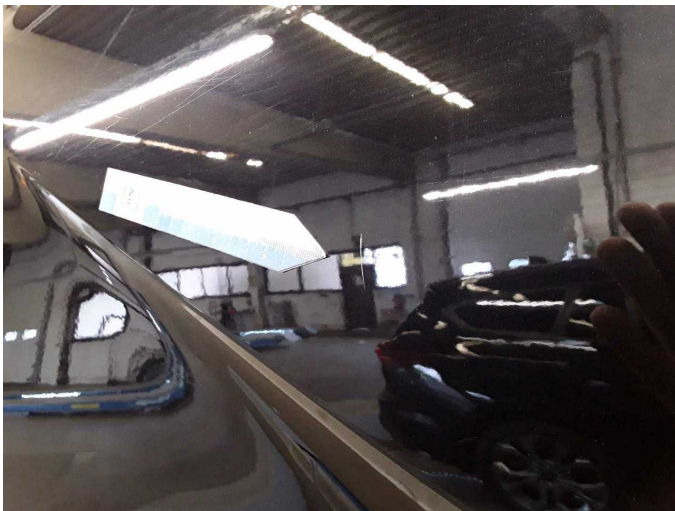
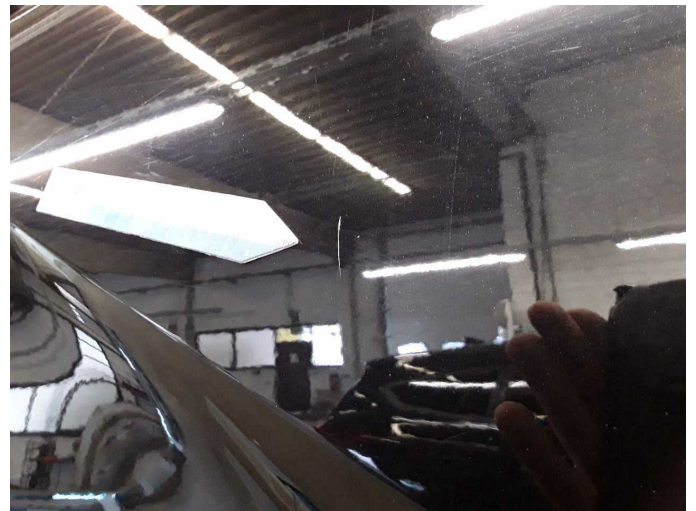
Damage 8: Door - rear right side: Door - Scratch(es) - Paint

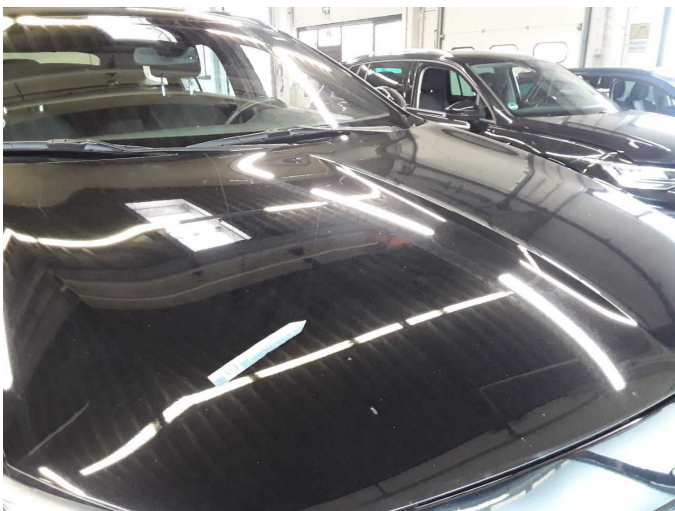
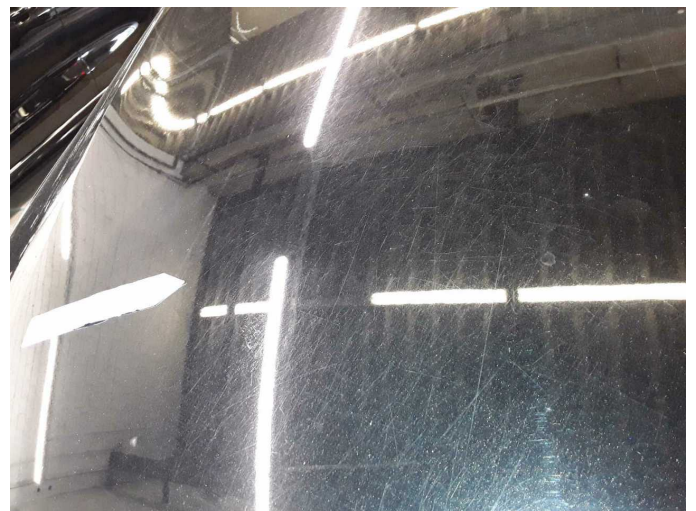
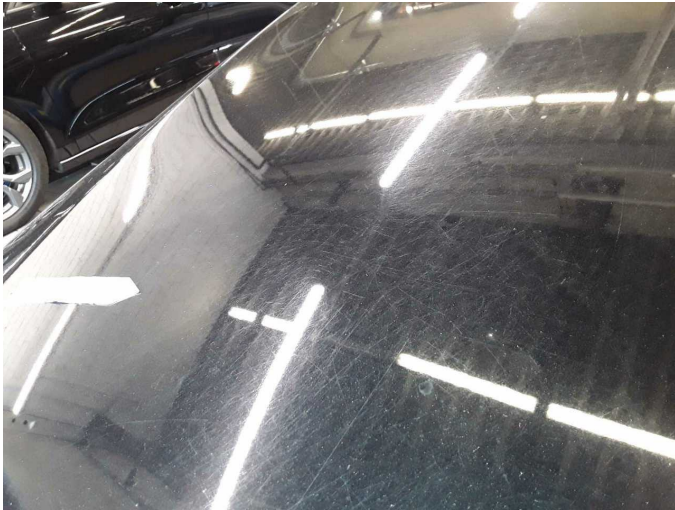
Damage 9: Bonnet: Bonnet - Scratched - Paint

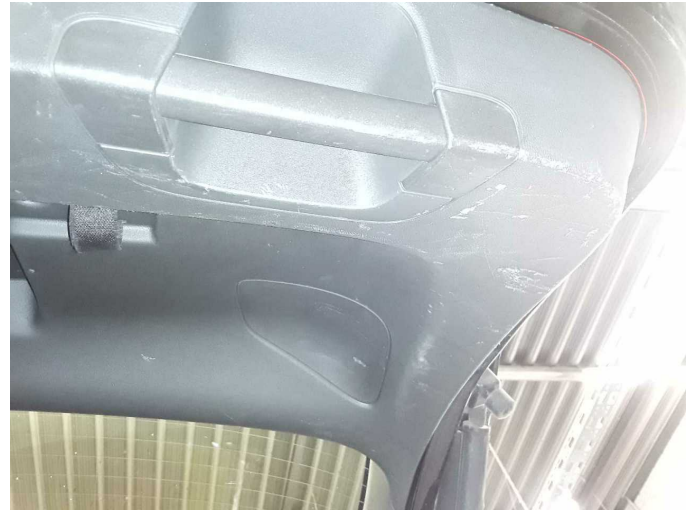
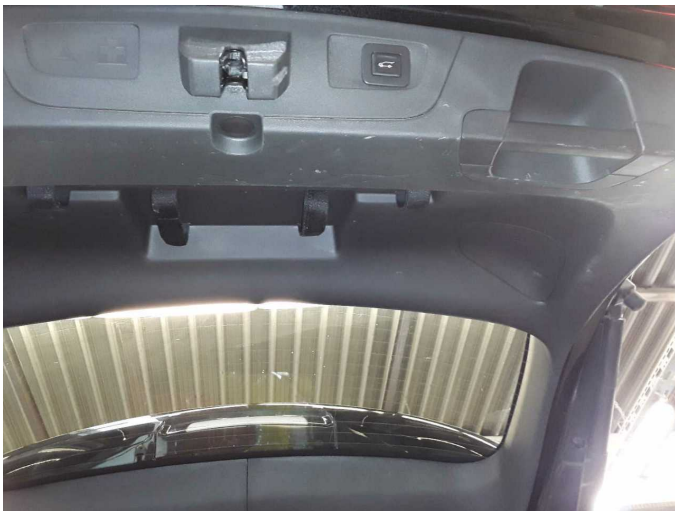
Wear and tear 1: Trim / covers: Boot lid - interior trim - Scratch(es) - No deduction

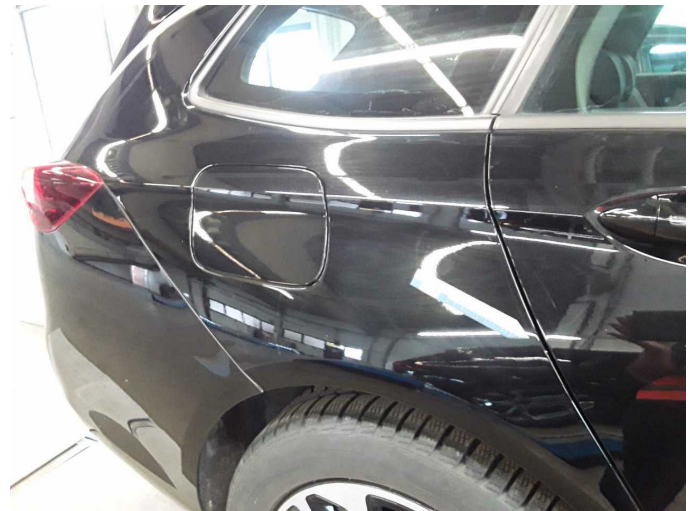
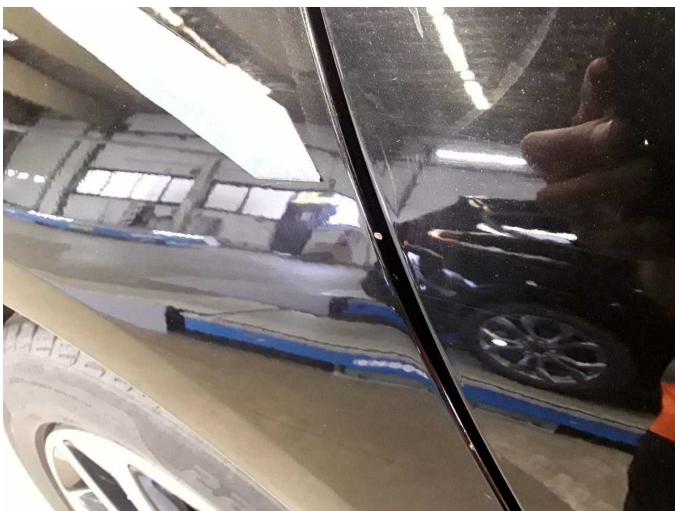
Wear and tear 2: Side panel - rear right side: Side panel - Stone chips - No deduction

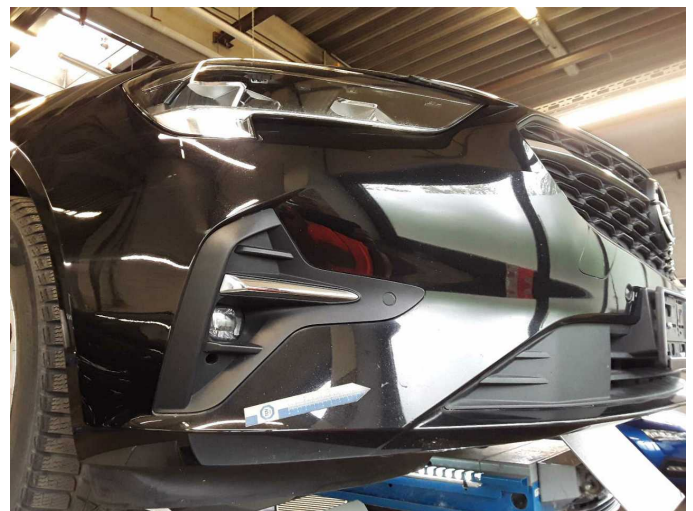
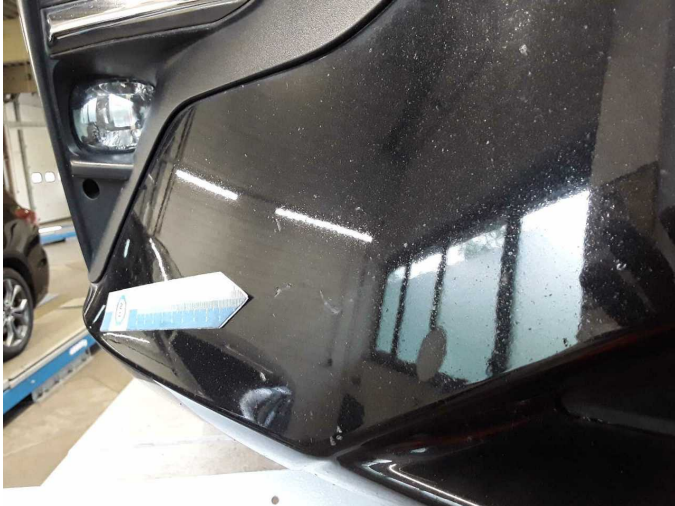
Wear and tear 3: Front bumper: Front bumper - Scratch(es) - No deduction

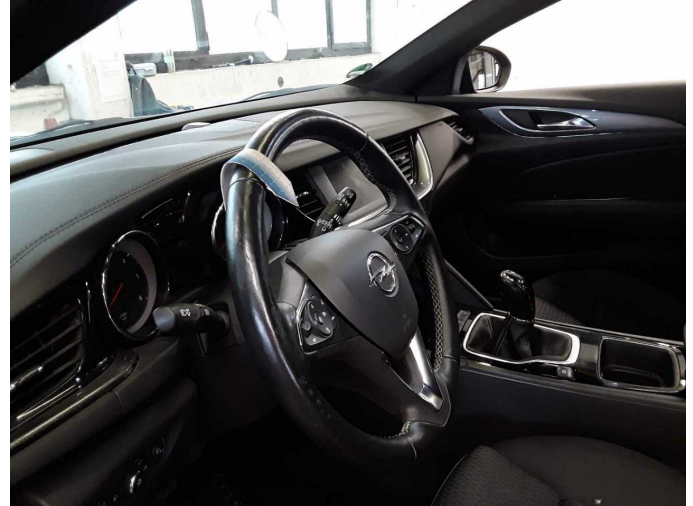
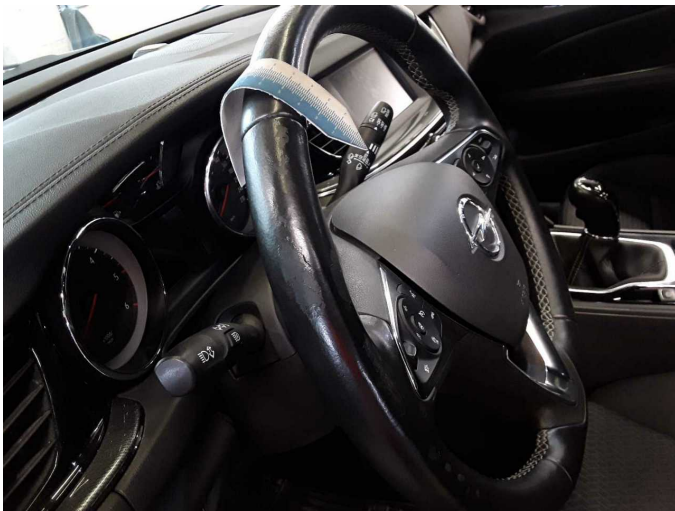
Wear and tear 4: Steering system: Steering wheel - Worn - No deduction
