## Expertise

Protocol number: 46318557  
Order No. / Reference: 26612856  
Inspection date: 2 Jul 2026

Manufacturer: Opel

Model: Combo Cargo 1.5 D Edition

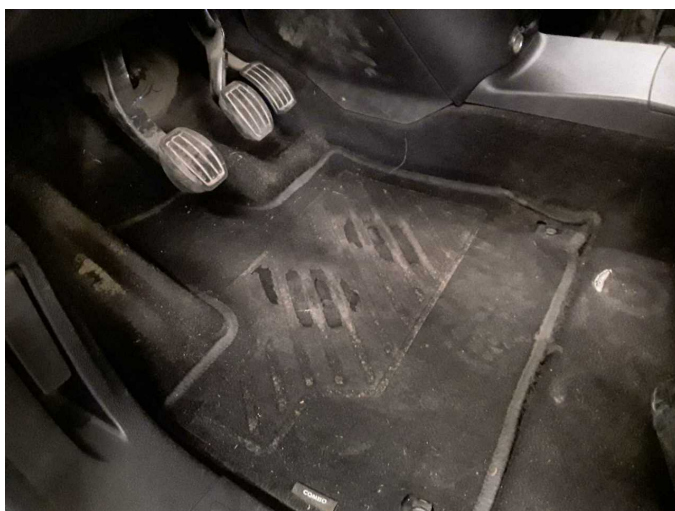
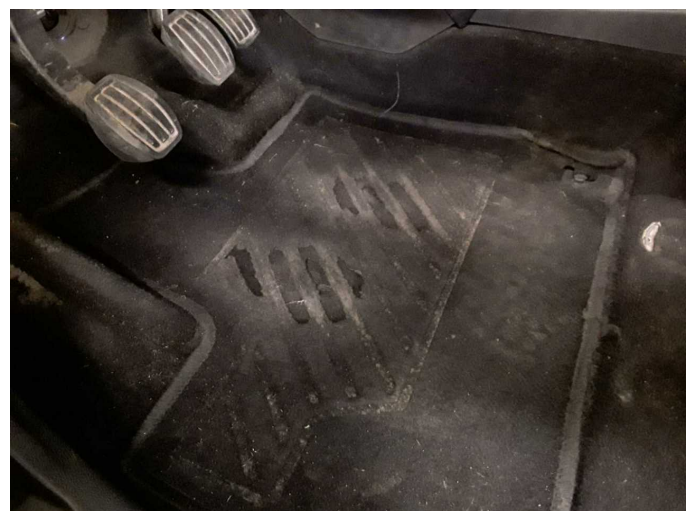
Damage 1: Trim / covers: Floor mats - Damaged - Replace

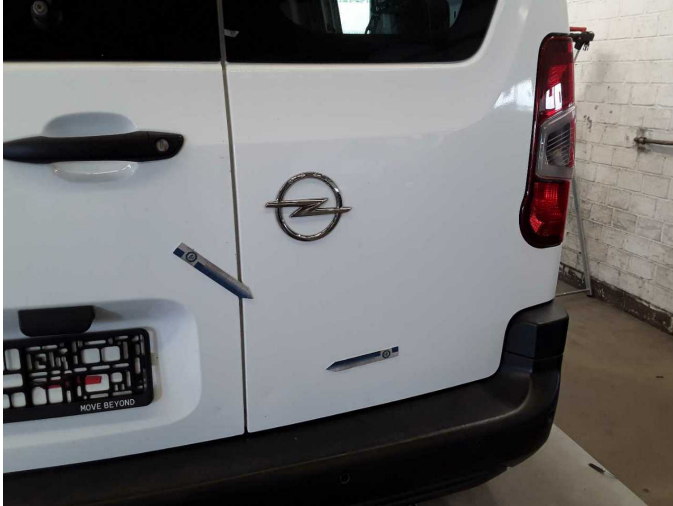
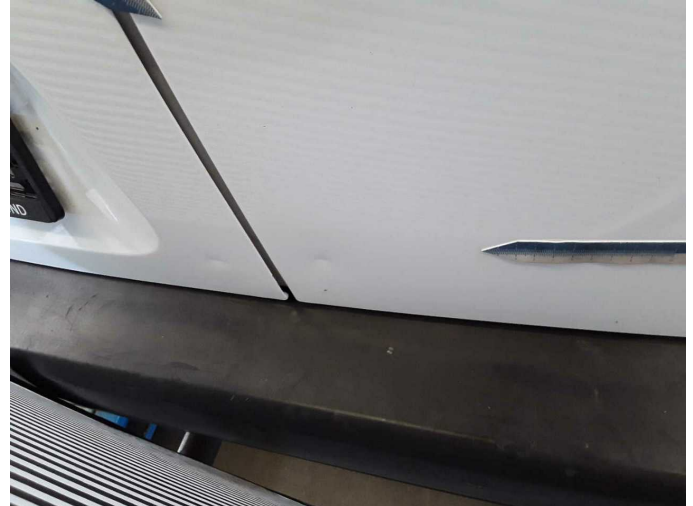
**Damage 2:** Boot lid / rear door: Rear door - right side - Dent / paintcoat damage - Smart repair

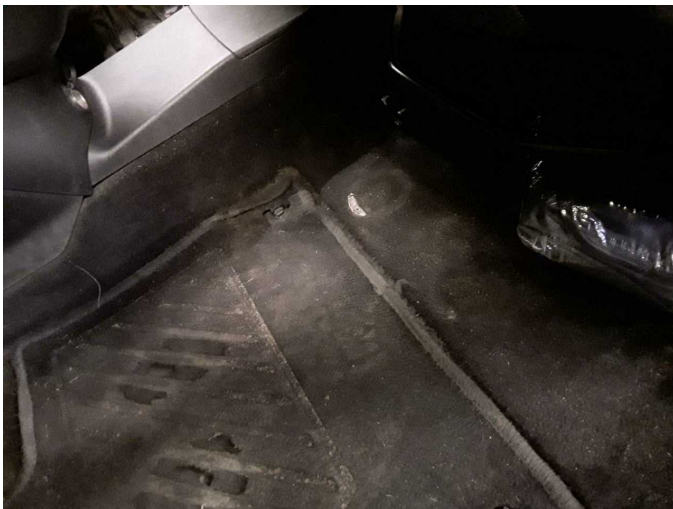
**Damage 3:** Trim / covers: Carpet - front left side - Damaged - Loss in value

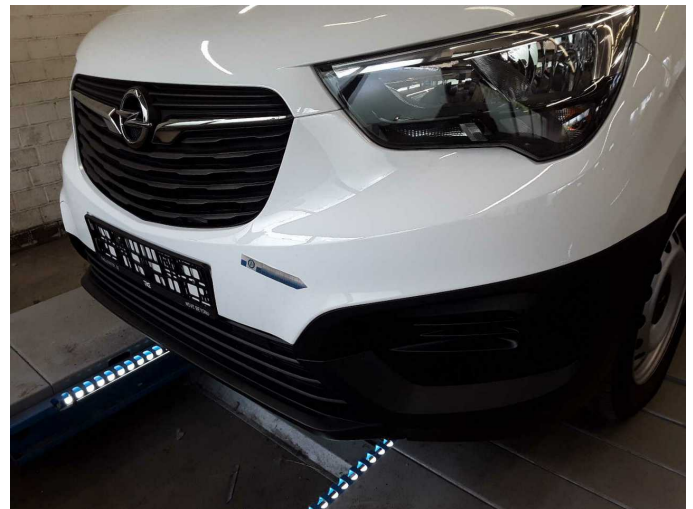
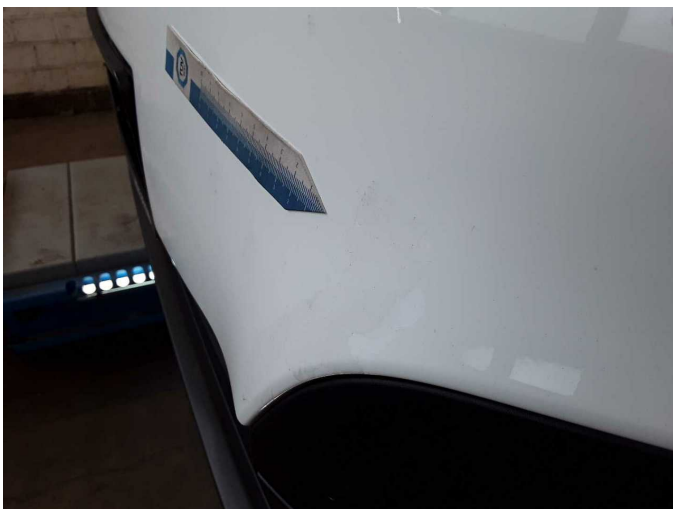
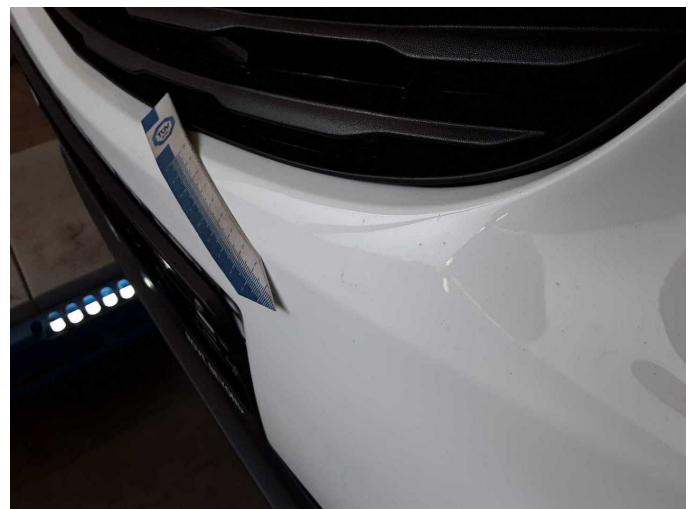
**Damage 4:** Front bumper: Front bumper (Klarlack abgeblättert) - Unprofessionally repaired - Paint

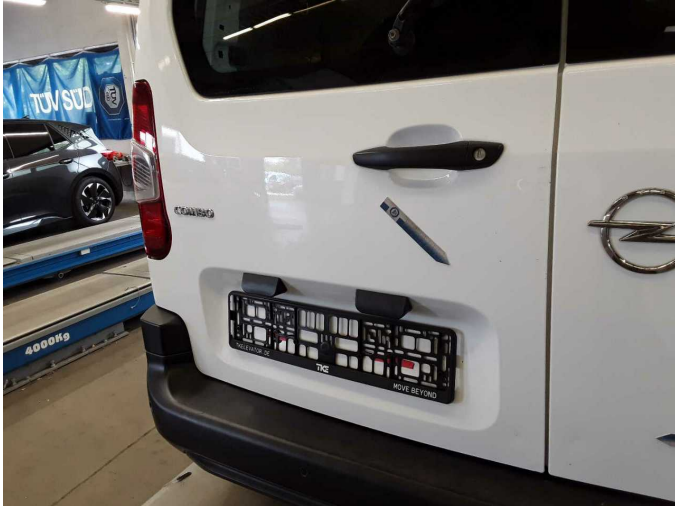
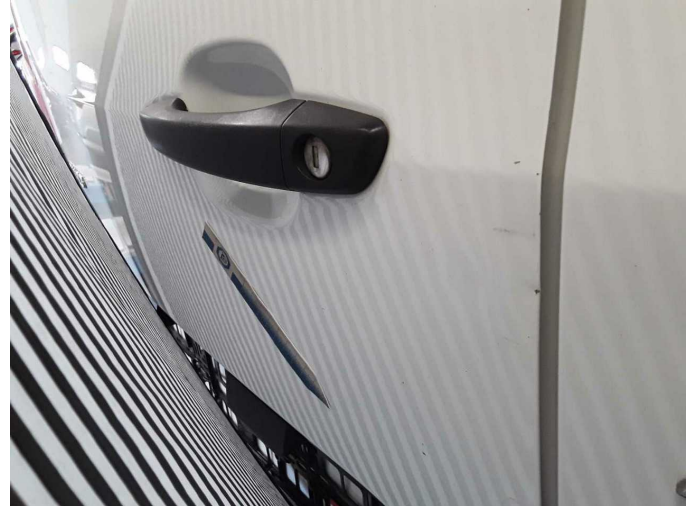
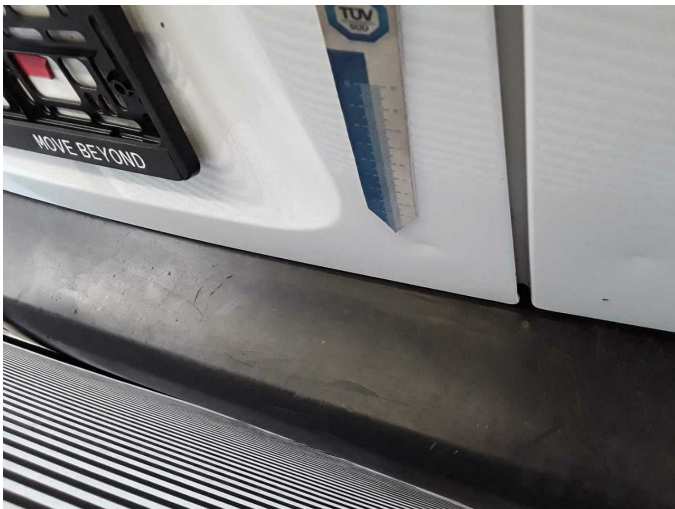
**Damage 5:** Boot lid / rear door: Rear door - left side - Dent / paintcoat damage - Repair and paint

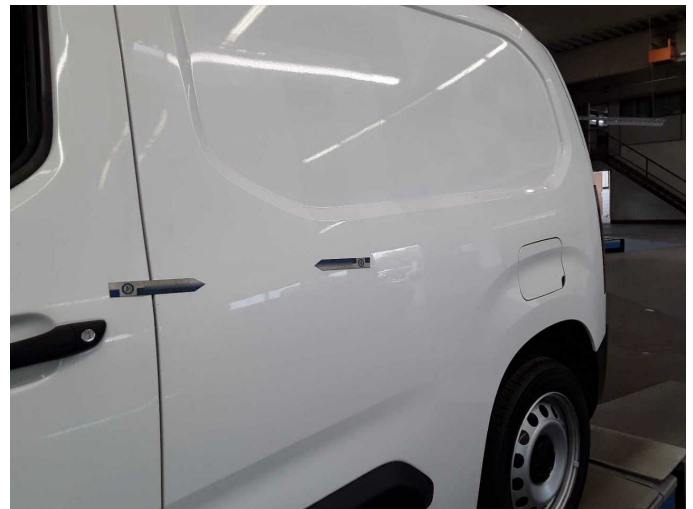
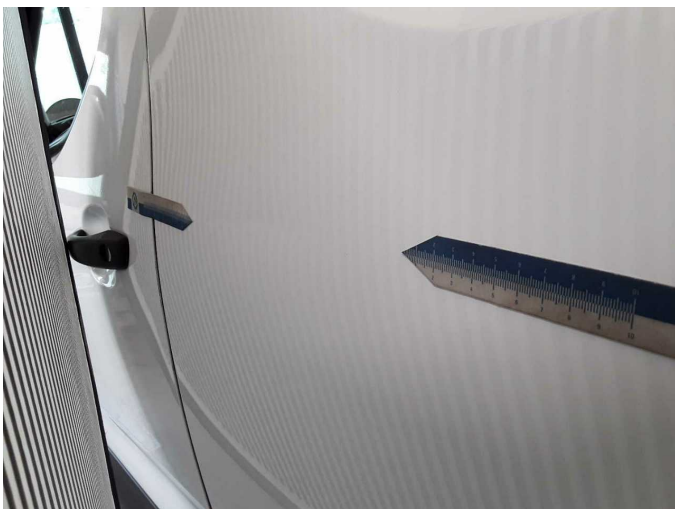
**Damage 6:** Side panel - rear left side: Side panel - Deformed - Repair and paint

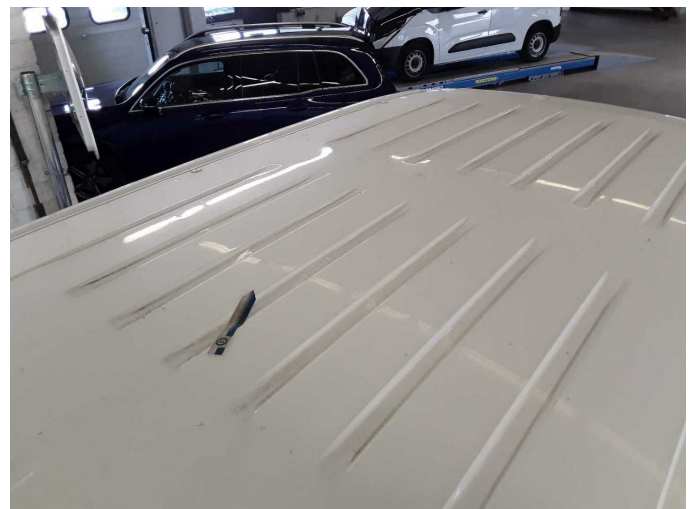
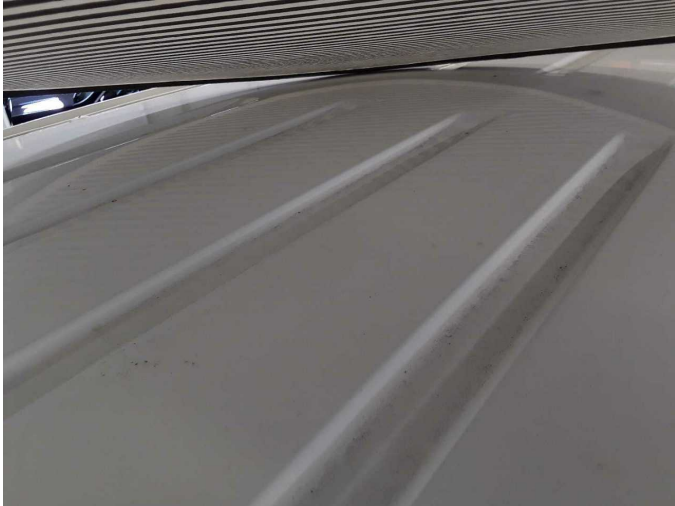
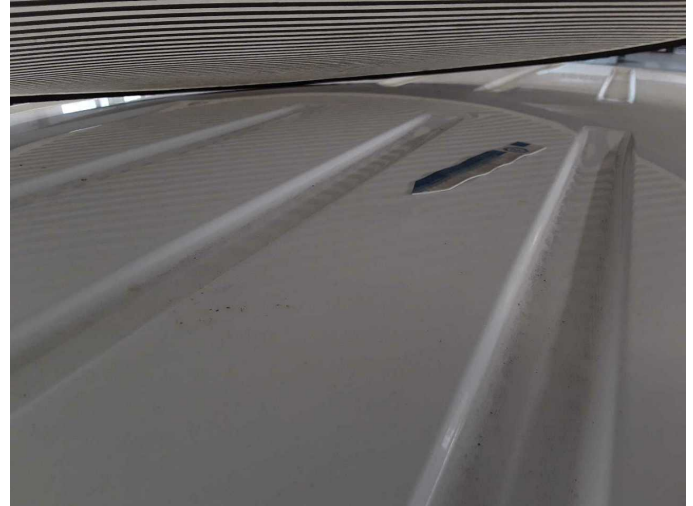
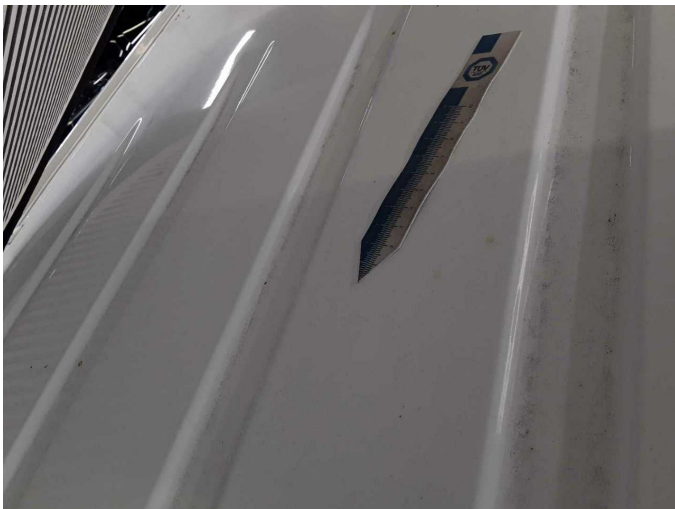
**Damage 7:** Roof: Roof - Deformed - Repair and paint

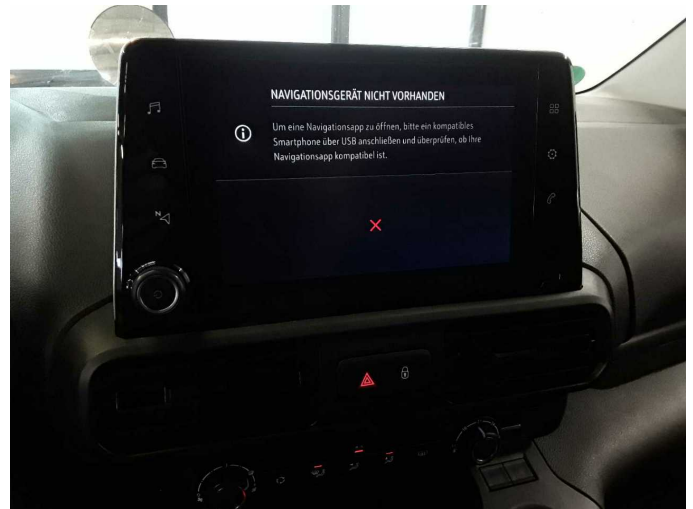
**Missing part 2:** Multimedia system: Navigation data storage - Missing - Replace

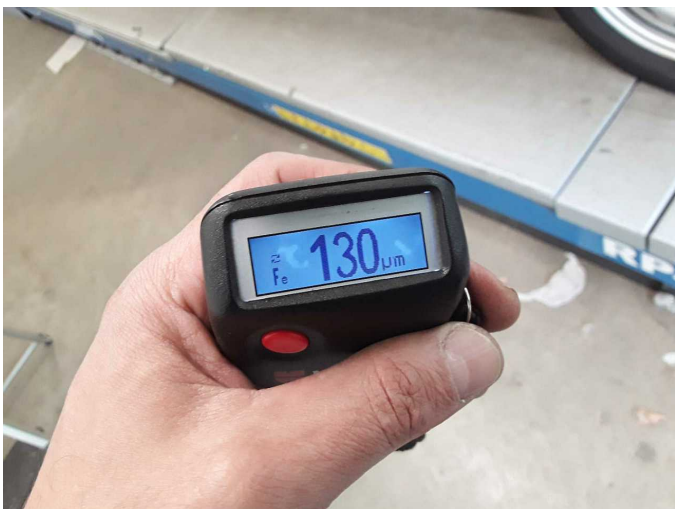
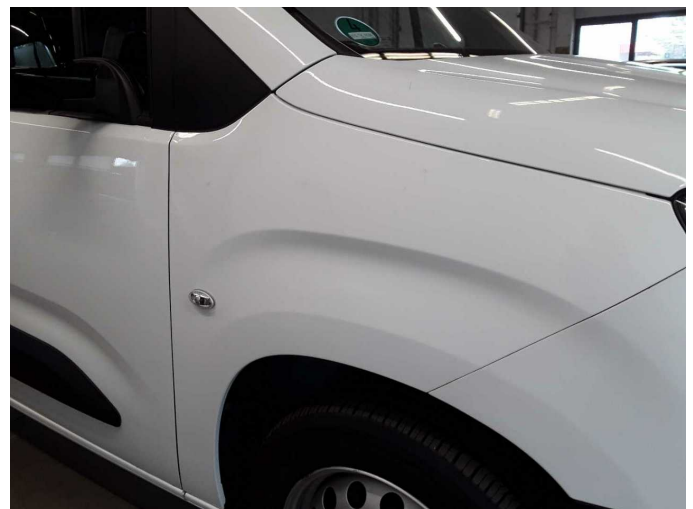
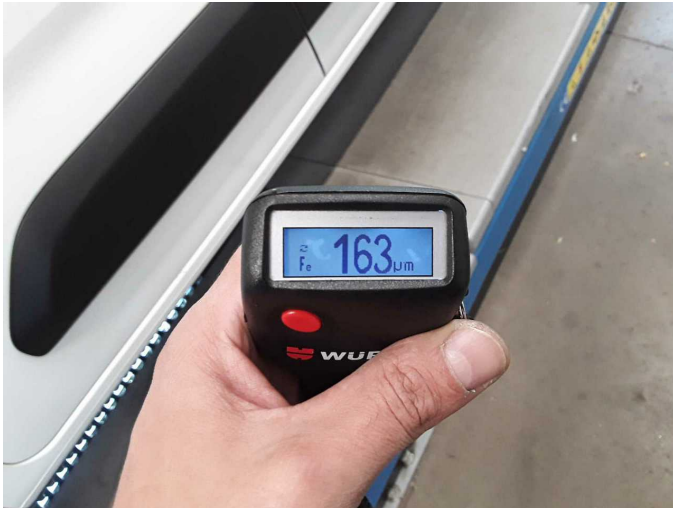
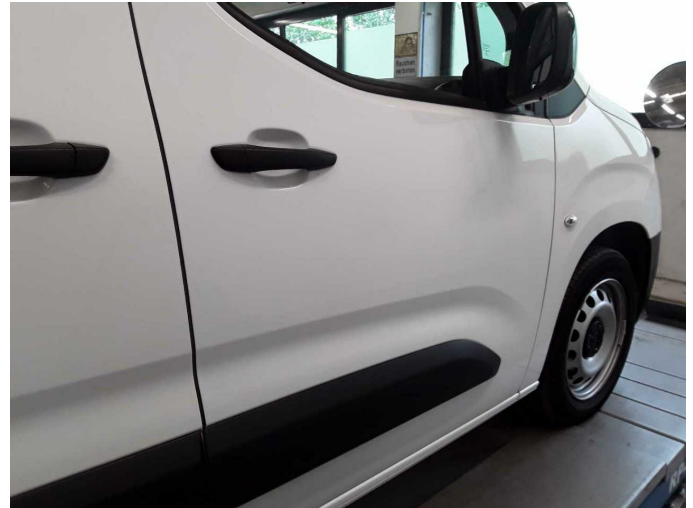
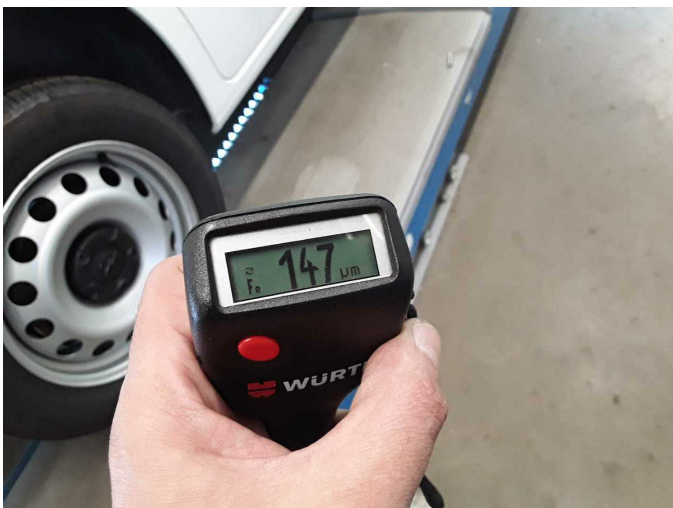
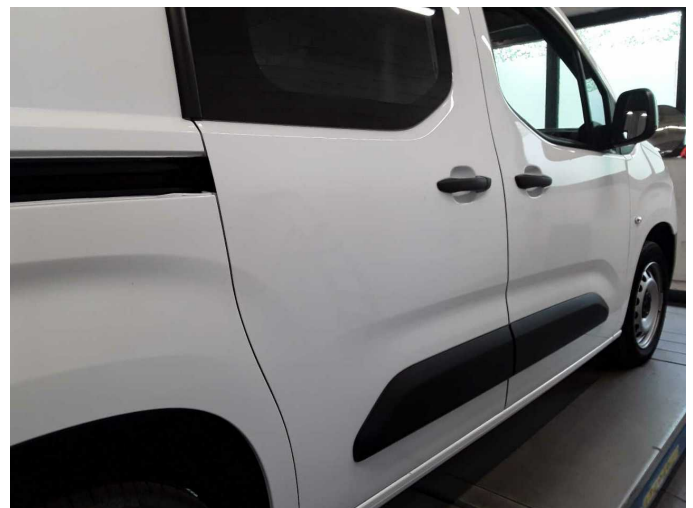
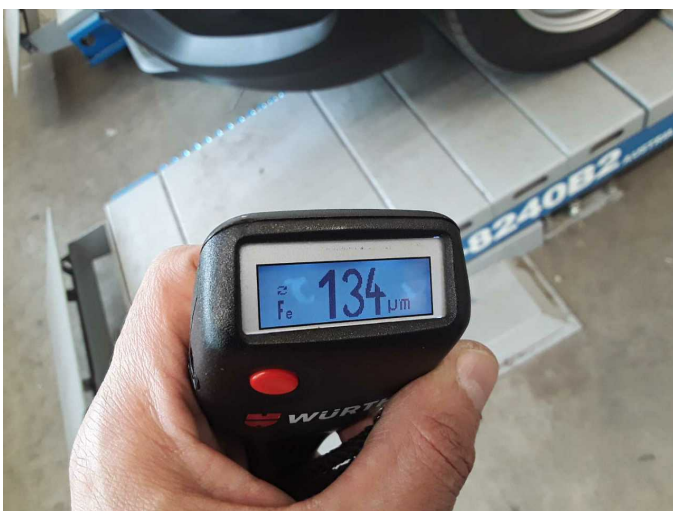
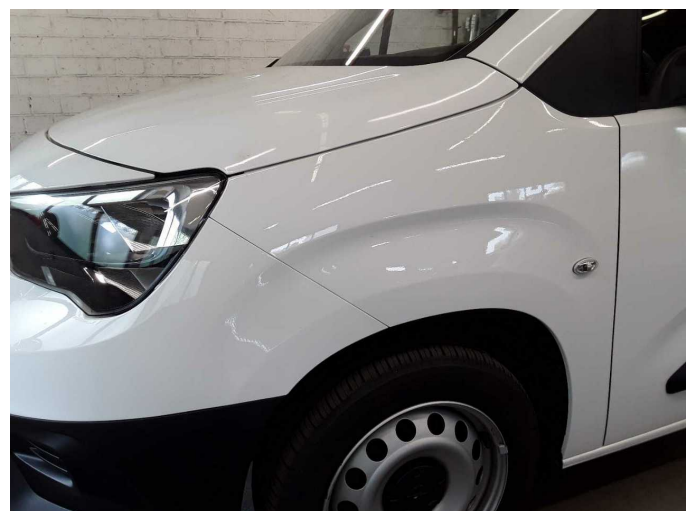
1	Mudguard - left side, Mudguard - right side, Door - rear right side, Door - front right side, Professionally carried out, Invoice of repair done	Non-existent
---	--	--------------

**Repainting 1:** Mudguard - left side, Mudguard - right side, Door - rear right side, Door - front right side
