Expertise

Protocol number: 45972765
Order No. / Reference: 26153877
Inspection date: 15 Jun 2026

Model: Vito 116 CDI Tourer Extralang Aut. PRO

VIN: W1VVLGFZ2T4547191

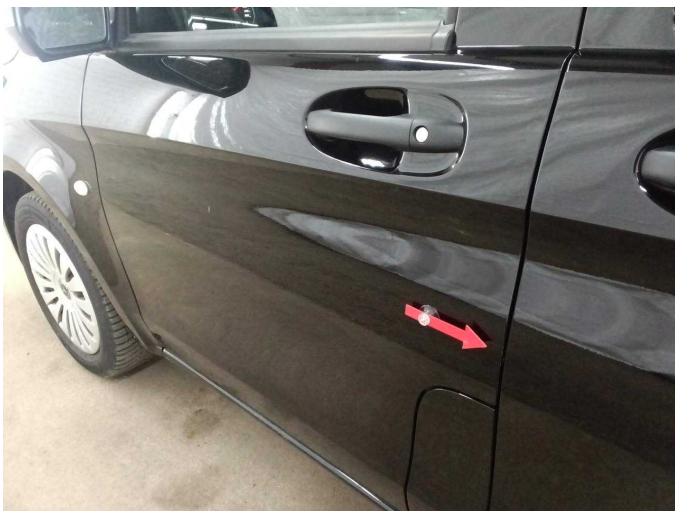
No.	Component group	Description
1	Door - front left side	Door edge - Scratch(es) - Smart repair
2	Sliding door, right	Sliding door - dent(s) - Smooth repair work
3	Roof	Roof - dent(s) - Smooth repair work
4	Rear bumper	Rear bumper - Scratch(es) - Smart repair
5	Front bumper	Front bumper - Stone chips - Smart repair
6	Wheel / tyres	Tyre - rear right side (Platten) - Leaking - Replace
7	Front bumper	Spoiler - Scratched - Replace
8	Sliding door - left side	Sliding door - Dent / paintcoat damage - Repair and paint

Damage 1: Door - front left side: Door edge - Scratch(es) - Smart repair

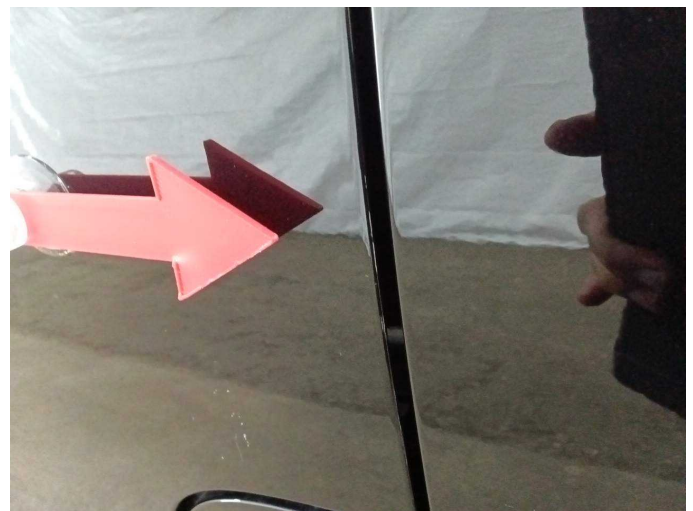
Damage 1: Door - front left side: Door edge - Scratch(es) - Smart repair

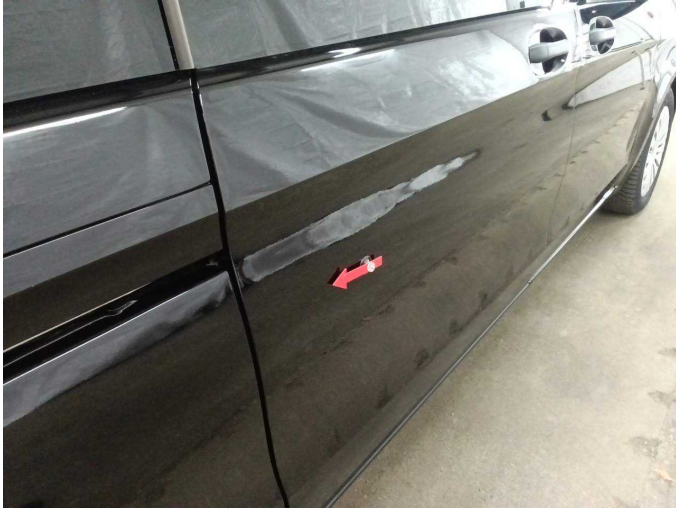
Damage 2: Sliding door, right: Sliding door - dent(s) - Smooth repair work

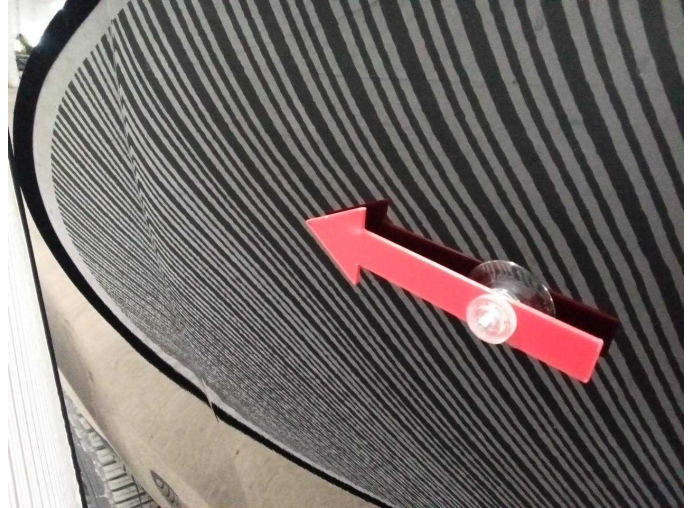
Damage 2: Sliding door, right: Sliding door - dent(s) - Smooth repair work

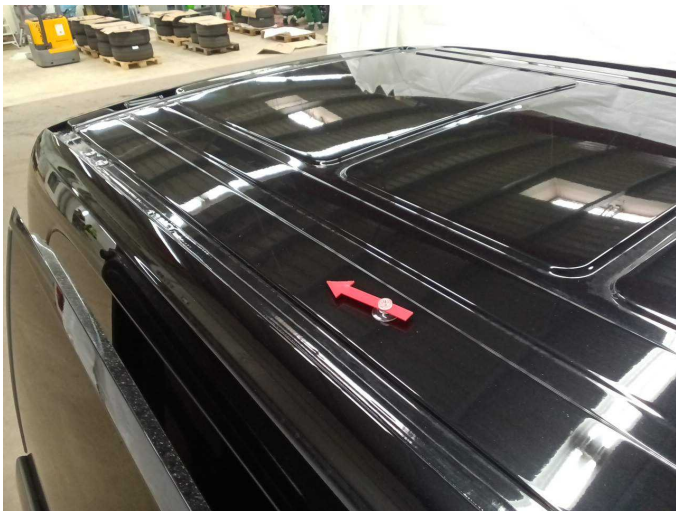
Damage 3: Roof: Roof - dent(s) - Smooth repair work

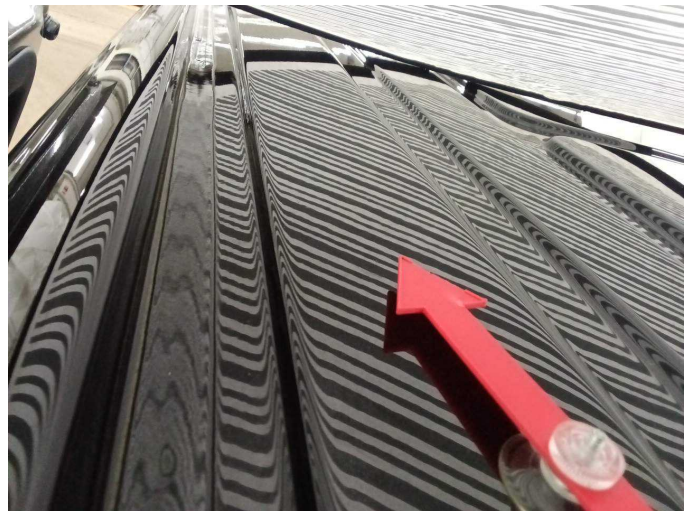
Damage 3: Roof: Roof - dent(s) - Smooth repair work

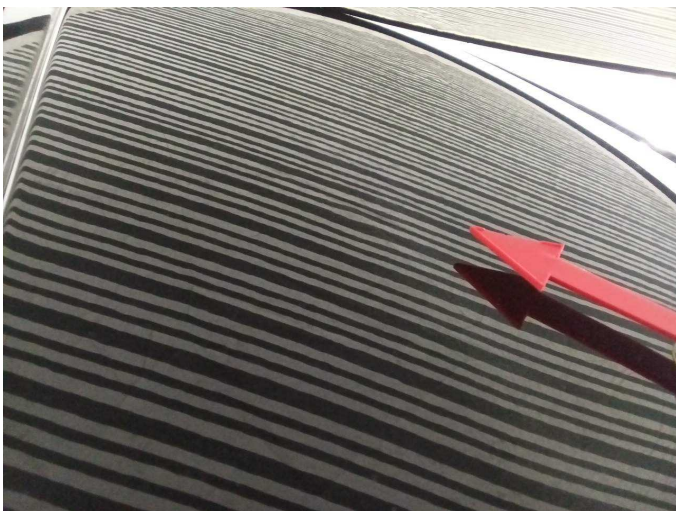
Damage 3: Roof: Roof - dent(s) - Smooth repair work

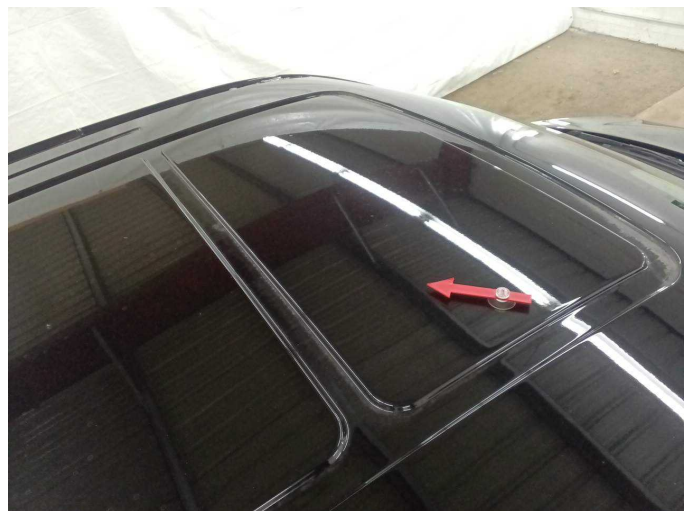
Damage 3: Roof: Roof - dent(s) - Smooth repair work

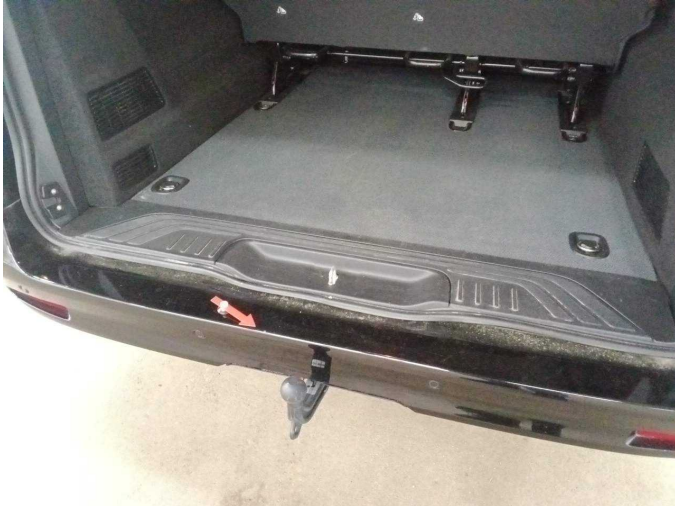
Damage 4: Rear bumper: Rear bumper - Scratch(es) - Smart repair

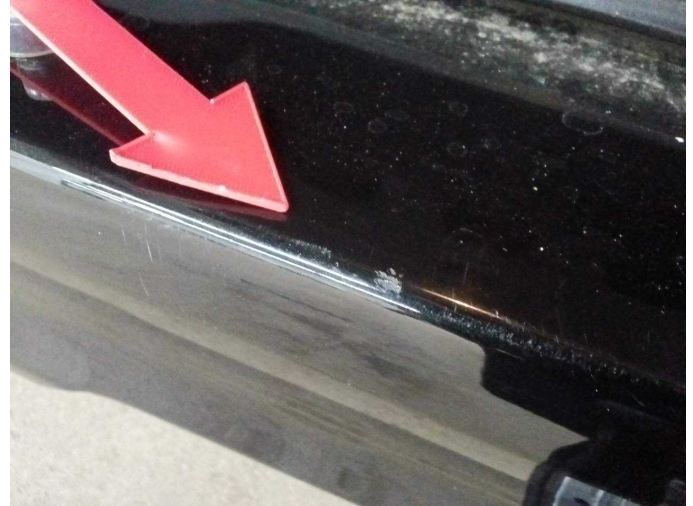
Damage 4: Rear bumper: Rear bumper - Scratch(es) - Smart repair

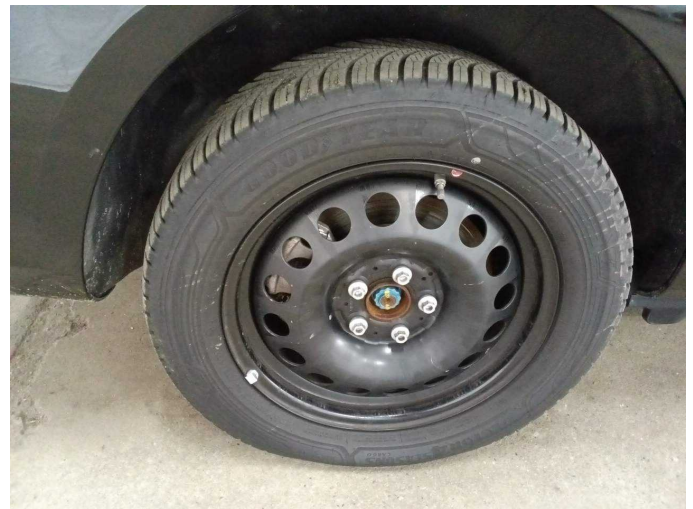
Documents submitted	At the time of the inspection, the vehicle registration certificate Part 2 (title) was available, but the vehicle registration certificate Part 1 (document) was not. (Copy)
VIN comparison	The vehicle identification number (VIN) was read from the vehicle and its conformity with the submitted documents was confirmed by the undersigned during the inspection.
Inspection	The inspection conditions were sufficient for the assessment of the vehicle. Lifting equipment and/or a pit were available for examining the vehicle.
Test drive	No test drive/shunting maneuver was carried out during the inspection of the vehicle.
Engine function test	An engine test run was performed.
readiness to drive	The vehicle was not capable of driving under its own power at the time of inspection, but can be moved on its own axle with the aid of assistance.

Damage 6: Wheel / tyres: Tyre - rear right side (Platten) - Leaking - Replace

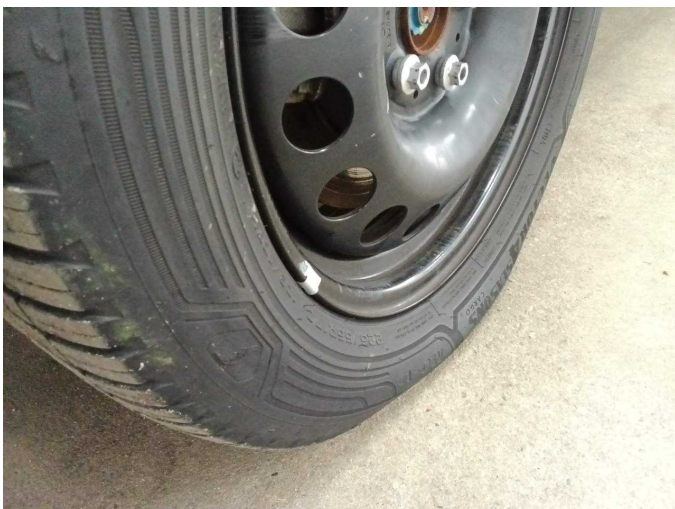
Damage 6: Wheel / tyres: Tyre - rear right side (Platten) - Leaking - Replace

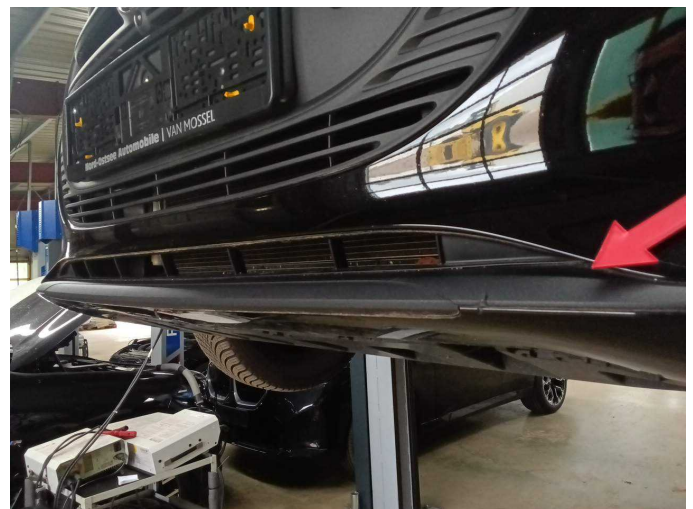
Damage 7: Front bumper: Spoiler - Scratched - Replace

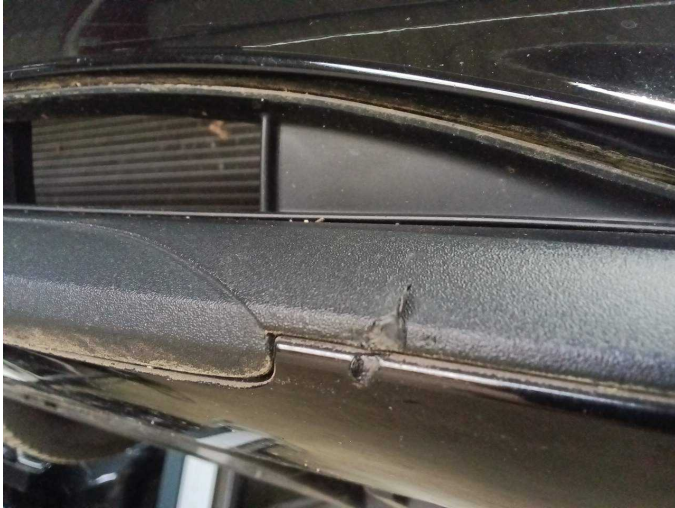
Damage 7: Front bumper: Spoiler - Scratched - Replace

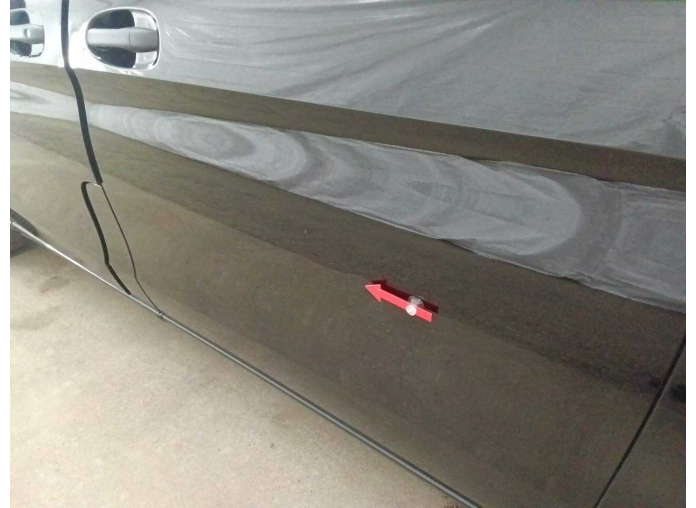
Damage 8: Sliding door - left side: Sliding door - Dent / paintcoat damage - Repair and paint

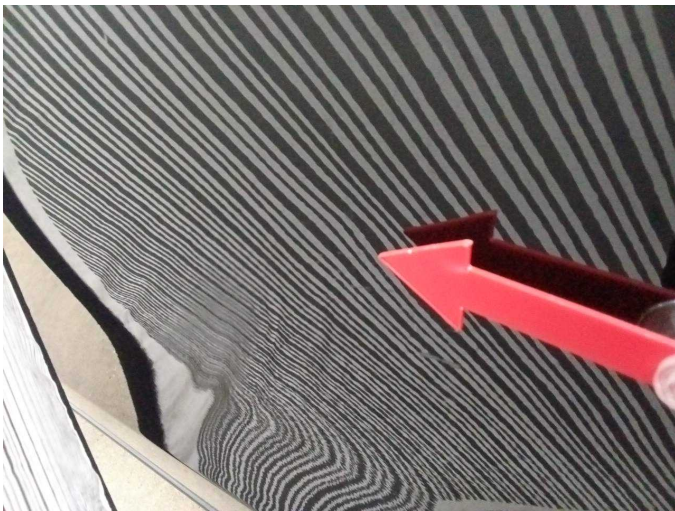
Damage 8: Sliding door - left side: Sliding door - Dent / paintcoat damage - Repair and paint

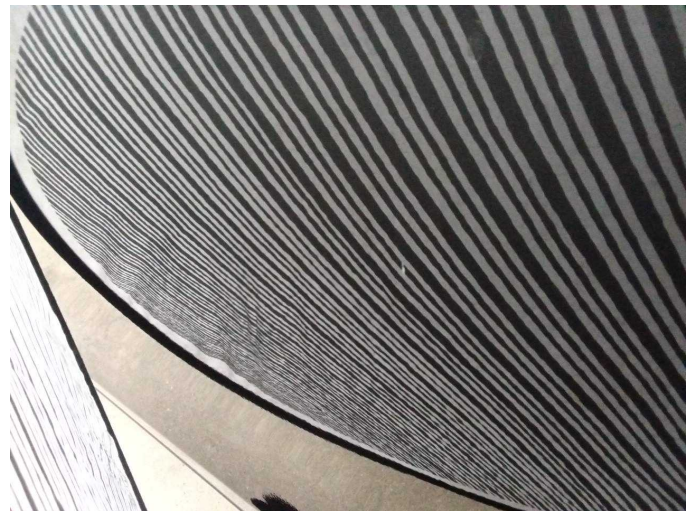
Damage 8: Sliding door - left side: Sliding door - Dent / paintcoat damage - Repair and paint
