Expertise

Protocol number: 46307479
Order No. / Reference: 26185430
Inspection date: 30 Jun 2026

Model: 317 CDI Sprinter Standard HA 9G-TRONIC PRO

VIN: W1V3KBFZ6TP862040

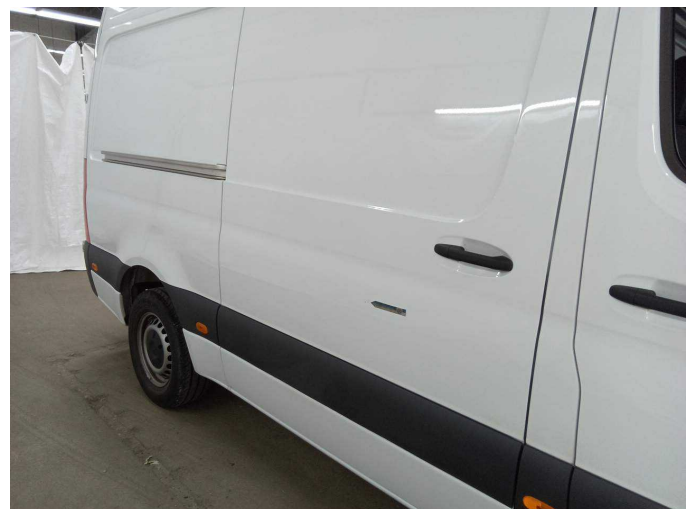
No.	Component group	Description
1	Sliding door, right	Sliding door - Dent / paintcoat damage - Paint

Damage 1: Sliding door, right: Sliding door - Dent / paintcoat damage - Paint

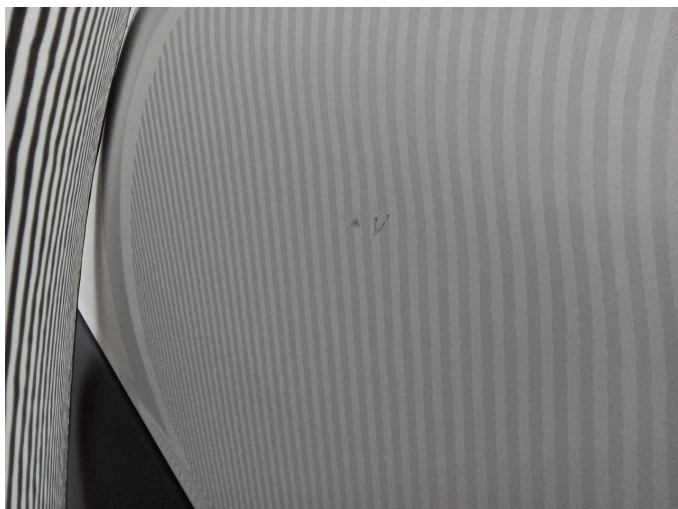
Damage 1: Sliding door, right: Sliding door - Dent / paintcoat damage - Paint

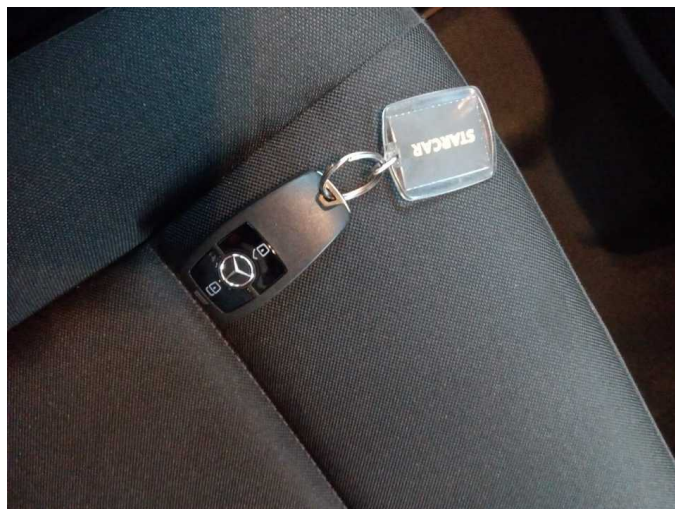
Equipment - Vehicle key

Missing part 1: Equipment: Vehicle key - Missing - No deduction
