Expertise

Protocol number: 45964803
Order No. / Reference: 26395319
Inspection date: 11 Jun 2026

Manufacturer: Volvo

Model: XC60 T6 AWD Recharge Core

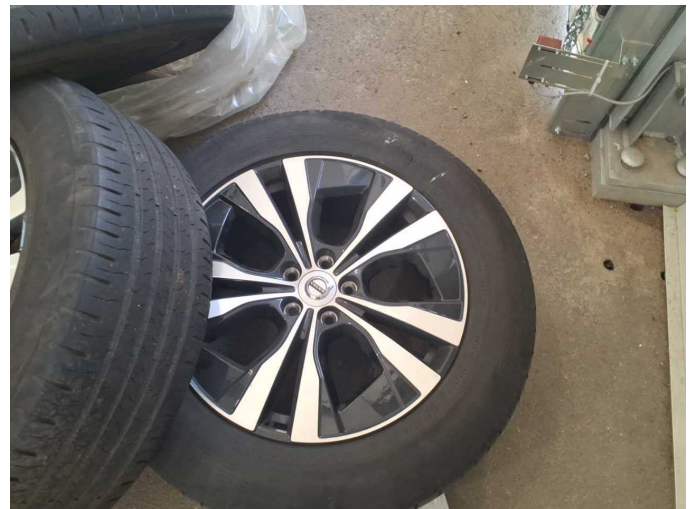
No.	Component group	Description
1	Misc.	Main inspection - No evidence - No deduction
2	Misc.	Inspection / maintenance (3. Wartung überzogen) - No deduction
3	2nd wheel set	1 tyre (Flankenbeschädigung) - Broken / torn - Replace

Damage 3: 2nd wheel set: 1 tyre (Flankenbeschädigung) - Broken / torn - Replace

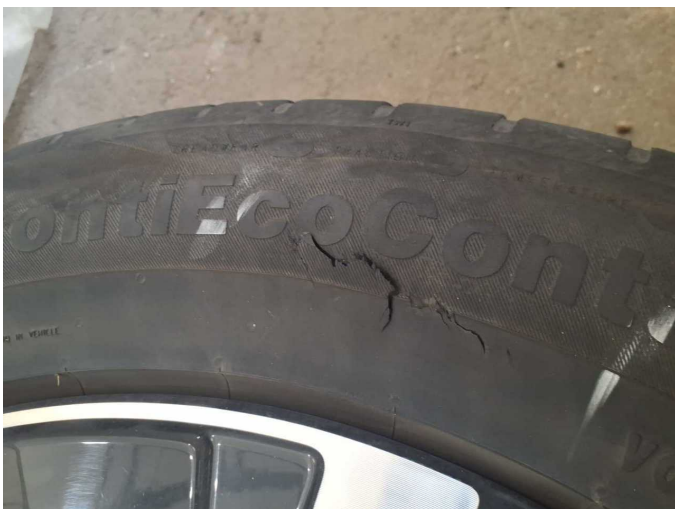
Damage 3: 2nd wheel set: 1 tyre (Flankenbeschädigung) - Broken / torn - Replace
