## Expertise

Protocol number: 45775803  
Order No. / Reference: 26433556  
Inspection date: 3 Jun 2026

Manufacturer: Ford

Model: Focus Turnier 2.0 EcoBlue Start-Stopp-System Aut.  
COOL&CONNECT

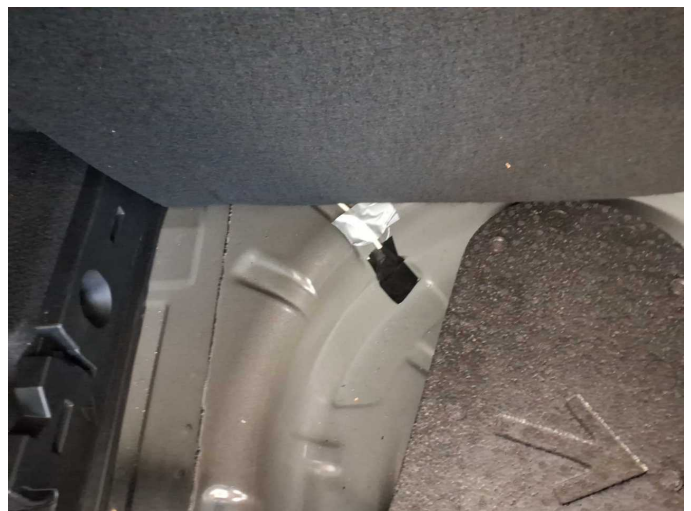
Damage 2: Electrical system: Cable strand - Specify findings - Remove

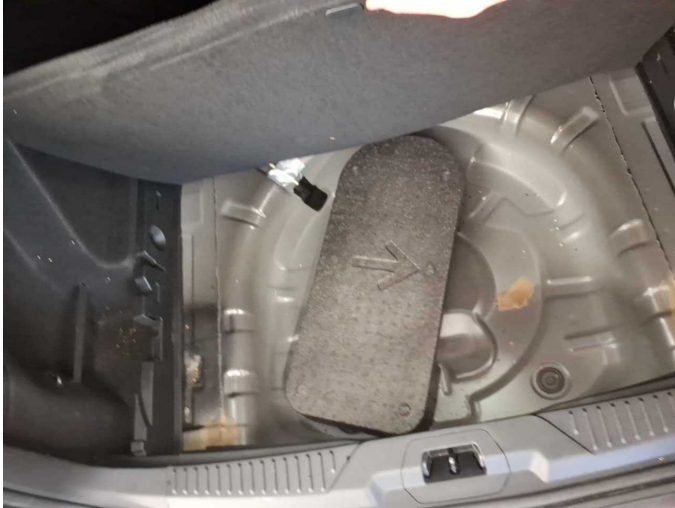
**Damage 2:** Electrical system: Cable strand - Specify findings - Remove

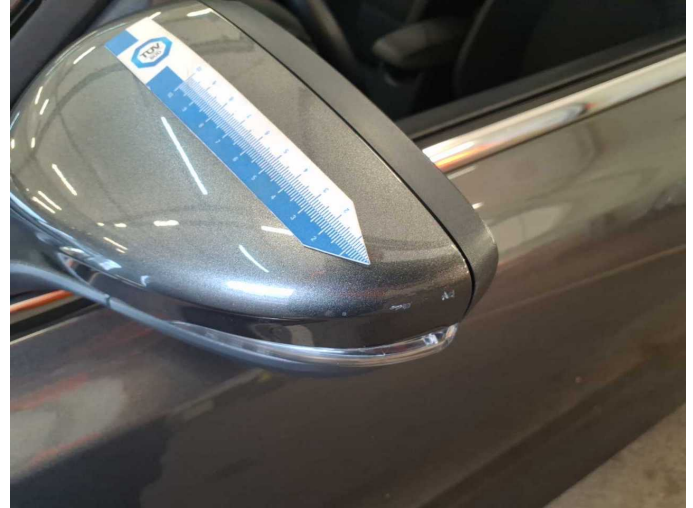
**Damage 3:** Wing mirror - left side: Cap - Scratch(es) - Smart repair

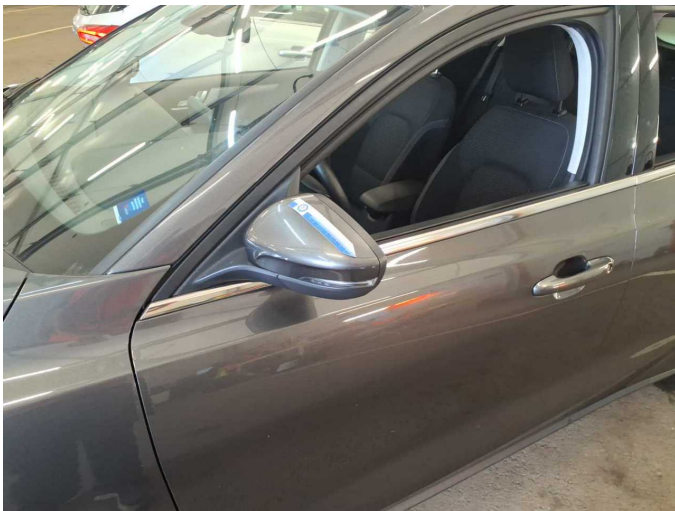
**Damage 3:** Wing mirror - left side: Cap - Scratch(es) - Smart repair

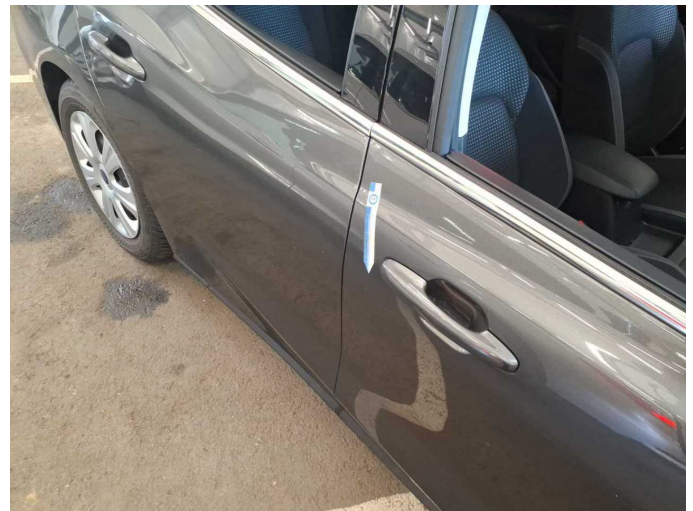
**Damage 4:** Door - front right side: Door - dent(s) - Smooth repair work

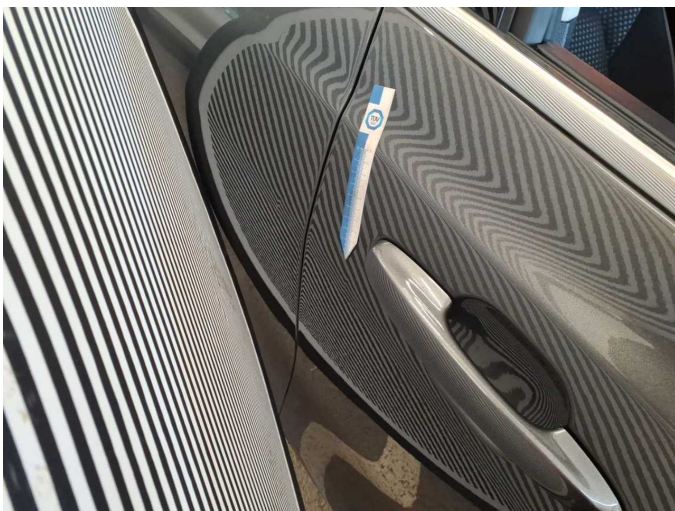
**Damage 4:** Door - front right side: Door - dent(s) - Smooth repair work

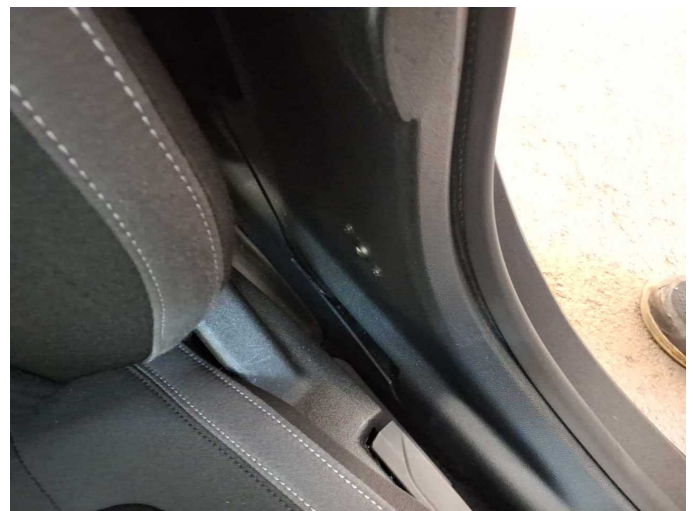
**Damage 5:** Trim / covers: B-pillar - trim - interior, left side - Damaged - Replace

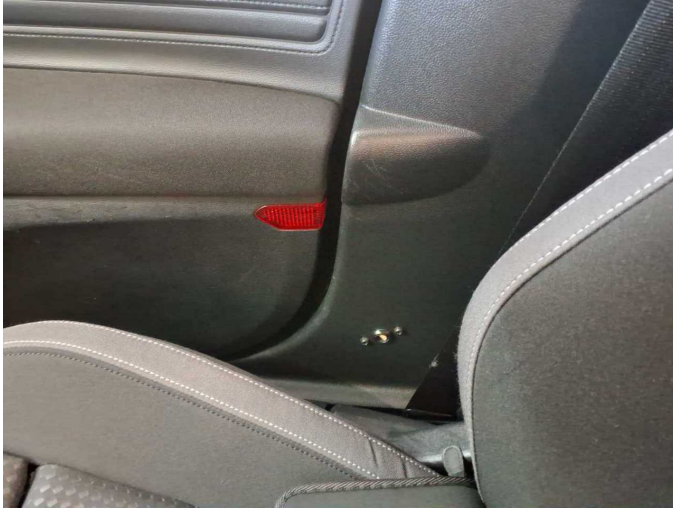
**Damage 6:** Trim / covers: B-pillar - trim - interior, right side - Damaged - Replace

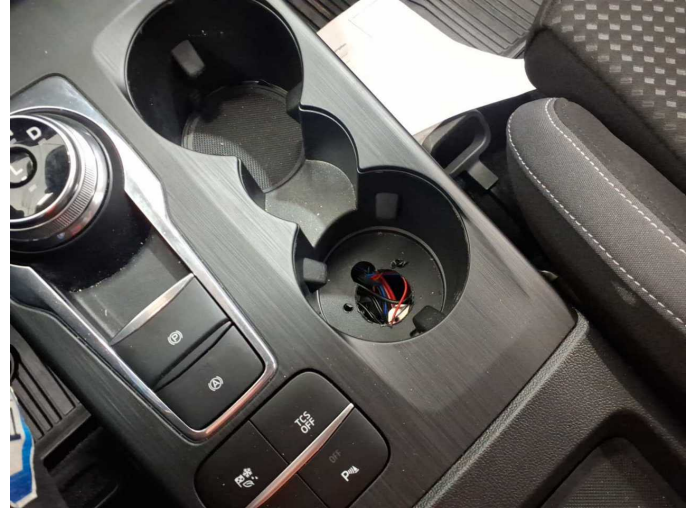
**Damage 7:** Instrument panel: Centre console - front - Damaged - Replace

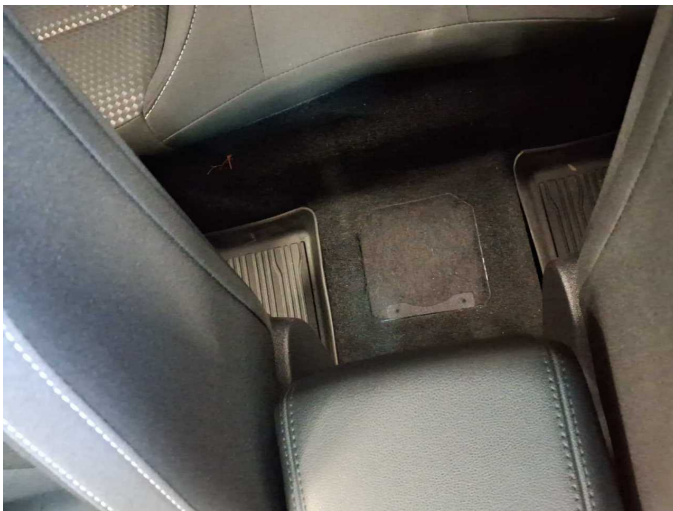
**Damage 8:** Trim / covers: Carpet - Damaged - Replace

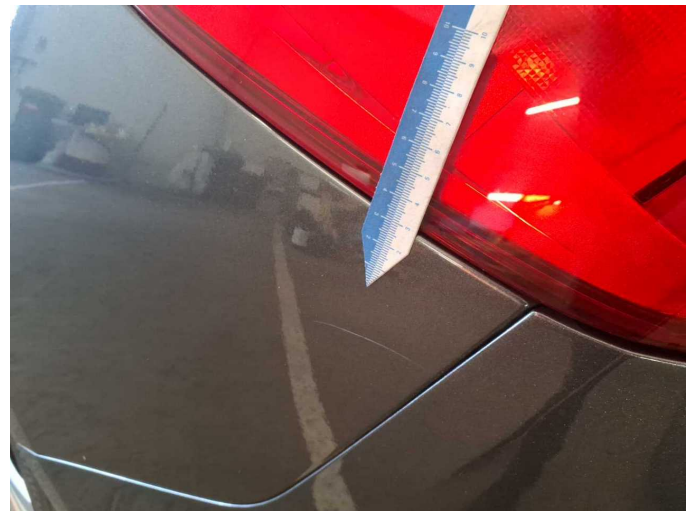
**Damage 9:** Side panel - rear left side: Side panel - Scratch(es) - Paint

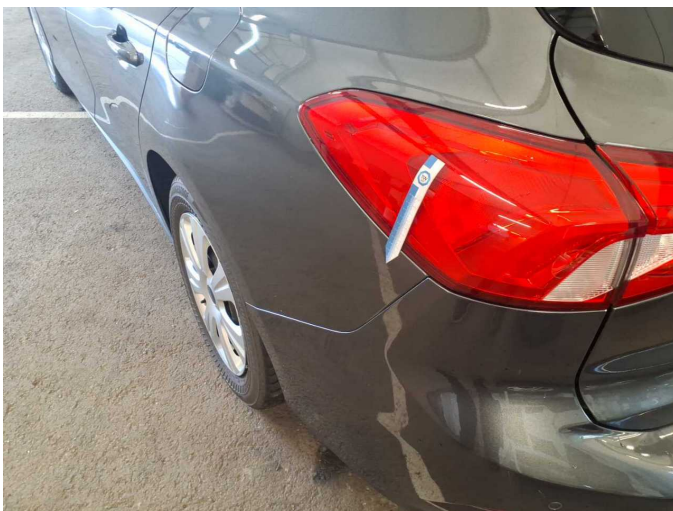
**Damage 9:** Side panel - rear left side: Side panel - Scratch(es) - Paint

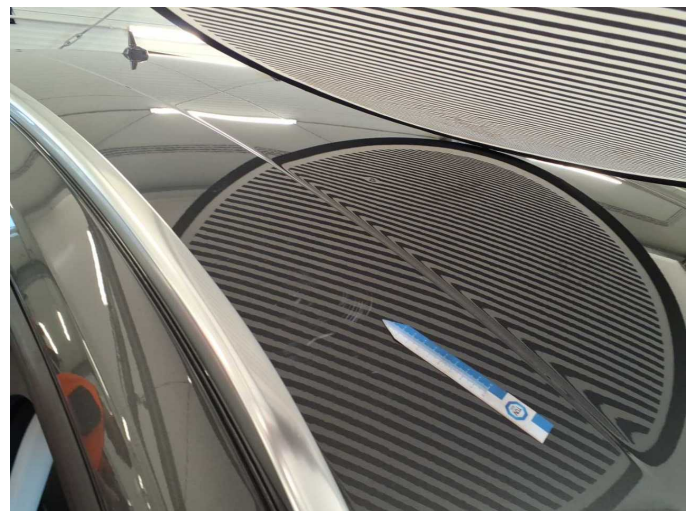
**Damage 10:** Roof: Roof - Dent / paintcoat damage - Repair and paint

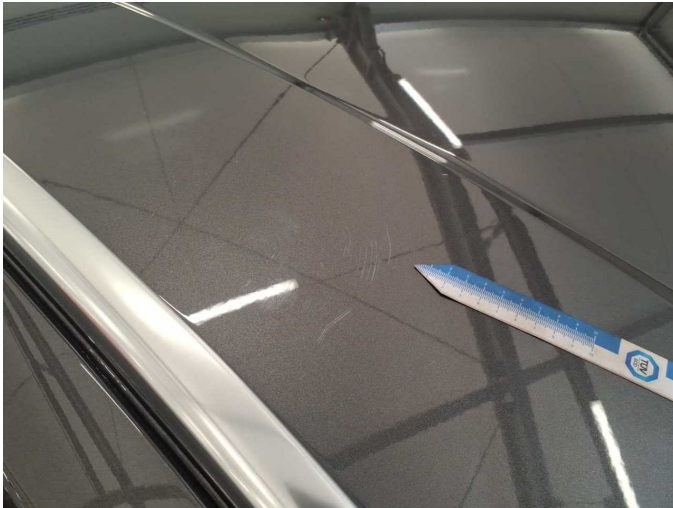
**Damage 10:** Roof: Roof - Dent / paintcoat damage - Repair and paint

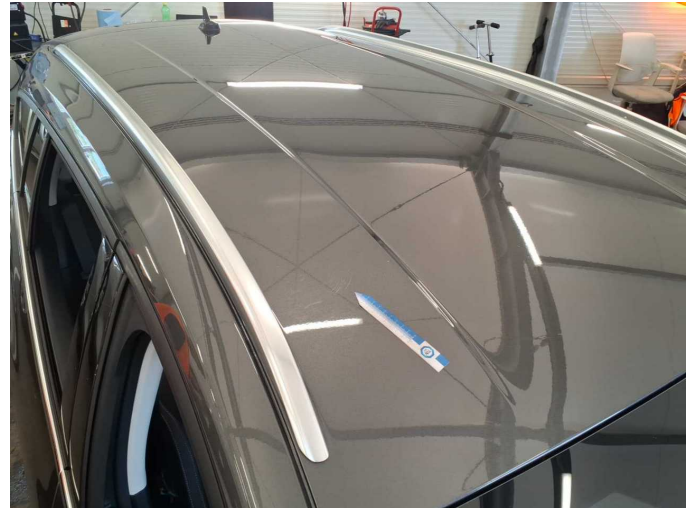
**Damage 10:** Roof: Roof - Dent / paintcoat damage - Repair and paint

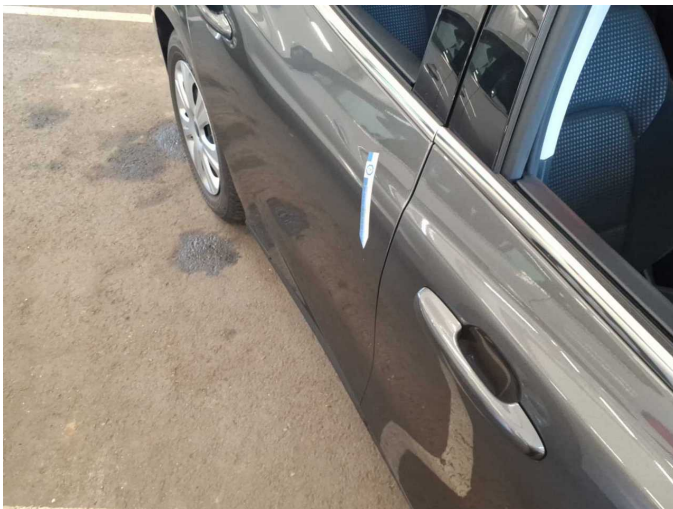
**Wear and tear 5:** Door - rear right side: Door - dent(s) - No deduction

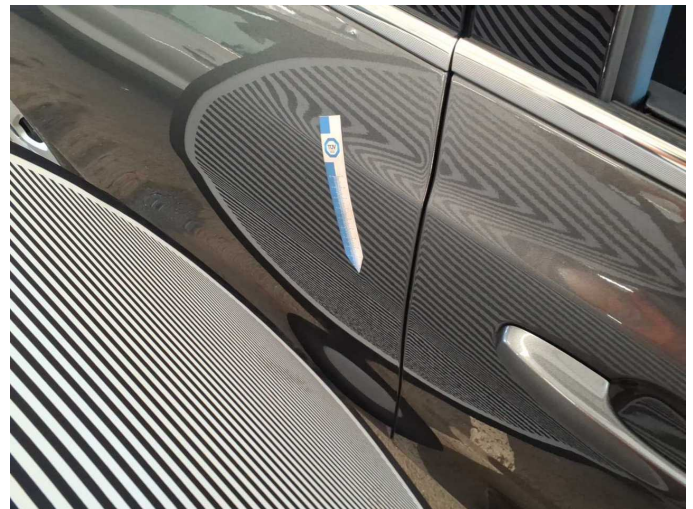
**Wear and tear 5:** Door - rear right side: Door - dent(s) - No deduction

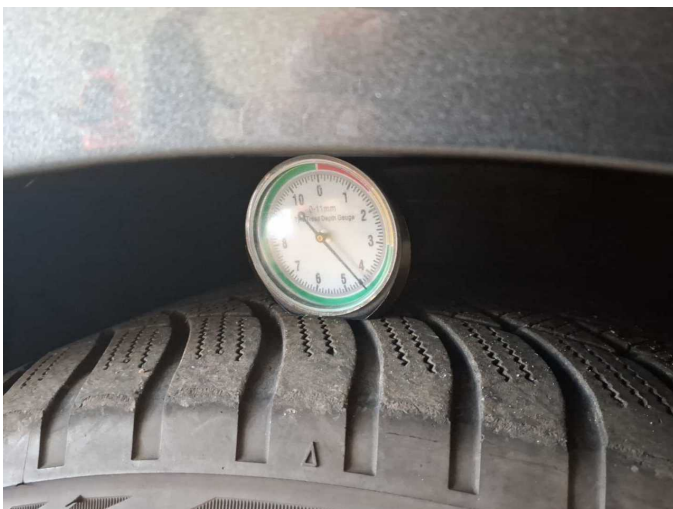
**Wear and tear 6:** Wheel / tyres: Tyre - front left side - Abrasion - No deduction

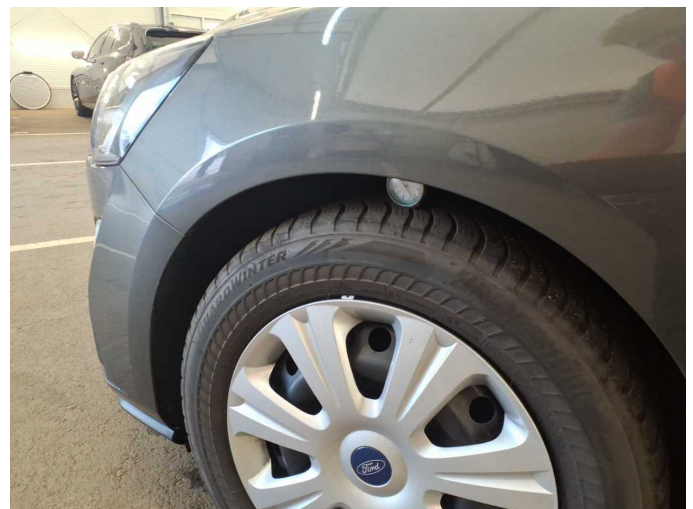
**Wear and tear 6:** Wheel / tyres: Tyre - front left side - Abrasion - No deduction

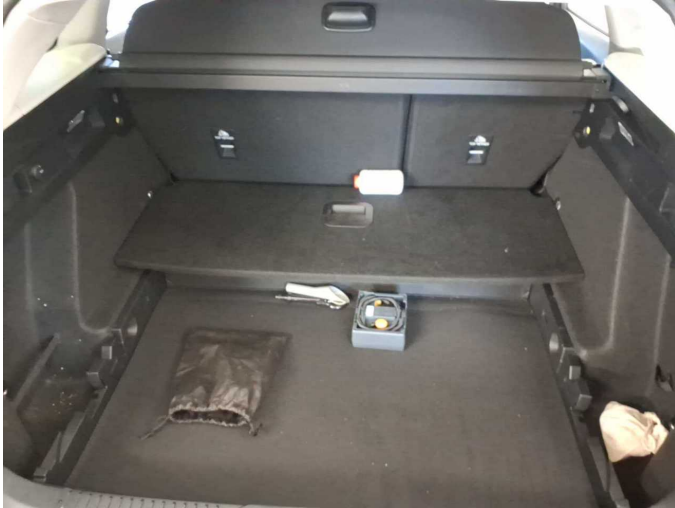
**Missing part 1:** Interior: Separation net - Missing - Replace
