Expertise

Protocol number: 46655185  
Order No. / Reference: 26623027  
Inspection date: 22 Jul 2026

Manufacturer: Opel

Model: Mokka 1.2 DI Turbo Edition

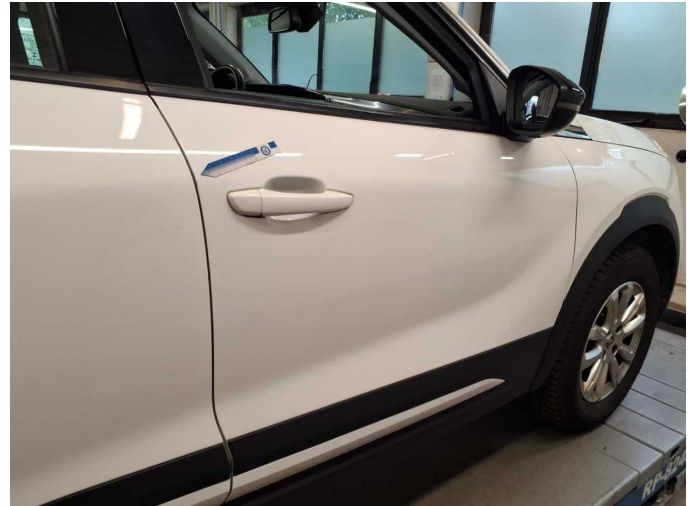
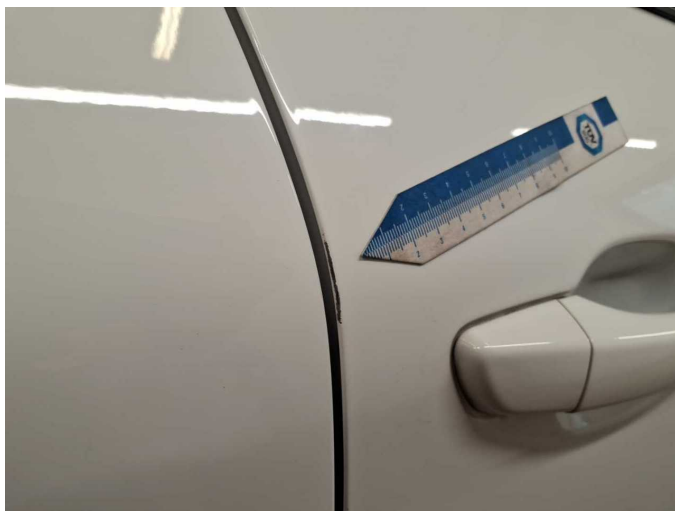
| No. | Component group | Description |
|---|---|---|
| 1 | Door - front right side | Door edge - Scratched - Smart repair |

**Damage 1:** Door - front right side: Door edge - Scratched - Smart repair

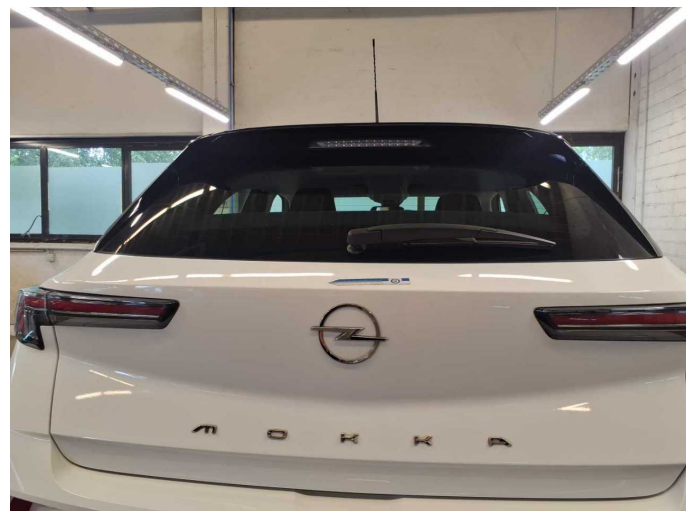
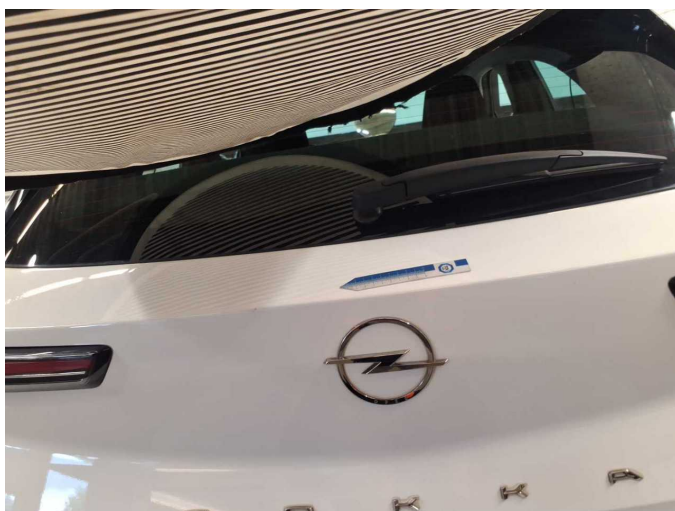
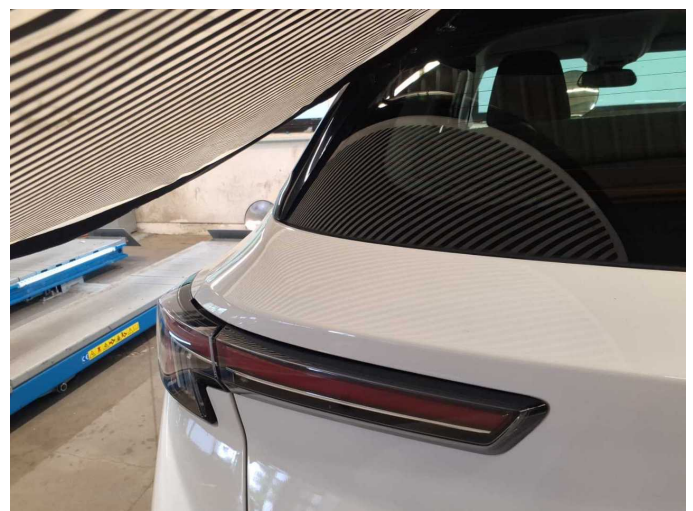
| No. | Component group | Description |
|---|---|---|
| 2 | Boot lid / rear door | Boot lid - dent(s) - Smooth repair work |

**Damage 2:** Boot lid / rear door: Boot lid - dent(s) - Smooth repair work

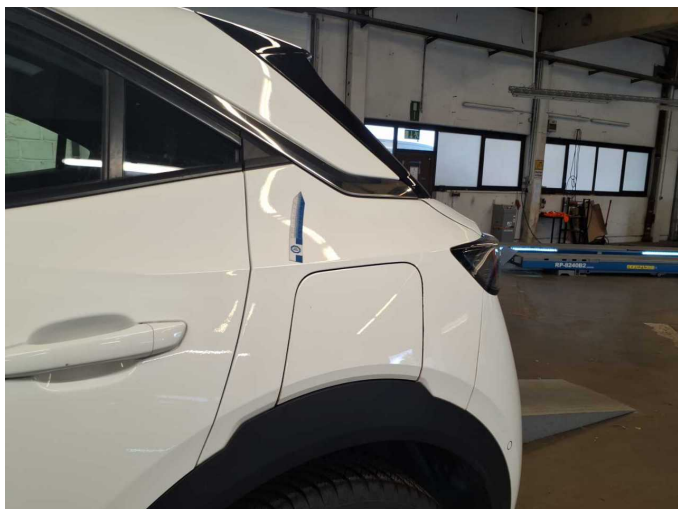
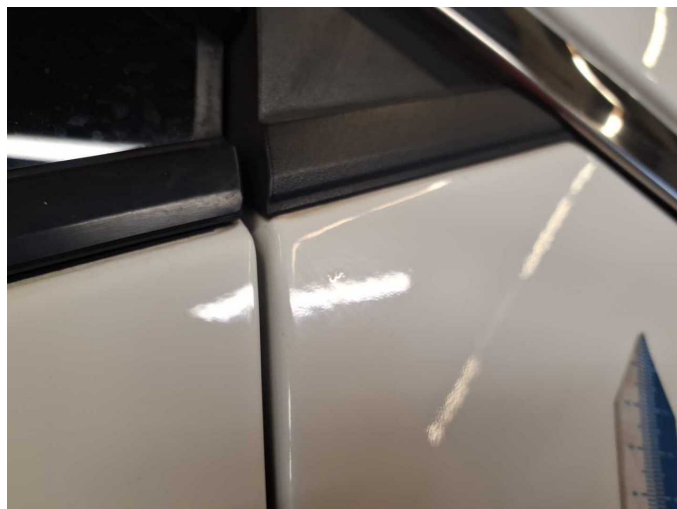
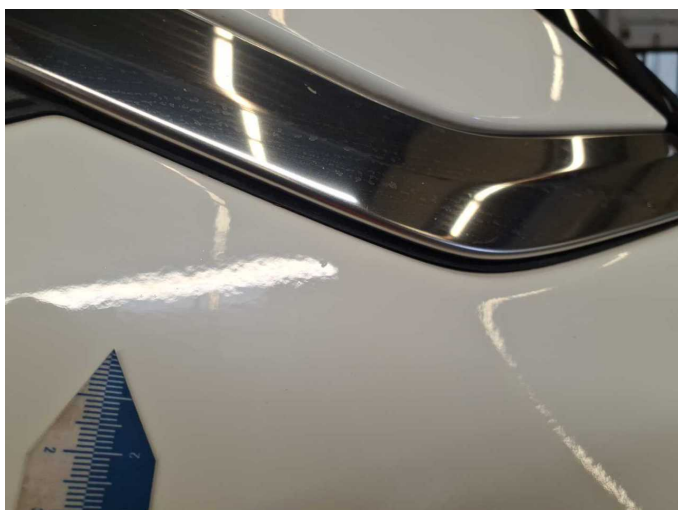
| No. | Component group | Description |
|---|---|---|
| 3 | Side panel - rear left side | Side panel (Lackpickel) - Unprofessionally repaired - Smart repair |

**Damage 3:** Side panel - rear left side: Side panel (Lackpickel) - Unprofessionally repaired - Smart repair

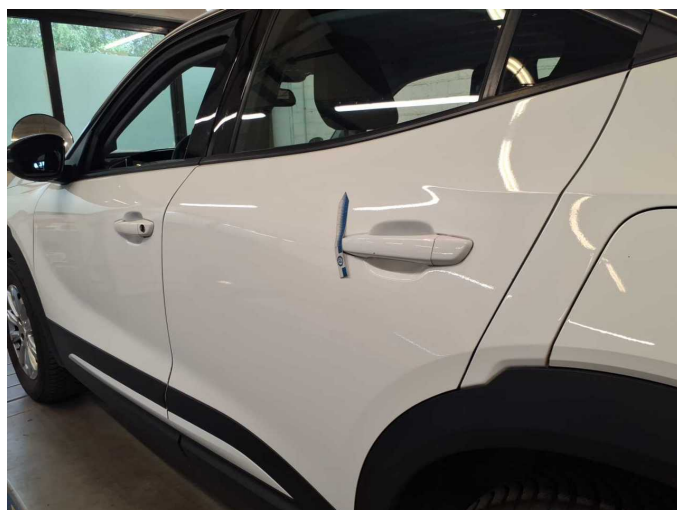
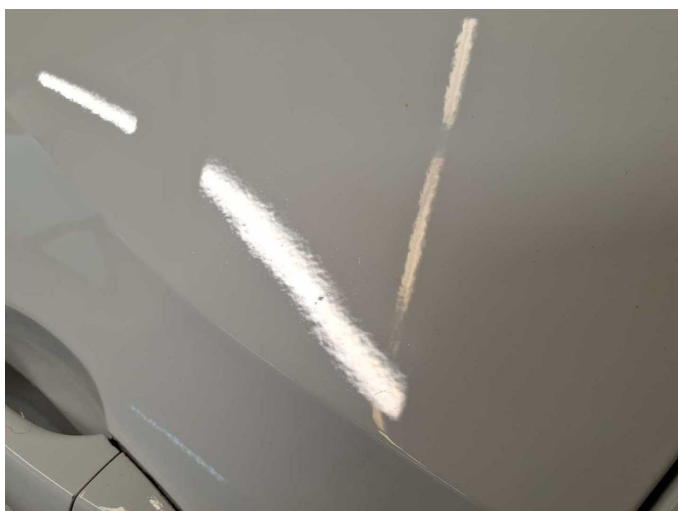
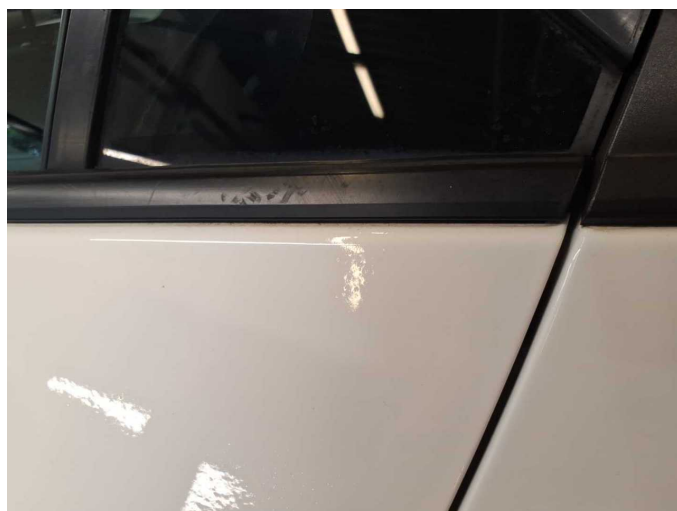
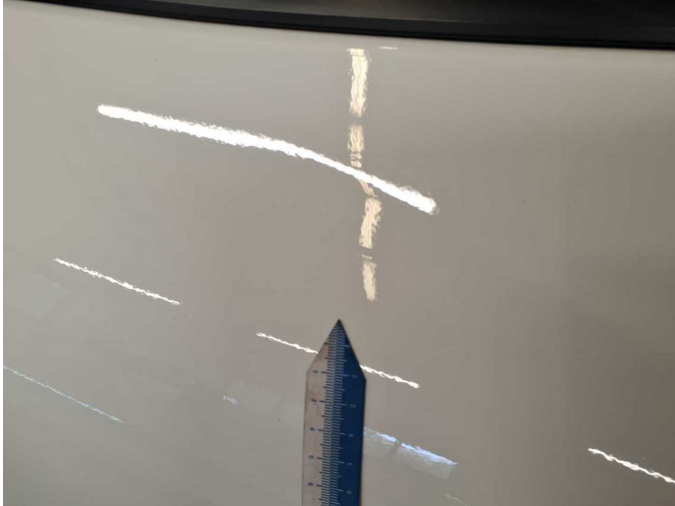
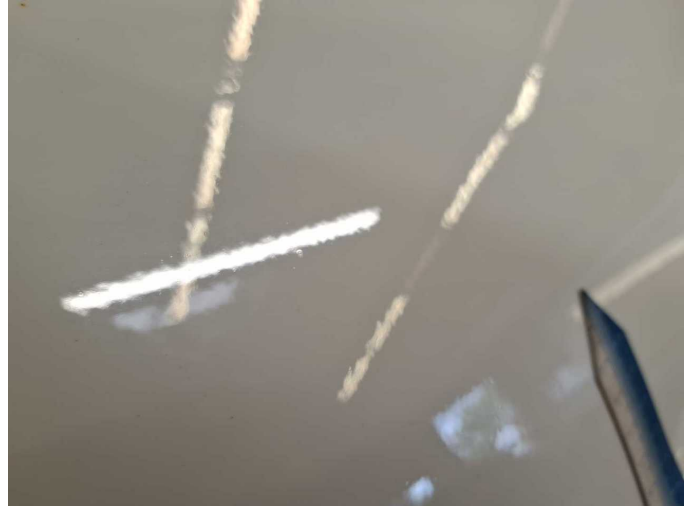
| No. | Component group | Description |
|---|---|---|
| 5 | Door - rear left side | Door (Lackpickel) - Unprofessionally repaired - Paint |

**Damage 5:** Door - rear left side: Door (Lackpickel) - Unprofessionally repaired - Paint

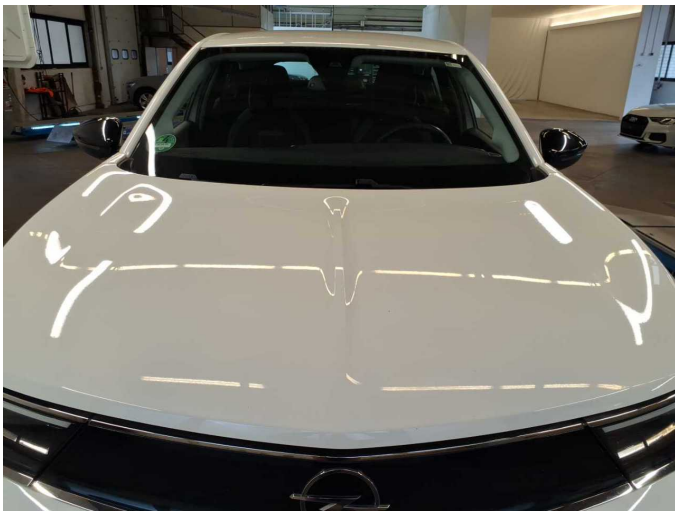
| No. | Component group | Description |
|---|---|---|
| 1 | Bonnet | Bonnet - Stone chips - No deduction |

**Wear and tear 1:** Bonnet: Bonnet - Stone chips - No deduction

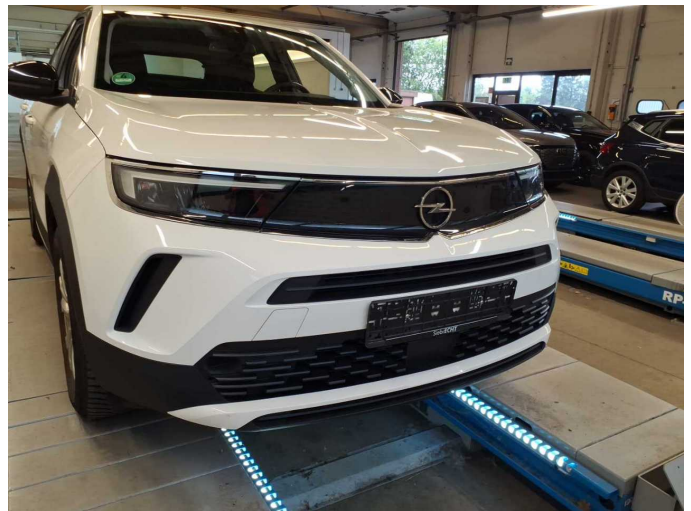
| No. | Component group | Description |
|---|---|---|
| 2 | Front bumper | Front bumper - Stone chips - No deduction |

**Wear and tear 2:** Front bumper: Front bumper - Stone chips - No deduction

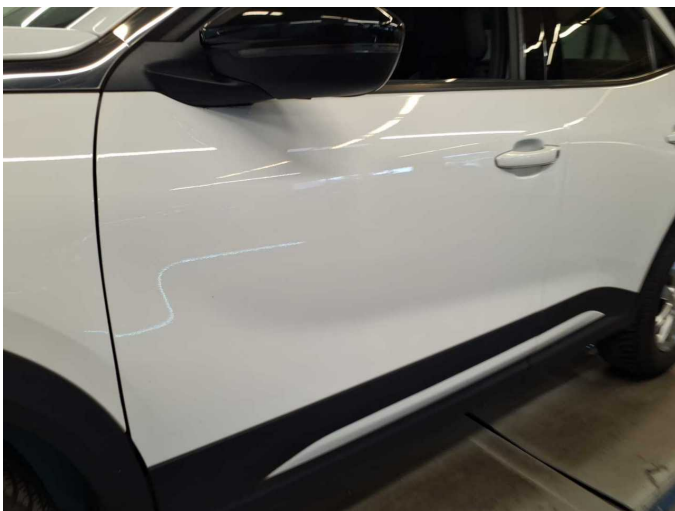
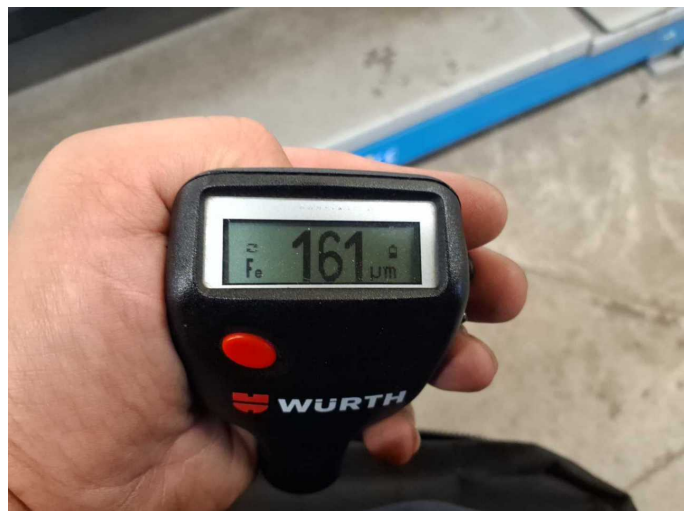
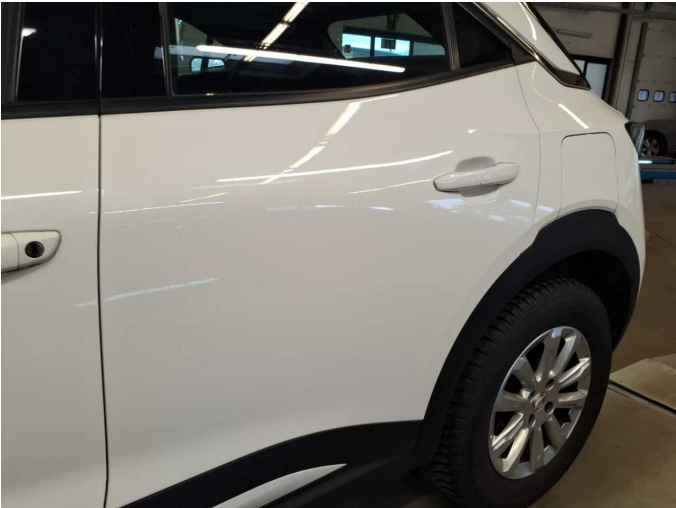
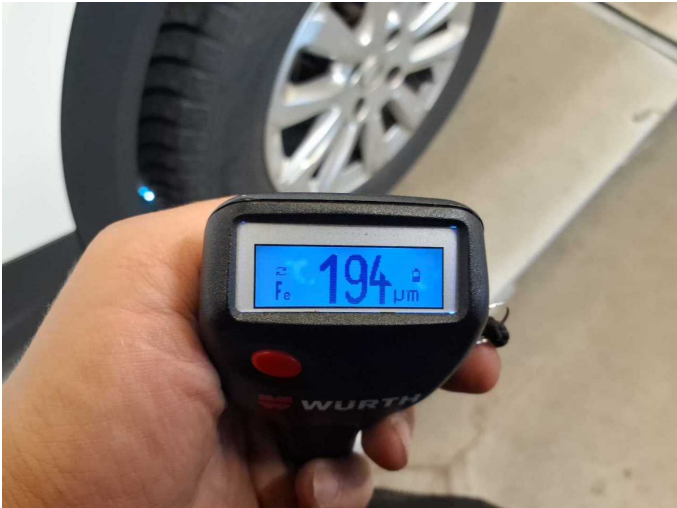
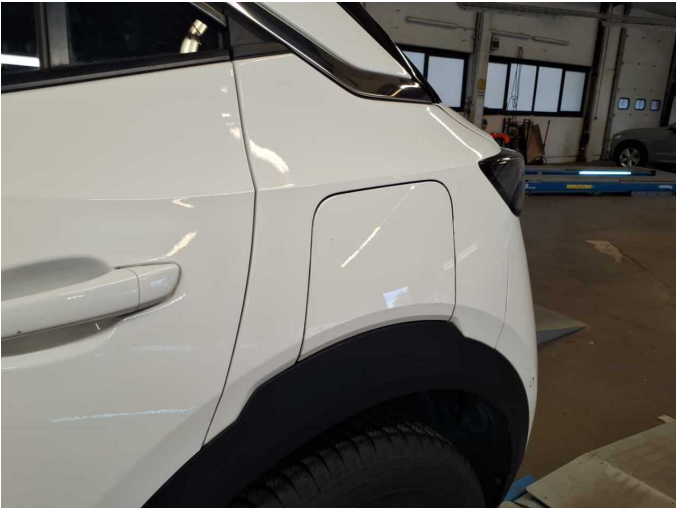
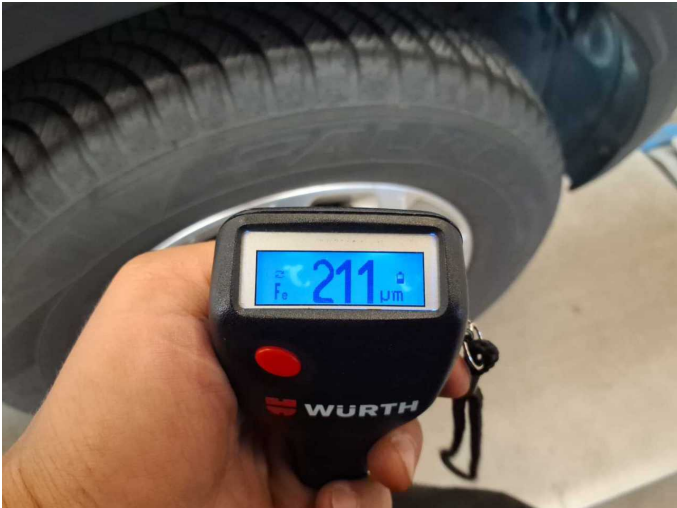
| No. | Repainting |
|---|---|
| 1 | Side panel - rear left side, Door - rear left side, Door - front left side |

| Side panel - rear left side | 219 µm | Door - rear left side | 190 µm |
| Door - front left side | 159 µm | | |

**Repainting 1:** Side panel - rear left side, Door - rear left side, Door - front left side
