Expertise

Protocol number: 46192141
Order No. / Reference: 26151819
Inspection date: 21 May 2026

Model: Vito 116 CDI Tourer Extralang Aut. PRO

VIN: W1VVLGFZ2T4557297

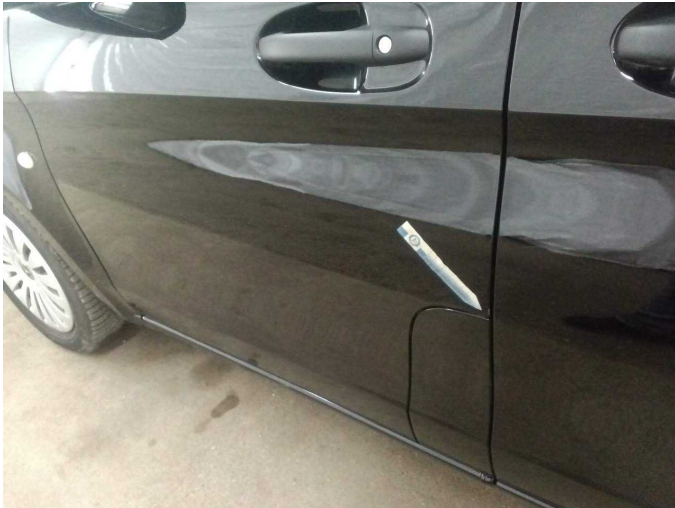
Damage 1: Door - front left side: Door edge - Scratch(es) - Smart repair

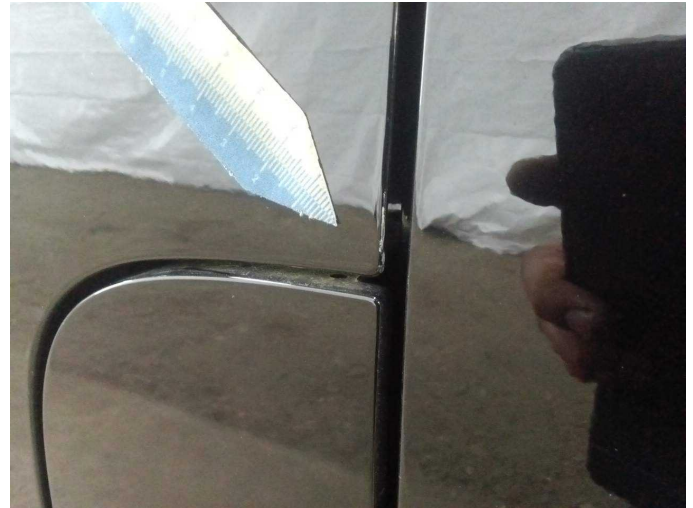
Damage 1: Door - front left side: Door edge - Scratch(es) - Smart repair

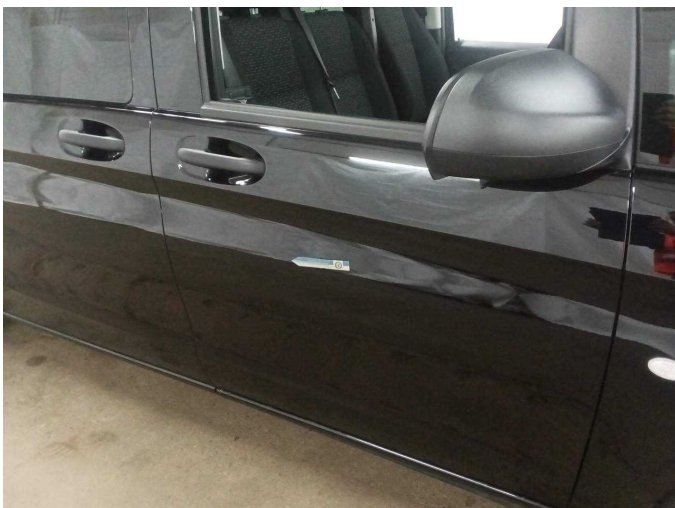
Damage 2: Door - front right side: Door - dent(s) - Smooth repair work

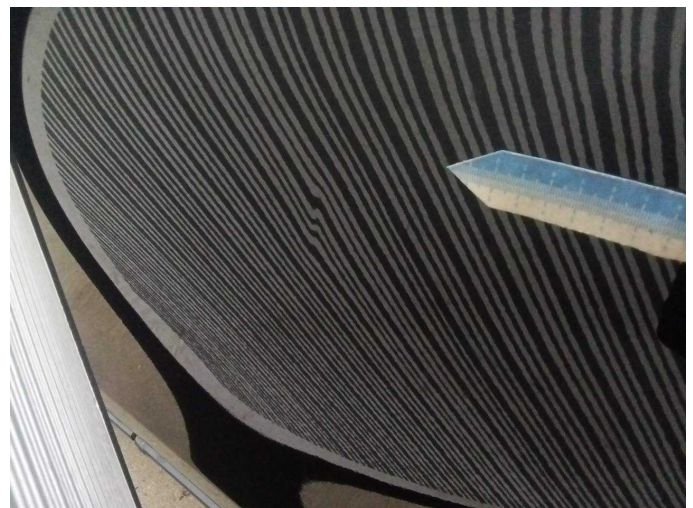
Damage 2: Door - front right side: Door - dent(s) - Smooth repair work

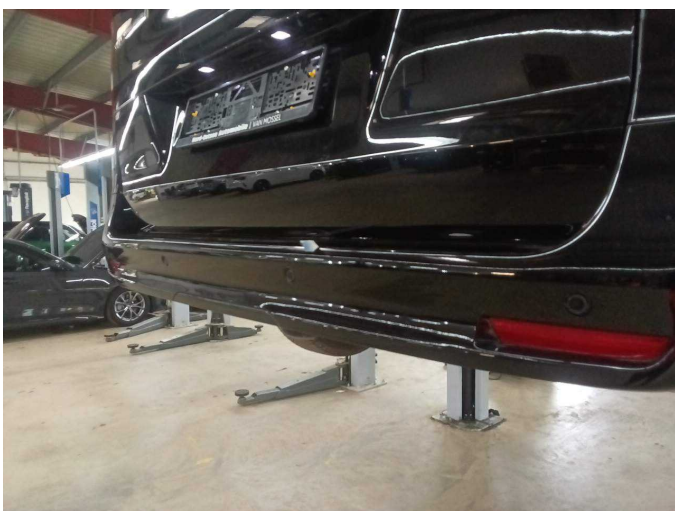
Damage 3: Rear bumper: Rear bumper - Scratch(es) - Smart repair

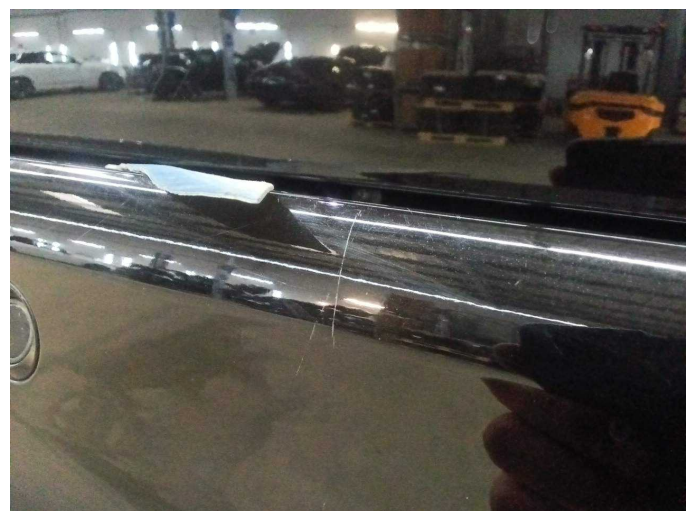
Damage 3: Rear bumper: Rear bumper - Scratch(es) - Smart repair

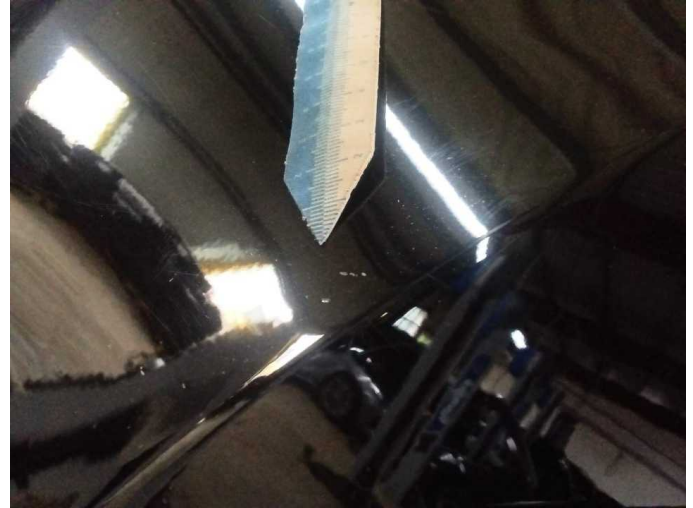
Damage 4: Side panel - rear left side: Side panel - Scratch(es) - Smart repair

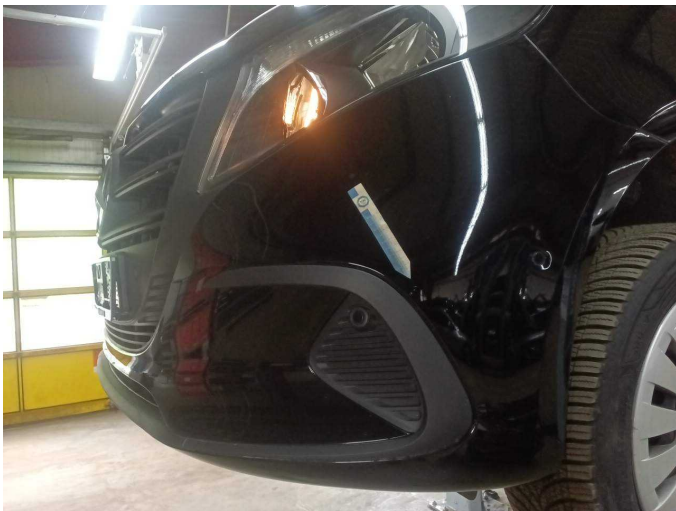
Damage 5: Front bumper: Front bumper - Stone chips - Paint

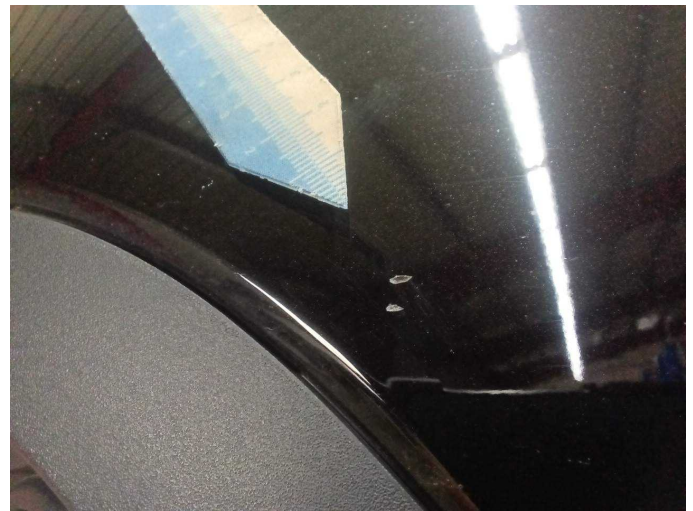
Damage 5: Front bumper: Front bumper - Stone chips - Paint

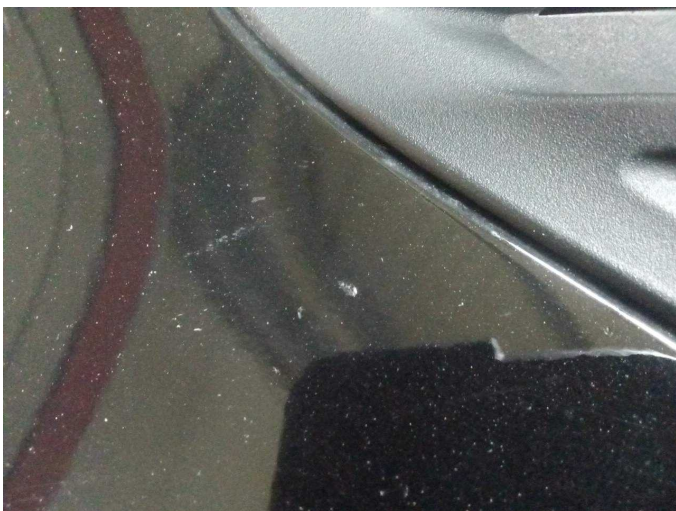
Damage 5: Front bumper: Front bumper - Stone chips - Paint

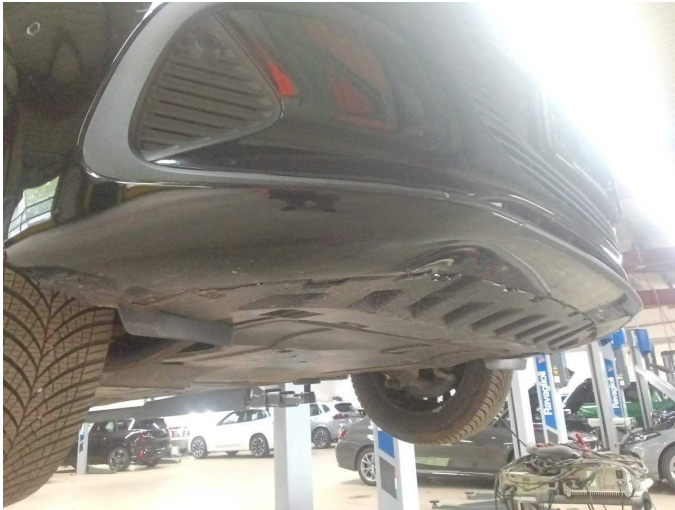
Damage 5: Front bumper: Front bumper - Stone chips - Paint

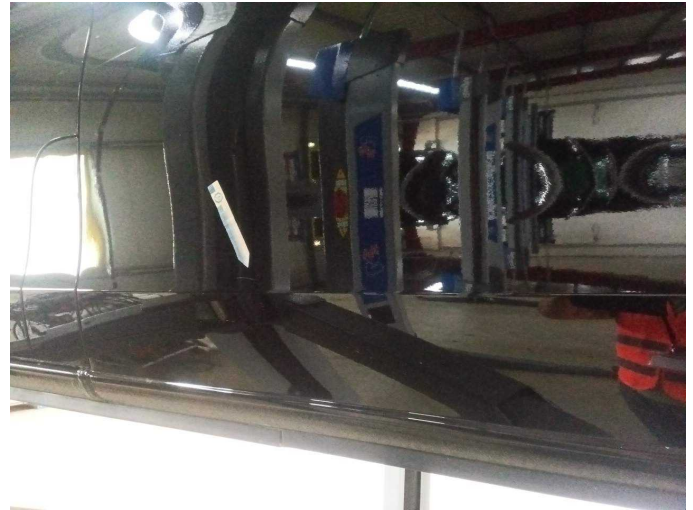
Damage 6: Sliding door - left side: Sliding door - Scratch(es) - Paint

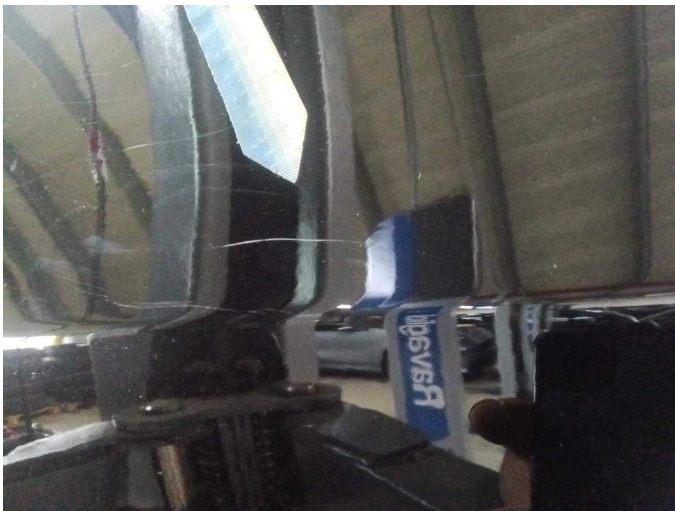
Damage 6: Sliding door - left side: Sliding door - Scratch(es) - Paint

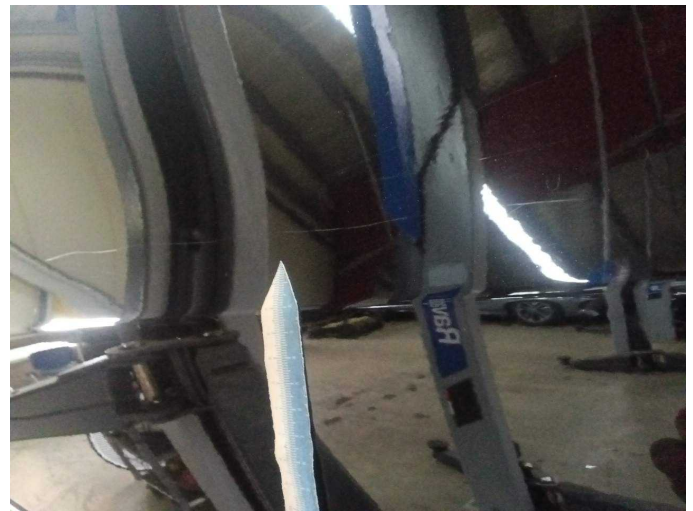
Damage 6: Sliding door - left side: Sliding door - Scratch(es) - Paint

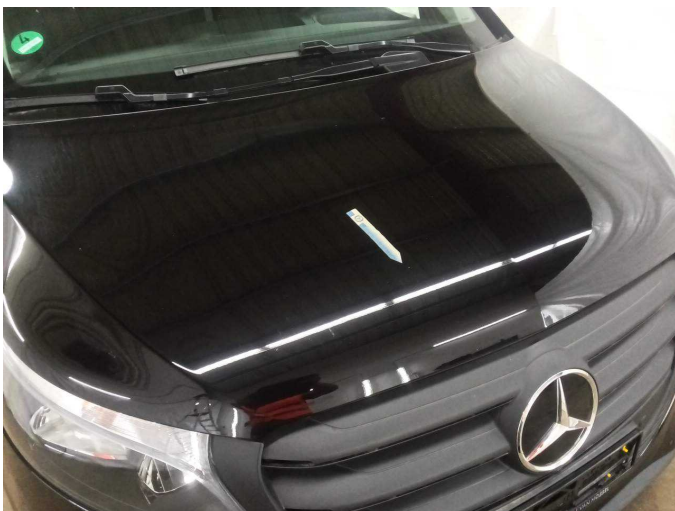
Damage 7: Bonnet: Bonnet - Stone chips - Paint

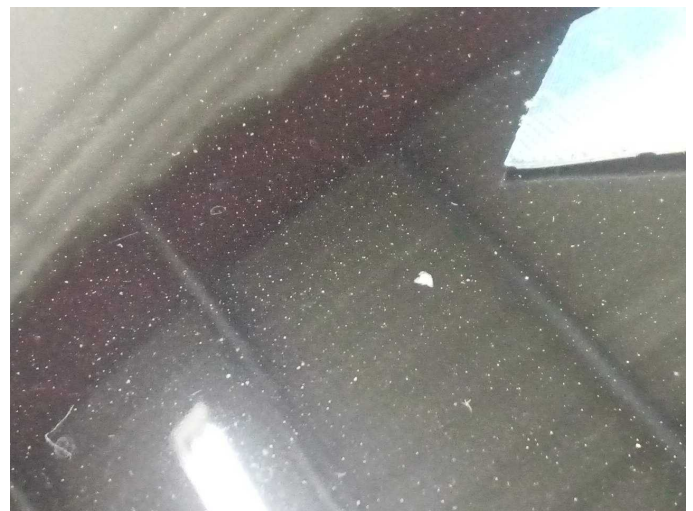
Damage 7: Bonnet: Bonnet - Stone chips - Paint

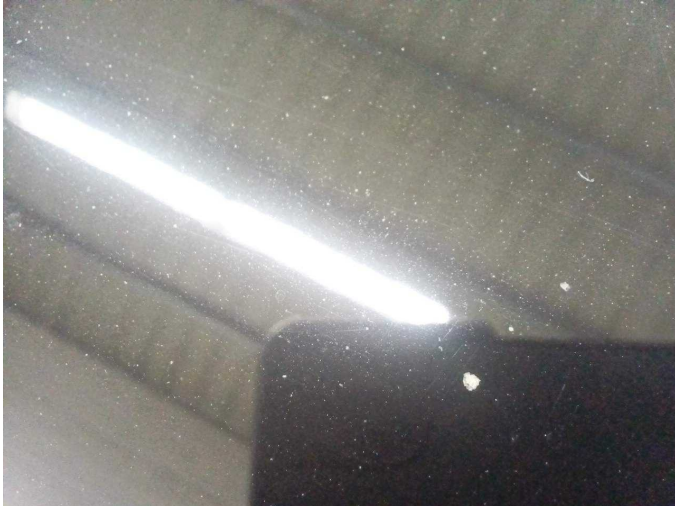
Damage 7: Bonnet: Bonnet - Stone chips - Paint

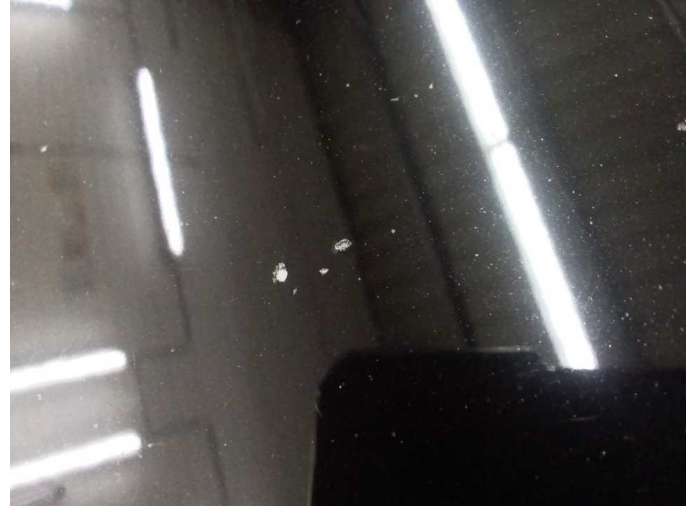
Damage 7: Bonnet: Bonnet - Stone chips - Paint

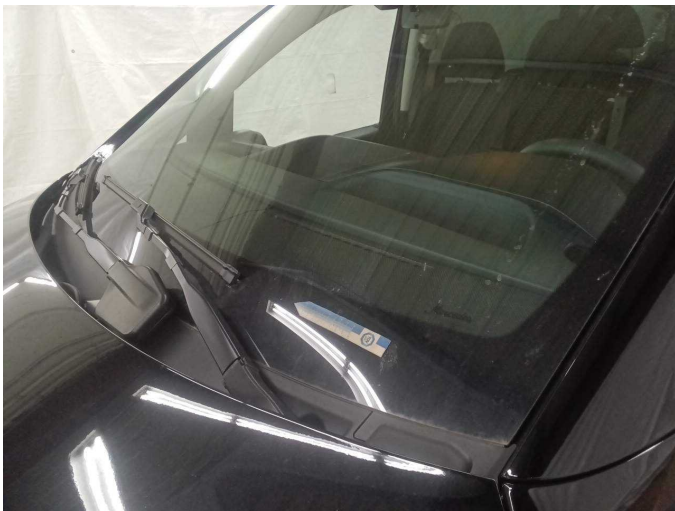
Damage 8: Vehicle glazing: Windscreen - Stone chips - Replace

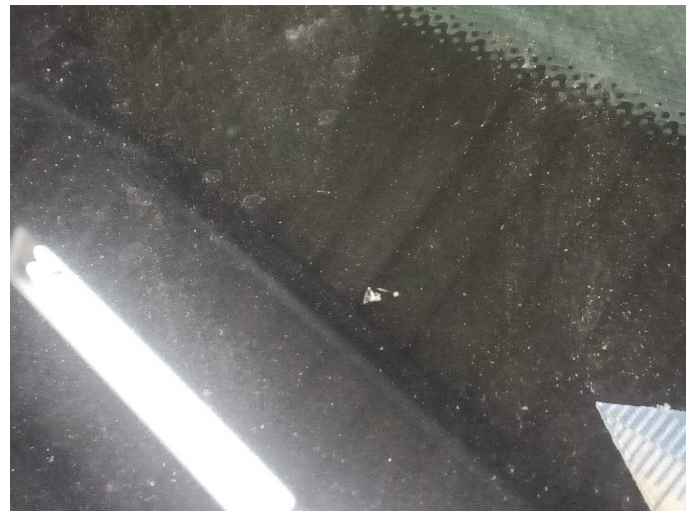
Damage 8: Vehicle glazing: Windscreen - Stone chips - Replace

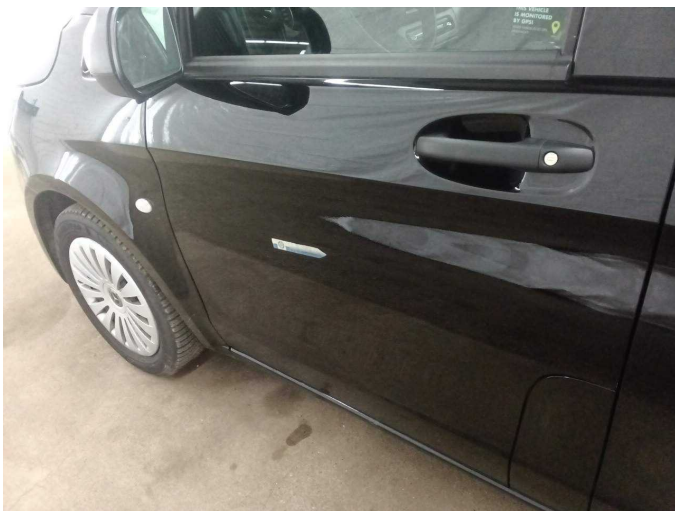
Wear and tear 2: Door - front left side: Door - dent(s) - No deduction

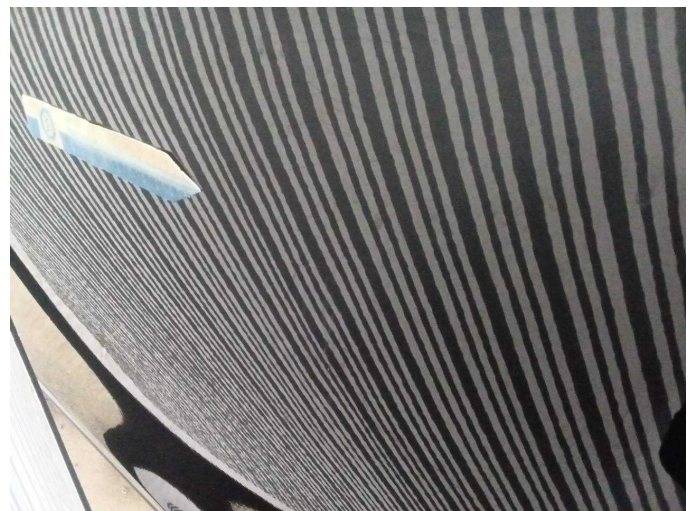
Wear and tear 2: Door - front left side: Door - dent(s) - No deduction

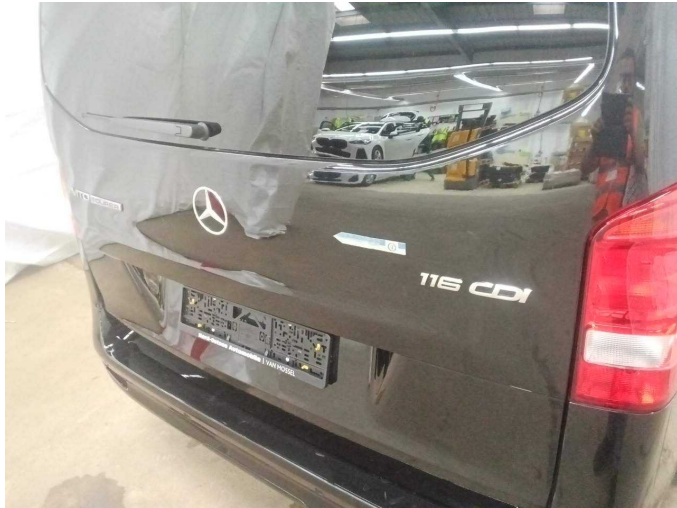
Wear and tear 3: Boot lid / rear door: Boot lid (2 Dellen) - dent(s) - No deduction

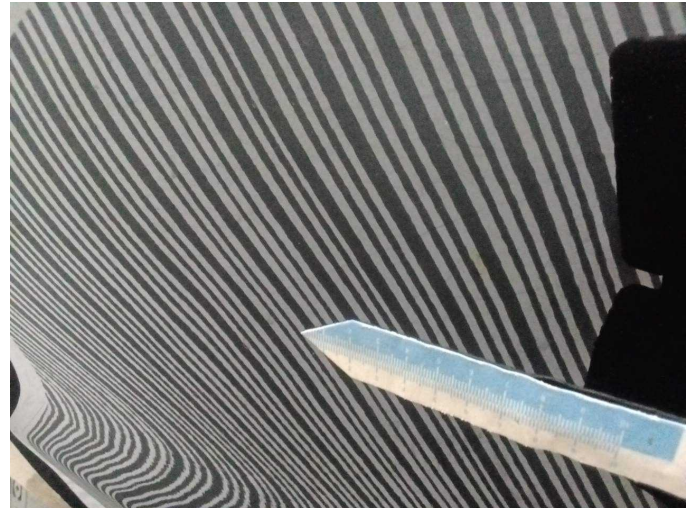
Wear and tear 3: Boot lid / rear door: Boot lid (2 Dellen) - dent(s) - No deduction

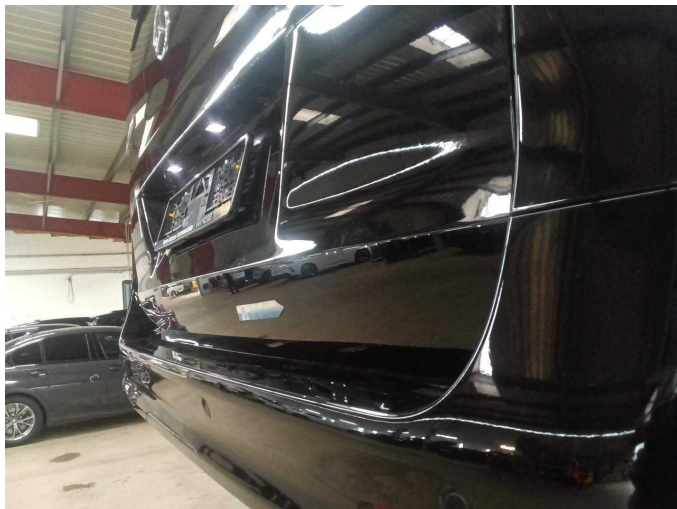
Wear and tear 3: Boot lid / rear door: Boot lid (2 Dellen) - dent(s) - No deduction

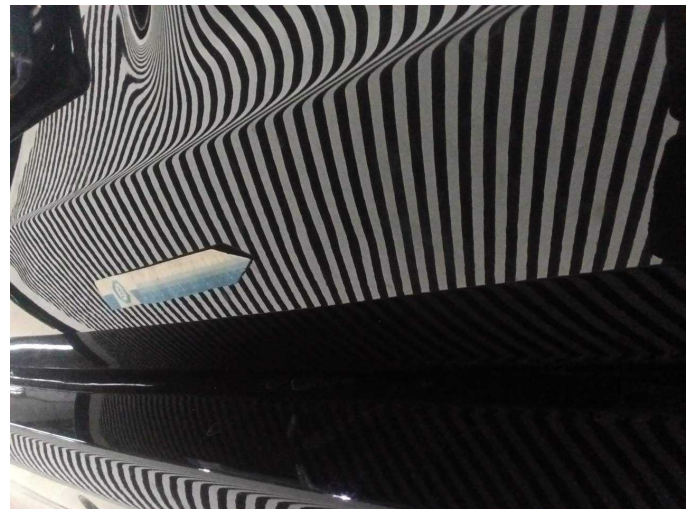
Wear and tear 3: Boot lid / rear door: Boot lid (2 Dellen) - dent(s) - No deduction

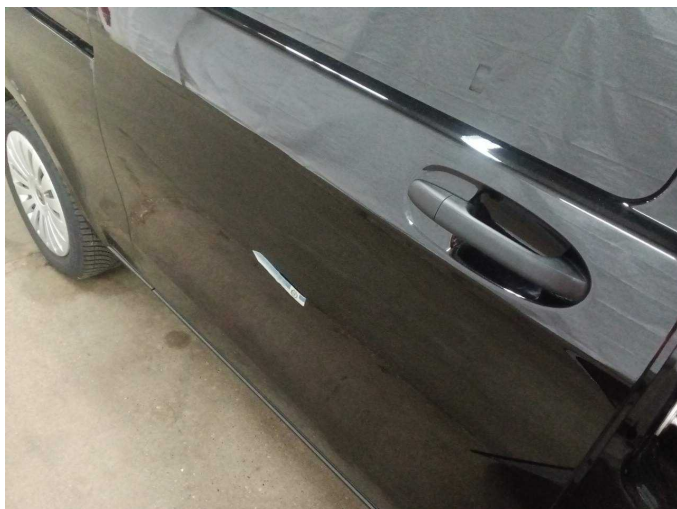
Wear and tear 4: Sliding door, right: Sliding door - dent(s) - No deduction

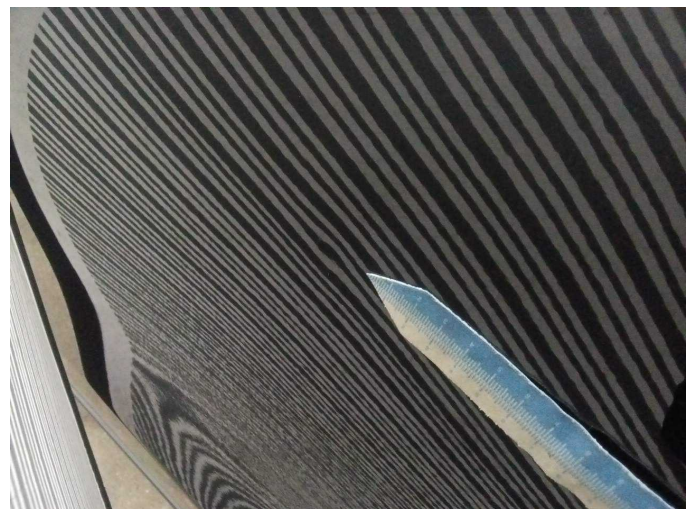
Wear and tear 4: Sliding door, right: Sliding door - dent(s) - No deduction

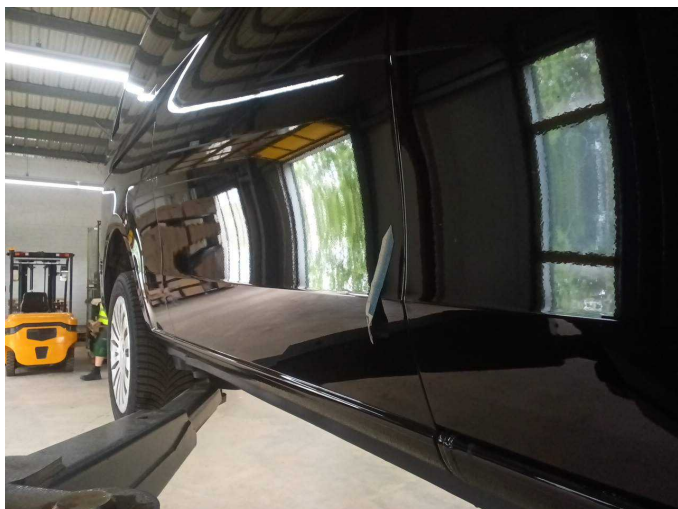
Wear and tear 4: Sliding door, right: Sliding door - dent(s) - No deduction

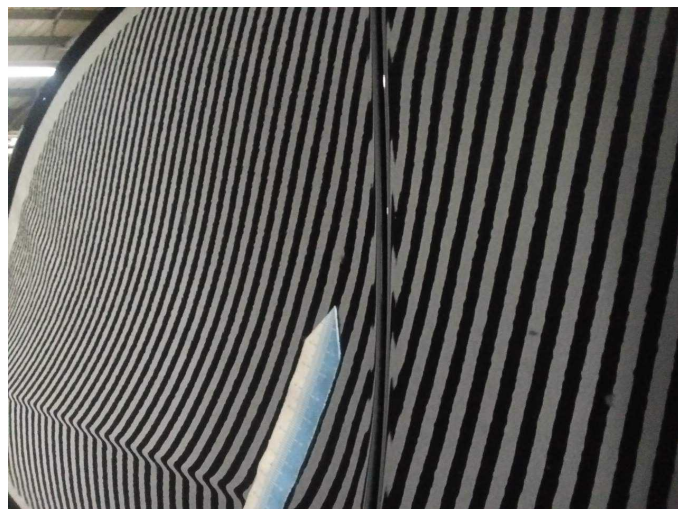
Wear and tear 4: Sliding door, right: Sliding door - dent(s) - No deduction
