Expertise

Protocol number: 46349713
Order No. / Reference: 26185520
Inspection date: 2 Jul 2026

Manufacturer: Mercedes-Benz

Model: Vito 116 CDI Extralang HA PRO

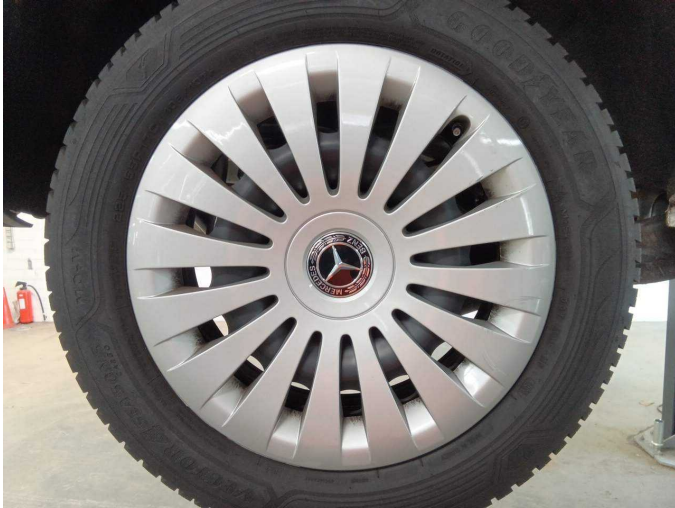
No.	Component group	Description
1	Wheel / tyres	Wheel cover - rear right side - Scratch(es) - Replace
2	Door - front left side	Door edge - Scratch(es) - Smart repair
3	Door - front right side	Door edge - Scratch(es) - Smart repair
4	Front bumper	Front bumper - Scratch(es) - Replace

Damage 1: Wheel / tyres: Wheel cover - rear right side - Scratch(es) - Replace

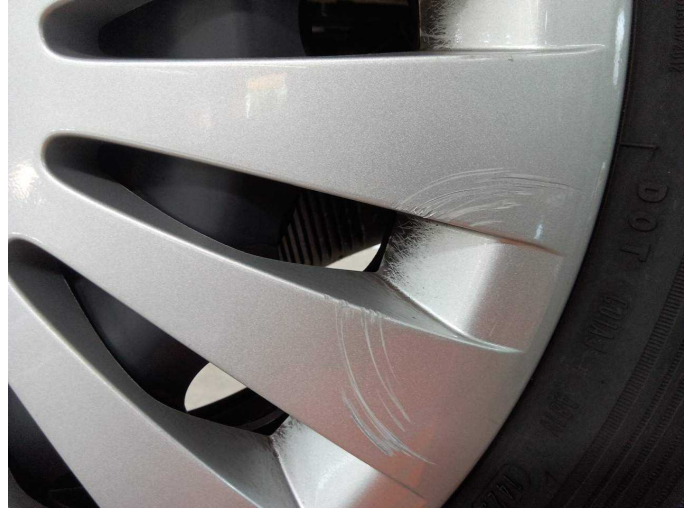
Damage 1: Wheel / tyres: Wheel cover - rear right side - Scratch(es) - Replace

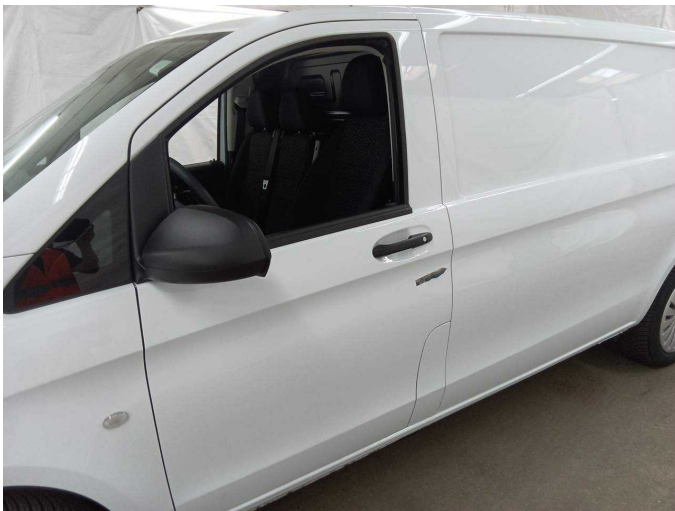
Damage 2: Door - front left side: Door edge - Scratch(es) - Smart repair

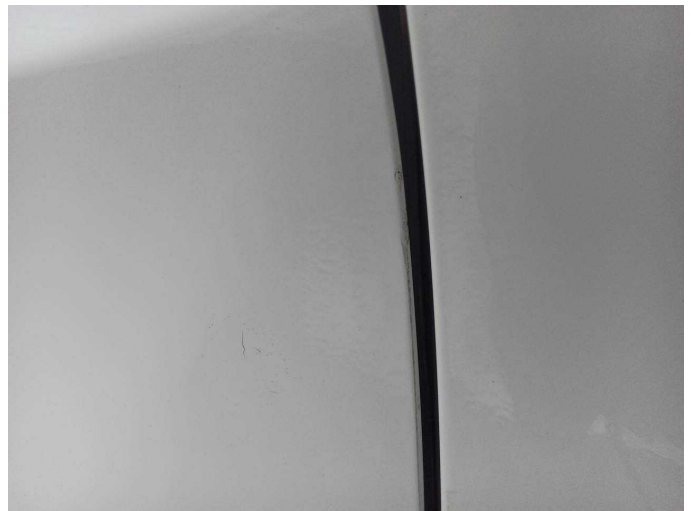
Damage 2: Door - front left side: Door edge - Scratch(es) - Smart repair

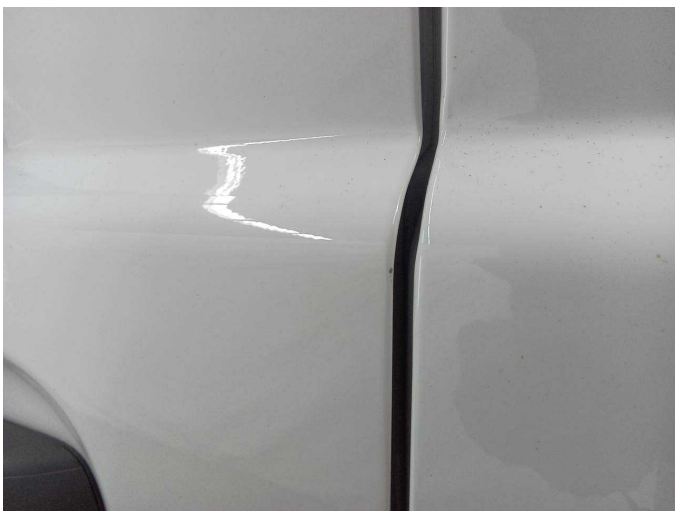
Damage 2: Door - front left side: Door edge - Scratch(es) - Smart repair

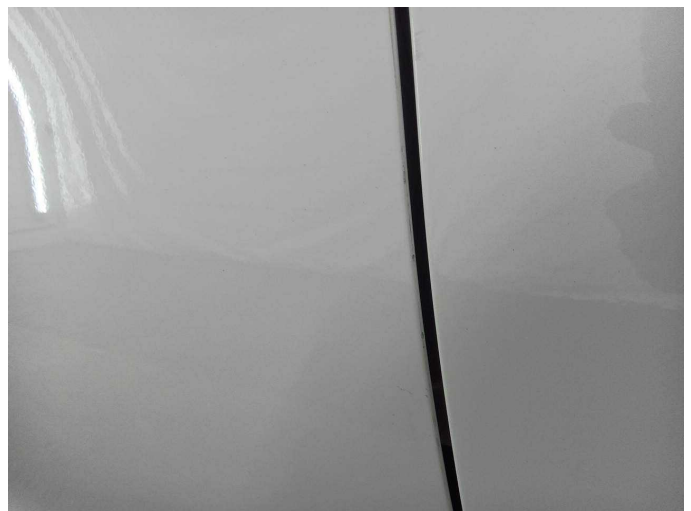
Damage 2: Door - front left side: Door edge - Scratch(es) - Smart repair

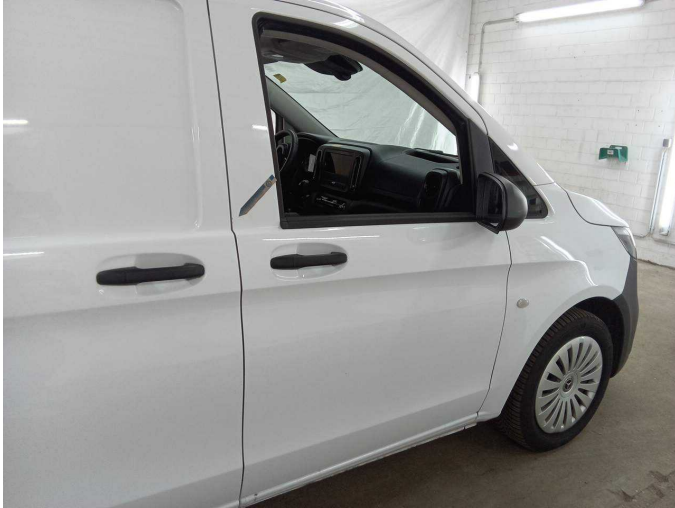
Damage 3: Door - front right side: Door edge - Scratch(es) - Smart repair

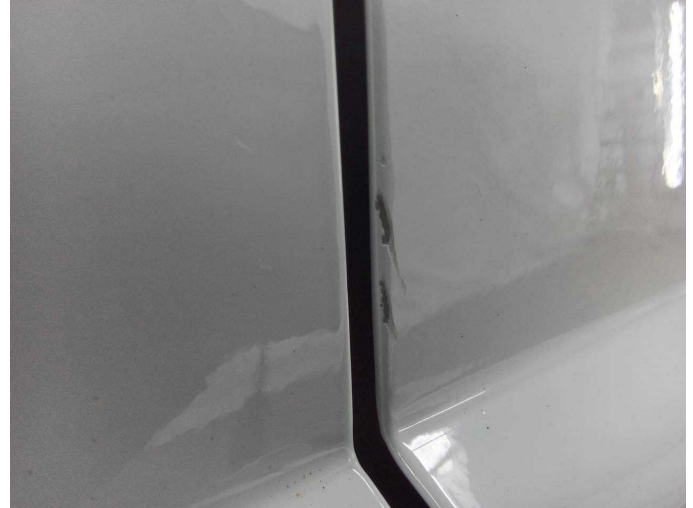
Damage 3: Door - front right side: Door edge - Scratch(es) - Smart repair

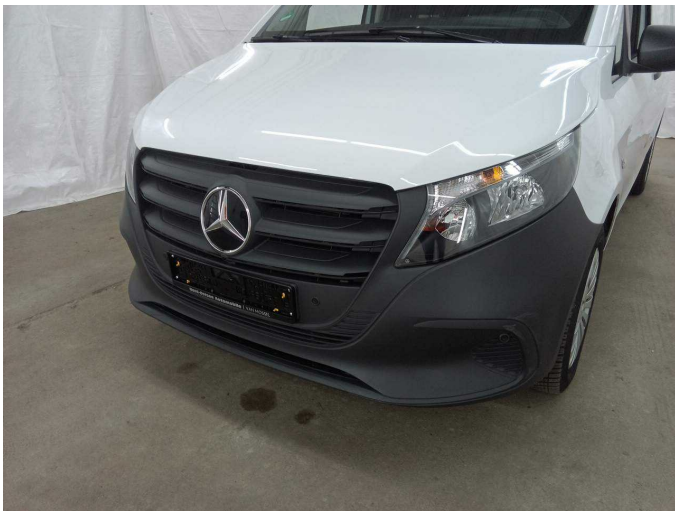
Damage 4: Front bumper: Front bumper - Scratch(es) - Replace

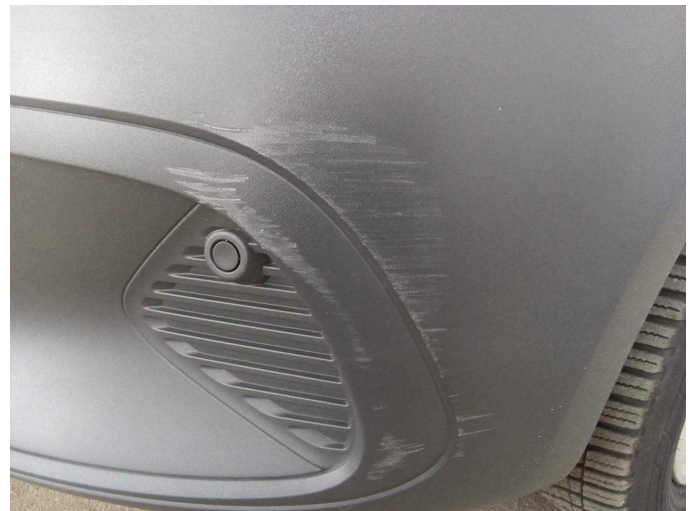
Damage 4: Front bumper: Front bumper - Scratch(es) - Replace

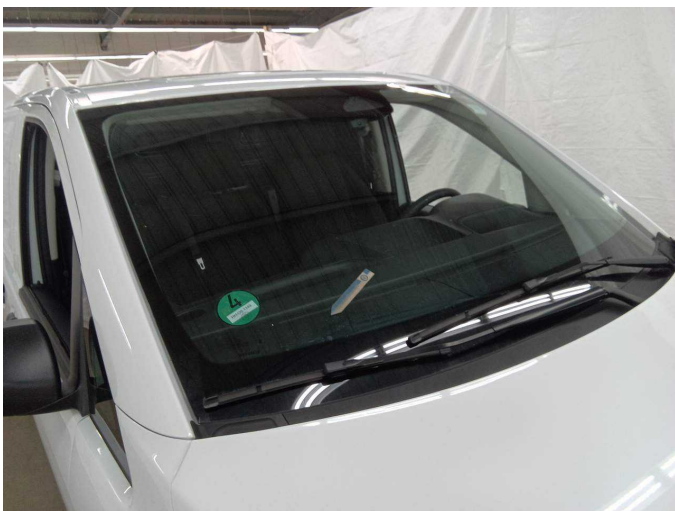
No.	Component group	Description
1	Vehicle glazing	Windscreen - Stone chips - No deduction

Wear and tear 1: Vehicle glazing: Windscreen - Stone chips - No deduction

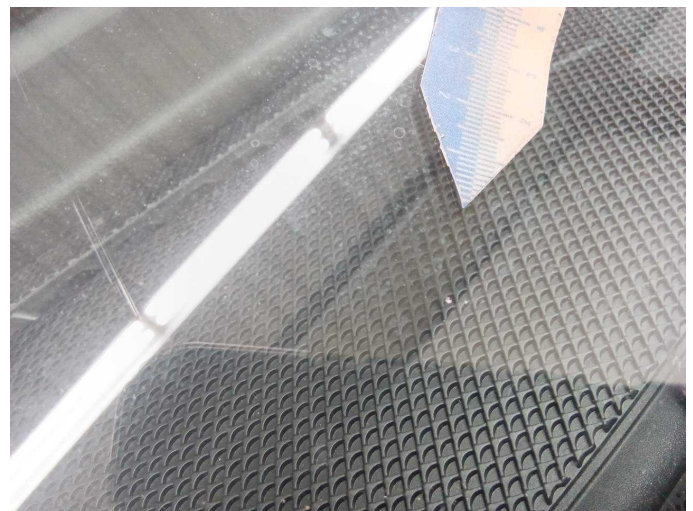
Wear and tear 1: Vehicle glazing: Windscreen - Stone chips - No deduction

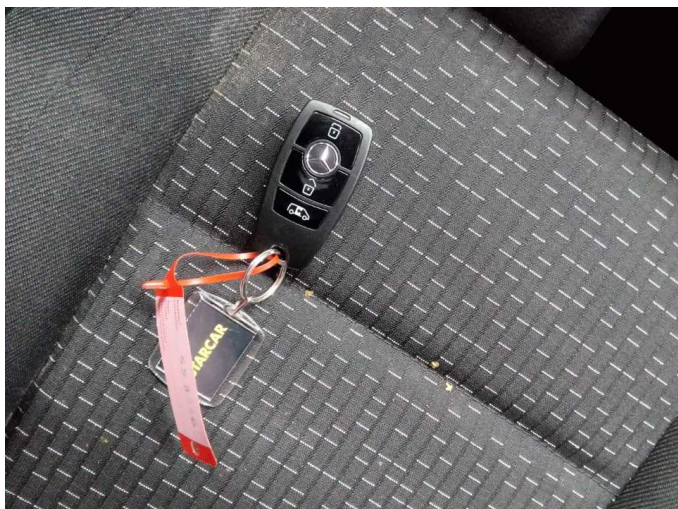
Missing part 1: Equipment: Vehicle key - Missing - Replace
