Expertise

Protocol number: 46297600  
Order No. / Reference: 26642169  
Inspection date: 4 Jun 2026

| Manufacturer: Ford | Model: Focus Turnier 1.5 EcoBlue Start-Stopp-System Aut. ACTIVE |
| VIN: WF0PXXGCHPNA25666 | |

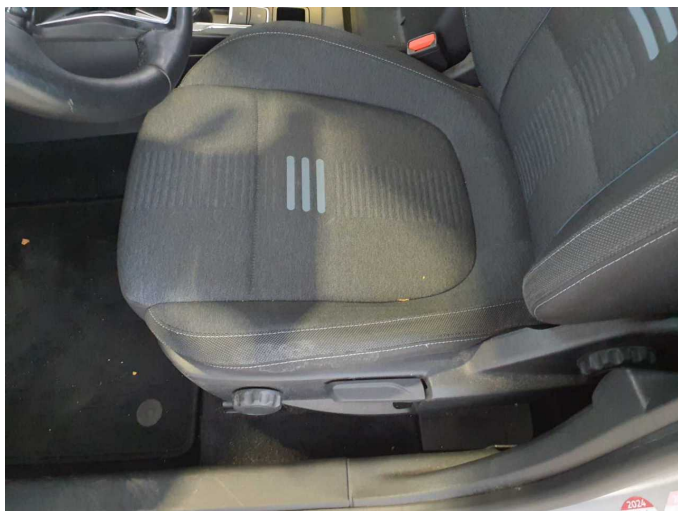
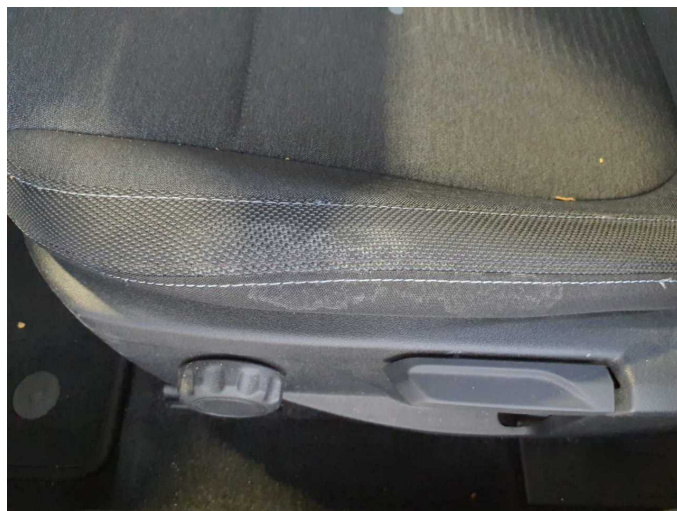
| No. | Component group | Description |
|---|---|---|
| 2 | Seat - front | Seat cover - left side - Clean |

**Damage 2:** Seat - front: Seat cover - left side - Clean

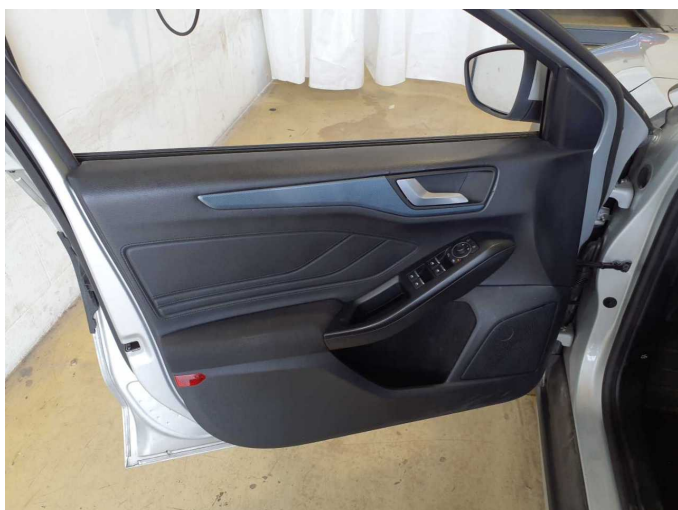
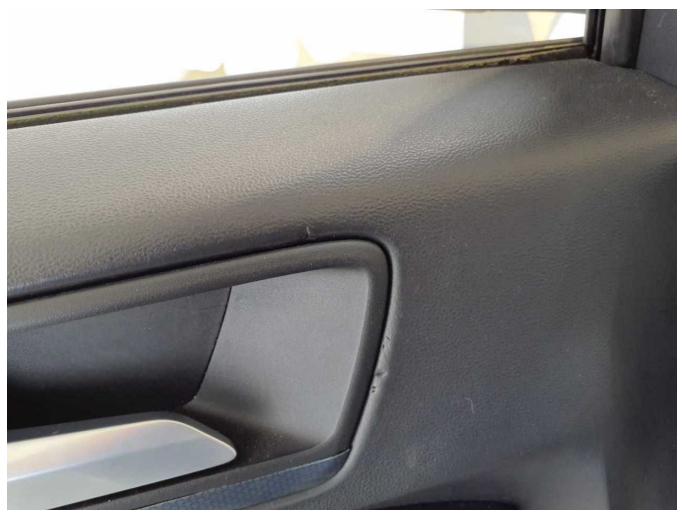
| No. | Component group | Description |
|---|---|---|
| 3 | Trim / covers | Door trim - front left side - Scratched - Loss in value |

**Damage 3:** Trim / covers: Door trim - front left side - Scratched - Loss in value

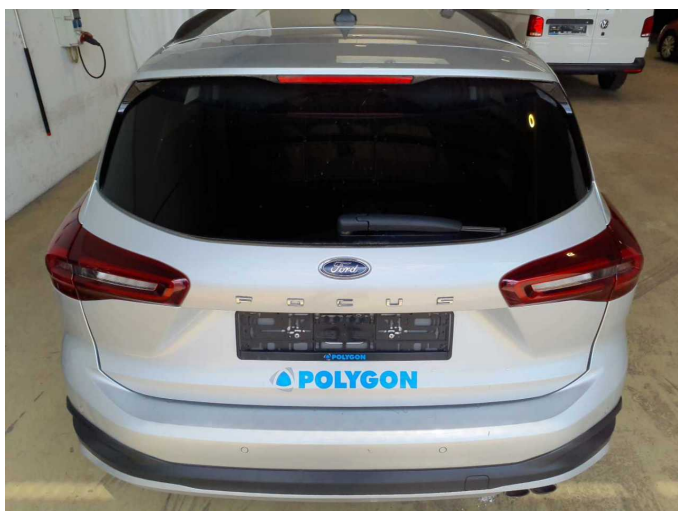
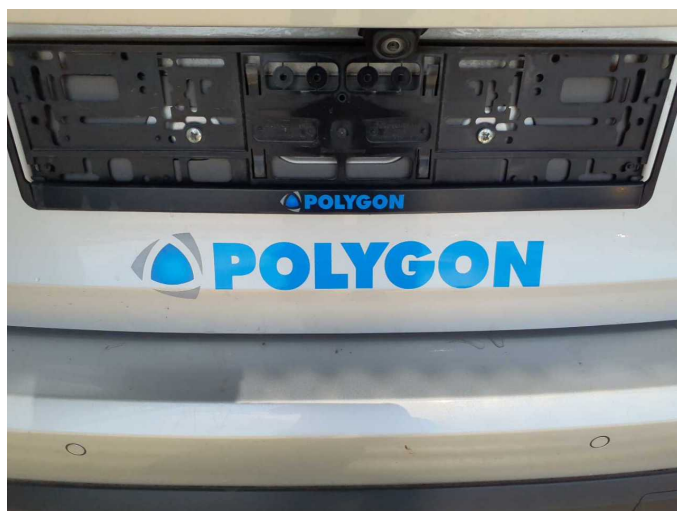
| No. | Component group | Description |
|---|---|---|
| 4 | Boot lid / rear door | Boot lid - Glued / labelled - De-glue / neutralise |

**Damage 4:** Boot lid / rear door: Boot lid - Glued / labelled - De-glue / neutralise

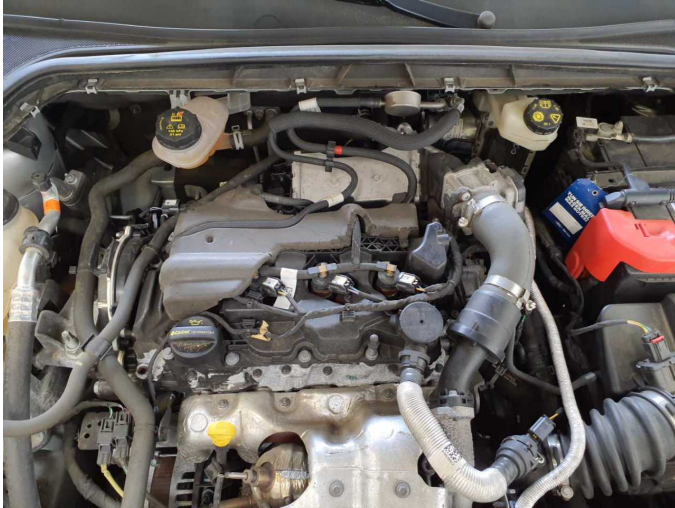
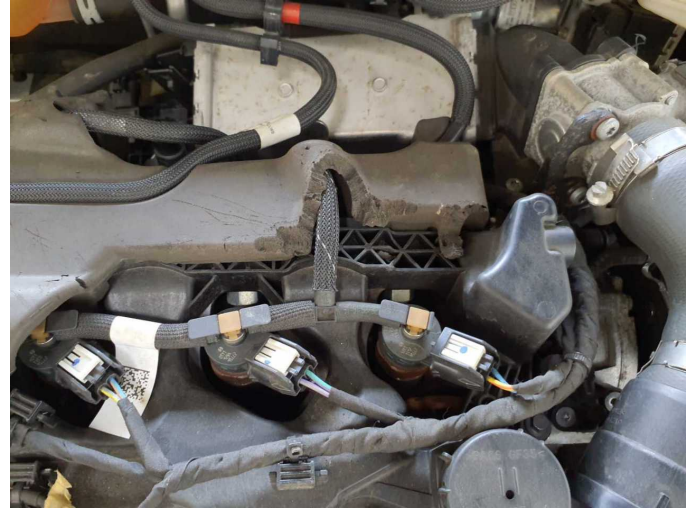
| No. | Component group | Description |
|---|---|---|
| 5 | Engine | Engine cover - Damaged - Replace |

**Damage 5:** Engine: Engine cover - Damaged - Replace

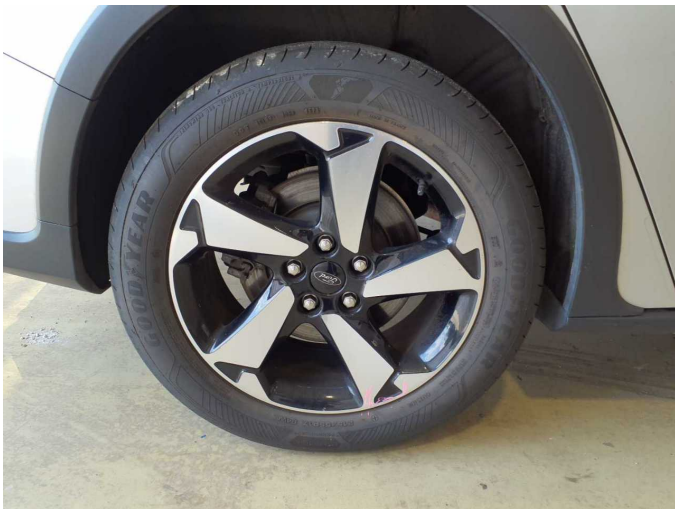
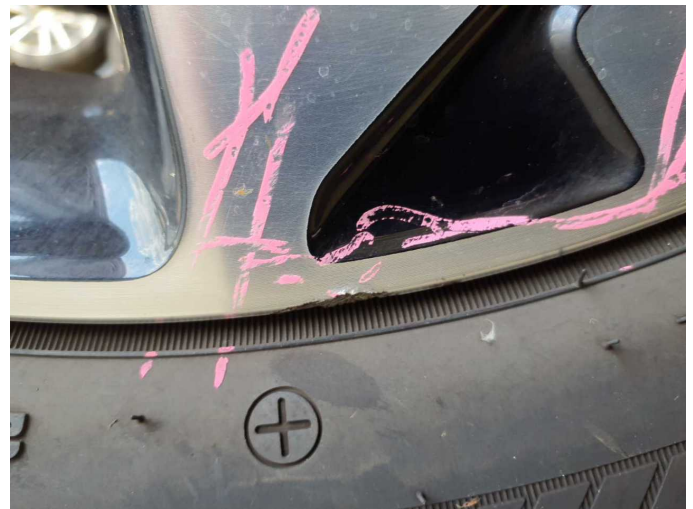
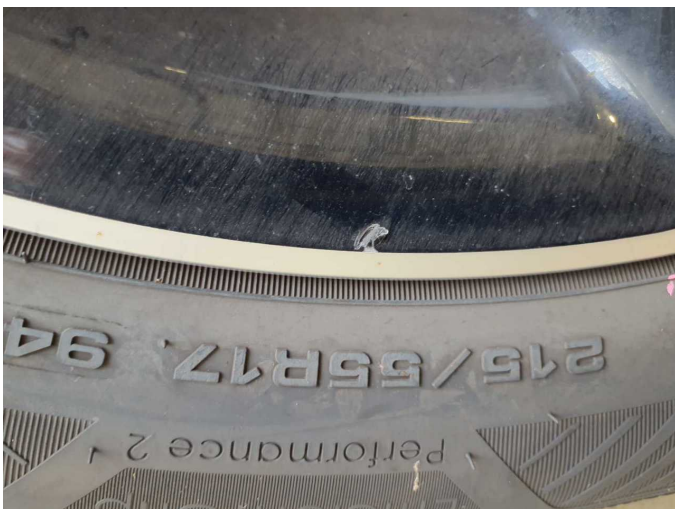
| No. | Component group | Description |
|---|---|---|
| 6 | Wheel / tyres | Alloy rim - rear right side - Scratched - Loss in value |

**Damage 6:** Wheel / tyres: Alloy rim - rear right side - Scratched - Loss in value

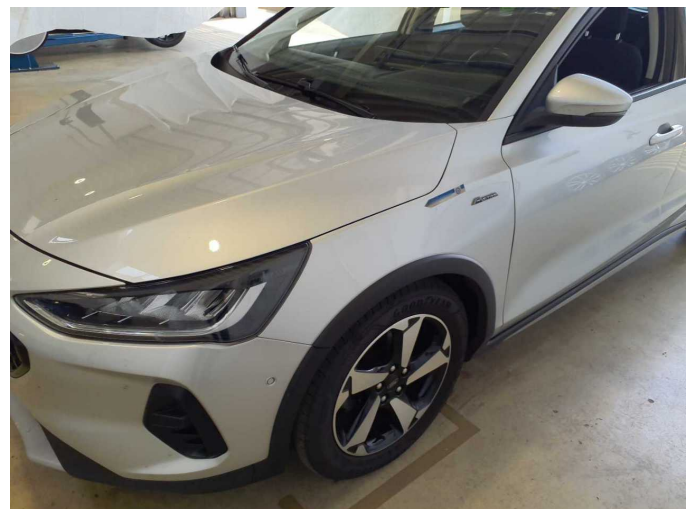
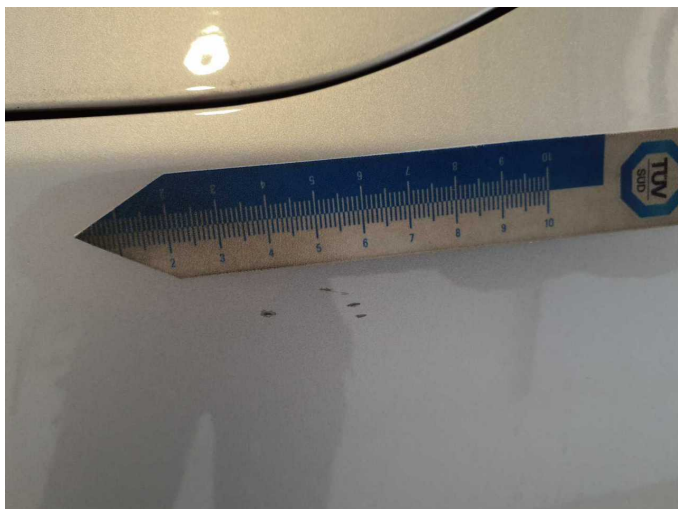
| No. | Component group | Description |
|---|---|---|
| 7 | Mudguard - left side | Mudguard - left side - Stone chips - Paint |

**Damage 7:** Mudguard - left side: Mudguard - left side - Stone chips - Paint

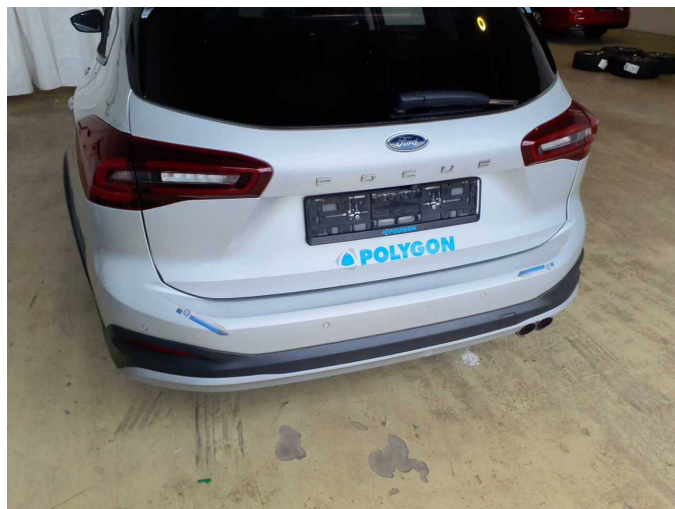
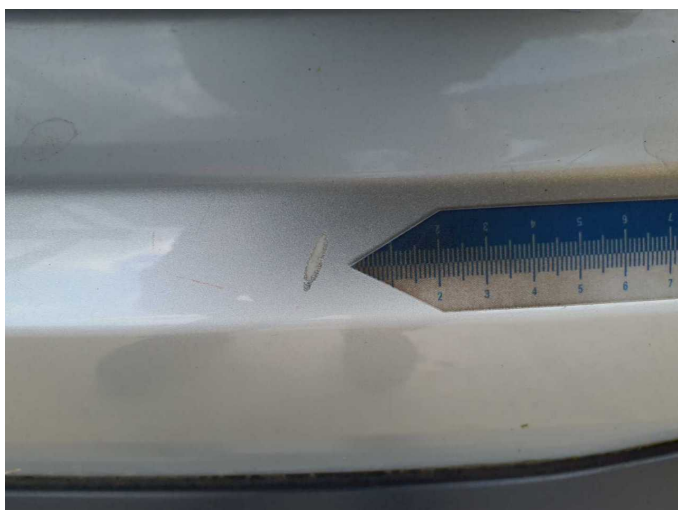
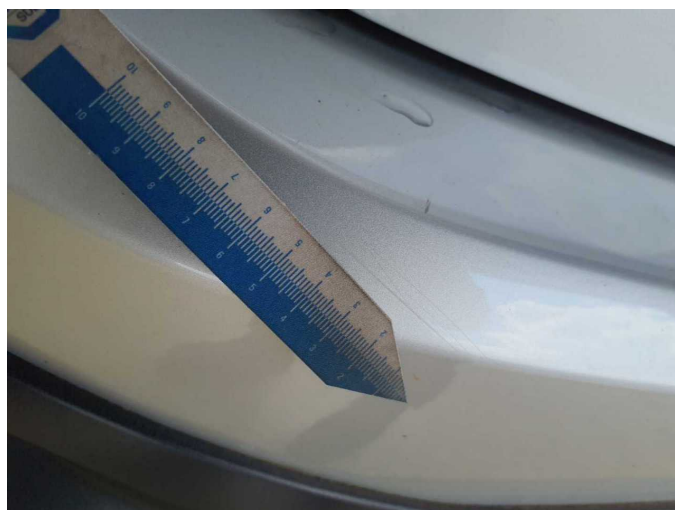
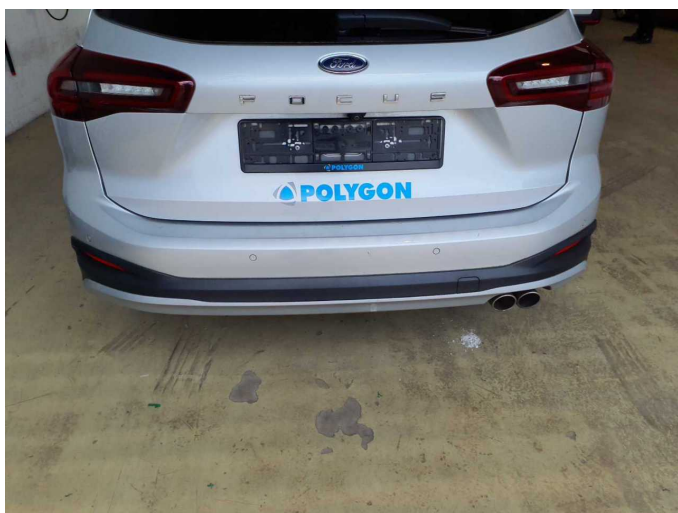
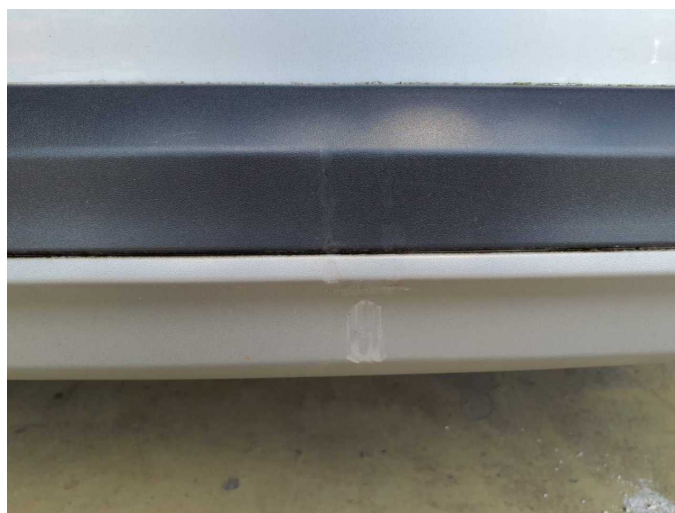
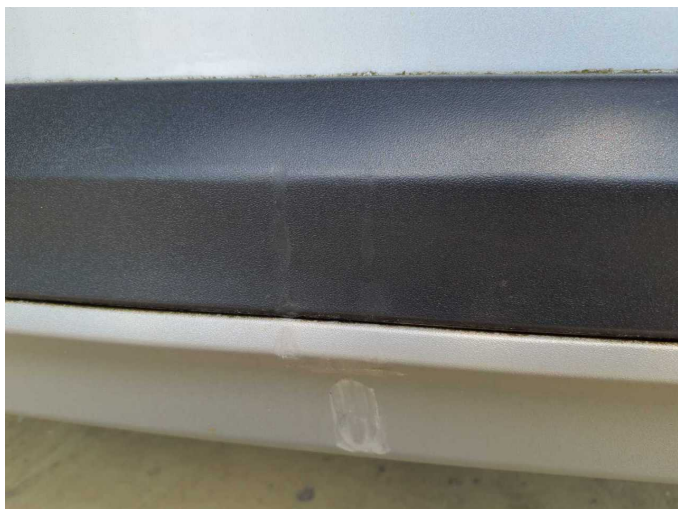
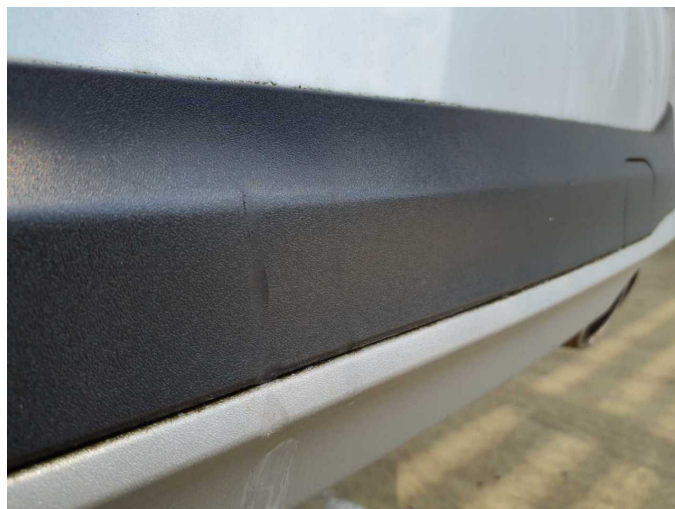
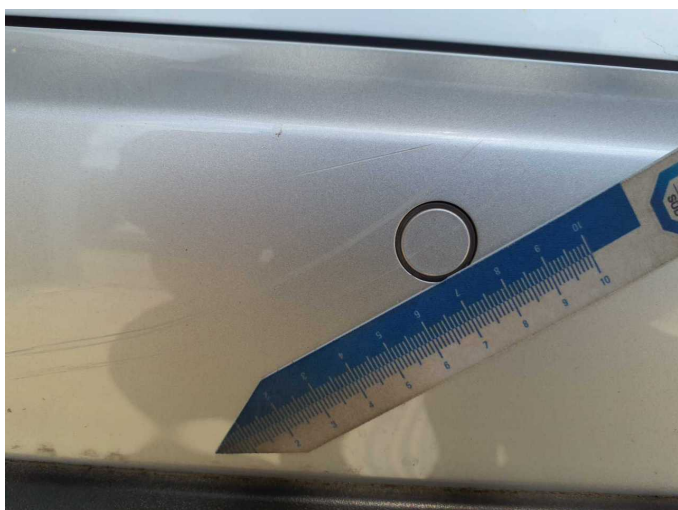
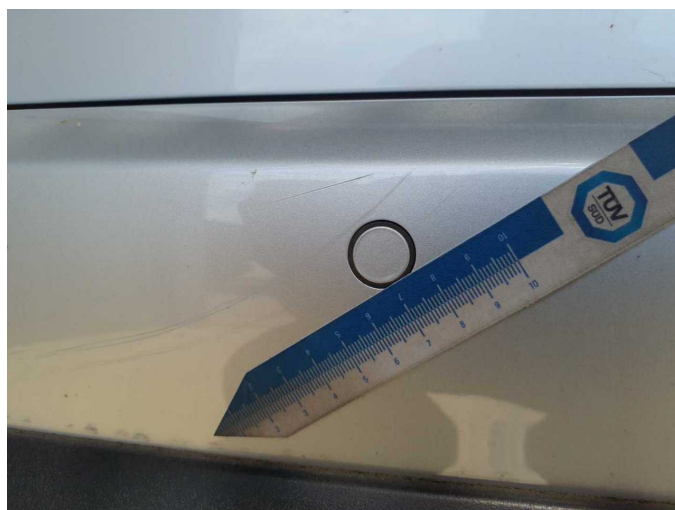
| No. | Component group | Description |
|---|---|---|
| 8 | Rear bumper | Rear bumper (Zusätzlich Spoiler und Blende Kratzer) - Scratched - Paint |

**Damage 8:** Rear bumper: Rear bumper (Zusätzlich Spoiler und Blende Kratzer) - Scratched - Paint

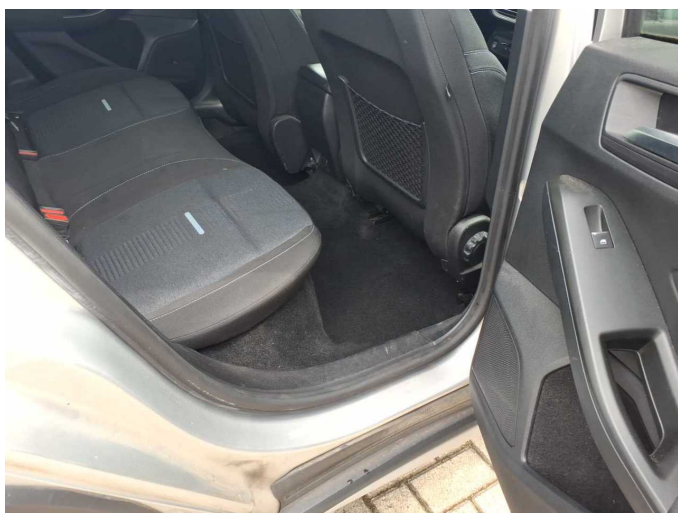
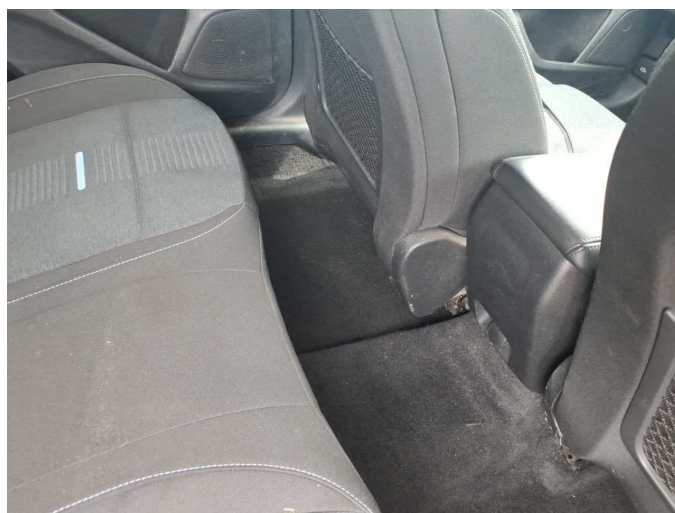
Trim / covers - Floor mats

**Missing part 1:** Trim / covers: Floor mats - Missing - Replace

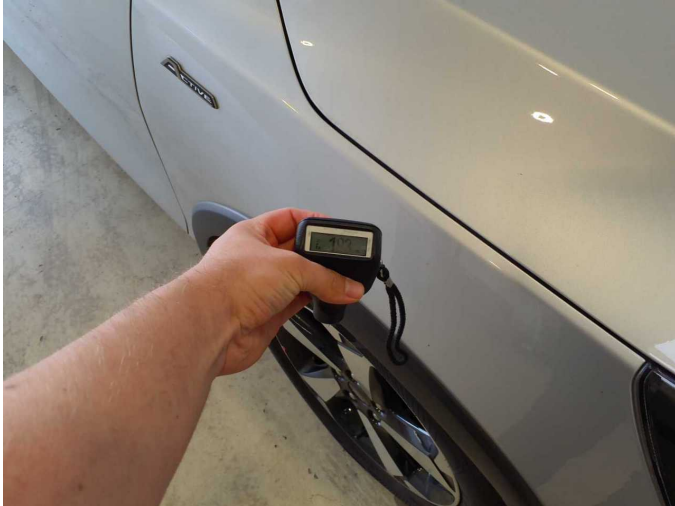
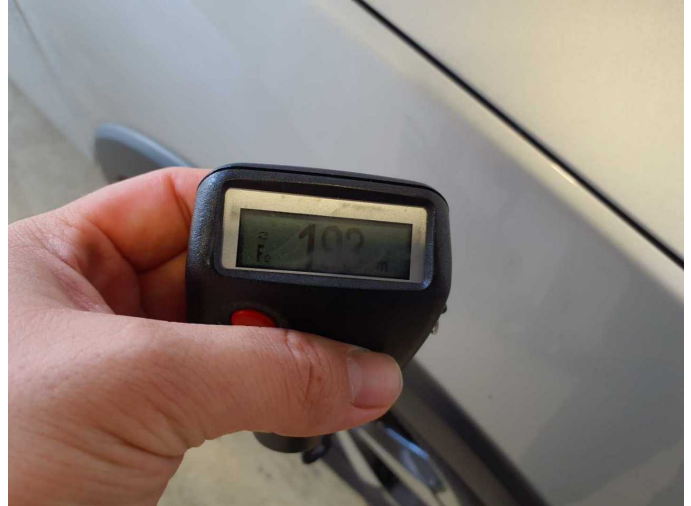
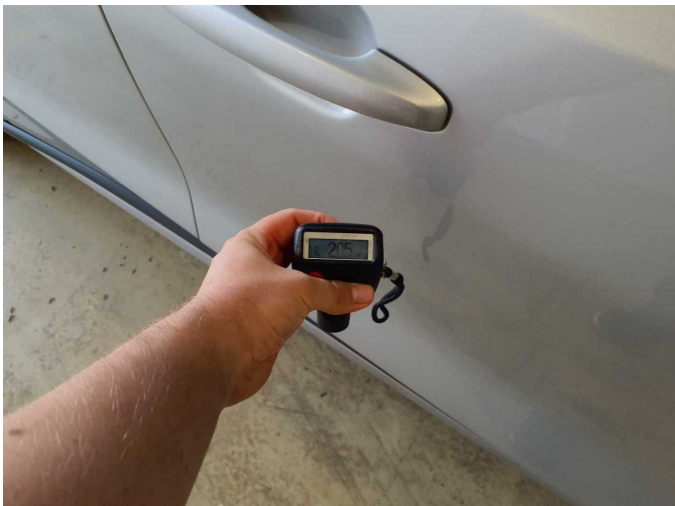
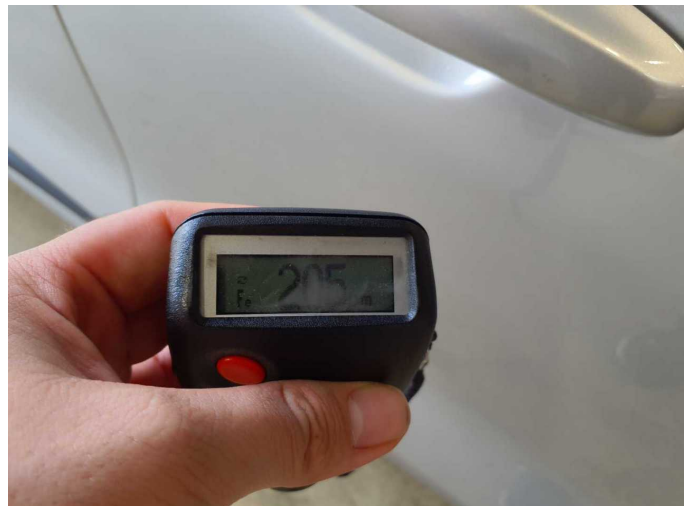
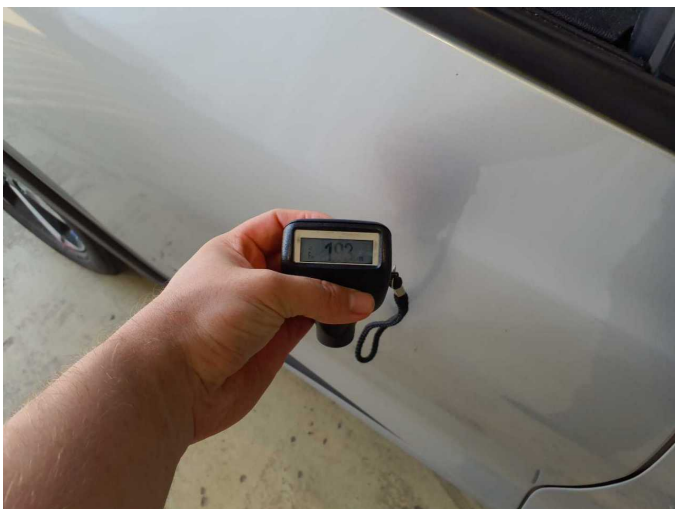
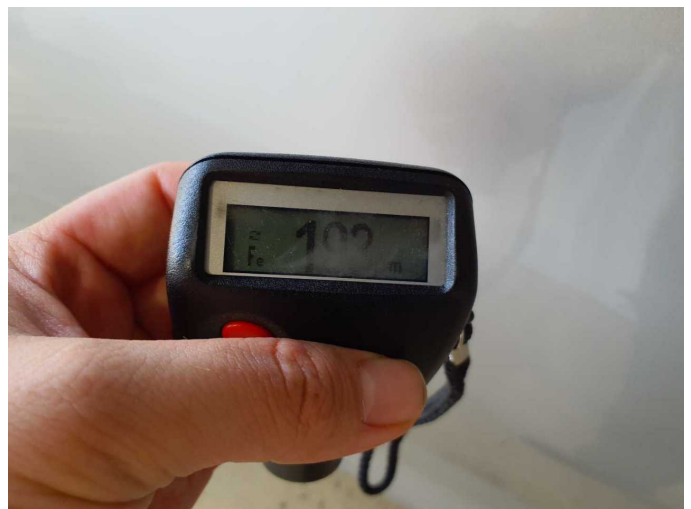
1 Mudguard - right side, Door - rear right side, Door - front right side, Professionally carried out

| Mudguard - right side | 193 µm | Door - rear right side | 193 µm |
| Door - front right side | 205 µm | | |

An mehreren Karosserieteilen wurde eine erhöhte Lackschichtdicke festgestellt, was auf nachträgliche Lackierarbeiten oder Reparaturen hinweisen kann.

**Repainting 1:** Mudguard - right side, Door - rear right side, Door - front right side
