Expertise

Protocol number: 46445747  
Order No. / Reference: 26626274  
Inspection date: 10 Jul 2026

Manufacturer: Ford

Model: Transit Connect 230 L2 LKW S&S Autm. Trend

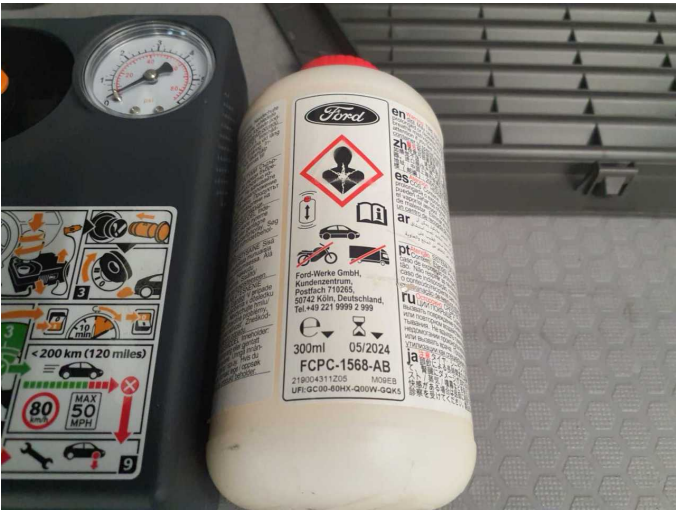
| No. | Component group | Description |
|---|---|---|
| 1 | Equipment | Tirefit filler - Expired - Replace |

Damage 1: Equipment: Tirefit filler - Expired - Replace

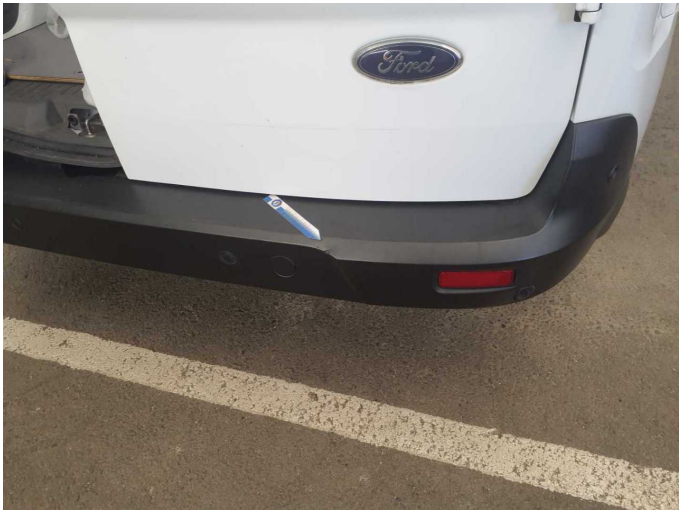
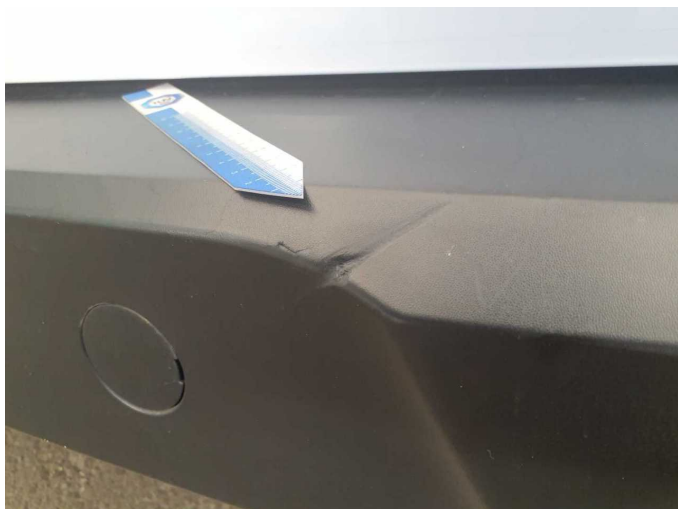
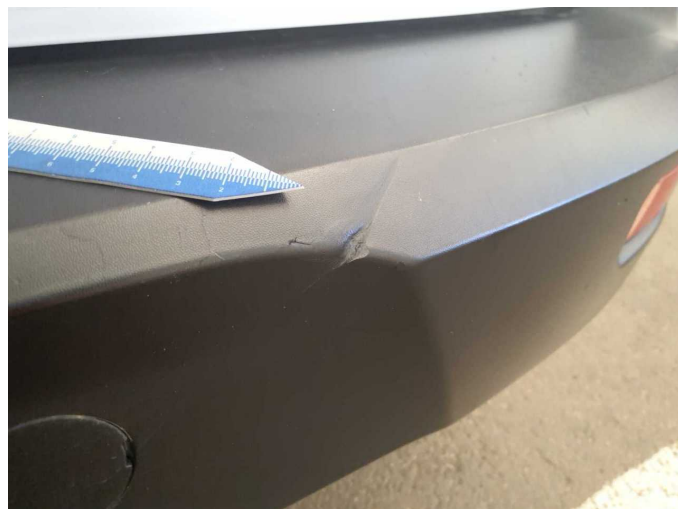
| No. | Component group | Description |
|---|---|---|
| 3 | Rear bumper | Rear bumper - Deformed - Loss in value |

Damage 3: Rear bumper: Rear bumper - Deformed - Loss in value

**Damage 3:** Rear bumper: Rear bumper - Deformed - Loss in value

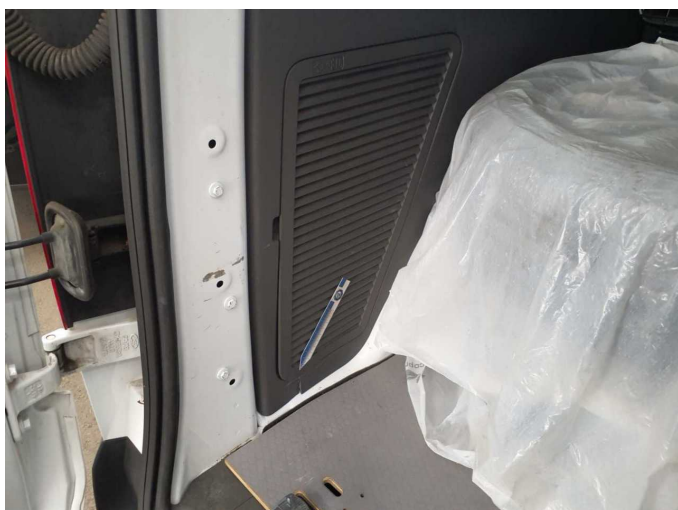
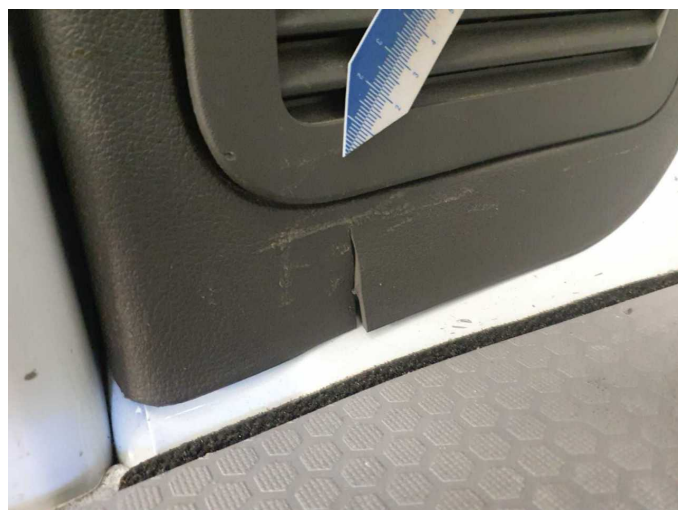
| No. | Component group | Description |
|---|---|---|
| 4 | Trim / covers | Cargo area - lining -left side - Broken / torn - Replace |

**Damage 4:** Trim / covers: Cargo area - lining -left side - Broken / torn - Replace

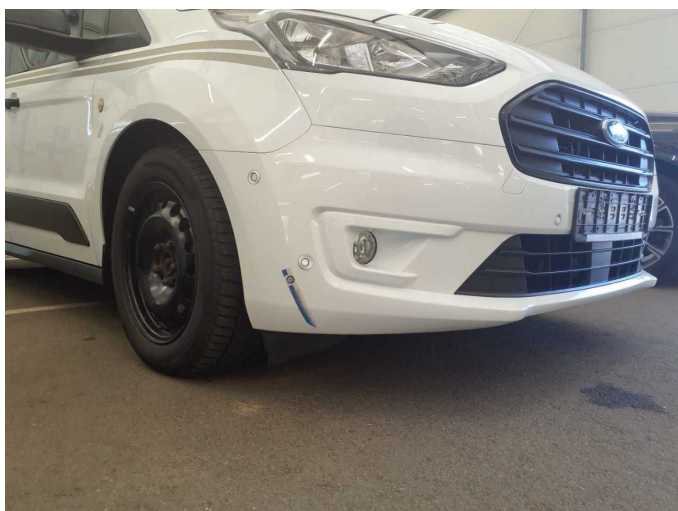
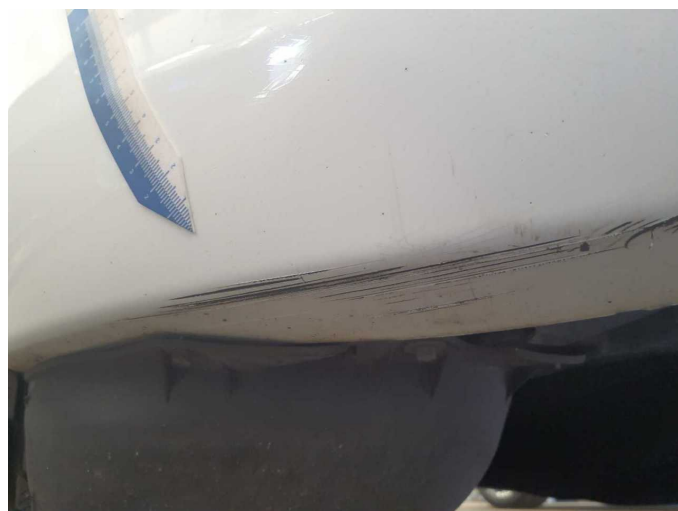
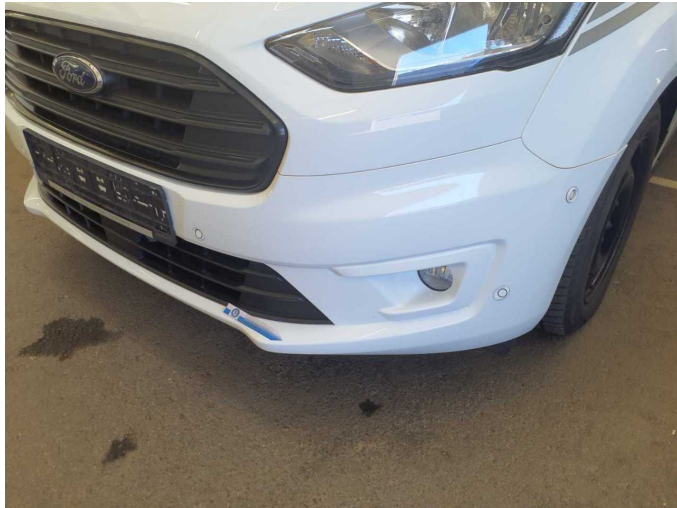
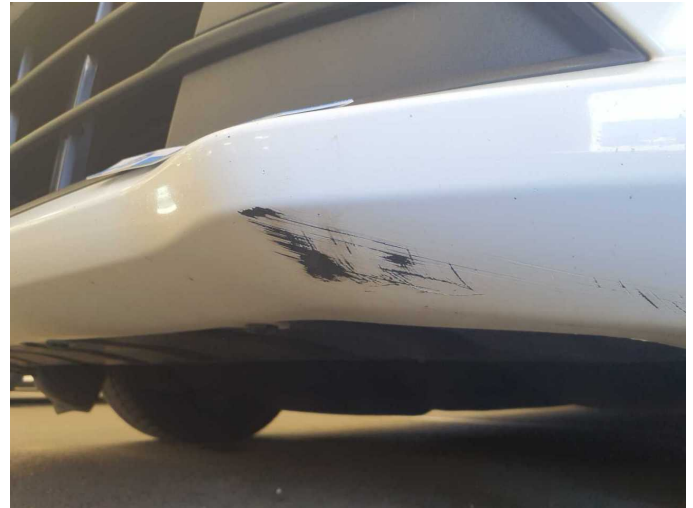
| No. | Component group | Description |
|---|---|---|
| 5 | Front bumper | Front bumper - Scratch(es) - Paint |

**Damage 5:** Front bumper: Front bumper - Scratch(es) - Paint

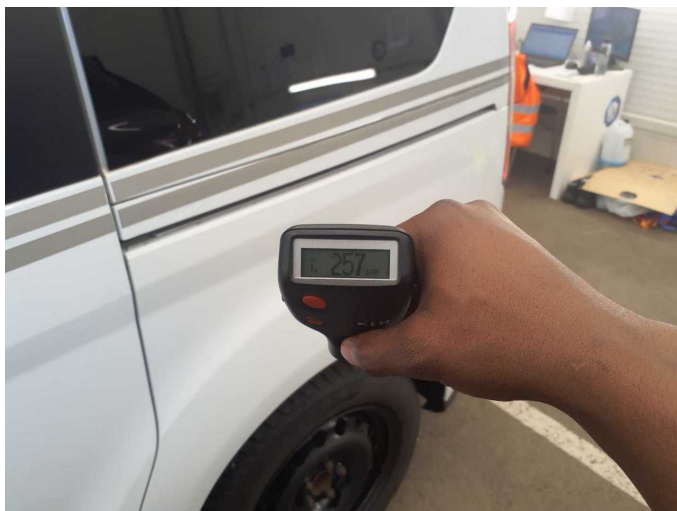
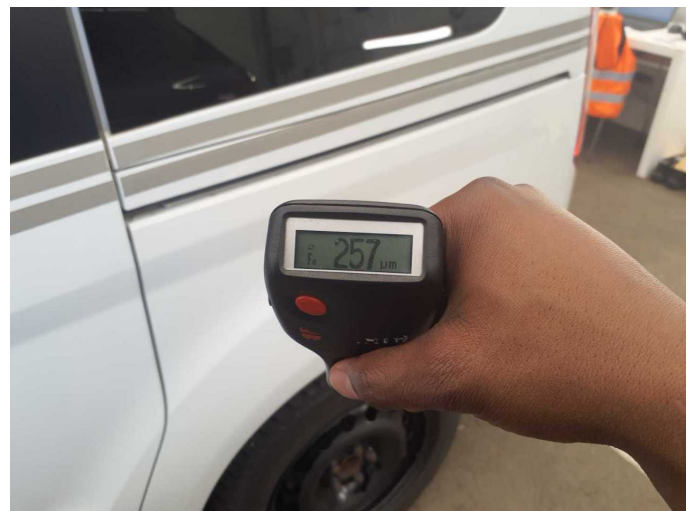
| No. | Repainting |
|---|---|
| 1 | Side panel - rear left side, Professionally carried out, Invoice of repair done Non-existent |

| Side panel - rear left side | 257 µm |

**Repainting 1:** Side panel - rear left side
