Expertise

Protocol number: 46487078  
Order No. / Reference: 26190816  
Inspection date: 10 Jul 2026

Manufacturer: Mercedes-Benz

Model: Vito 116 CDI Lang HA PRO Kasten

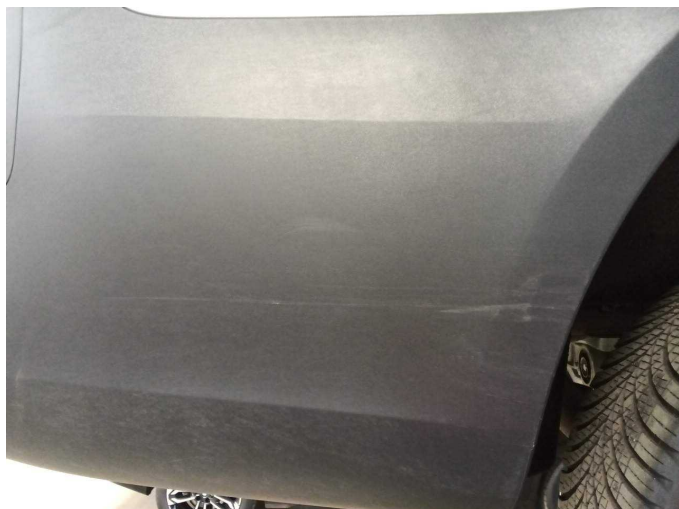
| No. | Component group | Description |
|---|---|---|
| 1 | Rear bumper | Rear bumper - Scratch(es) - Loss in value |

**Damage 1:** Rear bumper: Rear bumper - Scratch(es) - Loss in value

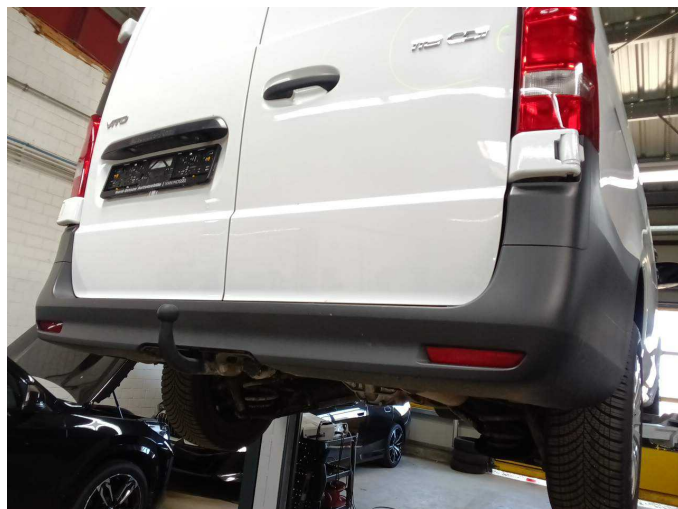
**Damage 1:** Rear bumper: Rear bumper - Scratch(es) - Loss in value

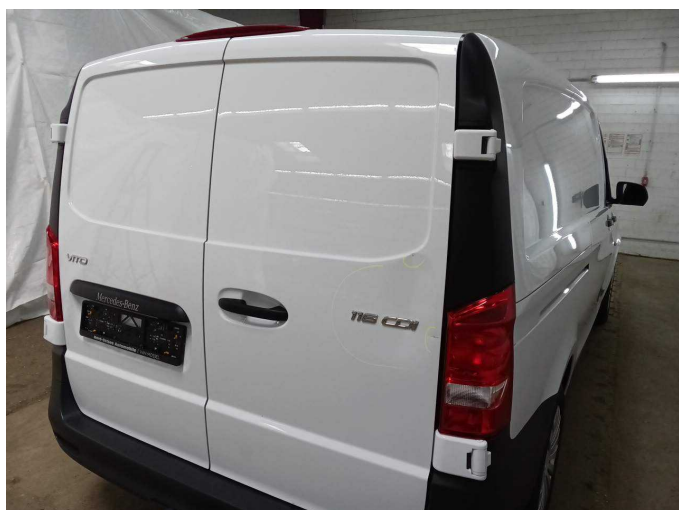
| No. | Component group | Description |
|---|---|---|
| 2 | Boot lid / rear door | Rear door - right side - Dent / paintcoat damage - Repair and paint |

**Damage 2:** Boot lid / rear door: Rear door - right side - Dent / paintcoat damage - Repair and paint

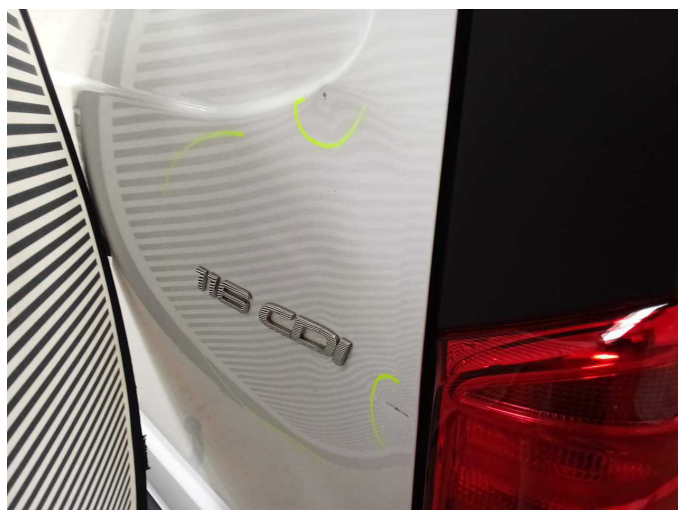
**Damage 2:** Boot lid / rear door: Rear door - right side - Dent / paintcoat damage - Repair and paint

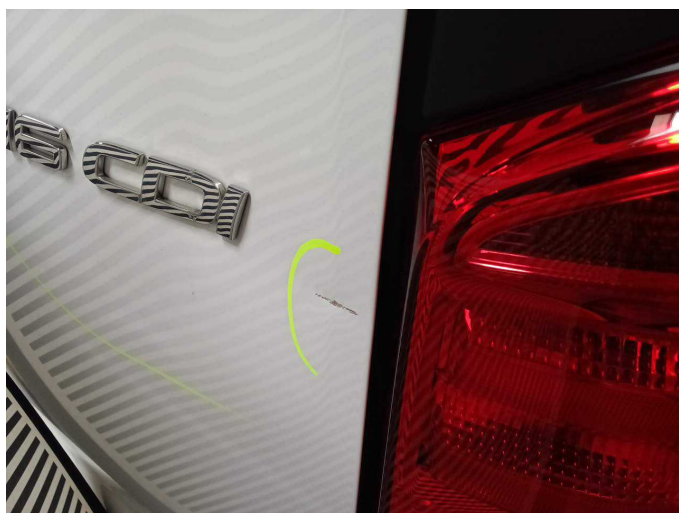
**Damage 2:** Boot lid / rear door: Rear door - right side - Dent / paintcoat damage - Repair and paint

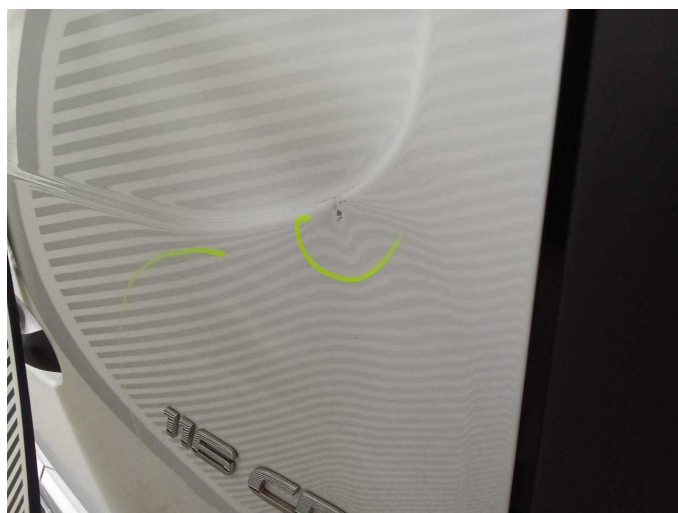
**Damage 2:** Boot lid / rear door: Rear door - right side - Dent / paintcoat damage - Repair and paint

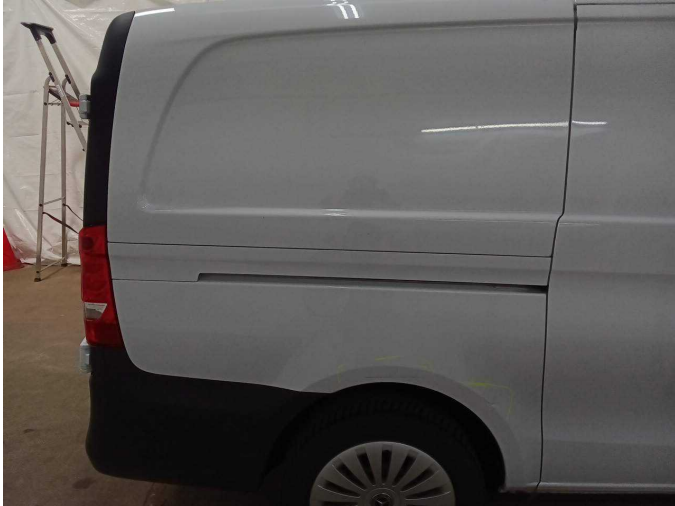
| No. | Component group | Description |
|---|---|---|
| 3 | Side panel - rear right side | Side panel - Dent / paintcoat damage - Repair and paint |

**Damage 3:** Side panel - rear right side: Side panel - Dent / paintcoat damage - Repair and paint

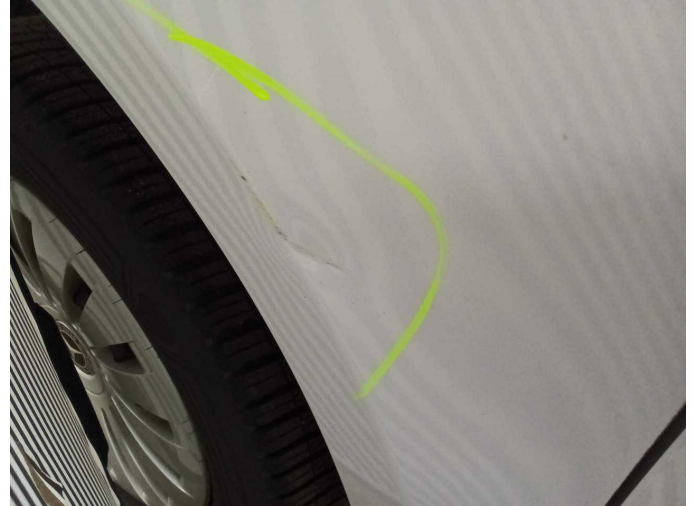
**Damage 3:** Side panel - rear right side: Side panel - Dent / paintcoat damage - Repair and paint

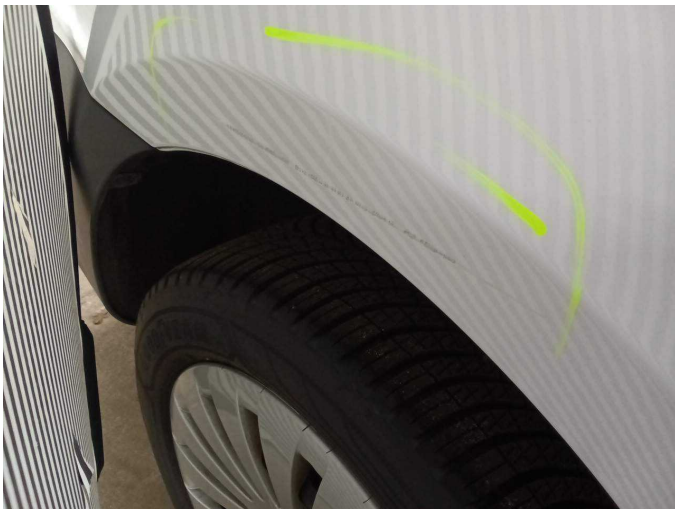
**Damage 3:** Side panel - rear right side: Side panel - Dent / paintcoat damage - Repair and paint
