Expertise

Protocol number: 46471717  
Order No. / Reference: 26027720  
Inspection date: 9 Jul 2026

Manufacturer: Mercedes-Benz

Model: Vito 116 CDI Lang HA Aut. PRO

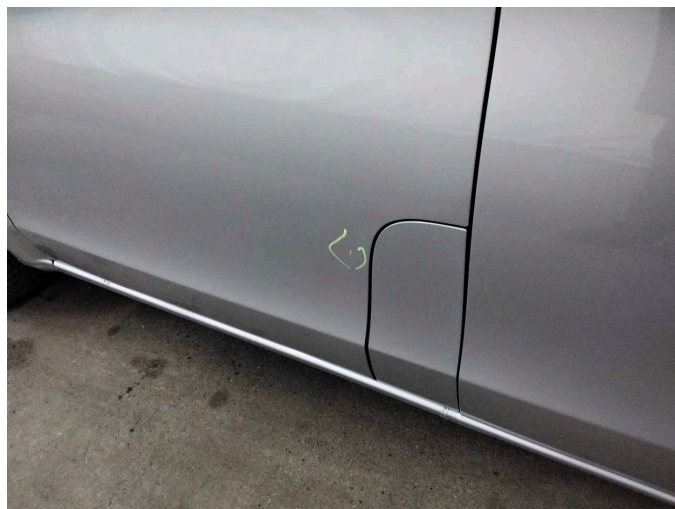
| No. | Component group | Description |
|---|---|---|
| 1 | Door - front left side | Door - Scratch(es) - Smart repair |

**Damage 1:** Door - front left side: Door - Scratch(es) - Smart repair

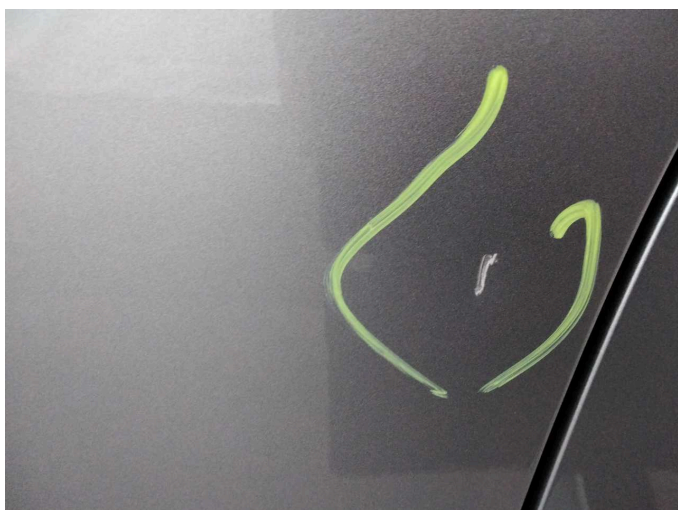
**Damage 1:** Door - front left side: Door - Scratch(es) - Smart repair

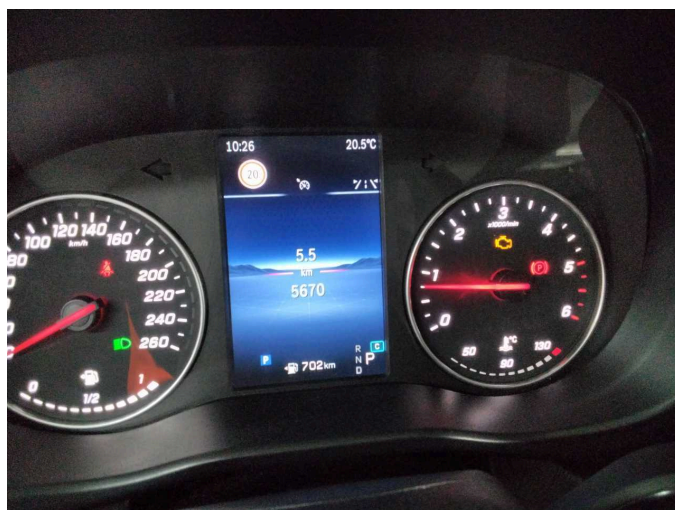
| Engine function test | An engine test run was performed, problem has been detected<br>This is due to the following reason.:<br>Kontrollleuchten aktiv |

| No. | Component group | Description |
|---|---|---|
| 2 | Instrument panel | Indicator light (Motorkontrolle) - on - Perform diagnosis |

**Damage 2:** Instrument panel: Indicator light (Motorkontrolle) - on - Perform diagnosis

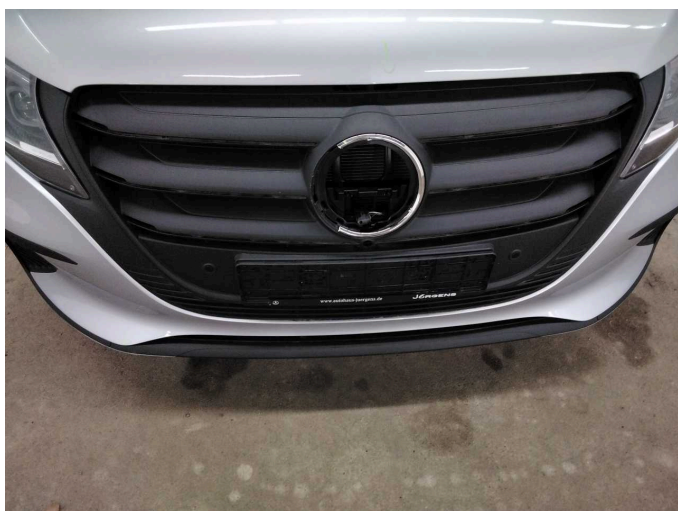
| No. | Component group | Description |
|---|---|---|
| 3 | Bonnet | Radiator grille (Emblem) - Broken / torn - Replace |

**Damage 3:** Bonnet: Radiator grille (Emblem) - Broken / torn - Replace

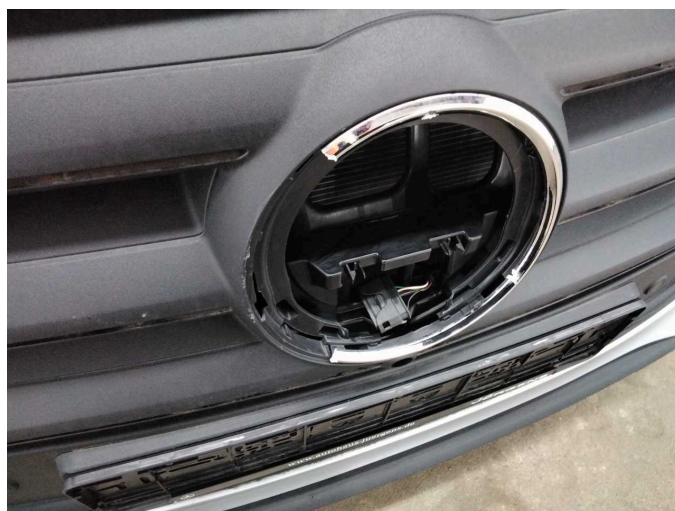
**Damage 3:** Bonnet: Radiator grille (Emblem) - Broken / torn - Replace

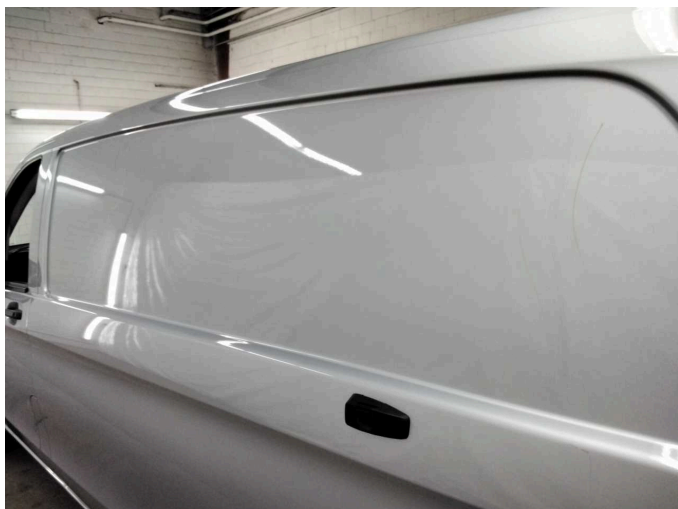
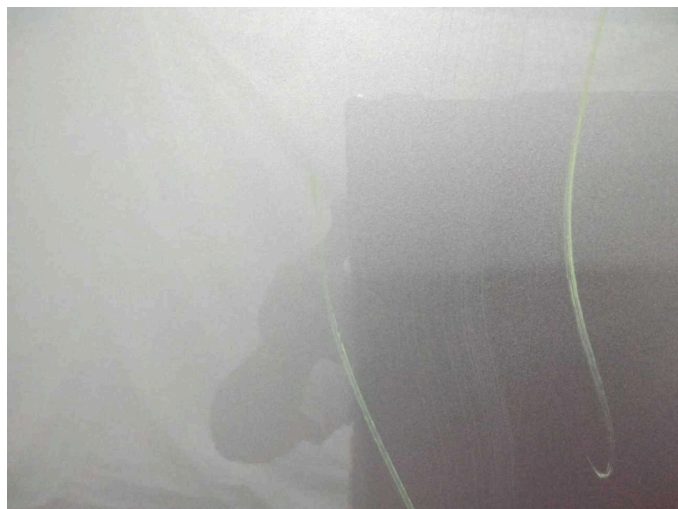
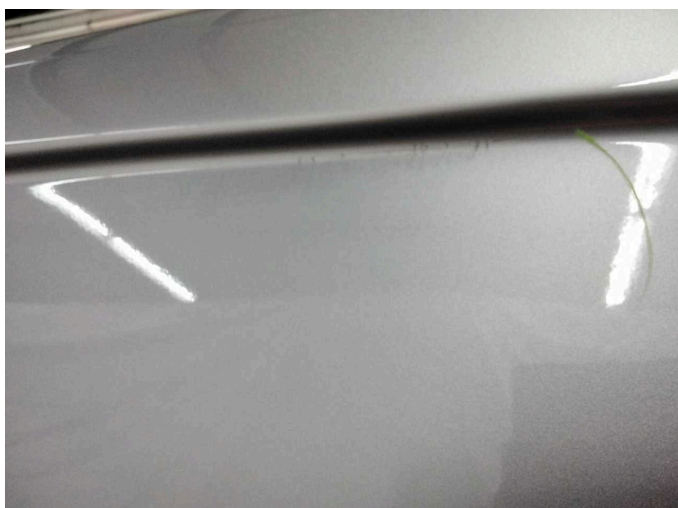
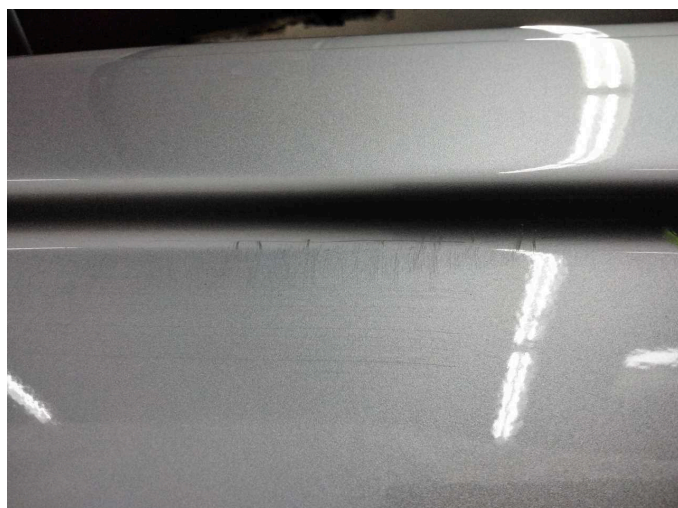
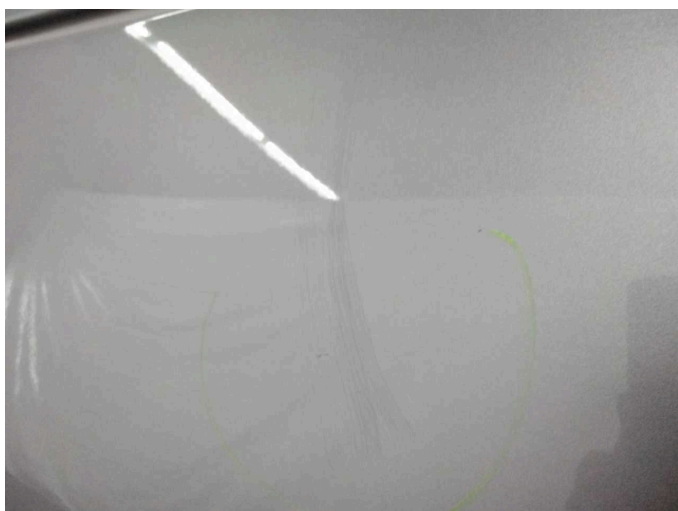
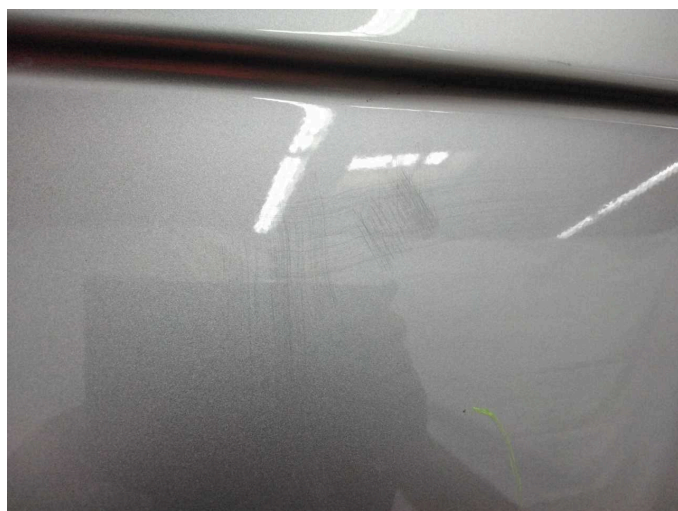
| No. | Component group | Description |
|---|---|---|
| 4 | Side panel - rear left side | Side panel - Scratch(es) - Paint |

**Damage 4:** Side panel - rear left side: Side panel - Scratch(es) - Paint

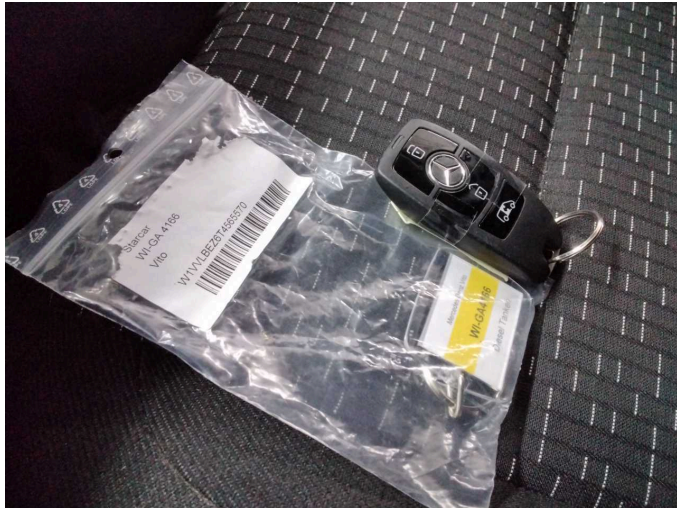
Documents - Log book  
Equipment - Vehicle key

**Missing part 2:** Equipment: Vehicle key - Missing - Replace
