Expertise

Protocol number: 46550588  
Order No. / Reference: 26566618  
Inspection date: 15 Jul 2026

Manufacturer: Ford

Model: Kuga 2.5 Duratec PHEV TITANIUM X

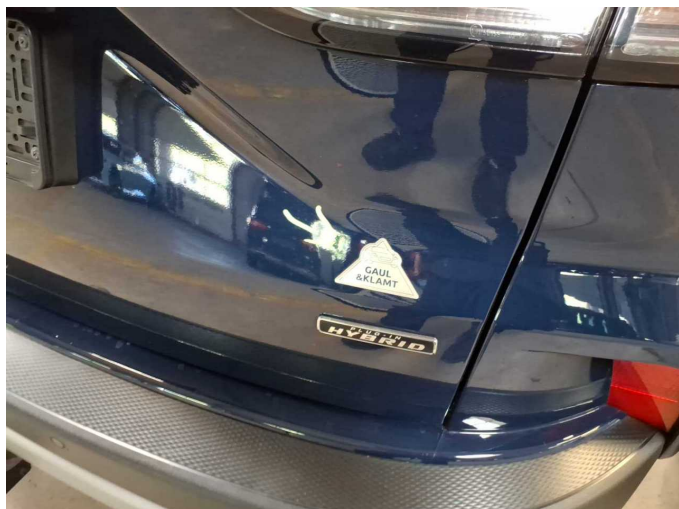
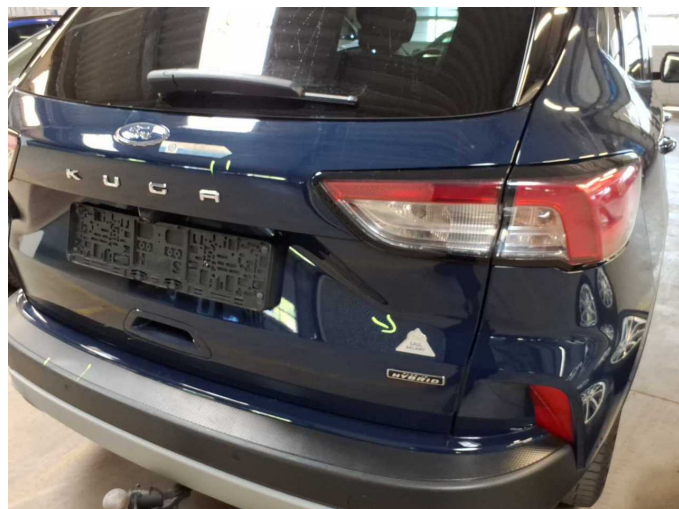
| No. | Component group | Description |
|---|---|---|
| 1 | Boot lid / rear door | Boot lid - Glued / labelled - De-glue / neutralise |

**Damage 1:** Boot lid / rear door: Boot lid - Glued / labelled - De-glue / neutralise

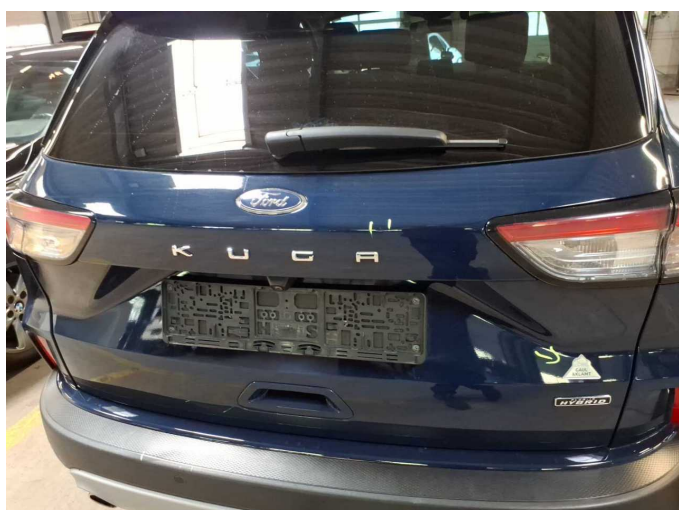
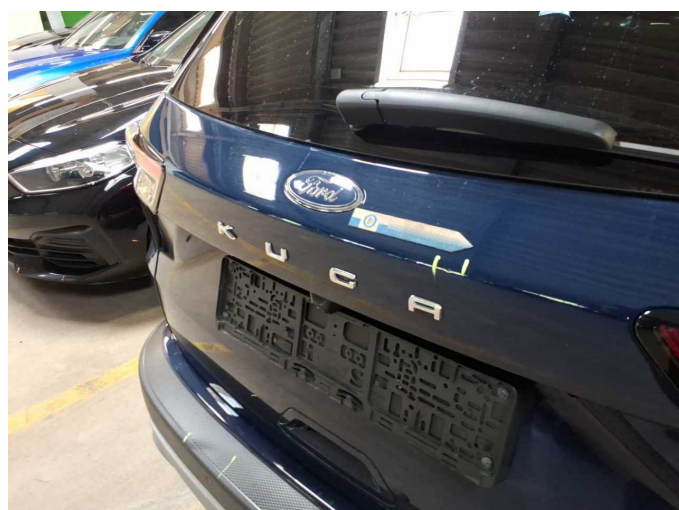
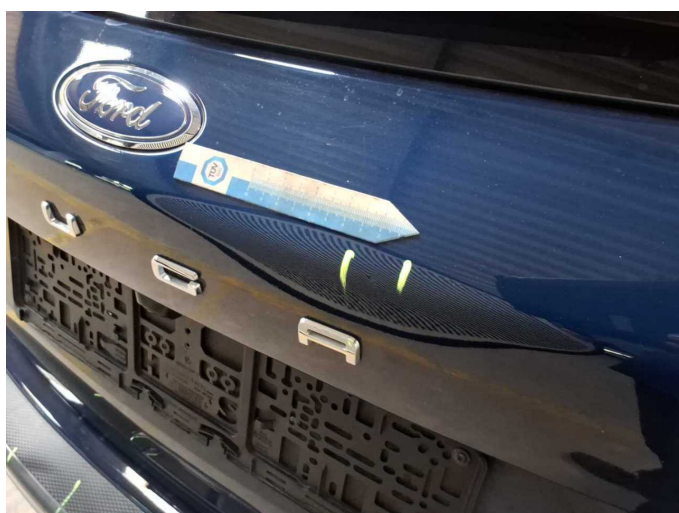
| No. | Component group | Description |
|---|---|---|
| 2 | Boot lid / rear door | Boot lid - dent(s) - Smooth repair work |

**Damage 2:** Boot lid / rear door: Boot lid - dent(s) - Smooth repair work

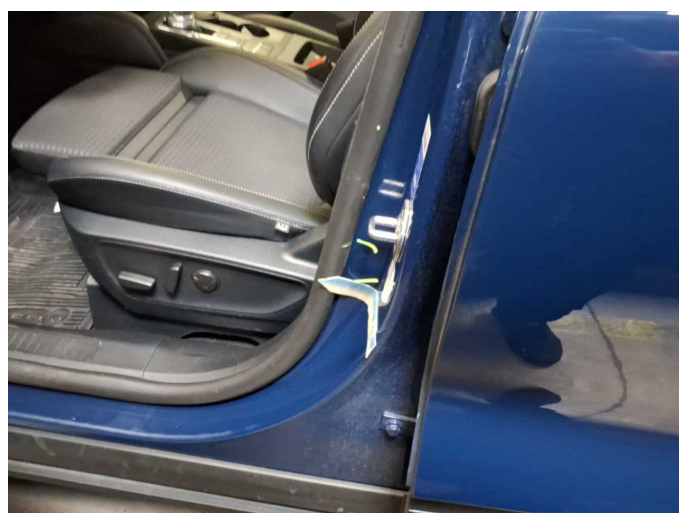
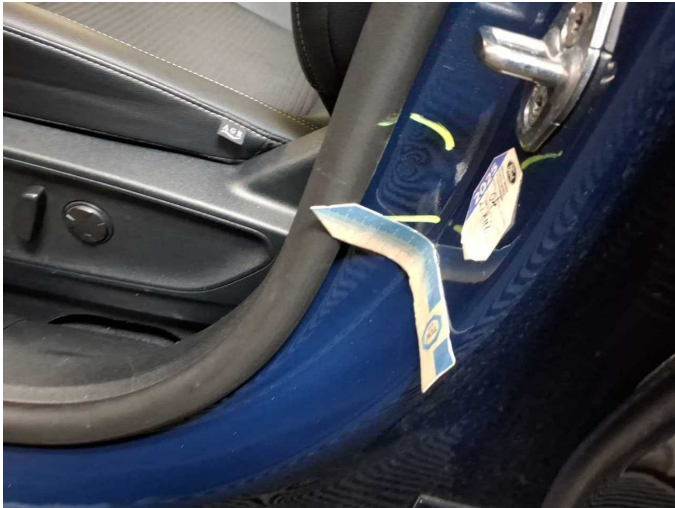
| No. | Component group | Description |
|---|---|---|
| 3 | Body | B-pillar - left side - dent(s) - Smooth repair work |

**Damage 3:** Body: B-pillar - left side - dent(s) - Smooth repair work

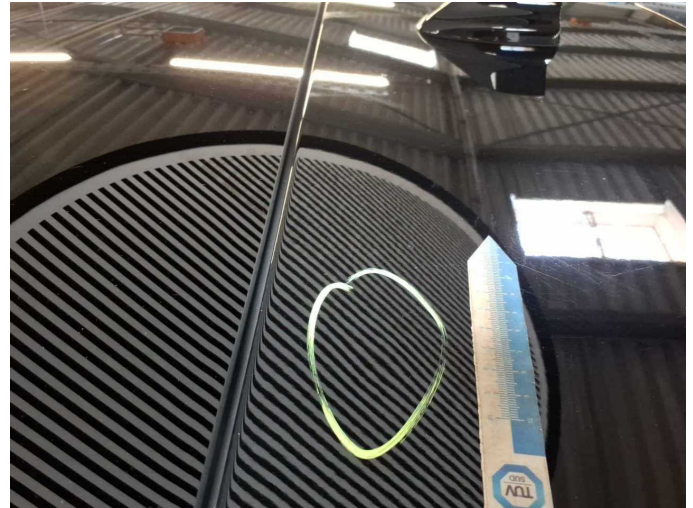
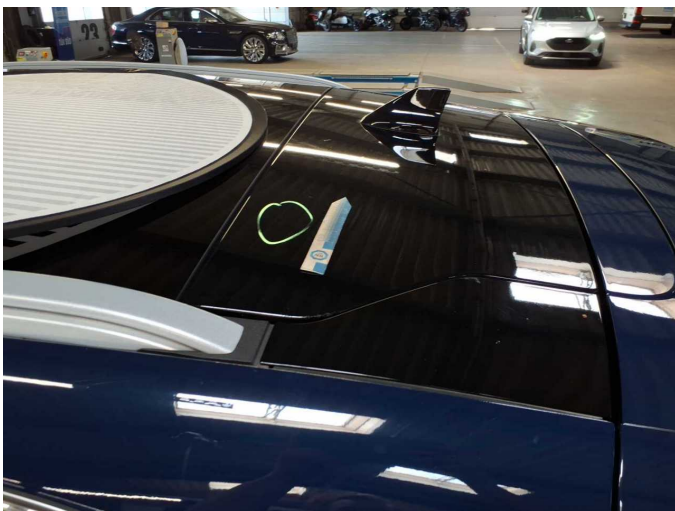
| No. | Component group | Description |
|---|---|---|
| 4 | Roof | Roof - dent(s) - Smooth repair work |

**Damage 4:** Roof: Roof - dent(s) - Smooth repair work

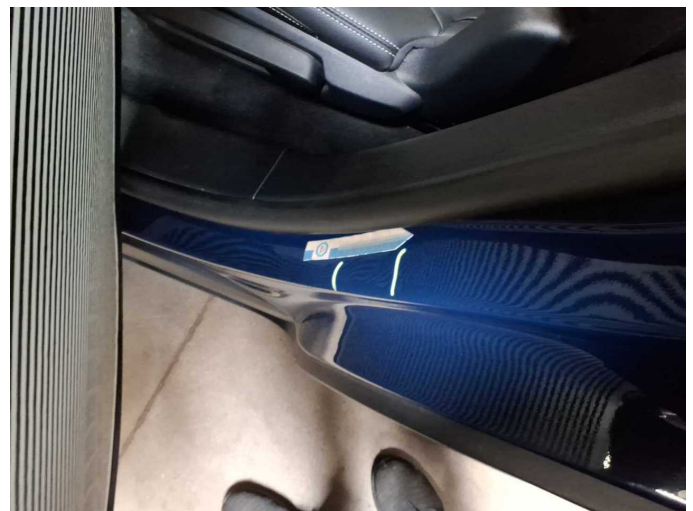
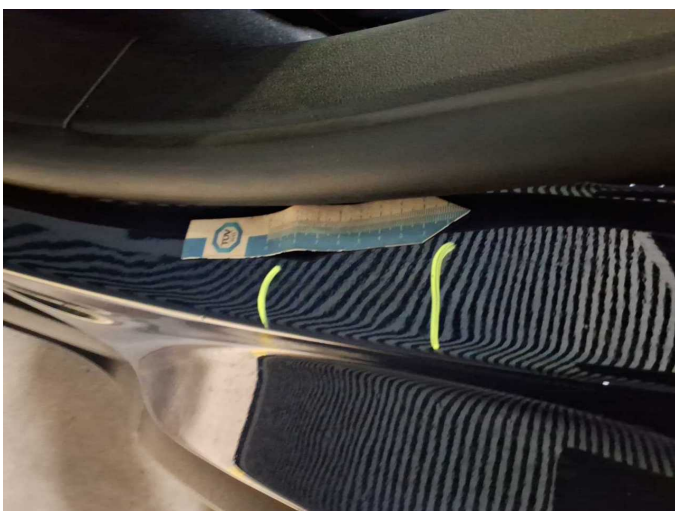
| No. | Component group | Description |
|---|---|---|
| 5 | Side panel - rear left side | Sill - dent(s) - Smooth repair work |

**Damage 5:** Side panel - rear left side: Sill - dent(s) - Smooth repair work

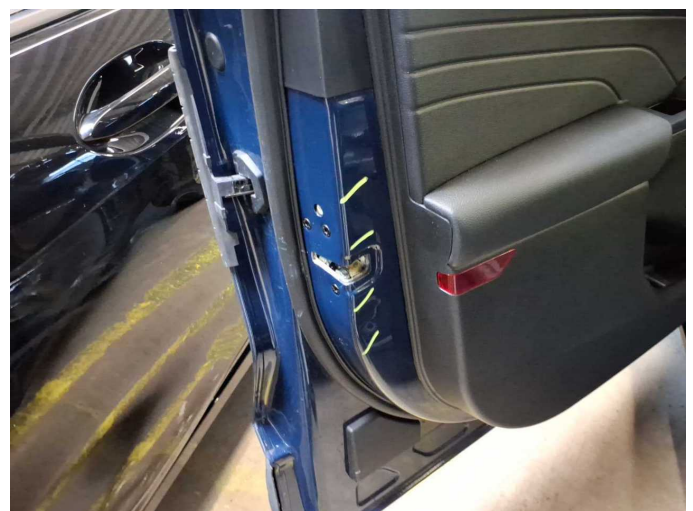
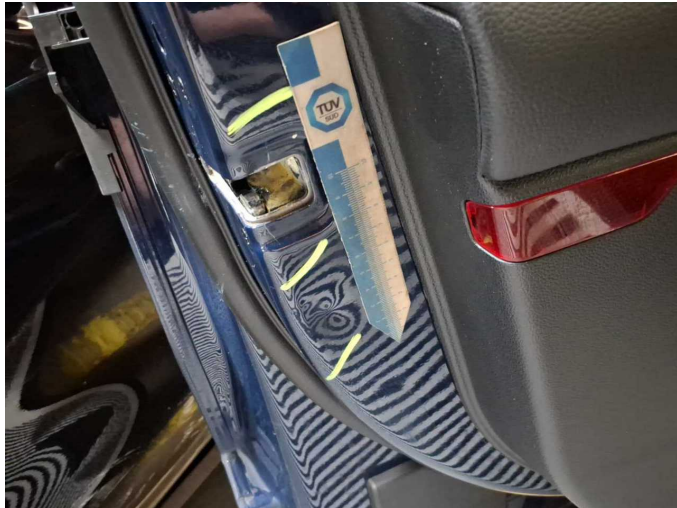
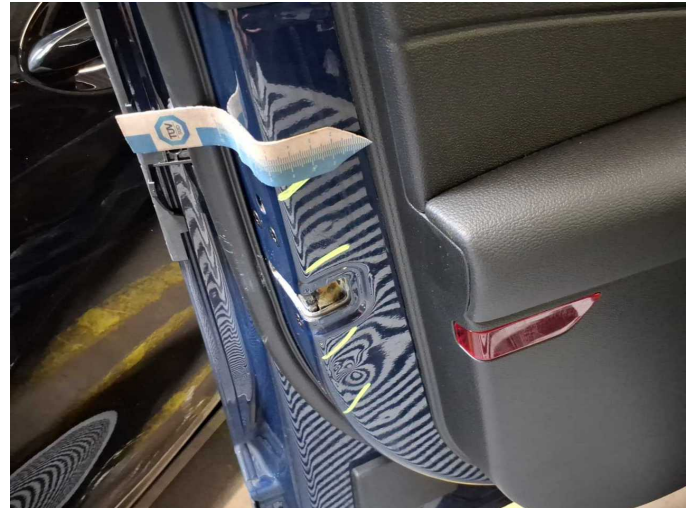
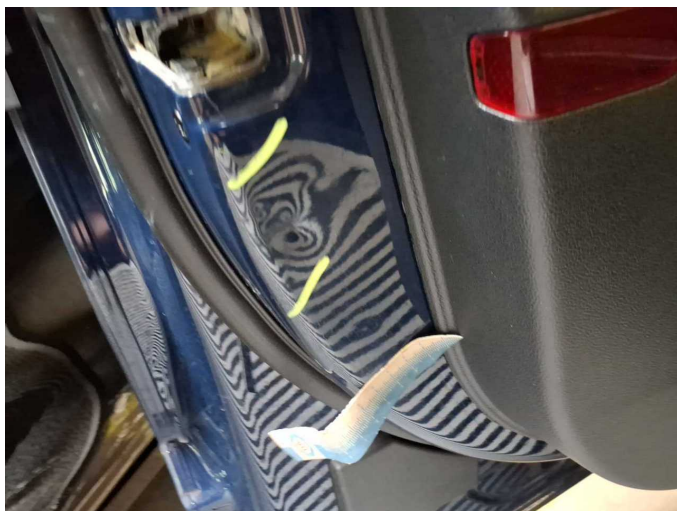
| No. | Component group | Description |
|---|---|---|
| 6 | Door - front left side | Door - dent(s) - Smooth repair work |

**Damage 6:** Door - front left side: Door - dent(s) - Smooth repair work

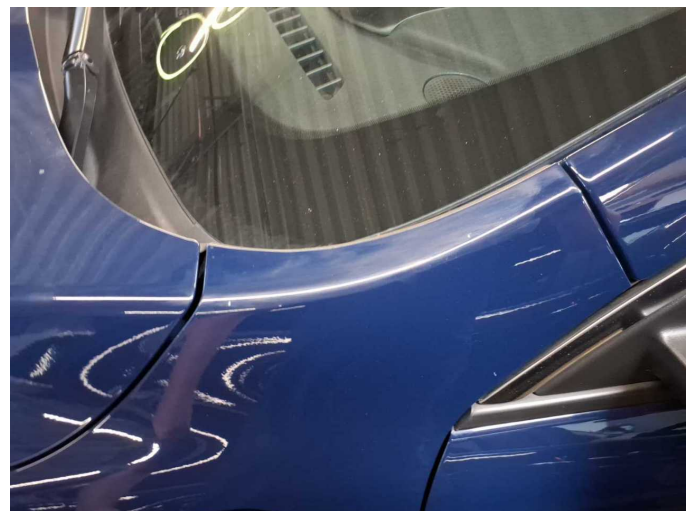
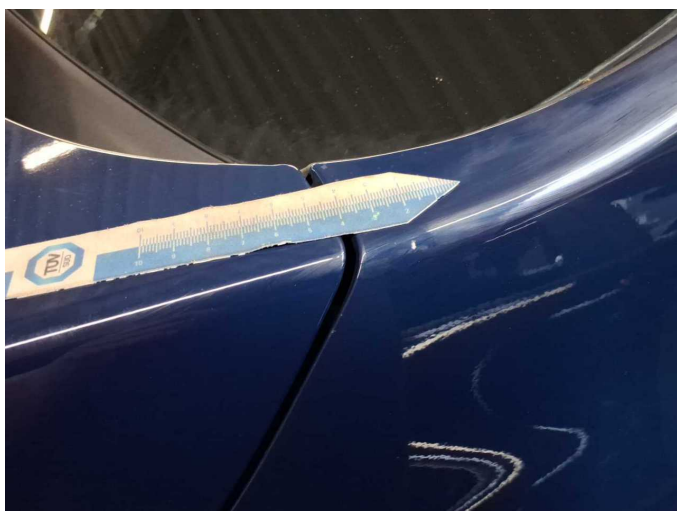
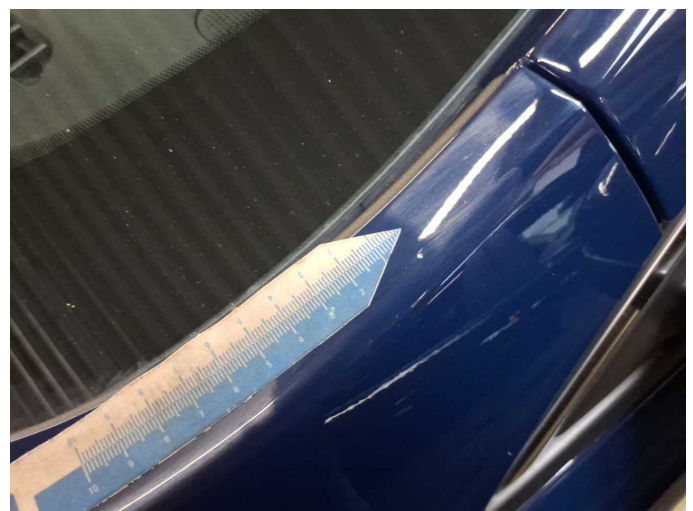
| No. | Component group | Description |
|---|---|---|
| 7 | Mudguard - left side | Mudguard - left side - Stone chips - Smart repair |

**Damage 7:** Mudguard - left side: Mudguard - left side - Stone chips - Smart repair

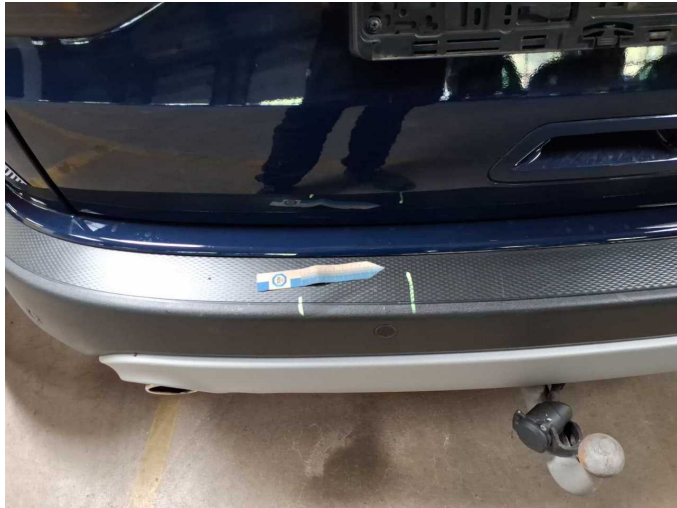
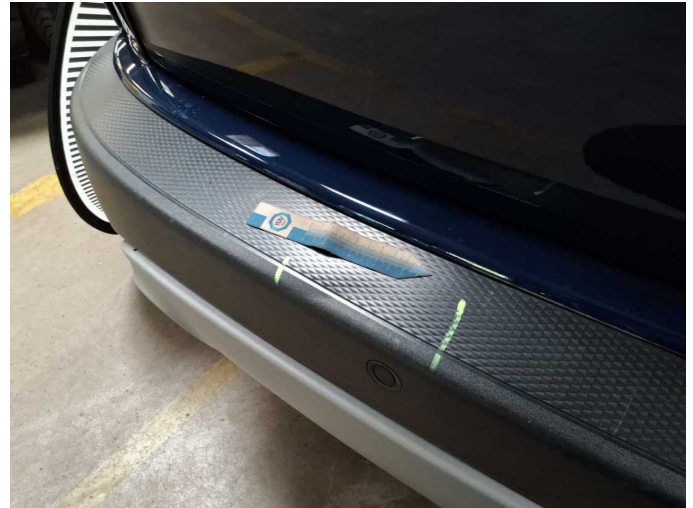
| No. | Component group | Description |
|---|---|---|
| 9 | Rear bumper | Rear bumper (unpainted) - dent(s) - Loss in value |

**Damage 9:** Rear bumper: Rear bumper (unpainted) - dent(s) - Loss in value

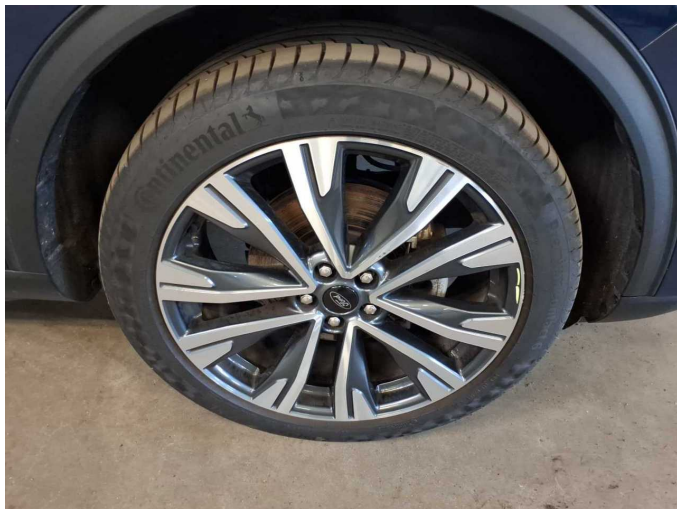
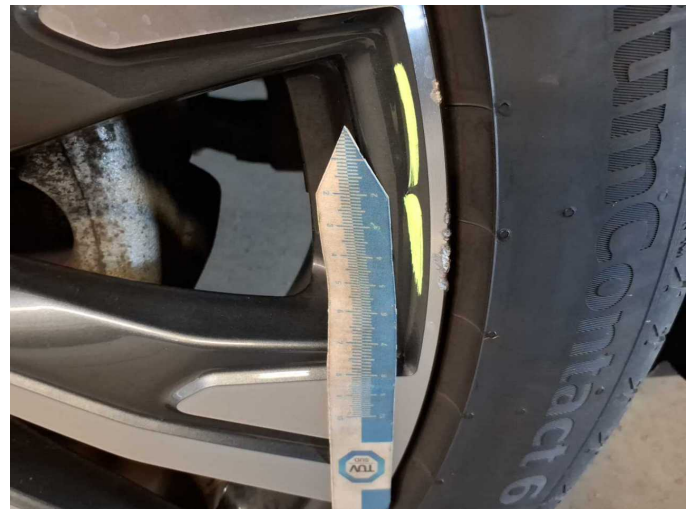
| No. | Component group | Description |
|---|---|---|
| 10 | Wheel / tyres | Alloy rim - front right side (Materialabtrag) - Scratch(es) - Replace |

**Damage 10:** Wheel / tyres: Alloy rim - front right side (Materialabtrag) - Scratch(es) - Replace

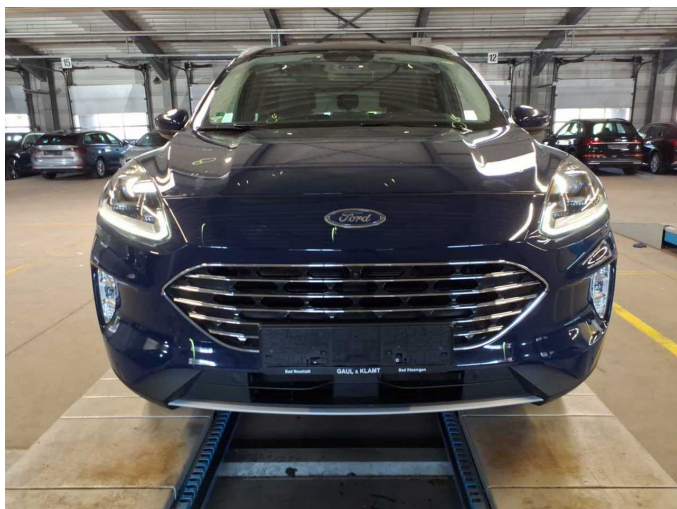
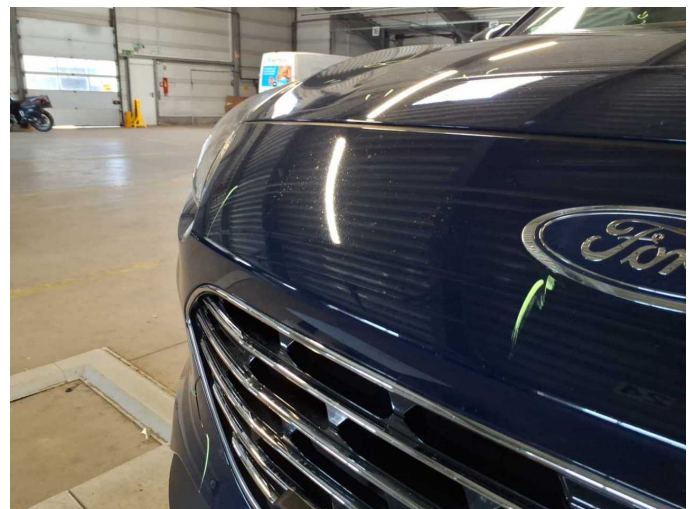
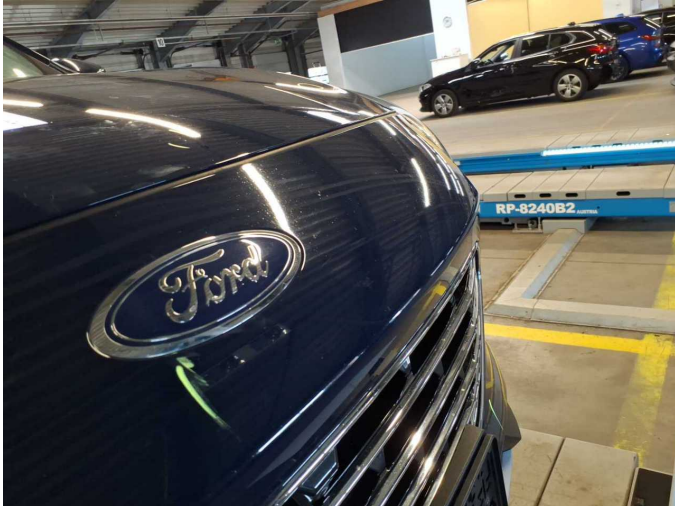
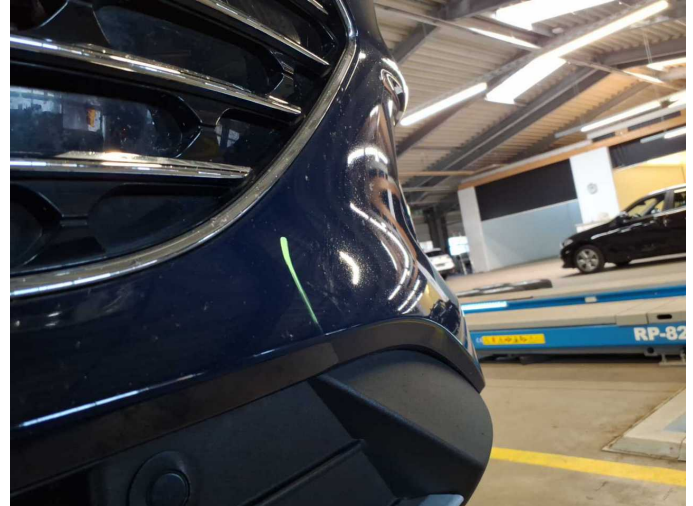
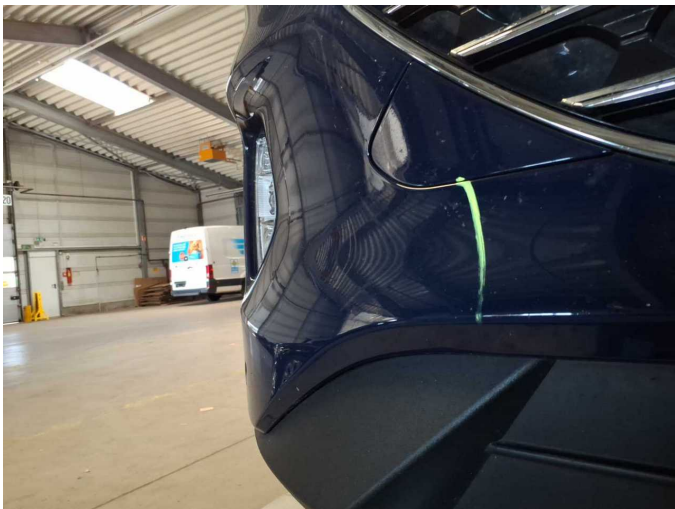
| No. | Component group | Description |
|---|---|---|
| 11 | Front bumper | Front bumper (Sandstrahleffekt) - Stone chips - Paint |

**Damage 11:** Front bumper: Front bumper (Sandstrahleffekt) - Stone chips - Paint

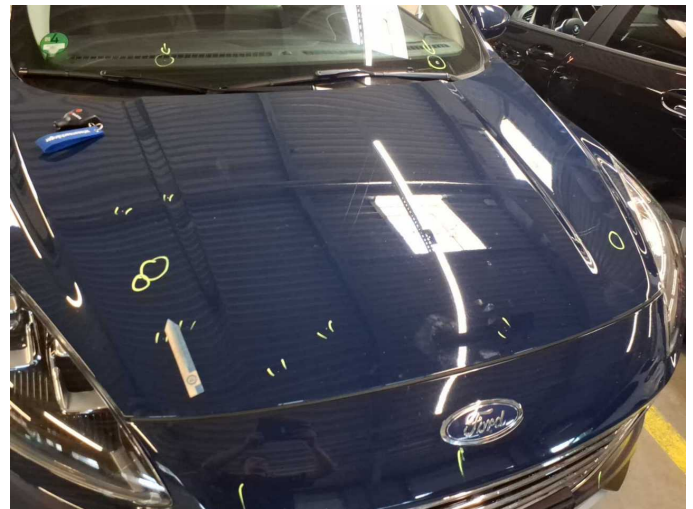
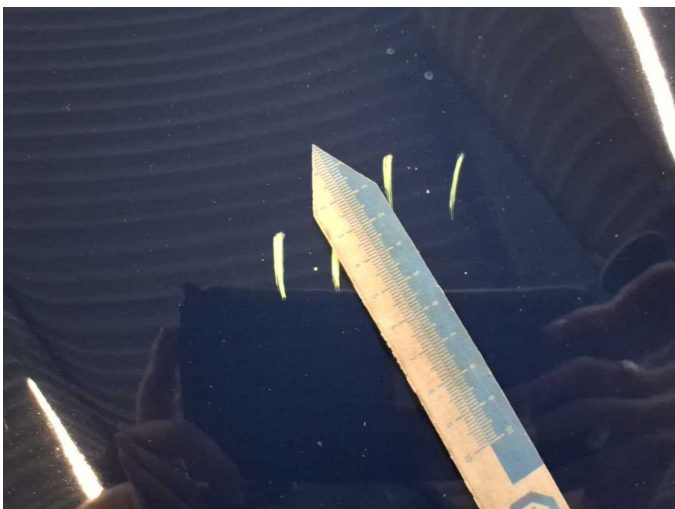
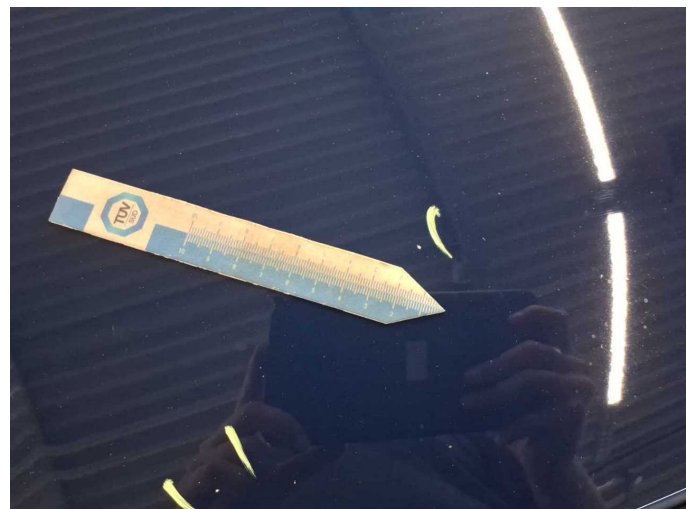
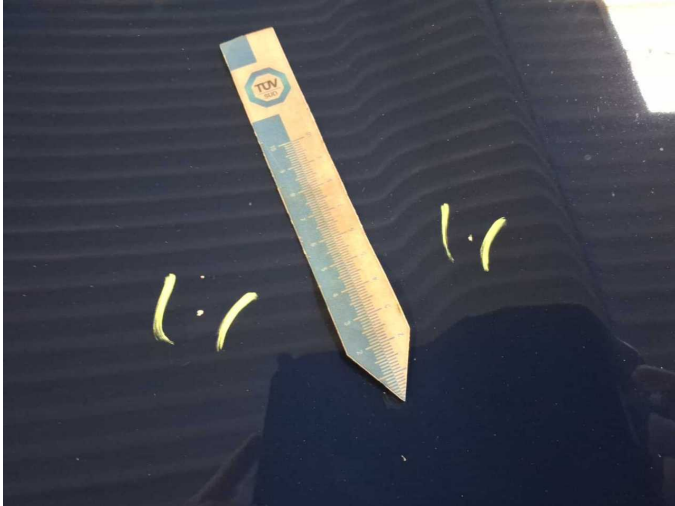
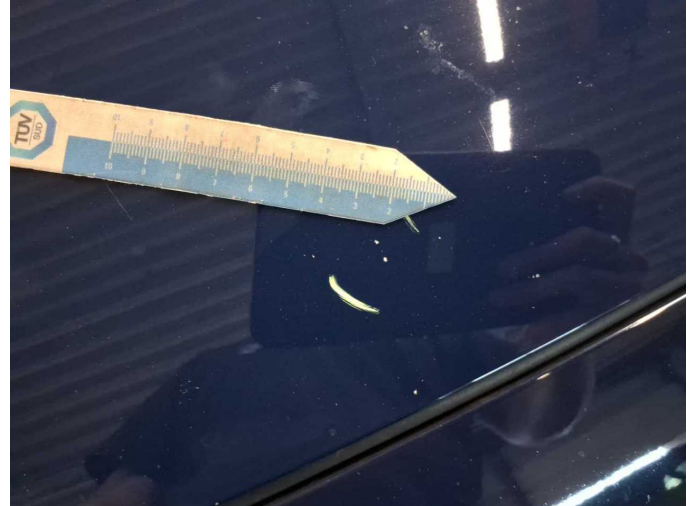
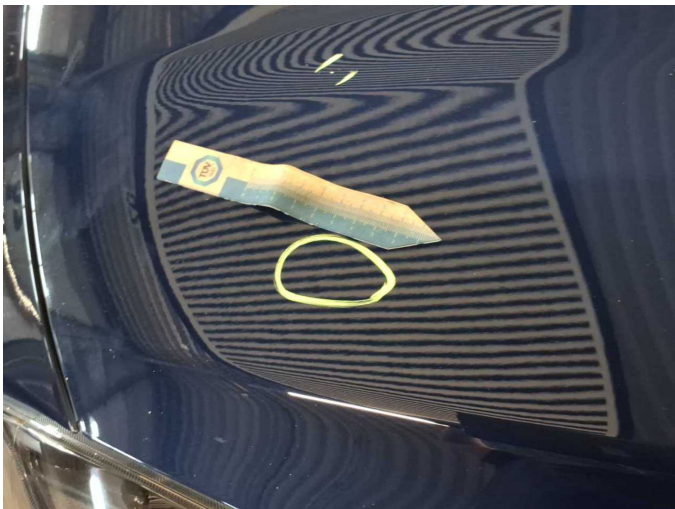
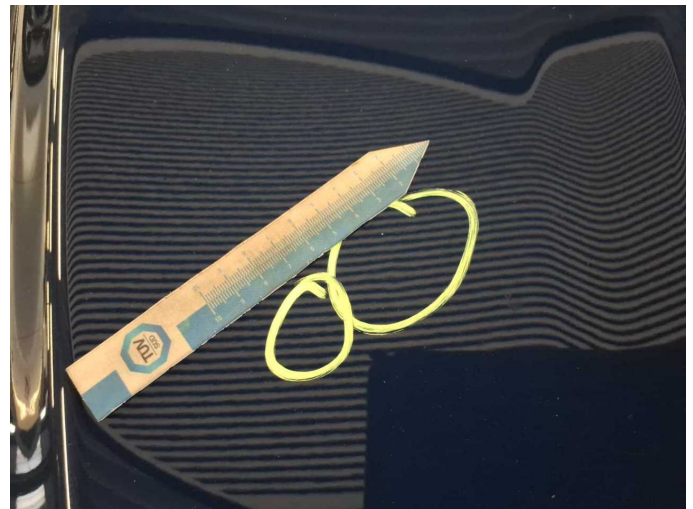
| No. | Component group | Description |
|---|---|---|
| 12 | Bonnet | Bonnet - Dent / paintcoat damage - Repair and paint |

**Damage 12:** Bonnet: Bonnet - Dent / paintcoat damage - Repair and paint

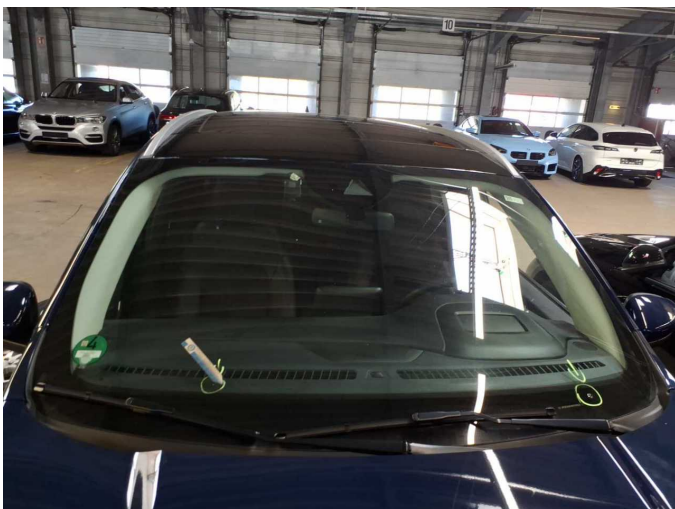
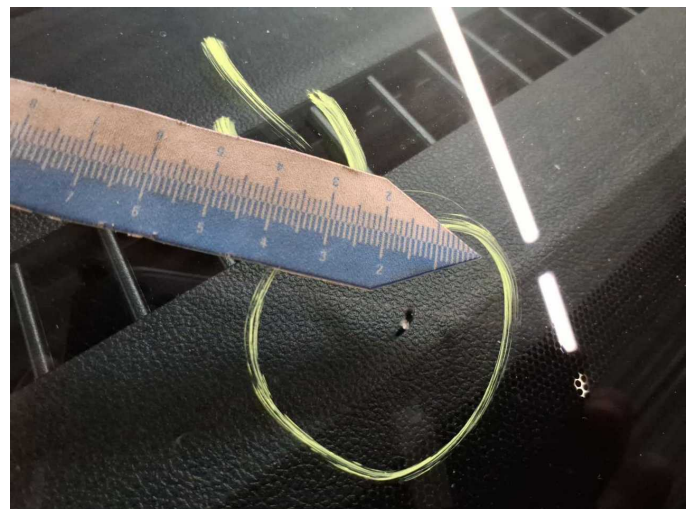
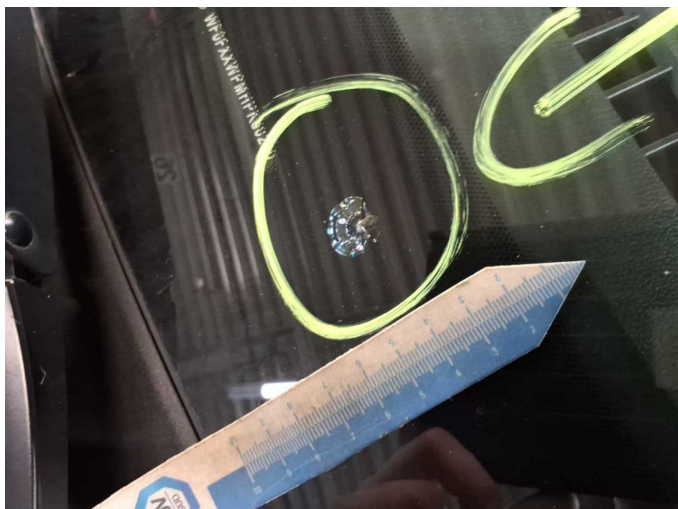
| No. | Component group | Description |
|---|---|---|
| 13 | Vehicle glazing | Windscreen - Stone chips - repair according to calculation |

**Damage 13:** Vehicle glazing: Windscreen - Stone chips - repair according to calculation

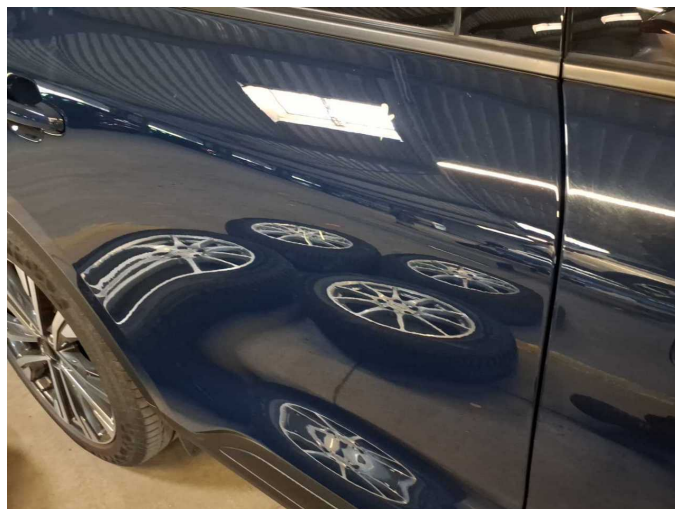
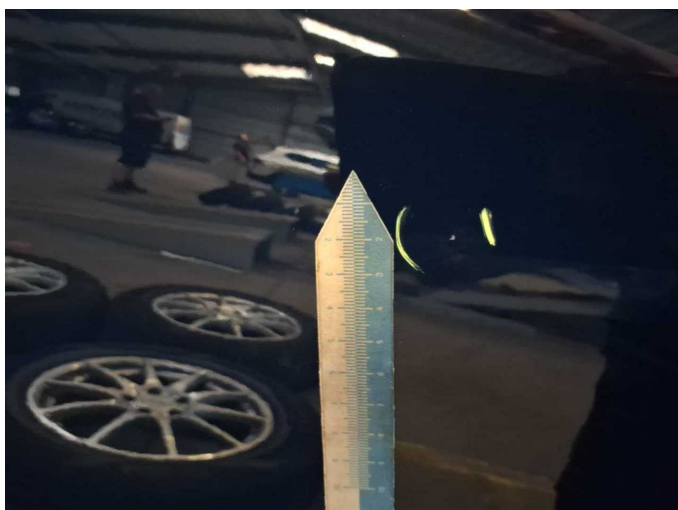
| No. | Component group | Description |
|---|---|---|
| 2 | Door - rear right side | Door - Stone chips |

**Wear and tear 2:** Door - rear right side: Door - Stone chips

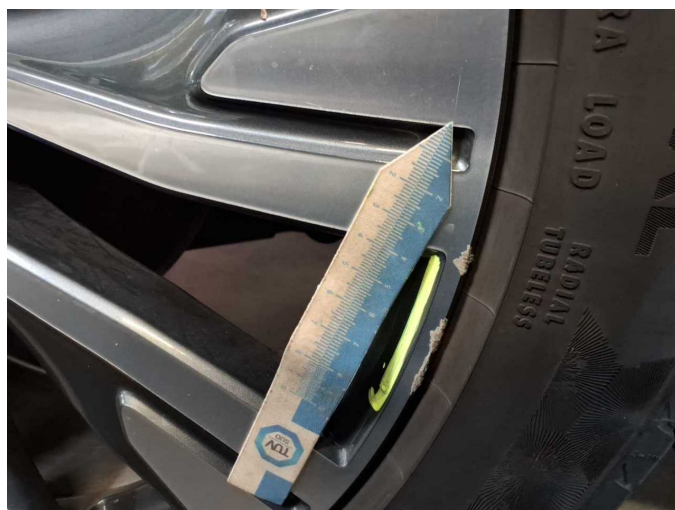
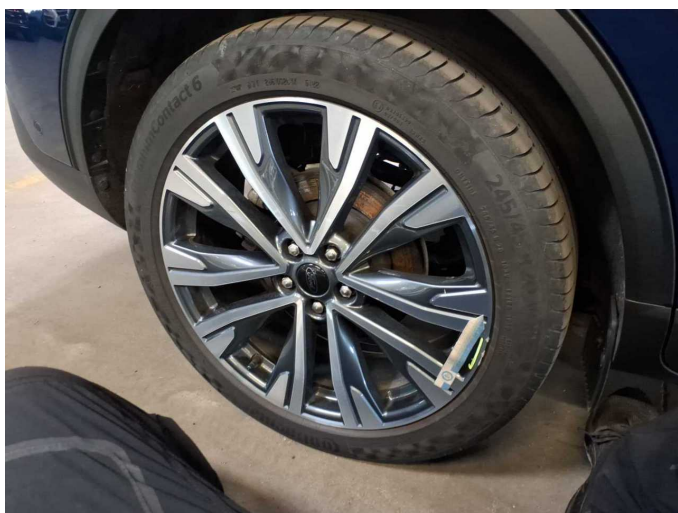
| No. | Component group | Description |
|---|---|---|
| 3 | Wheel / tyres | Alloy rim - rear right side - Scratch(es) |

**Wear and tear 3:** Wheel / tyres: Alloy rim - rear right side - Scratch(es)

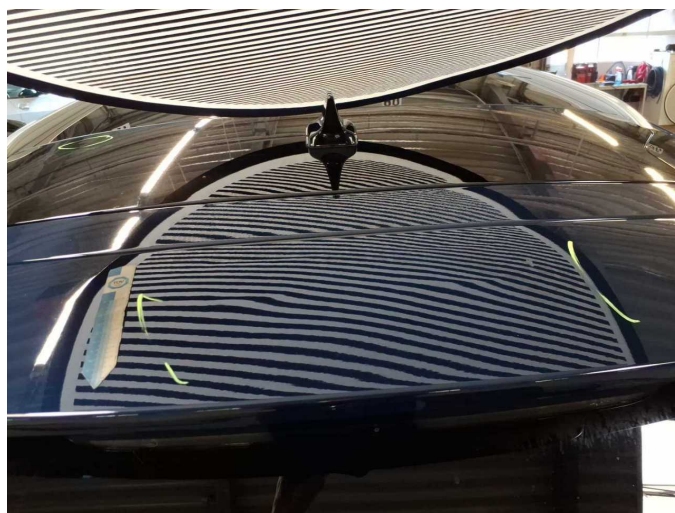
| No. | Component group | Description |
|---|---|---|
| 4 | Boot lid / rear door | Rear spoiler - dent(s) |

**Wear and tear 4:** Boot lid / rear door: Rear spoiler - dent(s)

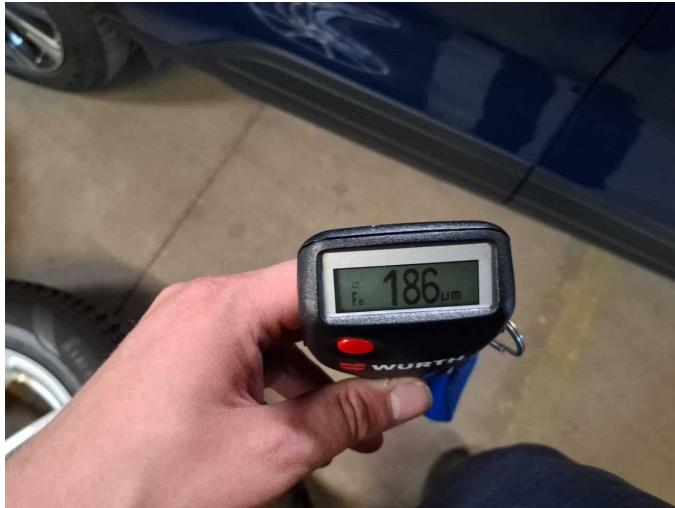
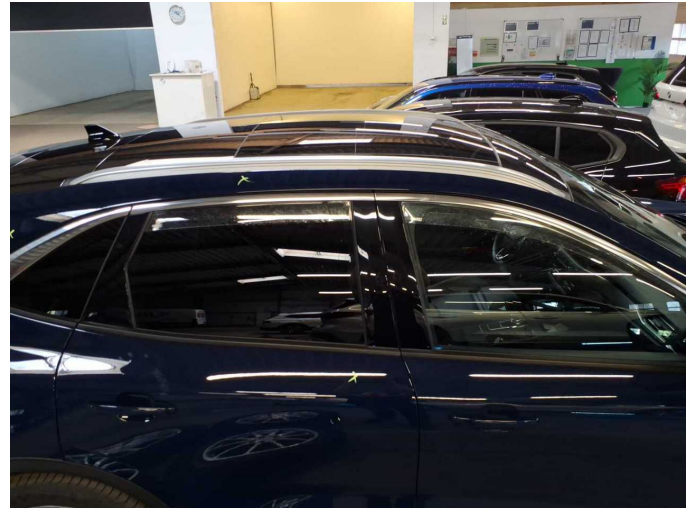
| No. | Repainting |
|---|---|
| 1 | Roof rail - right side, Professionally carried out, Invoice of repair done Non-existent |

**Repainting 1:** Roof rail - right side

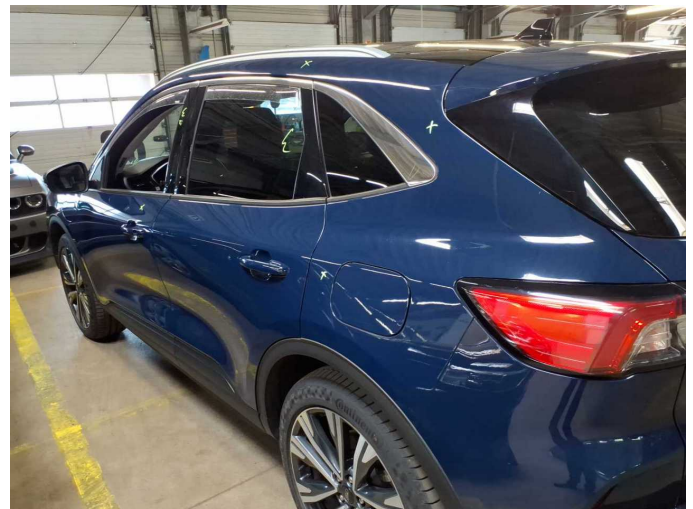
| No. | Repainting |
|---|---|
| 2 | Side panel - rear left side, Professionally carried out, Invoice of repair done Non-existent |

**Repainting 2:** Side panel - rear left side

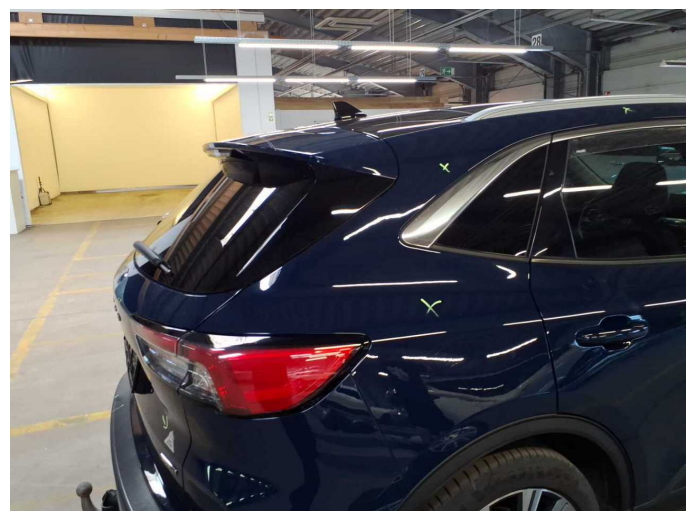
| No. | Repainting |
|---|---|
| 3 | Side panel - rear right side, Professionally carried out, Invoice of repair done Non-existent |

**Repainting 3:** Side panel - rear right side

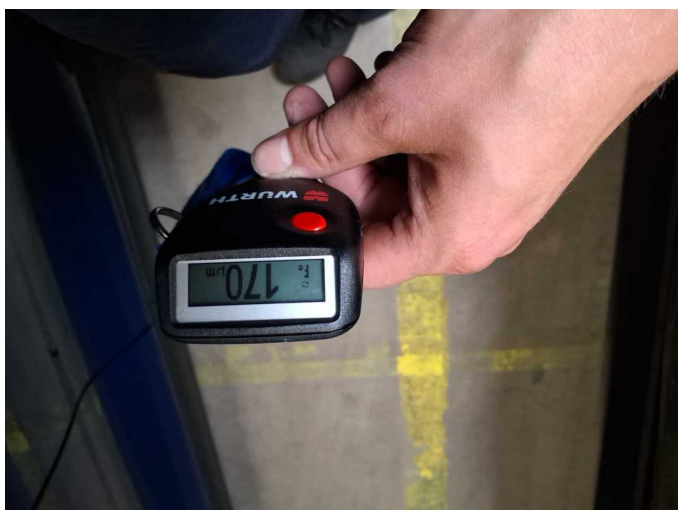
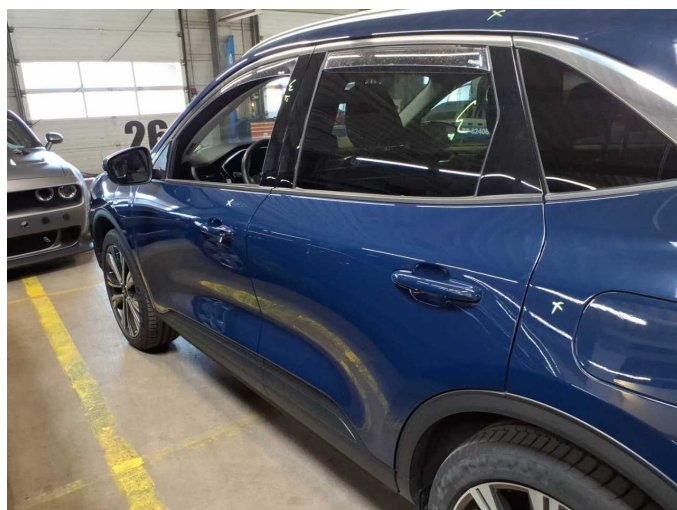
| No. | Repainting |
|---|---|
| 5 | Door - rear left side, Professionally carried out, Invoice of repair done Non-existent |

**Repainting 5:** Door - rear left side

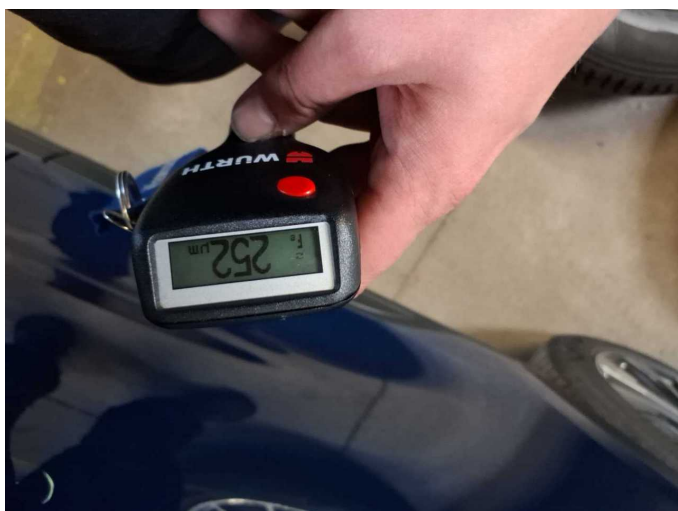
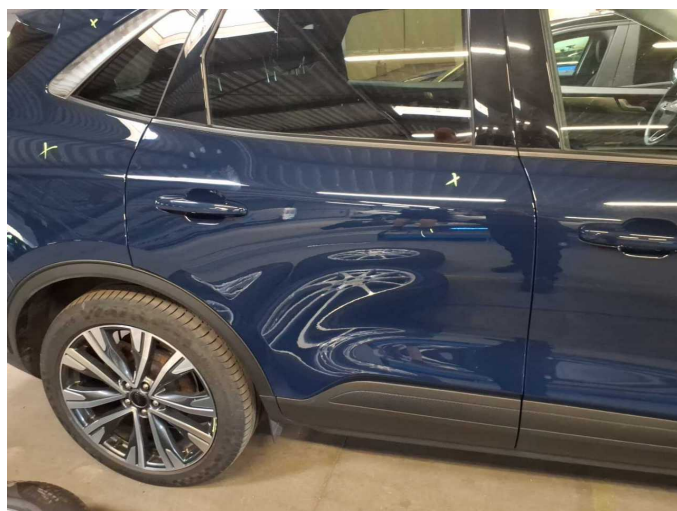
| No. | Repainting |
|---|---|
| 6 | Door - rear right side, Professionally carried out, Invoice of repair done Non-existent |

**Repainting 6:** Door - rear right side

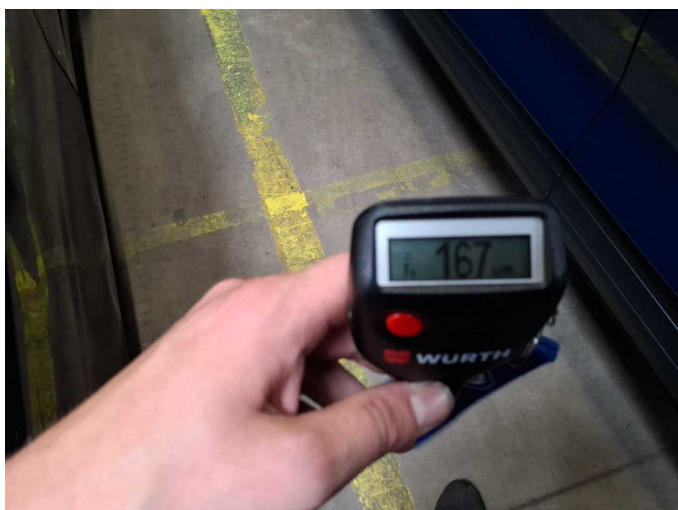
| No. | Repainting |
|---|---|
| 7 | Door - front left side |

**Repainting 7: Door - front left side**

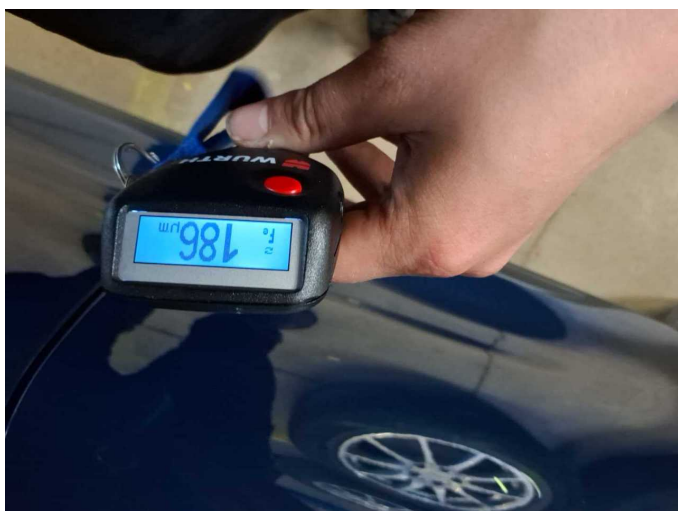
**Roof rail - right side: 186 µm**

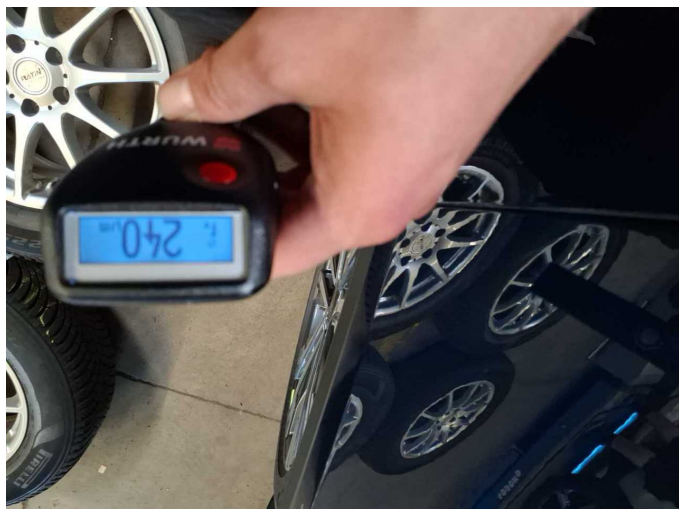
Side panel - rear right side: 240 µm

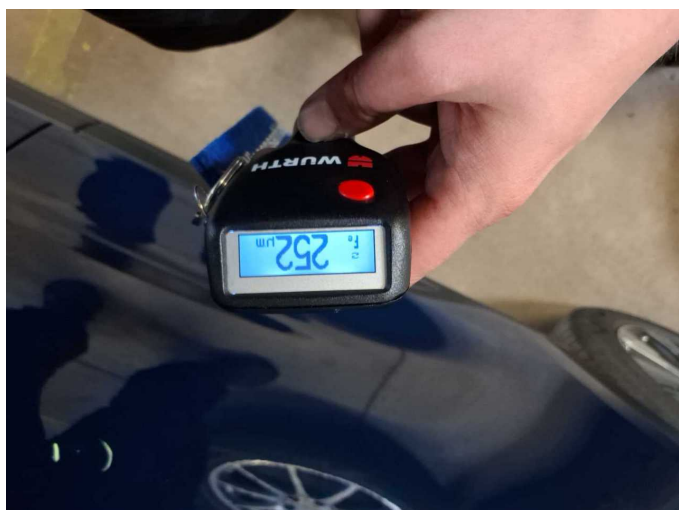
Door - rear right side: 252 µm
