Expertise

Protocol number: 46193589
Order No. / Reference: 26559608
Inspection date: 29 Jun 2026

Manufacturer: CUPRA

Model: Born 150kW/58kWh

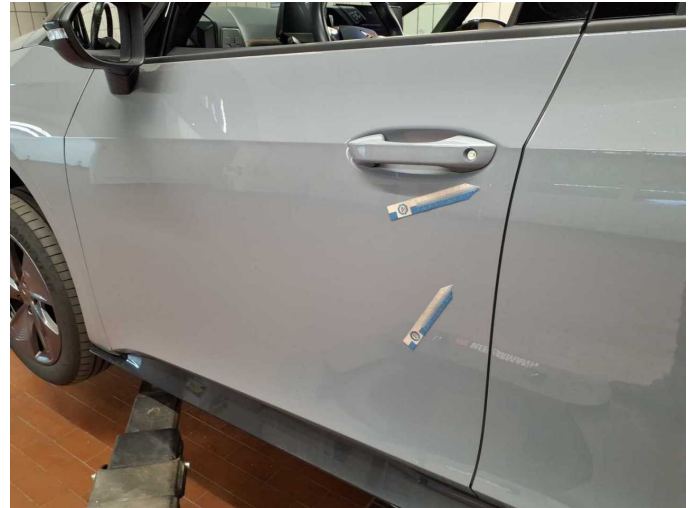
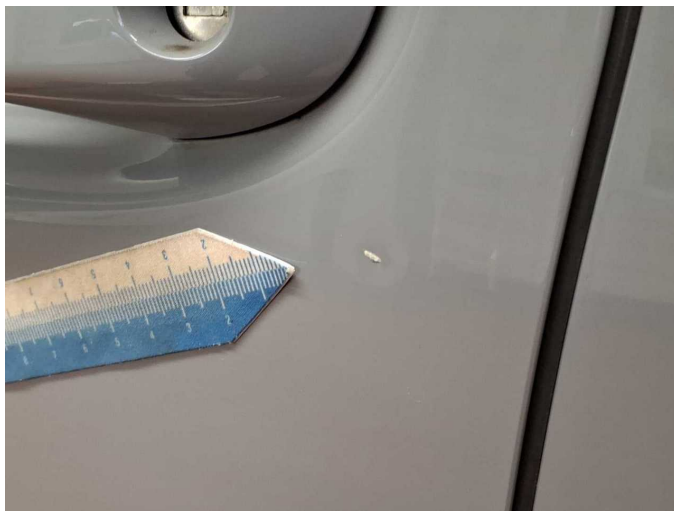
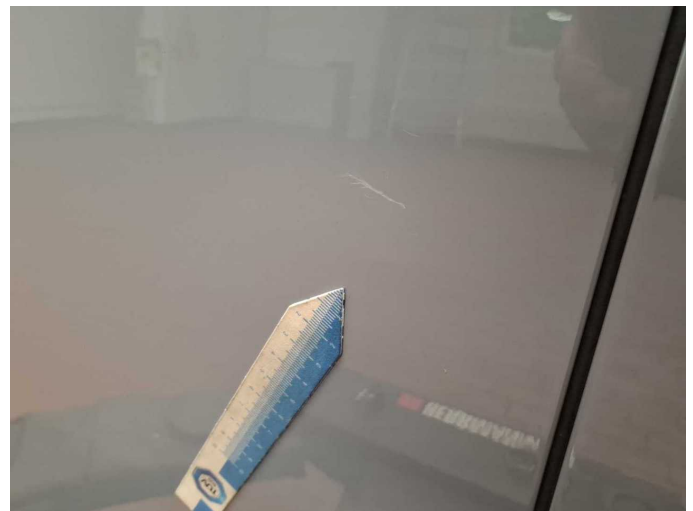
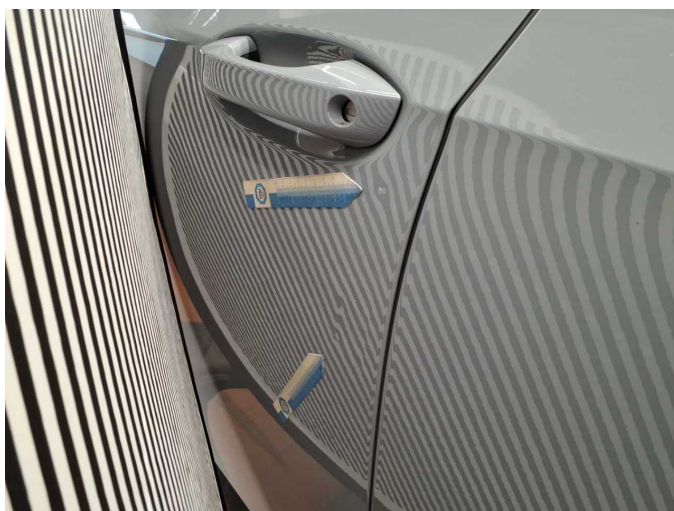
No.	Component group	Description
1	Door - front left side	Door - Dent / paintcoat damage - Repair and paint

Damage 1: Door - front left side: Door - Dent / paintcoat damage - Repair and paint
