Expertise

Protocol number: 46427260  
Order No. / Reference: 26512746  
Inspection date: 9 Jul 2026

Manufacturer: Volkswagen

Model: Passat Variant 2.0 TDI SCR Business

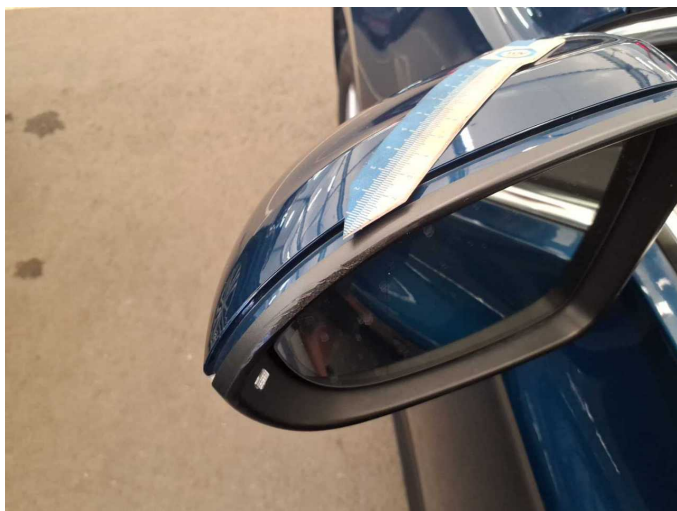
| No. | Component group | Description |
|---|---|---|
| 1 | Wing mirror - left side | Chassis - Scratch(es) - Replace |

Damage 1: Wing mirror - left side: Chassis - Scratch(es) - Replace

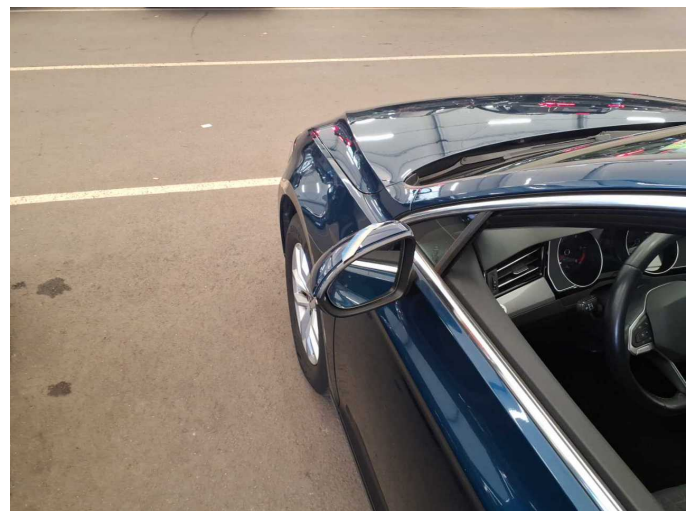
Damage 1: Wing mirror - left side: Chassis - Scratch(es) - Replace

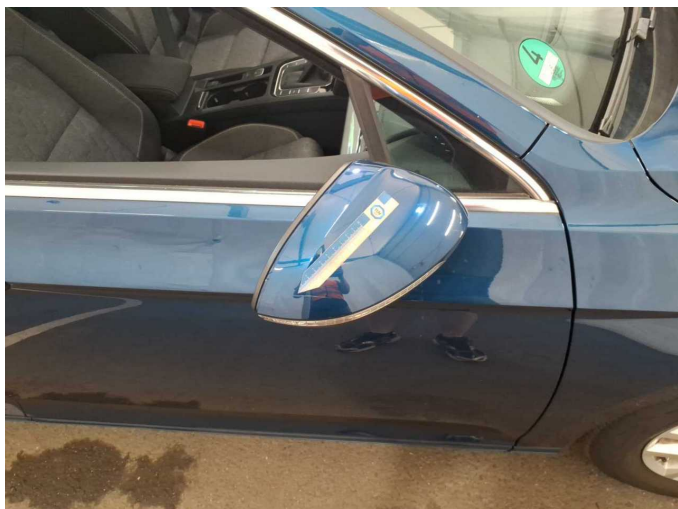
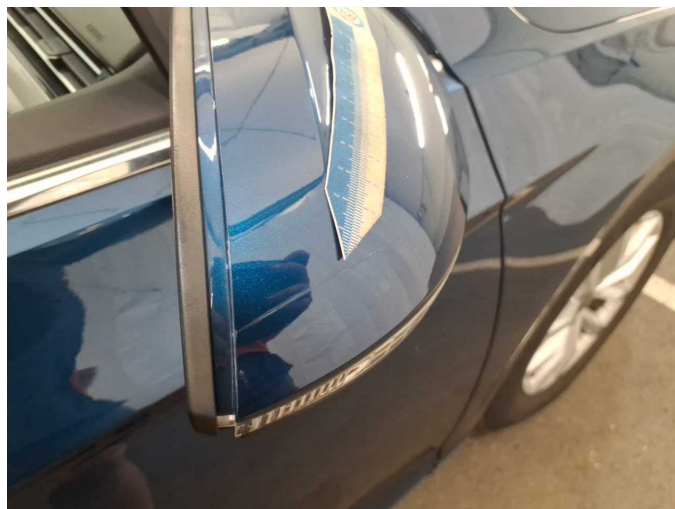
| No. | Component group | Description |
|---|---|---|
| 2 | Wing mirror - right side | Cap - Scratch(es) - Smart repair |

**Damage 2:** Wing mirror - right side: Cap - Scratch(es) - Smart repair

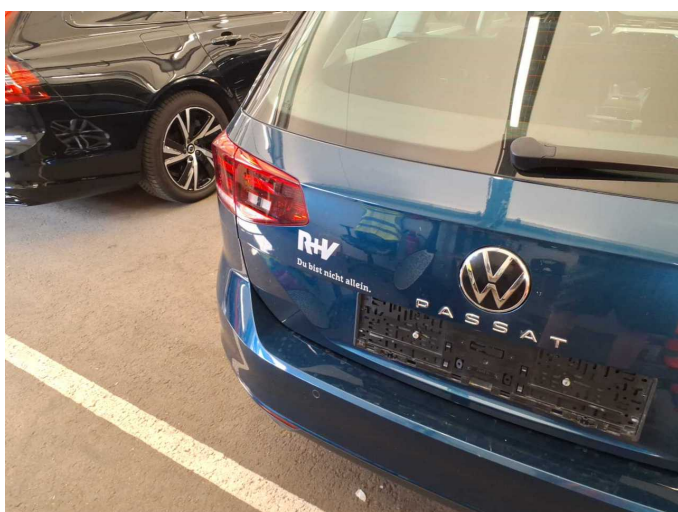
| No. | Component group | Description |
|---|---|---|
| 3 | Boot lid / rear door | Boot lid - Glued / labelled - De-glue / neutralise |

**Damage 3:** Boot lid / rear door: Boot lid - Glued / labelled - De-glue / neutralise

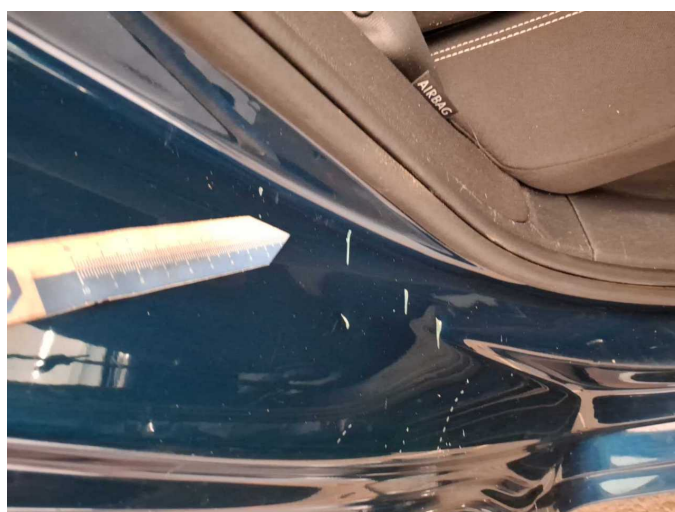
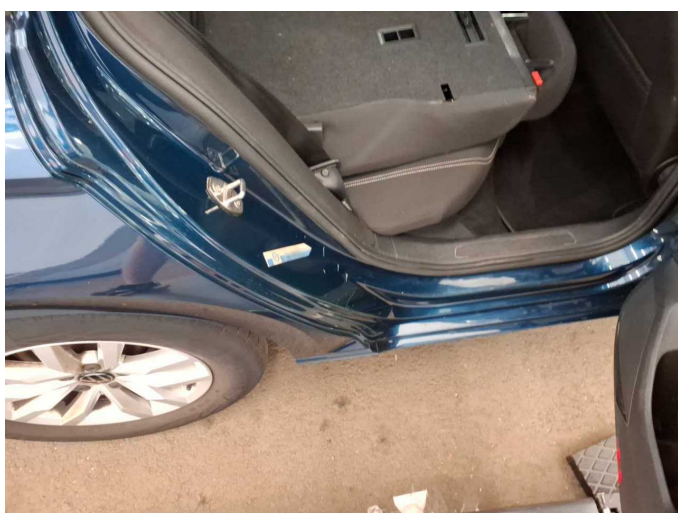
| No. | Component group | Description |
|---|---|---|
| 4 | Side panel - rear right side | Sill - Scratch(es) - Smart repair |

**Damage 4:** Side panel - rear right side: Sill - Scratch(es) - Smart repair

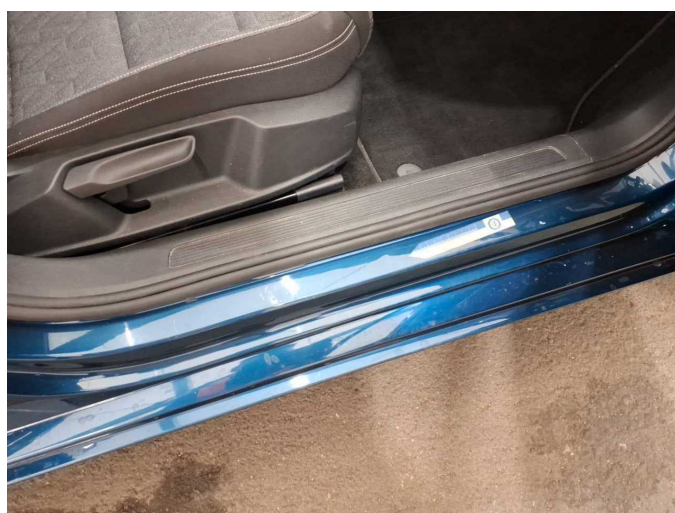
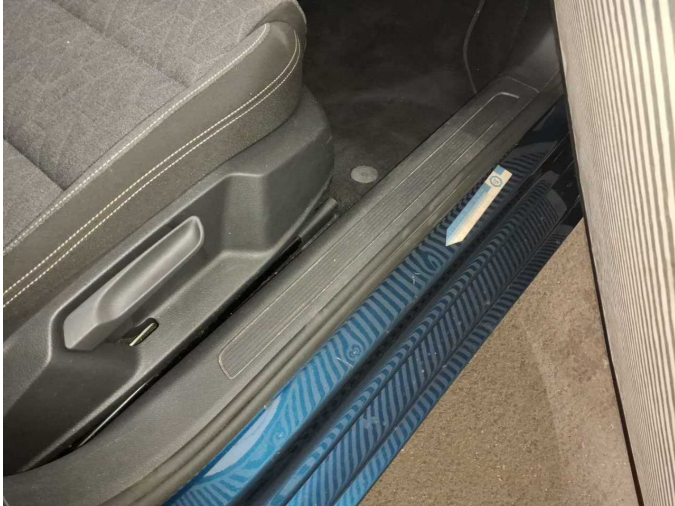
| No. | Component group | Description |
|---|---|---|
| 5 | Sill - right side | Sill - Dent / paintcoat damage - Smart repair |

**Damage 5:** Sill - right side: Sill - Dent / paintcoat damage - Smart repair

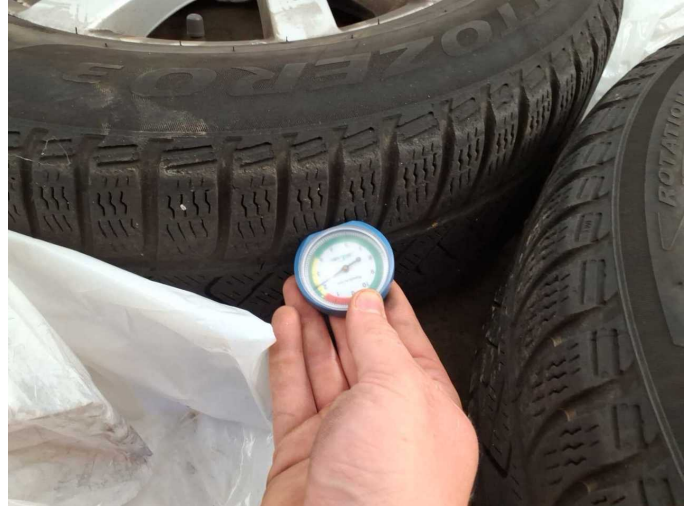
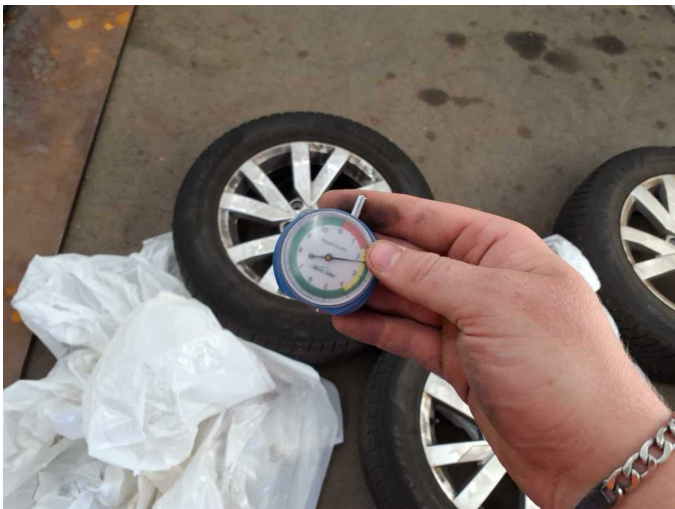
| No. | Component group | Description |
|---|---|---|
| 6 | 2nd wheel set | 1 tyre - Does not meet the leasing specifications - Replace |

**Damage 6:** 2nd wheel set: 1 tyre - Does not meet the leasing specifications - Replace

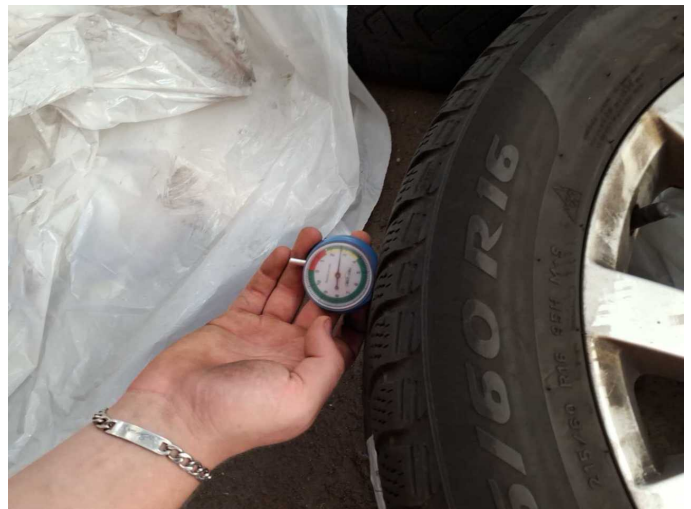
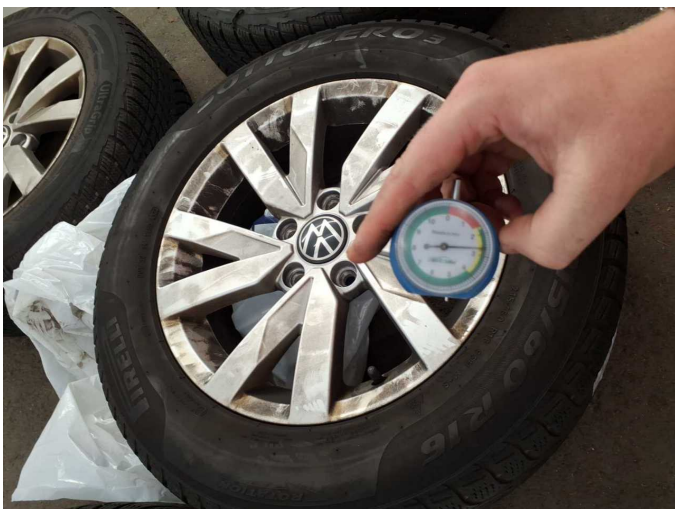
| No. | Component group | Description |
|---|---|---|
| 7 | 2nd wheel set | 1 tyre - Does not meet the leasing specifications - Replace |

**Damage 7:** 2nd wheel set: 1 tyre - Does not meet the leasing specifications - Replace

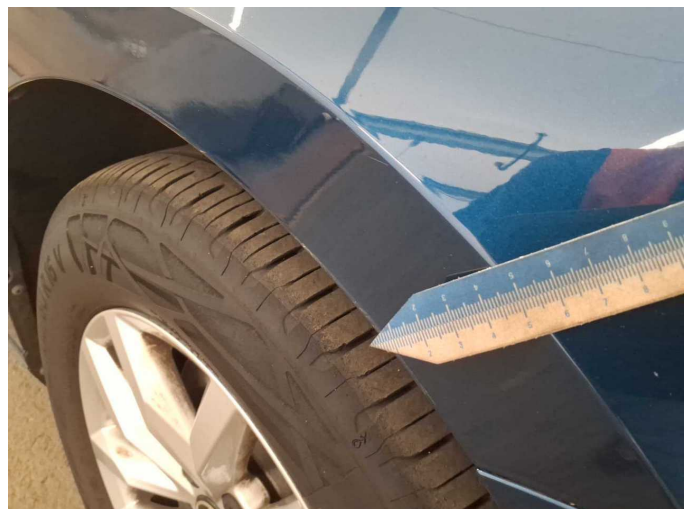
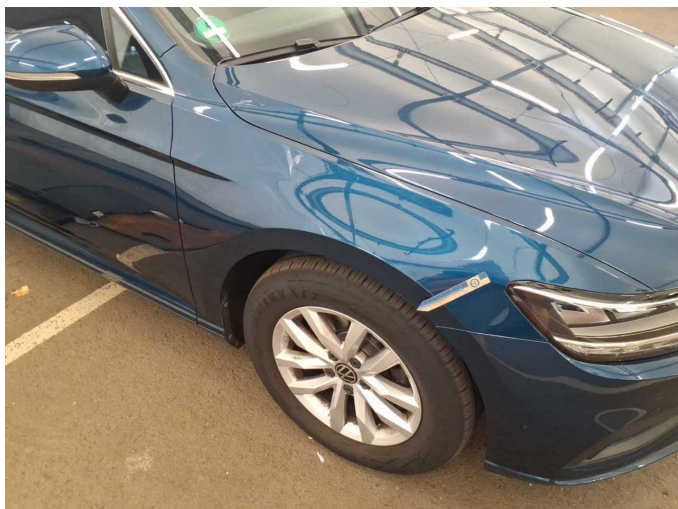
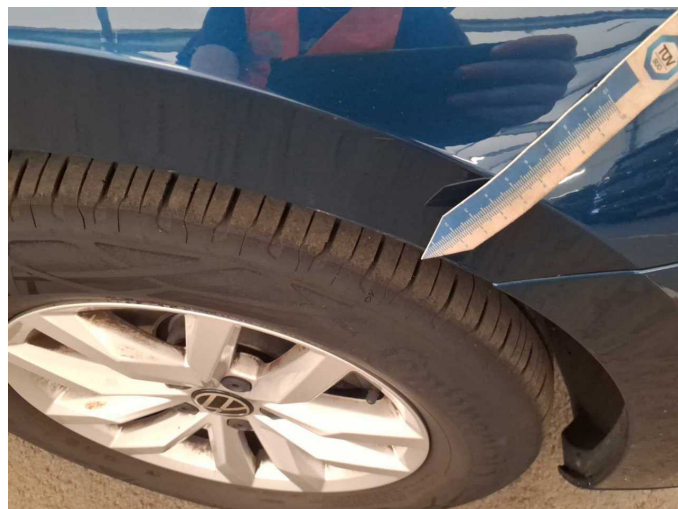
| No. | Component group | Description |
|---|---|---|
| 8 | Mudguard - right side | Mudguard - right side - Scratch(es) - Paint |

**Damage 8:** Mudguard - right side: Mudguard - right side - Scratch(es) - Paint

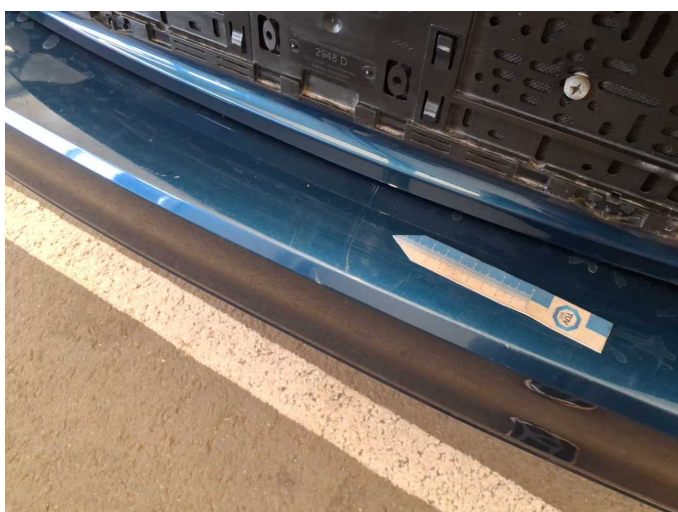
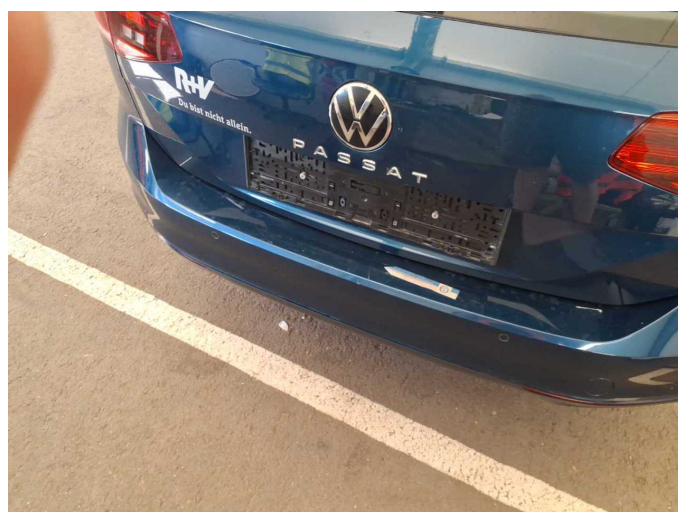
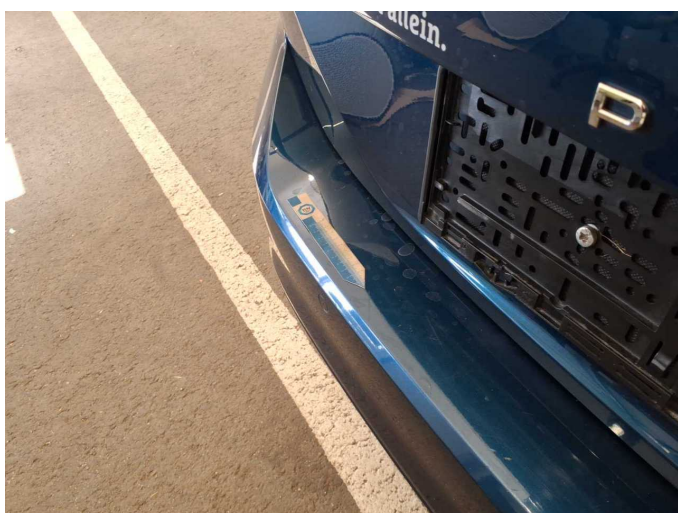
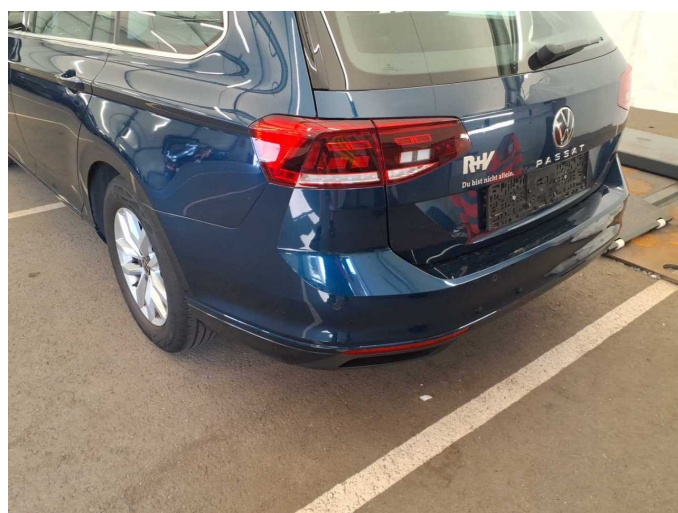
| No. | Component group | Description |
|---|---|---|
| 9 | Rear bumper | Rear bumper - Scratched - Paint |

**Damage 9:** Rear bumper: Rear bumper - Scratched - Paint

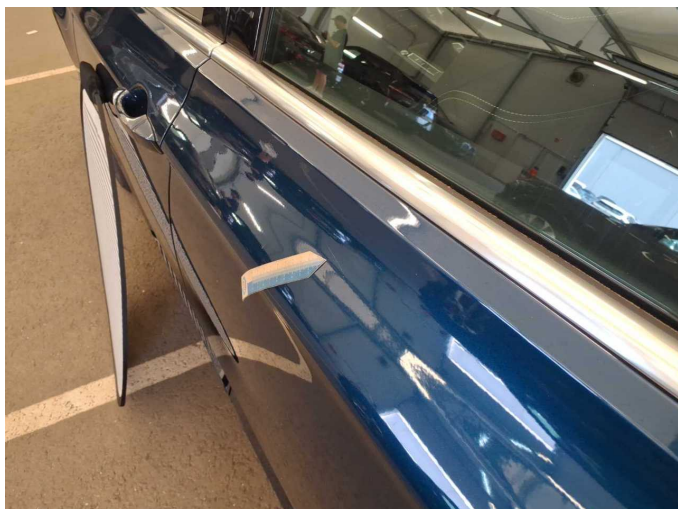
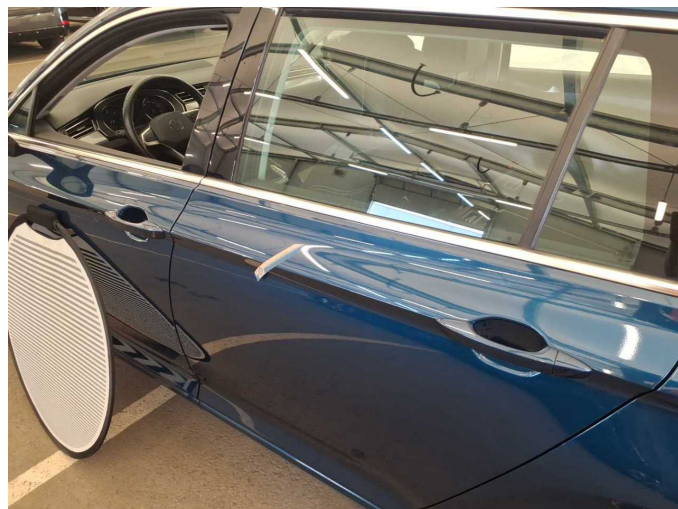
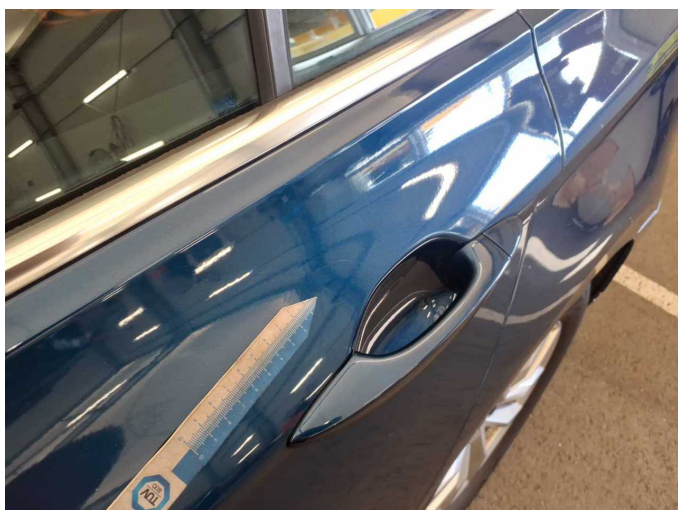
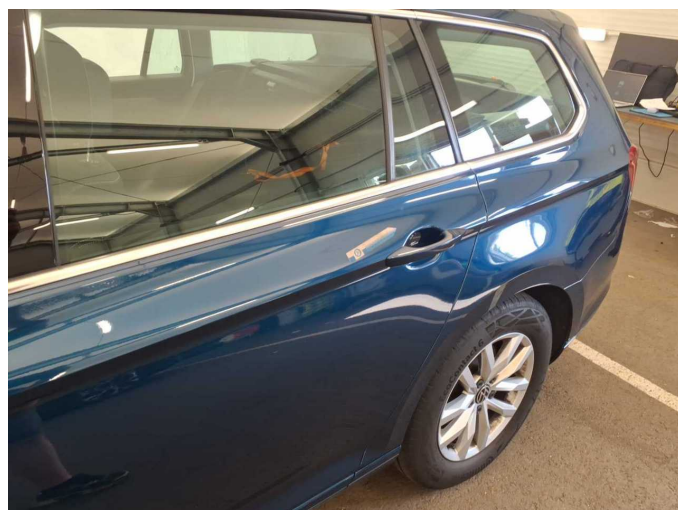
| No. | Component group | Description |
|---|---|---|
| 10 | Door - rear left side | Door - Scratch(es) - Paint |

**Damage 10:** Door - rear left side: Door - Scratch(es) - Paint

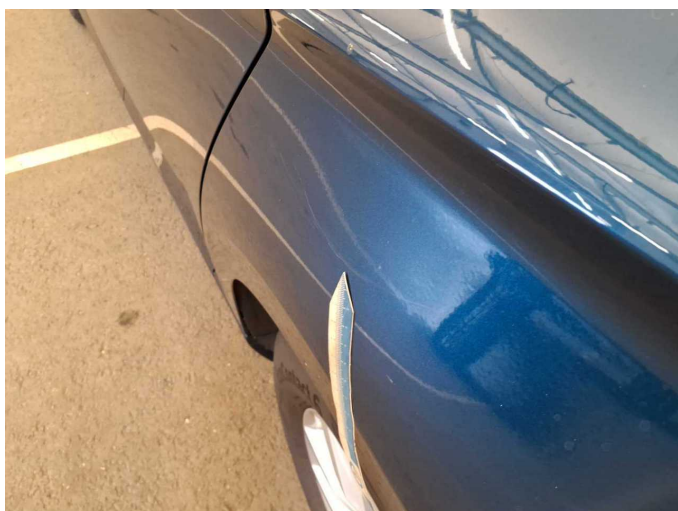
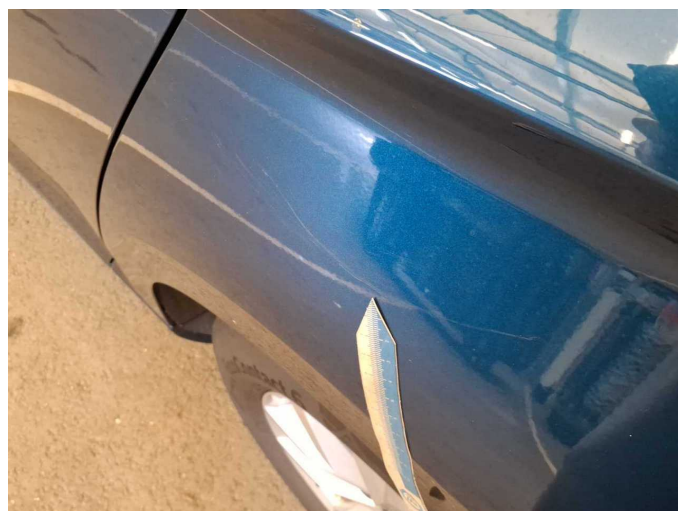
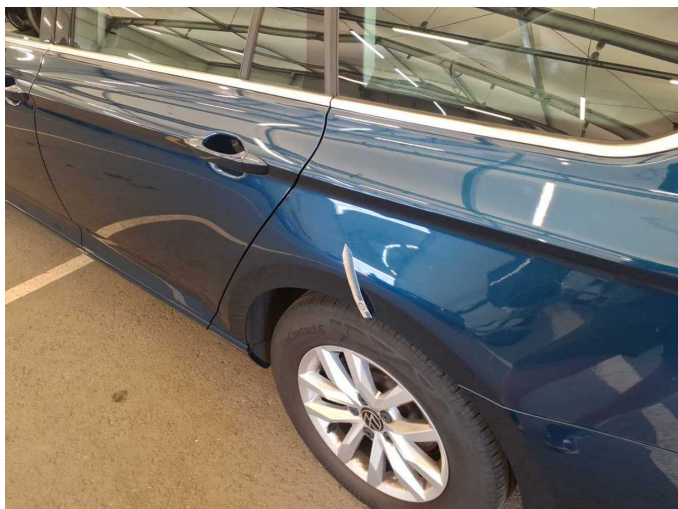
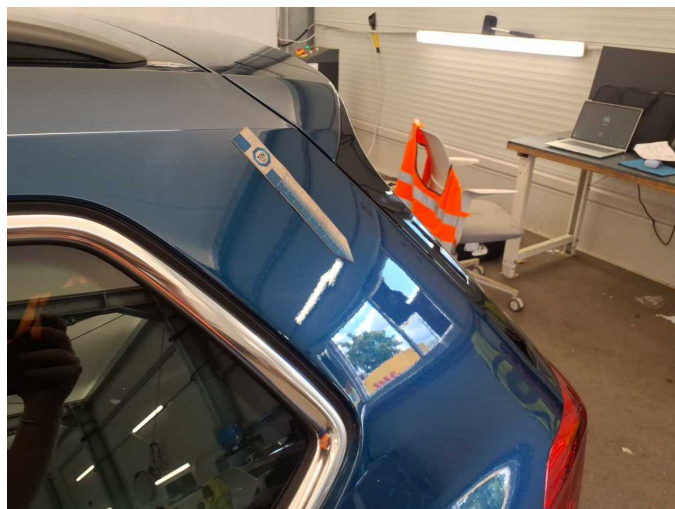
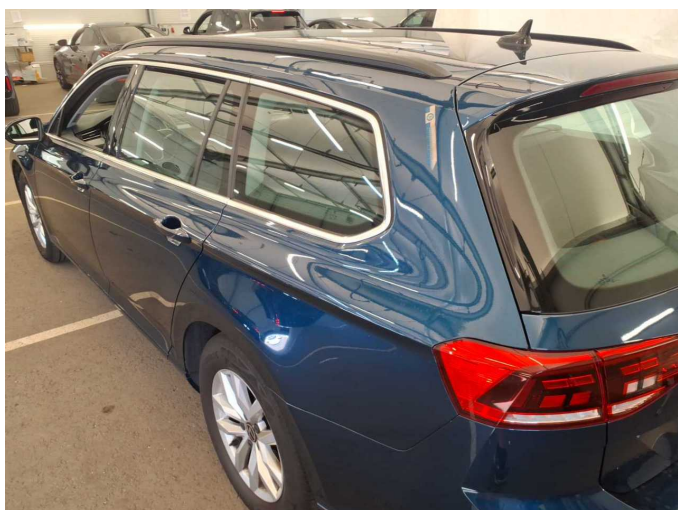
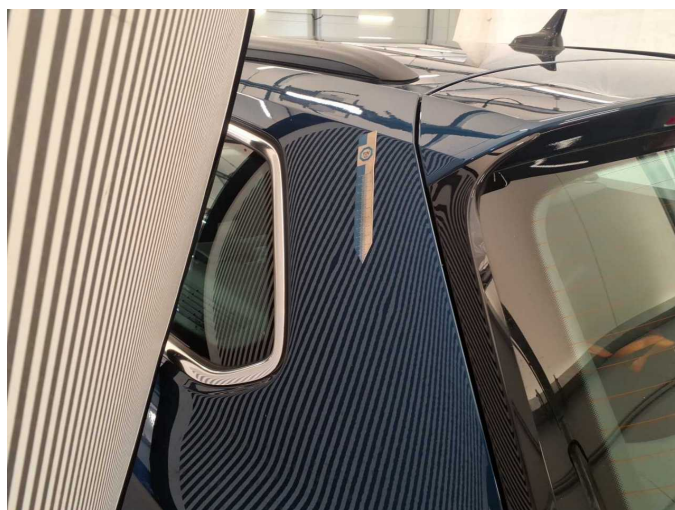
| No. | Component group | Description |
|---|---|---|
| 11 | Side panel - rear left side | Side panel - Dent / paintcoat damage - Repair and paint |

**Damage 11:** Side panel - rear left side: Side panel - Dent / paintcoat damage - Repair and paint

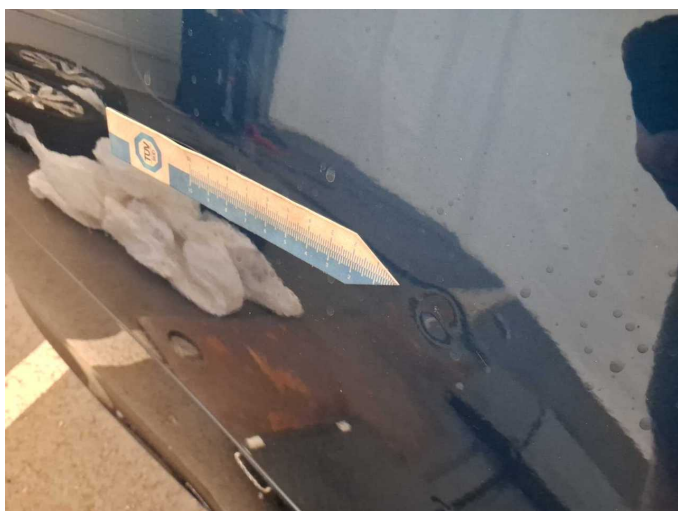
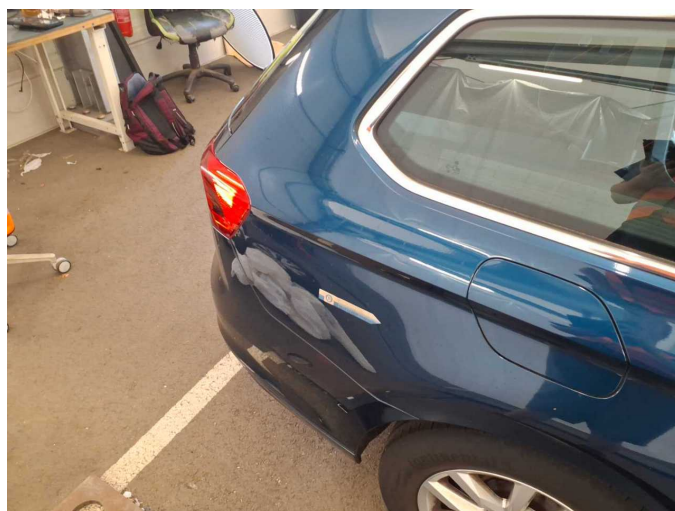
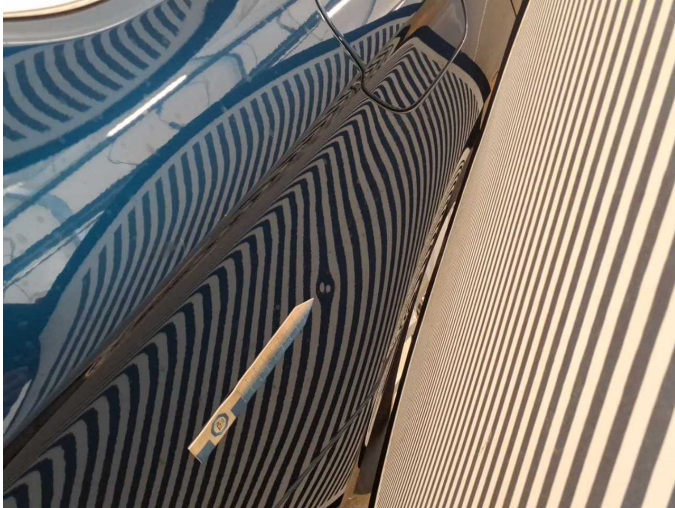
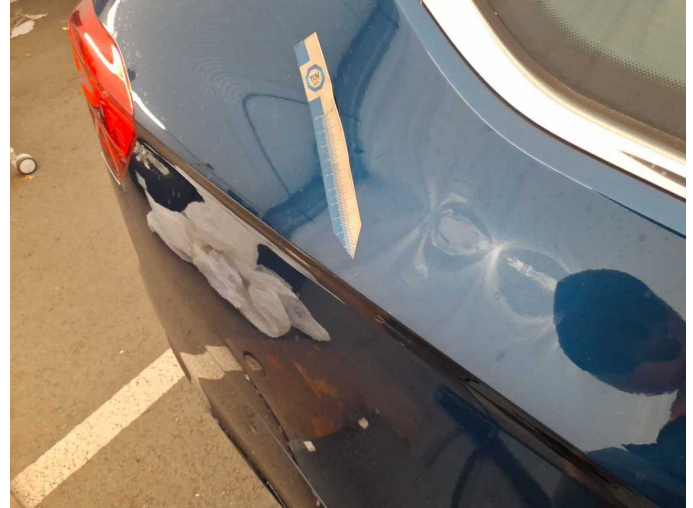
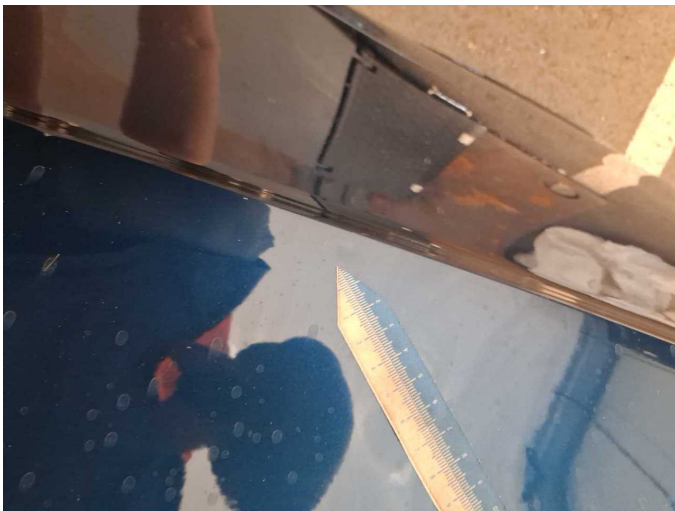
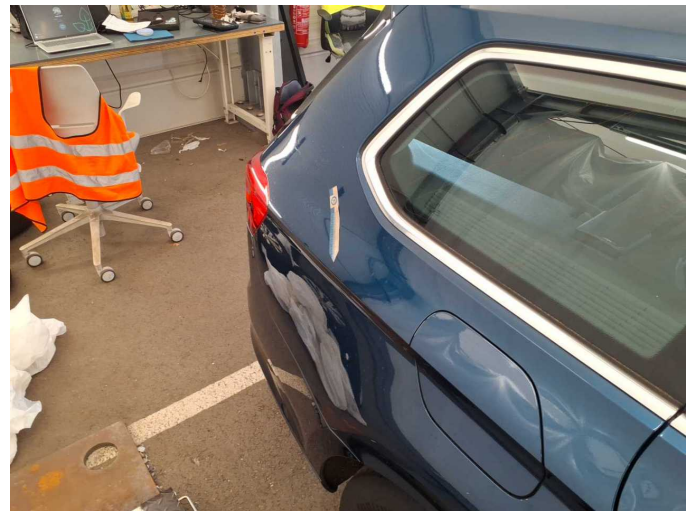
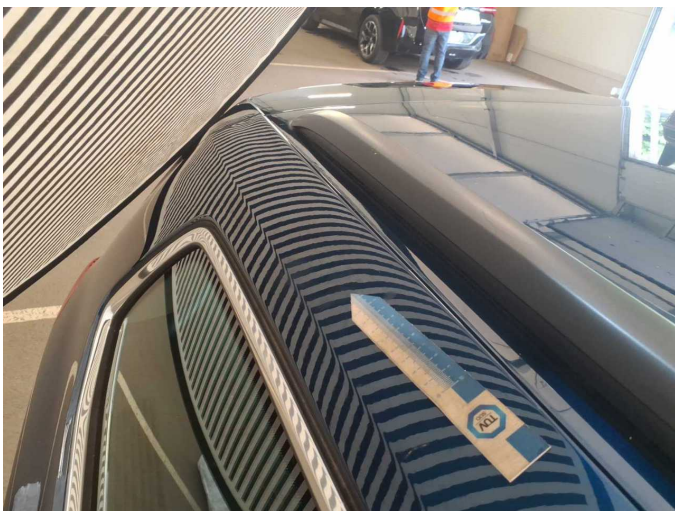
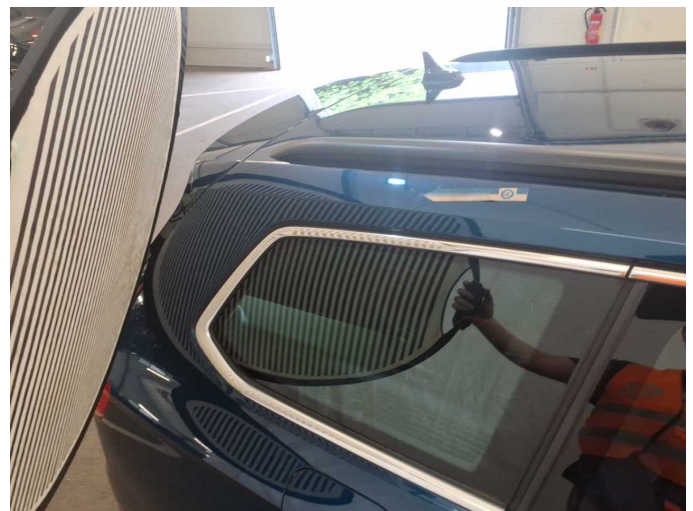
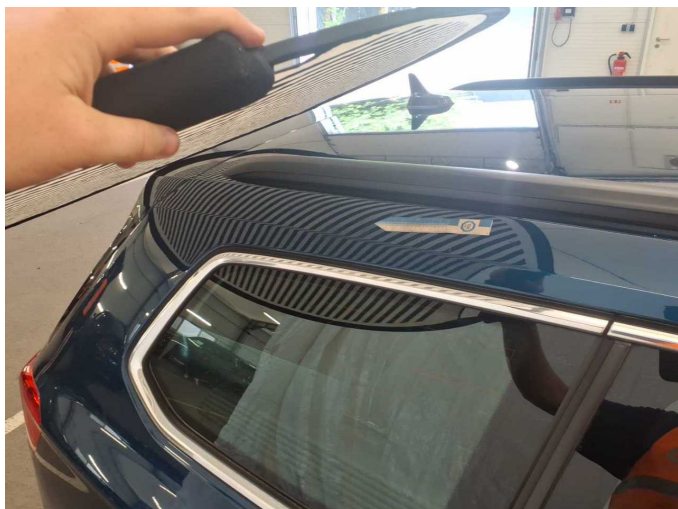
| No. | Component group | Description |
|---|---|---|
| 12 | Side panel - rear right side | Side panel - Dent / paintcoat damage - Repair and paint |

**Damage 12:** Side panel - rear right side: Side panel - Dent / paintcoat damage - Repair and paint

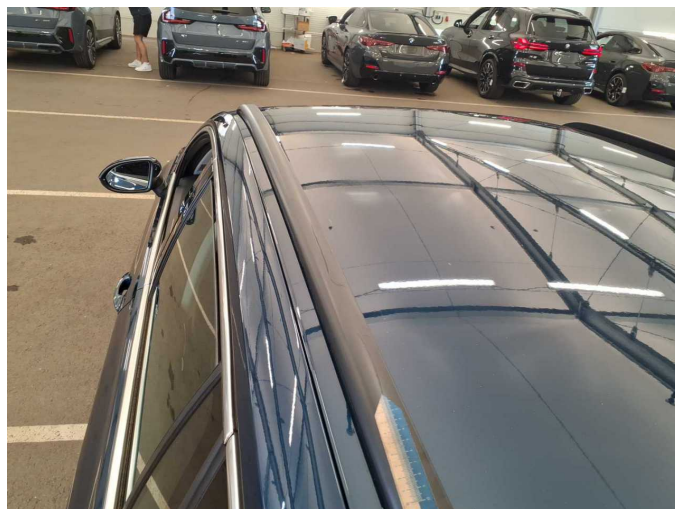
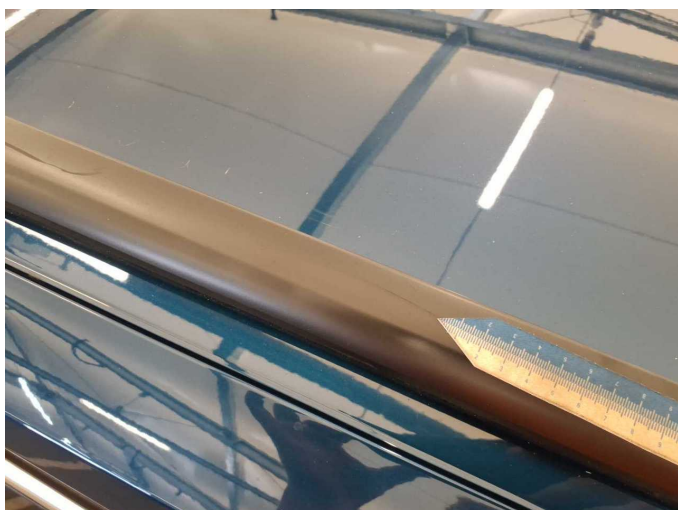
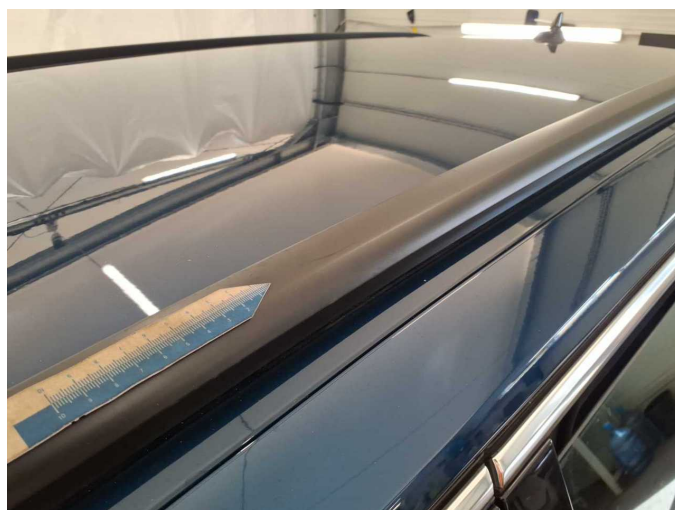
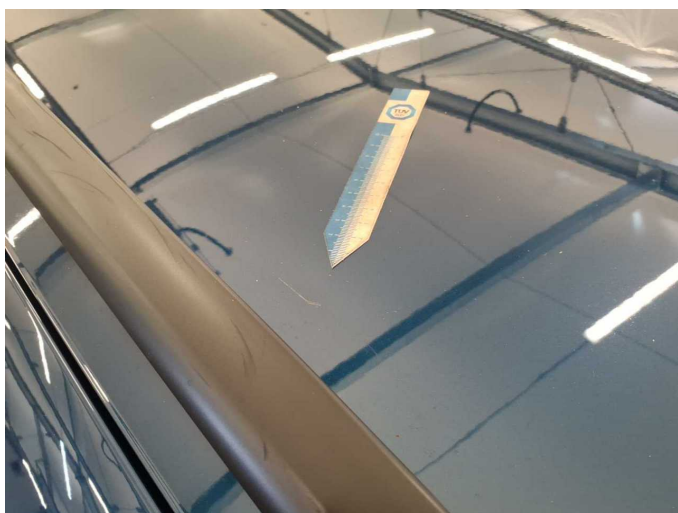
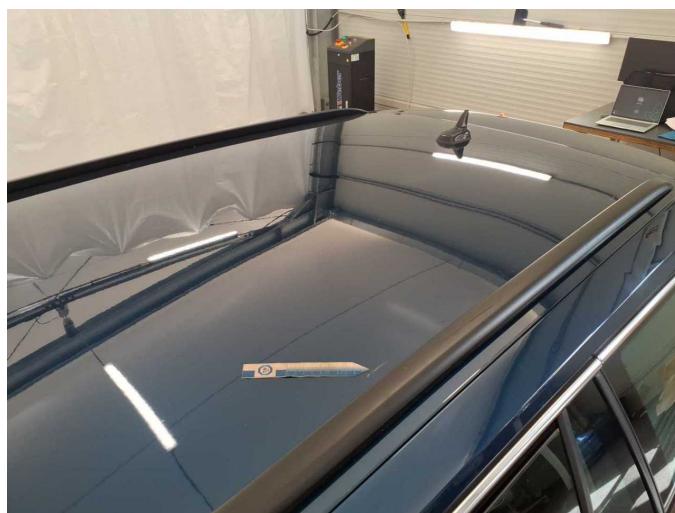
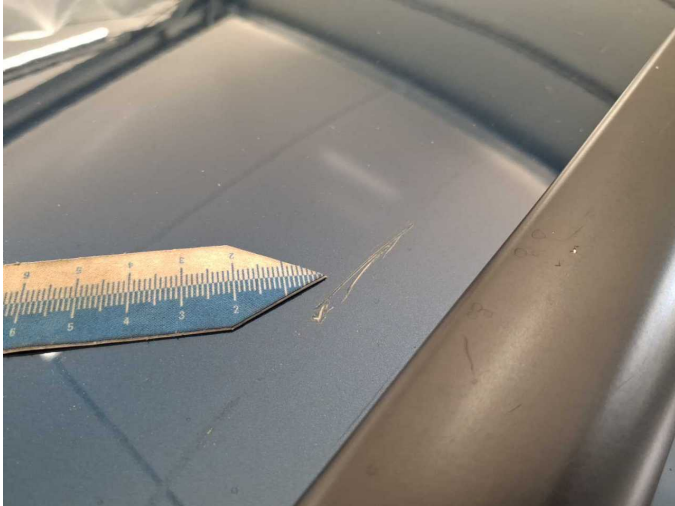
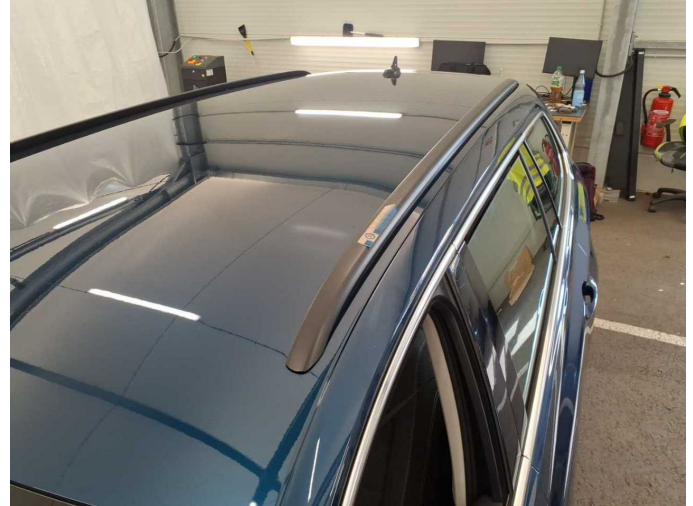
| No. | Component group | Description |
|---|---|---|
| 13 | Roof | Roof (inkl. Railing) - Scratched - Paint |

**Damage 13:** Roof: Roof (inkl. Railing) - Scratched - Paint

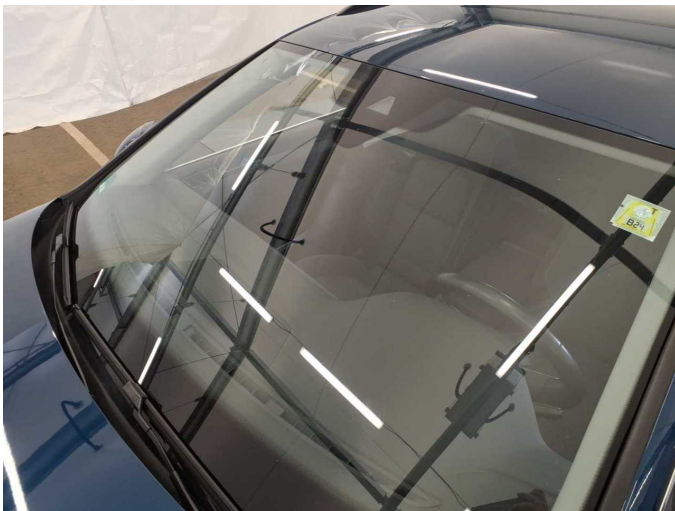
| No. | Component group | Description |
|---|---|---|
| 2 | Vehicle glazing | Windscreen - Stone chips - No deduction |

**Wear and tear 2:** Vehicle glazing: Windscreen - Stone chips - No deduction

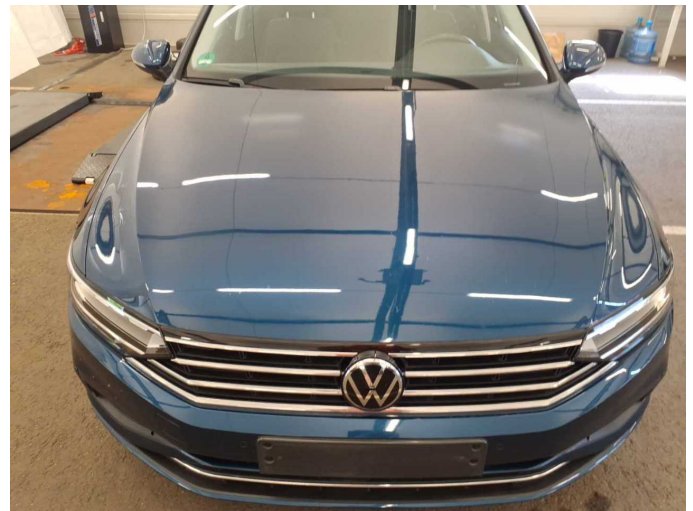
| No. | Component group | Description |
|---|---|---|
| 3 | Bonnet | Bonnet - Stone chips - No deduction |

**Wear and tear 3:** Bonnet: Bonnet - Stone chips - No deduction

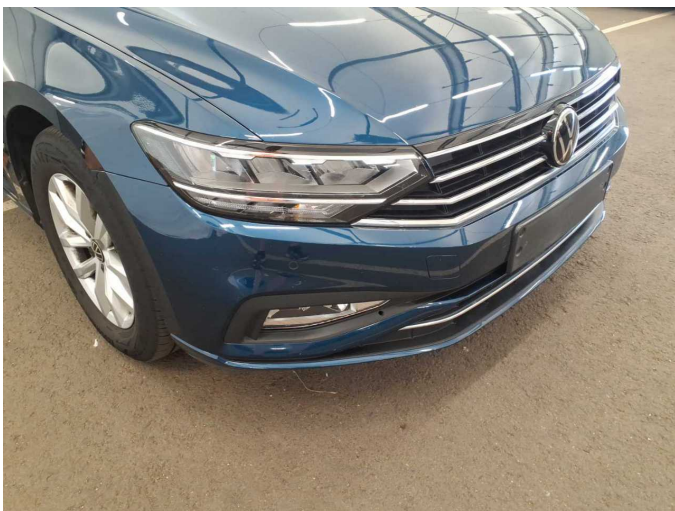
| No. | Component group | Description |
|---|---|---|
| 4 | Front bumper | Front bumper - Stone chips - No deduction |

**Wear and tear 4:** Front bumper: Front bumper - Stone chips - No deduction
