Expertise

Protocol number: 46593453  
Order No. / Reference: 26631258  
Inspection date: 17 Jul 2026

Manufacturer: Mercedes-Benz

Model: GLC 300 e 4Matic 9G-TRONIC Exclusive

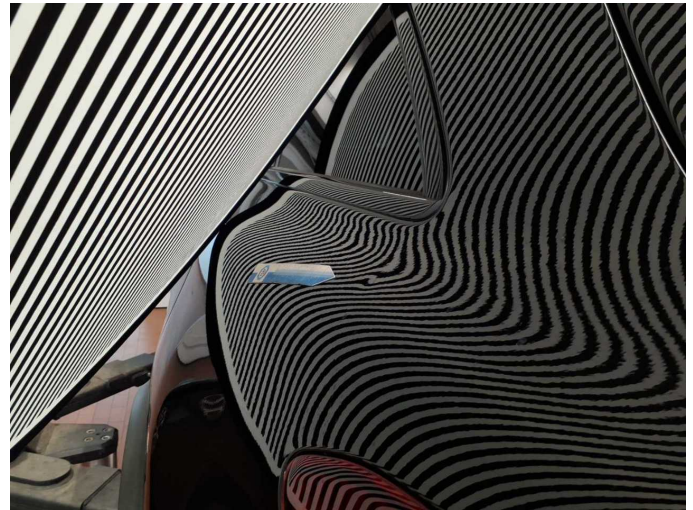
| No. | Component group | Description |
|---|---|---|
| 1 | Side panel - rear left side | Side panel - dent(s) - Smooth repair work |

Damage 1: Side panel - rear left side: Side panel - dent(s) - Smooth repair work

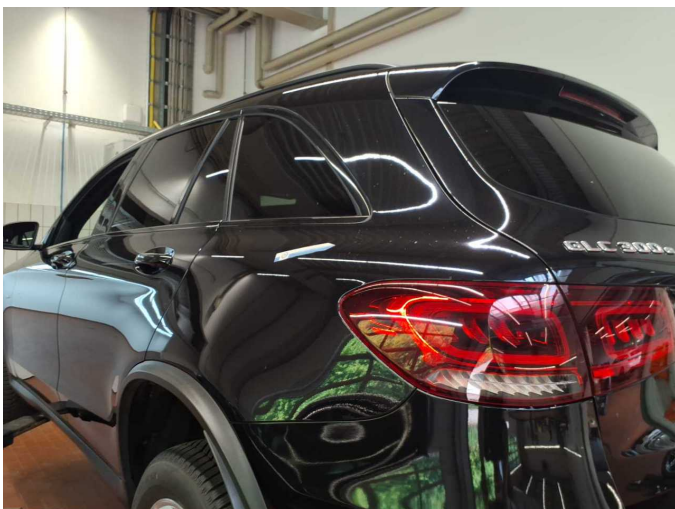
Damage 1: Side panel - rear left side: Side panel - dent(s) - Smooth repair work

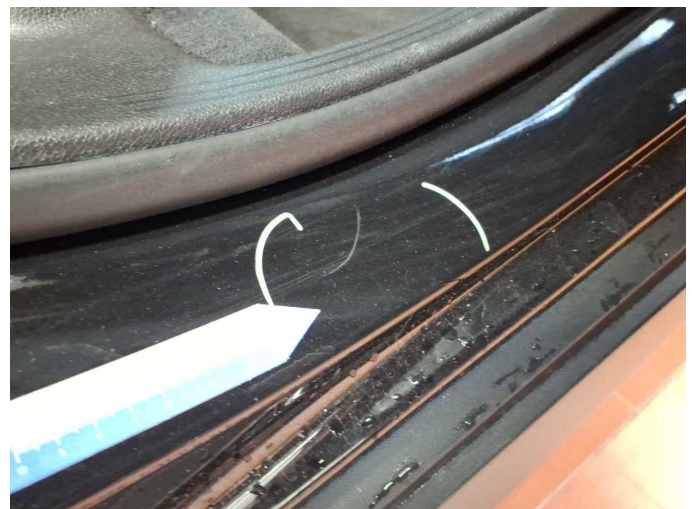
| No. | Component group | Description |
|---|---|---|
| 2 | Side panel - rear right side | Sill - Scratch(es) - Smart repair |

Damage 2: Side panel - rear right side: Sill - Scratch(es) - Smart repair

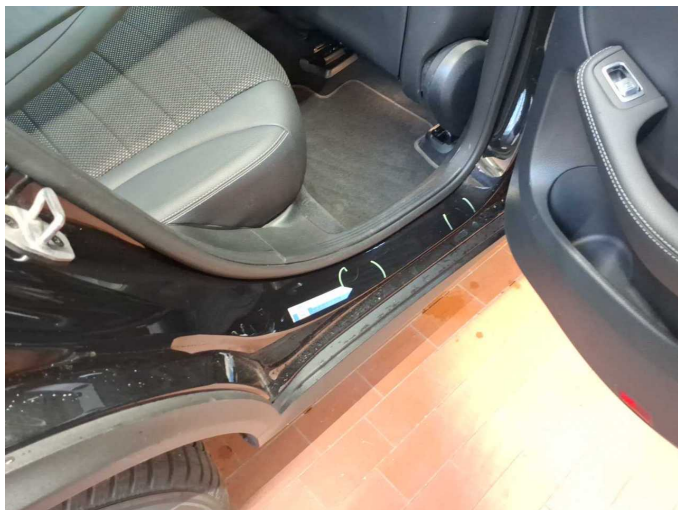
**Damage 2:** Side panel - rear right side: Sill - Scratch(es) - Smart repair

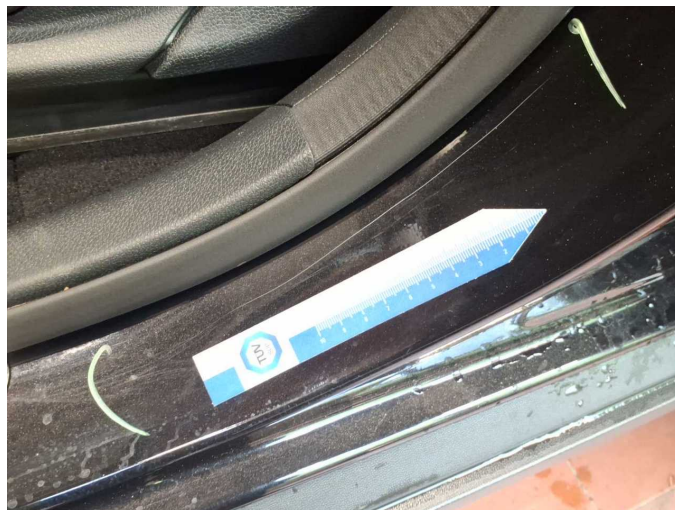
| No. | Component group | Description |
|---|---|---|
| 3 | Sill - left side | Sill - Scratch(es) - Smart repair |

**Damage 3:** Sill - left side: Sill - Scratch(es) - Smart repair

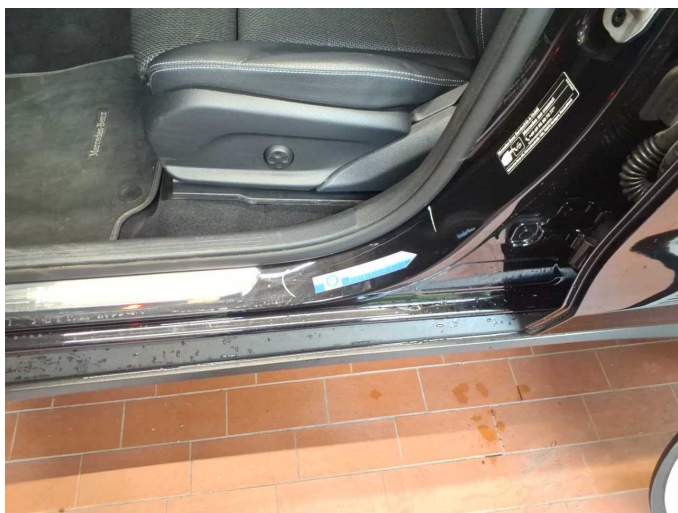
**Damage 3:** Sill - left side: Sill - Scratch(es) - Smart repair

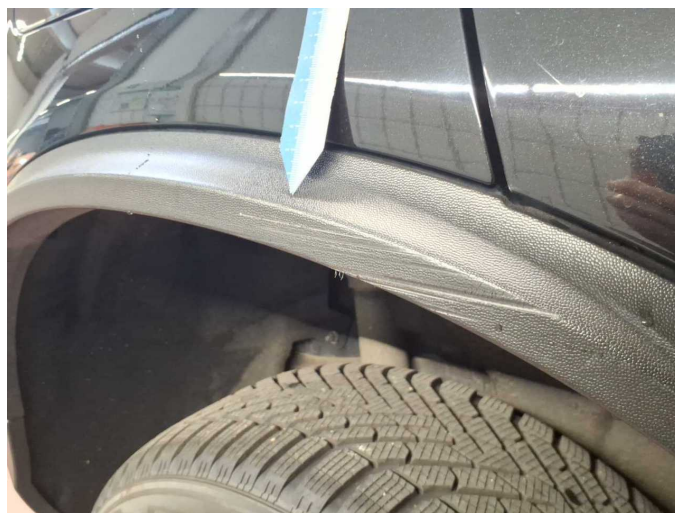
| No. | Component group | Description |
|---|---|---|
| 4 | Side panel - rear right side | Wheel well extension - Scratch(es) - Replace |

**Damage 4:** Side panel - rear right side: Wheel well extension - Scratch(es) - Replace

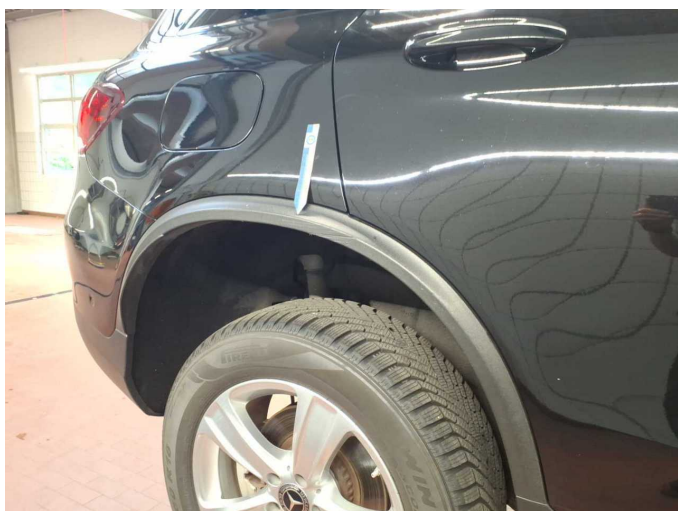
**Damage 4:** Side panel - rear right side: Wheel well extension - Scratch(es) - Replace

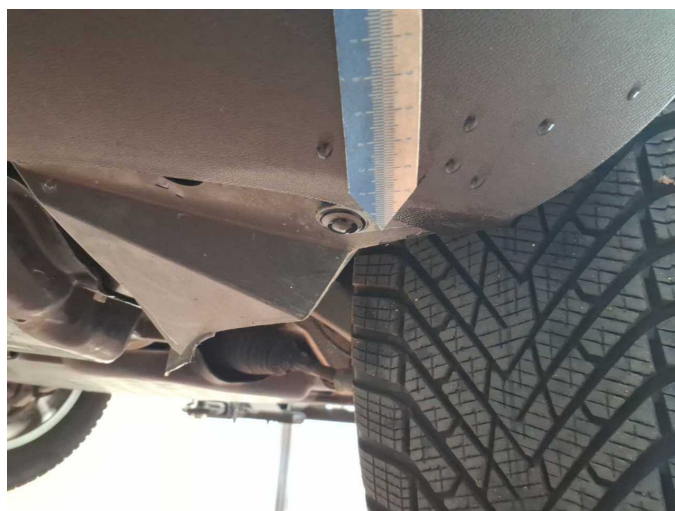
| No. | Component group | Description |
|---|---|---|
| 5 | Mudguard - left side | Inner mudguard - Broken / torn - Replace |

**Damage 5:** Mudguard - left side: Inner mudguard - Broken / torn - Replace

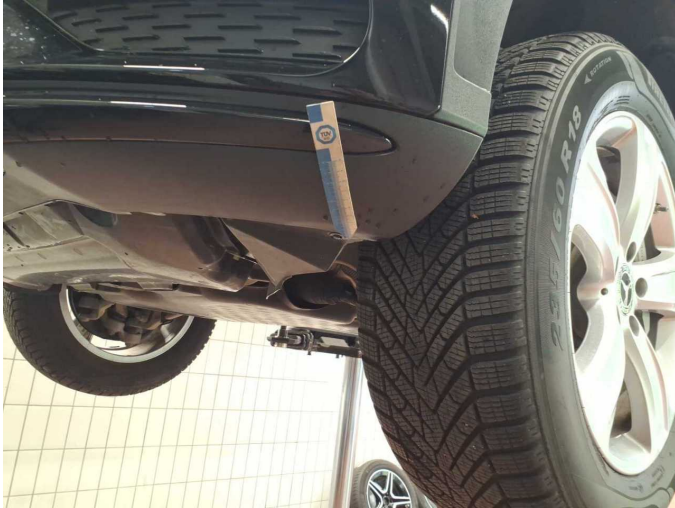
**Damage 5:** Mudguard - left side: Inner mudguard - Broken / torn - Replace

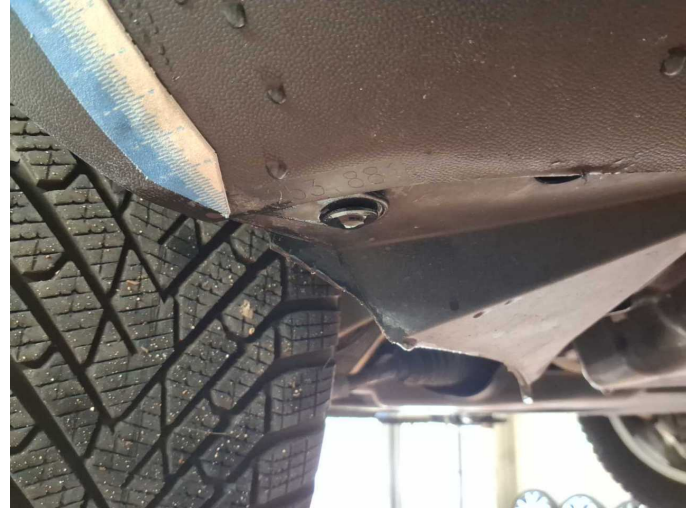
| No. | Component group | Description |
|---|---|---|
| 6 | Mudguard - right side | Inner mudguard - Broken / torn - Replace |

**Damage 6:** Mudguard - right side: Inner mudguard - Broken / torn - Replace

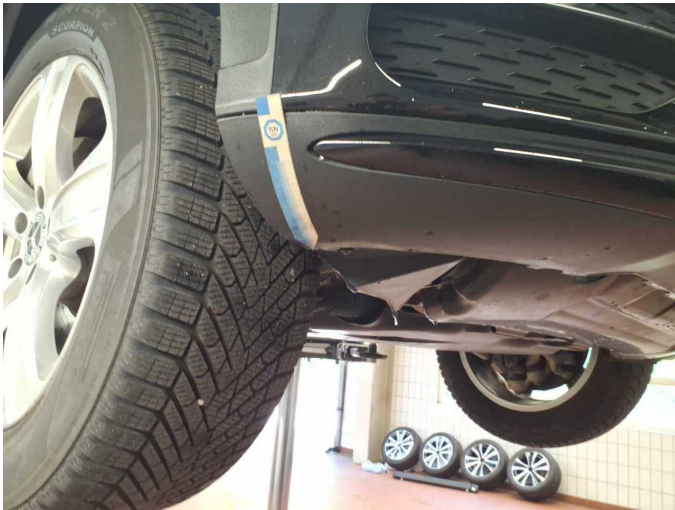
**Damage 6:** Mudguard - right side: Inner mudguard - Broken / torn - Replace

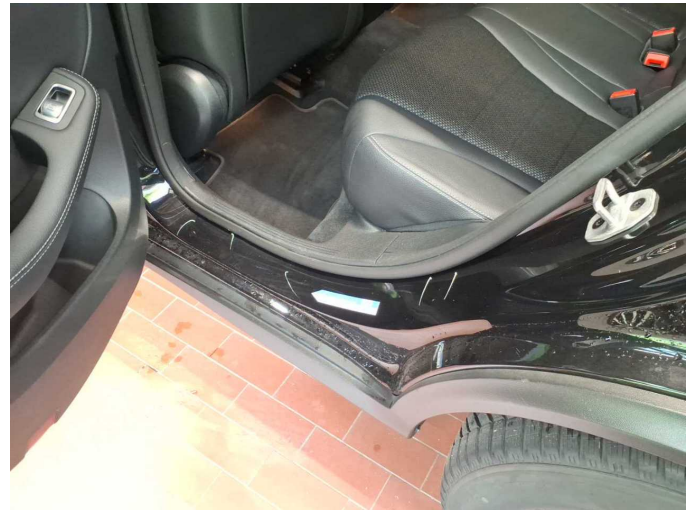
| No. | Component group | Description |
|---|---|---|
| 7 | Side panel - rear left side | Sill - Dent / paintcoat damage - Smart repair |

**Damage 7:** Side panel - rear left side: Sill - Dent / paintcoat damage - Smart repair

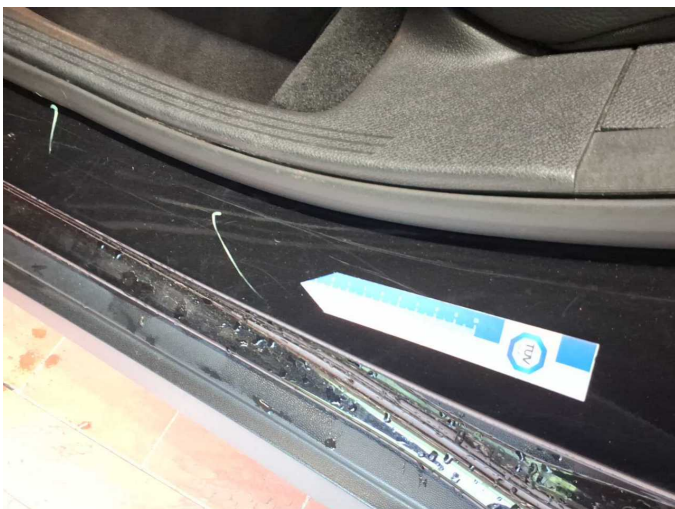
**Damage 7:** Side panel - rear left side: Sill - Dent / paintcoat damage - Smart repair

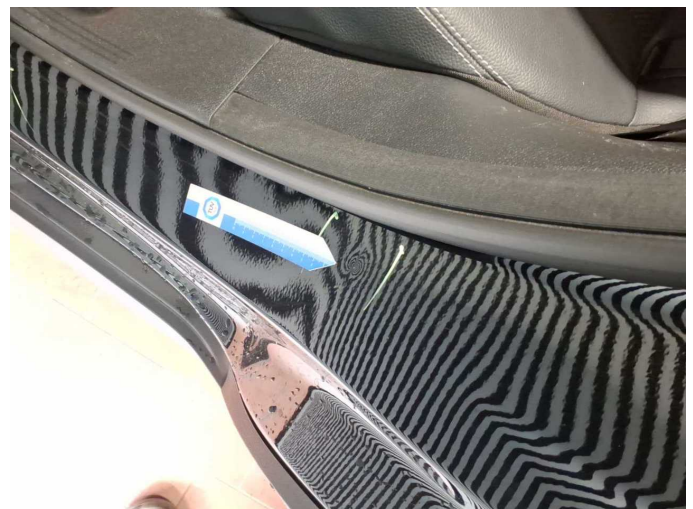
**Damage 7:** Side panel - rear left side: Sill - Dent / paintcoat damage - Smart repair

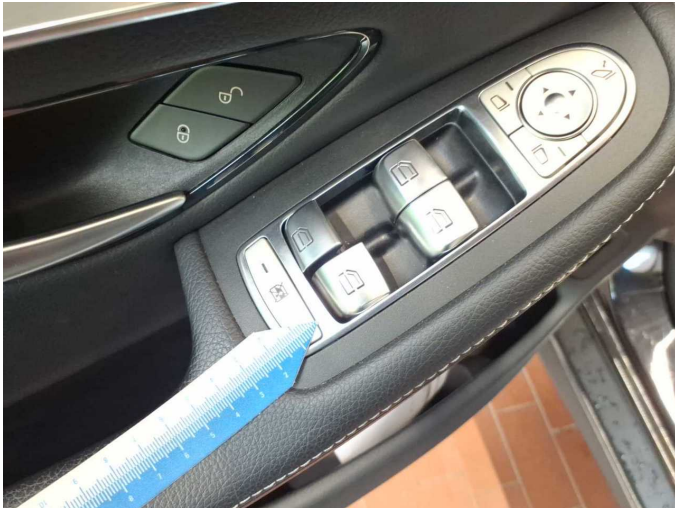
| No. | Component group | Description |
|---|---|---|
| 8 | Trim / covers | Door trim - front left side (Fensterblock) - Broken / torn - Replace |

**Damage 8:** Trim / covers: Door trim - front left side (Fensterblock) - Broken / torn - Replace

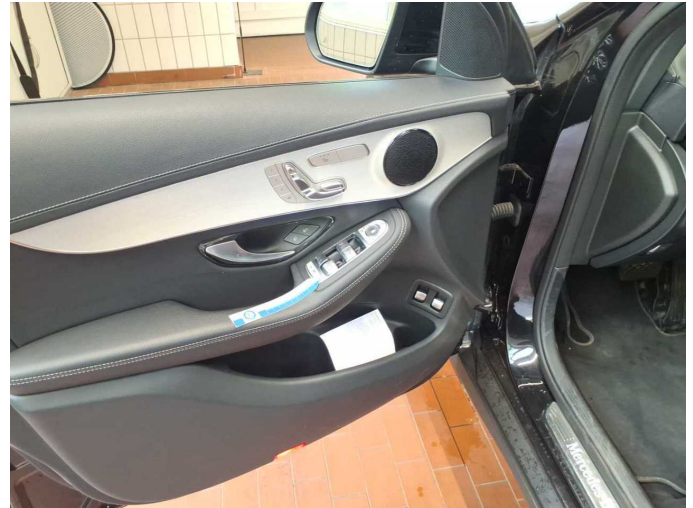
**Damage 8:** Trim / covers: Door trim - front left side (Fensterblock) - Broken / torn - Replace

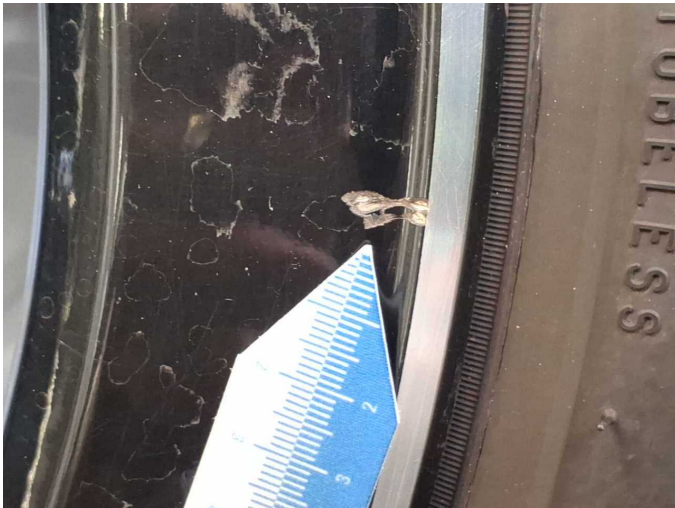
| No. | Component group | Description |
|---|---|---|
| 9 | 2nd wheel set | 1 alloy rim (Hinten Rechts) - Scratch(es) - Loss in value |

**Damage 9:** 2nd wheel set: 1 alloy rim (Hinten Rechts) - Scratch(es) - Loss in value

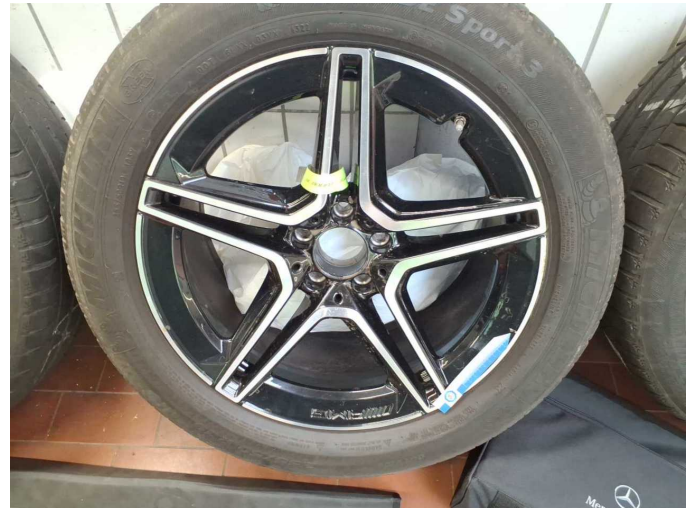
**Damage 9:** 2nd wheel set: 1 alloy rim (Hinten Rechts) - Scratch(es) - Loss in value

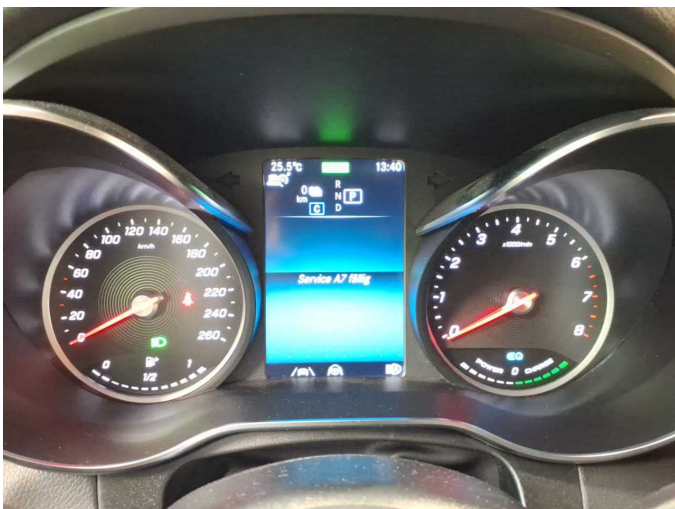
| No. | Component group | Description |
|---|---|---|
| 10 | Misc. | Inspection / maintenance - Due - Perform |

**Damage 10:** Misc.: Inspection / maintenance - Due - Perform

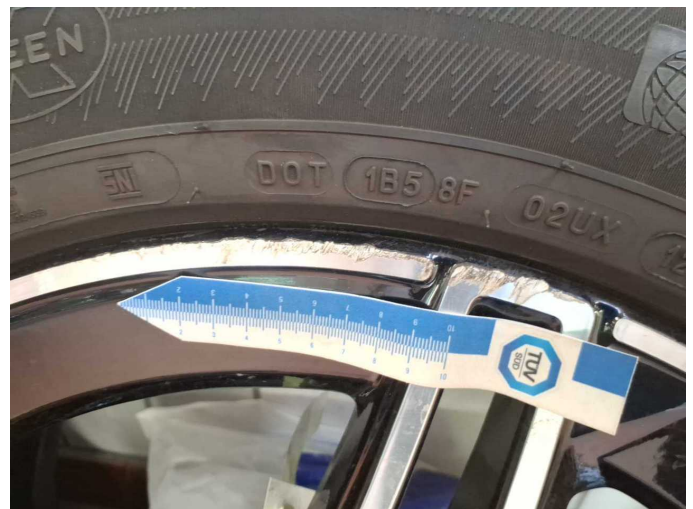
| No. | Component group | Description |
|---|---|---|
| 11 | 2nd wheel set | 1 alloy rim (Vorne Rechts) - Scratched - Replace |

**Damage 11:** 2nd wheel set: 1 alloy rim (Vorne Rechts) - Scratched - Replace

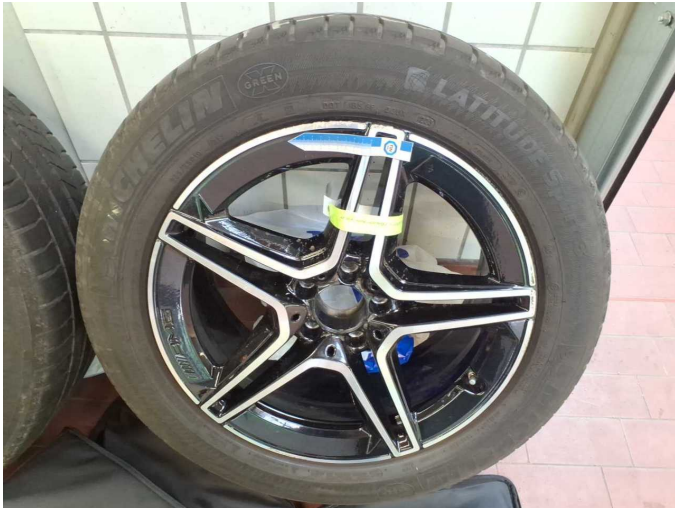
**Damage 11:** 2nd wheel set: 1 alloy rim (Vorne Rechts) - Scratched - Replace

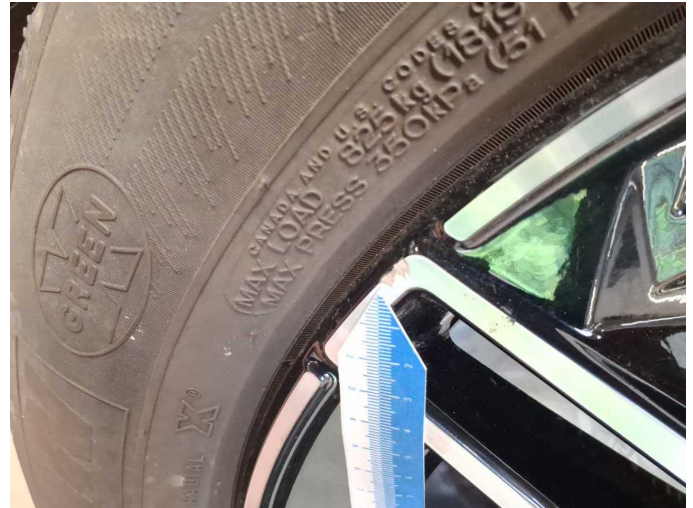
| No. | Component group | Description |
|---|---|---|
| 1 | 2nd wheel set | 1 alloy rim - Scratch(es) - No deduction |

**Wear and tear 1:** 2nd wheel set: 1 alloy rim - Scratch(es) - No deduction

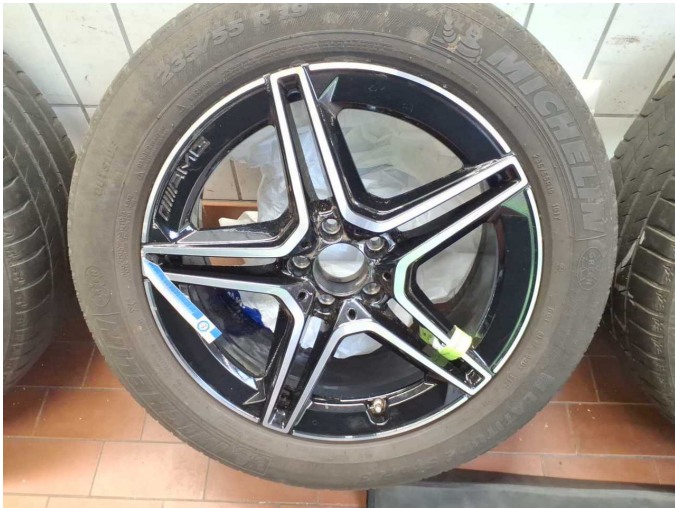
**Wear and tear 1:** 2nd wheel set: 1 alloy rim - Scratch(es) - No deduction

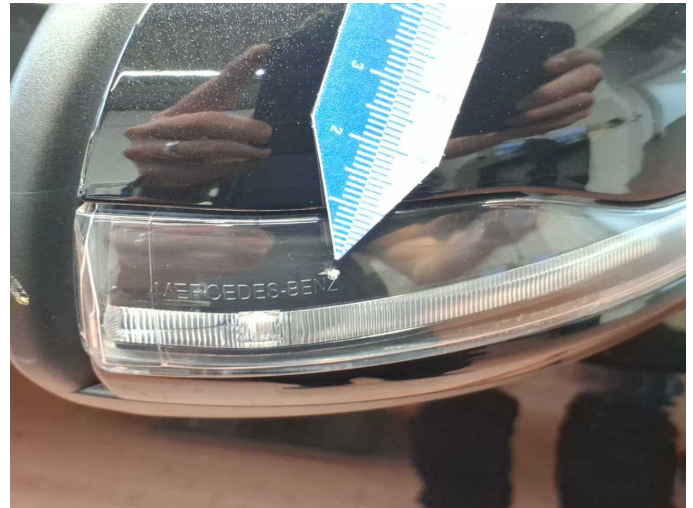
| No. | Component group | Description |
|---|---|---|
| 2 | Indicator - front | Mirror - right side - Scratch(es) - No deduction |

**Wear and tear 2:** Indicator - front: Mirror - right side - Scratch(es) - No deduction

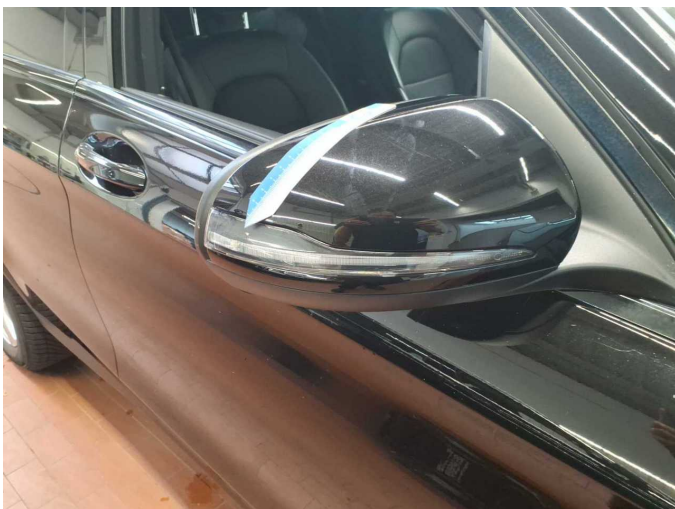
**Wear and tear 2:** Indicator - front: Mirror - right side - Scratch(es) - No deduction

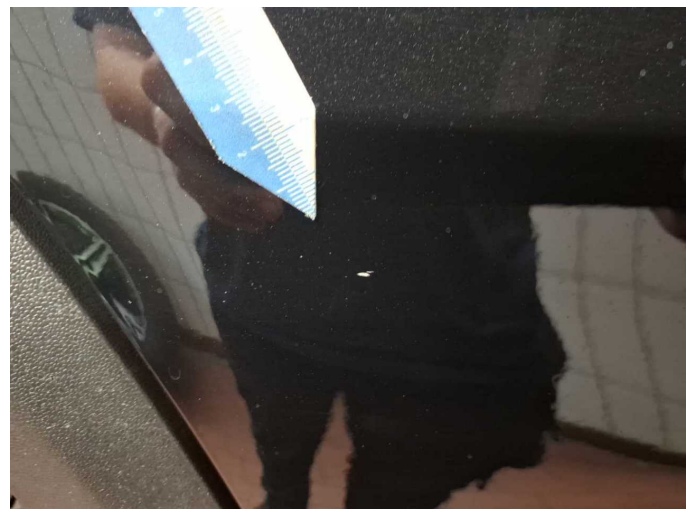
| No. | Component group | Description |
|---|---|---|
| 3 | Door - rear right side | Door - Scratch(es) - No deduction |

**Wear and tear 3:** Door - rear right side: Door - Scratch(es) - No deduction

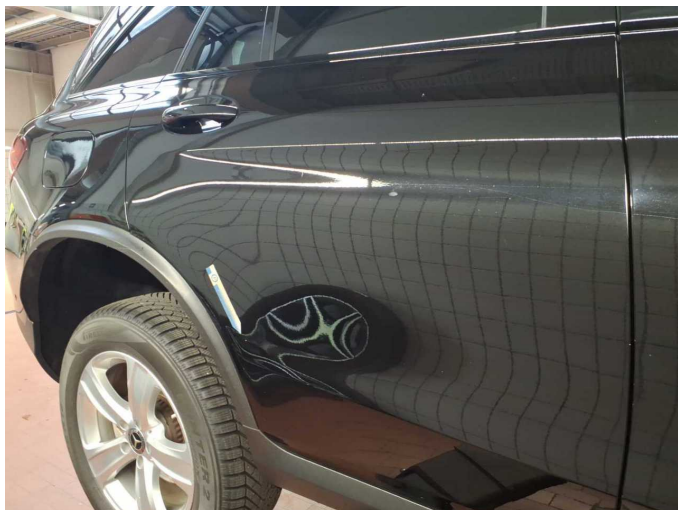
**Wear and tear 3:** Door - rear right side: Door - Scratch(es) - No deduction

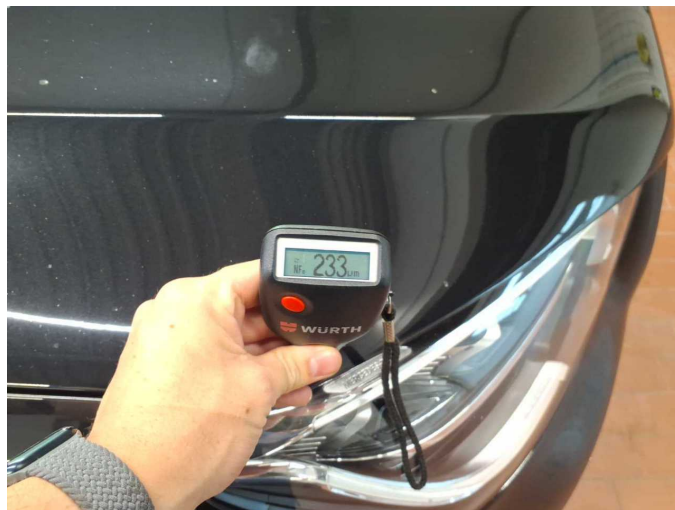
**Repainting 1:** Bonnet

- 1 Bonnet, Professionally carried out, Invoice of repair done Non-existent
- 2 Side panel - rear left side, Professionally carried out, Invoice of repair done Non-existent

| Bonnet | 233 µm | Side panel - rear left side | 175 µm |
