Expertise

Protocol number: 45720559
Order No. / Reference: 26529413
Inspection date: 1 Jun 2026

Model: Focus Turnier 1.5 EcoBlue Start-Stopp-System Aut. TITANIUM

VIN: WF0PXXGCHPPL83821

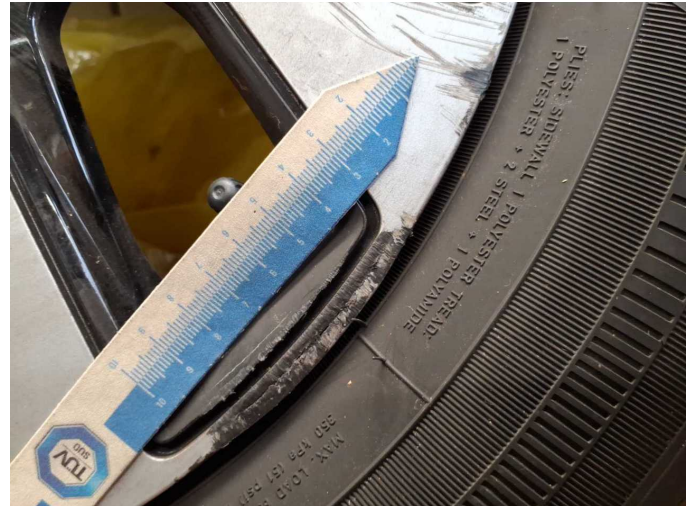
Damage 1: 2nd wheel set: 1 wheel cover - Scratch(es) - Replace

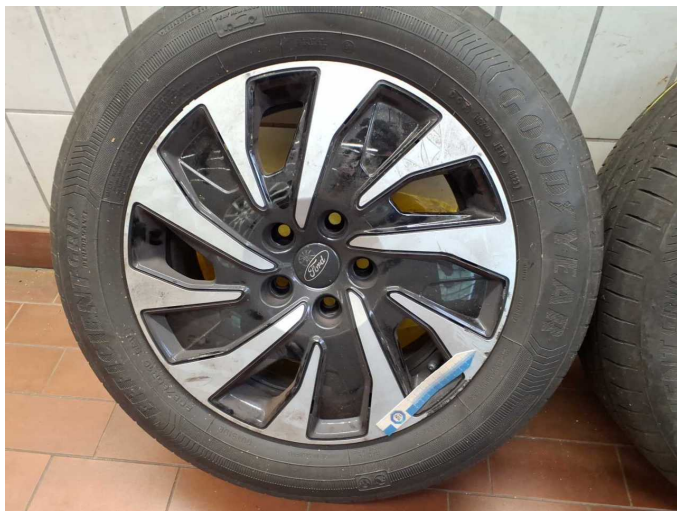
Damage 1: 2nd wheel set: 1 wheel cover - Scratch(es) - Replace

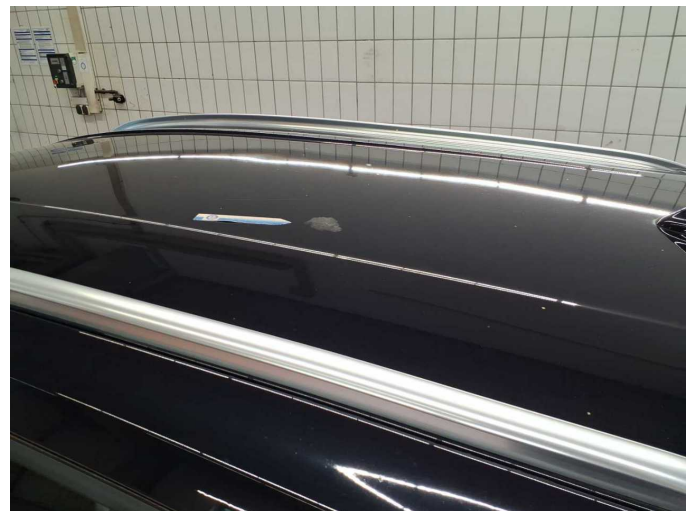
Damage 2: Roof: Roof - Soiled - Conditioning

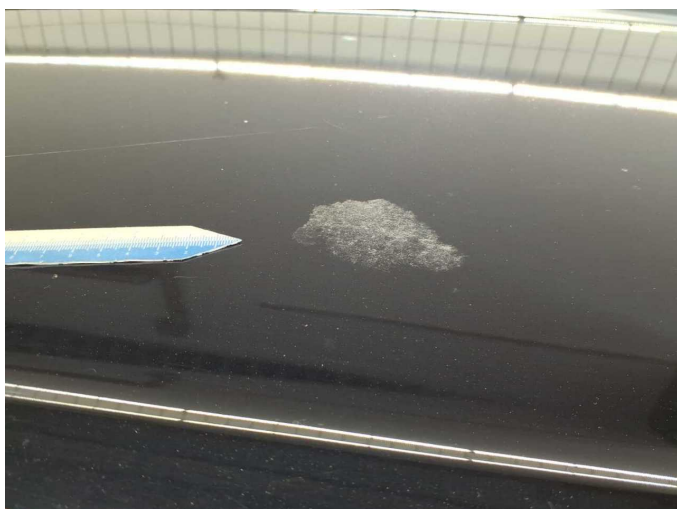
Damage 2: Roof: Roof - Soiled - Conditioning

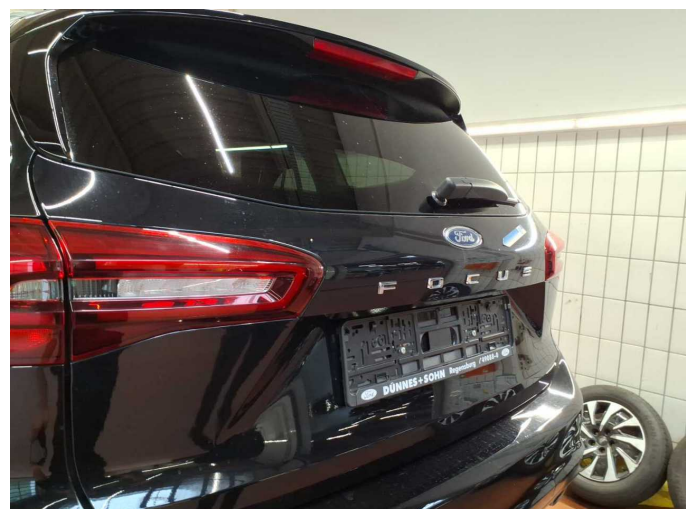
Damage 3: Boot lid / rear door: Boot lid - dent(s) - Smooth repair work

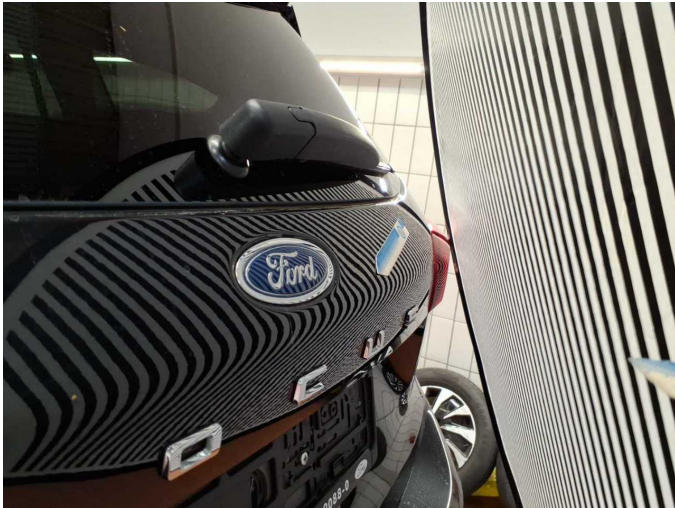
Damage 3: Boot lid / rear door: Boot lid - dent(s) - Smooth repair work

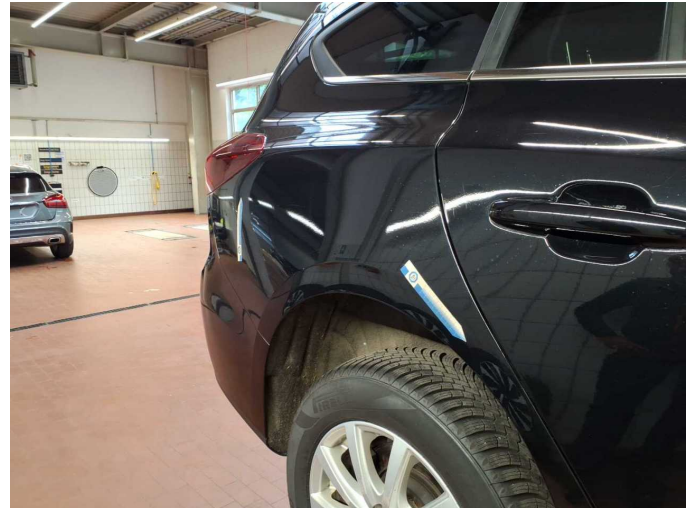
Damage 4: Side panel - rear right side: Side panel - dent(s) - Smooth repair work

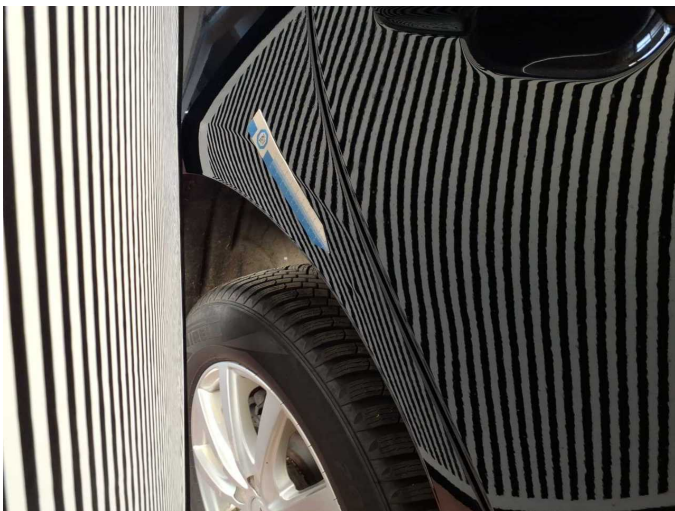
Damage 4: Side panel - rear right side: Side panel - dent(s) - Smooth repair work

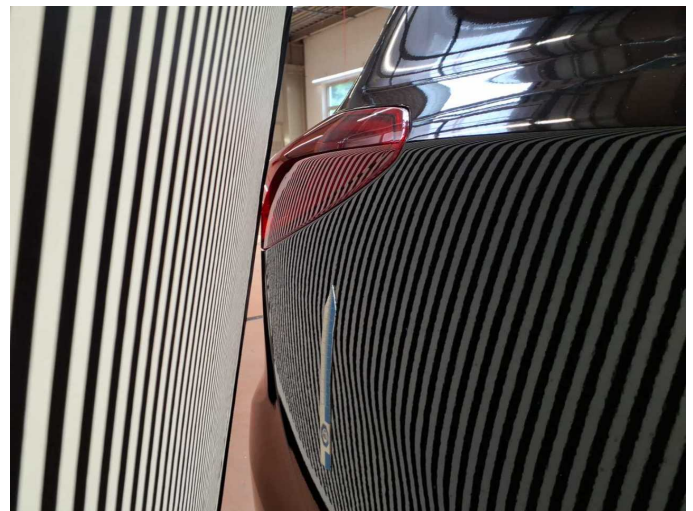
Damage 4: Side panel - rear right side: Side panel - dent(s) - Smooth repair work

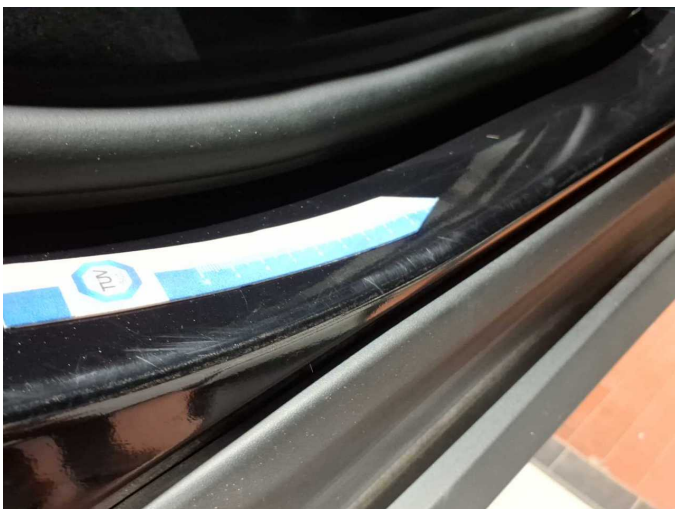
Damage 5: Side panel - rear right side: Sill - Scratch(es) - Smart repair

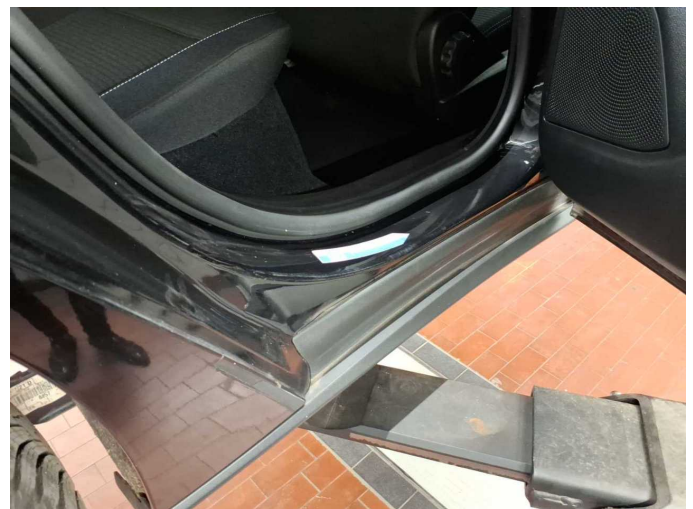
Damage 5: Side panel - rear right side: Sill - Scratch(es) - Smart repair

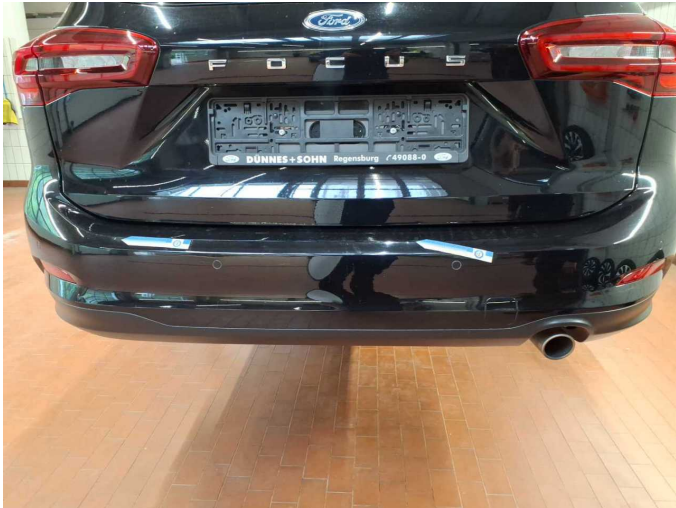
Damage 6: Rear bumper: Rear bumper - Scratch(es) - Smart repair

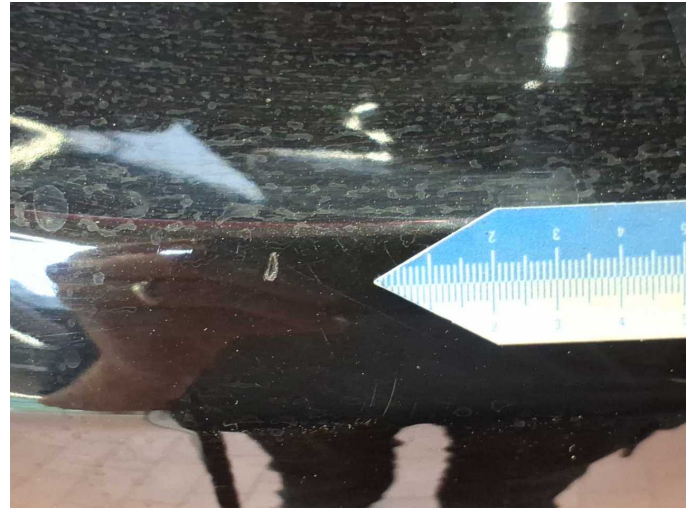
Damage 6: Rear bumper: Rear bumper - Scratch(es) - Smart repair

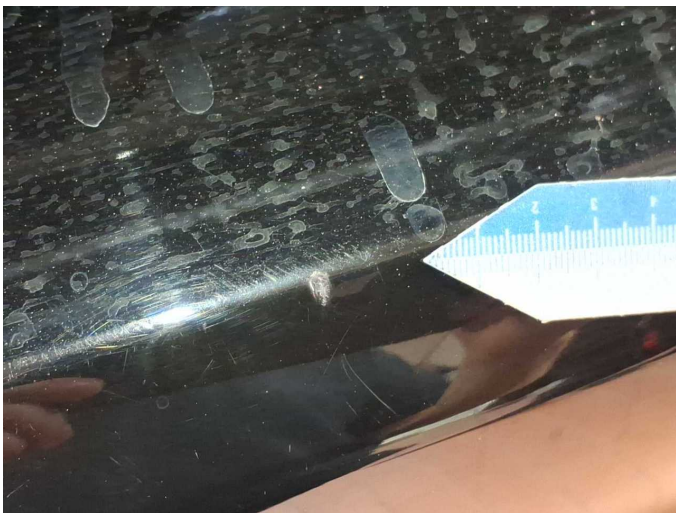
Damage 6: Rear bumper: Rear bumper - Scratch(es) - Smart repair

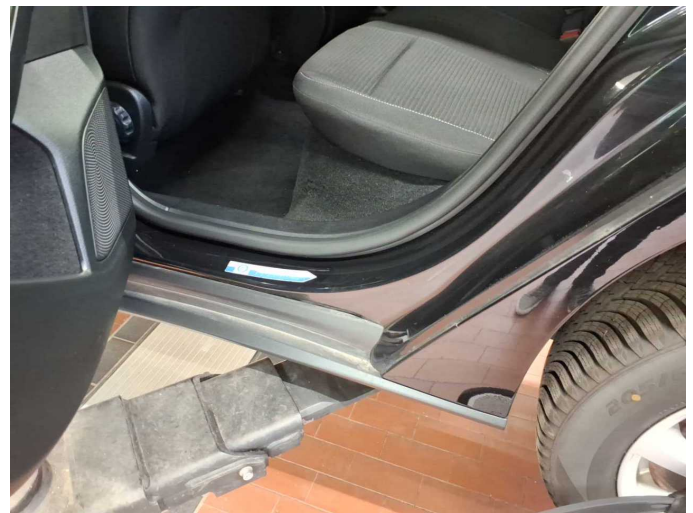
Damage 7: Side panel - rear left side: Sill - Scratch(es) - Smart repair

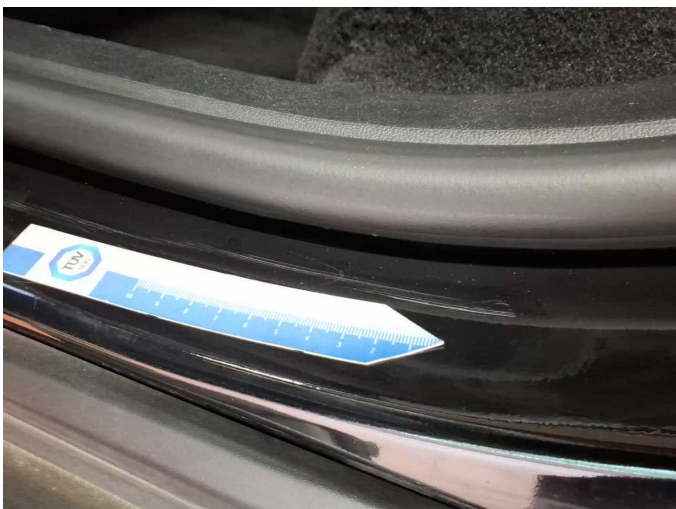
Damage 7: Side panel - rear left side: Sill - Scratch(es) - Smart repair

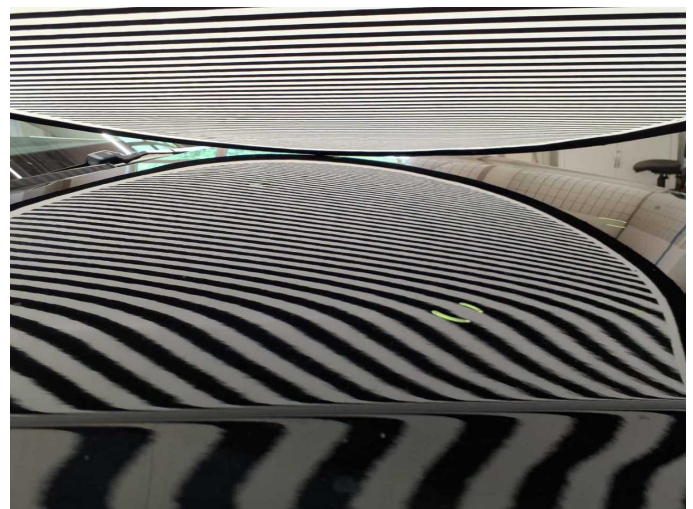
Damage 9: Bonnet: Bonnet - dent(s) - Smooth repair work

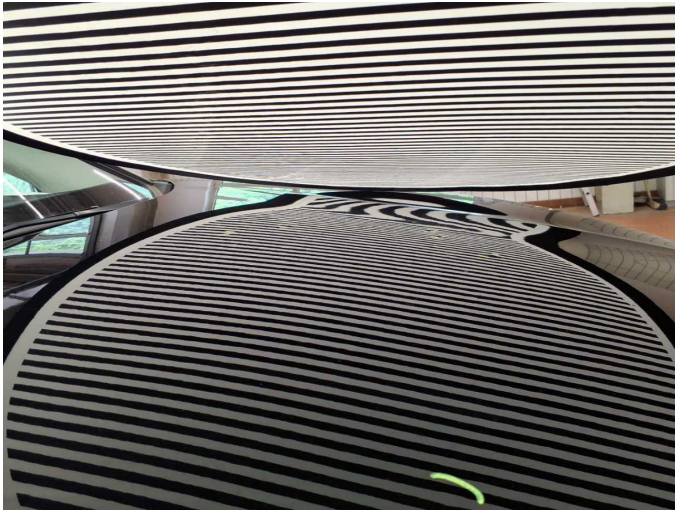
Damage 9: Bonnet: Bonnet - dent(s) - Smooth repair work

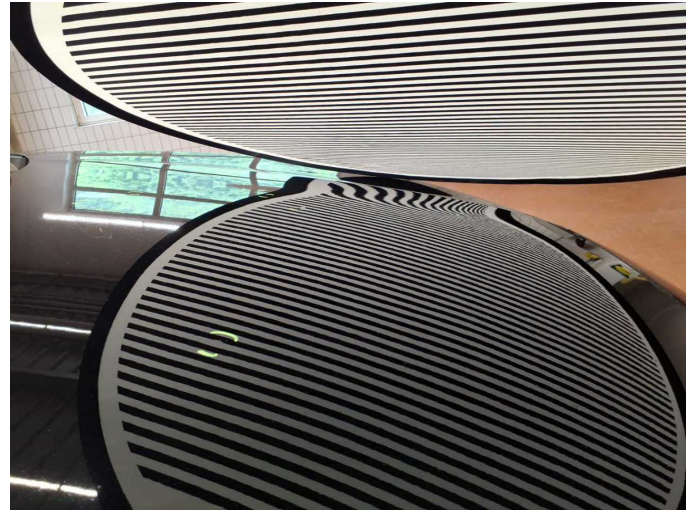
Damage 9: Bonnet: Bonnet - dent(s) - Smooth repair work

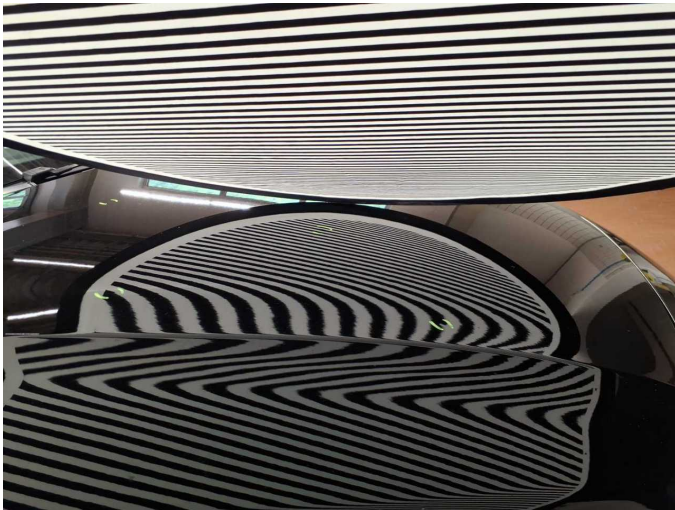
Damage 9: Bonnet: Bonnet - dent(s) - Smooth repair work

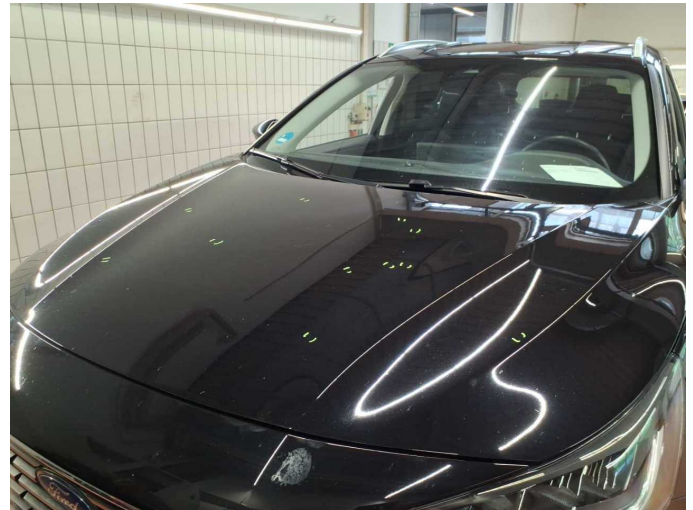
Damage 9: Bonnet: Bonnet - dent(s) - Smooth repair work

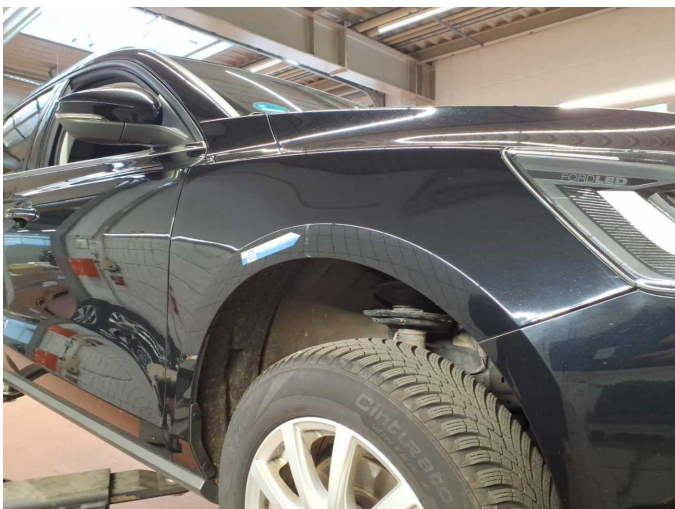
Damage 10: Mudguard - right side: Mudguard - right side - Dent / paintcoat damage - Repair and paint

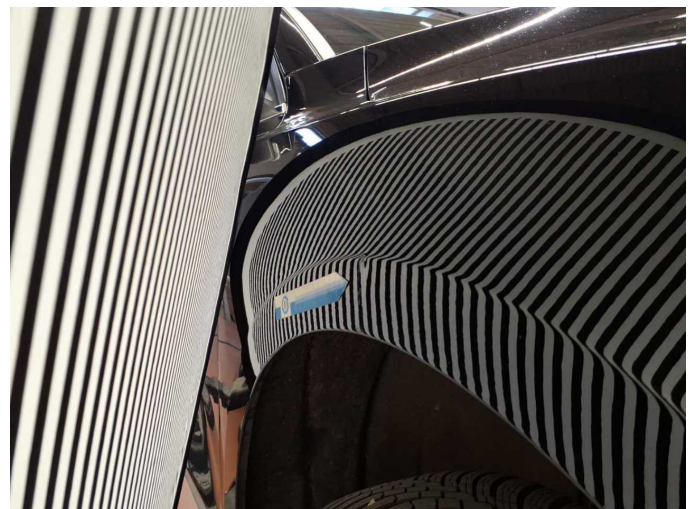
Damage 10: Mudguard - right side: Mudguard - right side - Dent / paintcoat damage - Repair and paint

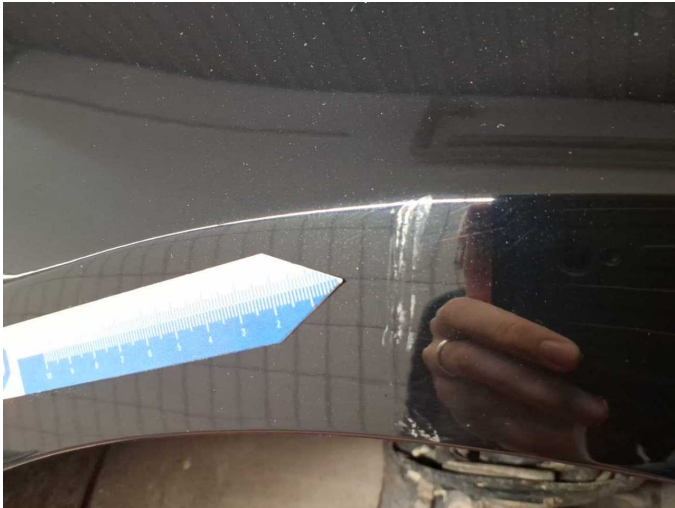
Damage 10: Mudguard - right side: Mudguard - right side - Dent / paintcoat damage - Repair and paint

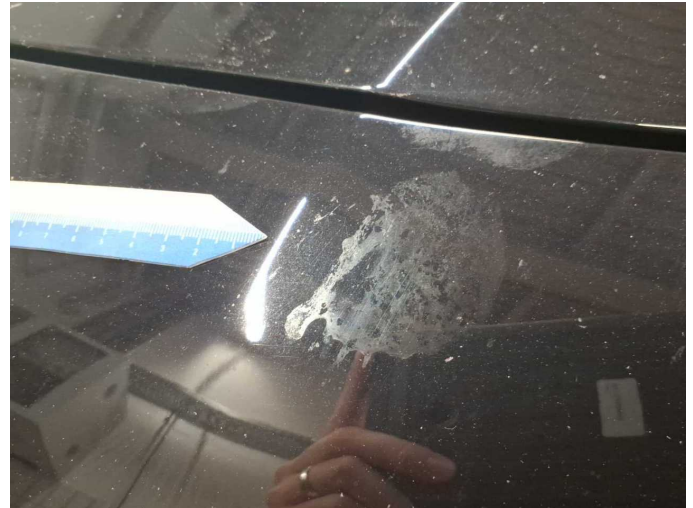
Damage 11: Front bumper: Front bumper (+ Verätzung) - Scratch(es) - Paint

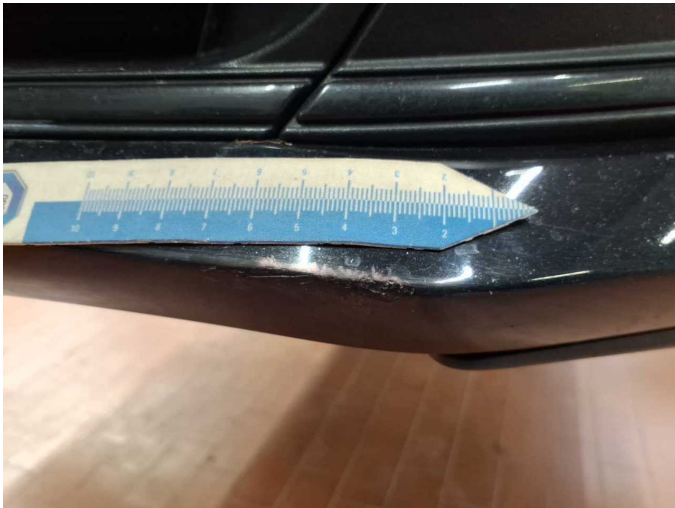
Damage 11: Front bumper: Front bumper (+ Verätzung) - Scratch(es) - Paint

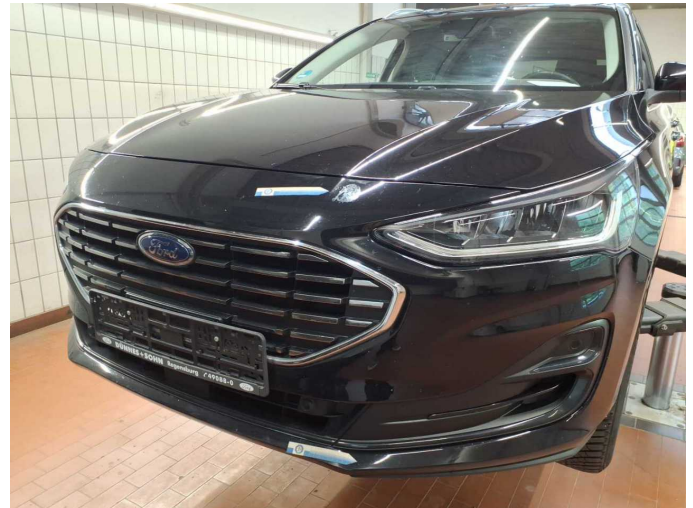
Damage 11: Front bumper: Front bumper (+ Verätzung) - Scratch(es) - Paint

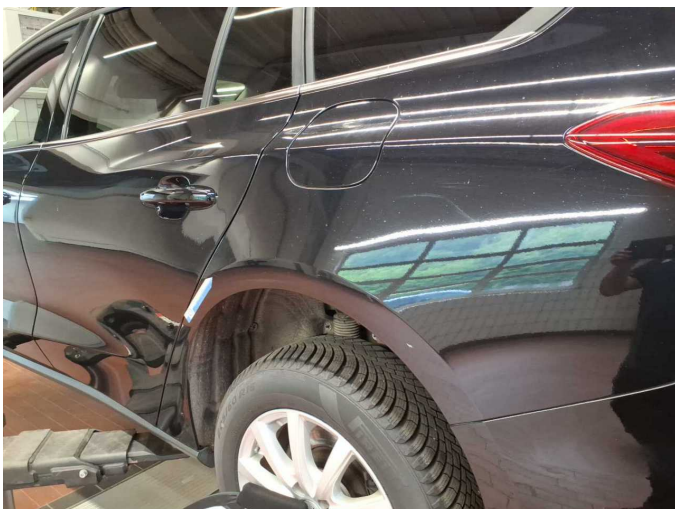
Damage 12: Side panel - rear left side: Side panel - Scratch(es) - Paint

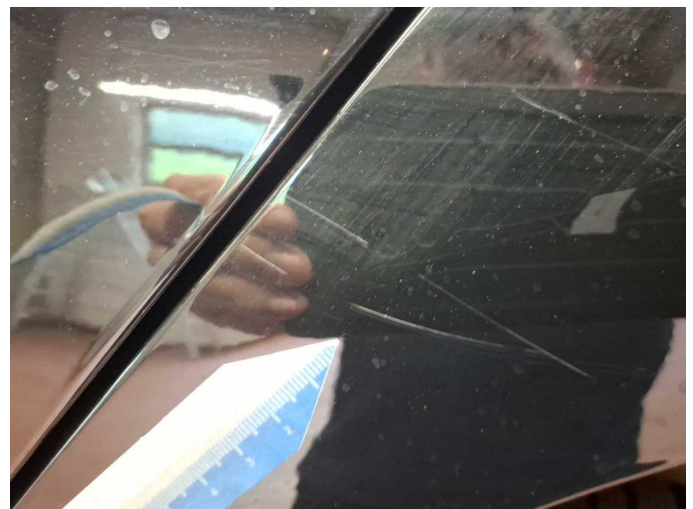
Damage 12: Side panel - rear left side: Side panel - Scratch(es) - Paint

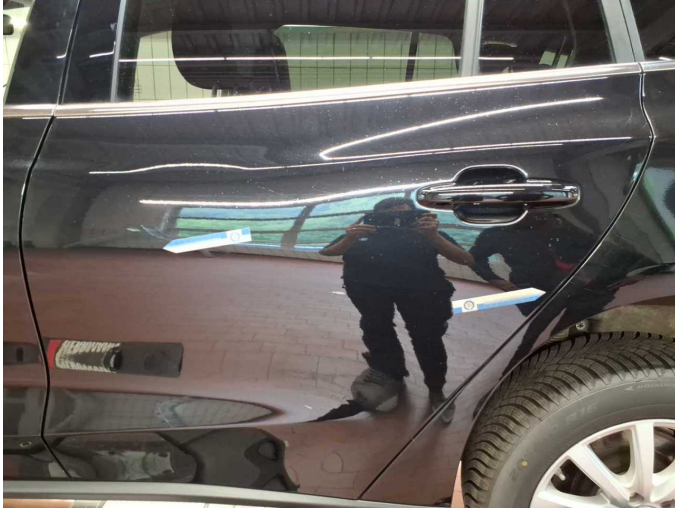
Damage 13: Door - rear left side: Door - Scratch(es) - Paint

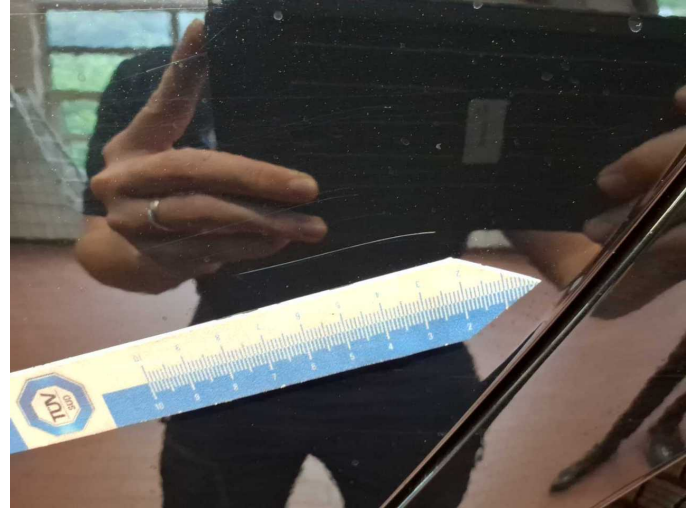
Damage 13: Door - rear left side: Door - Scratch(es) - Paint

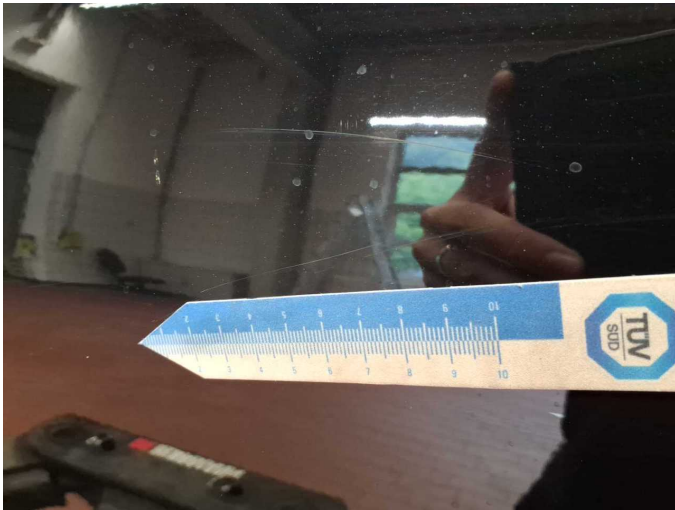
Damage 13: Door - rear left side: Door - Scratch(es) - Paint

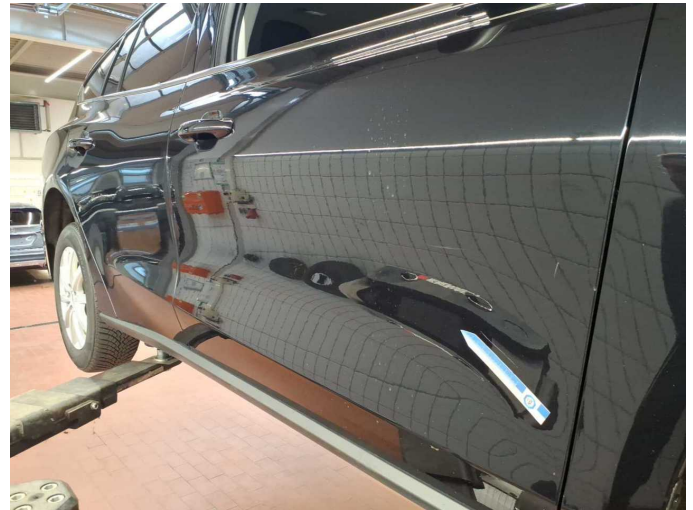
Damage 14: Door - front right side: Door - Scratch(es) - Paint

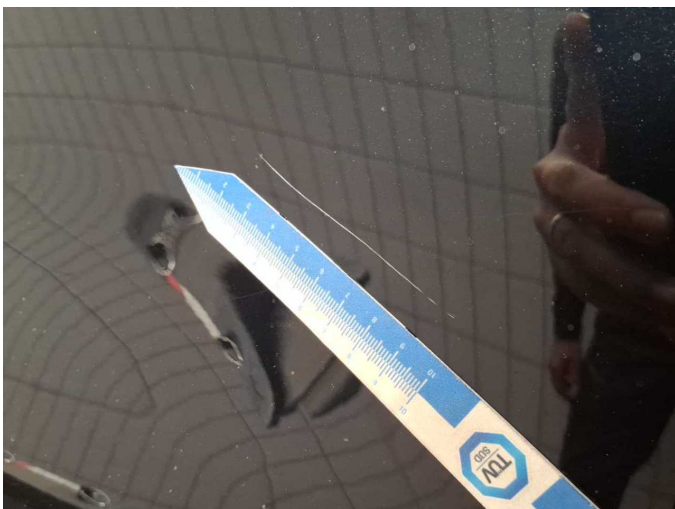
Damage 14: Door - front right side: Door - Scratch(es) - Paint

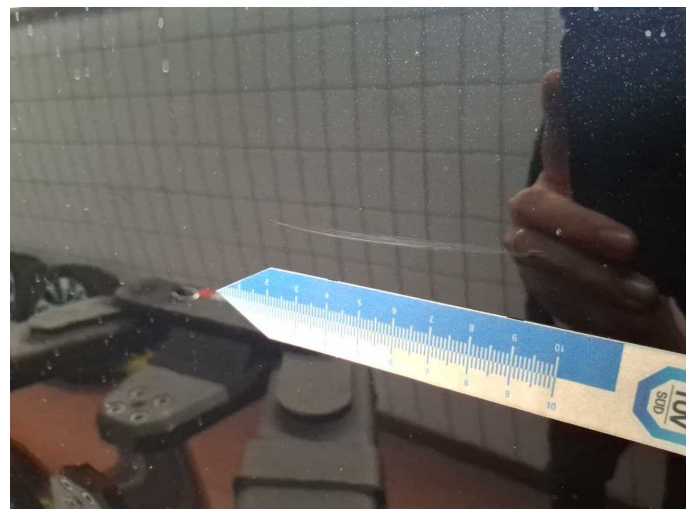
Damage 14: Door - front right side: Door - Scratch(es) - Paint

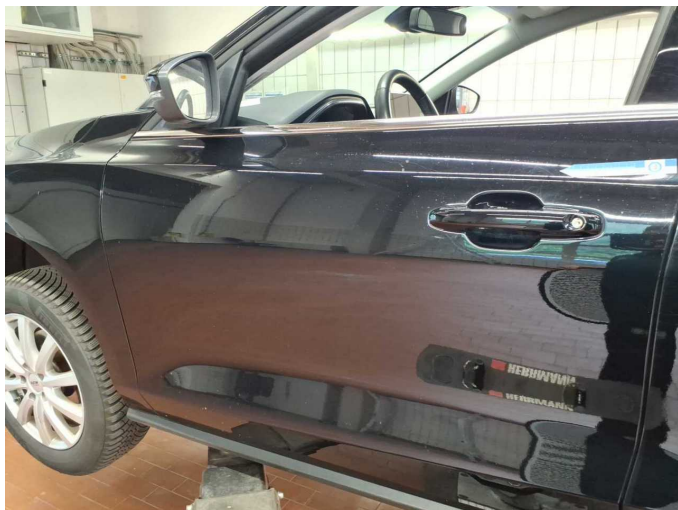
Wear and tear 1: Door - front left side: Door - Scratch(es) - No deduction

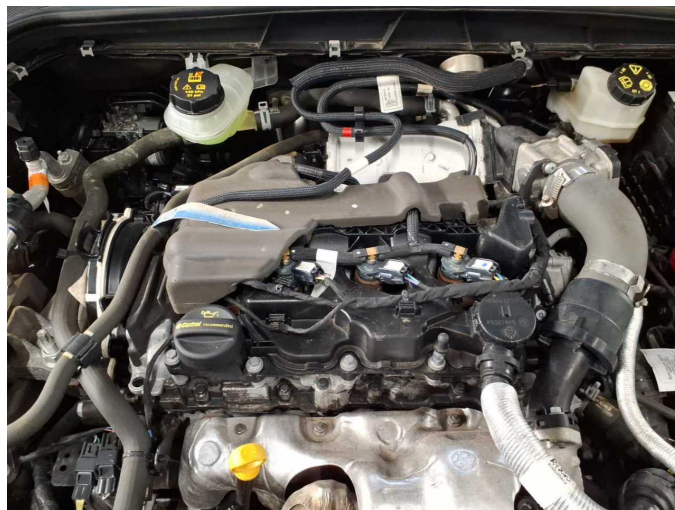
Missing part 1: Engine: Engine cover - Missing - Replace
