## Expertise

Protocol number: 45830570  
Order No. / Reference: 26373769  
Inspection date: 1 Jun 2026

Manufacturer: Seat

Model: CUPRA Born 150kW/58kWh

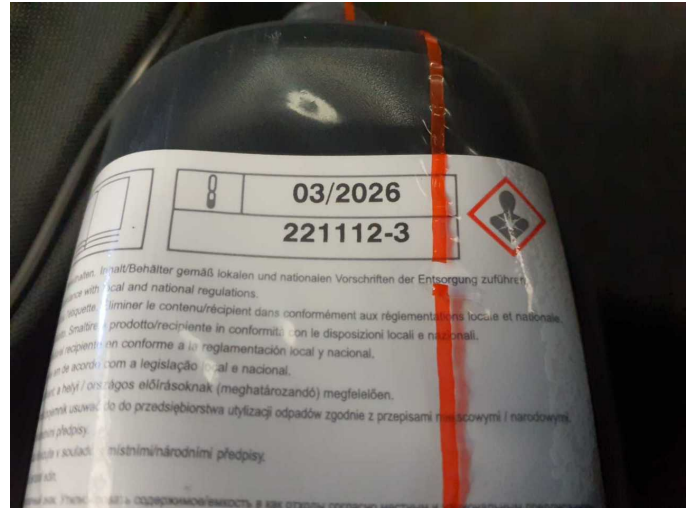
No.	Component group	Description
1	Misc.	Inspection / maintenance (Wartungsnachweis nicht vorhanden) - No evidence - No deduction
2	Wheel / tyres	Tyres - complete set - Differs from the original configuration - No deduction
3	Equipment	Tirefit filler - Expired - Replace
4	Wheel / tyres	Alloy rim - front right side (Mit Materialabtrag, Großflächig verkratzt) - Scratched - Replace

Damage 3: Equipment: Tirefit filler - Expired - Replace

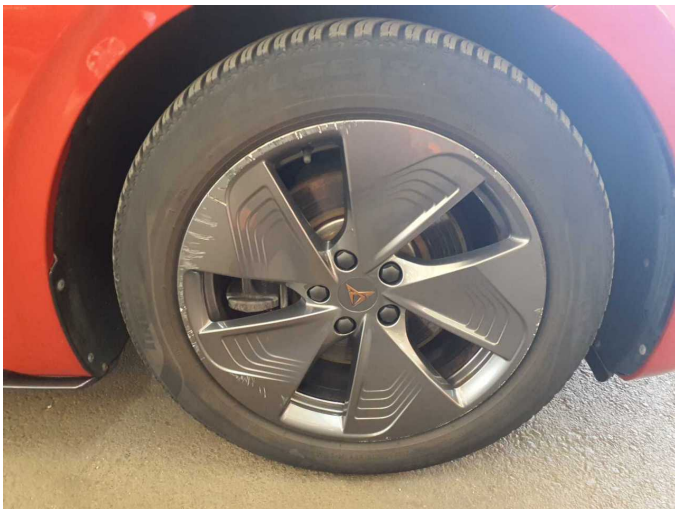
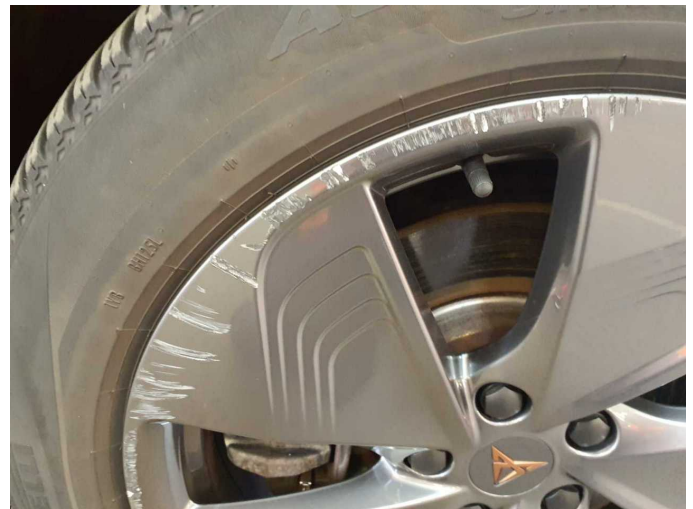
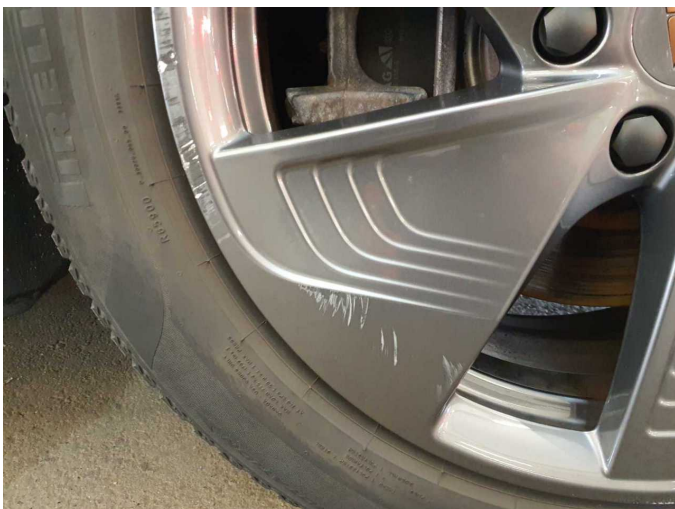
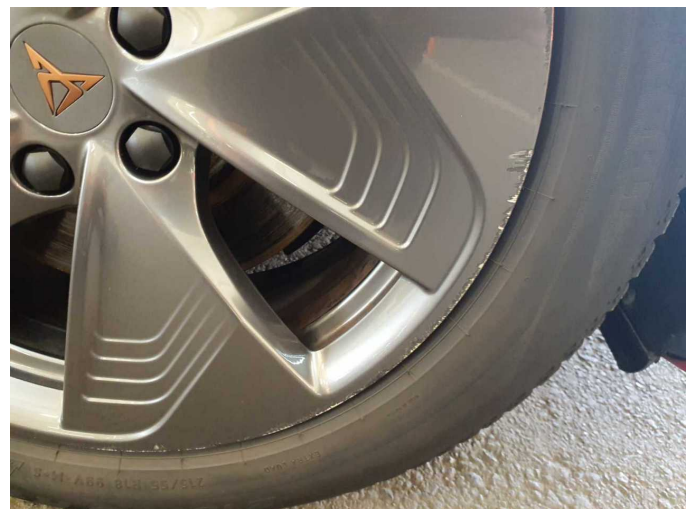
Damage 4: Wheel / tyres: Alloy rim - front right side (Mit Materialabtrag, Großflächig verkratzt) - Scratched - Replace

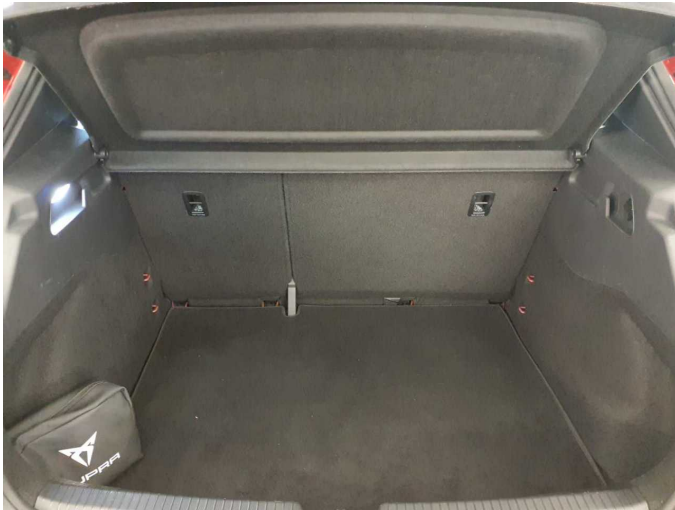
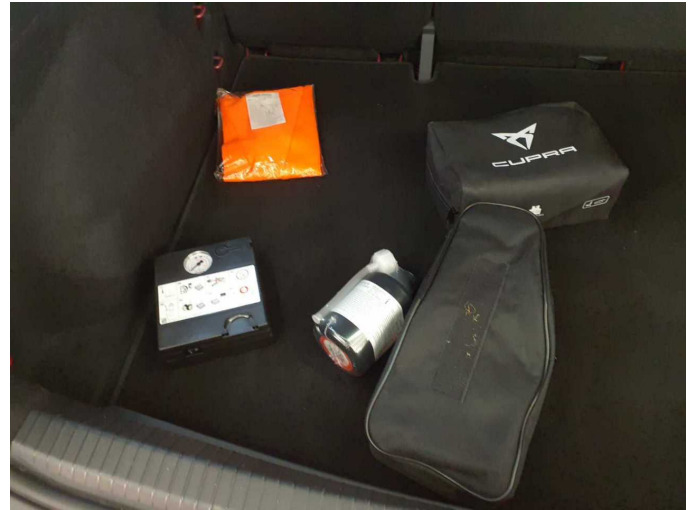
Documents - Service book (Digitaler Nachweis)  
Equipment - charging cable

**Missing part 2:** Equipment: charging cable - Missing - Replace

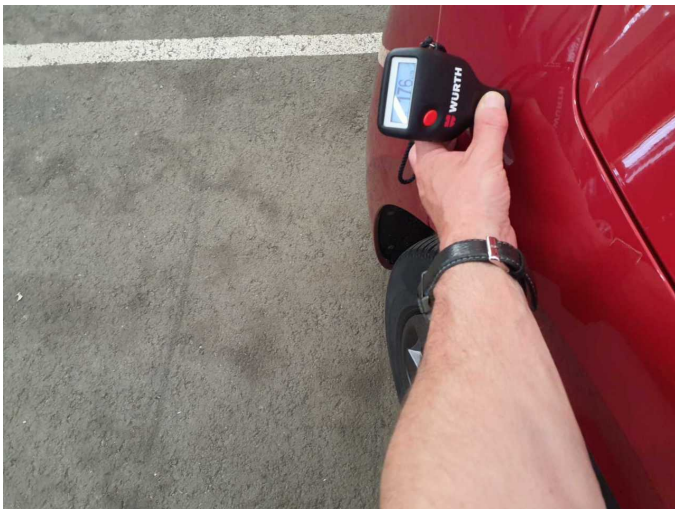
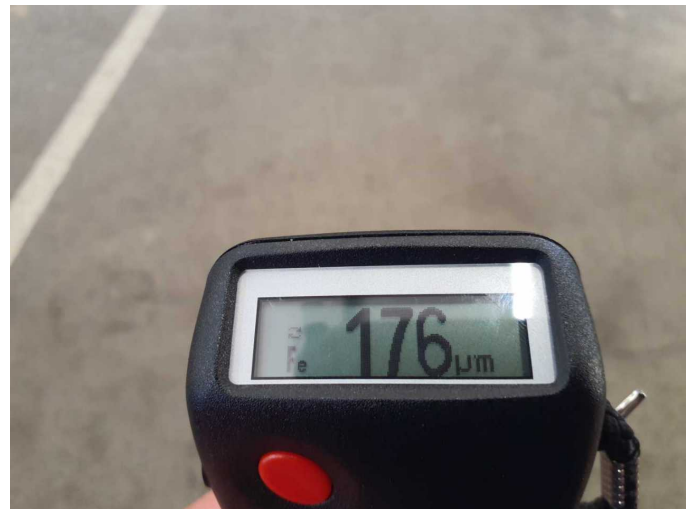
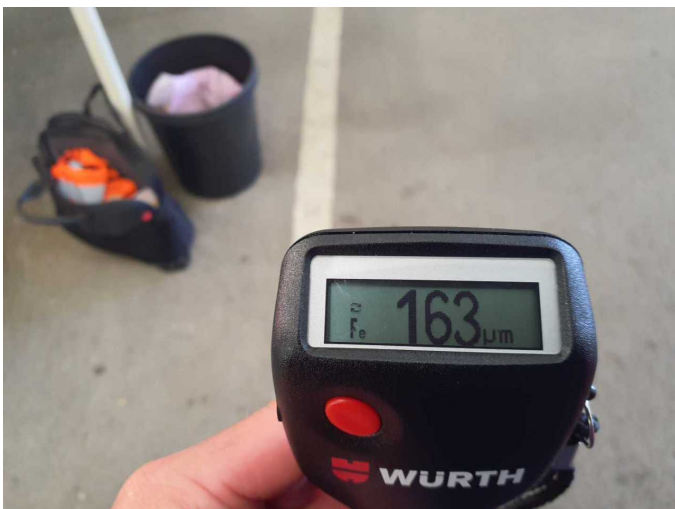
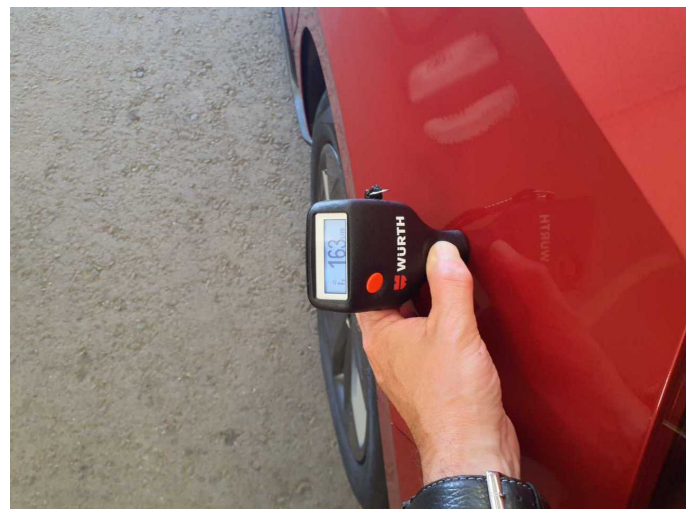
- 1 Side panel - rear left side, Side panel - rear right side, Professionally carried out, Invoice of repair done Non-existent

Side panel - rear left side	163 µm	Side panel - rear right side	176 µm
-----------------------------	--------	------------------------------	--------

**Repainting 1:** Side panel - rear left side, Side panel - rear right side
