Expertise

Protocol number: 46134408
Order No. / Reference: 26510142
Inspection date: 23 Jun 2026

Manufacturer: Ford

Model: Transit Custom 300 L1H1 LKW VA Trail

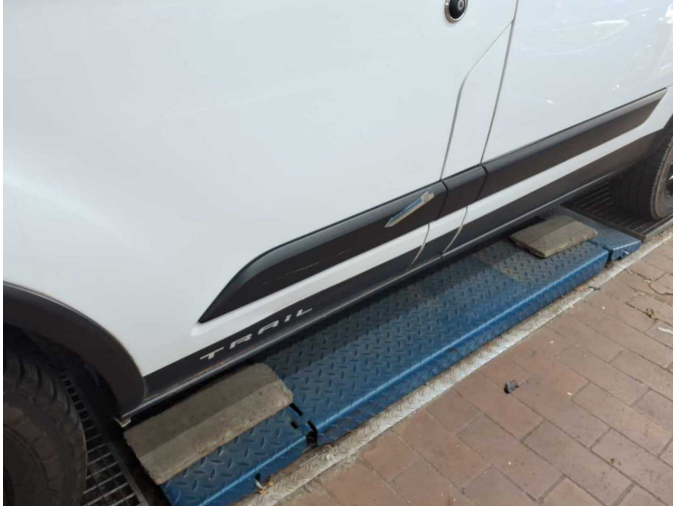
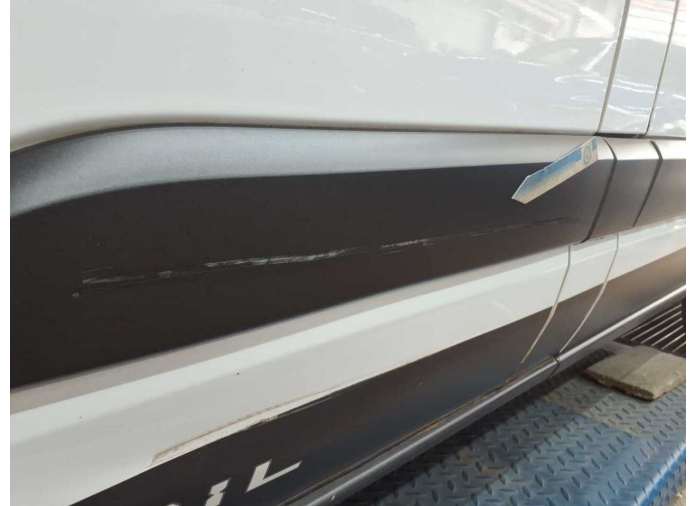
Damage 2: Door - front left side: Brightware - lower - Scratch(es) - Replace

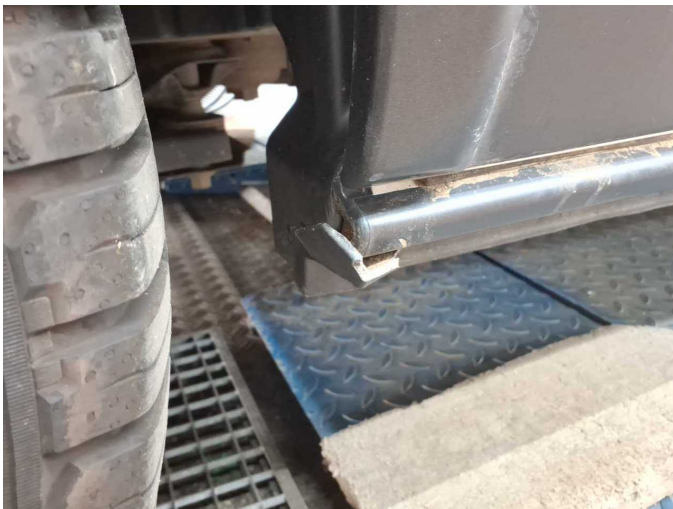
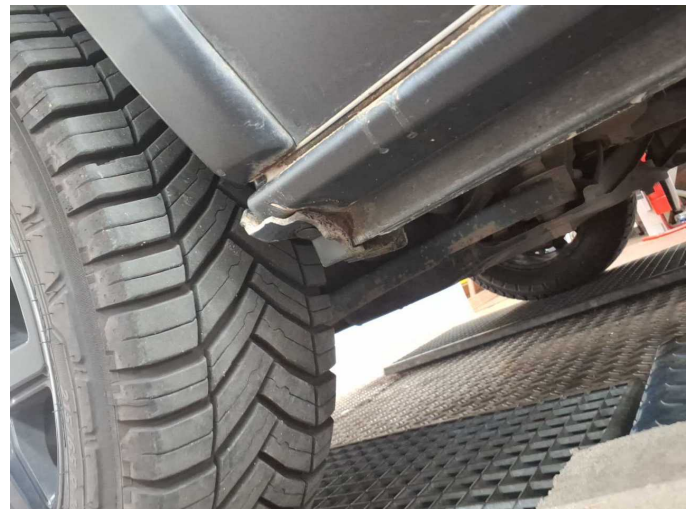
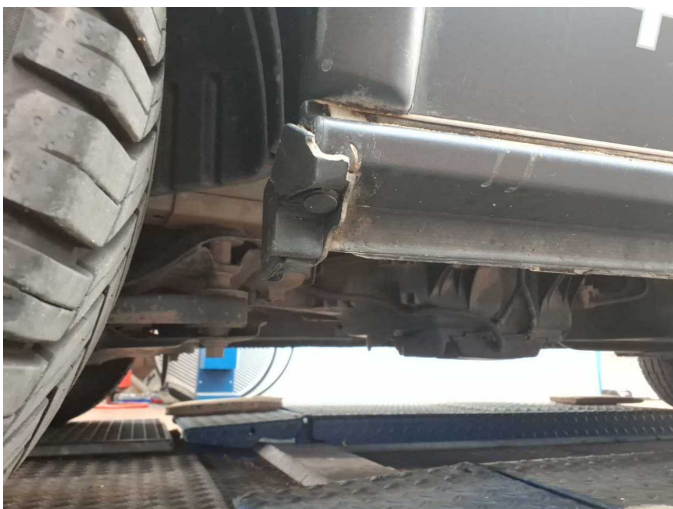
Damage 3: Mudguard - left side: Wheel arch (Spritzschutz) - Broken / torn - Replace

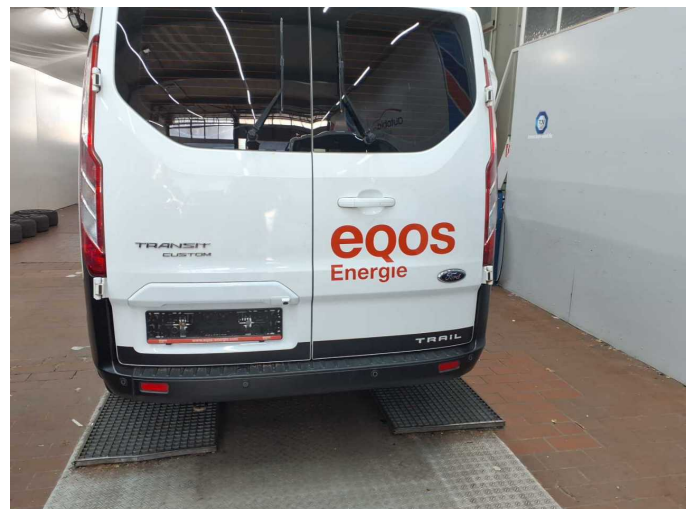
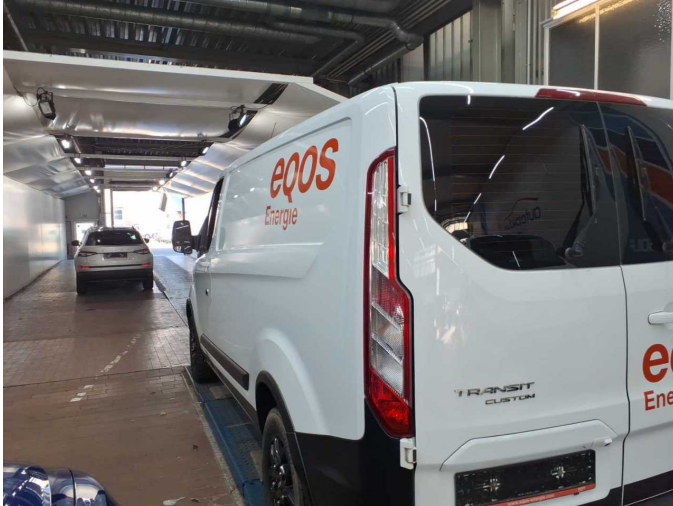
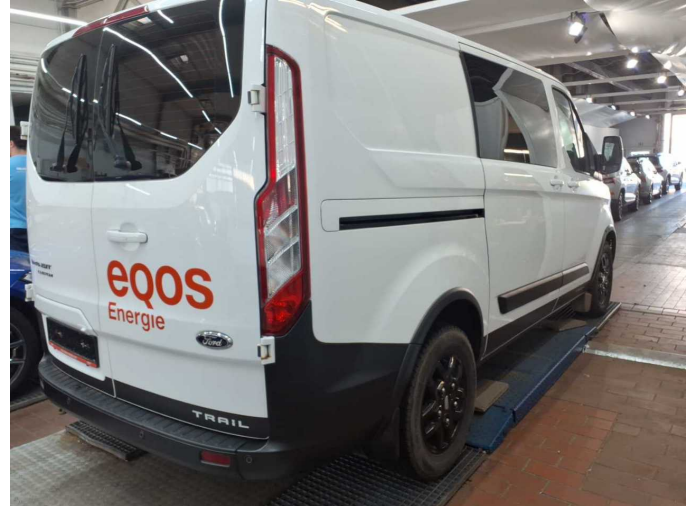
Damage 4: Body: Body - Glued / labelled - De-glug / neutralise

Damage 4: Body: Body - Glued / labelled - De-glude / neutralise

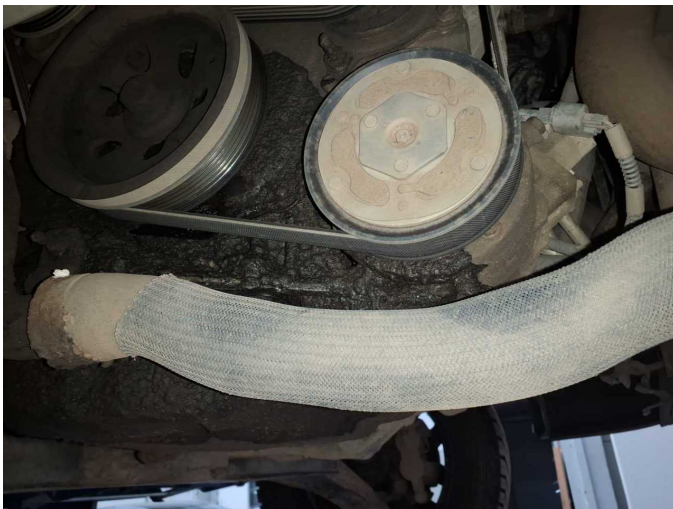
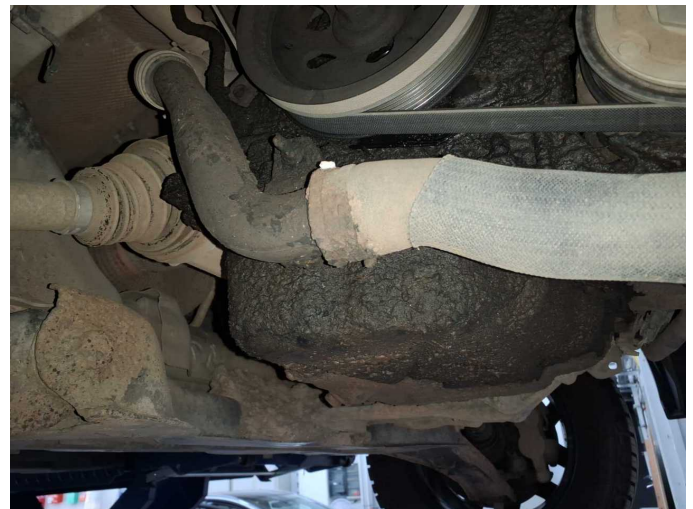
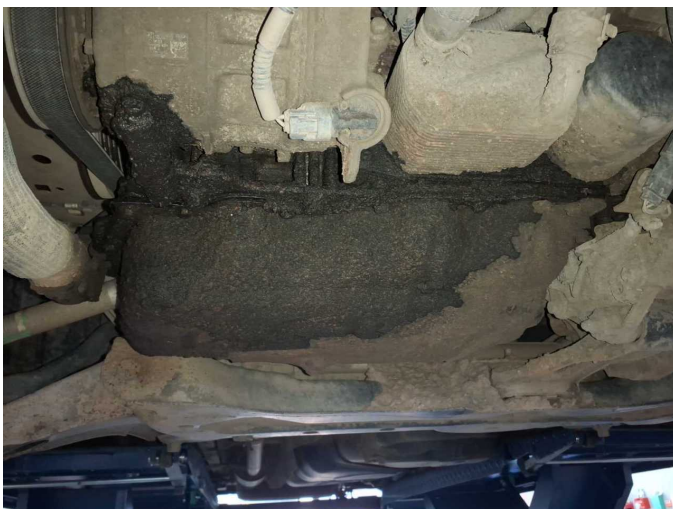
Damage 5: Engine: Engine - Leaking - Perform diagnosis

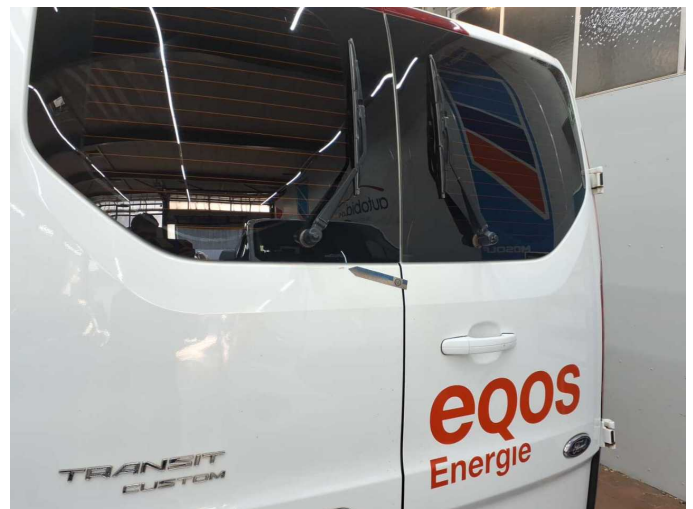
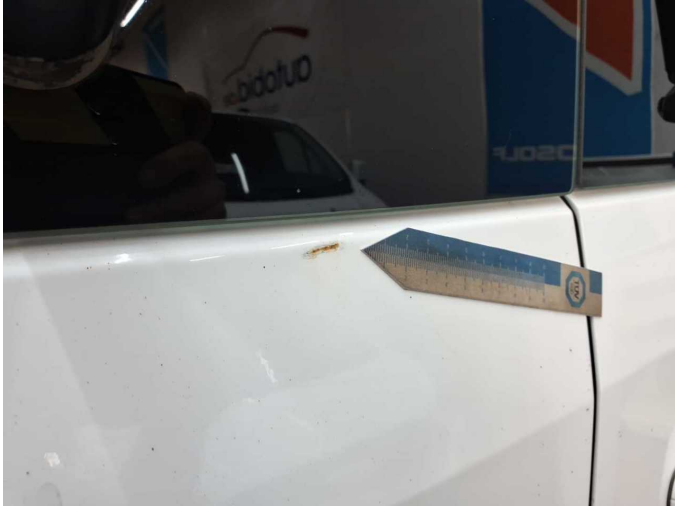
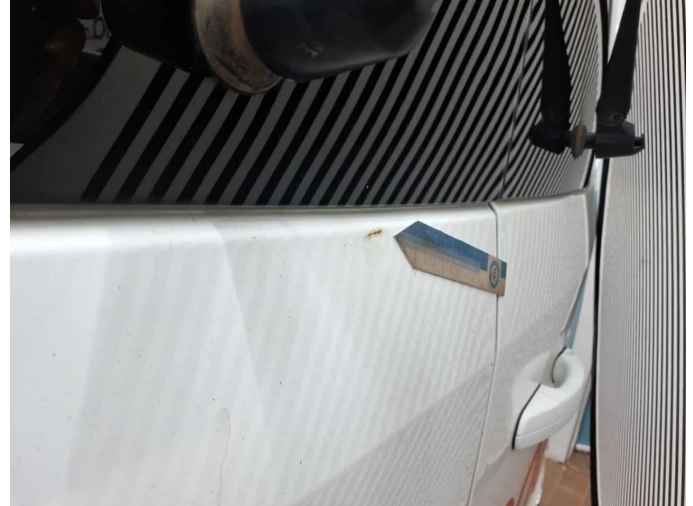
Damage 6: Boot lid / rear door: Rear door - left side (Außen) - Dent / paintcoat damage - Smart repair

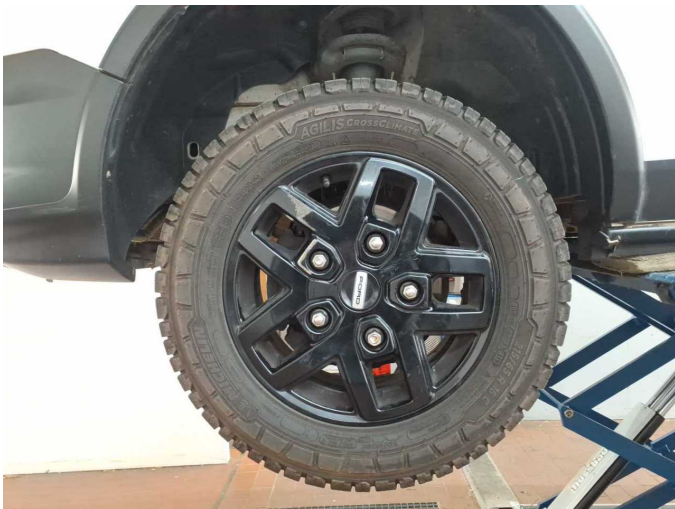
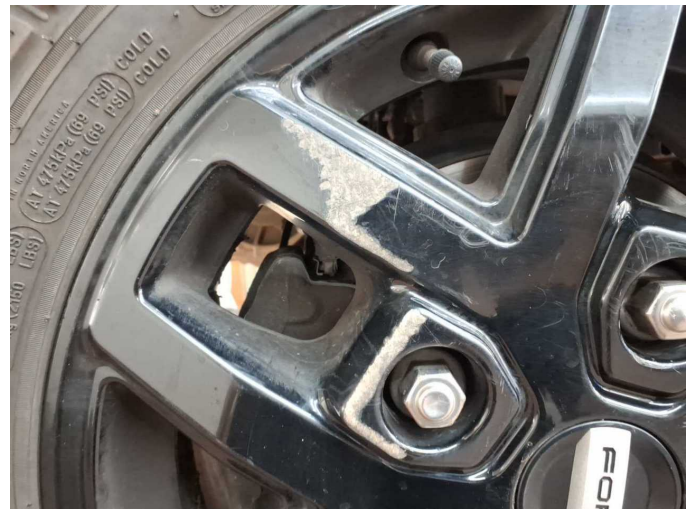
Damage 7: Wheel / tyres: Alloy rim - front left side - Scratch(es) - Loss in value

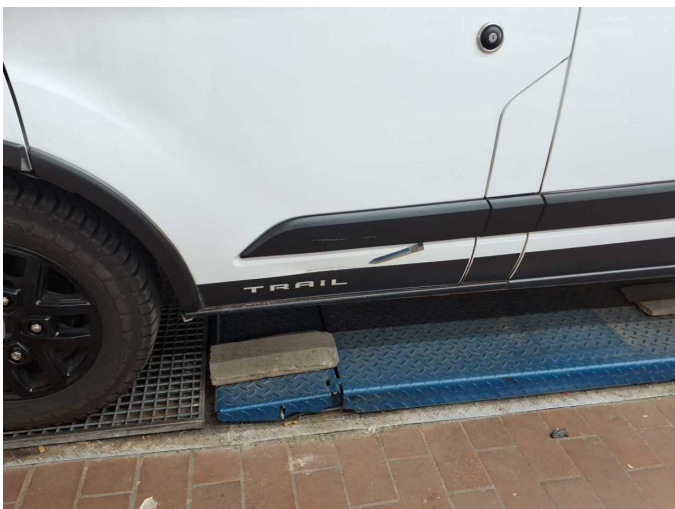
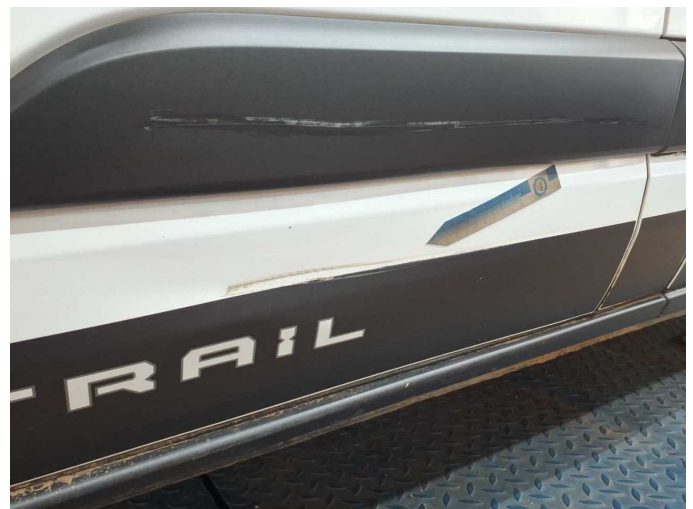
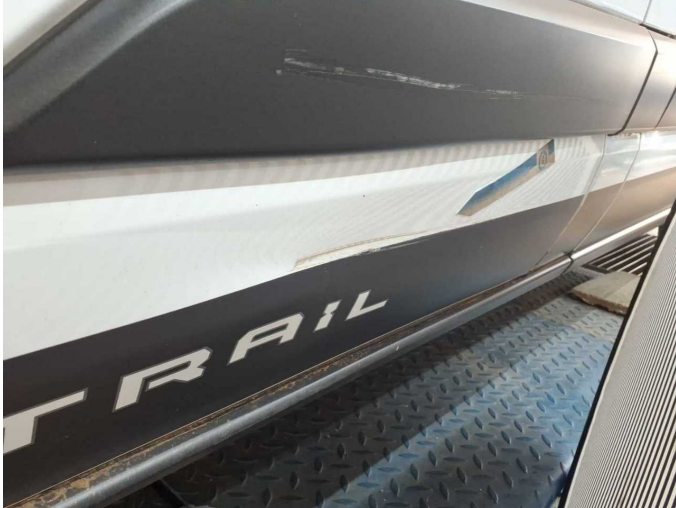
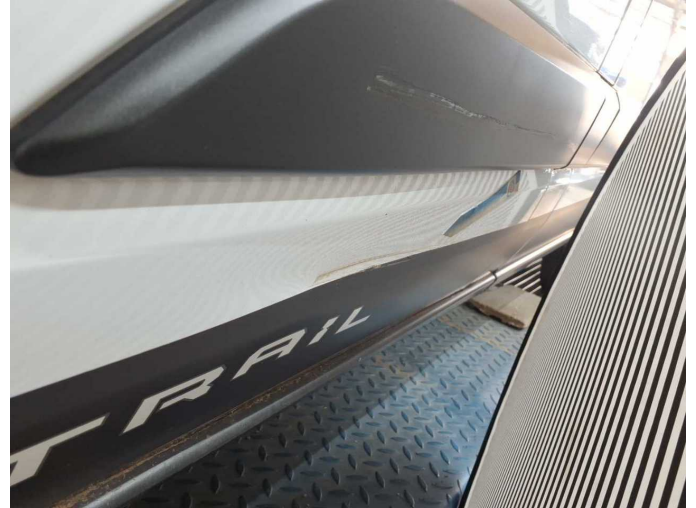
Damage 8: Door - front left side: Door - Dent / paintcoat damage - Smart repair

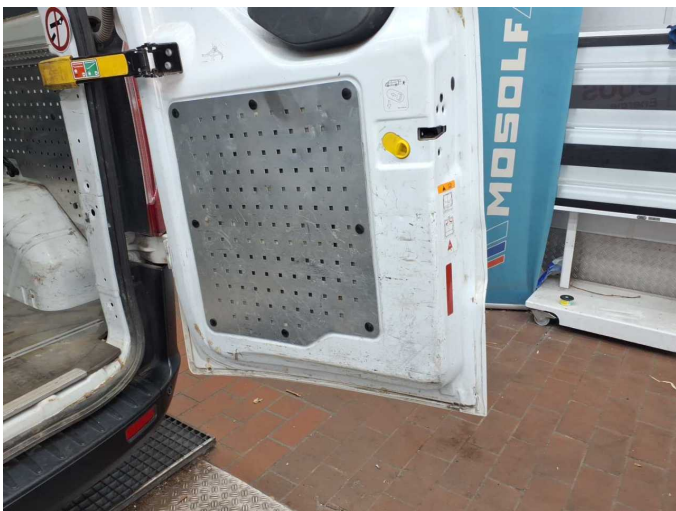
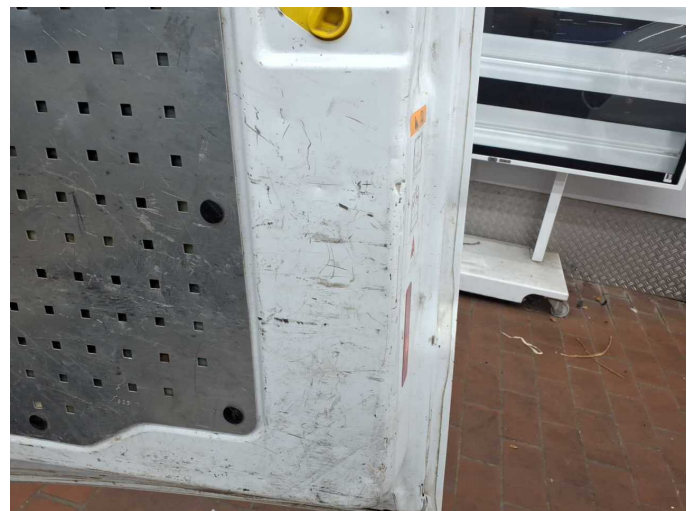
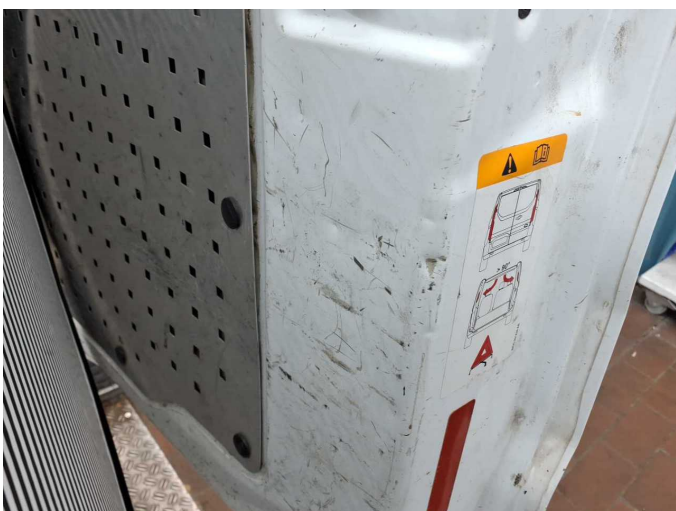
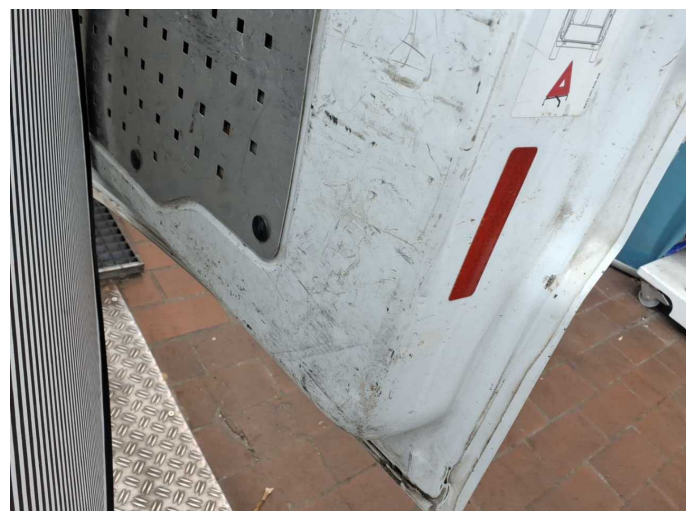
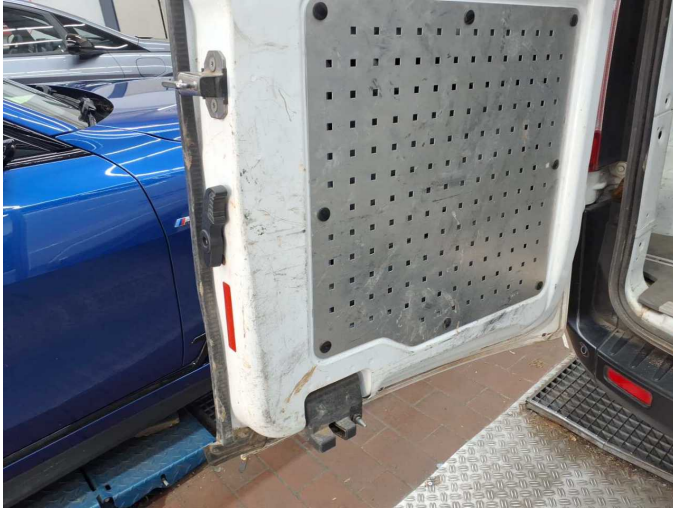
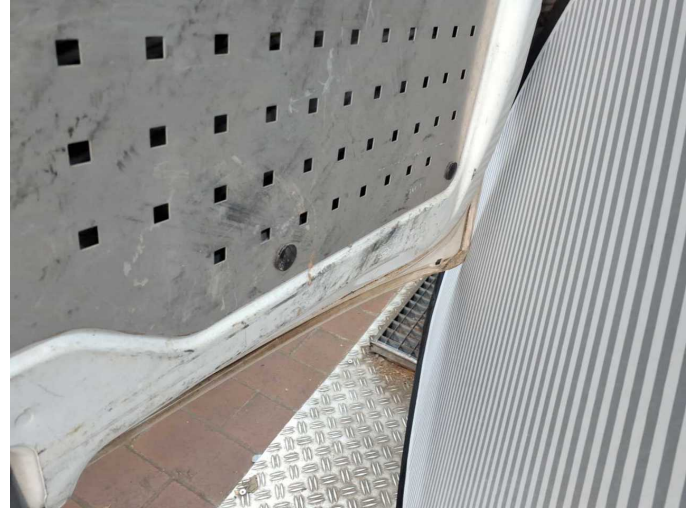
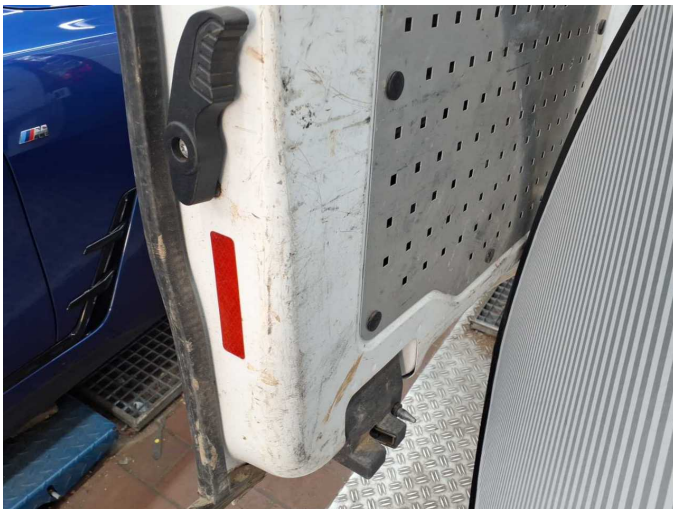
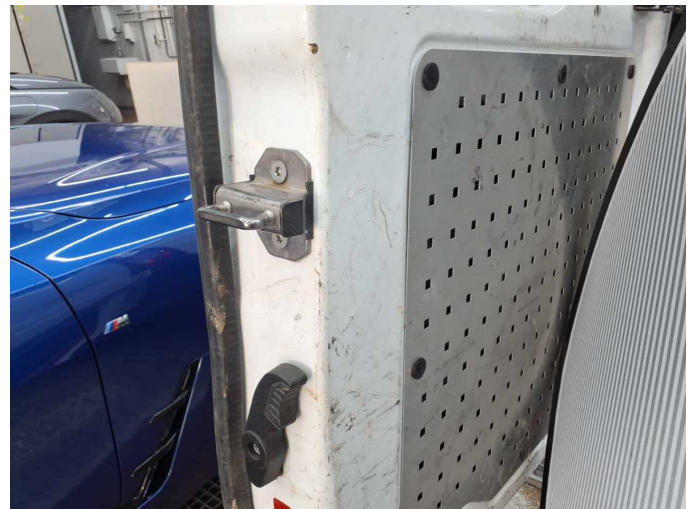
Damage 9: Boot lid / rear door: Rear door - right side (Und links) - Dent / paintcoat damage - Loss in value

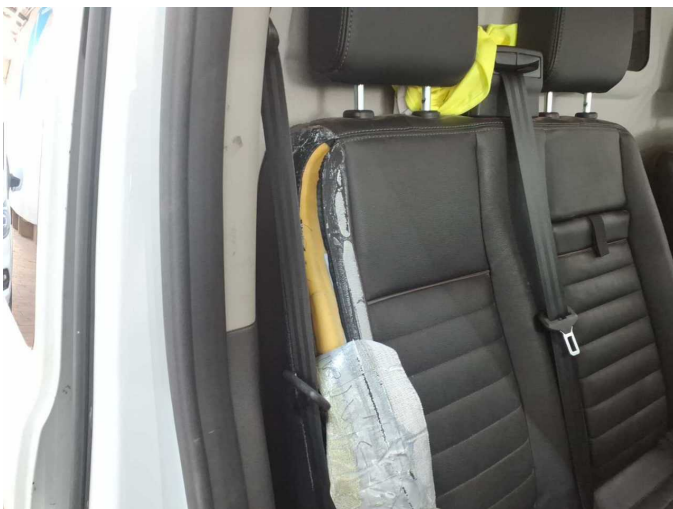
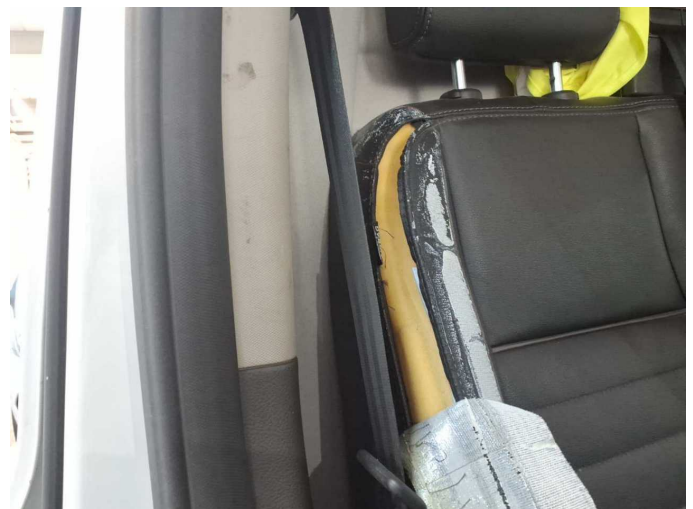
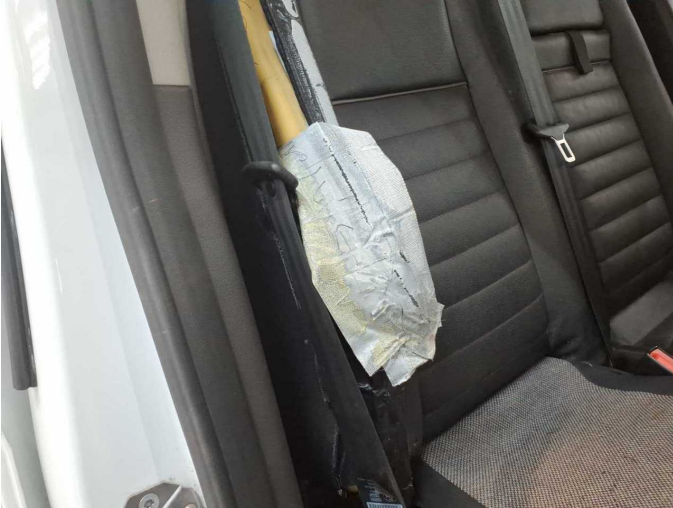
Damage 10: Seat - front: Backrest cover - 2 seater - right side - Broken / torn - Replace

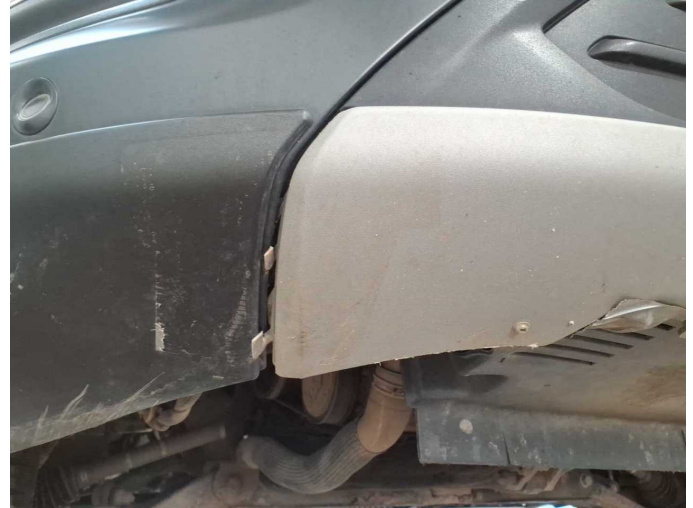
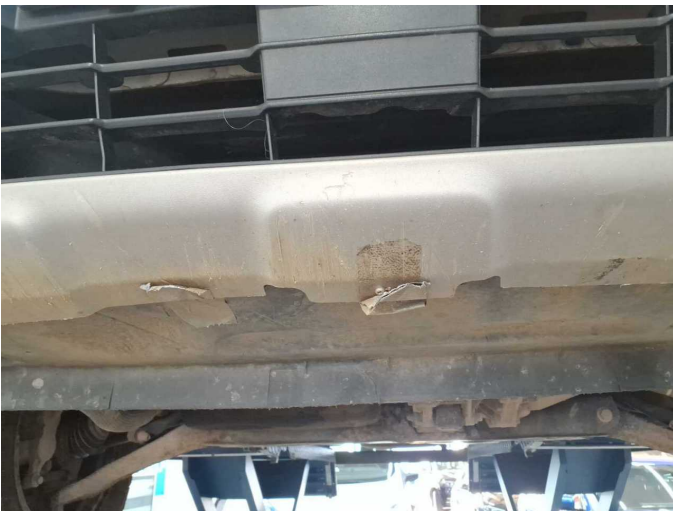
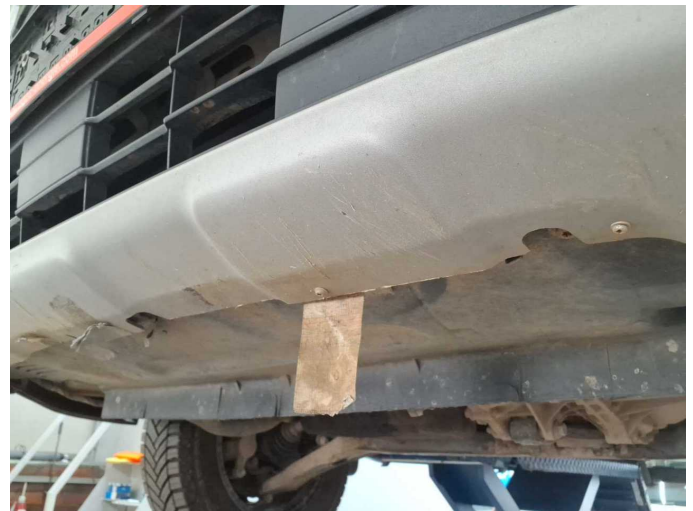
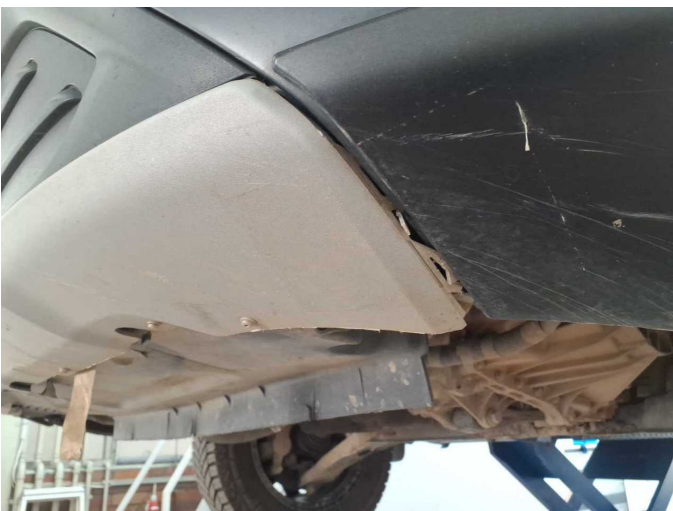
Damage 11: Front bumper: Spoiler (Mitte) - Deformed - Replace

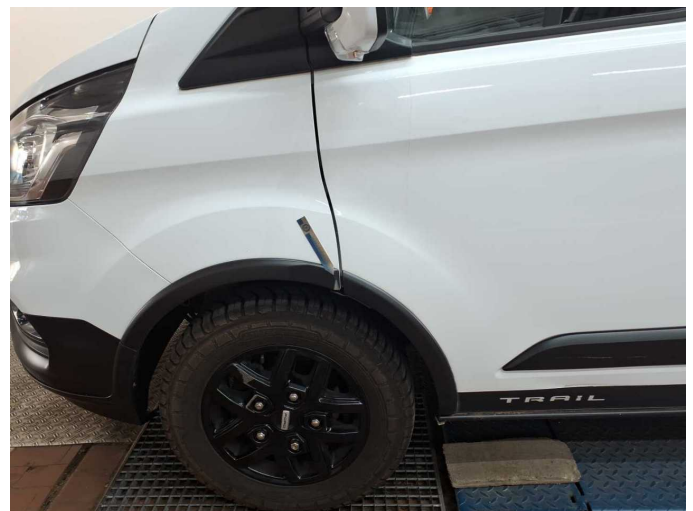
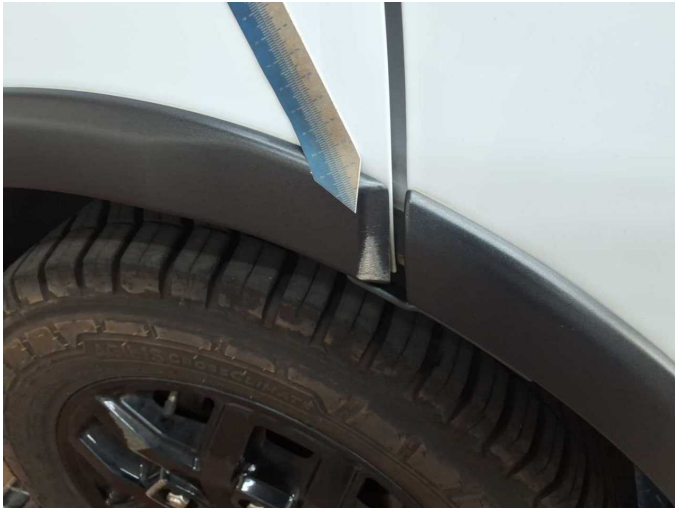
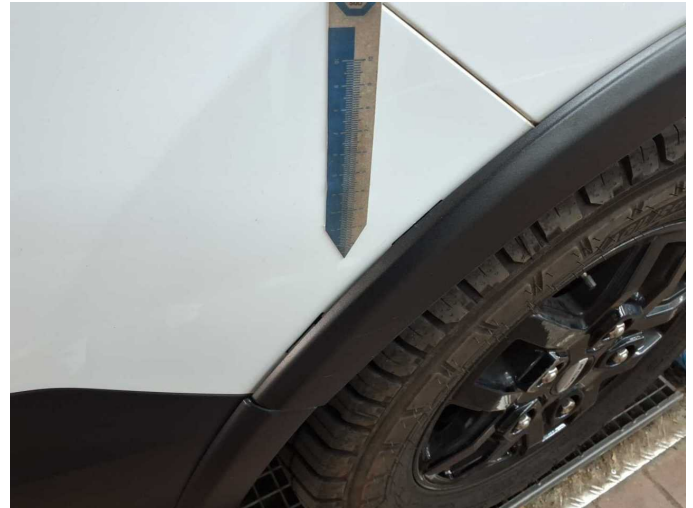
Damage 12: Mudguard - left side: Wheel well extension (Mit Verformung) - Scratch(es) - Replace

Damage 12: Mudguard - left side: Wheel well extension (Mit Verformung)
- Scratch(es) - Replace

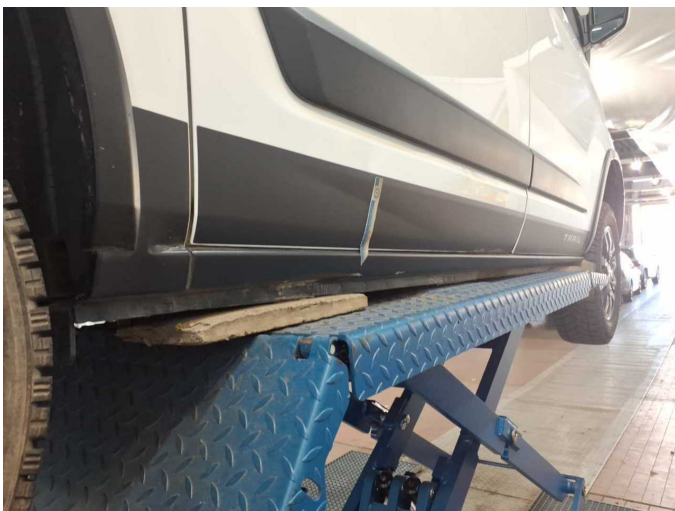
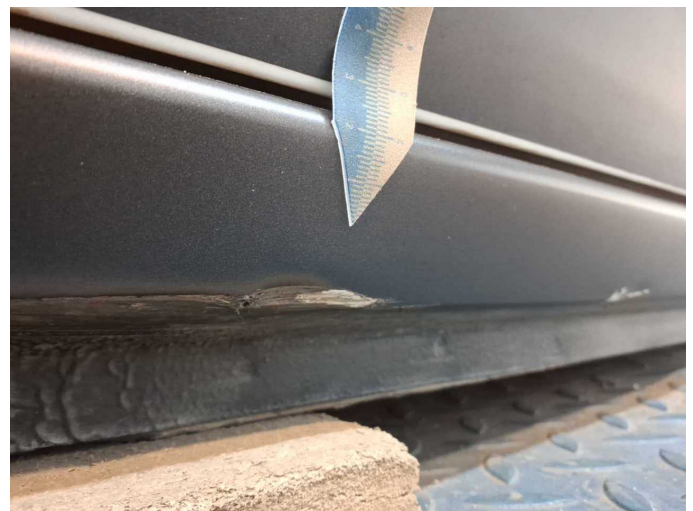
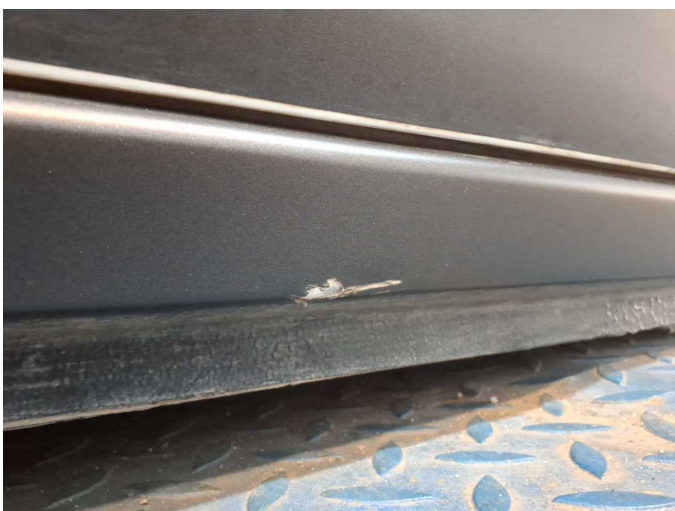
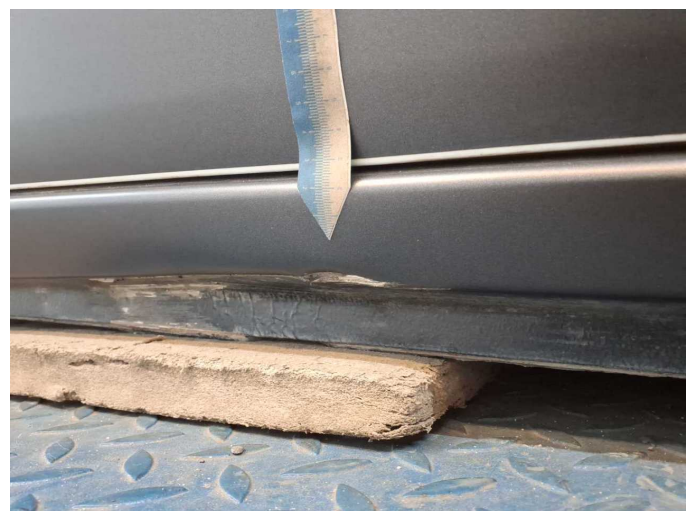
Damage 13: Sill - right side: Sill - Dent / paintcoat damage - Repair and paint

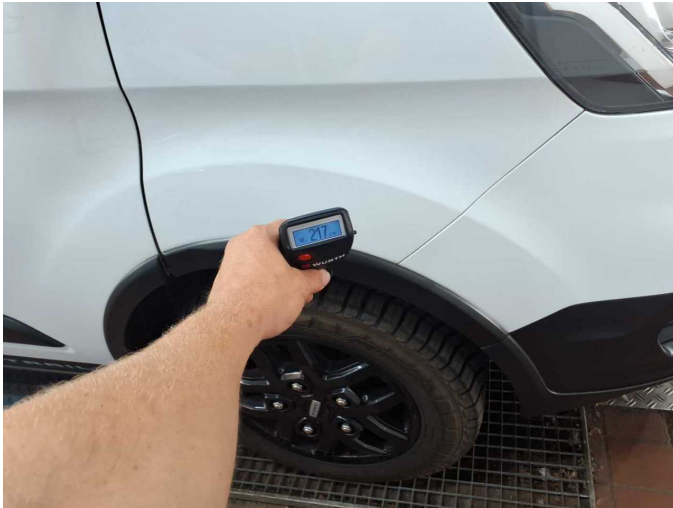
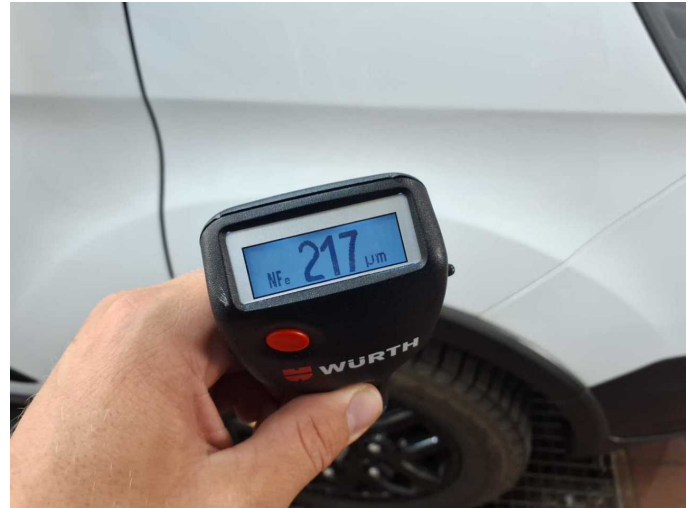
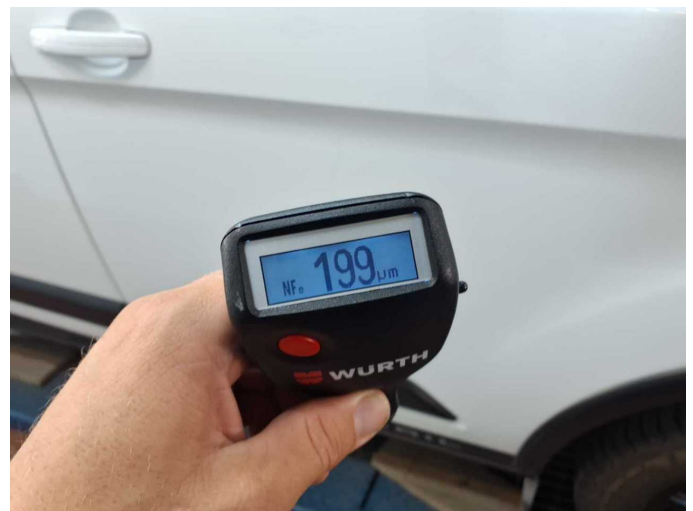
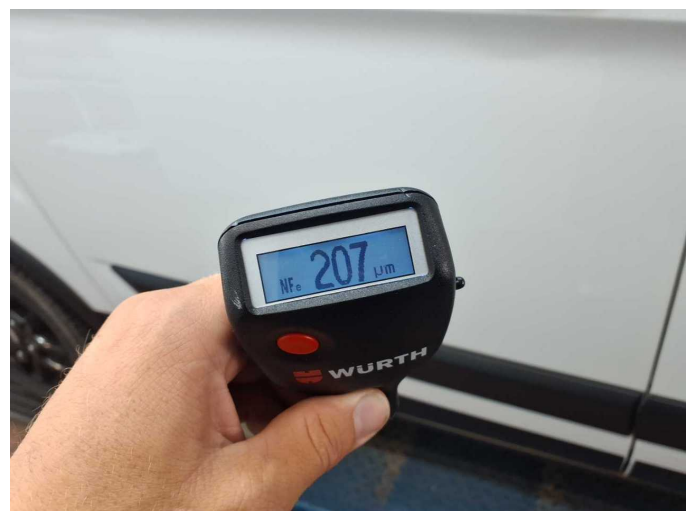
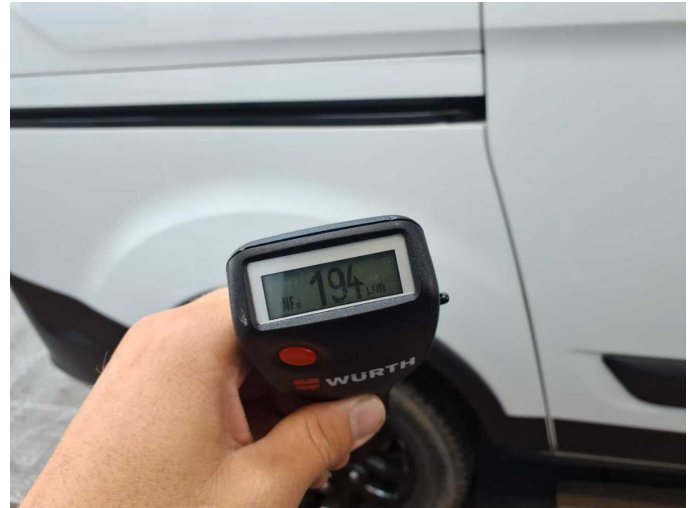
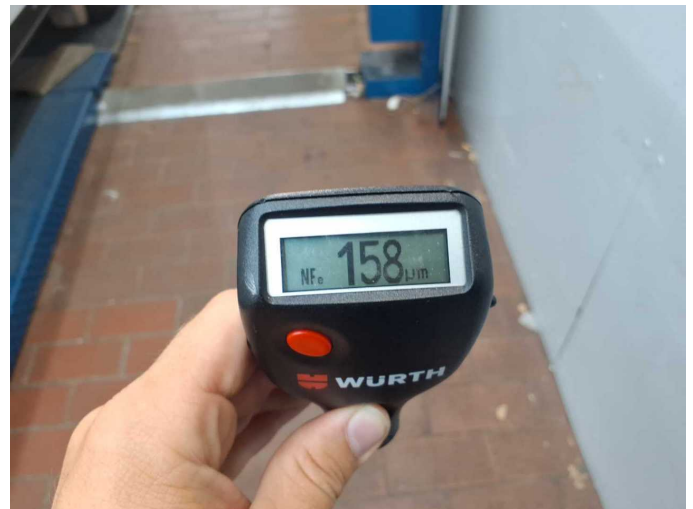
Roof rail - right side	158 µm	Mudguard - right side	217 µm
Side panel - rear right side	194 µm	Door - rear right side	207 µm
Door - front right side	199 µm

Repainting 1: Roof rail - right side, Mudguard - right side, Side panel - rear right side, Door - rear right side, Door - front right side
