Expertise

Protocol number: 46352680
Order No. / Reference: 26545161
Inspection date: 1 Jul 2026

Manufacturer: Seat

Model: Arona 1.0 TSI OPF Xperience

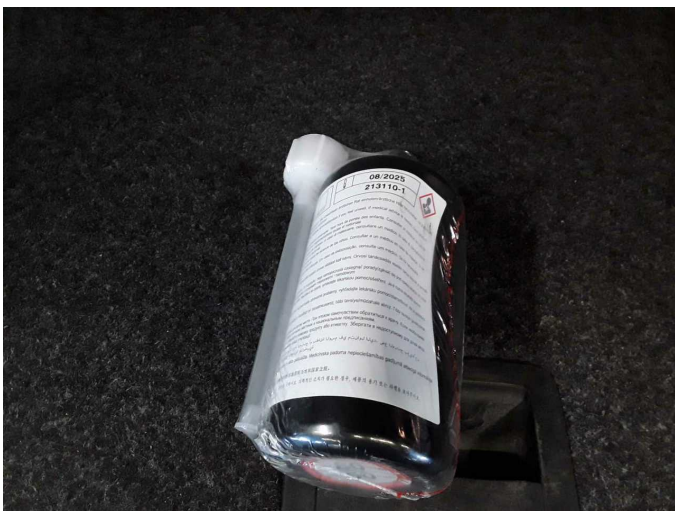
Damage 2: Equipment: Tirefit filler - Expired - Replace

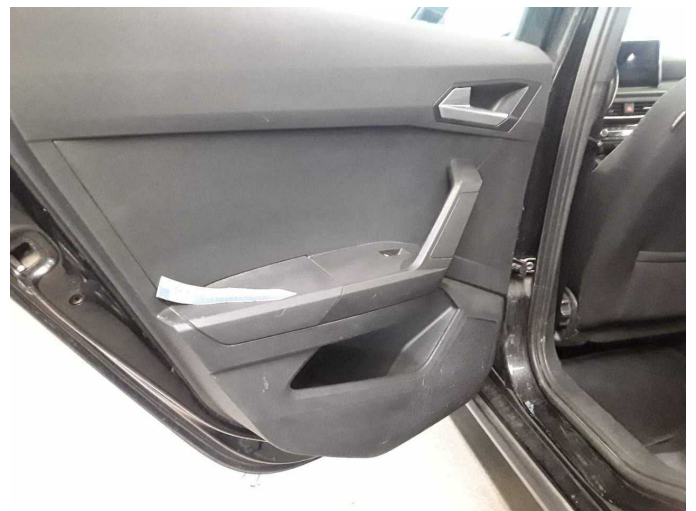
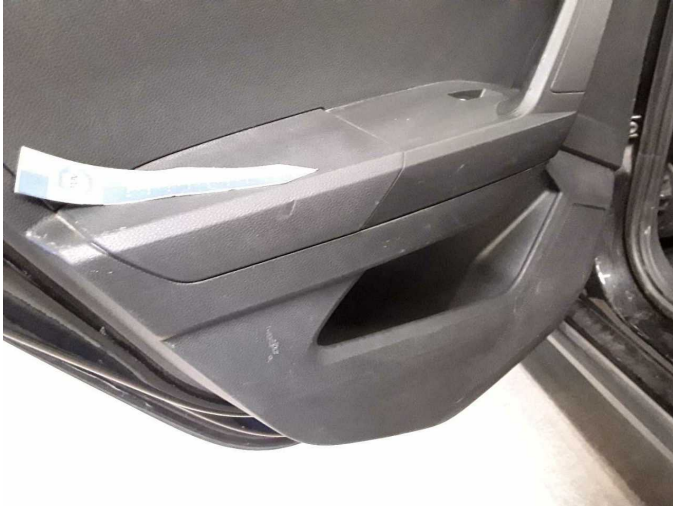
Damage 3: Trim / covers: Door trim - rear left side - Scratched - Smart repair

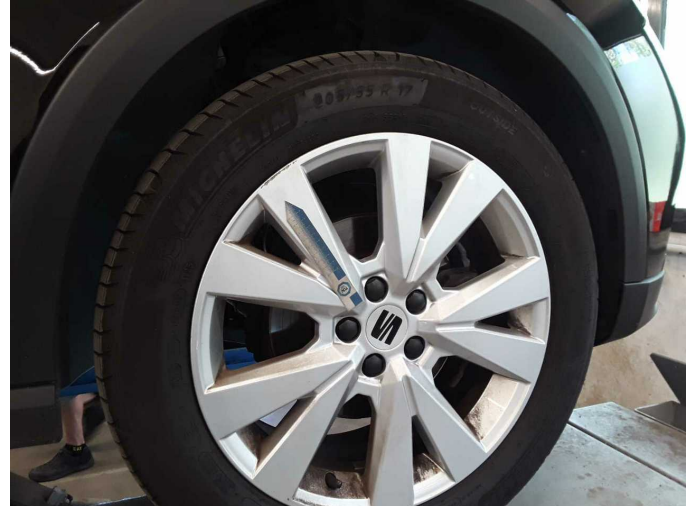
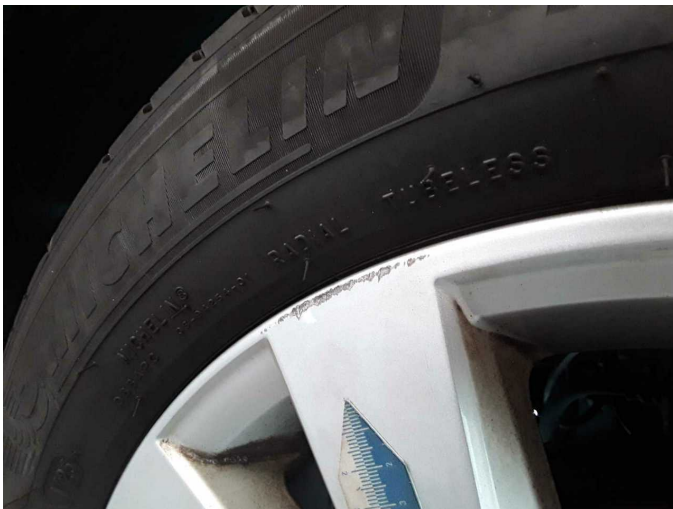
Damage 4: Wheel / tyres: Alloy rim - front right side - Scratch(es) - Smart repair

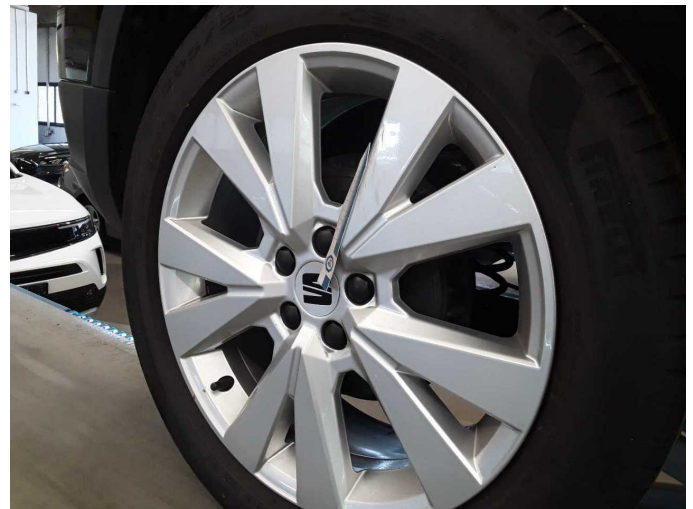
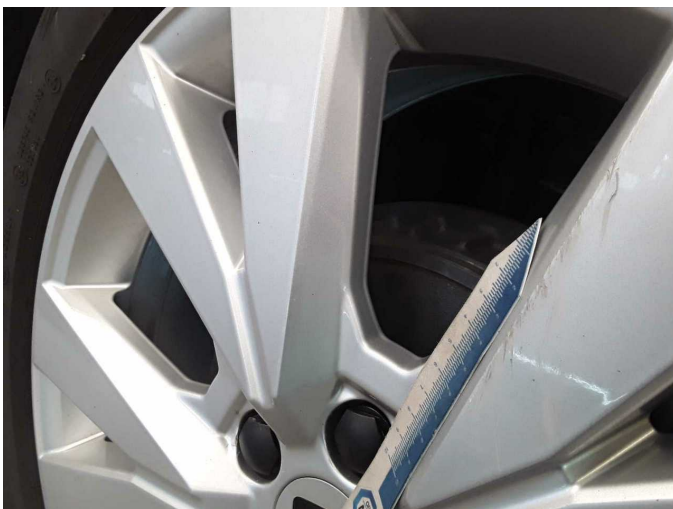
Damage 5: Wheel / tyres: Alloy rim - rear right side - Scratched - Smart repair

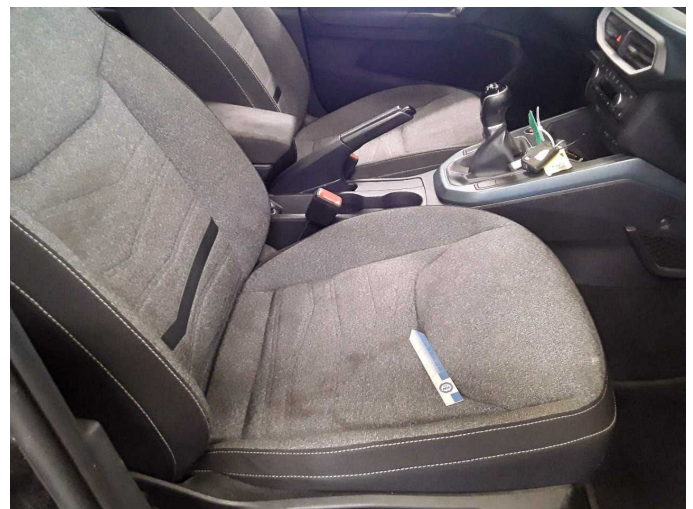
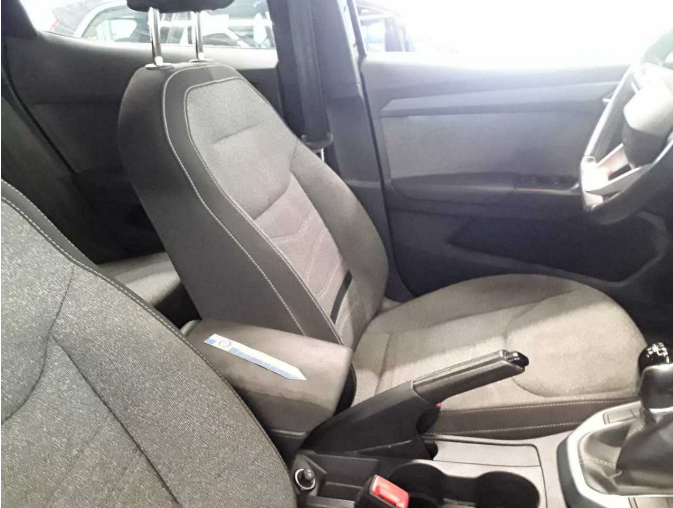
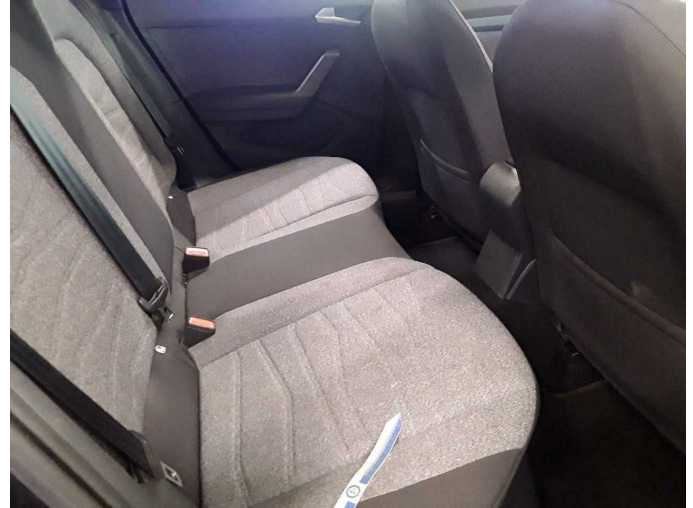
Damage 6: Interior: Interior - Soiled - Conditioning

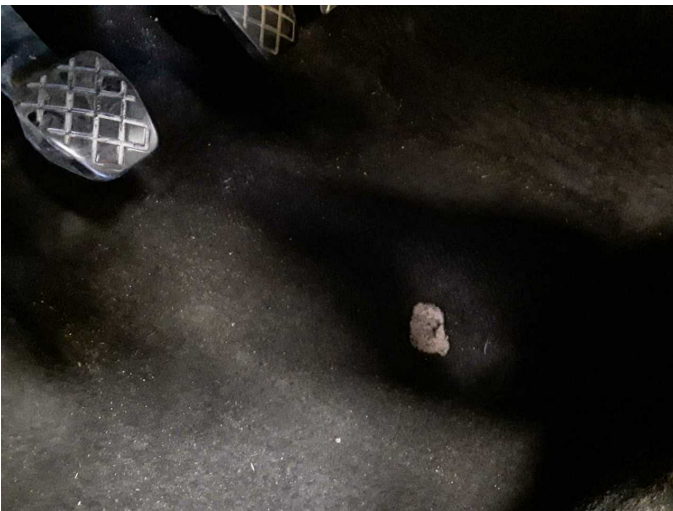
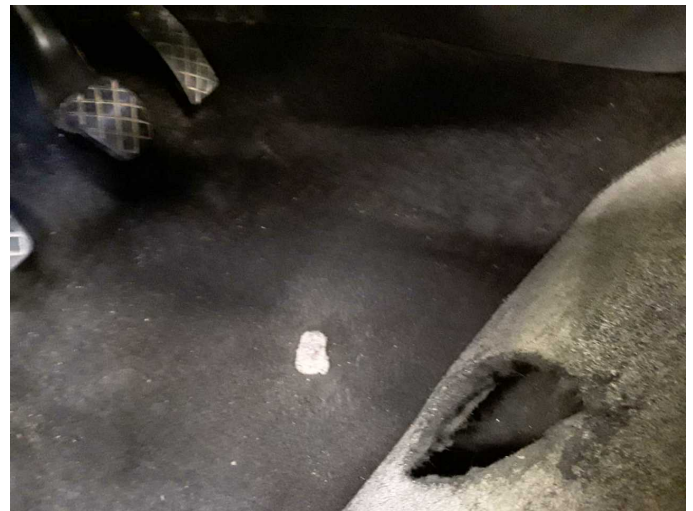
Damage 7: Trim / covers: Carpet - front left side - Damaged - Smart repair

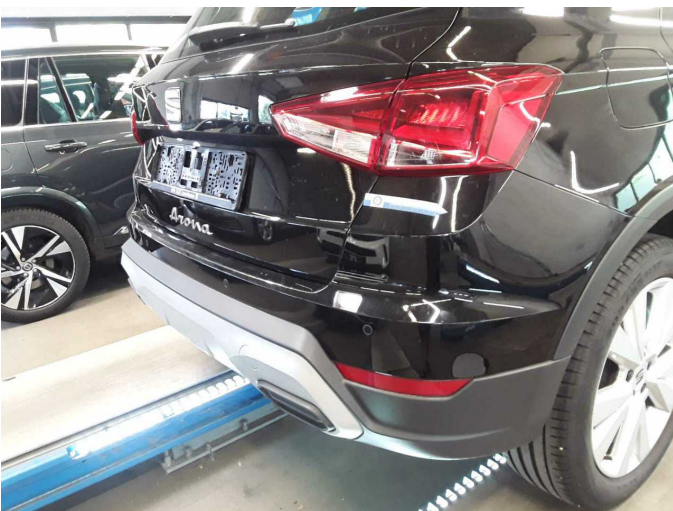
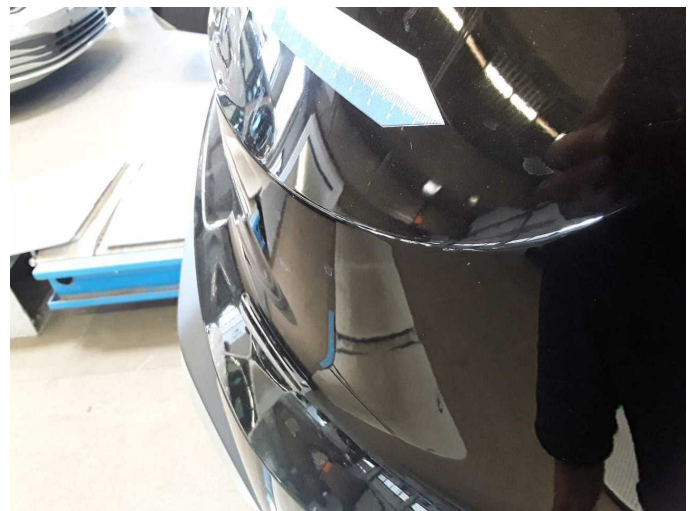
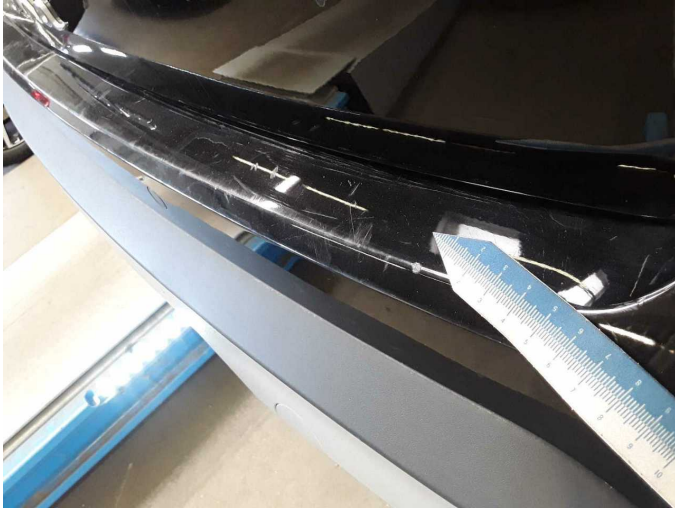
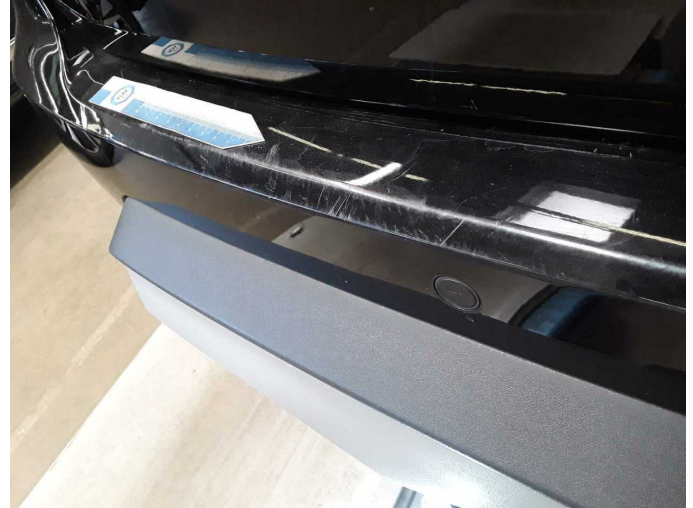
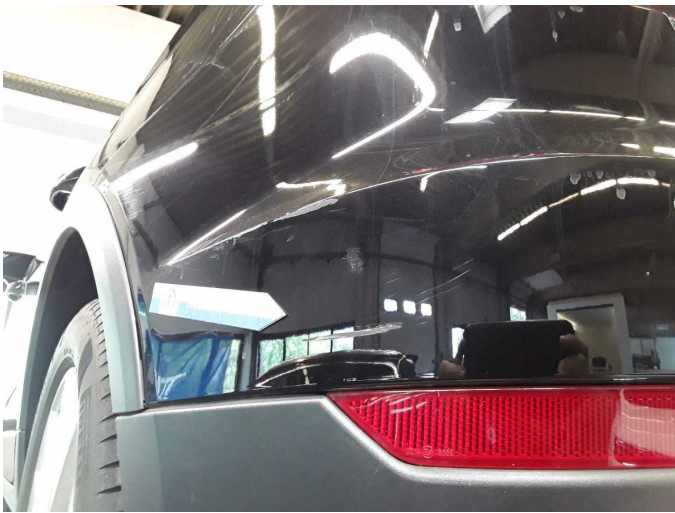
Damage 8: Rear bumper: Rear bumper - Scratch(es) - Paint

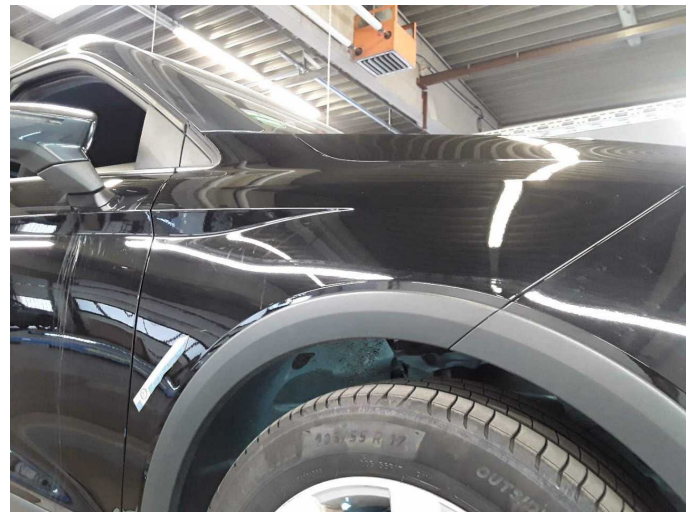
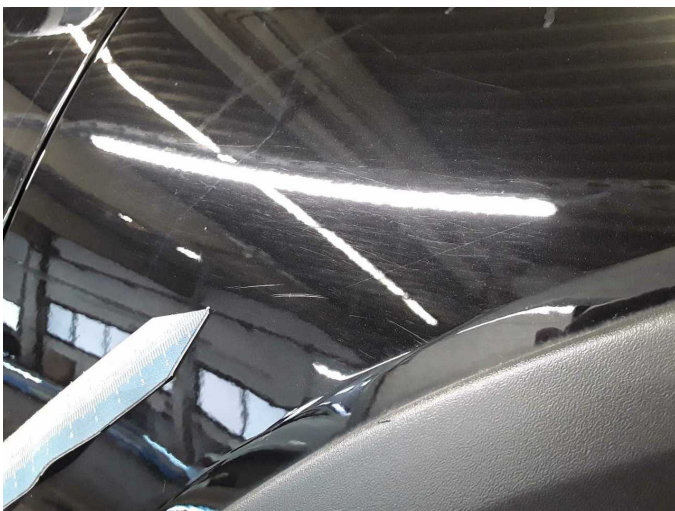
Damage 9: Mudguard - right side: Mudguard - right side - Scratch(es) - Paint

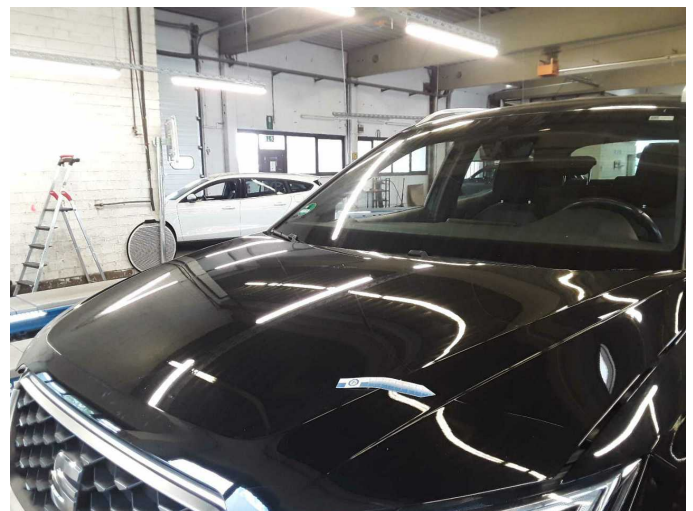
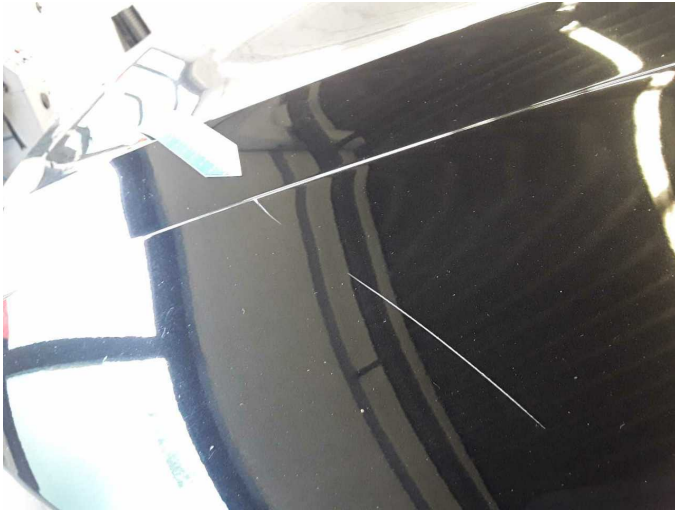
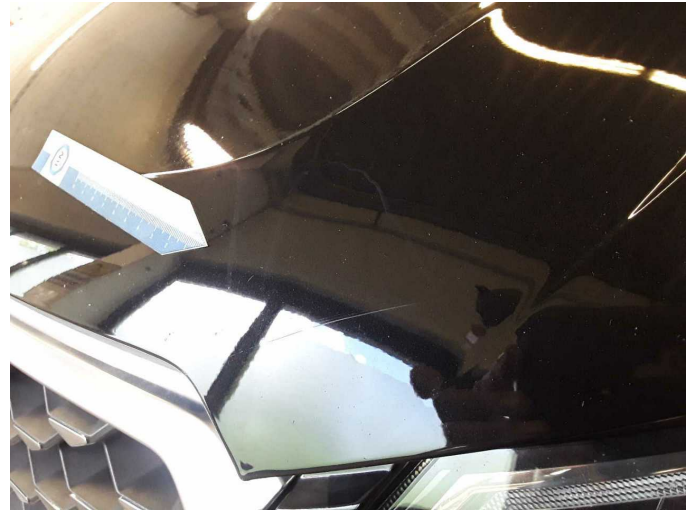
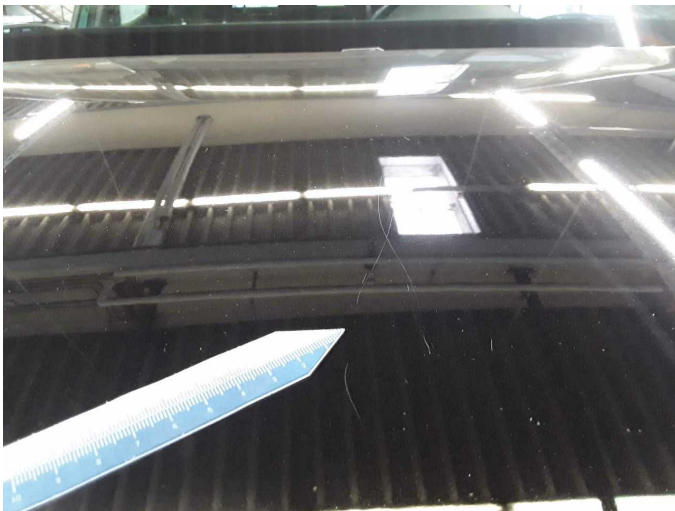
Damage 10: Bonnet: Bonnet - Scratch(es) - Paint

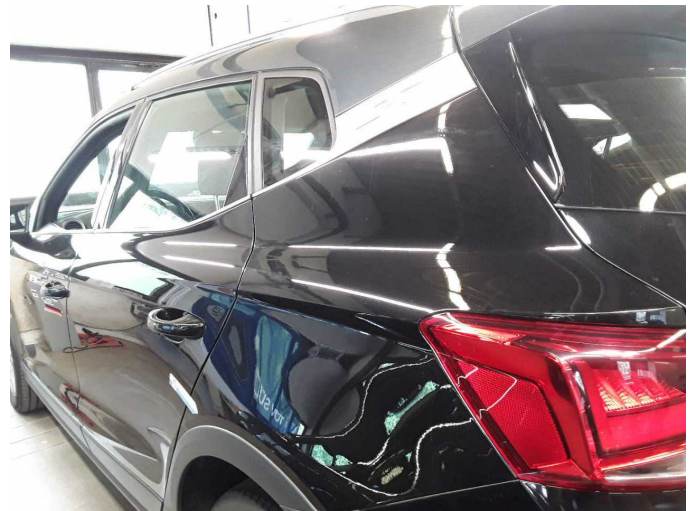
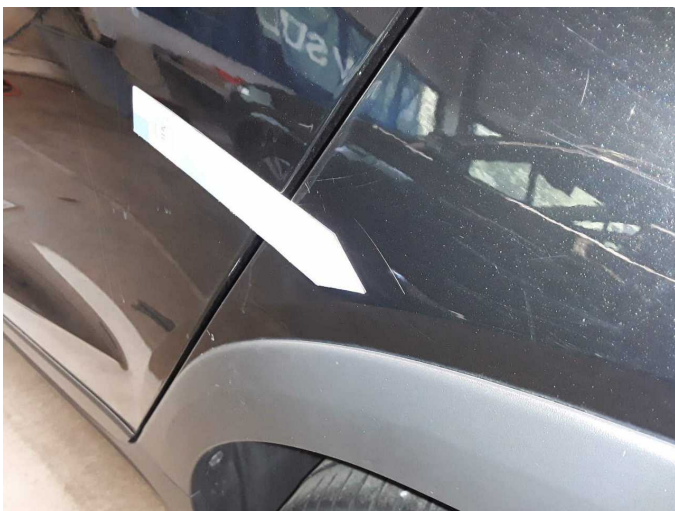
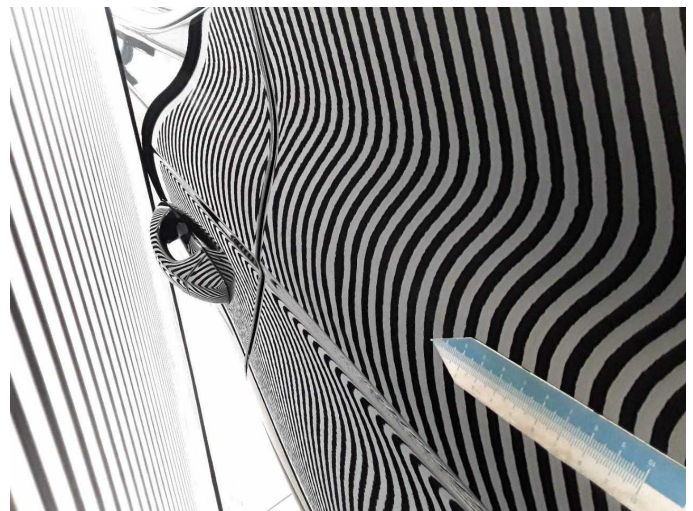
Damage 11: Side panel - rear left side: Side panel - Dent / paintcoat damage - Repair and paint

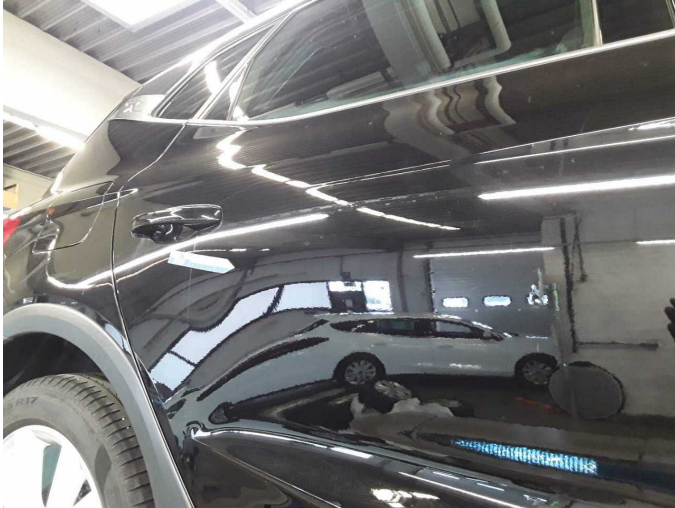
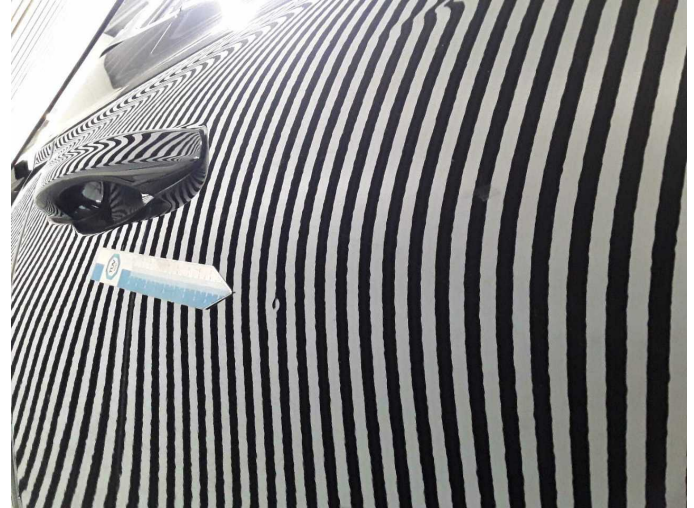
Wear and tear 2: Door - rear right side: Door - dent(s) - Smooth repair work

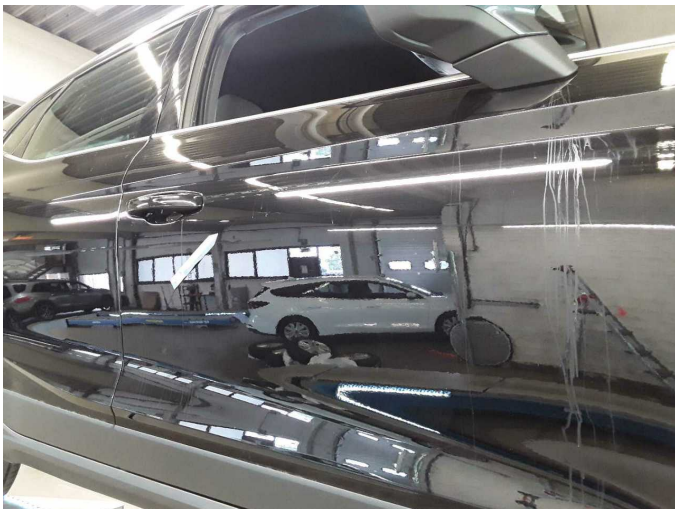
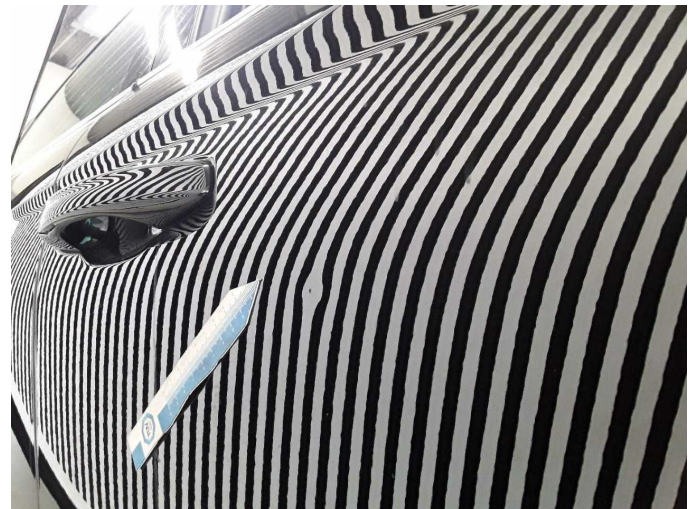
Wear and tear 3: Door - front right side: Door - dent(s) - Smooth repair work

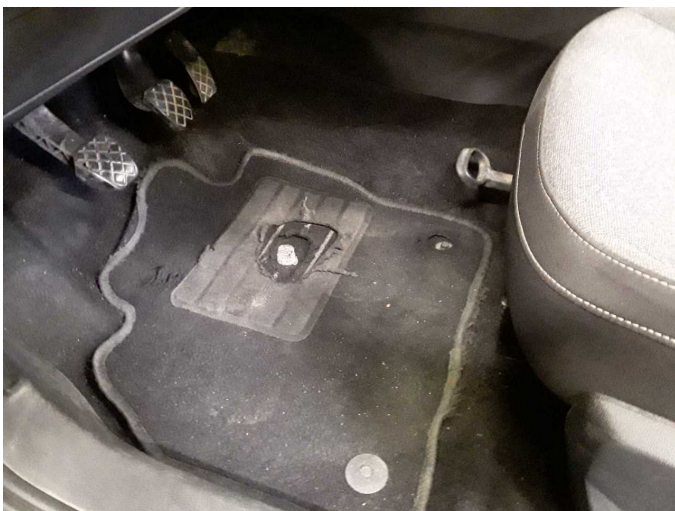
Wear and tear 4: Trim / covers: Floor mats - Worn - No deduction
