Expertise

Protocol number: 46249823  
Order No. / Reference: 26566147  
Inspection date: 30 Jun 2026

Manufacturer: Opel

Model: Combo Cargo 1.5 D EHZ Edition

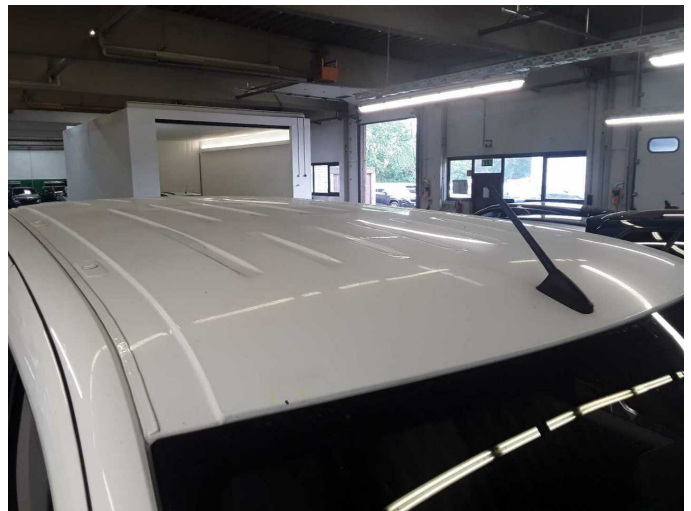
| No. | Component group | Description |
|---|---|---|
| 1 | Roof | Roof - Stone chips - Smart repair |

Damage 1: Roof: Roof - Stone chips - Smart repair

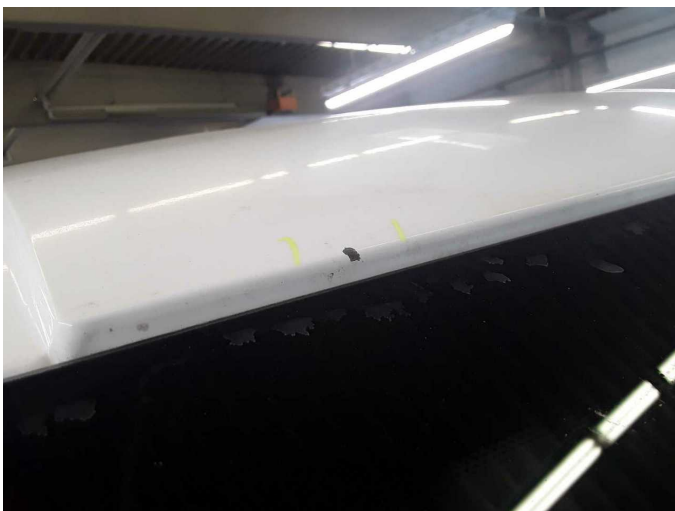
Damage 1: Roof: Roof - Stone chips - Smart repair

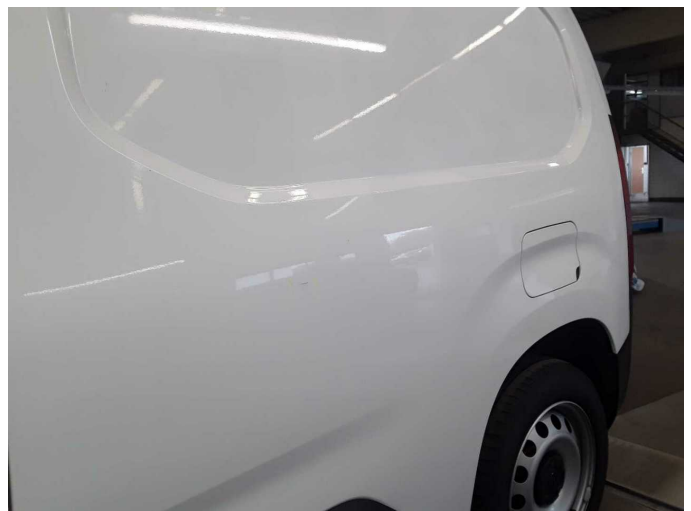
| No. | Component group | Description |
|---|---|---|
| 2 | Side panel - rear left side | Side panel - Scratch(es) - Smart repair |

Damage 2: Side panel - rear left side: Side panel - Scratch(es) - Smart repair

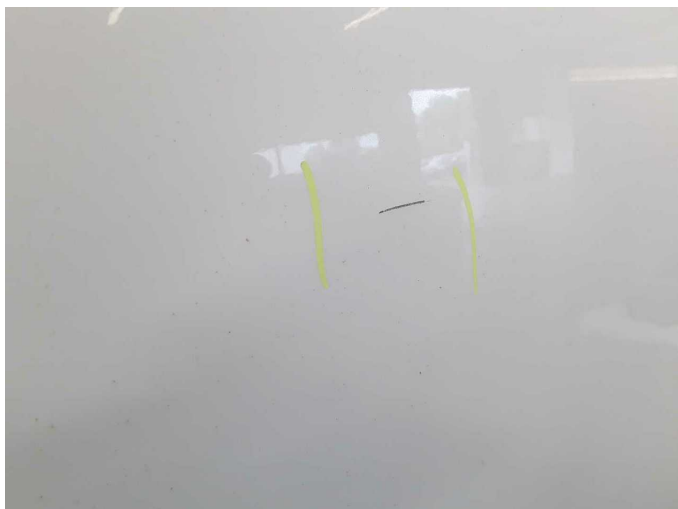
**Damage 2:** Side panel - rear left side: Side panel - Scratch(es) - Smart repair

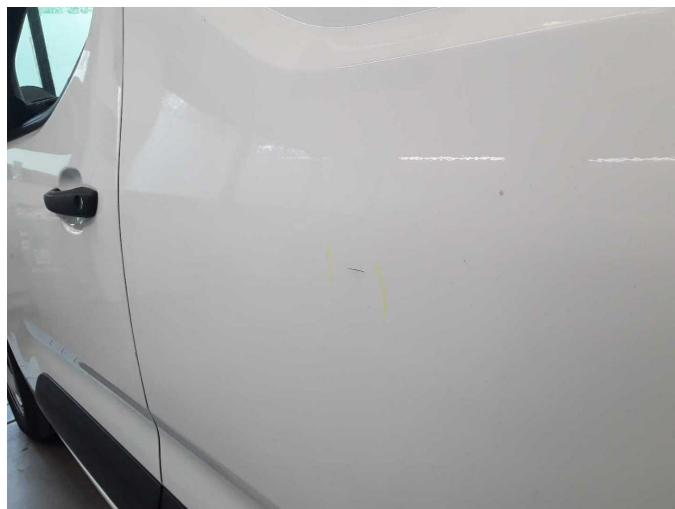
**Damage 2:** Side panel - rear left side: Side panel - Scratch(es) - Smart repair

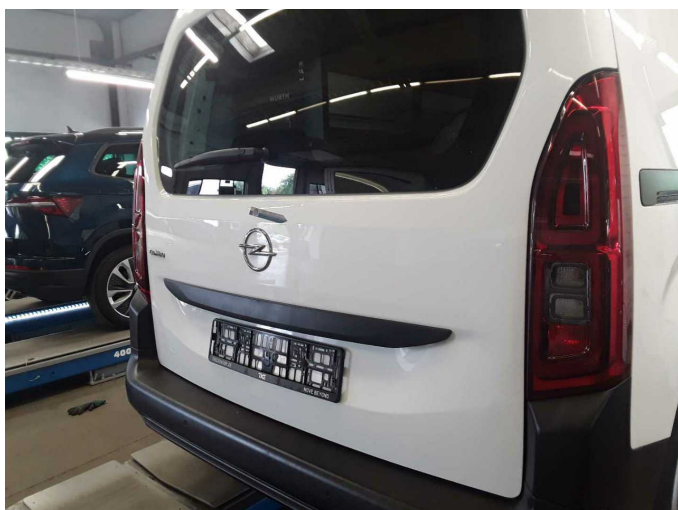
| No. | Component group | Description |
|---|---|---|
| 3 | Boot lid / rear door | Boot lid - dent(s) - Smooth repair work |

**Damage 3:** Boot lid / rear door: Boot lid - dent(s) - Smooth repair work

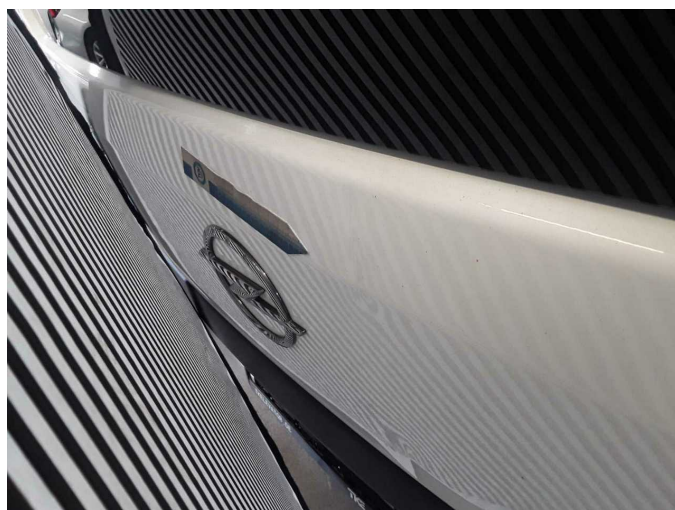
**Damage 3:** Boot lid / rear door: Boot lid - dent(s) - Smooth repair work

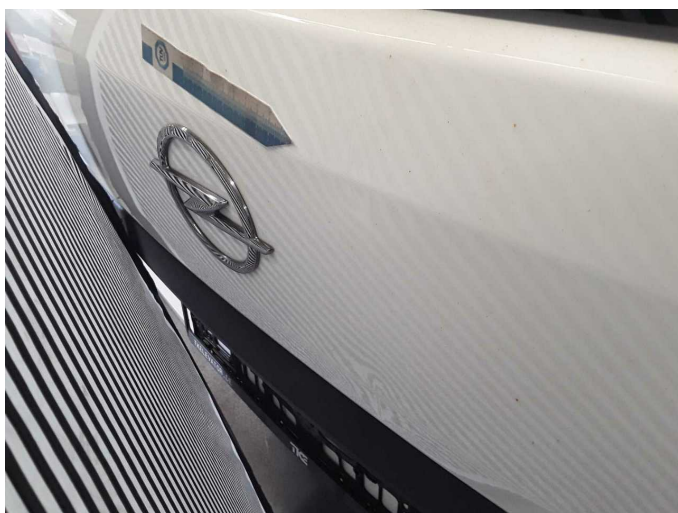
**Damage 3:** Boot lid / rear door: Boot lid - dent(s) - Smooth repair work

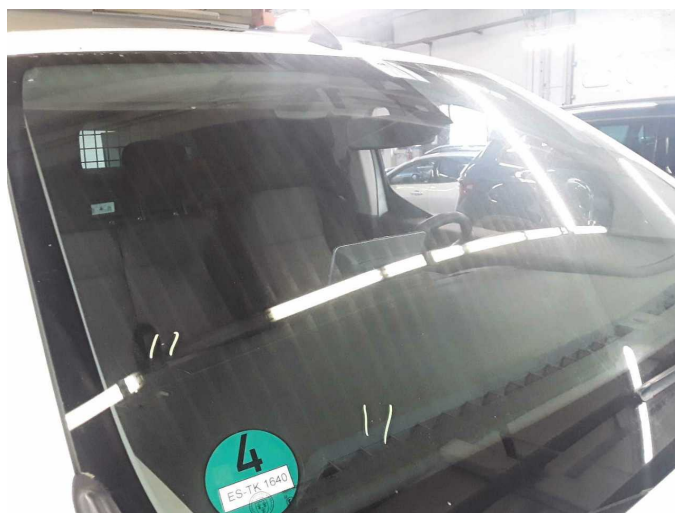
| No. | Component group | Description |
|---|---|---|
| 1 | Vehicle glazing | Windscreen - Stone chips - No deduction |

**Wear and tear 1:** Vehicle glazing: Windscreen - Stone chips - No deduction

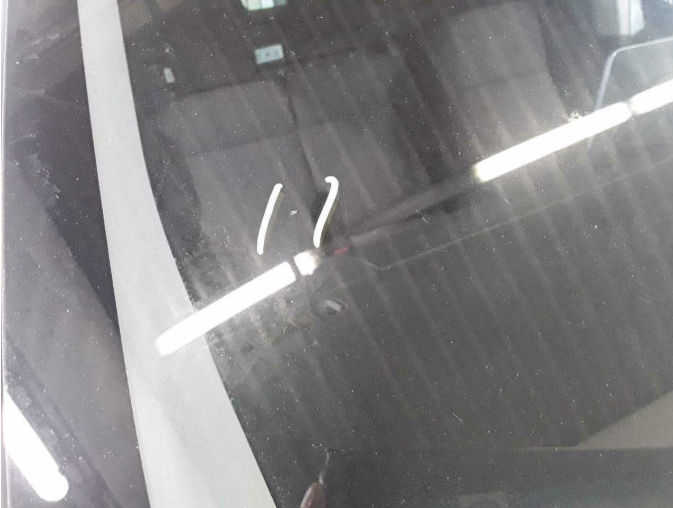
**Wear and tear 1:** Vehicle glazing: Windscreen - Stone chips - No deduction

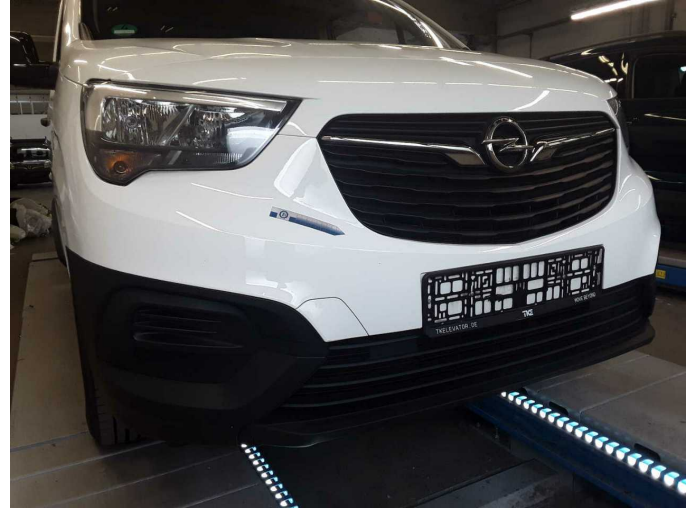
| No. | Component group | Description |
|---|---|---|
| 2 | Front bumper | Front bumper - Stone chips - No deduction |

**Wear and tear 2:** Front bumper: Front bumper - Stone chips - No deduction

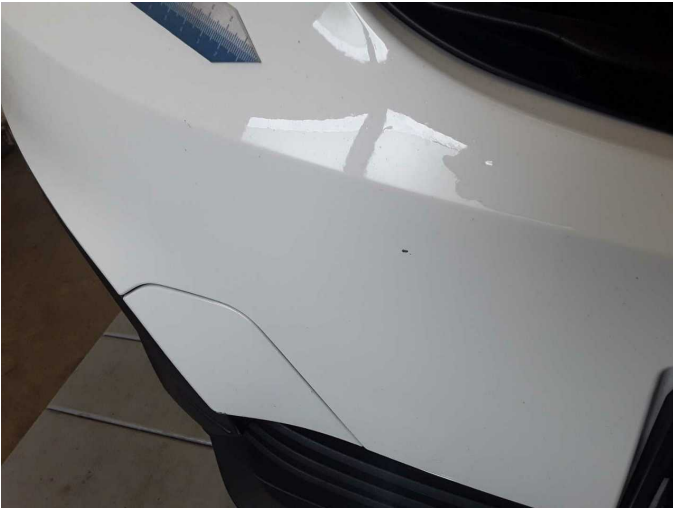
**Wear and tear 2:** Front bumper: Front bumper - Stone chips - No deduction
