Expertise

Protocol number: 45826322
Order No. / Reference: 26417361
Inspection date: 5 Jun 2026

Manufacturer: Renault

Model: Kangoo Rapid Blue dCi 75 Extra

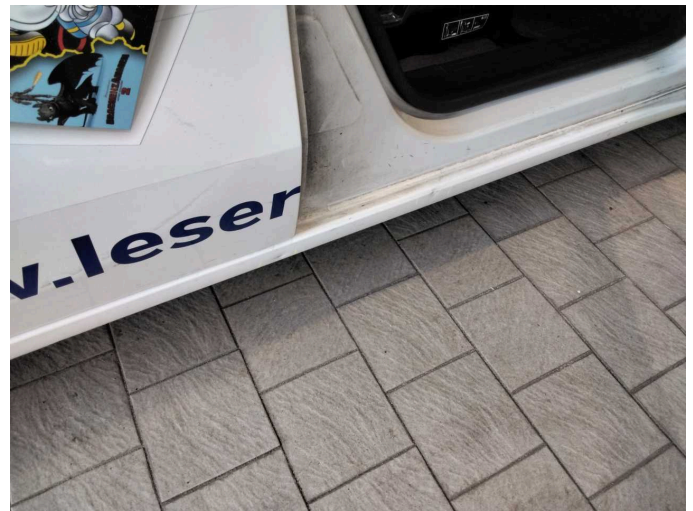
Damage 1: Sill - right side: Sill - dent(s) - Smooth repair work

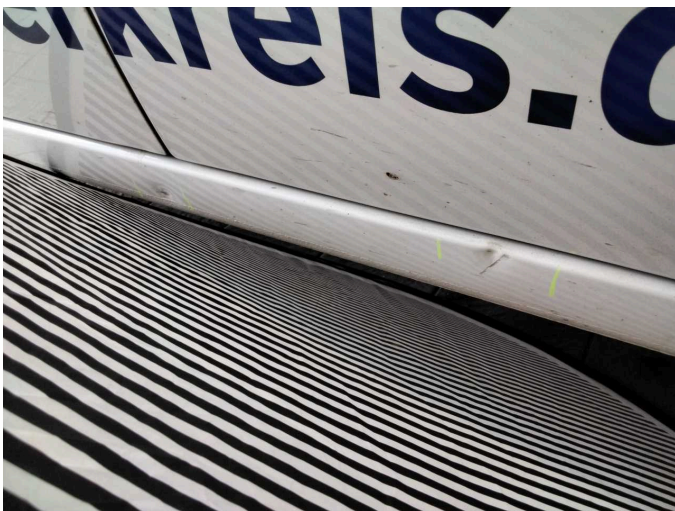
Damage 1: Sill - right side: Sill - dent(s) - Smooth repair work

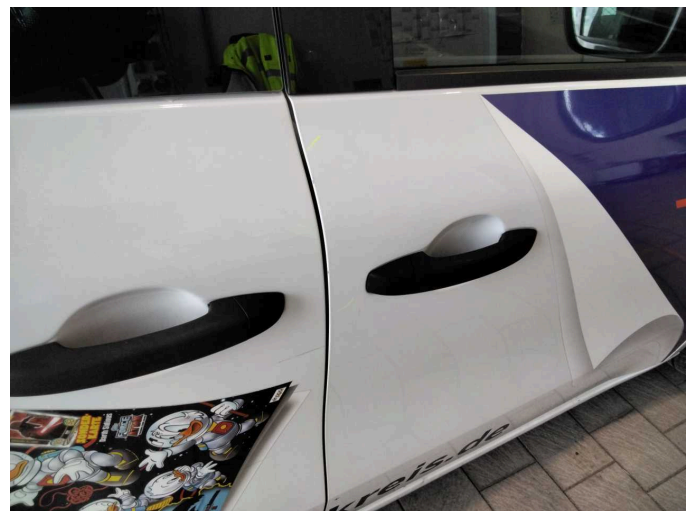
Damage 2: Door - front right side: Door edge - Scratch(es) - Smart repair

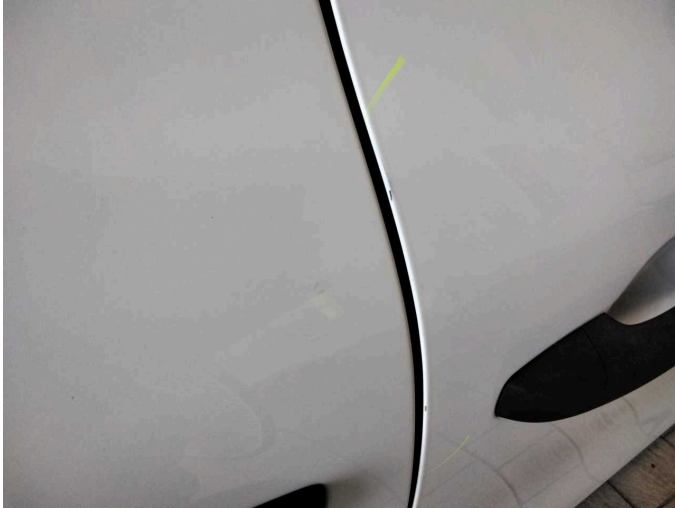
Damage 2: Door - front right side: Door edge - Scratch(es) - Smart repair

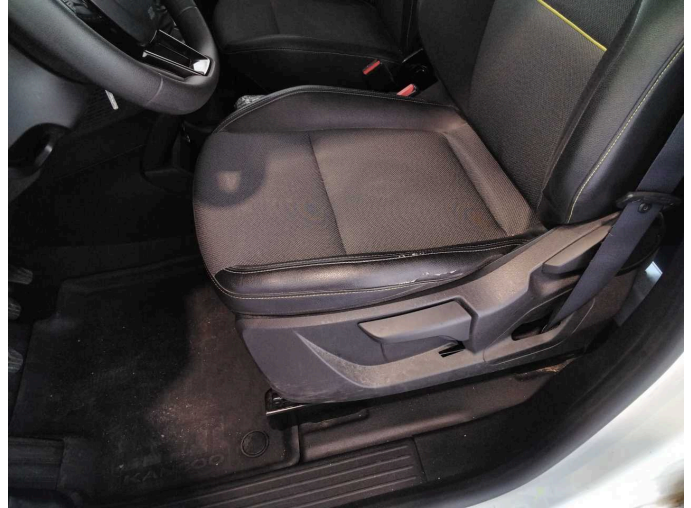
Damage 3: Seat - front: Seat cover - left side - Broken / torn - Smart repair

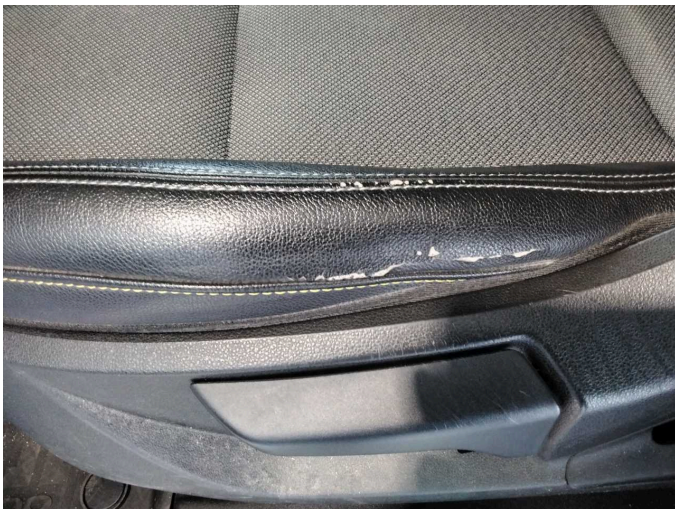
Damage 3: Seat - front: Seat cover - left side - Broken / torn - Smart repair

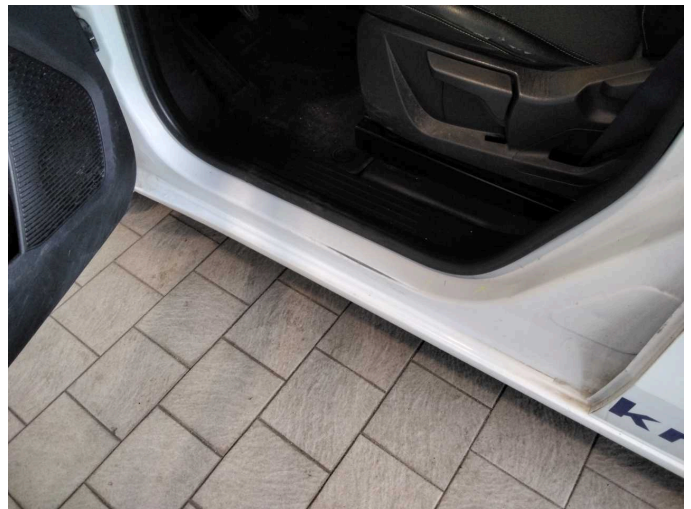
Damage 4: Sill - left side: Sill - Scratch(es) - Smart repair

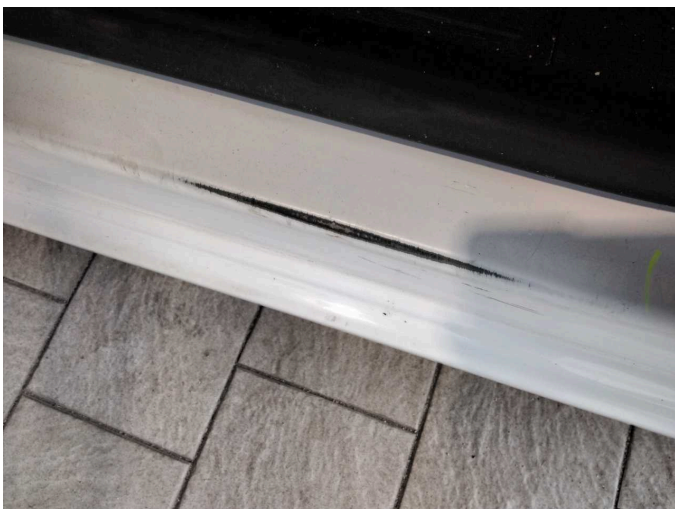
Damage 4: Sill - left side: Sill - Scratch(es) - Smart repair

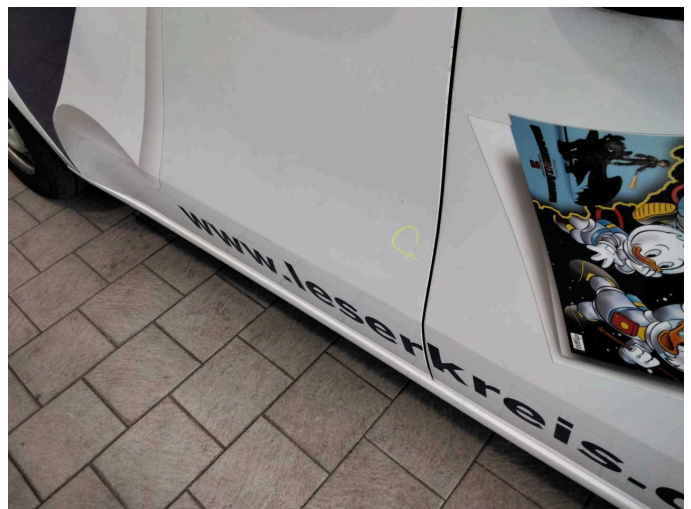
Damage 5: Door - front left side: Door - dent(s) - Smart repair

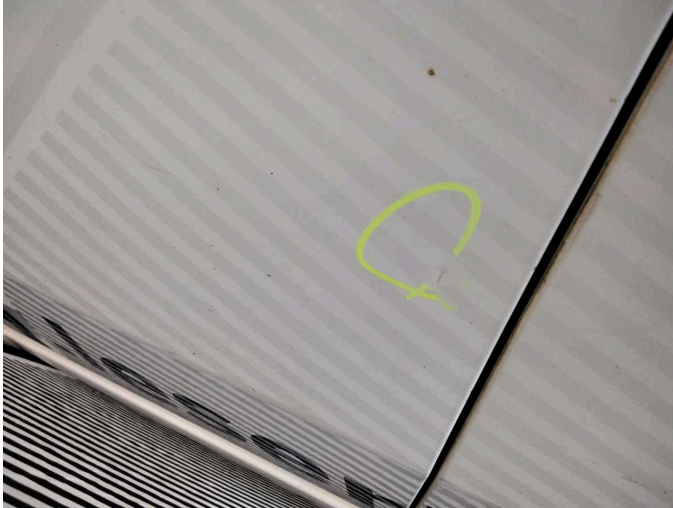
Damage 5: Door - front left side: Door - dent(s) - Smart repair

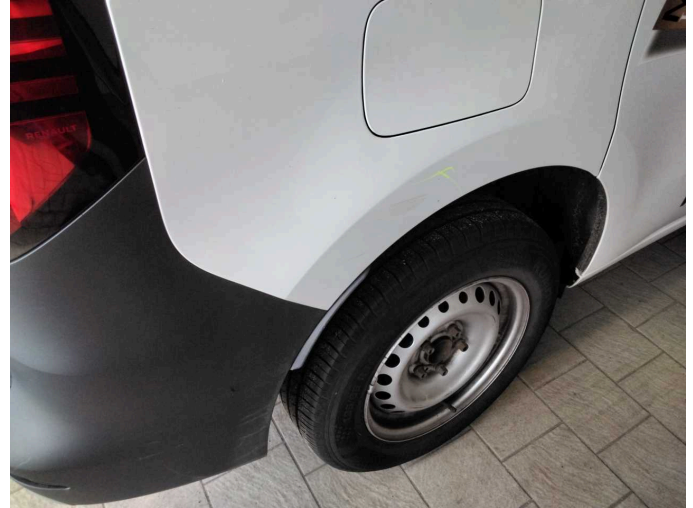
Damage 6: Side panel - rear right side: Side panel - Scratch(es) - Smart repair

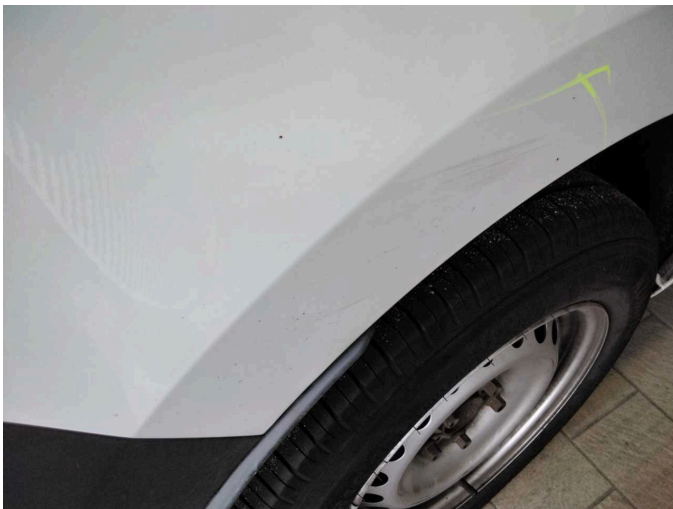
Damage 6: Side panel - rear right side: Side panel - Scratch(es) - Smart repair

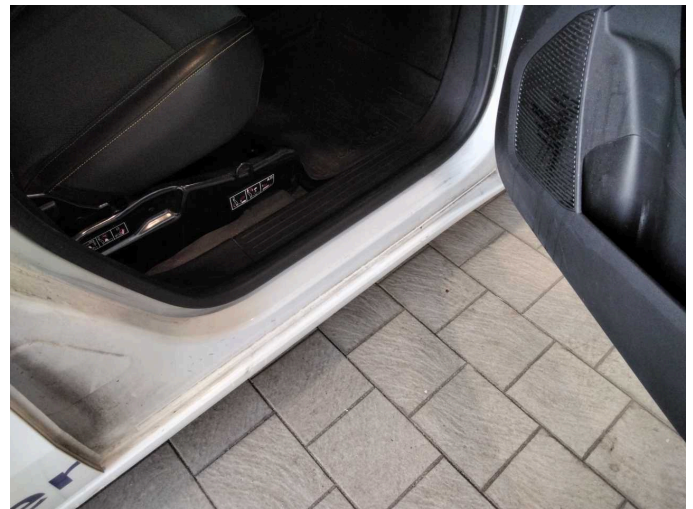
Damage 7: Sill - right side: Sill - Scratch(es) - Smart repair

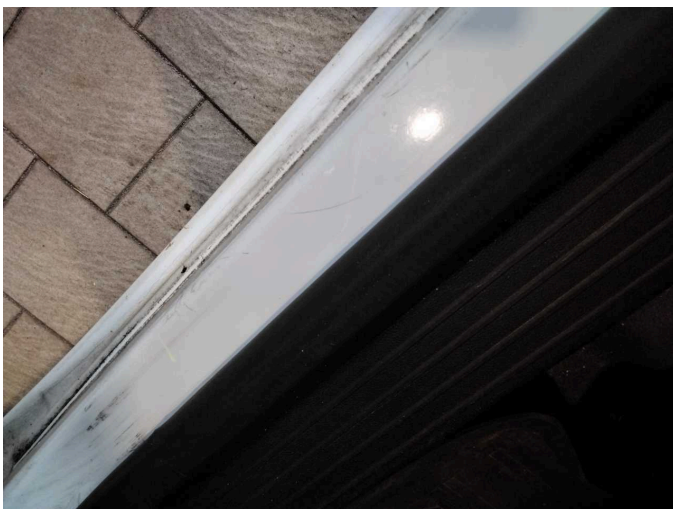
Damage 7: Sill - right side: Sill - Scratch(es) - Smart repair

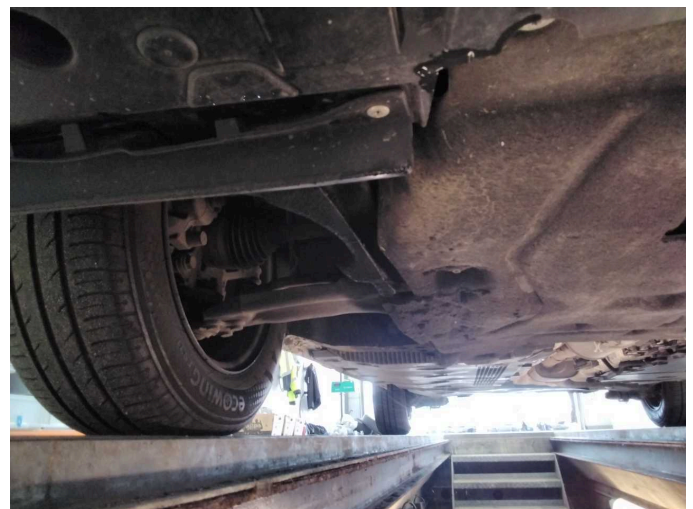
Damage 8: Body: Underbody panelling (Ölfeucht) - Perform diagnosis

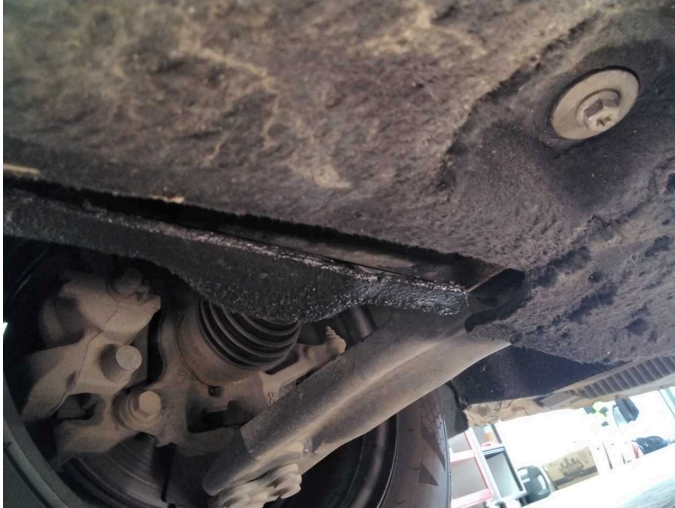
Damage 8: Body: Underbody panelling (Ölfeucht) - Perform diagnosis

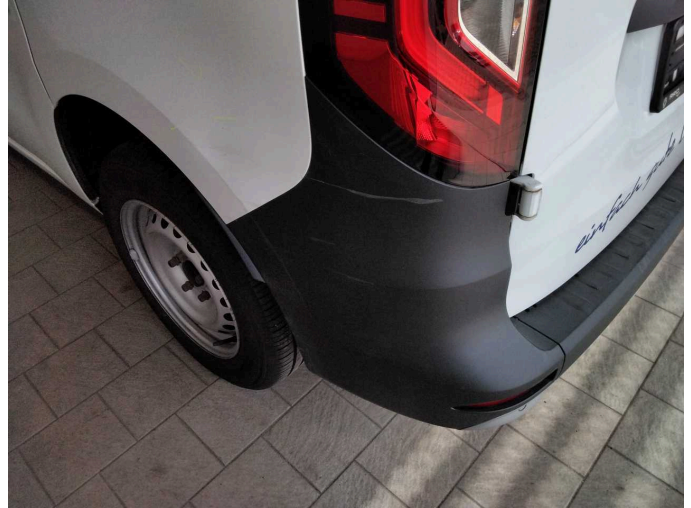
Damage 9: Rear bumper: Rear bumper - Scratch(es) - Loss in value

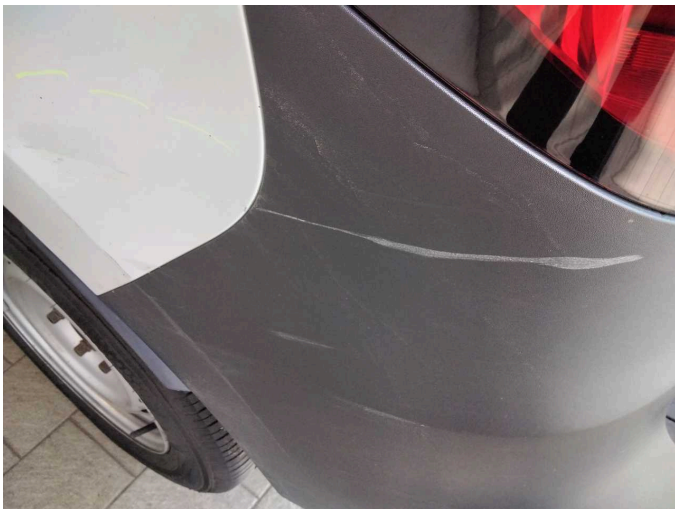
Damage 9: Rear bumper: Rear bumper - Scratch(es) - Loss in value

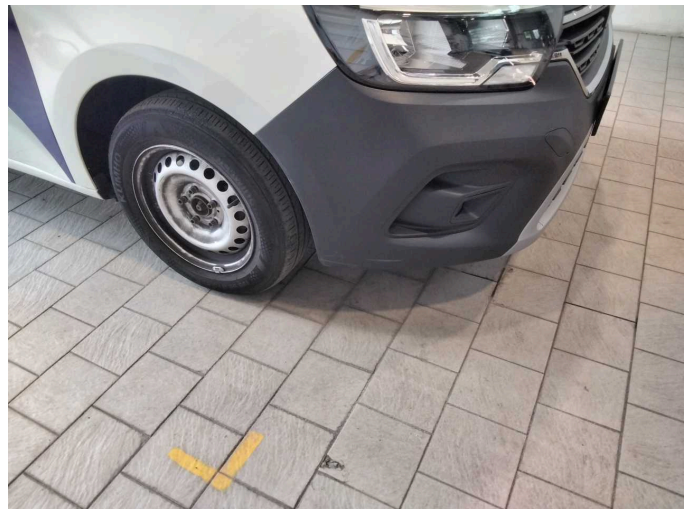
Damage 10: Front bumper: Front bumper - Scratch(es) - Loss in value

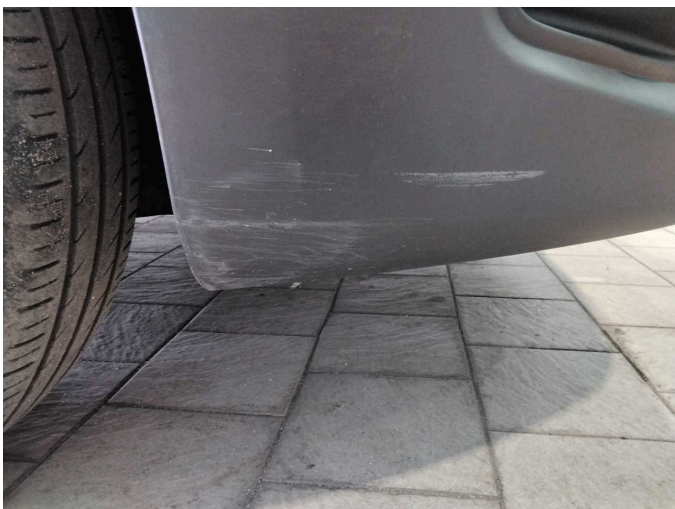
Damage 10: Front bumper: Front bumper - Scratch(es) - Loss in value

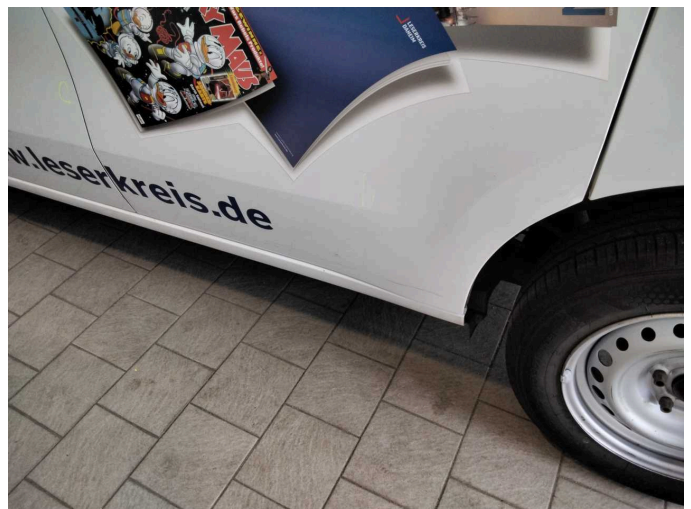
Damage 11: Sliding door - left side: Sliding door with glass panel (Unterhalb) - Scratch(es) - Smart repair

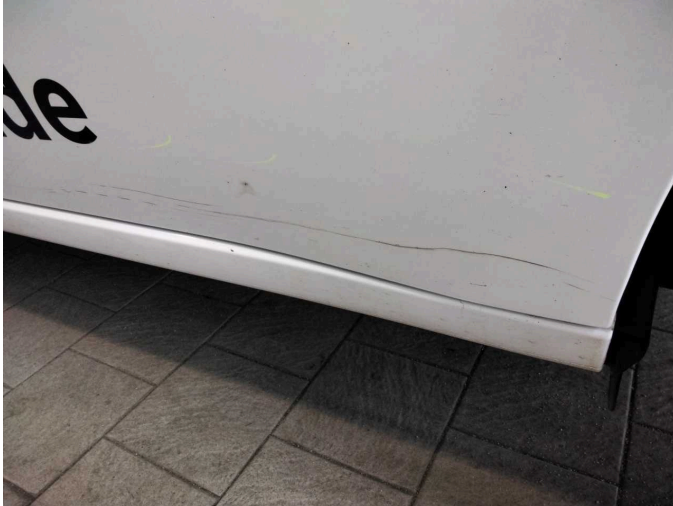
Damage 11: Sliding door - left side: Sliding door with glass panel (Unterhalb) - Scratch(es) - Smart repair

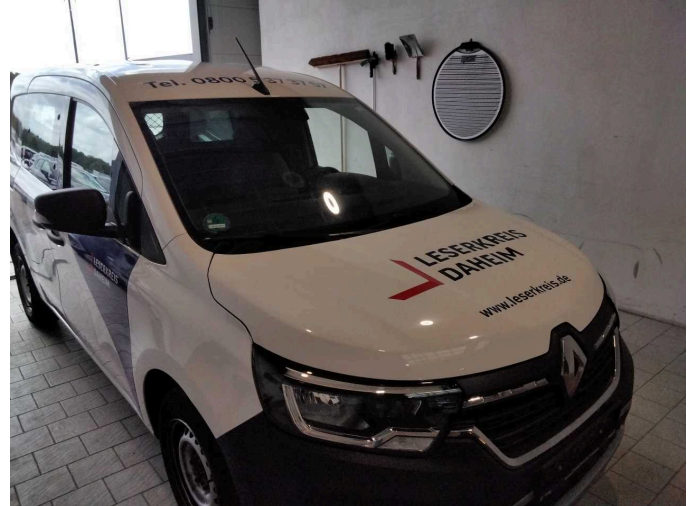
Damage 12: Body: Body - Glued / labelled - De-glug / neutralise

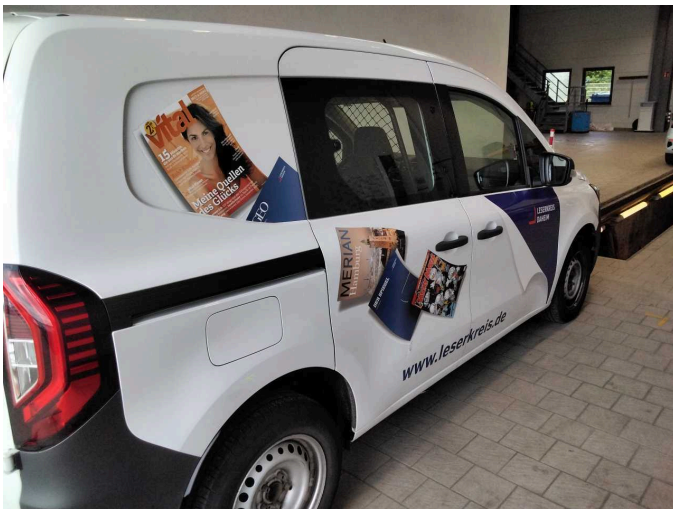
Damage 12: Body: Body - Glued / labelled - De-glug / neutralise

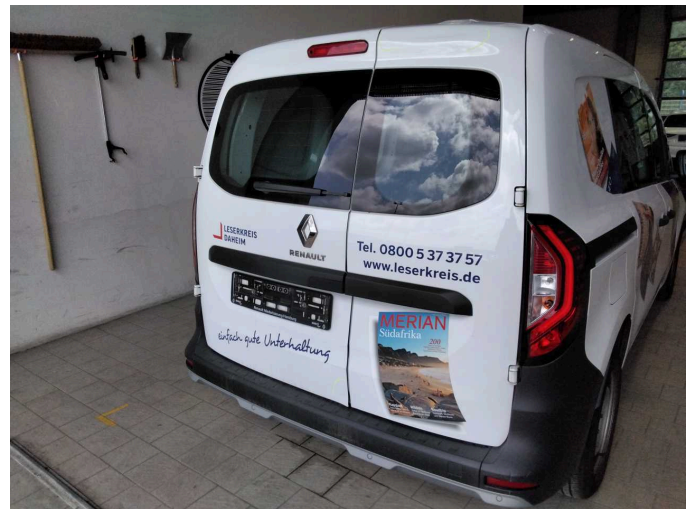
Damage 12: Body: Body - Glued / labelled - De-glug / neutralise

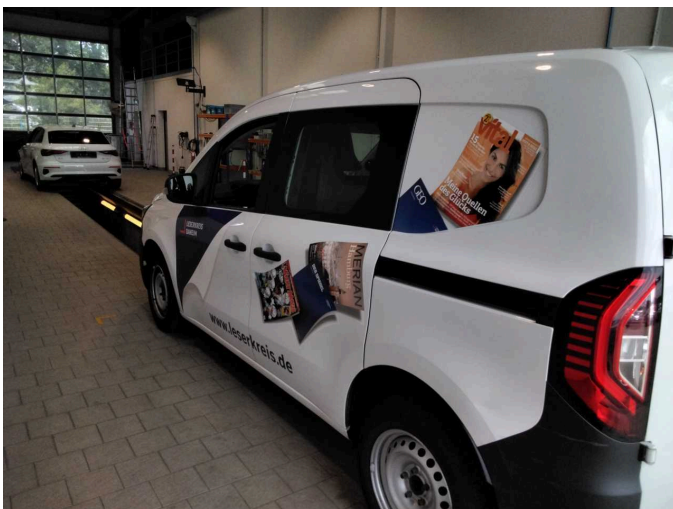
Damage 12: Body: Body - Glued / labelled - De-glug / neutralise

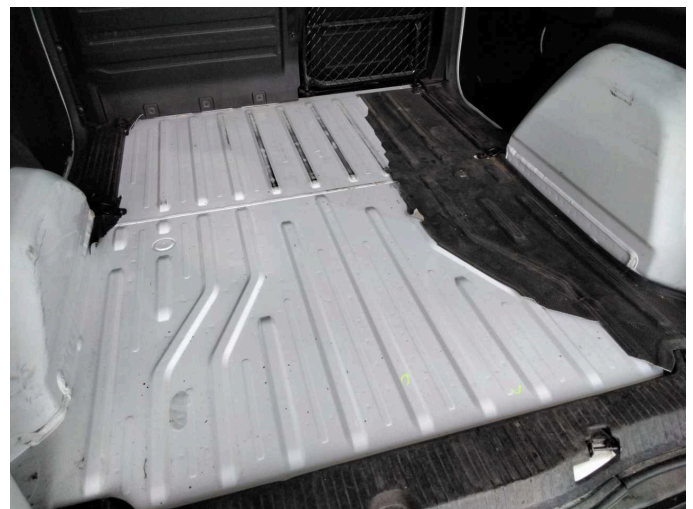
Damage 13: Rear of vehicle: Boot floor (Bodenbelag) - Broken / torn - Replace

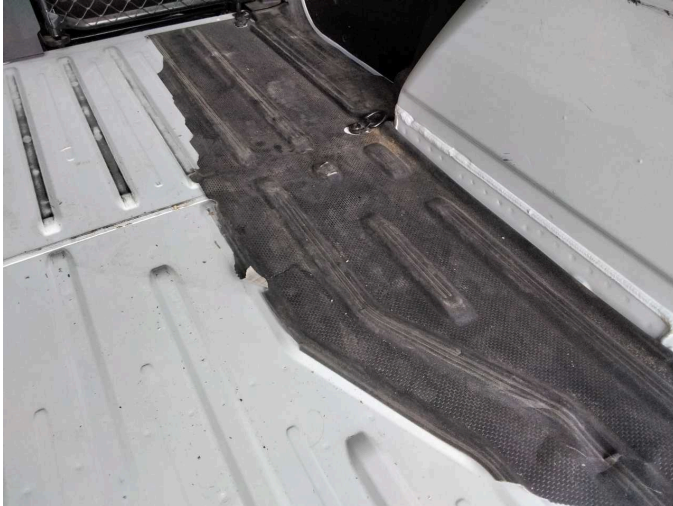
Damage 13: Rear of vehicle: Boot floor (Bodenbelag) - Broken / torn - Replace

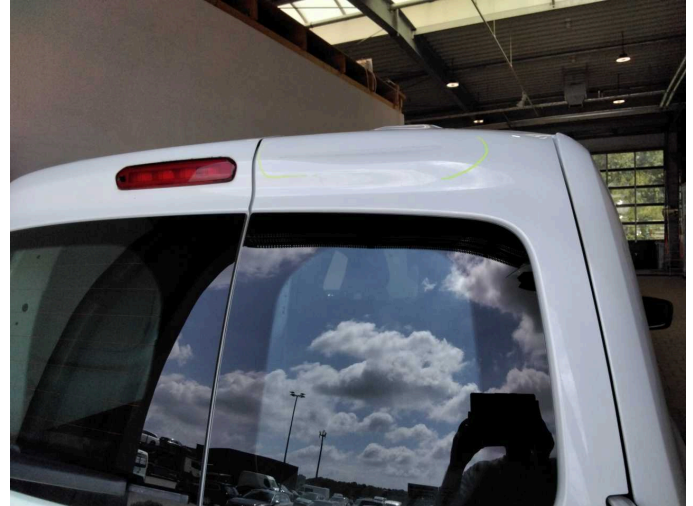
Damage 14: Boot lid / rear door: Rear door - right side - Dent / paintcoat damage - Repair and paint

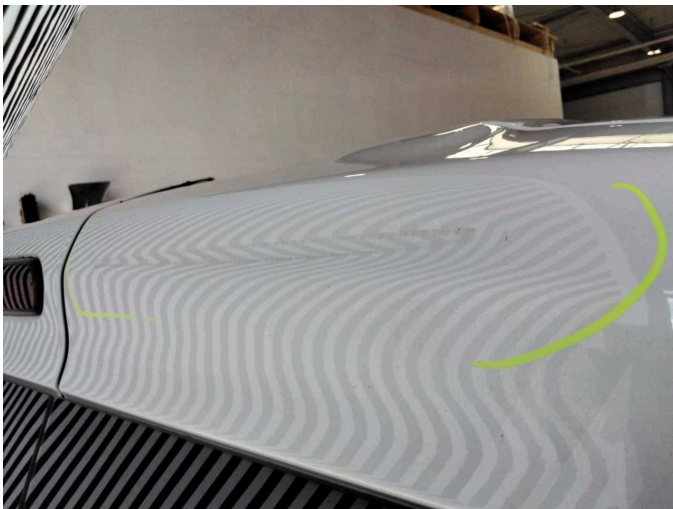
Damage 14: Boot lid / rear door: Rear door - right side - Dent / paintcoat damage - Repair and paint

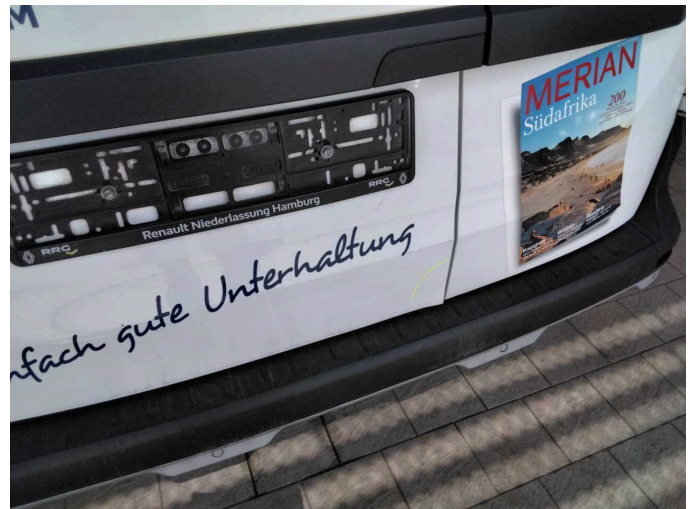
Damage 15: Boot lid / rear door: Rear door - left side - Deformed - Repair and paint

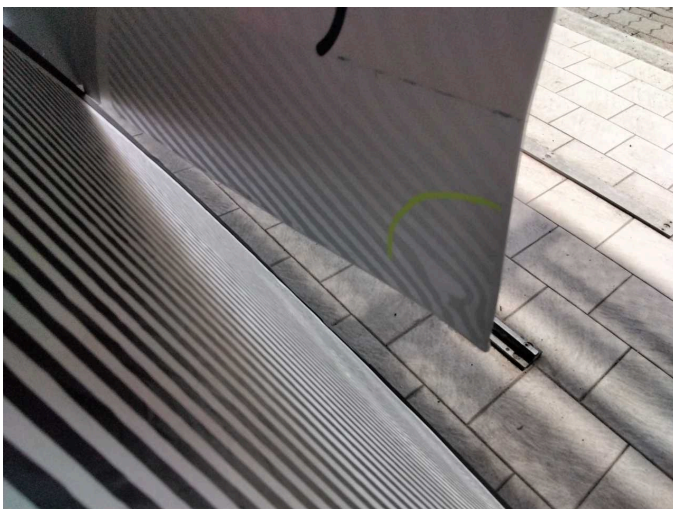
Damage 15: Boot lid / rear door: Rear door - left side - Deformed - Repair and paint

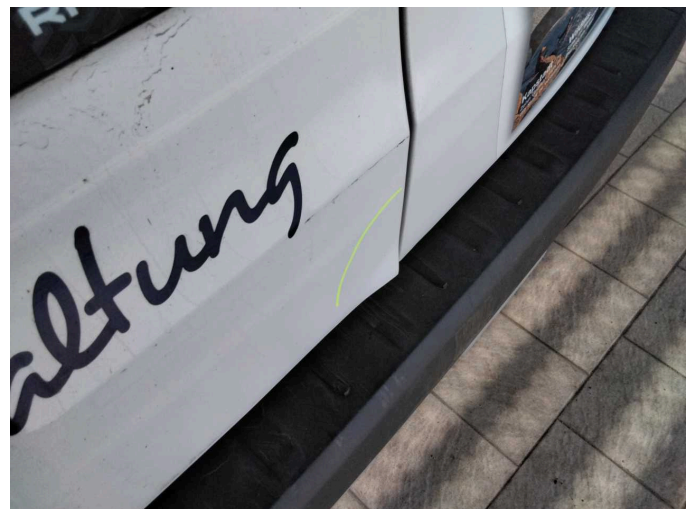
Damage 15: Boot lid / rear door: Rear door - left side - Deformed - Repair and paint

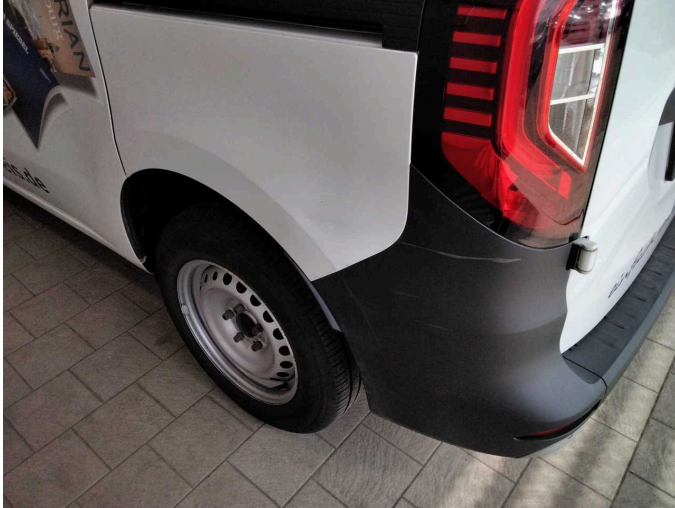
Damage 16: Side panel - rear left side: Side panel - Dent / paintcoat damage - Repair and paint

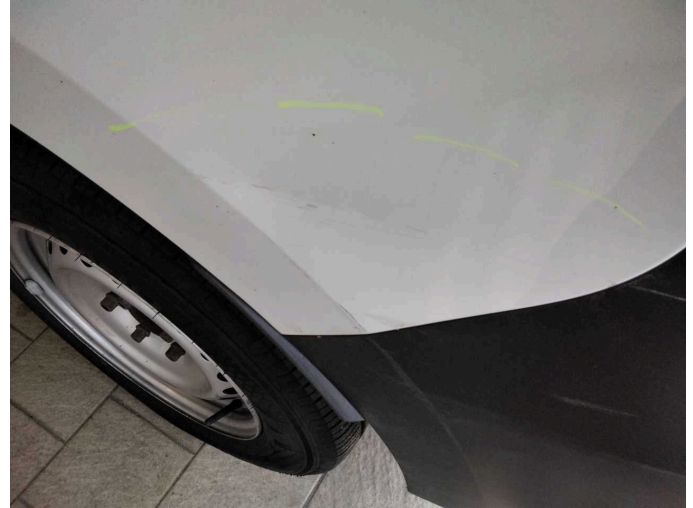
Damage 16: Side panel - rear left side: Side panel - Dent / paintcoat damage - Repair and paint

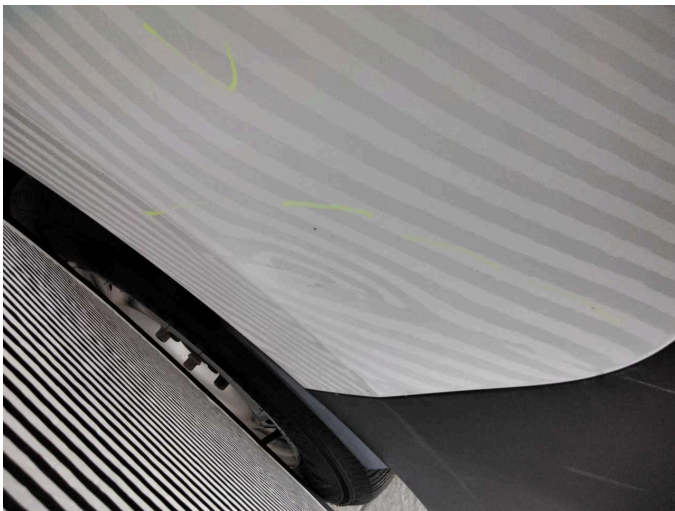
Damage 16: Side panel - rear left side: Side panel - Dent / paintcoat damage - Repair and paint

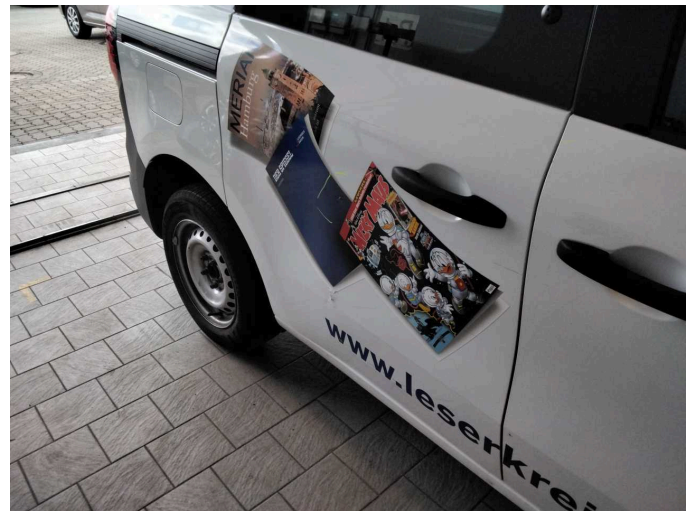
Damage 17: Sliding door, right: Sliding door with glass panel - Dent / paintcoat damage - Repair and paint

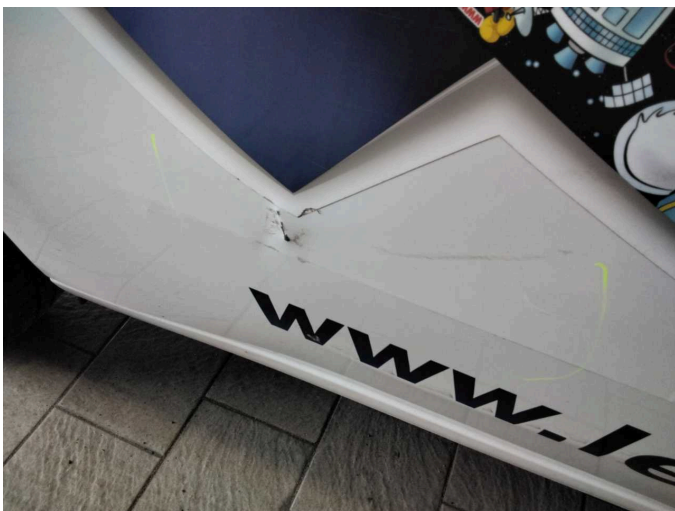
Damage 17: Sliding door, right: Sliding door with glass panel - Dent / paintcoat damage - Repair and paint

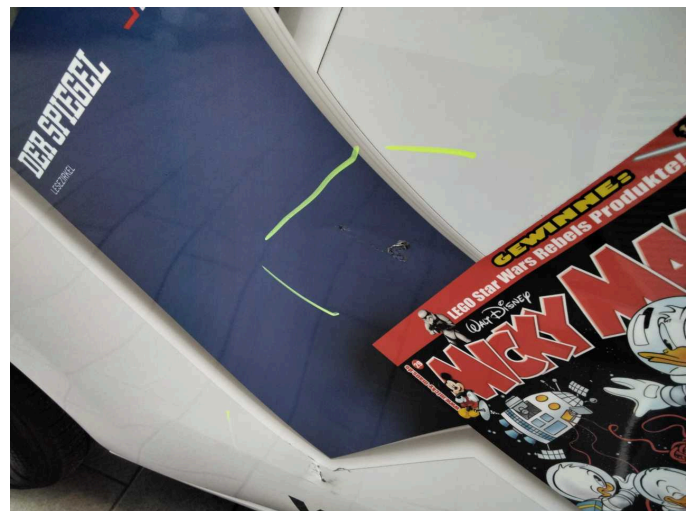
Damage 17: Sliding door, right: Sliding door with glass panel - Dent / paintcoat damage - Repair and paint

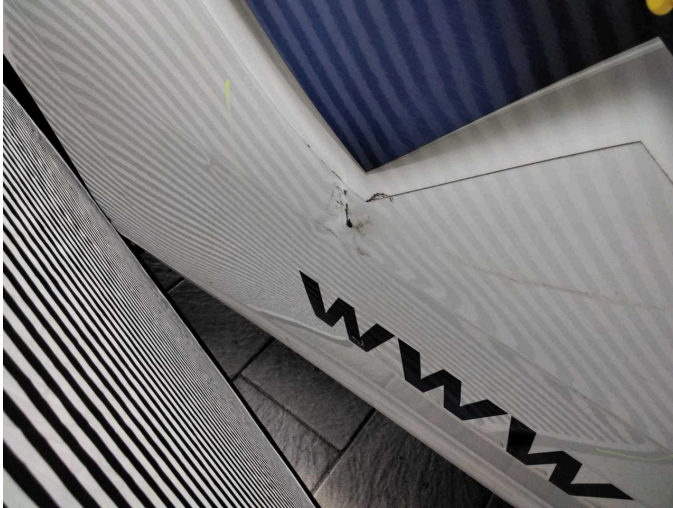
Damage 17: Sliding door, right: Sliding door with glass panel - Dent / paintcoat damage - Repair and paint

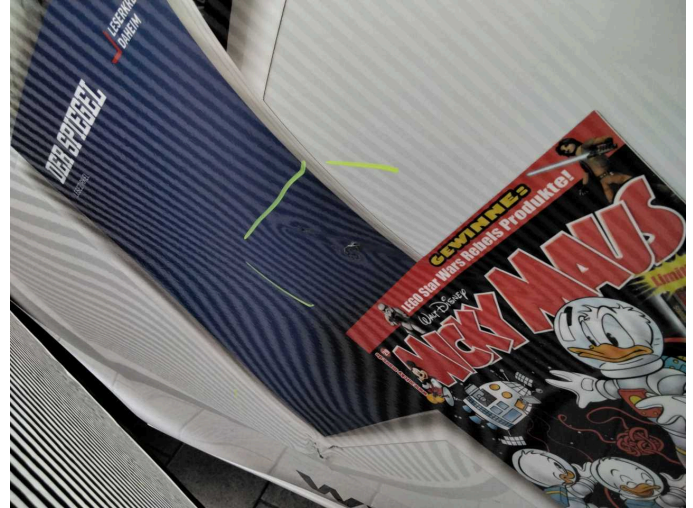
Damage 17: Sliding door, right: Sliding door with glass panel - Dent / paintcoat damage - Repair and paint

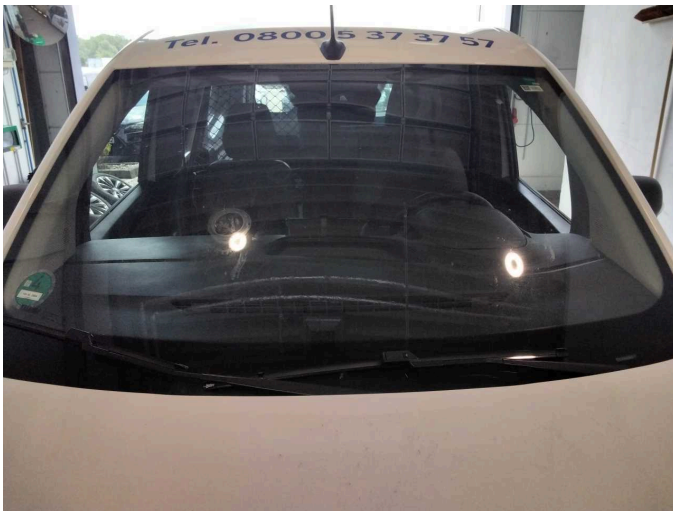
Wear and tear 1: Vehicle glazing: Windscreen - Stone chips - No deduction

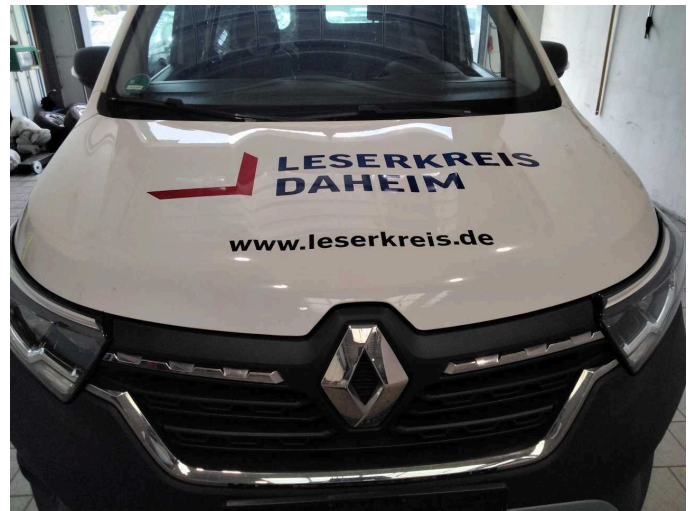
Wear and tear 2: Bonnet: Bonnet - Stone chips - No deduction
