Expertise

Protocol number: 46842028  
Order No. / Reference: 26594837  
Inspection date: 3 Aug 2026

| Manufacturer: Opel | Model: Astra Sports Tourer 1.5 D Automatik Business Elegance |
| VIN: VXXKFCYHZTP1100723 | |

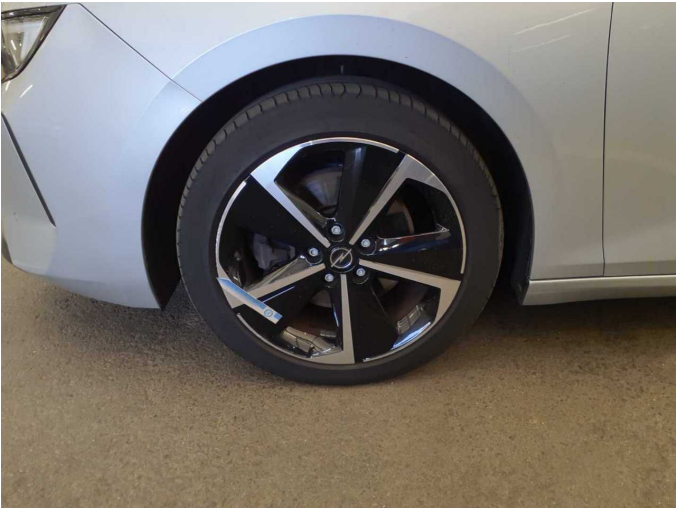
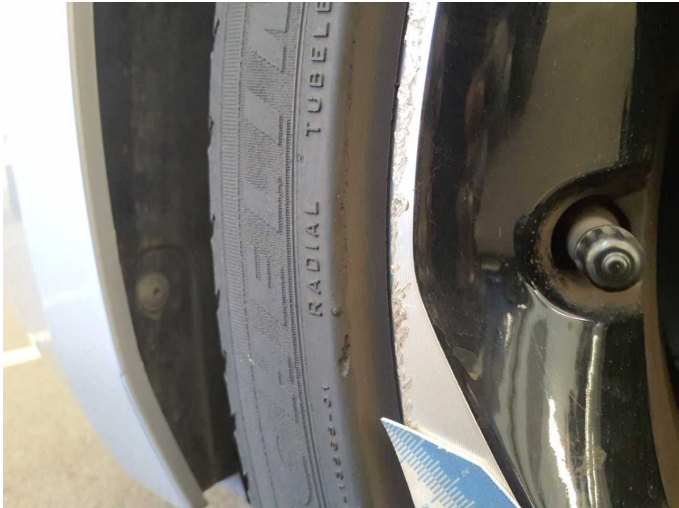
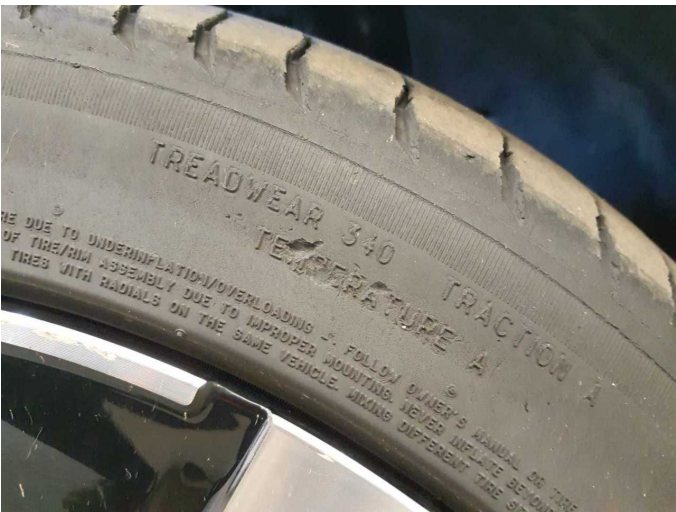
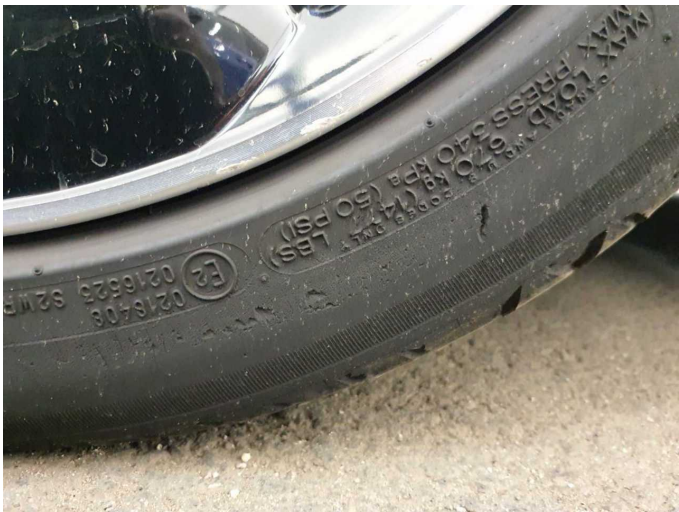
| No. | Component group | Description |
|---|---|---|
| 1 | Wheel / tyres | Tyre - front left side - Broken / torn - Replace |

Damage 1: Wheel / tyres: Tyre - front left side - Broken / torn - Replace

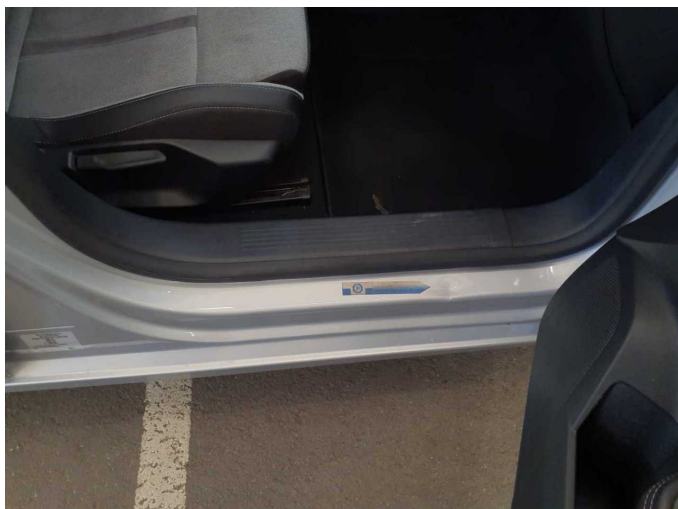
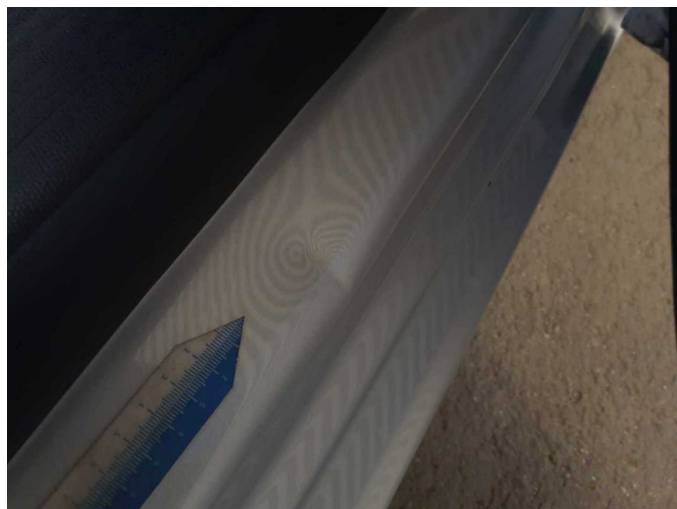
| No. | Component group | Description |
|---|---|---|
| 2 | Sill - right side | Sill - dent(s) - Smart repair |

**Damage 2:** Sill - right side: Sill - dent(s) - Smart repair

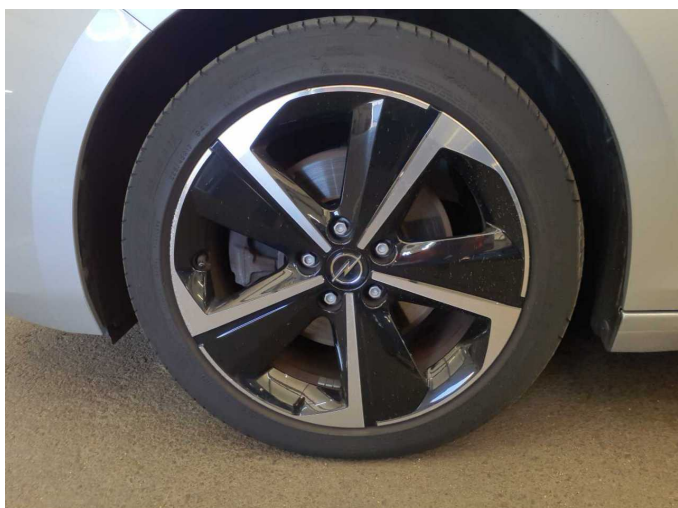
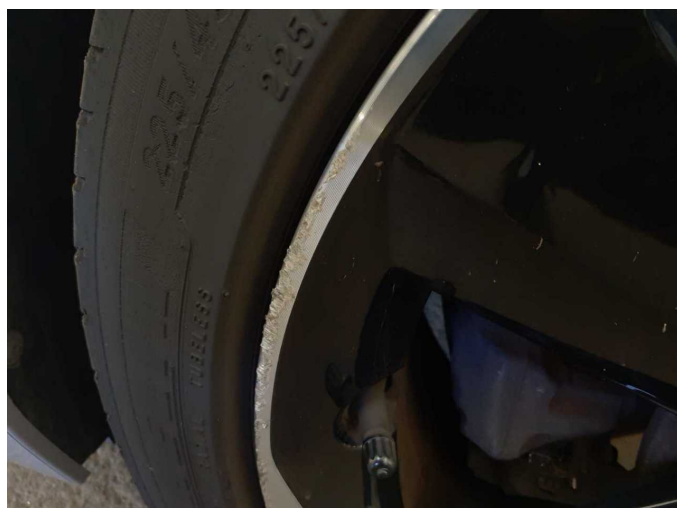
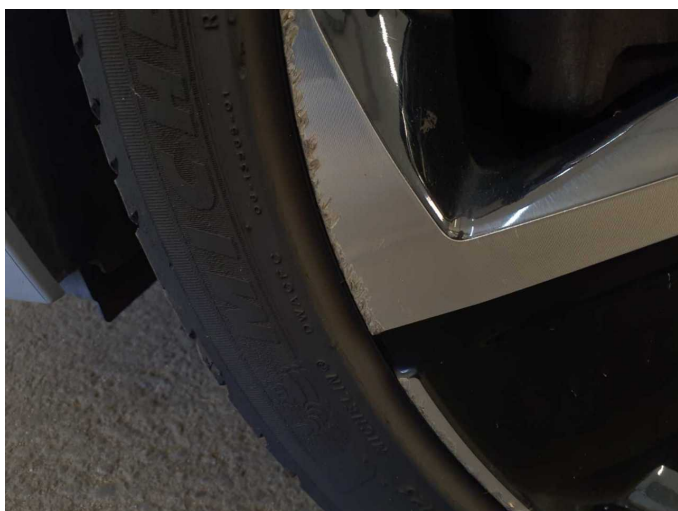
| No. | Component group | Description |
|---|---|---|
| 3 | Wheel / tyres | Alloy rim - front left side - Scratched - Replace |

**Damage 3:** Wheel / tyres: Alloy rim - front left side - Scratched - Replace

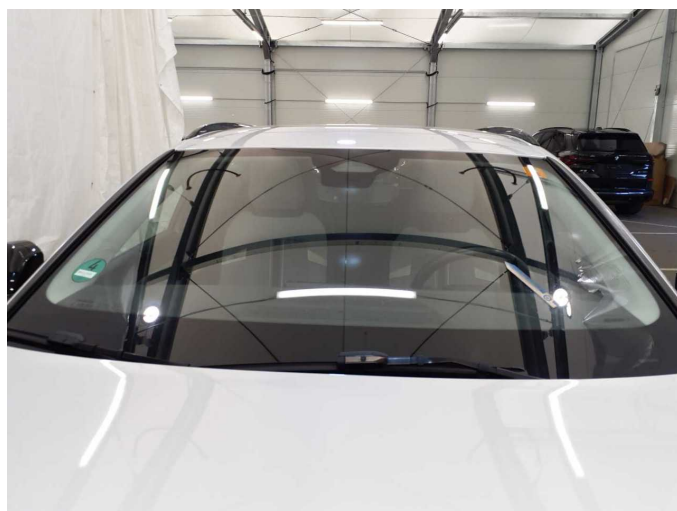
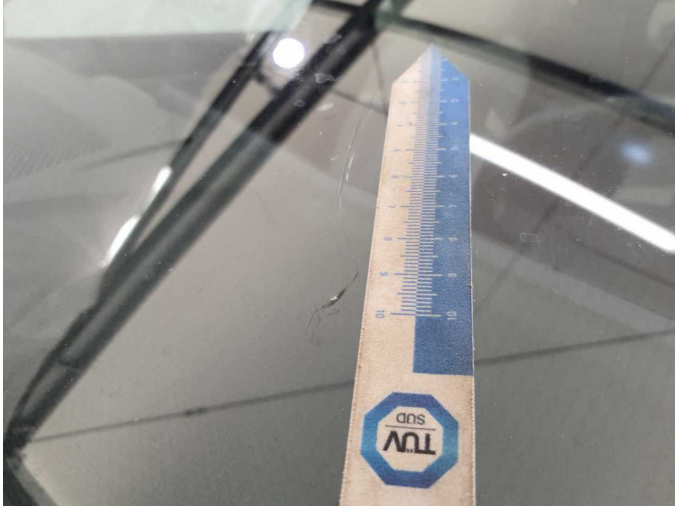
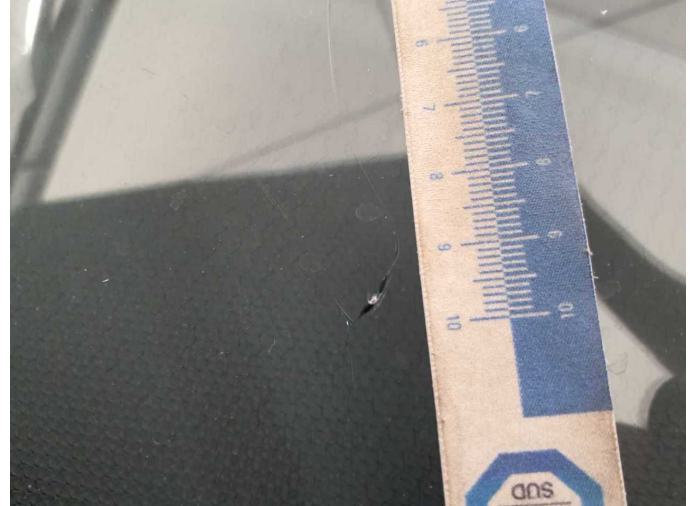
| No. | Component group | Description |
|---|---|---|
| 4 | Vehicle glazing | Windscreen - Broken / torn - Replace |

**Damage 4:** Vehicle glazing: Windscreen - Broken / torn - Replace

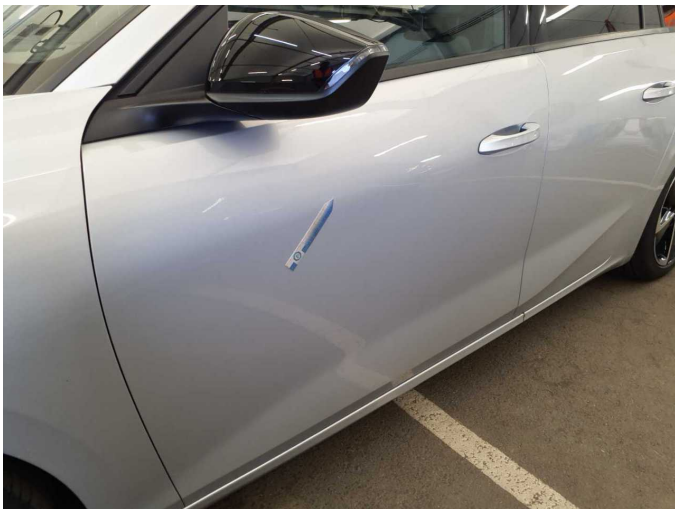
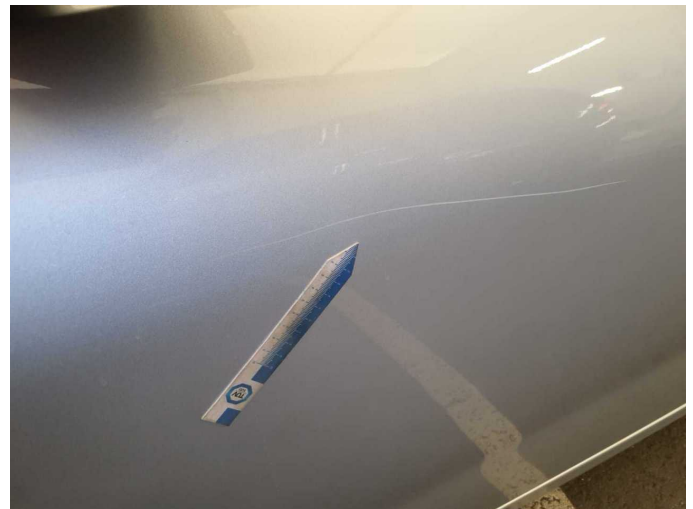
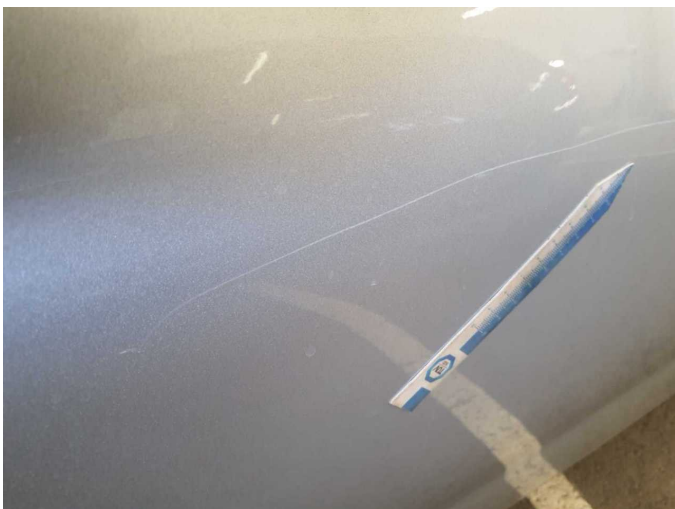
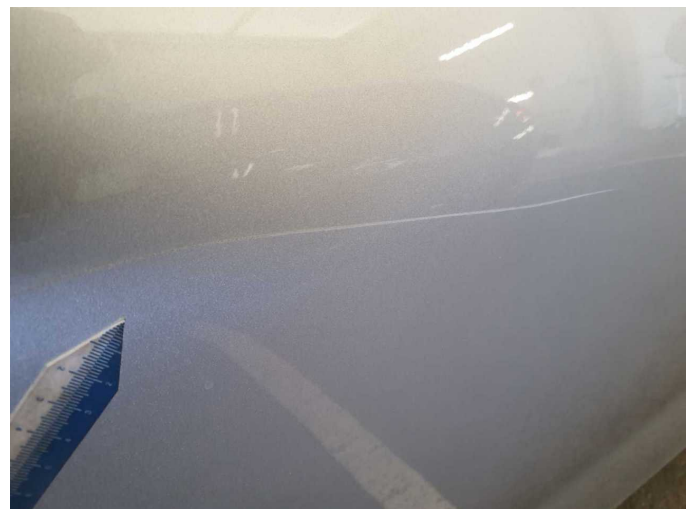
| No. | Component group | Description |
|---|---|---|
| 5 | Door - front left side | Door - Scratch(es) - Paint |

**Damage 5:** Door - front left side: Door - Scratch(es) - Paint

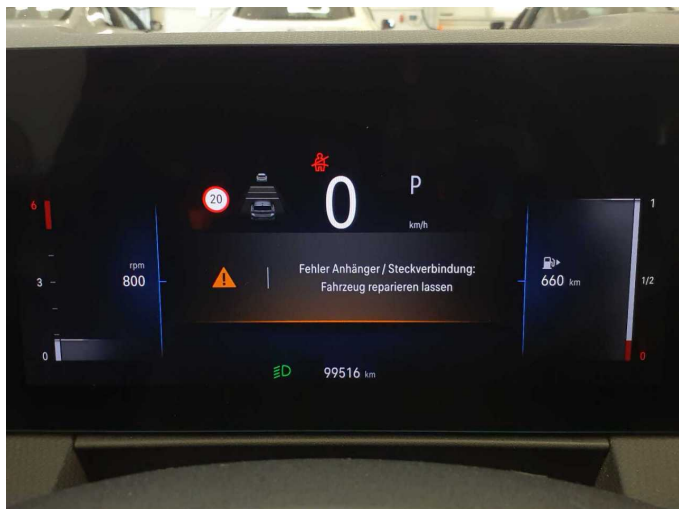
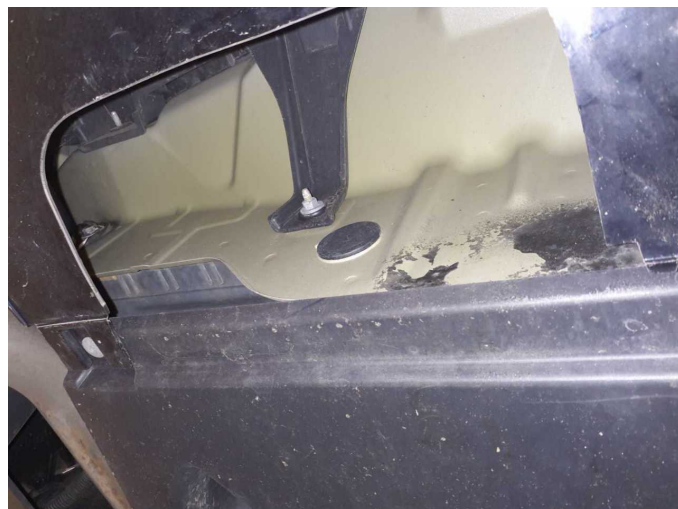
| No. | Component group | Description |
|---|---|---|
| 6 | Rear of vehicle | Trailer hitch (Träger, Dose & Kugelkopf) - Missing - Replace |

**Damage 6:** Rear of vehicle: Trailer hitch (Träger, Dose & Kugelkopf) - Missing - Replace

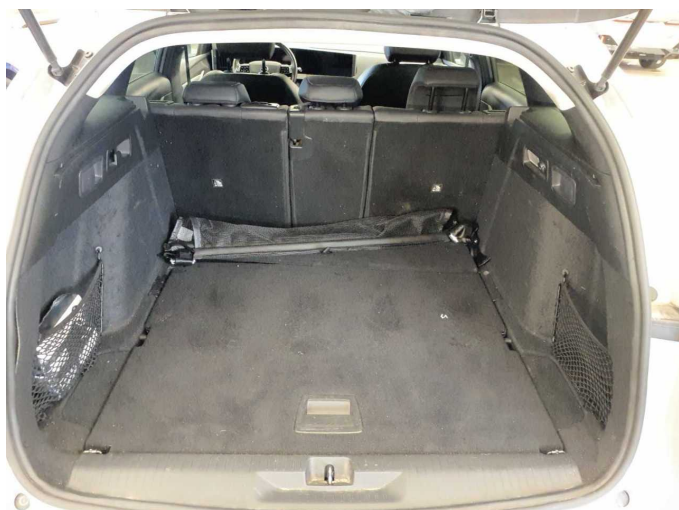
Interior - Boot cover / roller cover

**Missing part 1:** Interior: Boot cover / roller cover - Missing - Replace

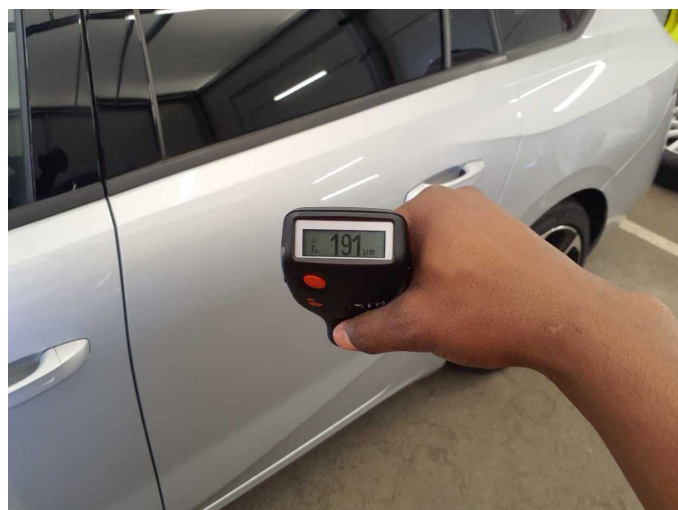
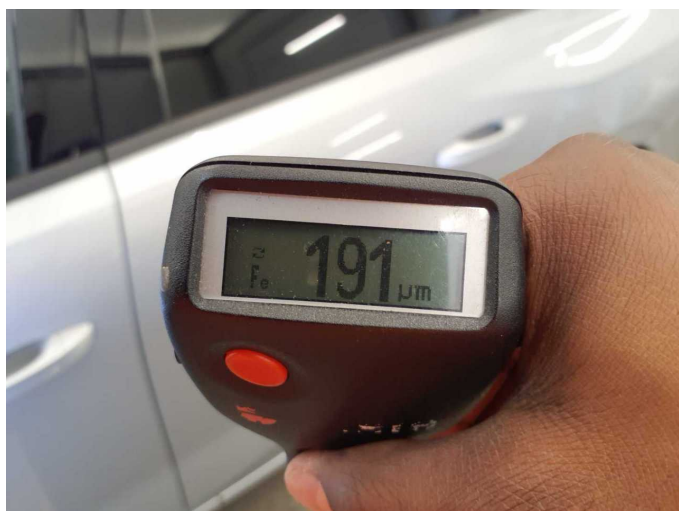
| Door - rear left side | 191 µm | Door - front left side | 433 µm |

**Repainting 1:** Door - rear left side

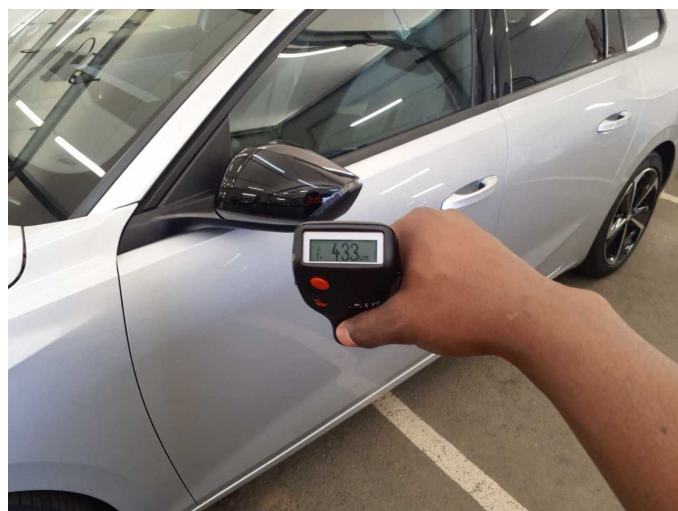
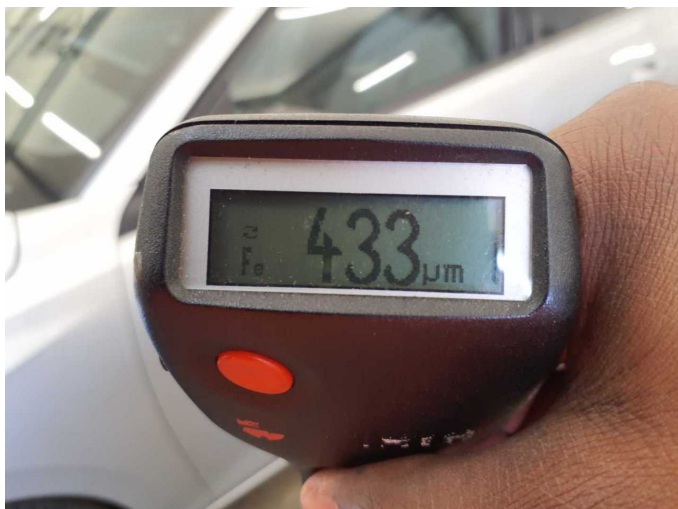
**Repainting 2:** Door - front left side
