Expertise

Protocol number: 46575792  
Order No. / Reference: 26739240  
Inspection date: 14 Jul 2026

Manufacturer: Volkswagen

Model: Touran 2.0 TDI SCR DSG Comfortline

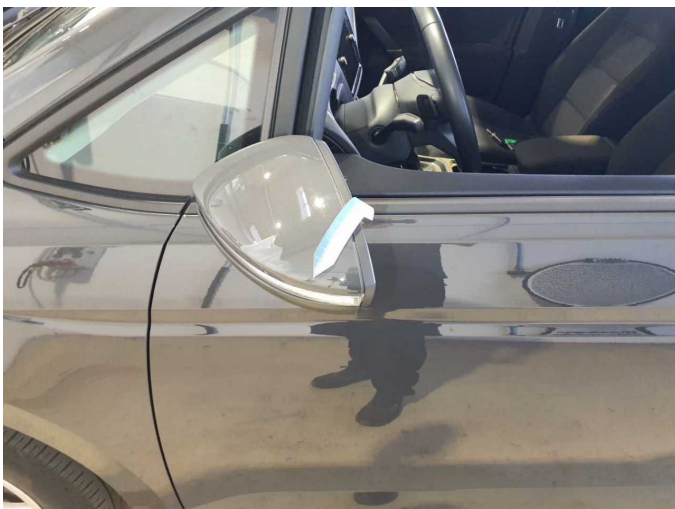
| No. | Component group | Description |
|---|---|---|
| 1 | Wing mirror - left side | Cap - Scratch(es) - Smart repair |

Damage 1: Wing mirror - left side: Cap - Scratch(es) - Smart repair

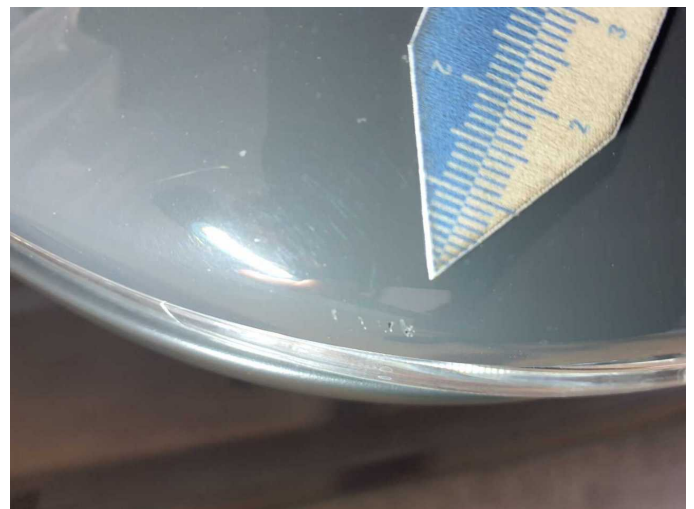
Damage 1: Wing mirror - left side: Cap - Scratch(es) - Smart repair

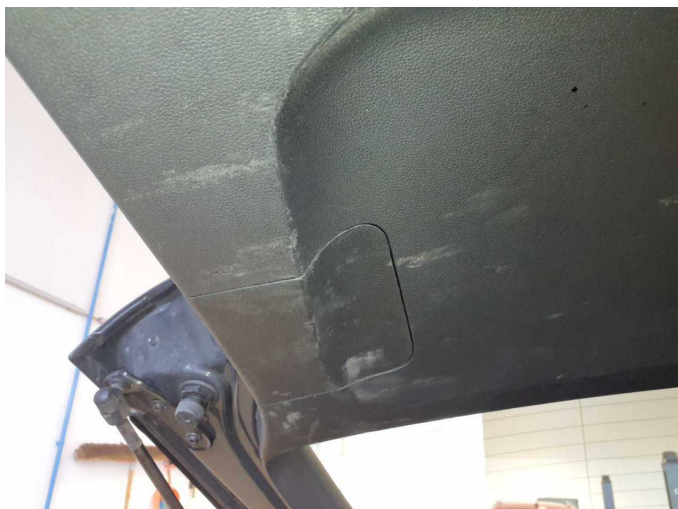
| No. | Component group | Description |
|---|---|---|
| 2 | Trim / covers | Boot lid - interior trim - Scratch(es) - Loss in value |

**Damage 2:** Trim / covers: Boot lid - interior trim - Scratch(es) - Loss in value

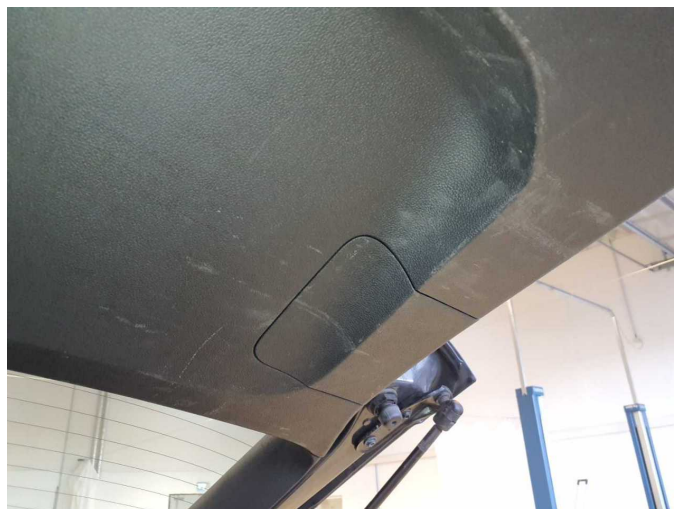
**Damage 2:** Trim / covers: Boot lid - interior trim - Scratch(es) - Loss in value

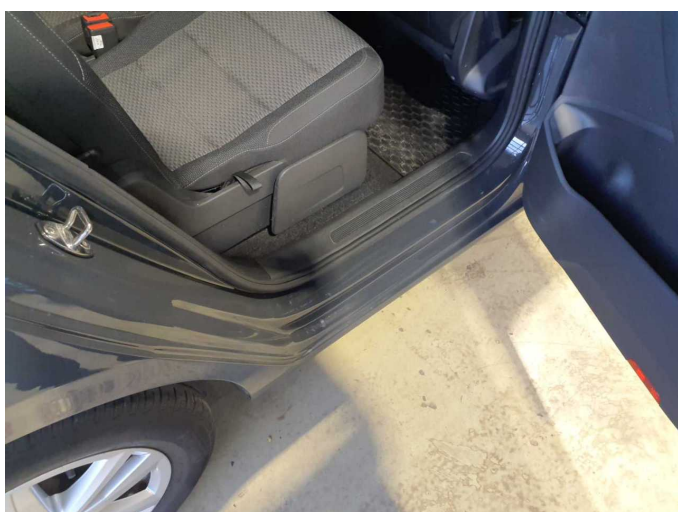
| No. | Component group | Description |
|---|---|---|
| 3 | Side panel - rear right side | Sill - Scratch(es) - Smart repair |

**Damage 3:** Side panel - rear right side: Sill - Scratch(es) - Smart repair

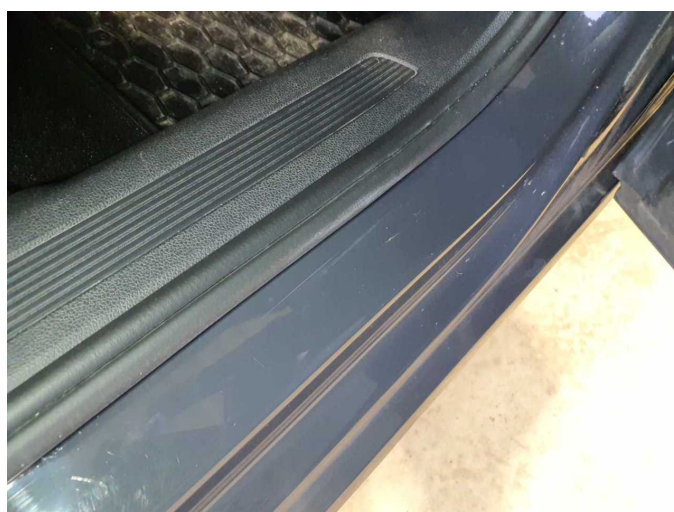
**Damage 3:** Side panel - rear right side: Sill - Scratch(es) - Smart repair

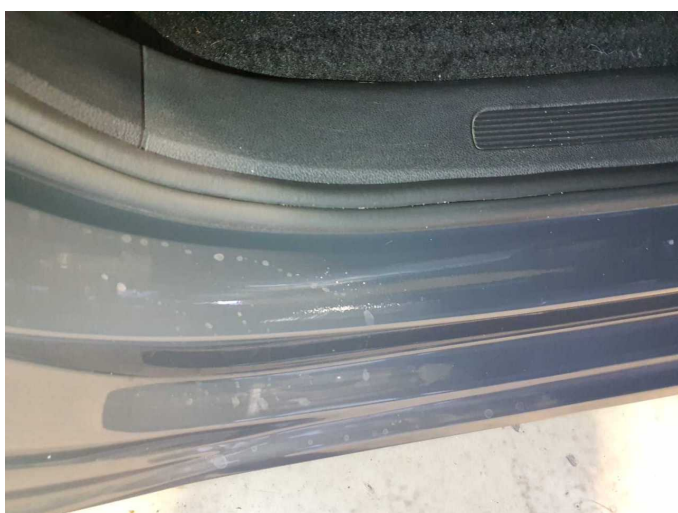
**Damage 3:** Side panel - rear right side: Sill - Scratch(es) - Smart repair

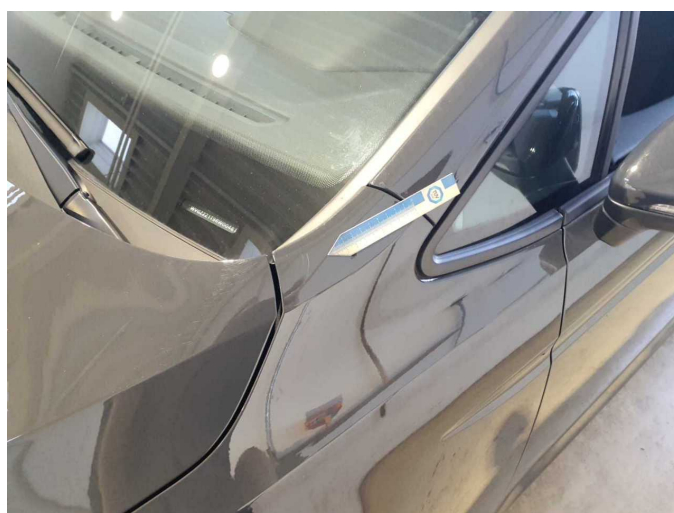
| No. | Component group | Description |
|---|---|---|
| 4 | Mudguard - left side | Mudguard - left side - Scratch(es) - Smart repair |

**Damage 4:** Mudguard - left side: Mudguard - left side - Scratch(es) - Smart repair

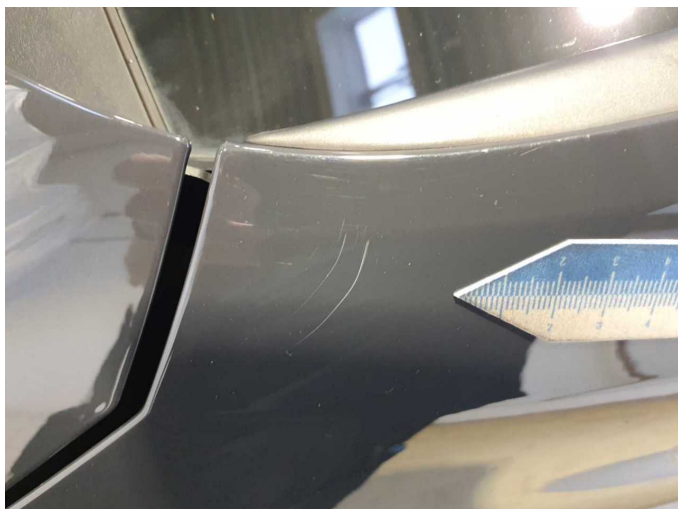
**Damage 4:** Mudguard - left side: Mudguard - left side - Scratch(es) - Smart repair

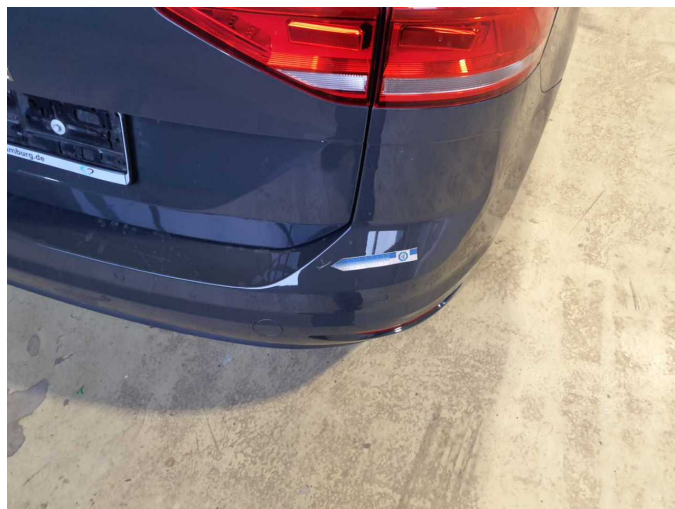
| No. | Component group | Description |
|---|---|---|
| 5 | Rear bumper | Rear bumper - Scratch(es) - Smart repair |

**Damage 5:** Rear bumper: Rear bumper - Scratch(es) - Smart repair

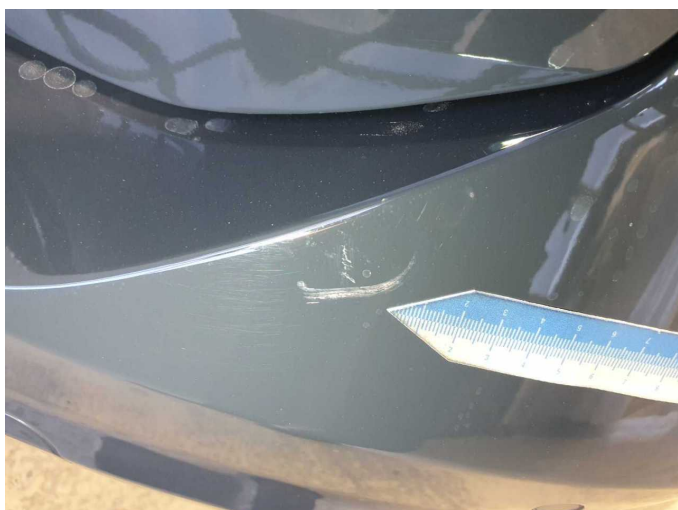
**Damage 5:** Rear bumper: Rear bumper - Scratch(es) - Smart repair

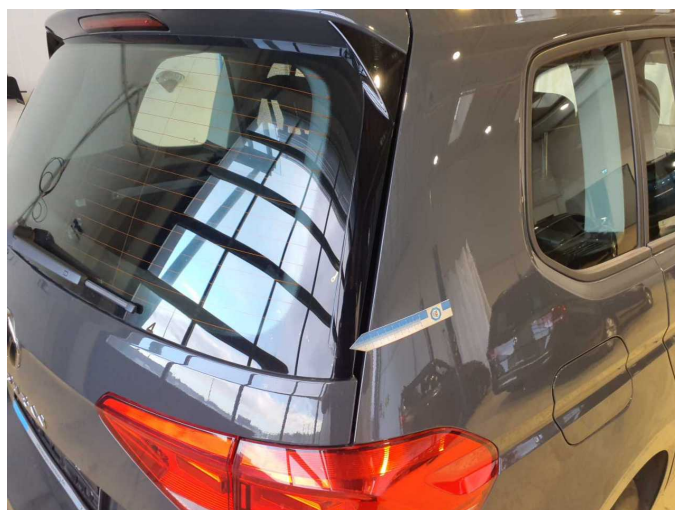
| No. | Component group | Description |
|---|---|---|
| 6 | Trim / covers | Trim / covers - Broken / torn - Replace |

**Damage 6:** Trim / covers: Trim / covers - Broken / torn - Replace

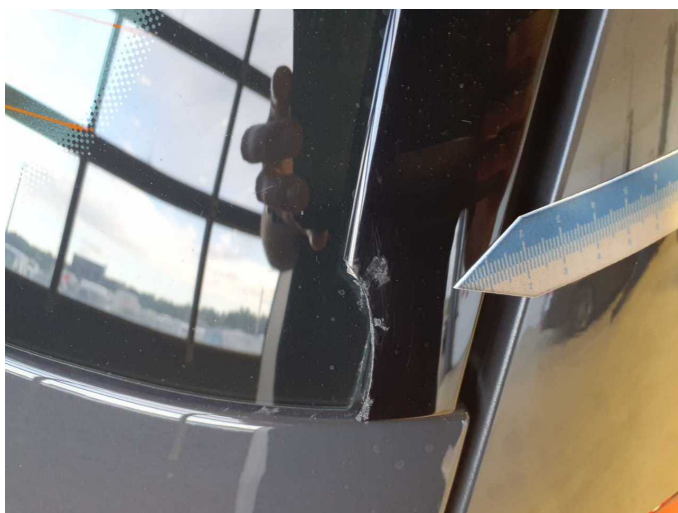
**Damage 6:** Trim / covers: Trim / covers - Broken / torn - Replace

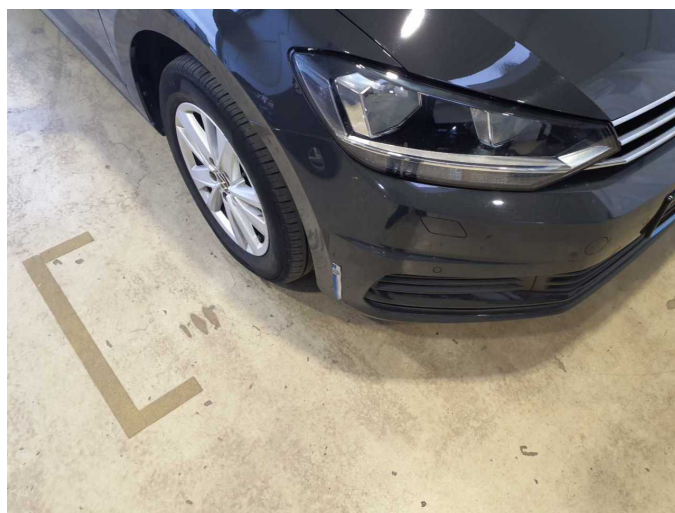
| No. | Component group | Description |
|---|---|---|
| 7 | Front bumper | Front bumper - Scratch(es) - Paint |

**Damage 7:** Front bumper: Front bumper - Scratch(es) - Paint

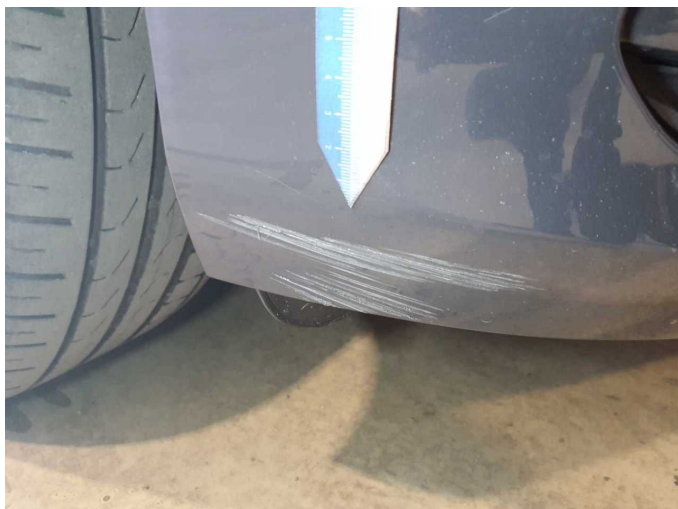
**Damage 7:** Front bumper: Front bumper - Scratch(es) - Paint

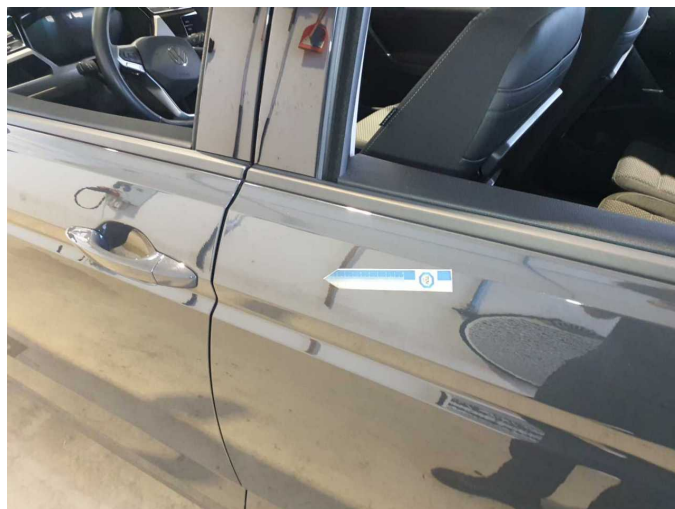
| No. | Component group | Description |
|---|---|---|
| 8 | Door - rear left side | Door - Scratch(es) - Paint |

**Damage 8:** Door - rear left side: Door - Scratch(es) - Paint

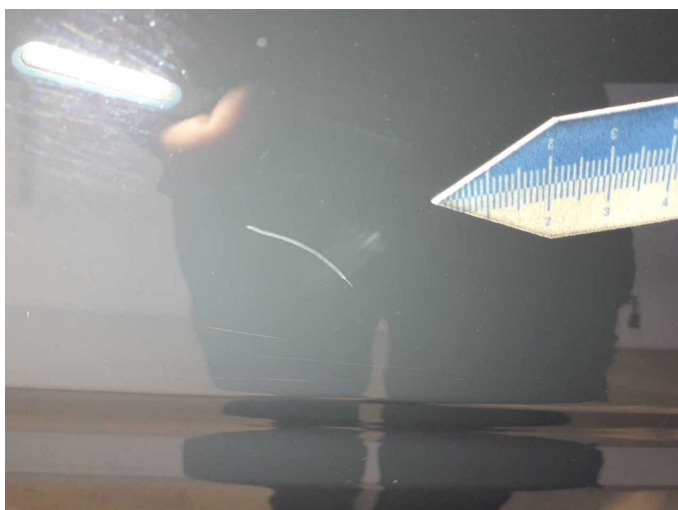
**Damage 8:** Door - rear left side: Door - Scratch(es) - Paint

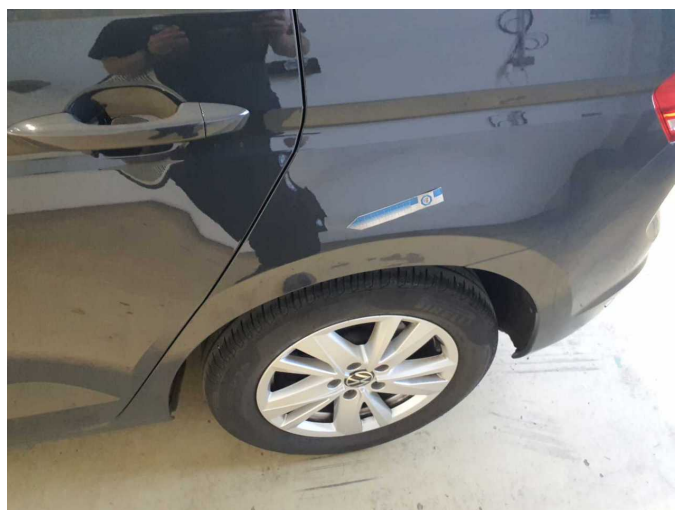
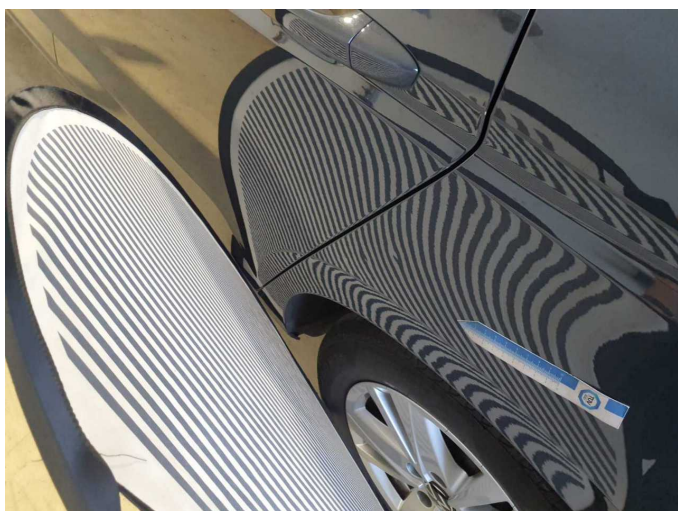
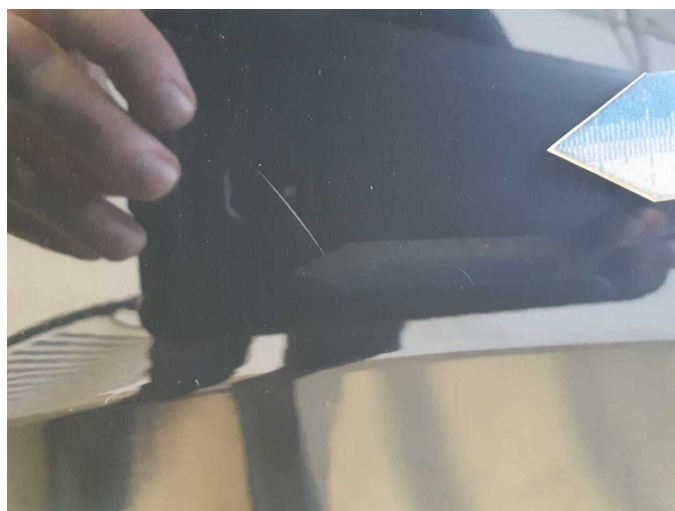
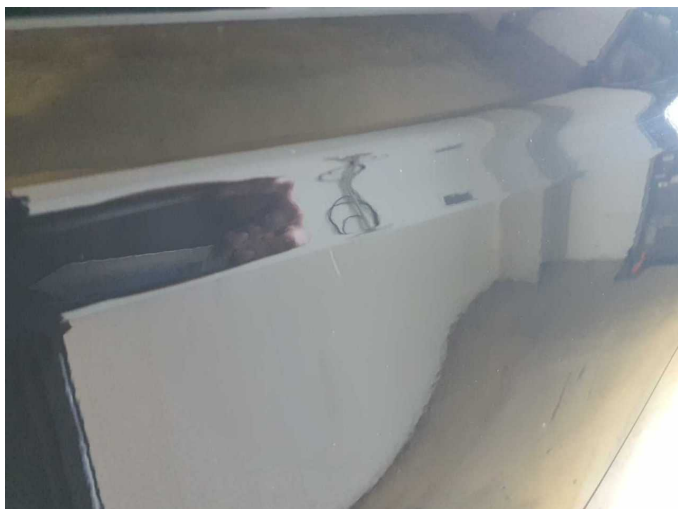
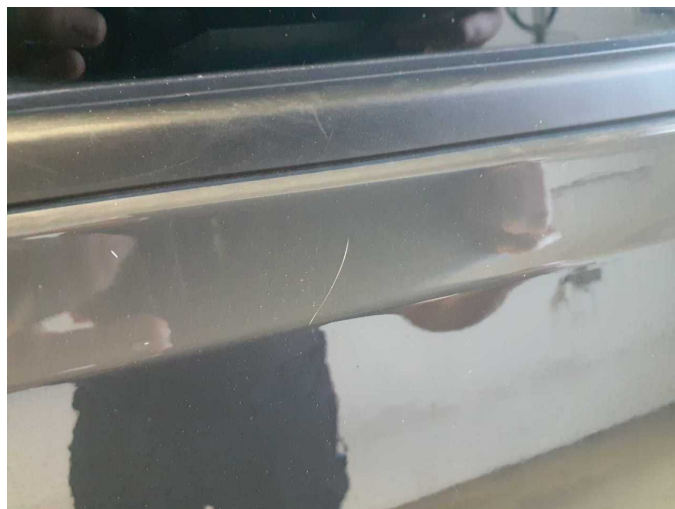
| No. | Component group | Description |
|---|---|---|
| 9 | Side panel - rear left side | Side panel - Dent / paintcoat damage - Repair and paint |

**Damage 9:** Side panel - rear left side: Side panel - Dent / paintcoat damage - Repair and paint

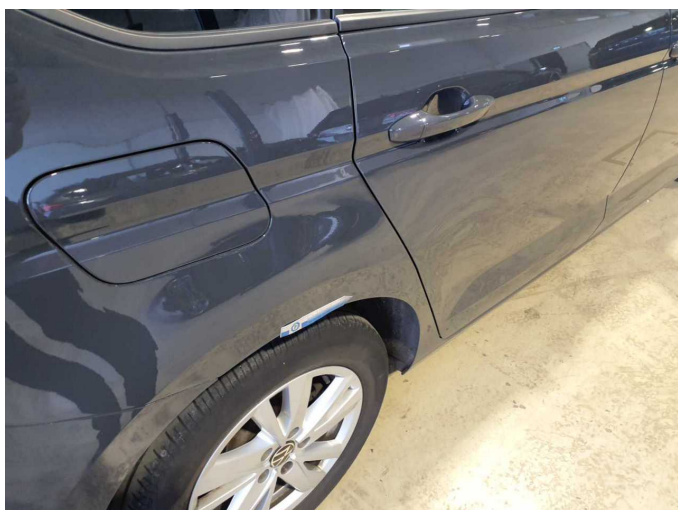
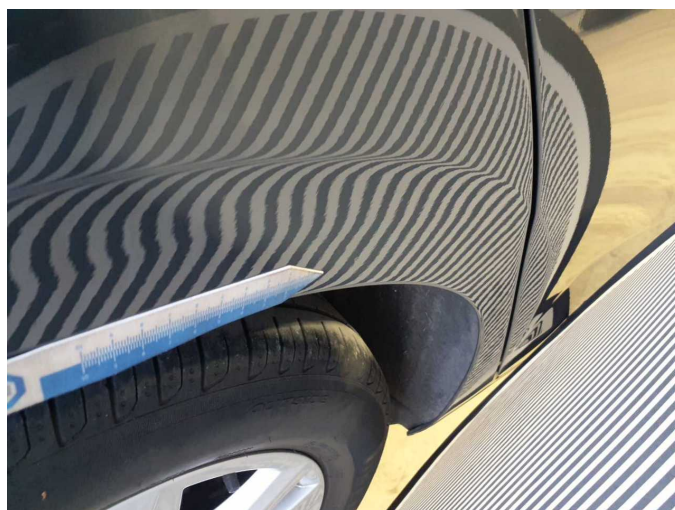
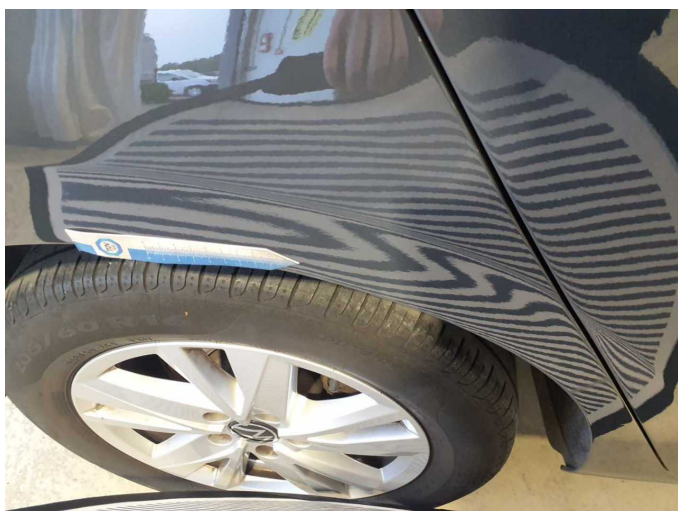
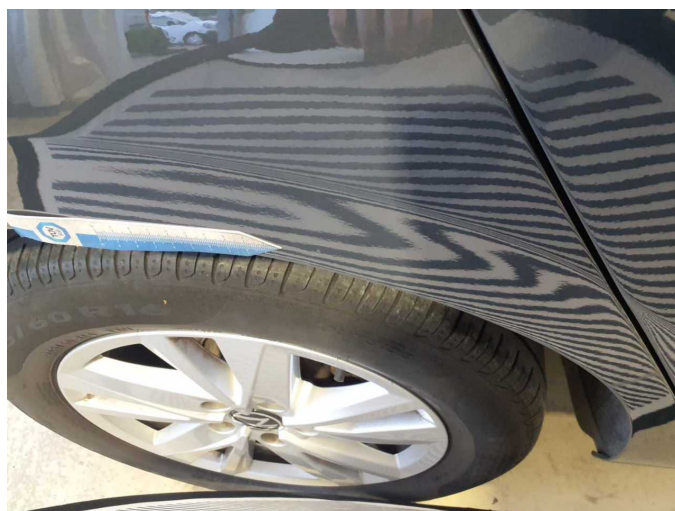
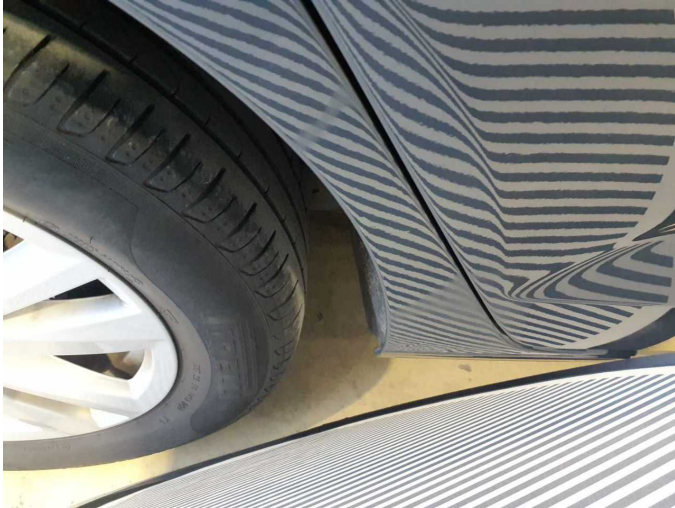
| No. | Component group | Description |
|---|---|---|
| 10 | Side panel - rear right side | Side panel (Einschlüsse) - Unprofessionally repaired - Repair and paint |

| No. | Repainting |
|---|---|
| 5 | Side panel - rear right side, Unprofessionally carried out, Invoice of repair done Non-existent |

| Side panel - rear right side | 2,080 µm | Door - rear right side | 191 µm |

**Damage 10:** Side panel - rear right side: Side panel (Einschlüsse) - Unprofessionally repaired - Repair and paint

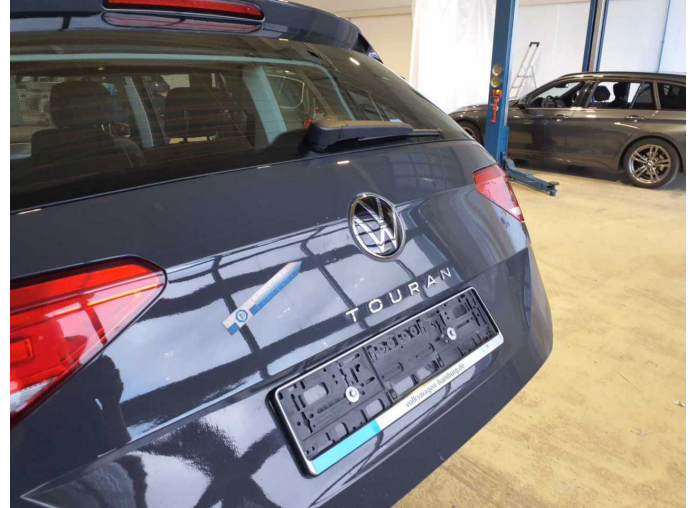
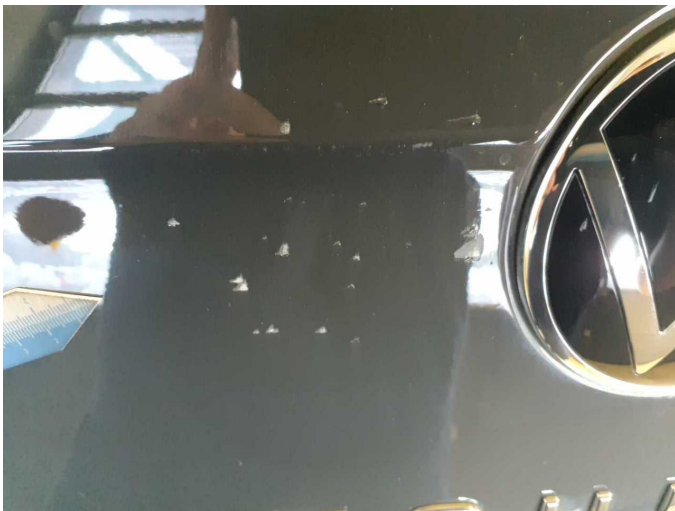
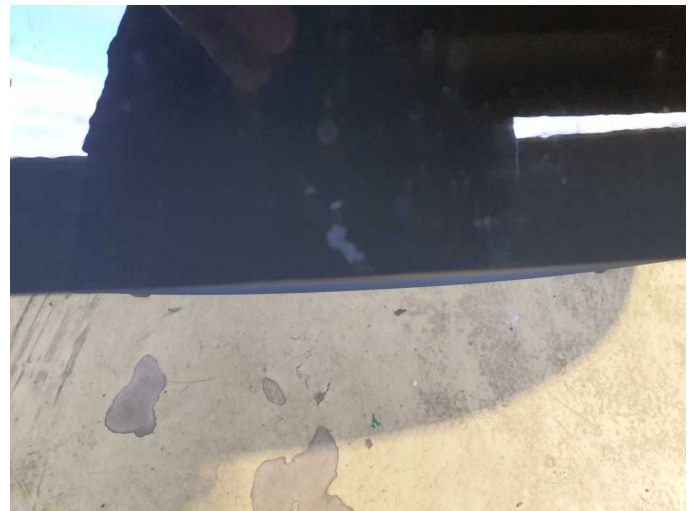
| No. | Component group | Description |
|---|---|---|
| 11 | Boot lid / rear door | Boot lid - Scratch(es) - Paint |

**Damage 11:** Boot lid / rear door: Boot lid - Scratch(es) - Paint

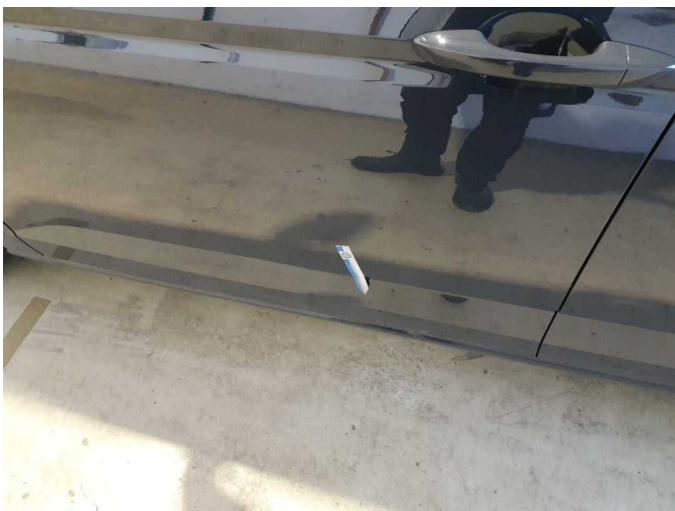
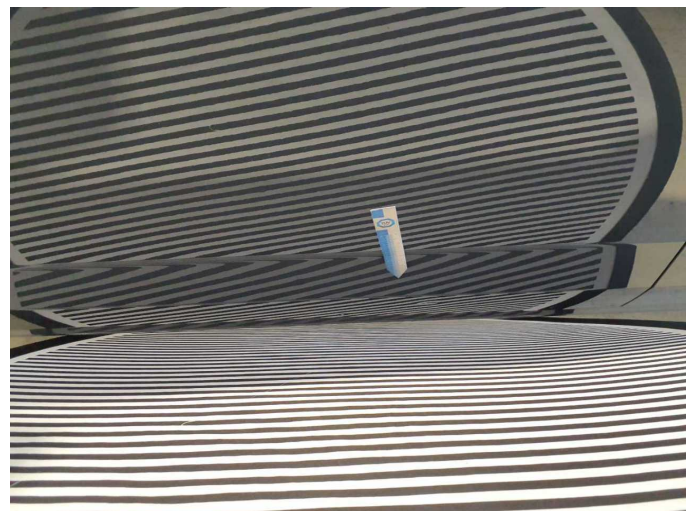
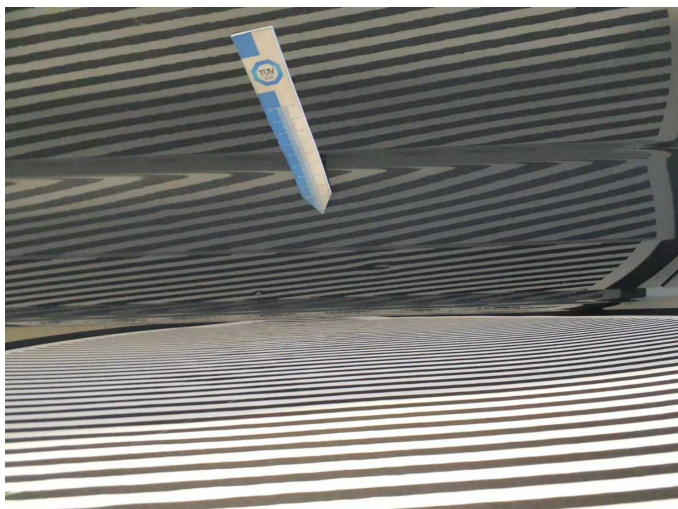
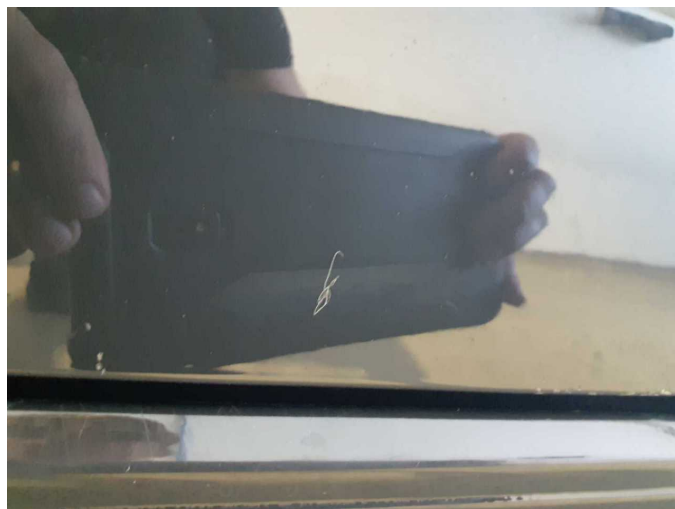
| No. | Component group | Description |
|---|---|---|
| 12 | Door - front left side | Door - Dent / paintcoat damage - Repair and paint |

**Damage 12:** Door - front left side: Door - Dent / paintcoat damage - Repair and paint

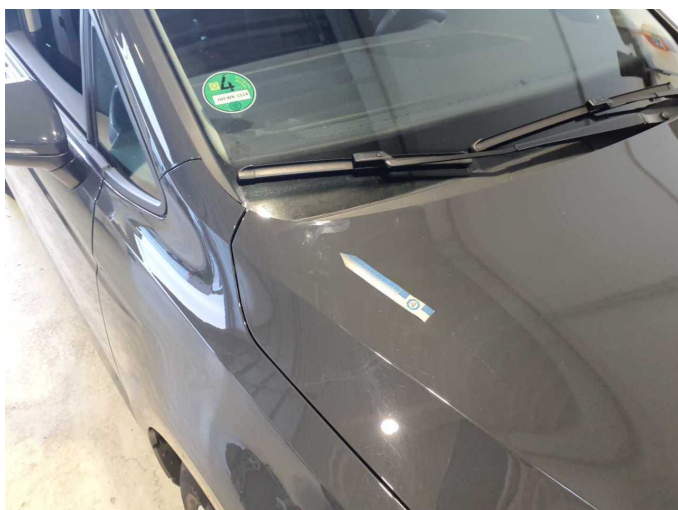
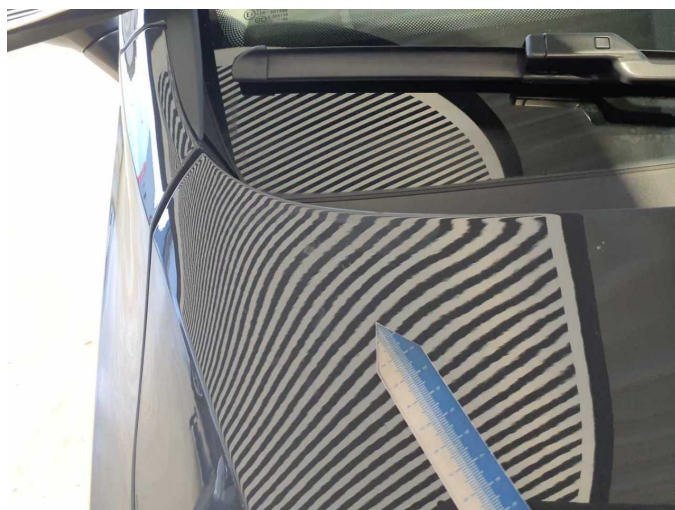
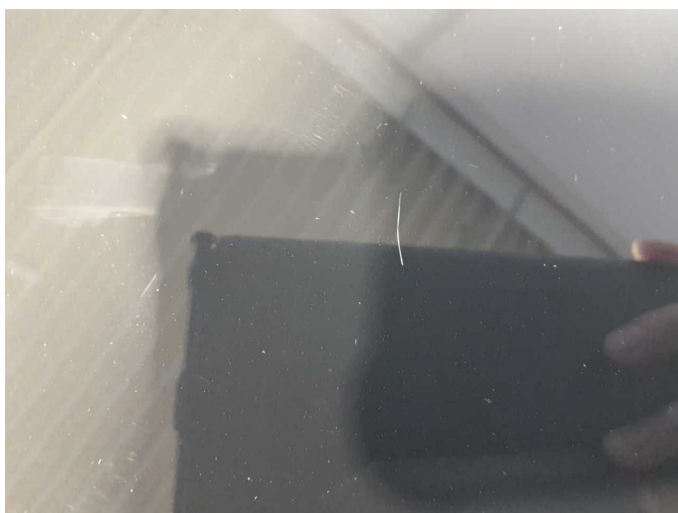
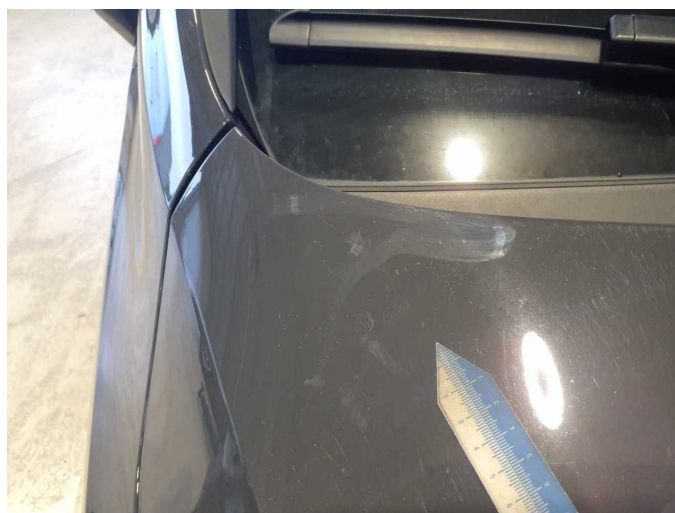
| No. | Component group | Description |
|---|---|---|
| 13 | Bonnet | Bonnet (Anätzung) - Paint defect - Repair and paint |

**Damage 13:** Bonnet: Bonnet (Anätzung) - Paint defect - Repair and paint

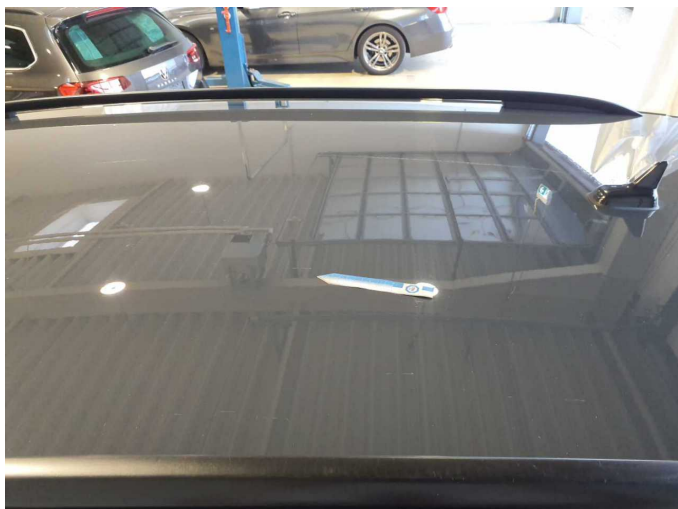
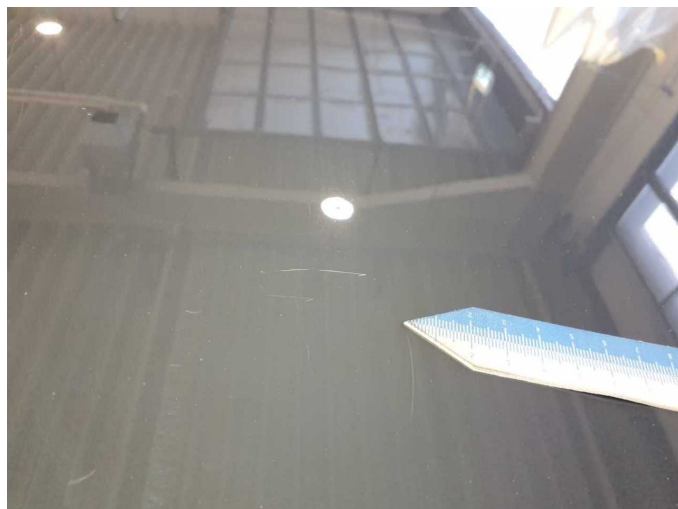
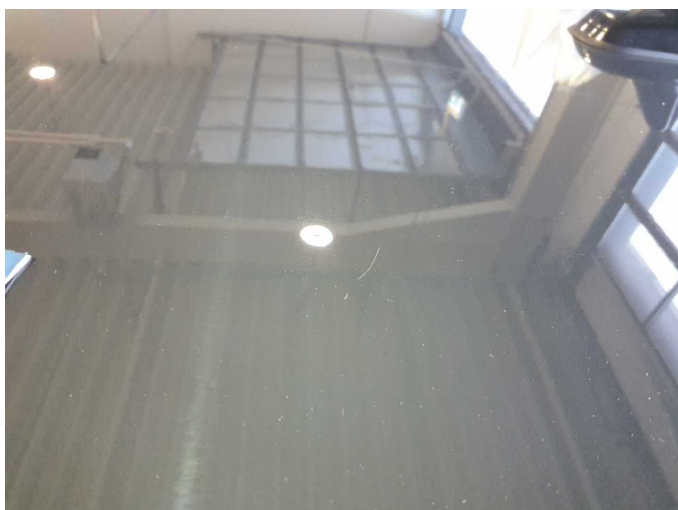
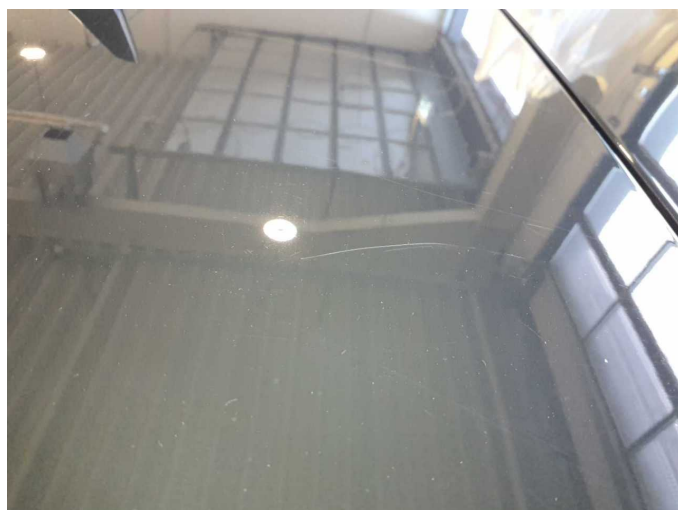
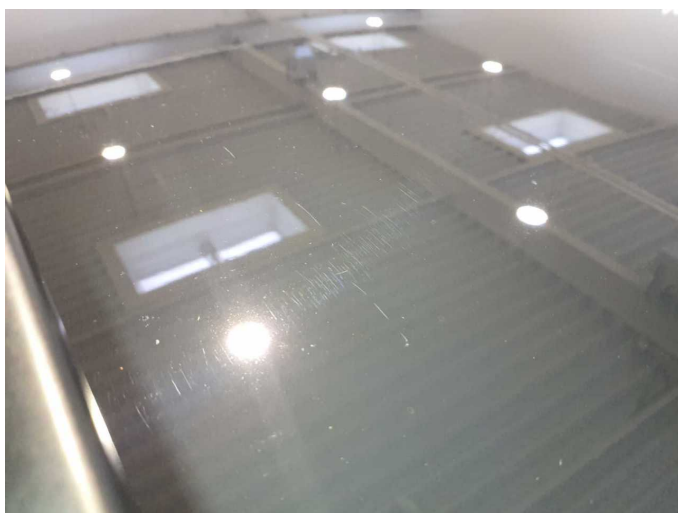
| No. | Component group | Description |
|---|---|---|
| 14 | Roof | Roof - Scratch(es) - Paint |

**Damage 14:** Roof: Roof - Scratch(es) - Paint

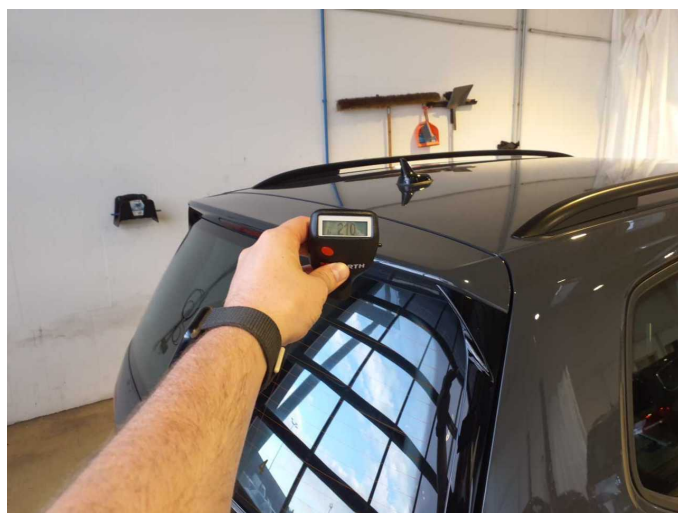
| No. | Repainting |
|---|---|
| 1 | Boot lid / rear door, Professionally carried out, Invoice of repair done Non-existent |

| Boot lid / rear door | 210 µm | Mudguard - right side | 181 µm |

**Repainting 1:** Boot lid / rear door

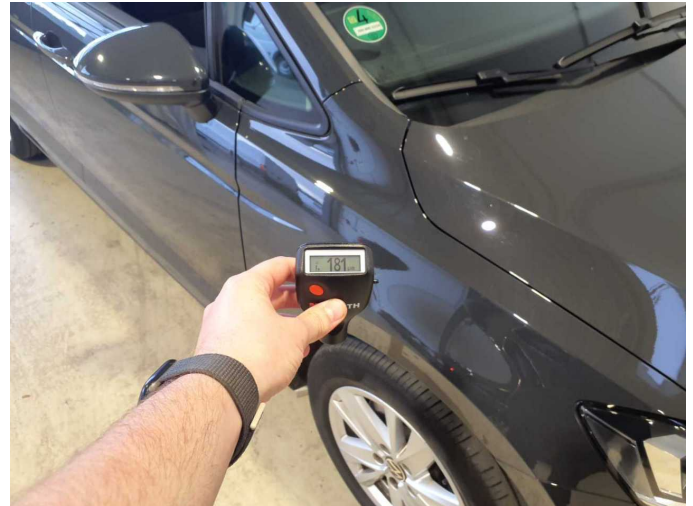
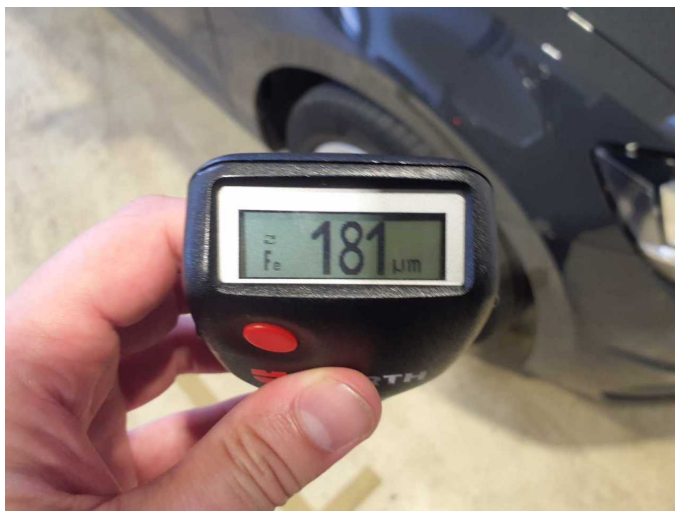
| No. | Repainting |
|---|---|
| 2 | Mudguard - right side, Professionally carried out, Invoice of repair done Non-existent |

**Repainting 2:** Mudguard - right side

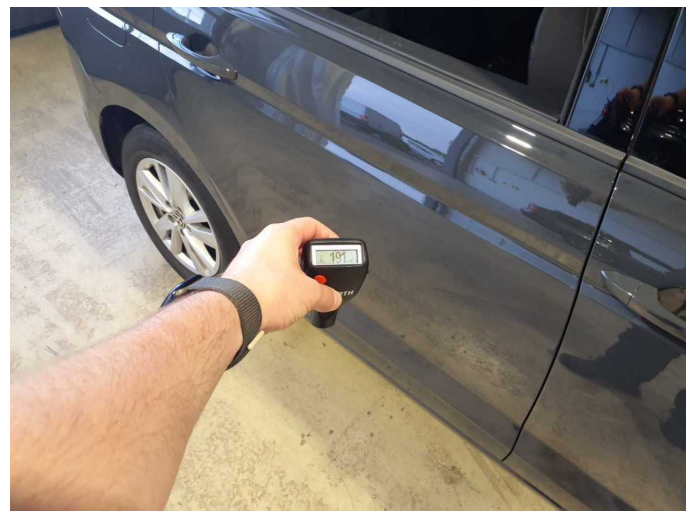
| No. | Repainting |
|---|---|
| 3 | Door - rear right side, Professionally carried out, Invoice of repair done Non-existent |

**Repainting 3:** Door - rear right side

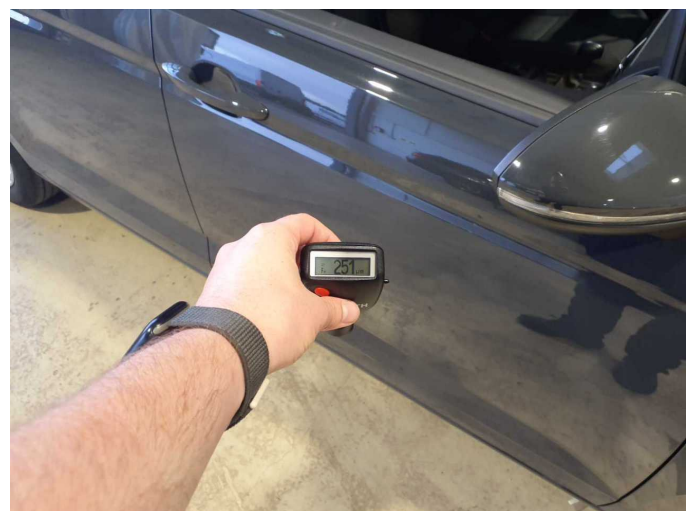
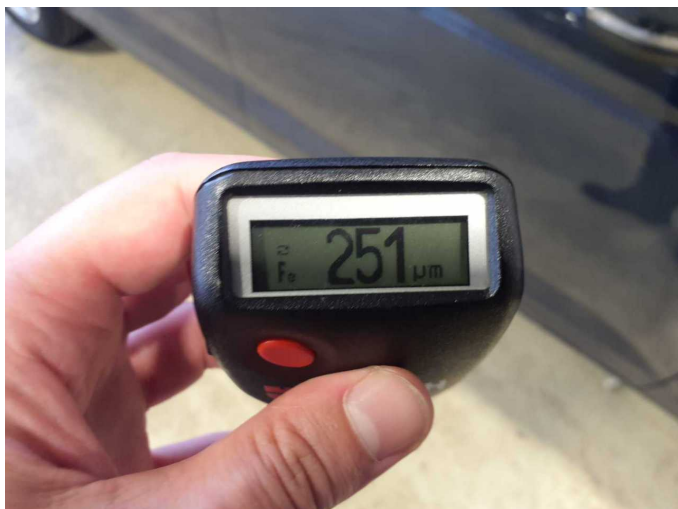
| No. | Repainting |
|---|---|
| 4 | Door - front right side, Professionally carried out, Invoice of repair done Non-existent |

| Door - front right side | 251 µm | | |

**Repainting 4:** Door - front right side

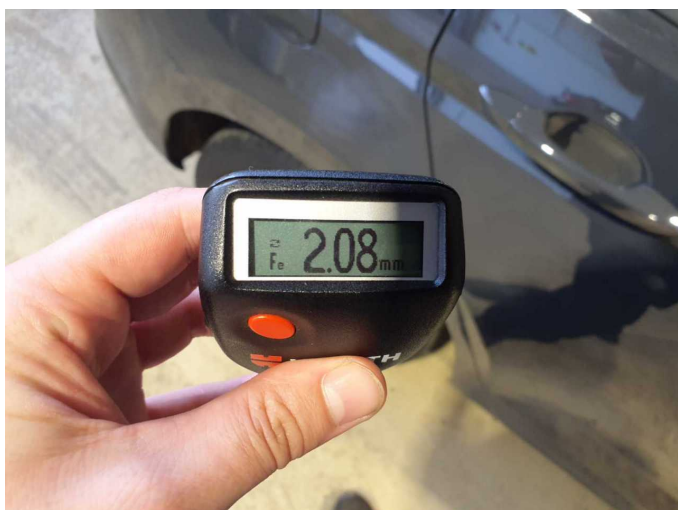
**Repainting 5:** Side panel - rear right side
