Expertise

Protocol number: 46868102  
Order No. / Reference: 26656782  
Inspection date: 24 Jul 2026

Manufacturer: Skoda  
VIN: TMBJR7NU0P5064888

Model: Karoq 1.5 TSI ACT DSG Sportline

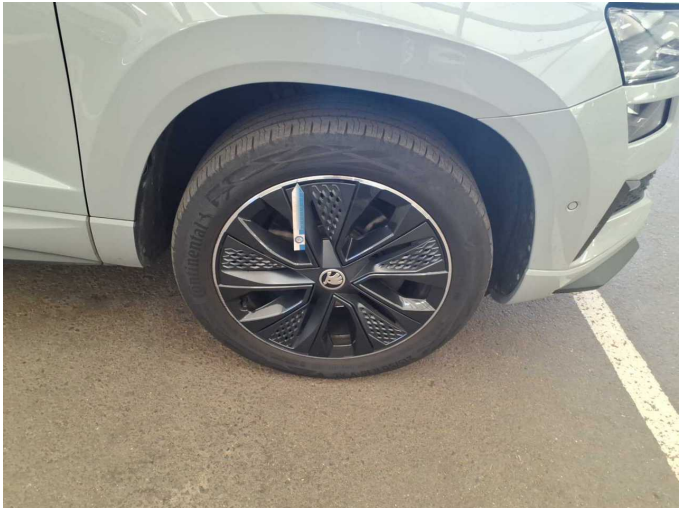
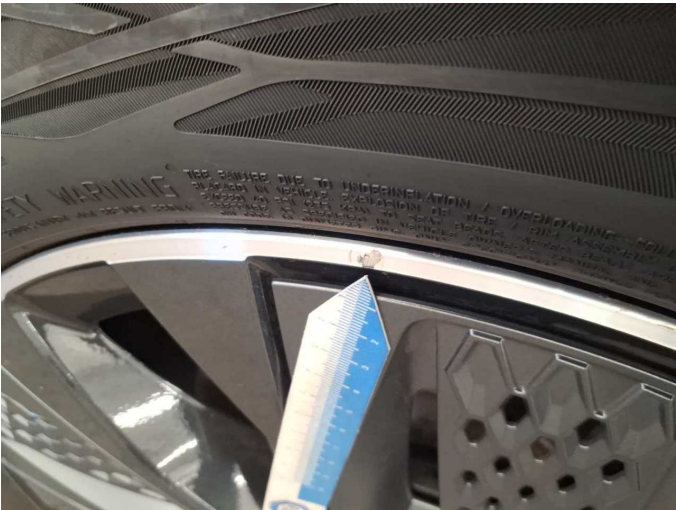
| No. | Component group | Description |
|---|---|---|
| 2 | Wheel / tyres | Alloy rim - front right side - Scratch(es) - Loss in value |

Damage 2: Wheel / tyres: Alloy rim - front right side - Scratch(es) - Loss in value

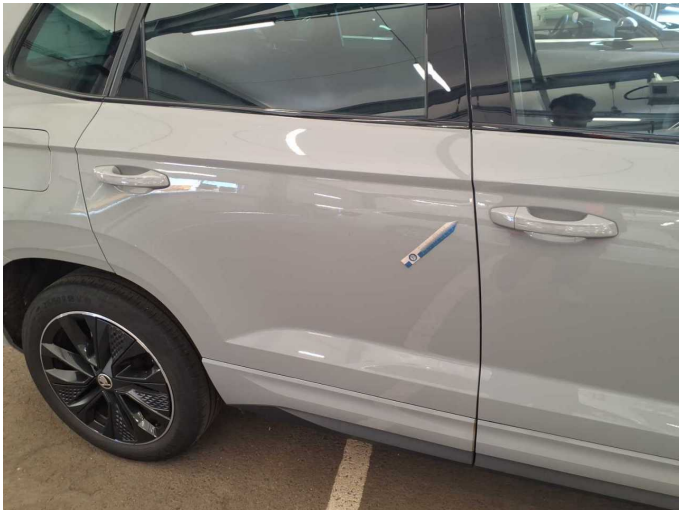
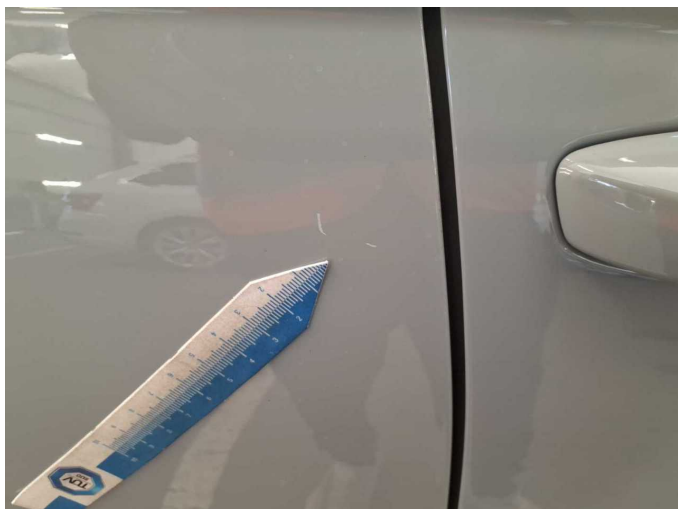
| No. | Component group | Description |
|---|---|---|
| 3 | Door - rear right side | Door - Scratch(es) - Smart repair |

Damage 3: Door - rear right side: Door - Scratch(es) - Smart repair

**Damage 3:** Door - rear right side: Door - Scratch(es) - Smart repair

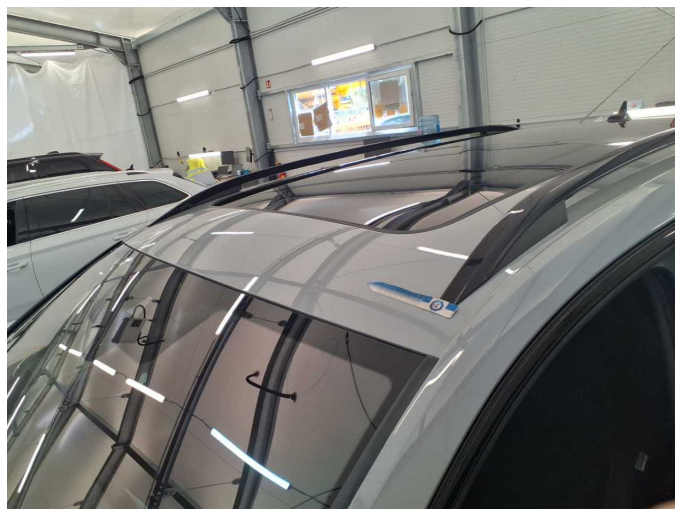
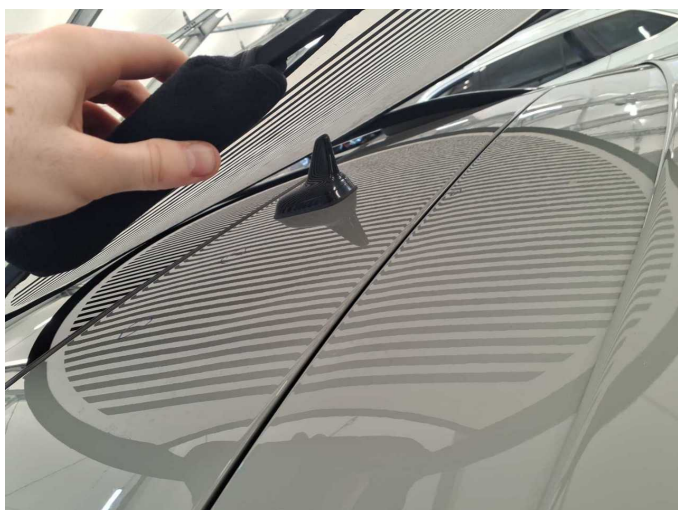
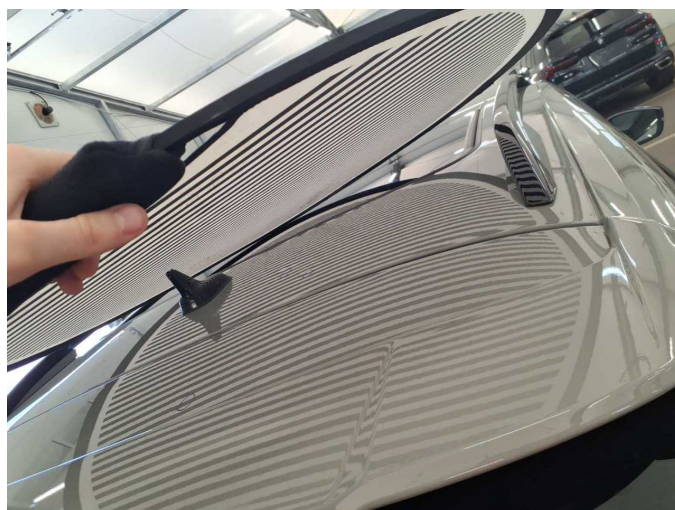
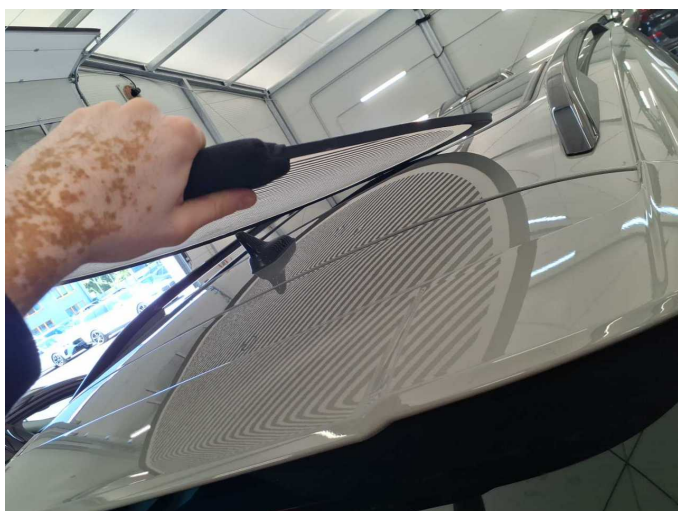
| No. | Component group | Description |
|---|---|---|
| 4 | Roof | Roof - Damage by hail - Smooth repair work |

**Damage 4:** Roof: Roof - Damage by hail - Smooth repair work

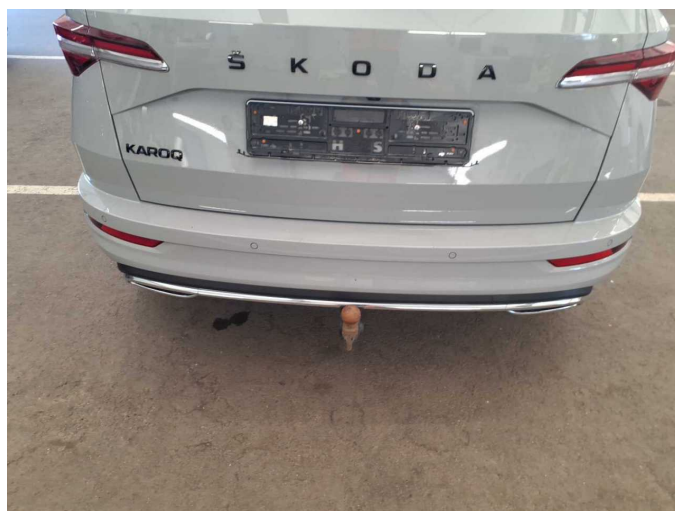
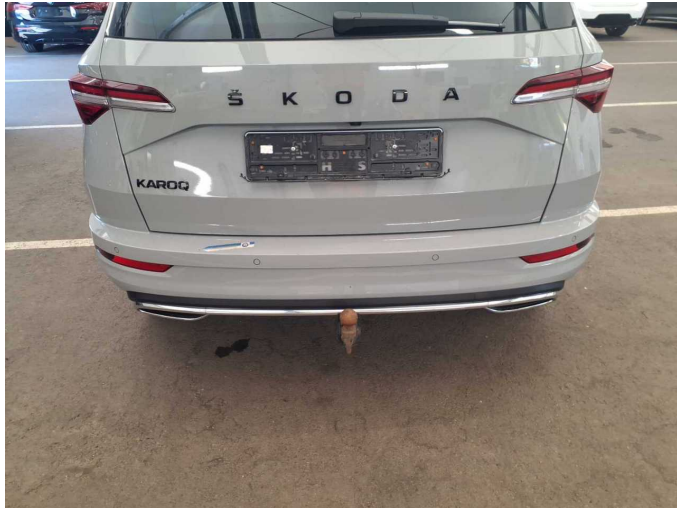
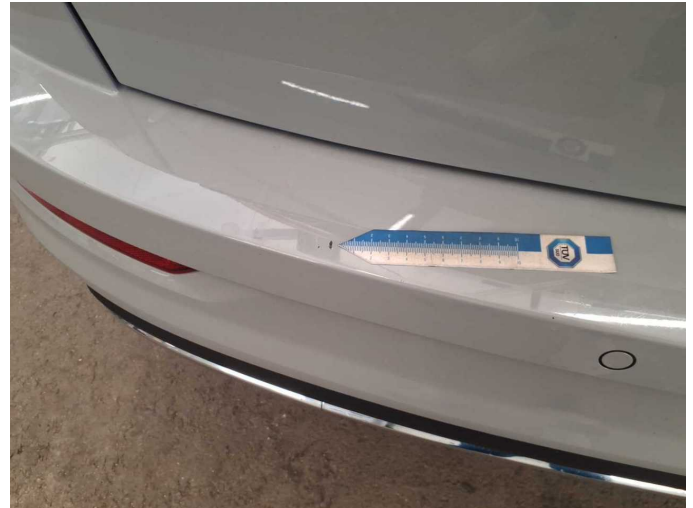
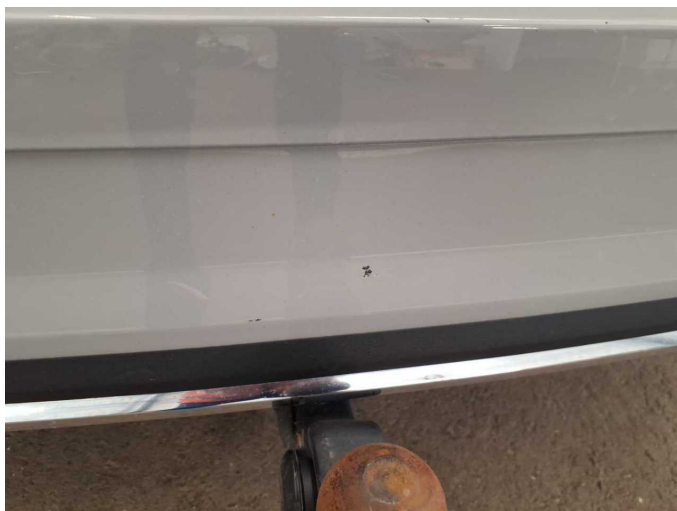
| No. | Component group | Description |
|---|---|---|
| 5 | Rear bumper | Rear bumper - Scratch(es) - Paint |

**Damage 5:** Rear bumper: Rear bumper - Scratch(es) - Paint

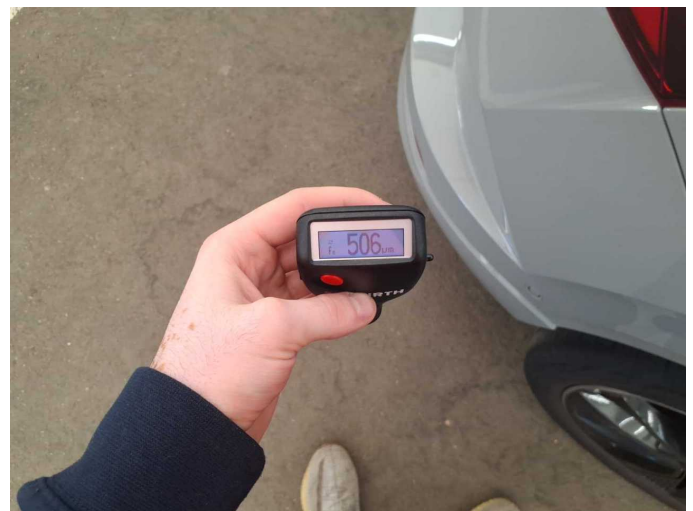
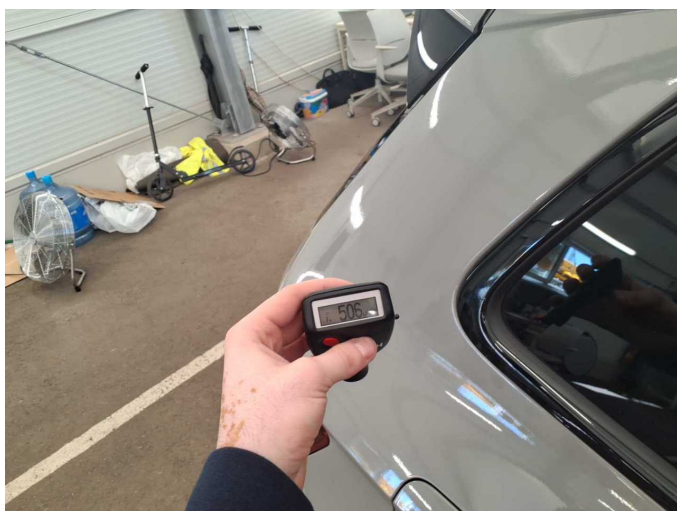
1 Side panel - rear right side

**Repainting 1:** Side panel - rear right side
