Expertise

Protocol number: 46525895  
Order No. / Reference: 26584535  
Inspection date: 8 Jul 2026

Manufacturer: Kia

Model: Niro 1.6 GDI PHEV 2WD OPF Aut. Vision

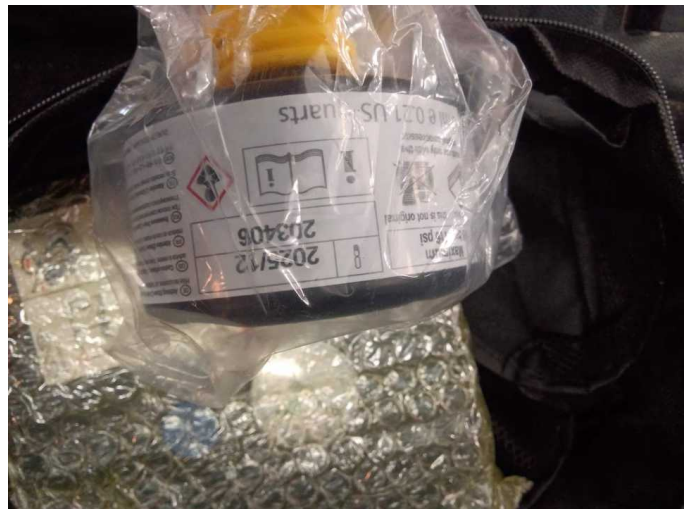
| No. | Component group | Description |
|---|---|---|
| 1 | Equipment | Tirefit filler - Expired - Replace |

**Damage 1:** Equipment: Tirefit filler - Expired - Replace

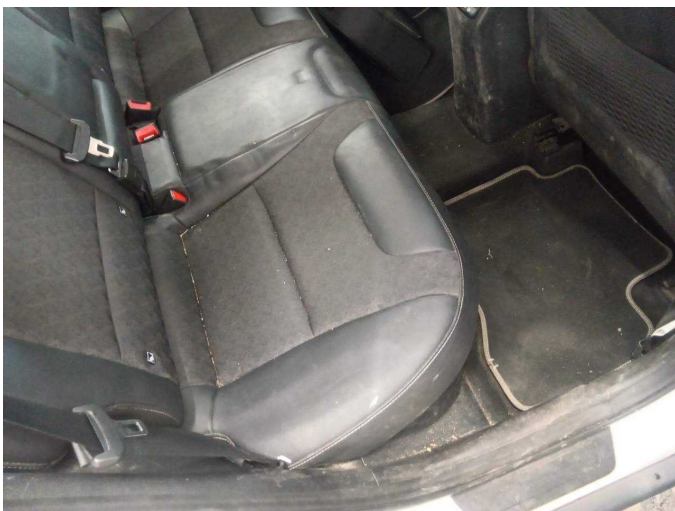
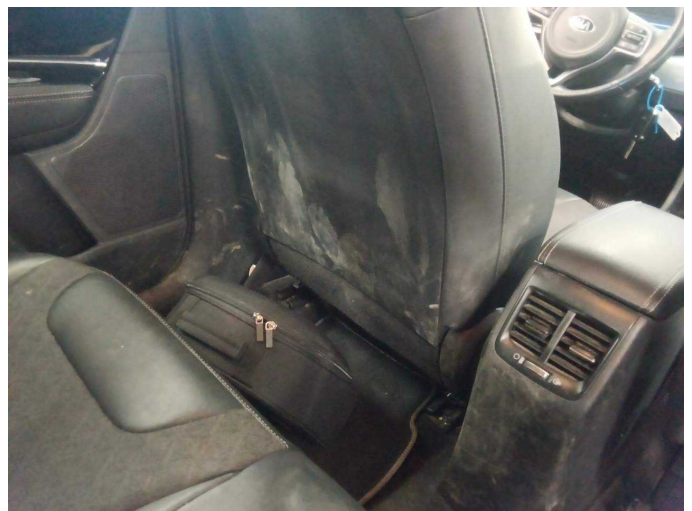
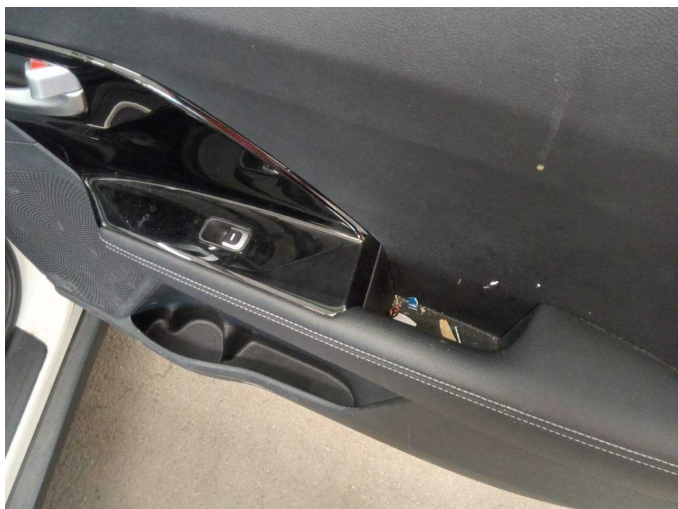
| No. | Component group | Description |
|---|---|---|
| 2 | Interior | Interior - Soiled - Clean |

**Damage 2:** Interior: Interior - Soiled - Clean

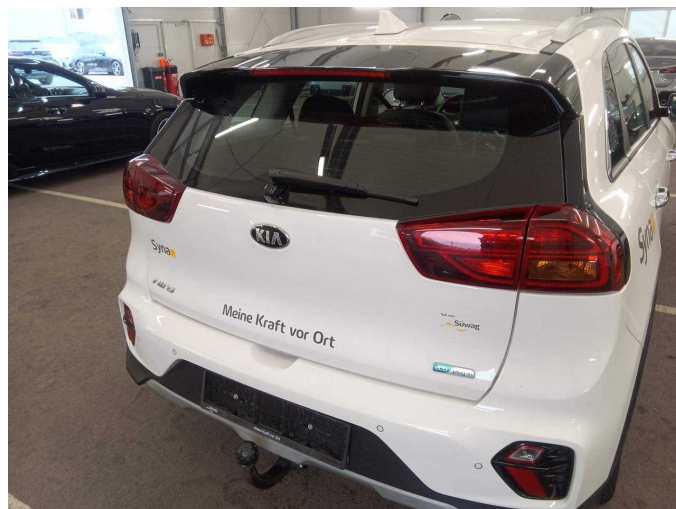
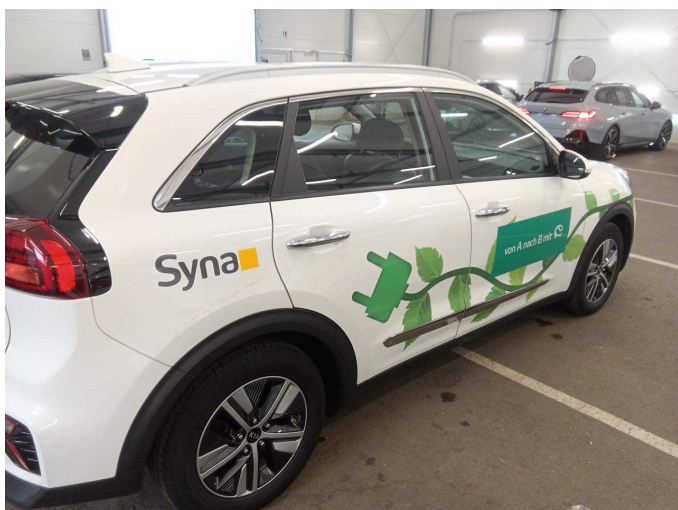
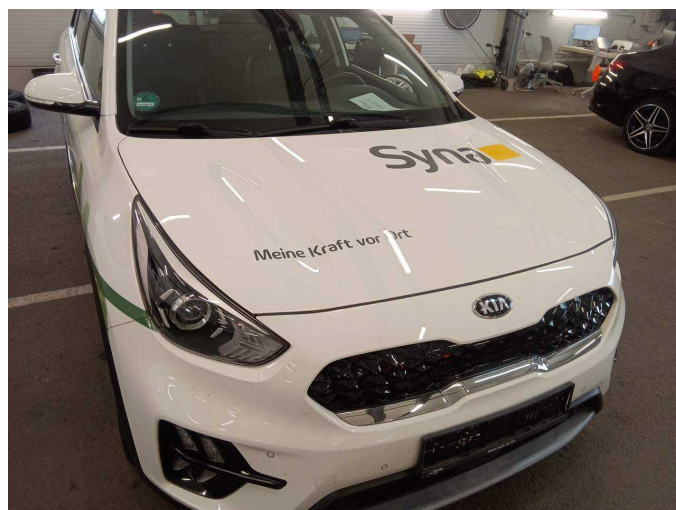
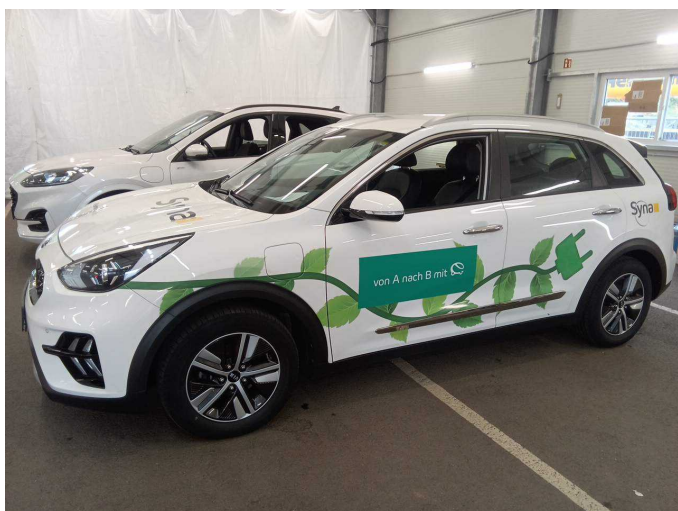
| No. | Component group | Description |
|---|---|---|
| 3 | Body | Body - Glued / labelled - De-glue / neutralise |

**Damage 3:** Body: Body - Glued / labelled - De-glue / neutralise

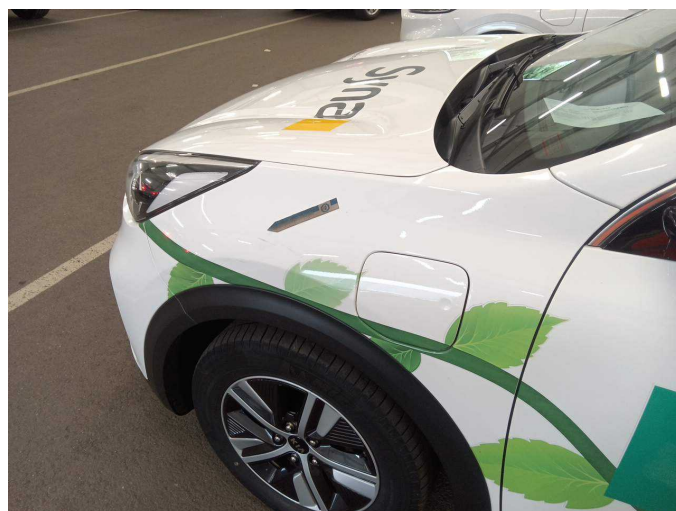
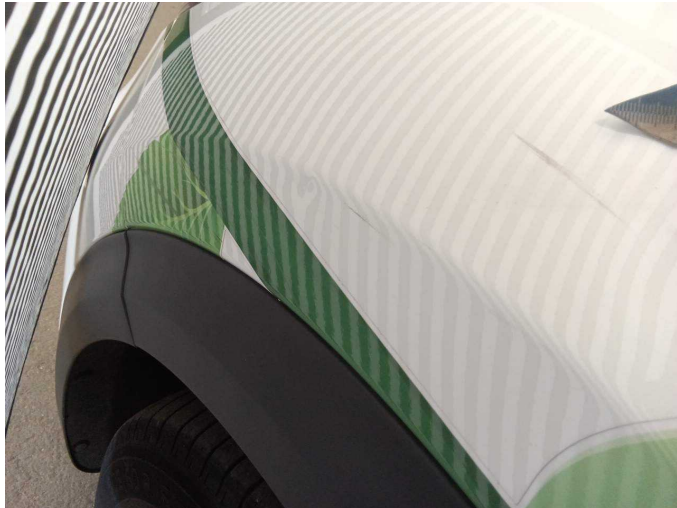
| No. | Component group | Description |
|---|---|---|
| 4 | Mudguard - left side | Mudguard - left side - Dent / paintcoat damage - Repair and paint |

**Damage 4:** Mudguard - left side: Mudguard - left side - Dent / paintcoat damage - Repair and paint

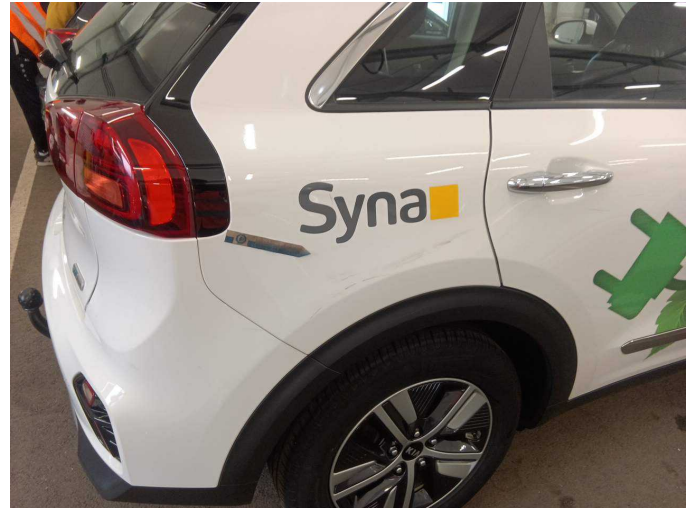
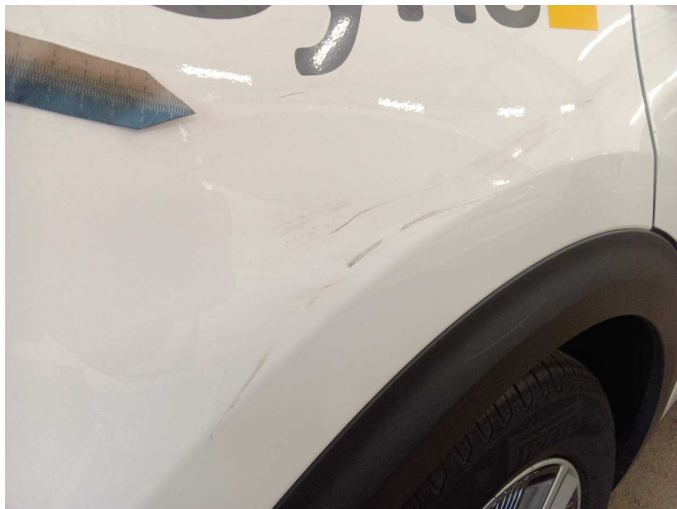
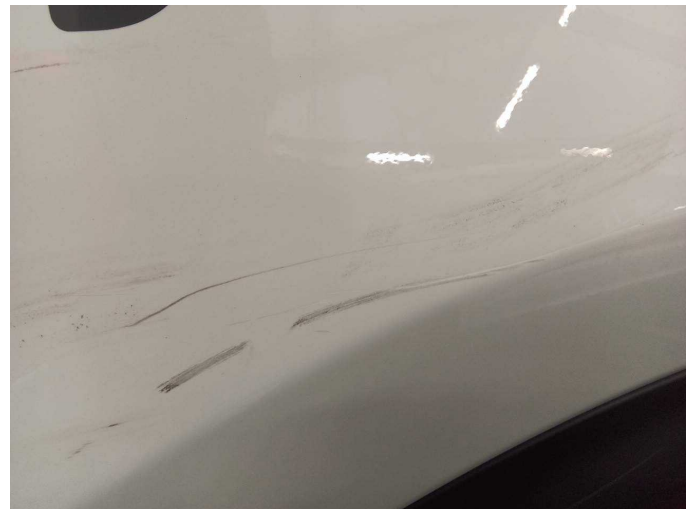
| No. | Component group | Description |
|---|---|---|
| 5 | Side panel - rear right side | Side panel - Scratch(es) - Paint |

**Damage 5:** Side panel - rear right side: Side panel - Scratch(es) - Paint

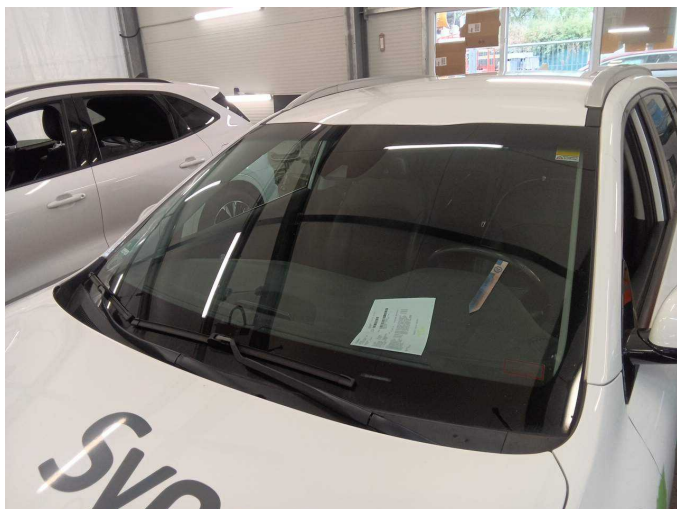
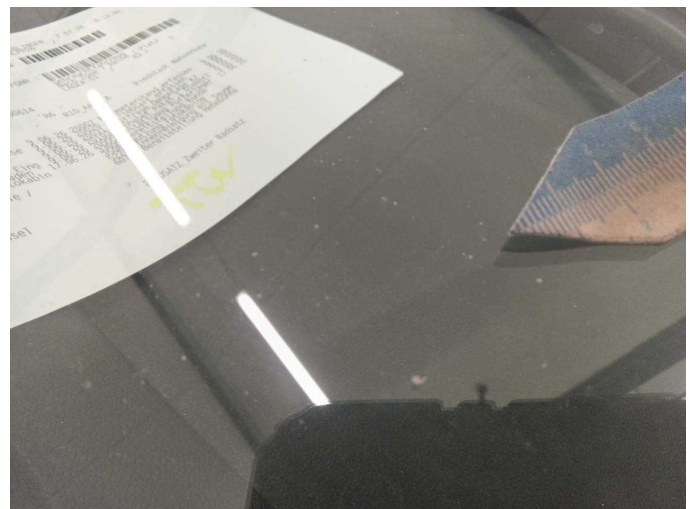
| No. | Component group | Description |
|---|---|---|
| 1 | Vehicle glazing | Windscreen - Stone chips - No deduction |

**Wear and tear 1:** Vehicle glazing: Windscreen - Stone chips - No deduction

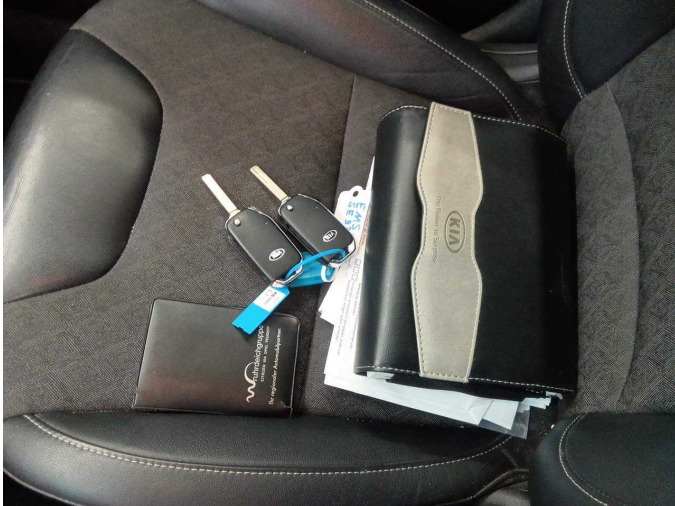
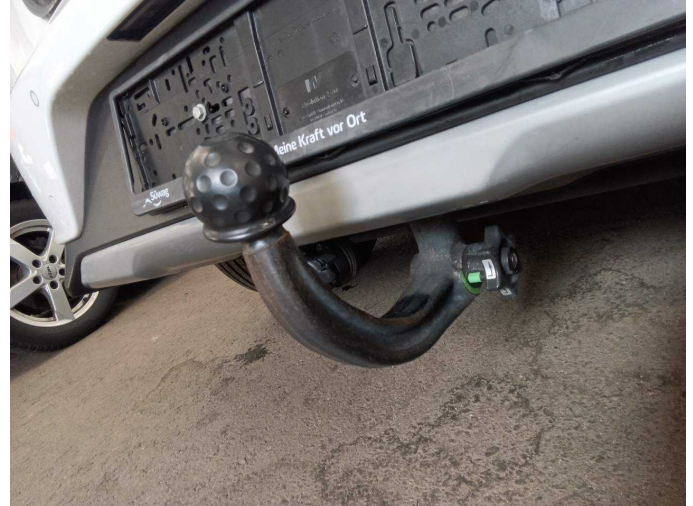
**Missing part 1:** Rear of vehicle: Key trailer hitch (2x) - Missing - Replace

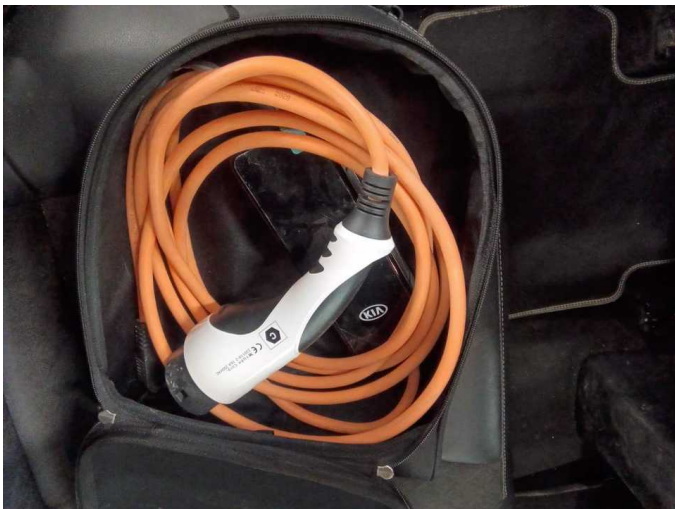
**Missing part 2:** Equipment: charging cable (Ladekabel für Wallboxes und Öffentliche Ladestationen) - Missing - Replace
