Expertise

Protocol number: 45960848
Order No. / Reference: 26423481-1
Inspection date: 9 Jun 2026

Manufacturer: Volkswagen

Model: Passat Variant 2.0 TDI SCR DSG Conceptline

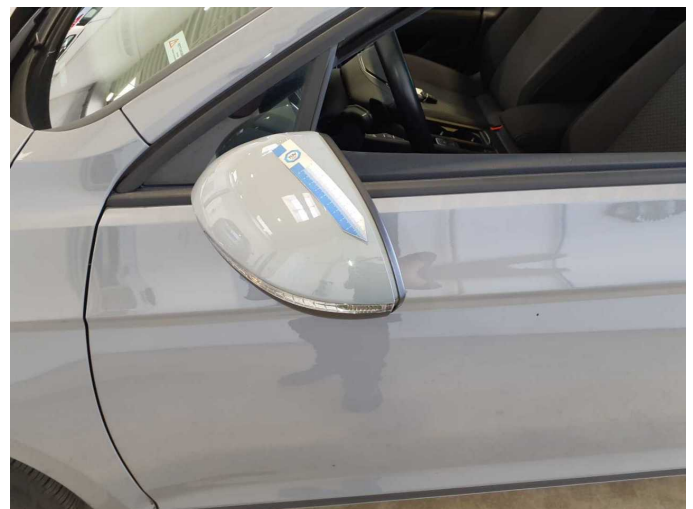
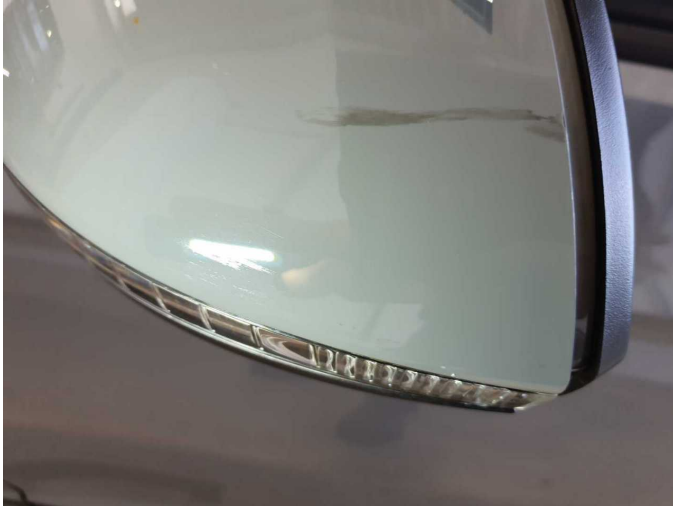
Damage 1: Wing mirror - left side: Cap - Scratch(es) - Smart repair

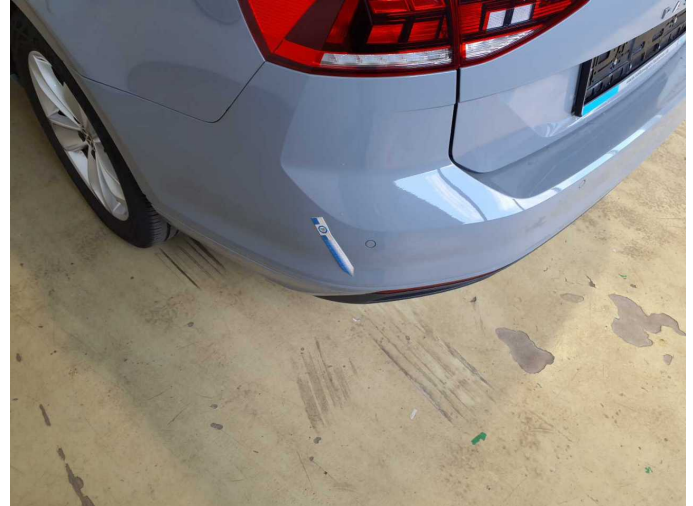
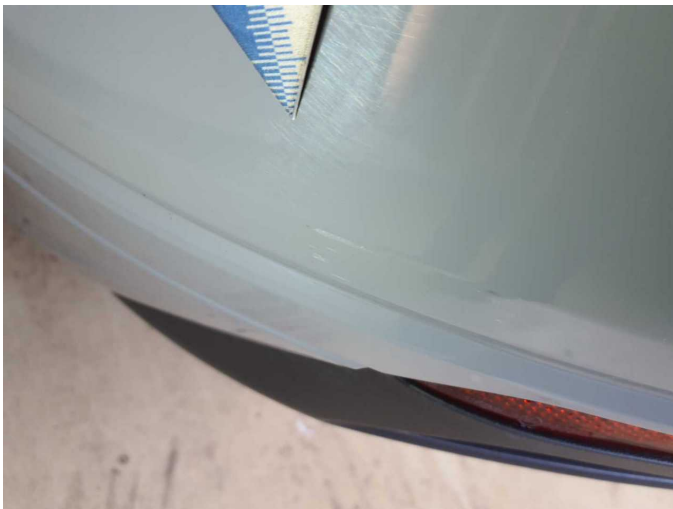
Damage 2: Rear bumper: Rear bumper - Scratch(es) - Smart repair

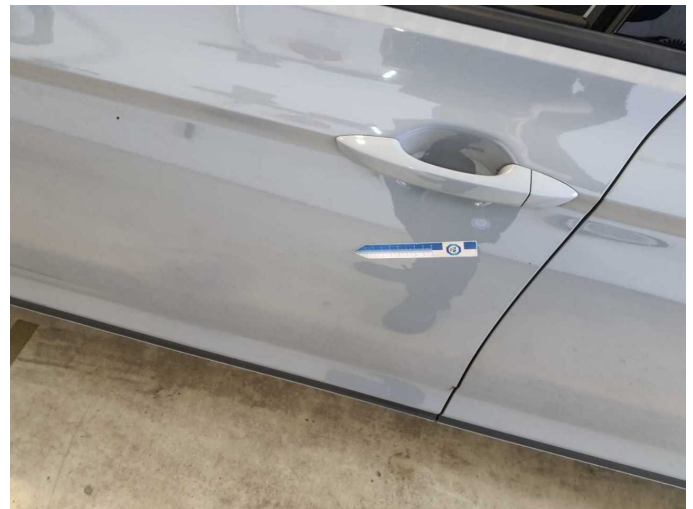
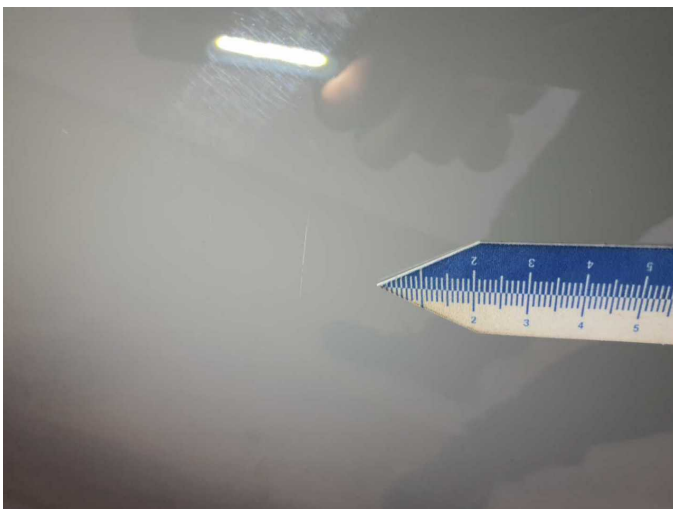
Damage 3: Door - front left side: Door - Scratch(es) - Smart repair

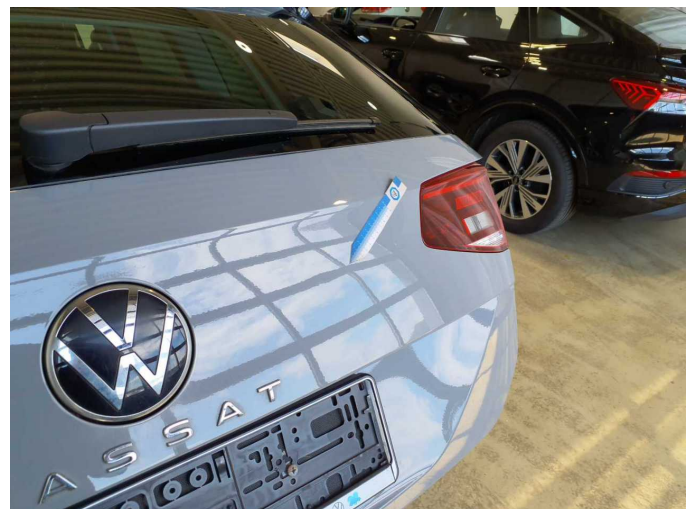
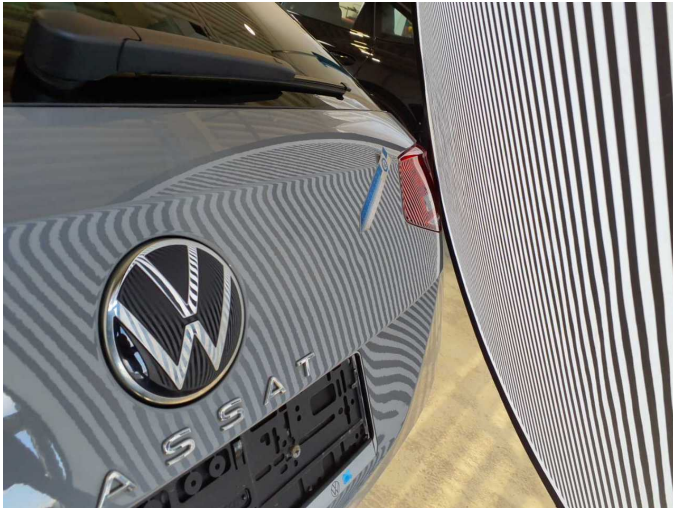
Damage 4: Boot lid / rear door: Boot lid - dent(s) - Smooth repair work

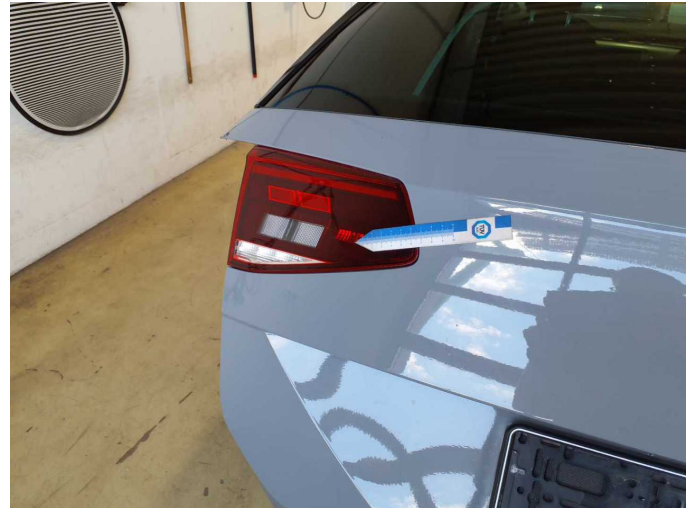
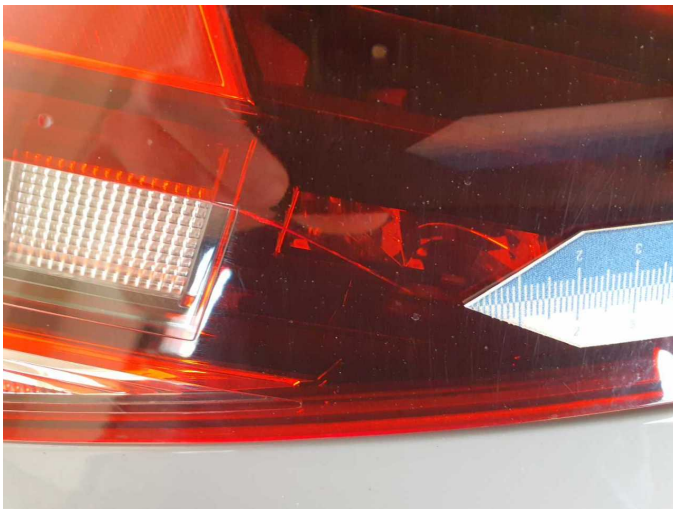
Damage 5: Tail light: Tail lamp - left side - Broken / torn - Replace

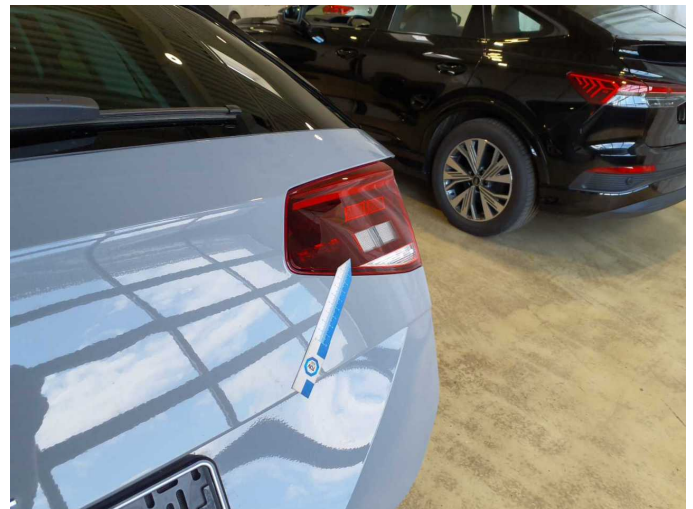
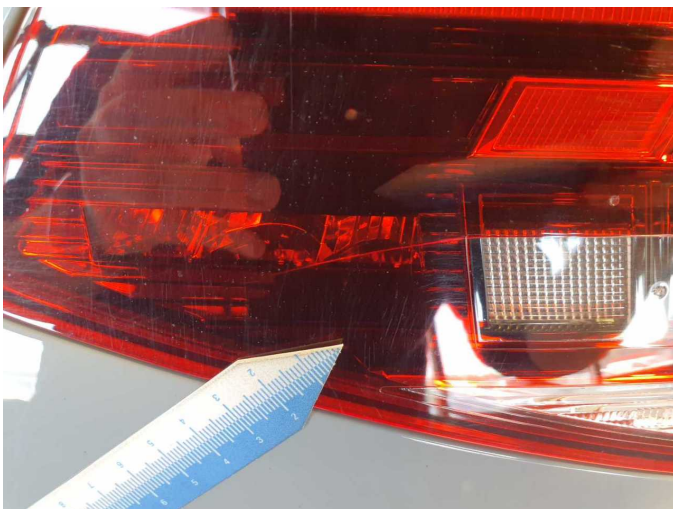
Damage 6: Tail light: Tail lamp - right side - Broken / torn - Replace

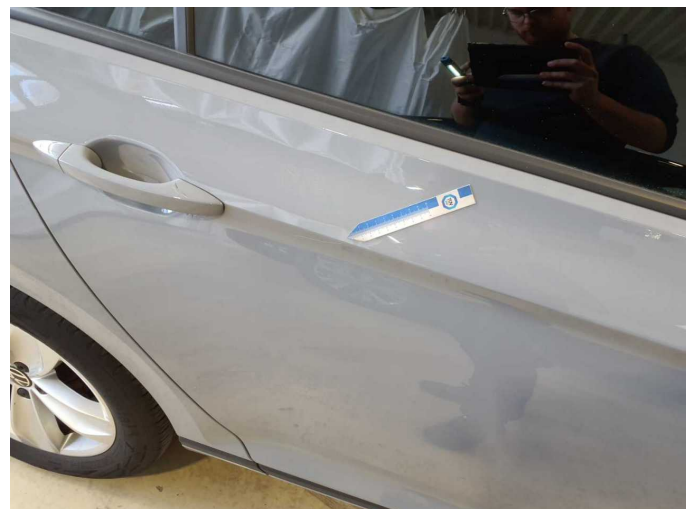
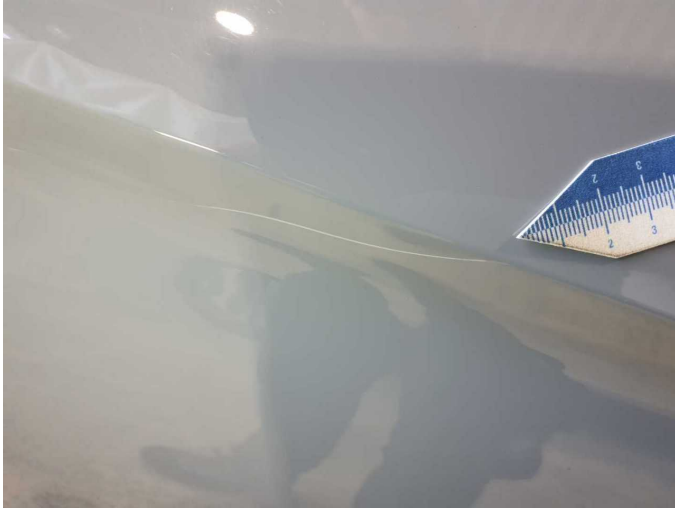
Damage 7: Door - rear right side: Door - Scratch(es) - Paint

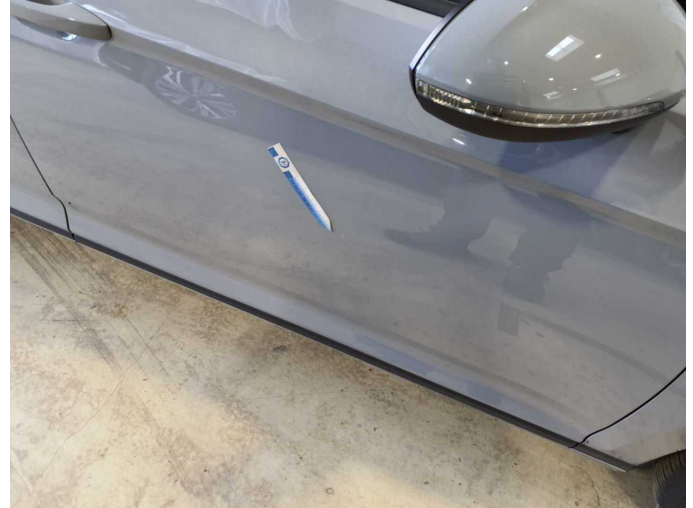
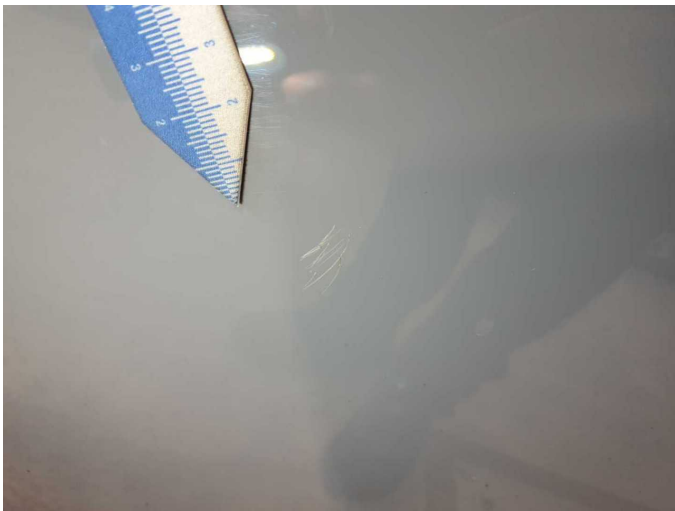
Damage 8: Door - front right side: Door - Scratch(es) - Paint

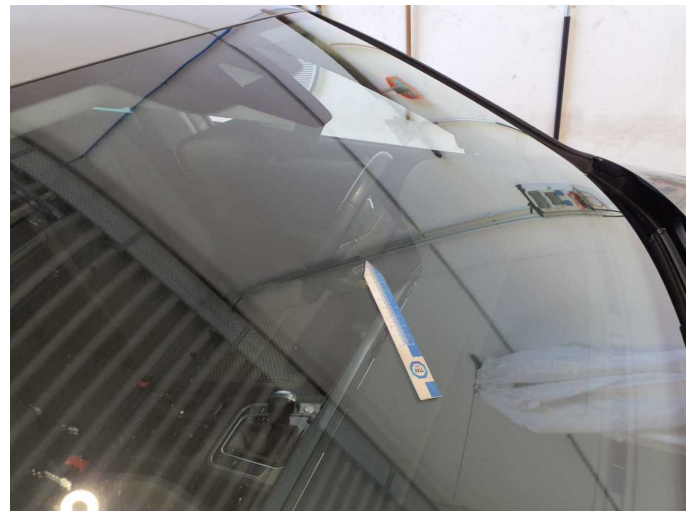
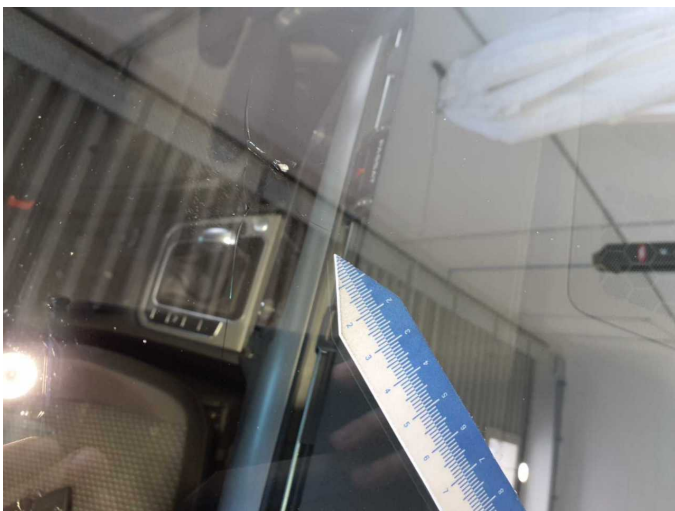
Damage 9: Vehicle glazing: Windscreen - Broken / torn - Replace
