Expertise

Protocol number: 46705478  
Order No. / Reference: 26803921  
Inspection date: 24 Jul 2026

Manufacturer: Mercedes-Benz

Model: Vito 116 CDI Lang HA Aut. BASE

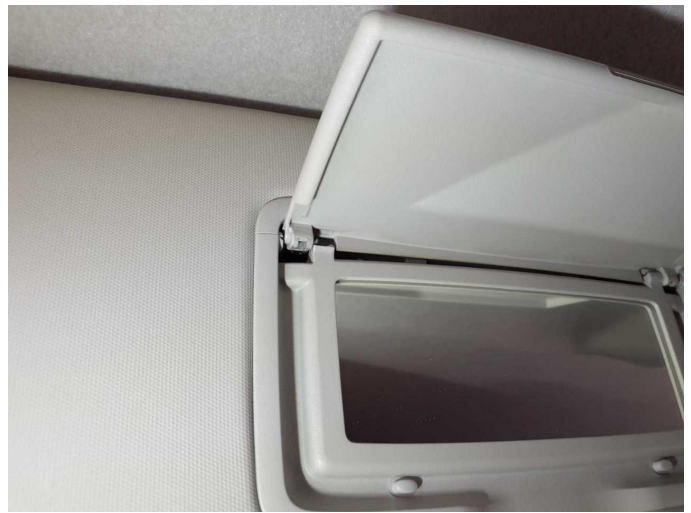
**Damage 1:** Interior: Sun visor - left side - Broken / torn - Replace

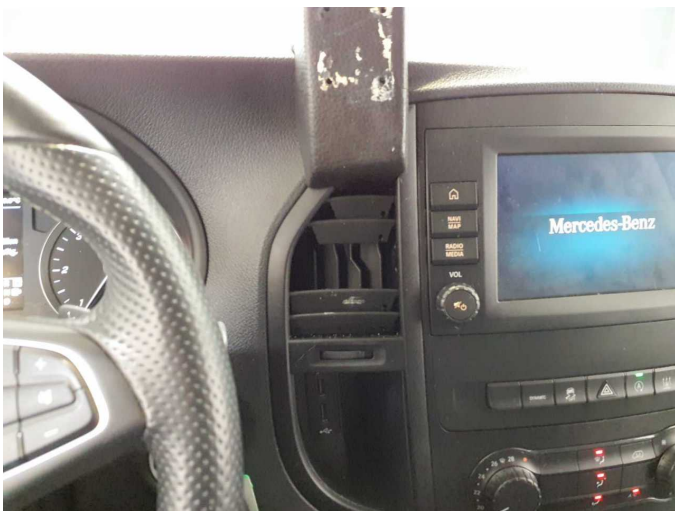
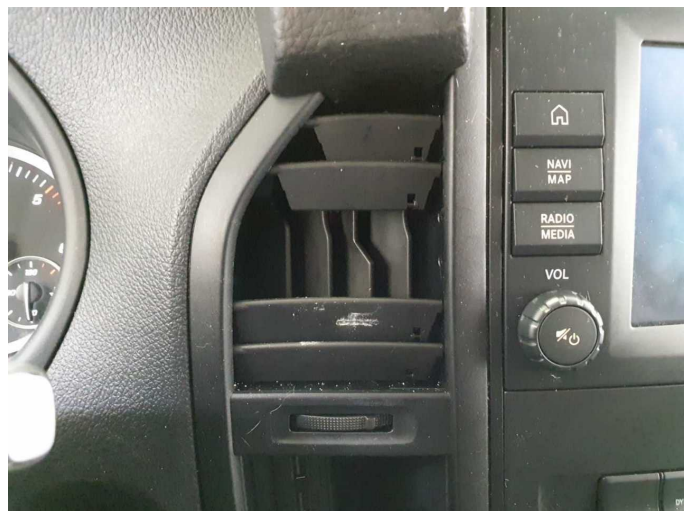
**Damage 2:** Instrument panel: Air nozzle - centre (links) - Broken / torn - Replace

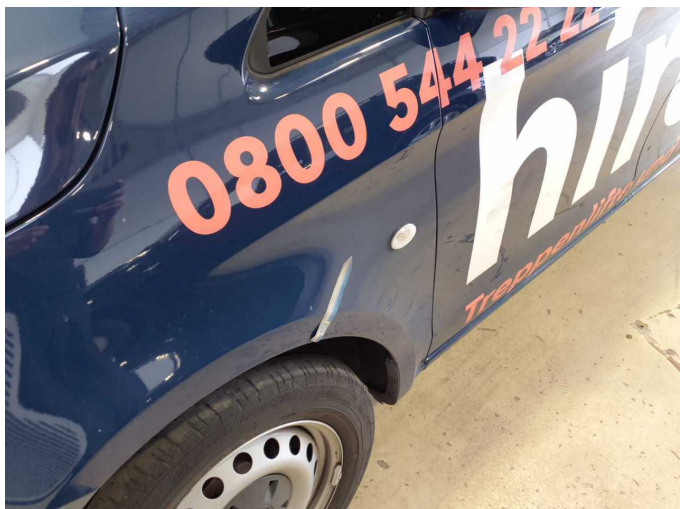
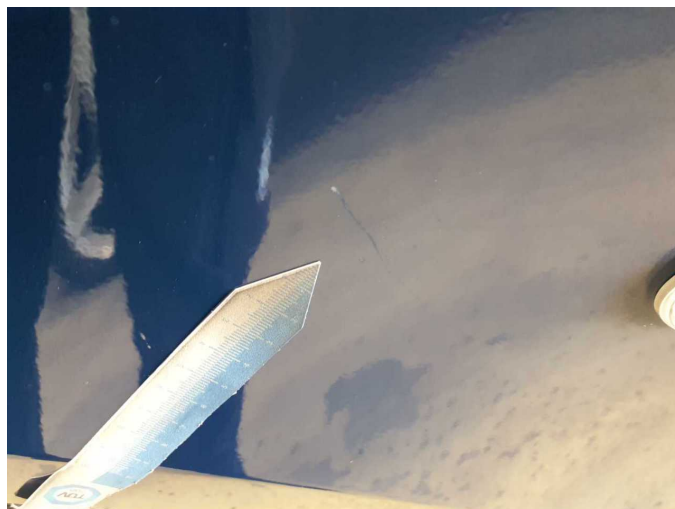
**Damage 3:** Mudguard - left side: Mudguard - left side - Scratch(es) - Smart repair

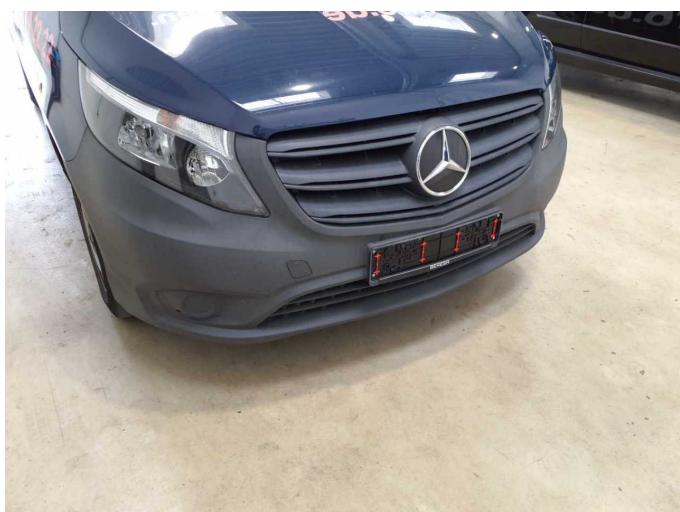
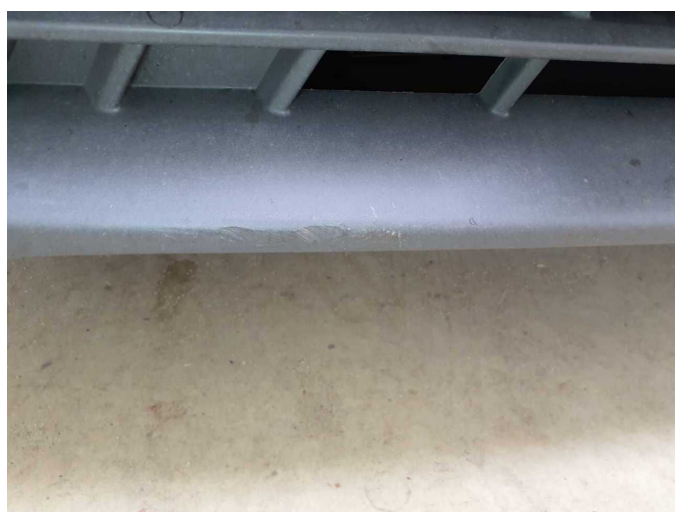
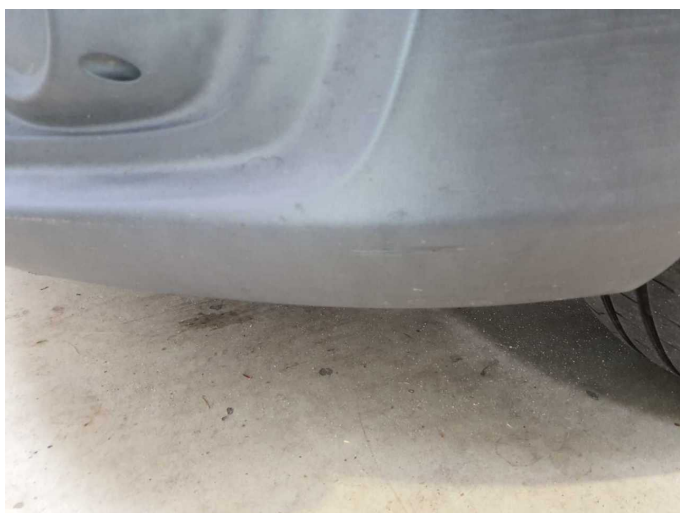
**Damage 4:** Front bumper: Front bumper - Scratch(es) - Loss in value

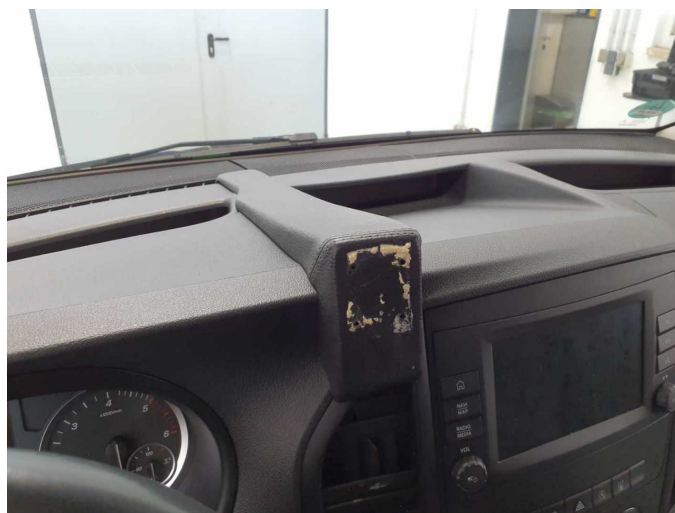
**Damage 5:** Instrument panel: Centre console - front - Differs from the original configuration - Smart repair

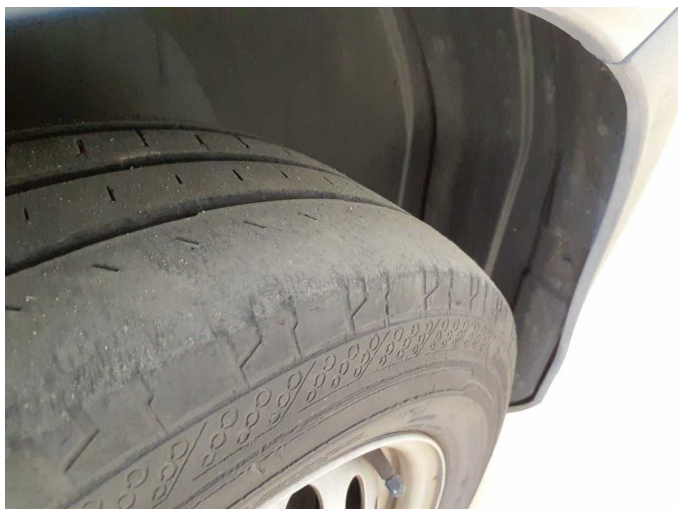
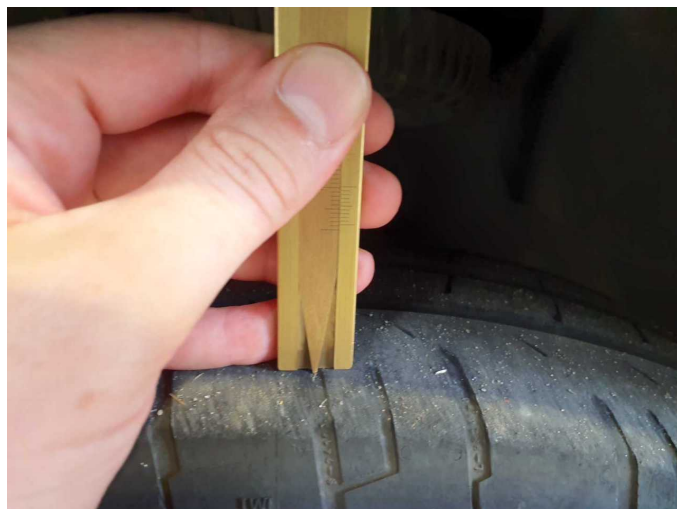
| # | Tyre size | Type of tyre | Manufacturer | Tread depth |
|---|---|---|---|---|
| 1) | 205/65 R16 107T | Summer tyres on Steel rim with wheel cover | Continental | 1mm / 0mm |

**Damage 6:** Wheel / tyres: Tyre - front - Worn - Replace

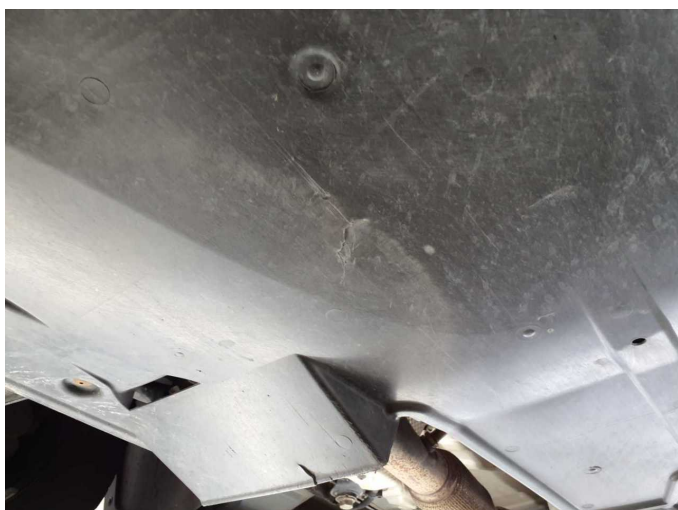
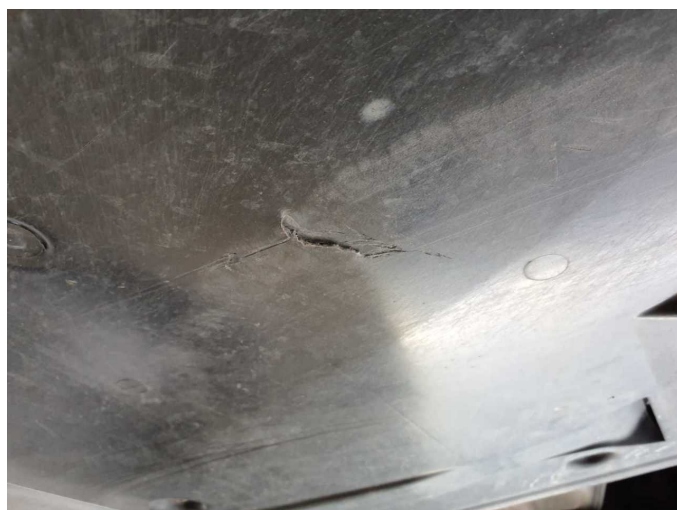
**Damage 7:** Body: Underbody panelling - Broken / torn - Replace

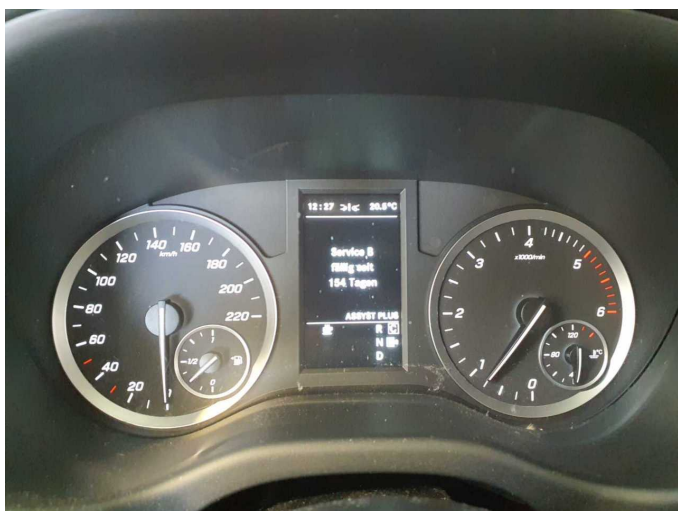
**Damage 8:** Misc.: Inspection / maintenance - Due - Perform

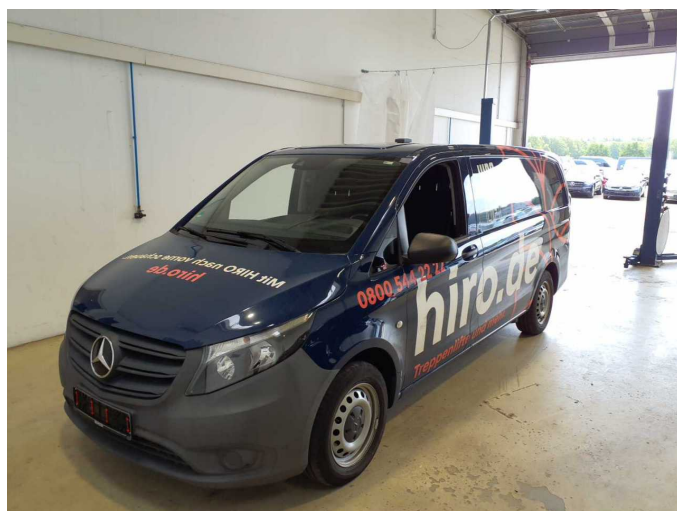
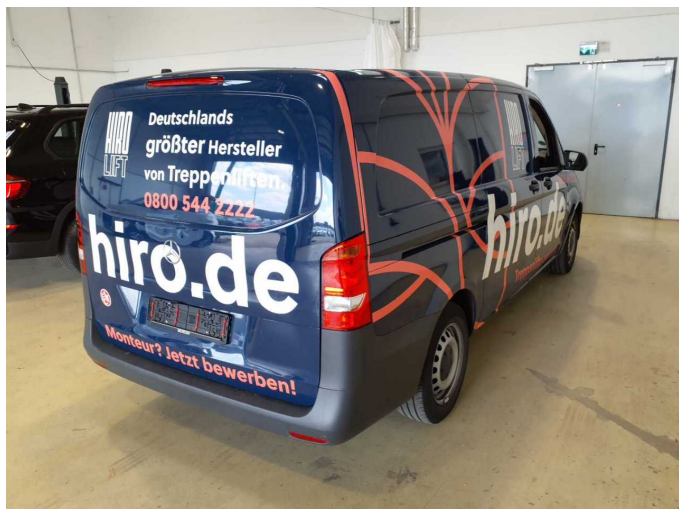
**Damage 9:** Body: Body - Glued / labelled - De-glue / neutralise

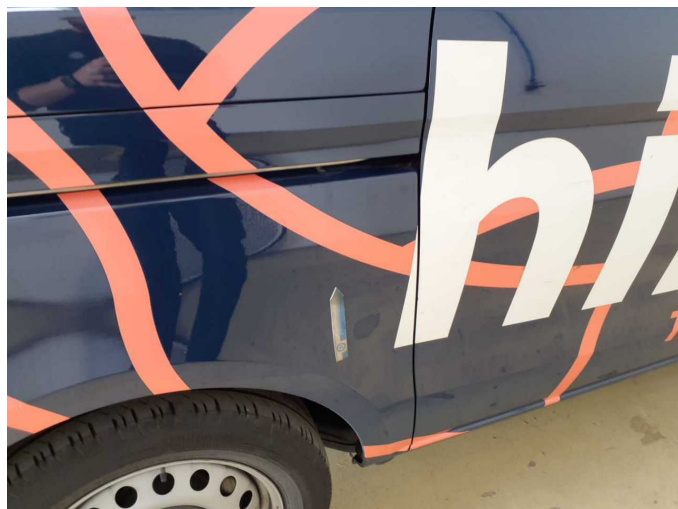
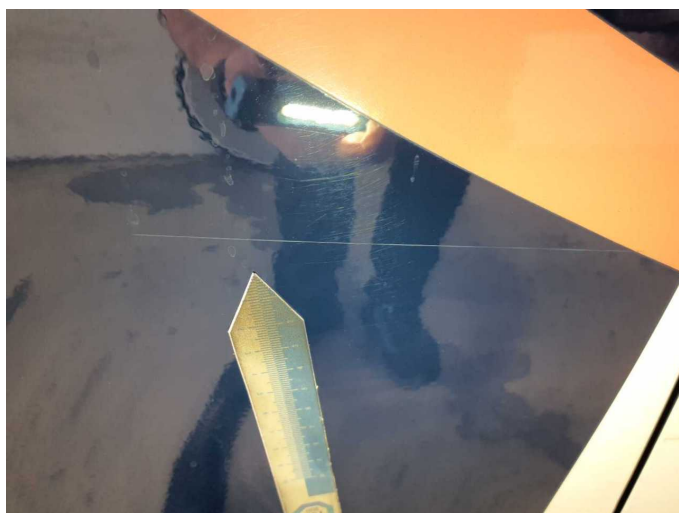
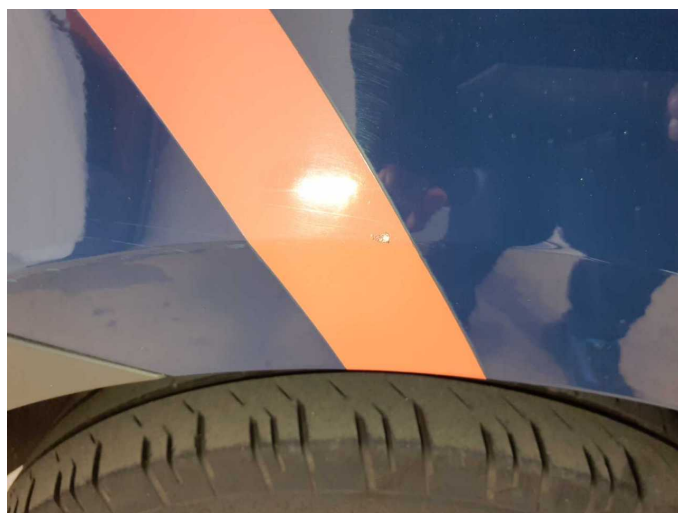
**Damage 10:** Side panel - rear right side: Side panel - Scratch(es) - Paint

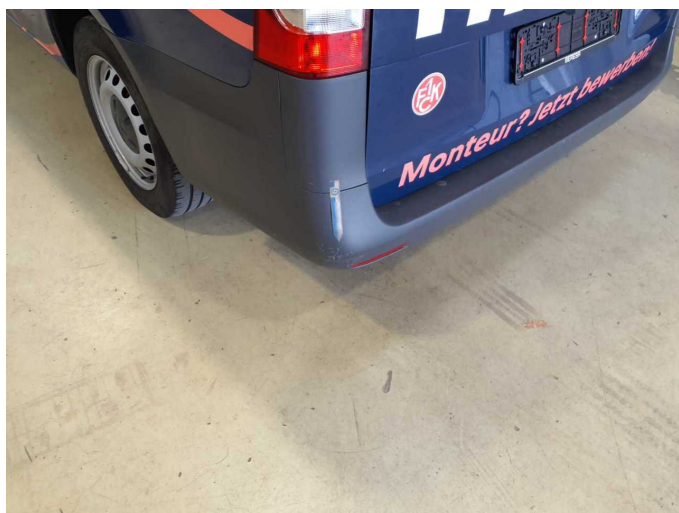
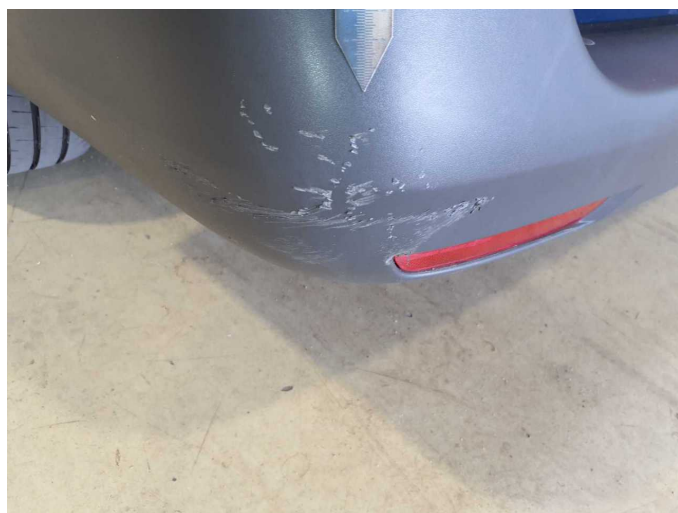
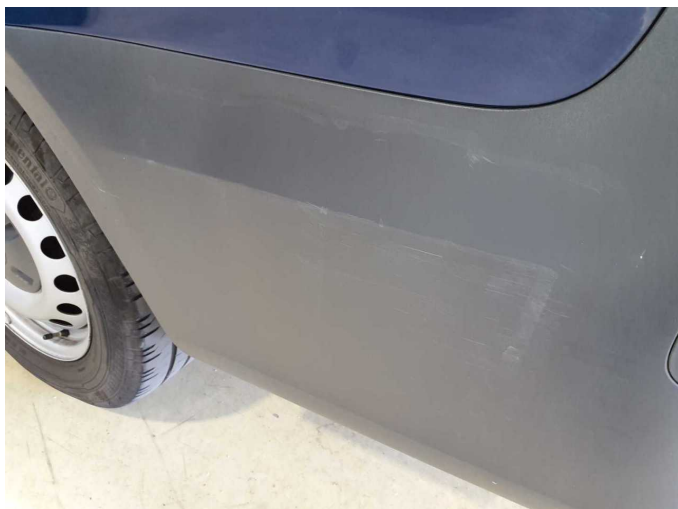
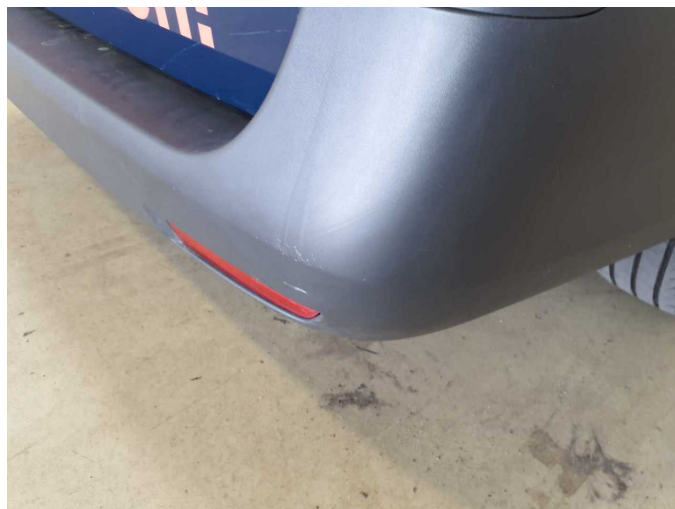
**Damage 11:** Rear bumper: Rear bumper (unpainted) - Scratch(es) - Replace

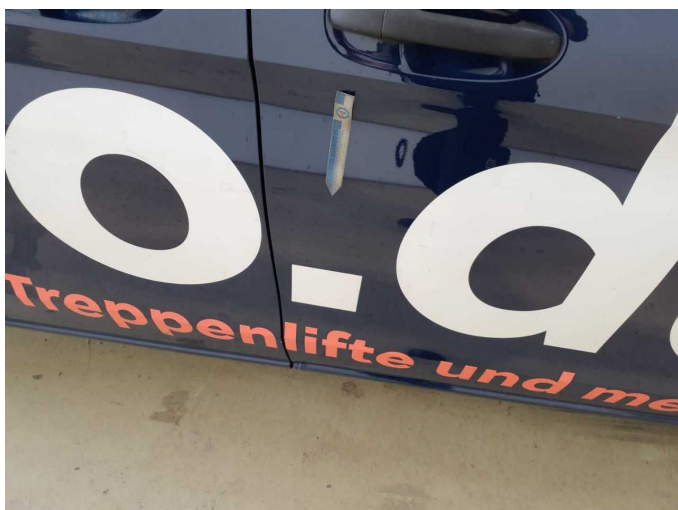
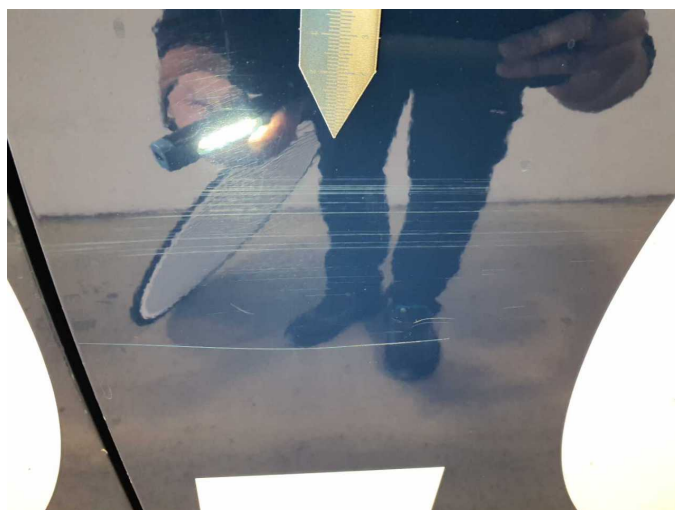
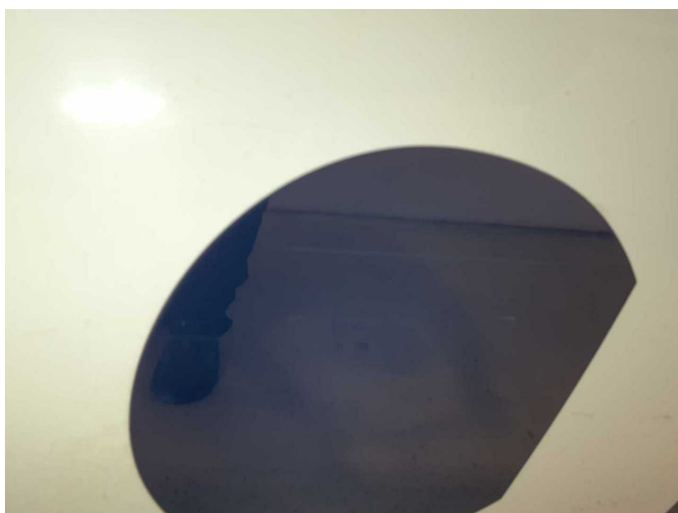
**Damage 12:** Door - front right side: Door (unterer Teil) - Scratch(es) - Paint

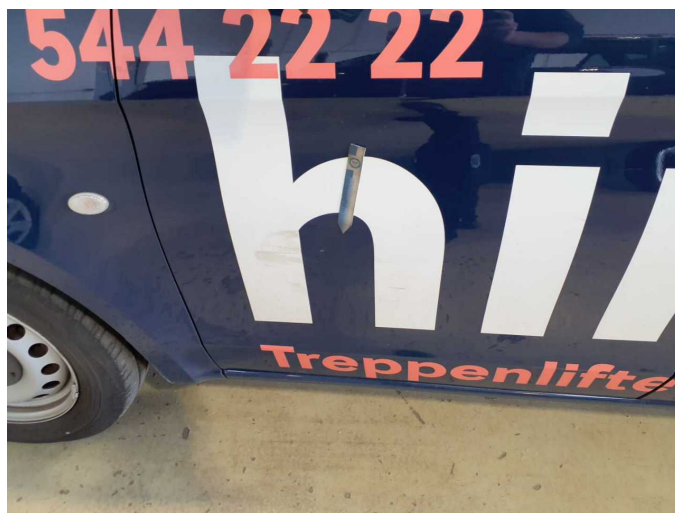
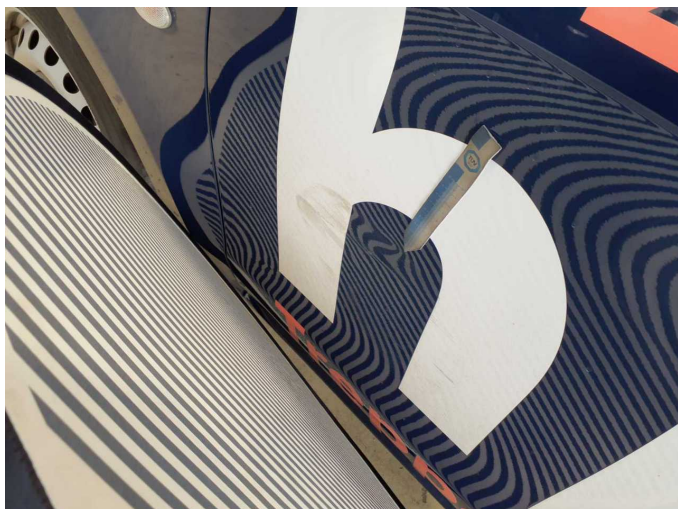
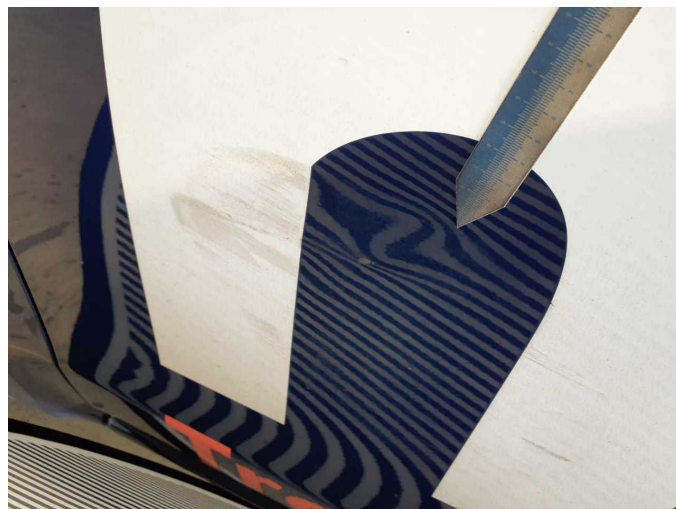
**Damage 13:** Door - front left side: Door (unterer Teil) - Dent / paintcoat damage - Repair and paint

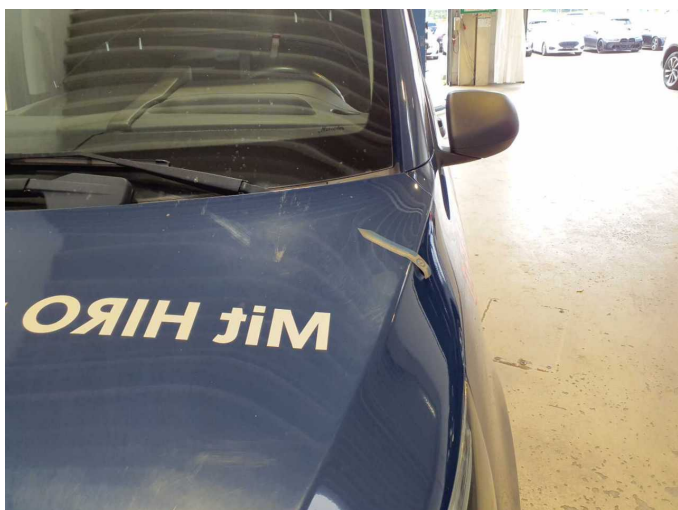
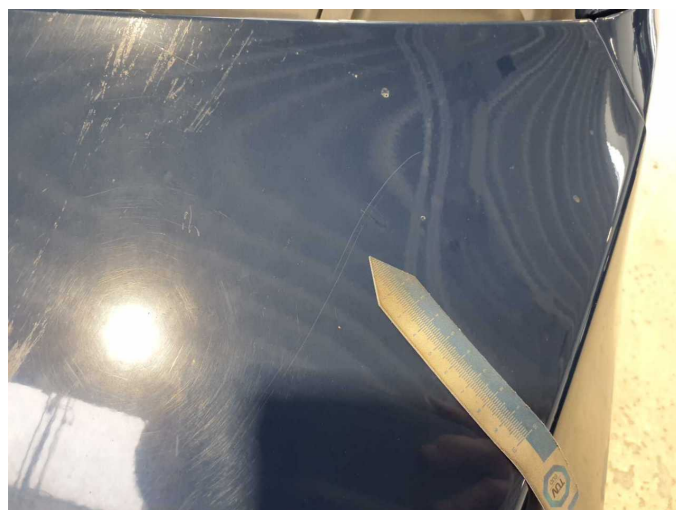
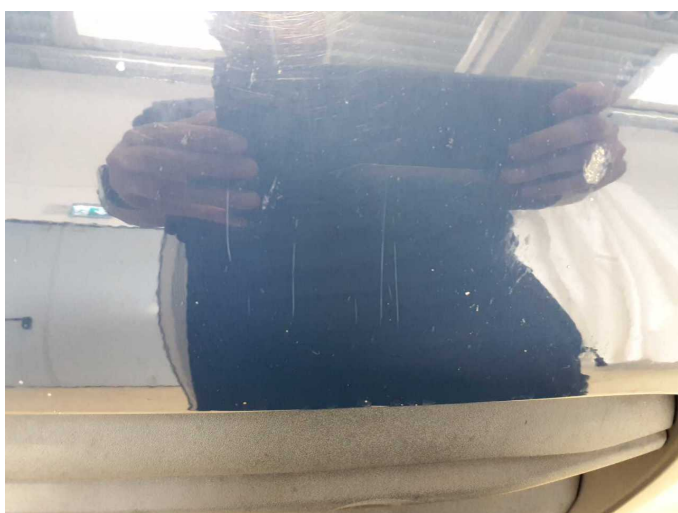
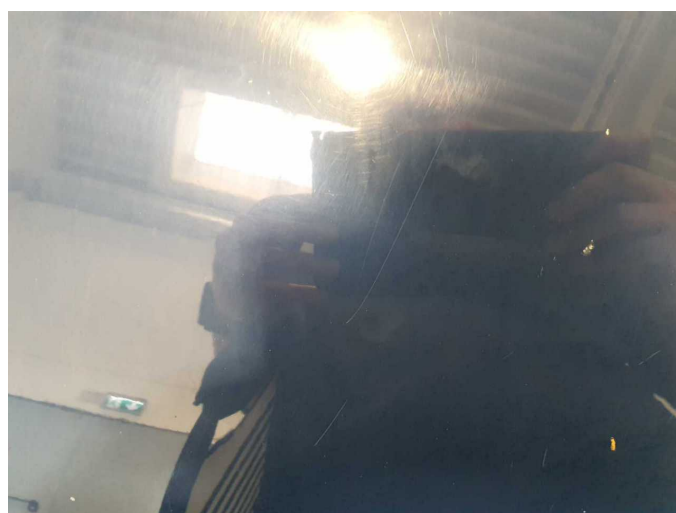
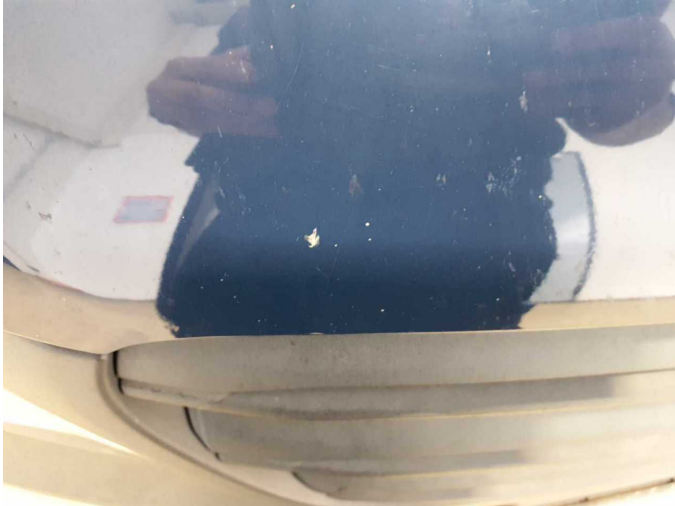
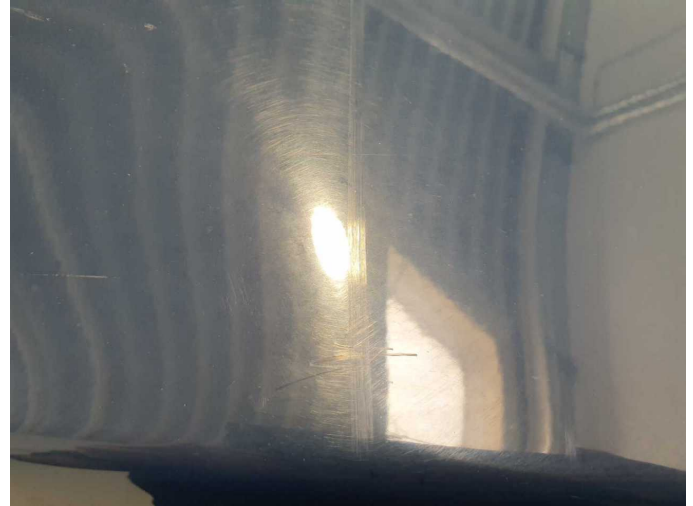
**Damage 14:** Bonnet: Bonnet - Scratch(es) - Paint

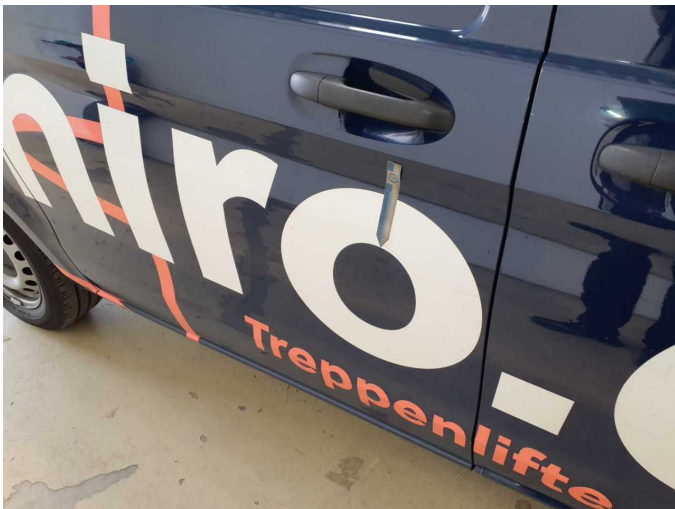
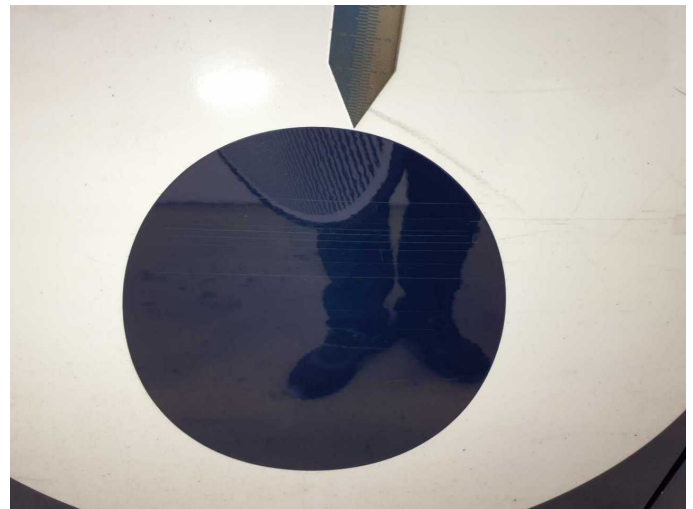
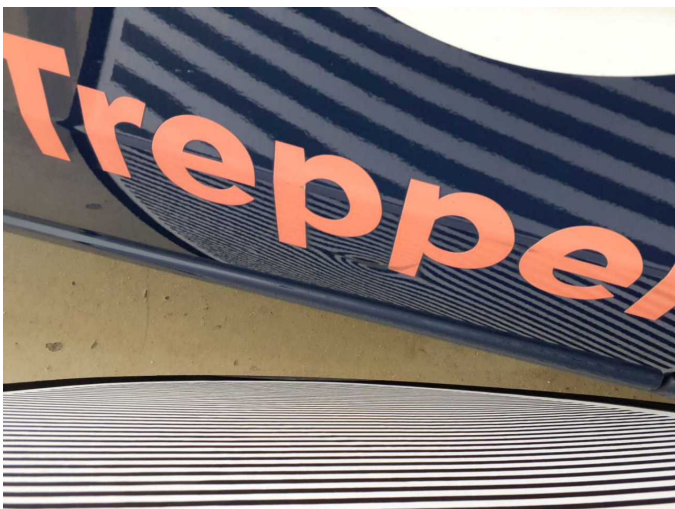
**Damage 15:** Sliding door, right: Sliding door - Dent / paintcoat damage - Paint

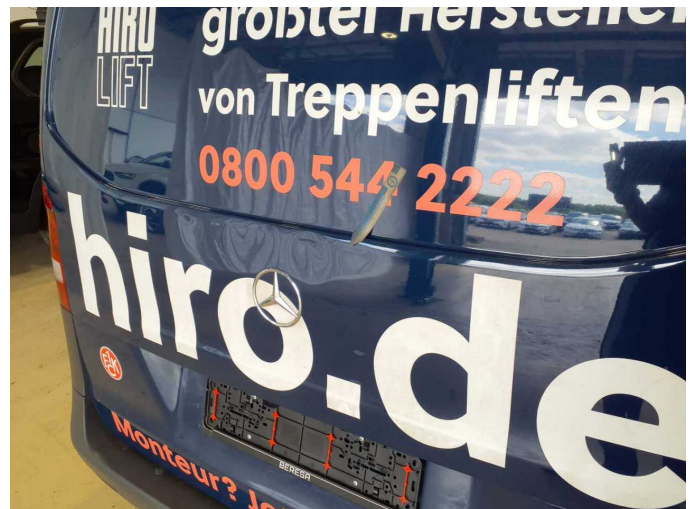
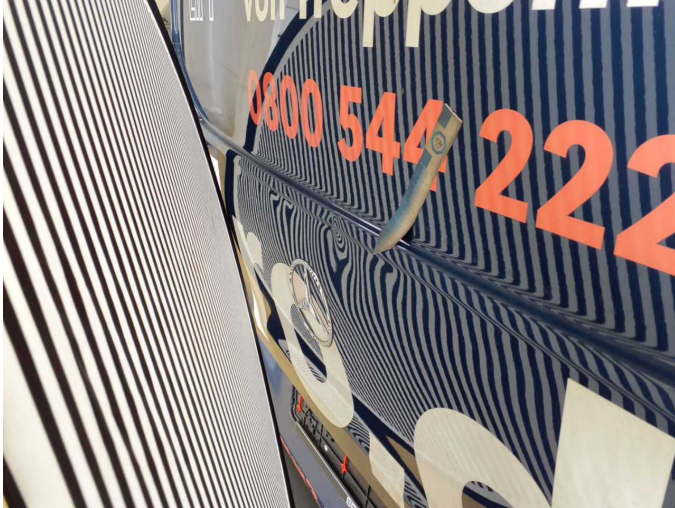
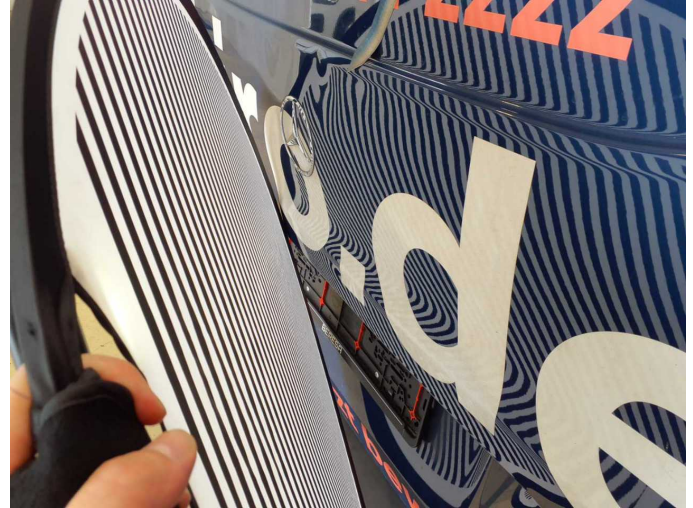
**Damage 16:** Boot lid / rear door: Boot lid - Deformed - Repair and paint

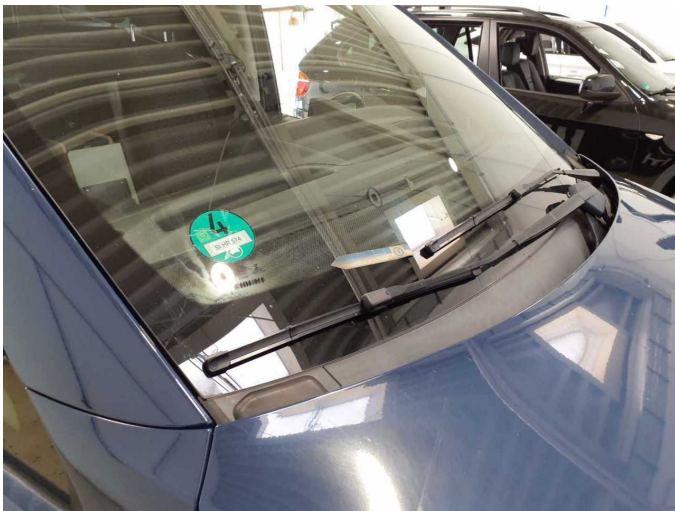
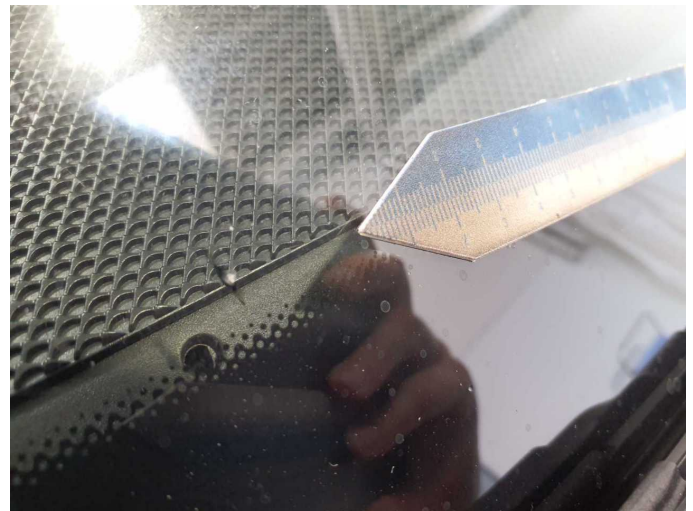
**Damage 17:** Vehicle glazing: Windscreen - Broken / torn - Replace

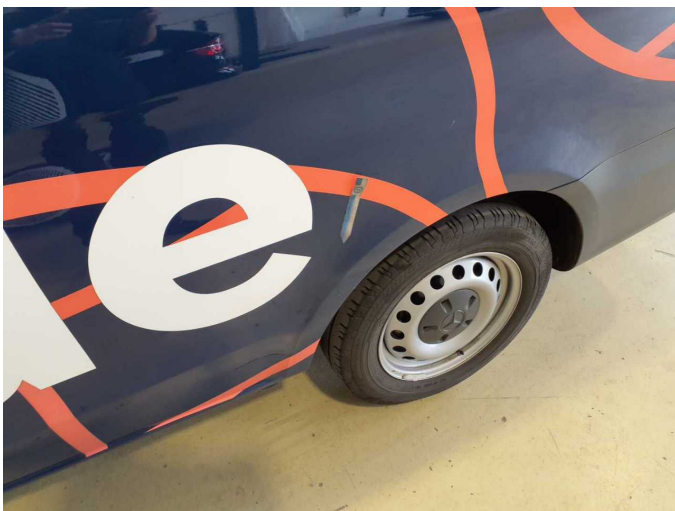
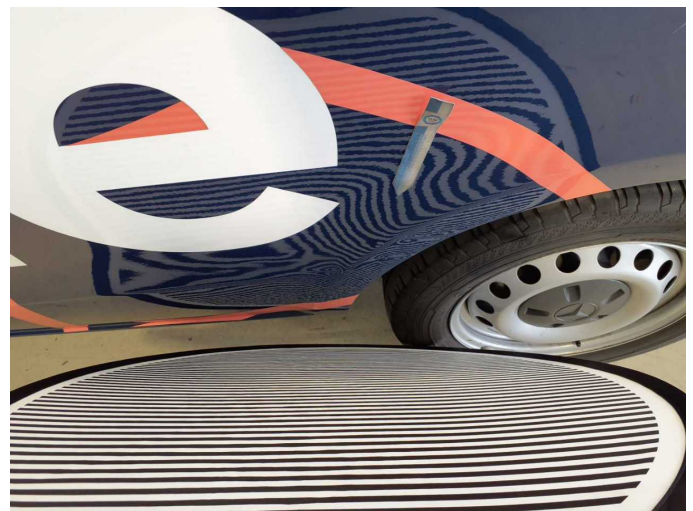
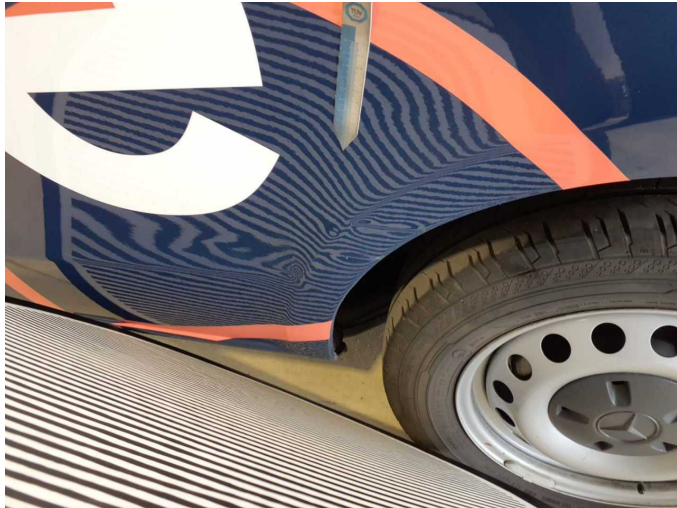
| No. | Previous damage | Extent of damage (Net) |
|---|---|---|
| 1 | Side - left, Professionally repaired, Invoice of repair done Non-existent, from 31 Dec 2023 | 2.166,15 € |

**Damage 18:** Side panel - rear left side: Side panel - Deformed - Repair and paint

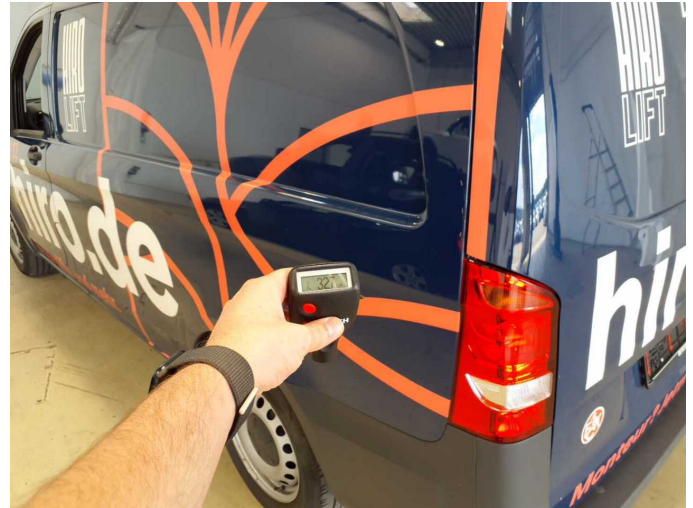
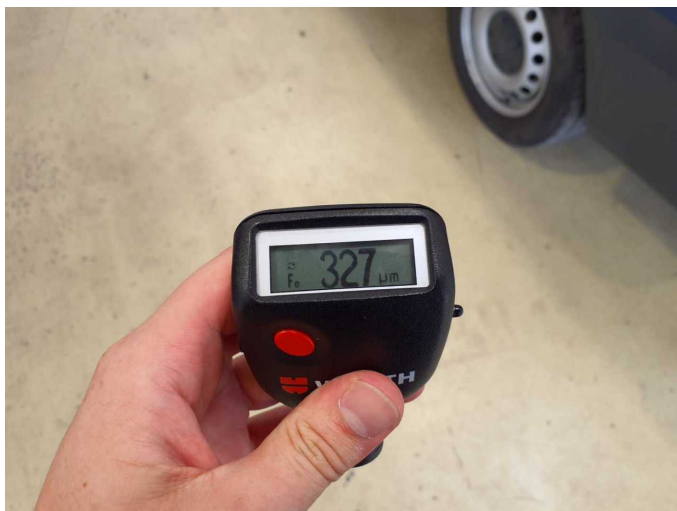
| No. | Repainting |
|---|---|
| 1 | Side panel - rear left side, Professionally carried out, Invoice of repair done Non-existent |

327 µm |

**Repainting 1:** Side panel - rear left side
