Expertise

Protocol number: 46881945  
Order No. / Reference: 26782872  
Inspection date: 4 Aug 2026

Manufacturer: Opel

Model: Astra 1.5 D Start/Stop Sports Tourer Elegance

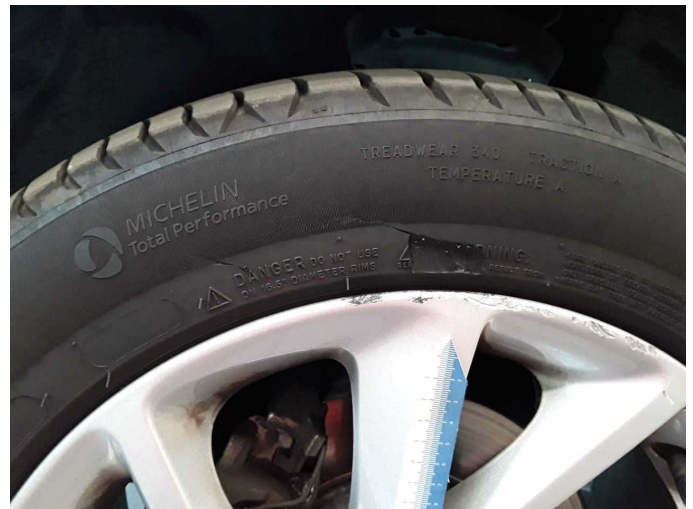
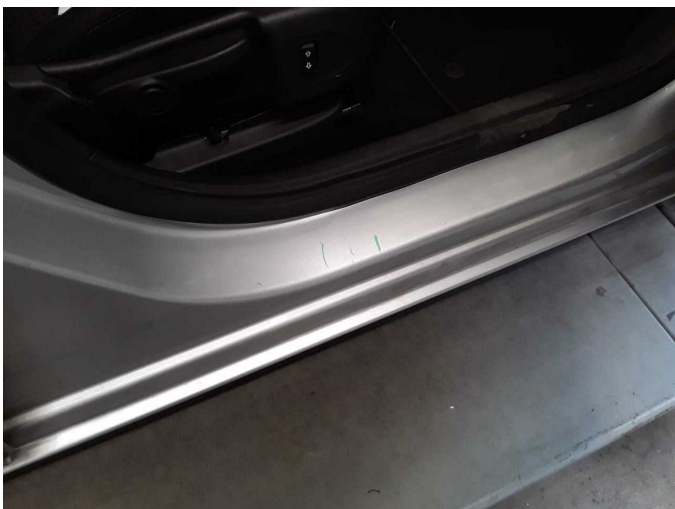
| No. | Component group | Description |
|---|---|---|
| 4 | Wheel / tyres | Tyre - front left side - Damaged - Replace |

**Damage 4:** Wheel / tyres: Tyre - front left side - Damaged - Replace

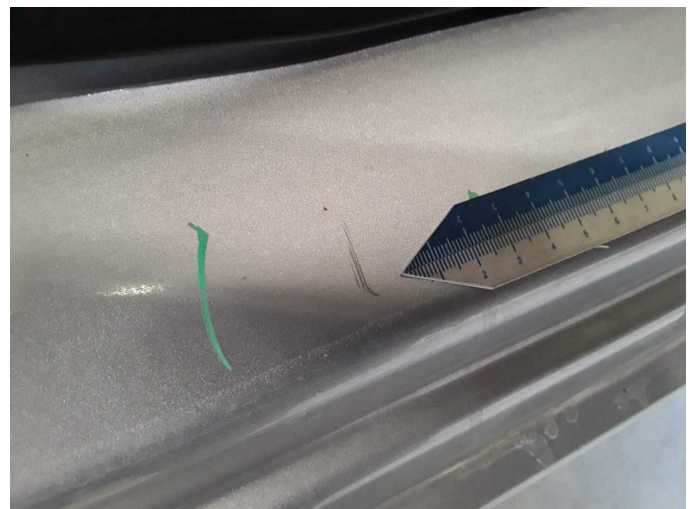
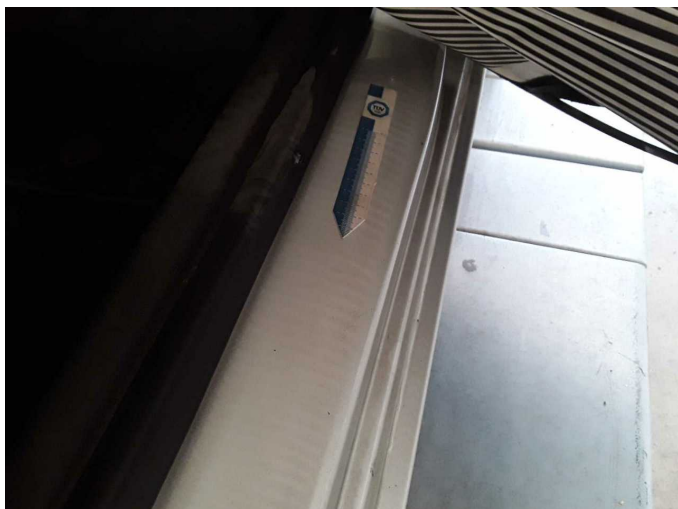
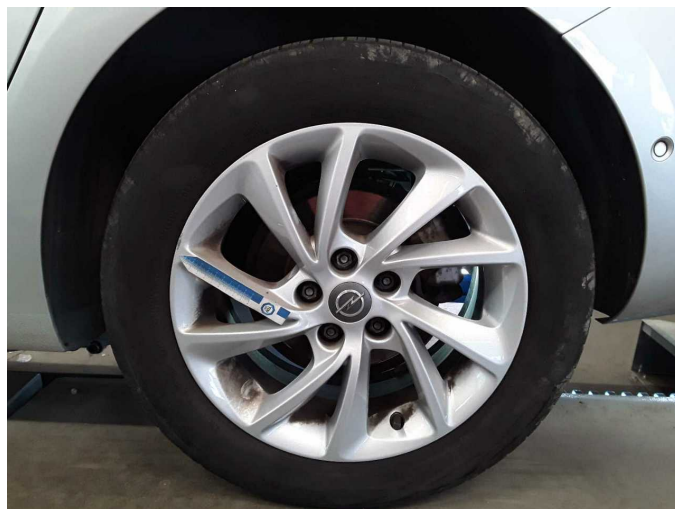
| No. | Component group | Description |
|---|---|---|
| 5 | Sill - right side | Sill - Dent / paintcoat damage - Smart repair |

**Damage 5:** Sill - right side: Sill - Dent / paintcoat damage - Smart repair

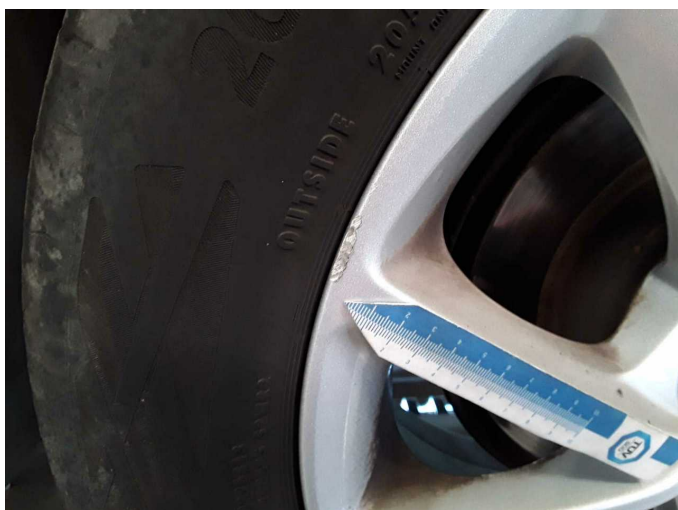
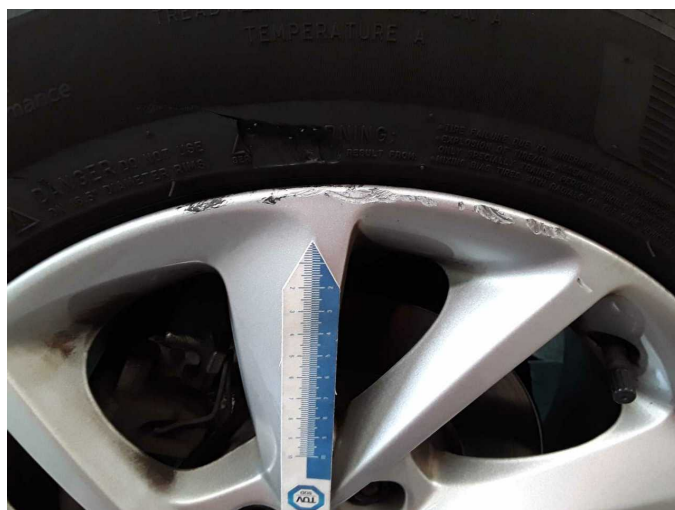
| No. | Component group | Description |
|---|---|---|
| 6 | Wheel / tyres | Alloy rim - rear left side - Scratched - Loss in value |

**Damage 6:** Wheel / tyres: Alloy rim - rear left side - Scratched - Loss in value

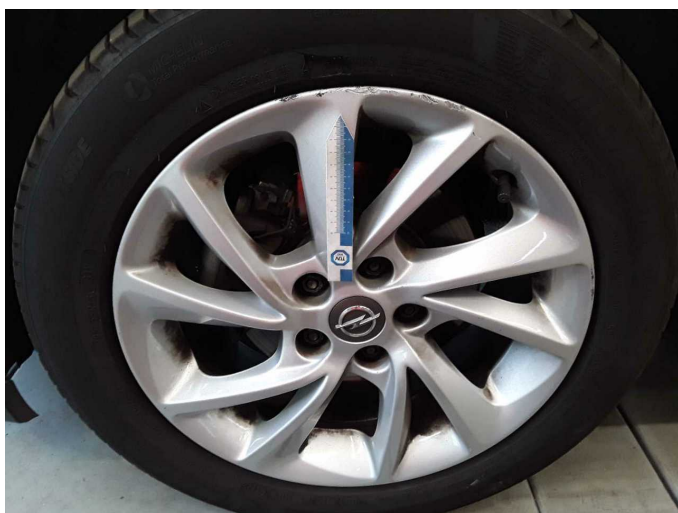
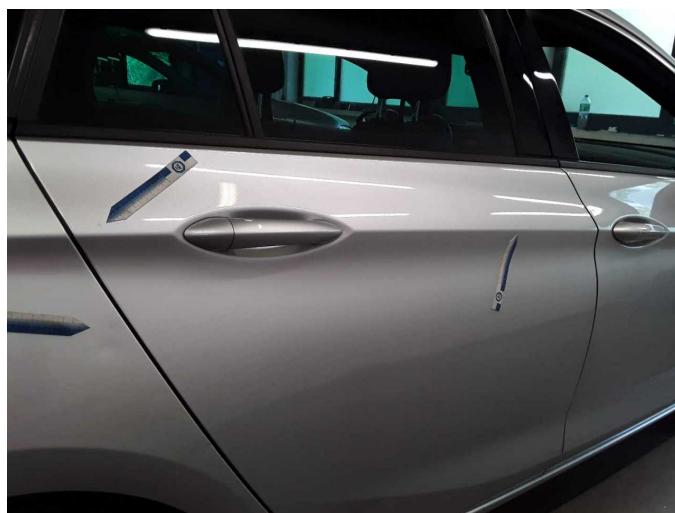
| No. | Component group | Description |
|---|---|---|
| 7 | Wheel / tyres | Alloy rim - front left side - Scratched - Replace |

**Damage 7:** Wheel / tyres: Alloy rim - front left side - Scratched - Replace

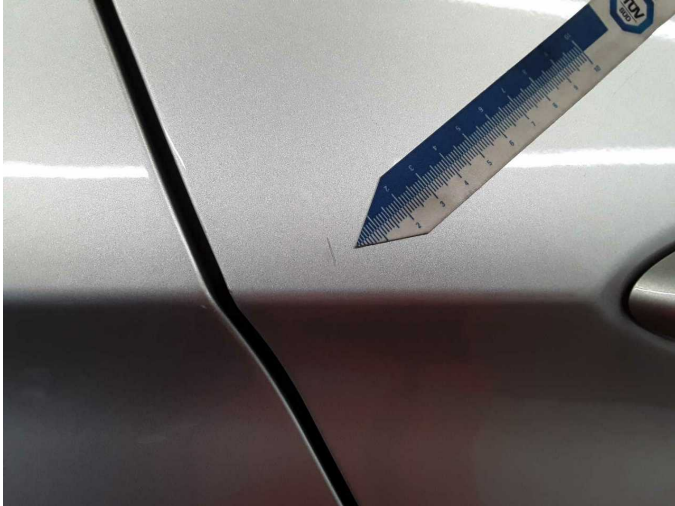
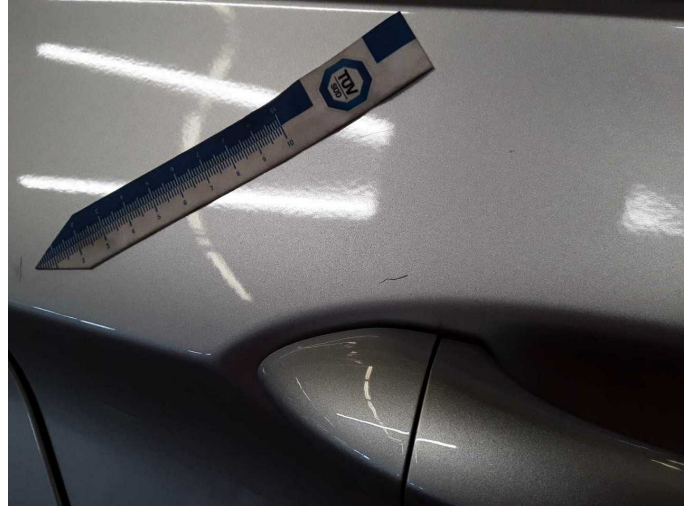
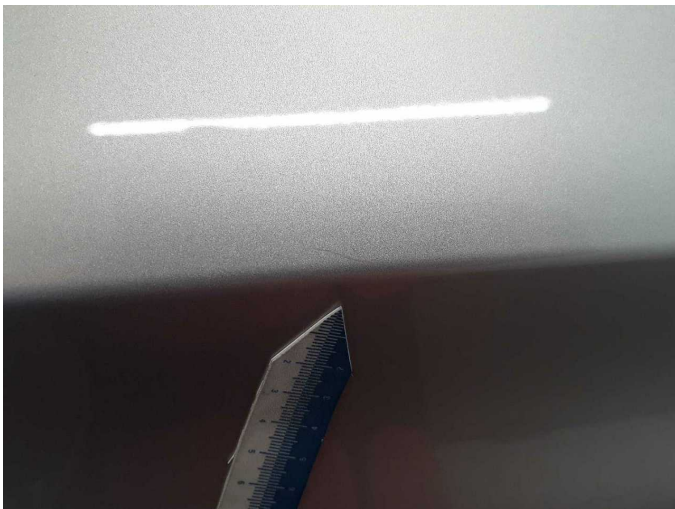
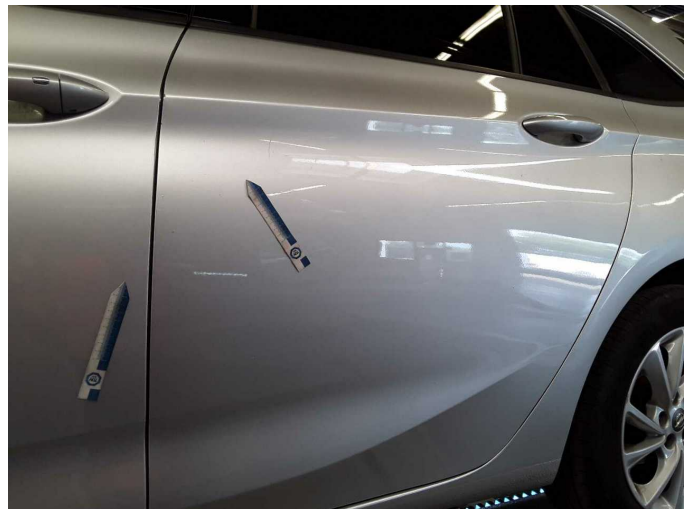
| No. | Component group | Description |
|---|---|---|
| 8 | Door - rear right side | Door - Scratched - Paint |

**Damage 8:** Door - rear right side: Door - Scratched - Paint

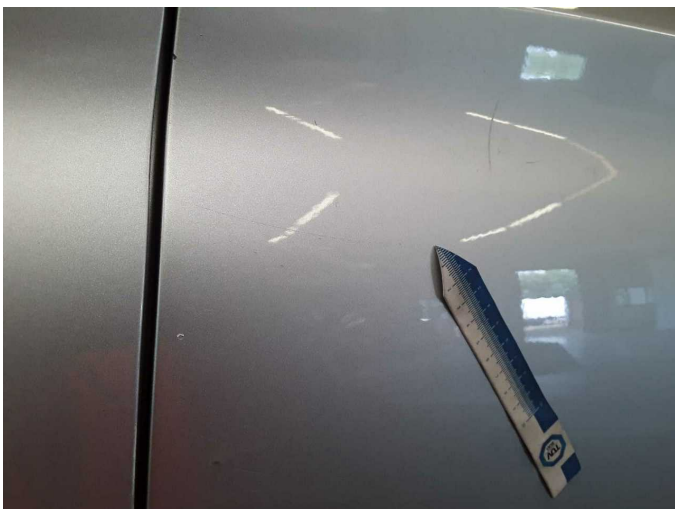
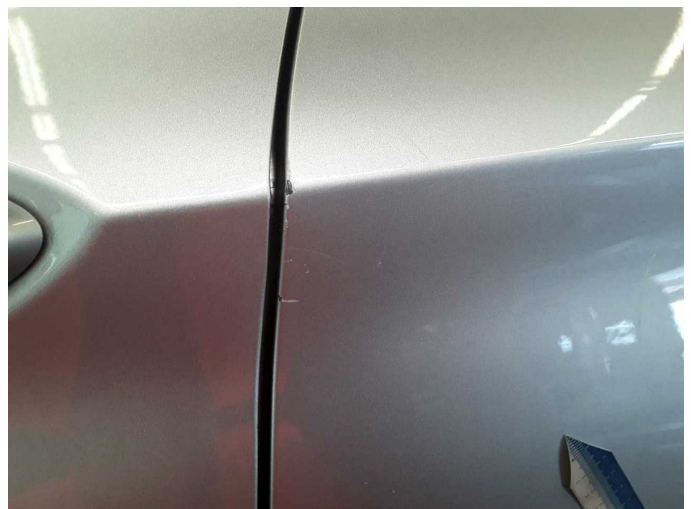
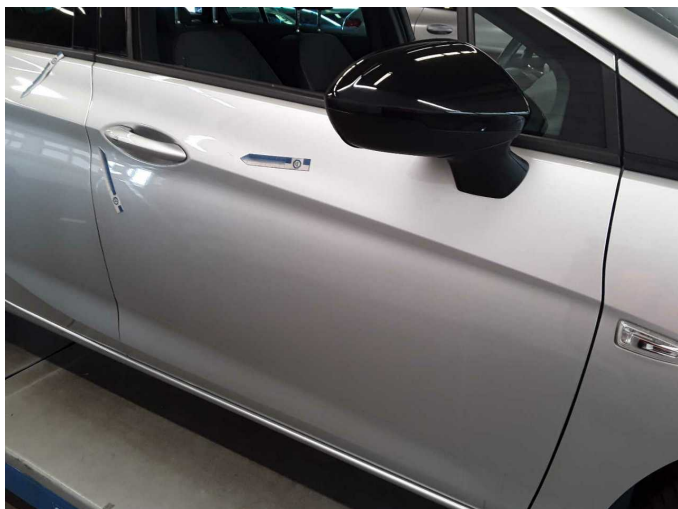
| No. | Component group | Description |
|---|---|---|
| 9 | Door - rear left side | Door - Scratched - Paint |

**Damage 9:** Door - rear left side: Door - Scratched - Paint

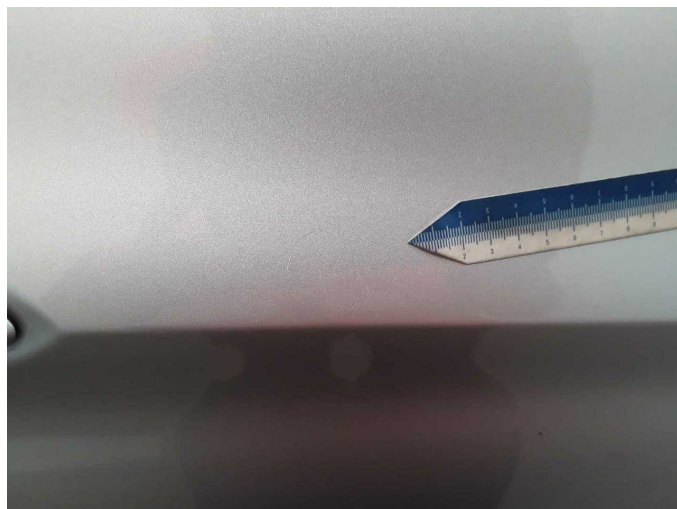
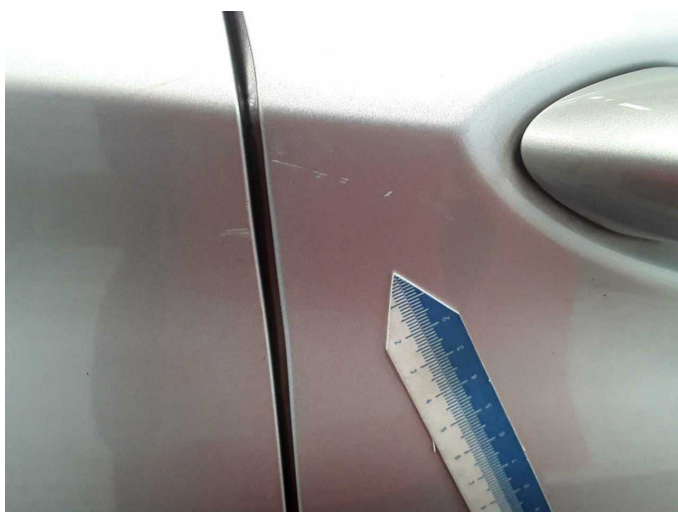
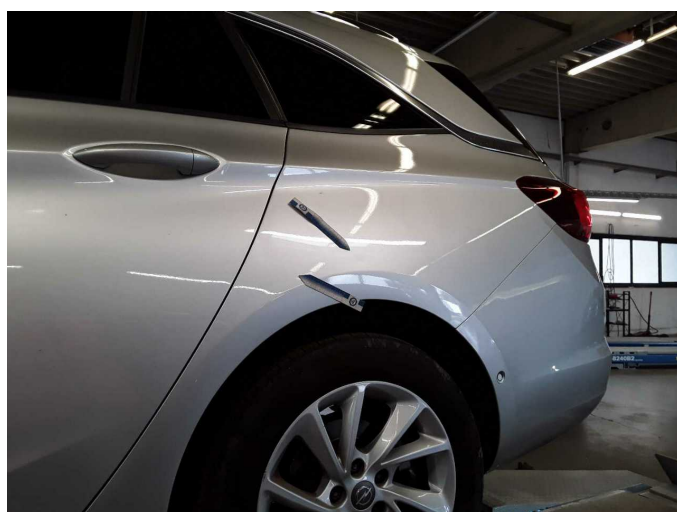
| No. | Component group | Description |
|---|---|---|
| 10 | Door - front right side | Door - Scratched - Paint |

**Damage 10:** Door - front right side: Door - Scratched - Paint

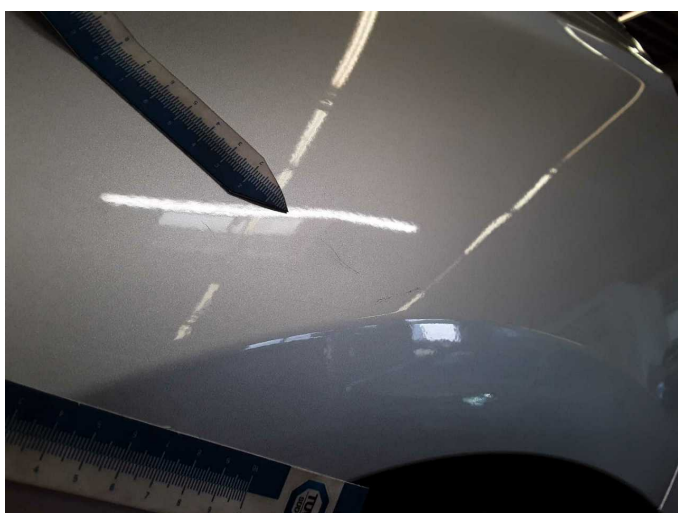
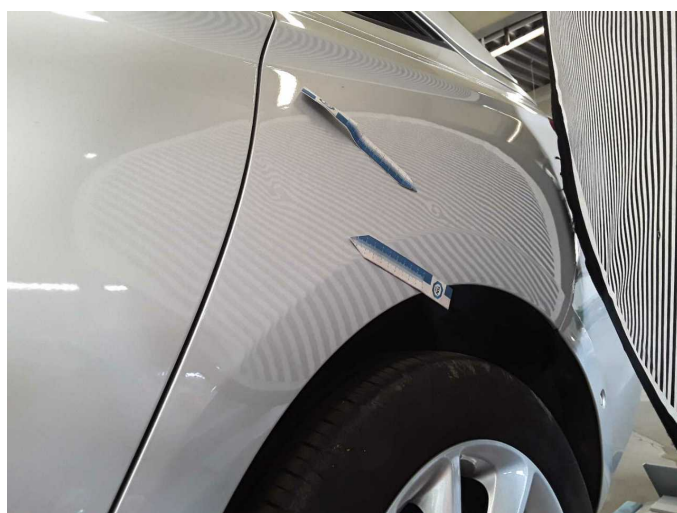
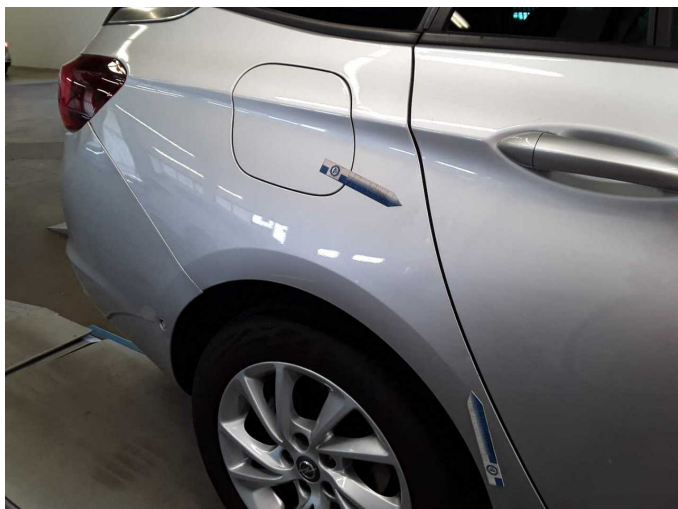
| No. | Component group | Description |
|---|---|---|
| 11 | Side panel - rear left side | Side panel - Dent / paintcoat damage - Repair and paint |

**Damage 11:** Side panel - rear left side: Side panel - Dent / paintcoat damage - Repair and paint

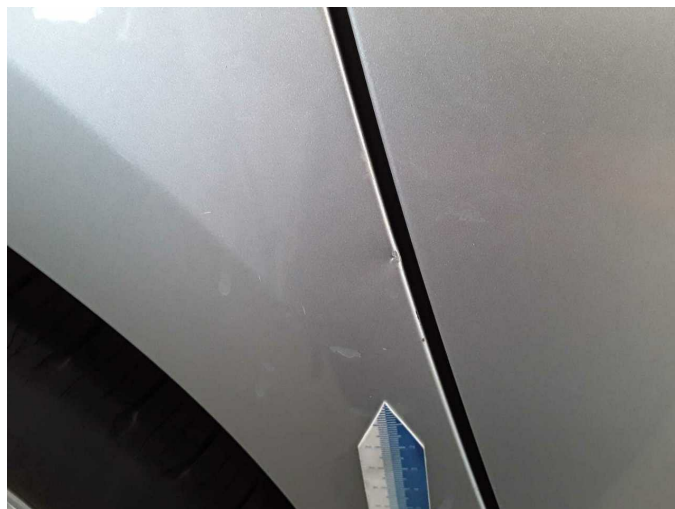
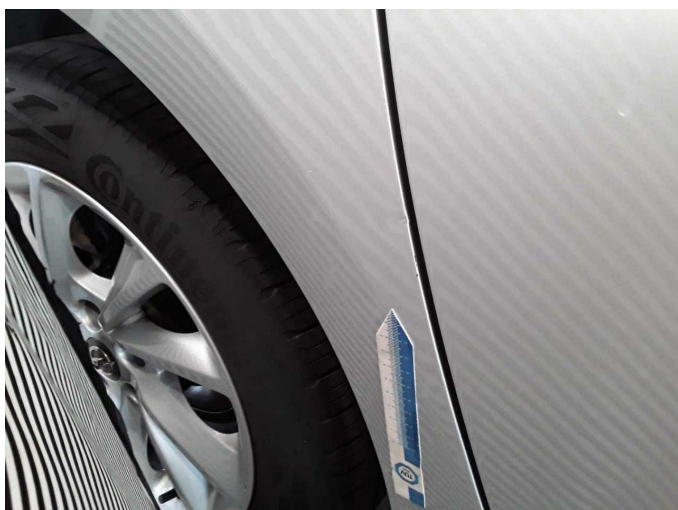
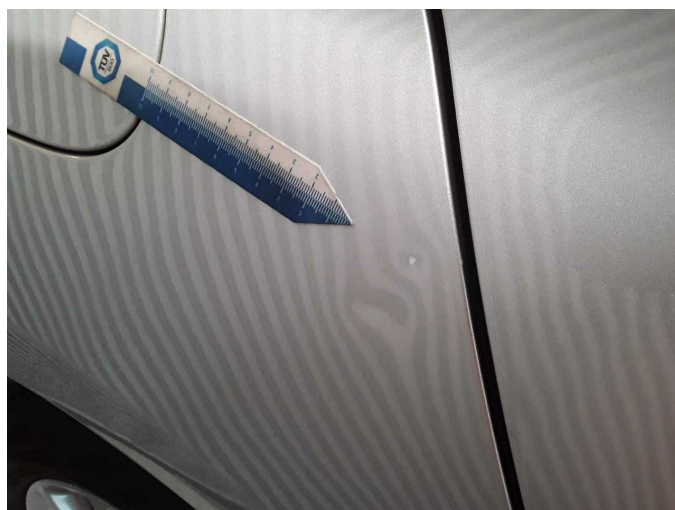
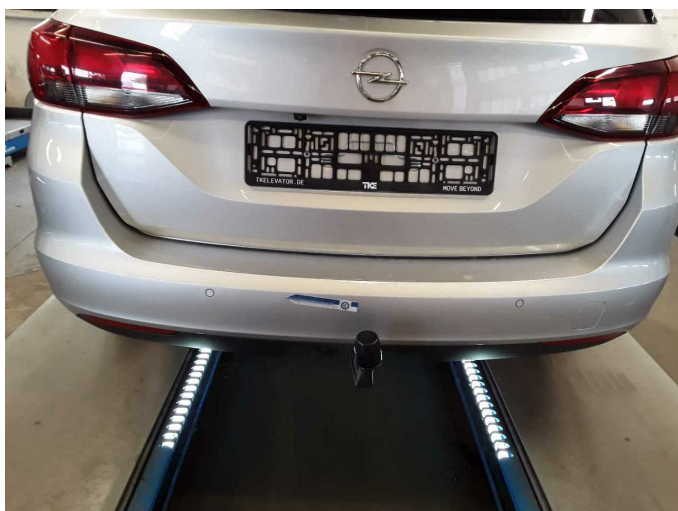
| No. | Component group | Description |
|---|---|---|
| 12 | Side panel - rear right side | Side panel - Dent / paintcoat damage - Repair and paint |

**Damage 12:** Side panel - rear right side: Side panel - Dent / paintcoat damage - Repair and paint

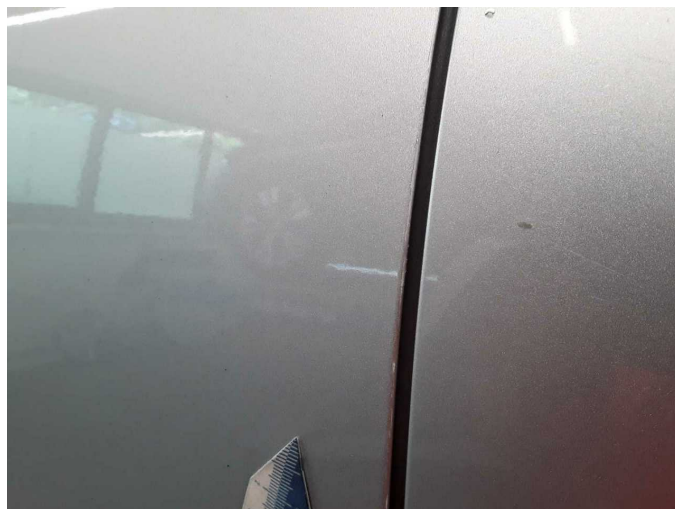
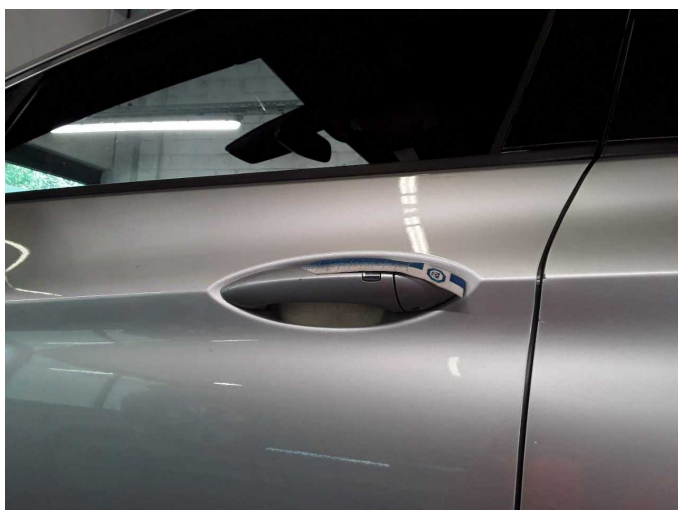
| No. | Component group | Description |
|---|---|---|
| 2 | Door - front left side | Door edge - Scratched - No deduction |

**Wear and tear 2:** Door - front left side: Door edge - Scratched - No deduction

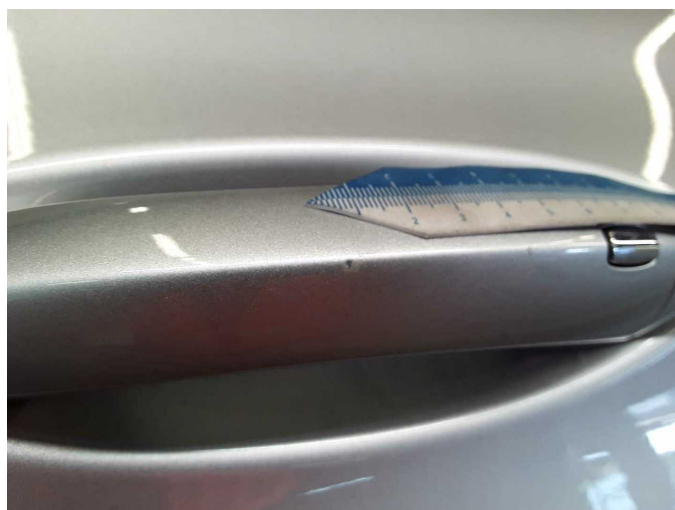
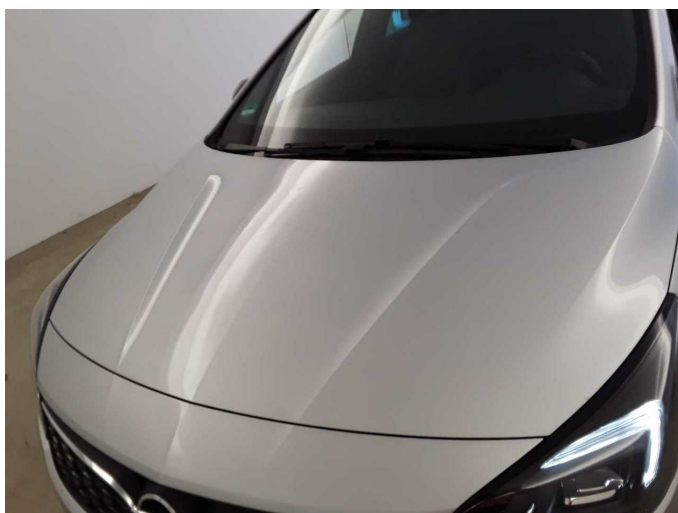
| No. | Component group | Description |
|---|---|---|
| 3 | Door - front left side | Door handle - outside - Stone chips - No deduction |

**Wear and tear 3:** Door - front left side: Door handle - outside - Stone chips - No deduction

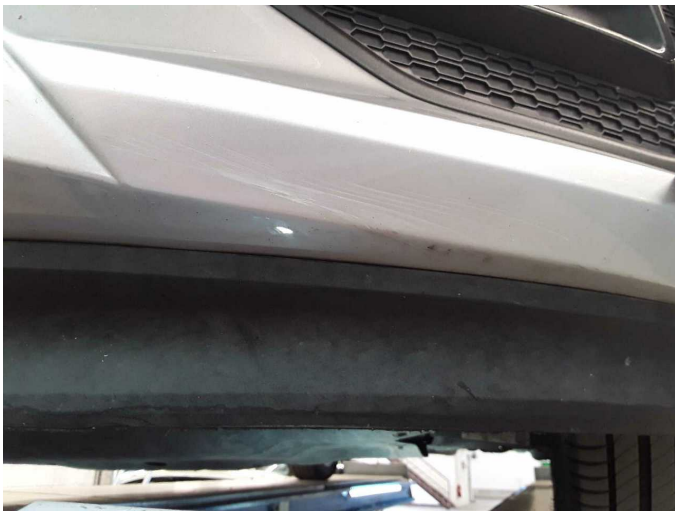
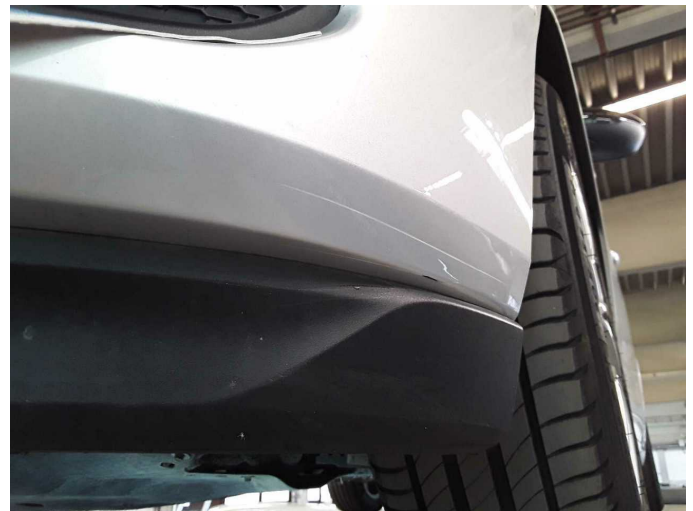
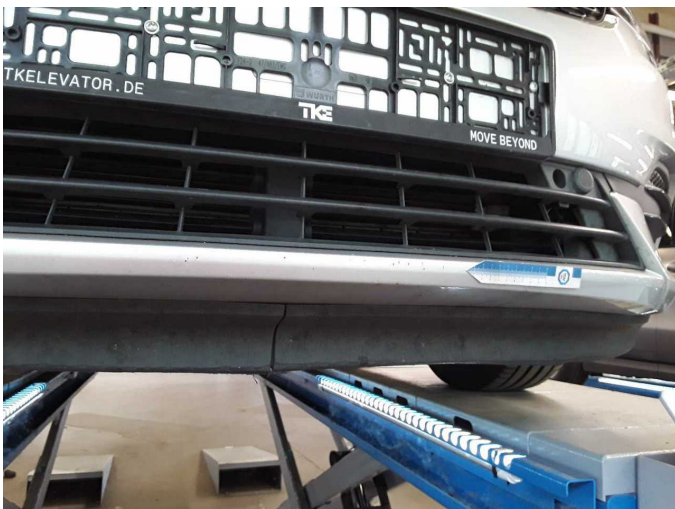
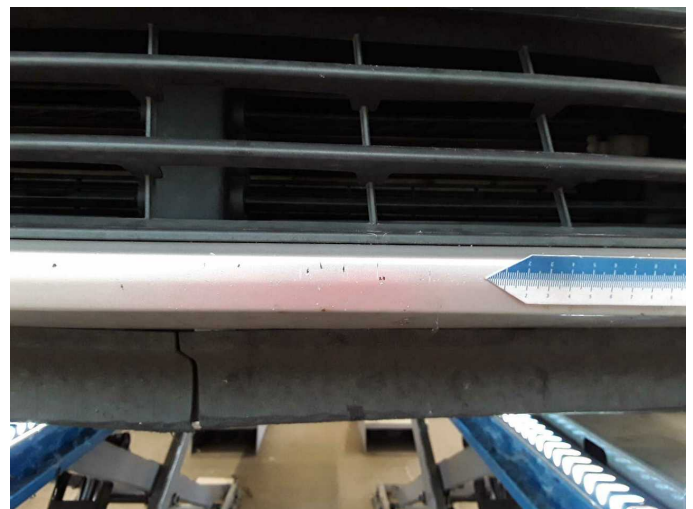
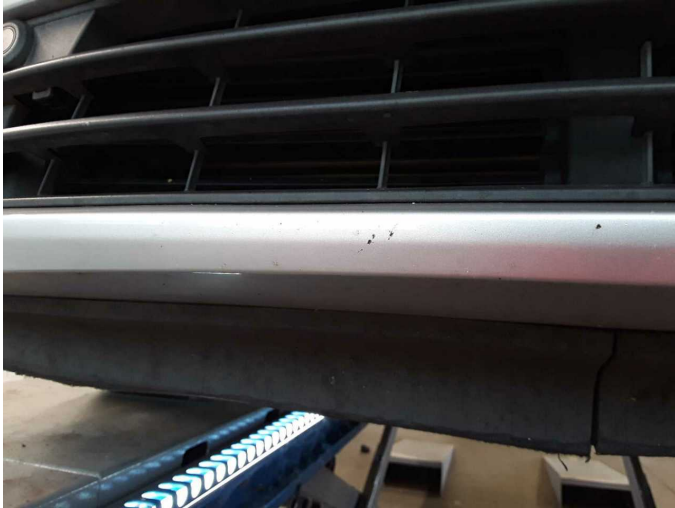
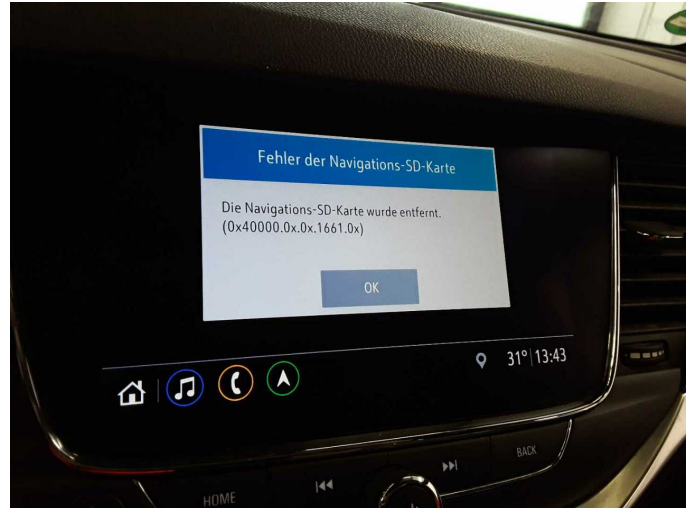
| No. | Component group | Description |
|---|---|---|
| 6 | Front bumper | Front bumper - Scratched - No deduction |

**Wear and tear 6:** Front bumper: Front bumper - Scratched - No deduction
