Expertise

Protocol number: 45896700
Order No. / Reference: 26428456
Inspection date: 10 Jun 2026

Manufacturer: Opel

Model: Astra 1.5 D Automatik Business Edition

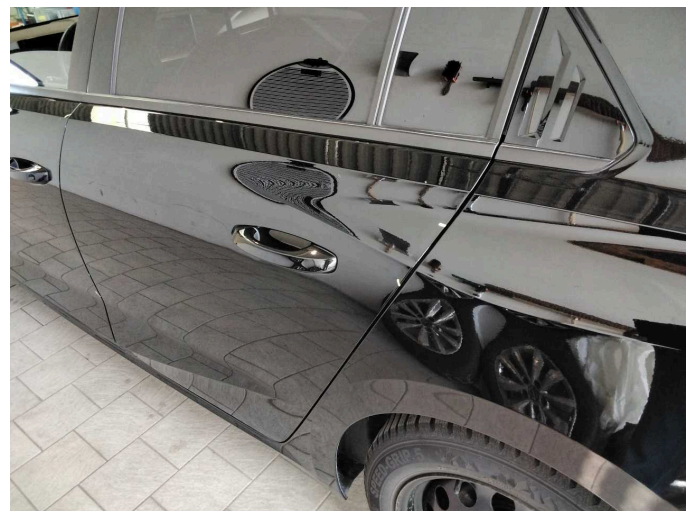
Damage 1: Door - rear left side: Door edge - Scratch(es) - Smart repair

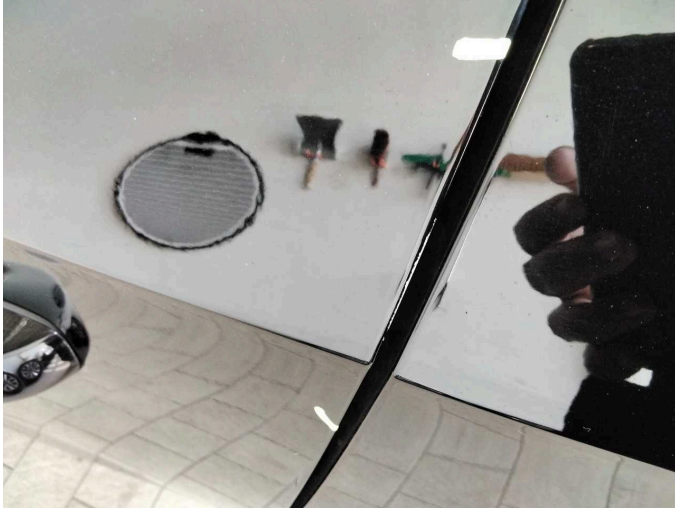
Damage 1: Door - rear left side: Door edge - Scratch(es) - Smart repair

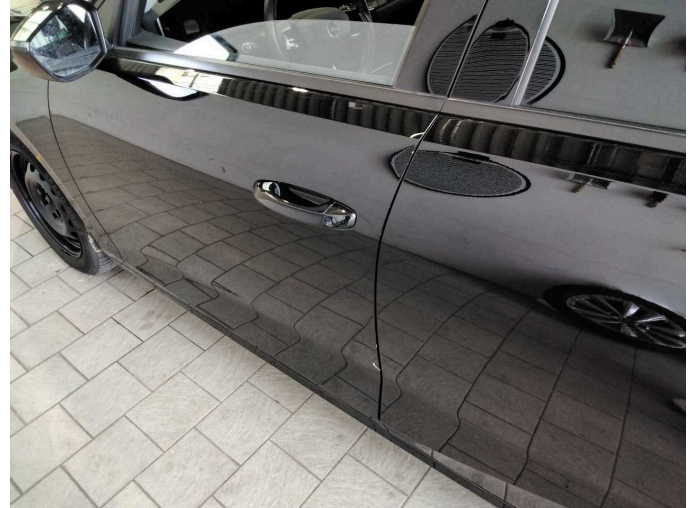
Damage 2: Door - front left side: Door edge - Scratch(es) - Smart repair

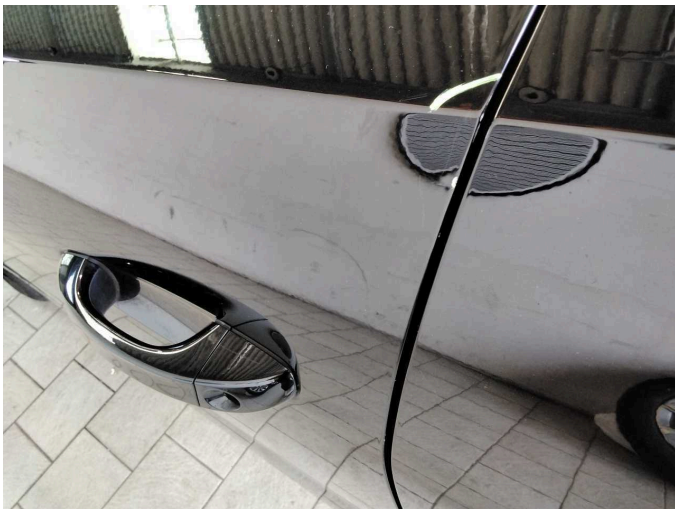
Damage 2: Door - front left side: Door edge - Scratch(es) - Smart repair

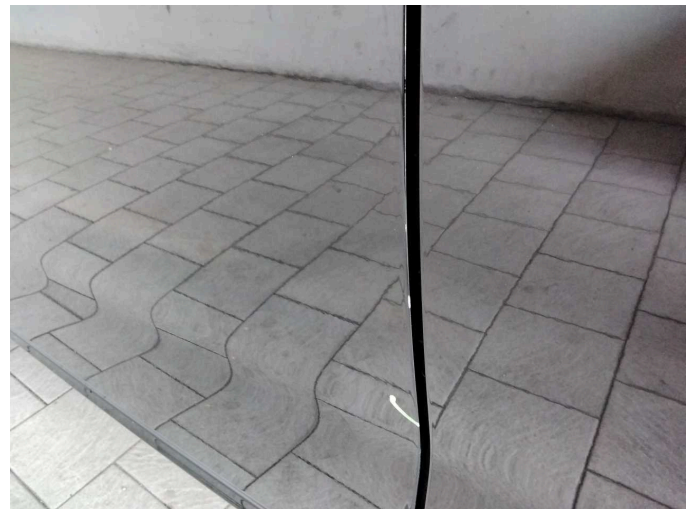
Damage 2: Door - front left side: Door edge - Scratch(es) - Smart repair

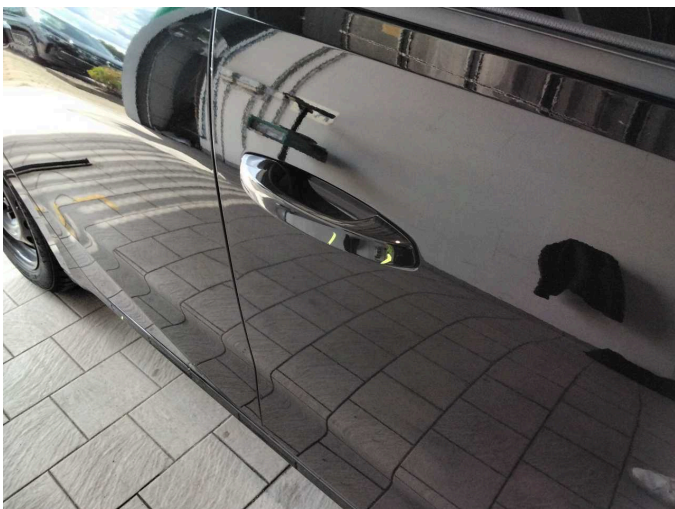
Damage 3: Door - front right side: Door handle - outside - Scratch(es) - Smart repair

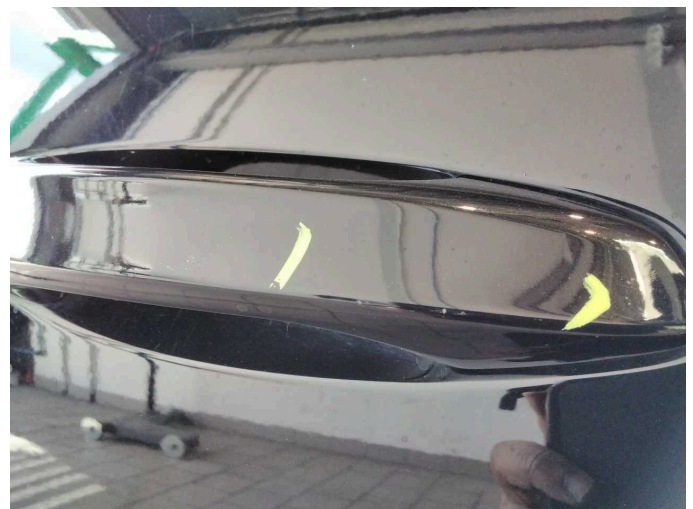
Damage 3: Door - front right side: Door handle - outside - Scratch(es) - Smart repair

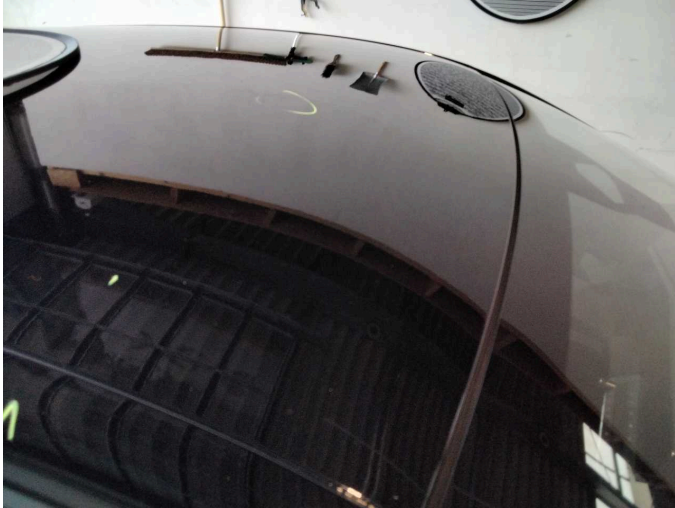
Damage 4: Roof: Roof - dent(s) - Smooth repair work

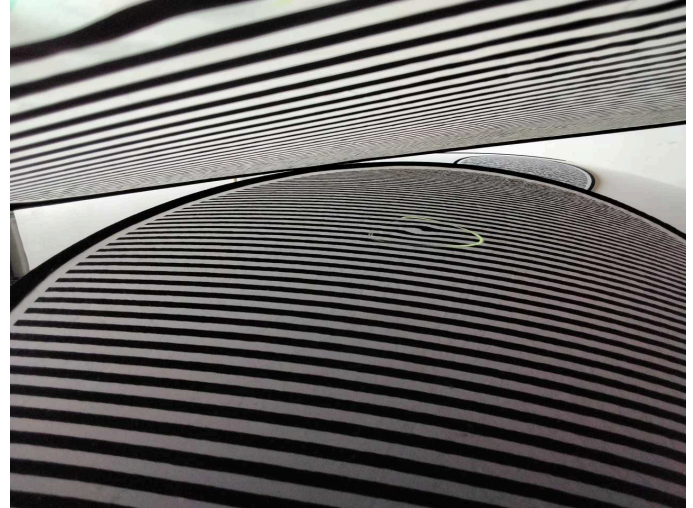
Damage 4: Roof: Roof - dent(s) - Smooth repair work

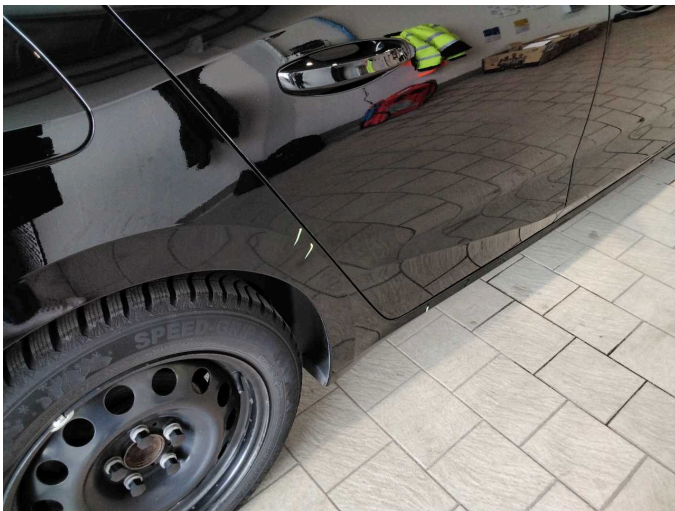
Damage 5: Side panel - rear right side: Side panel - dent(s) - Smooth repair work

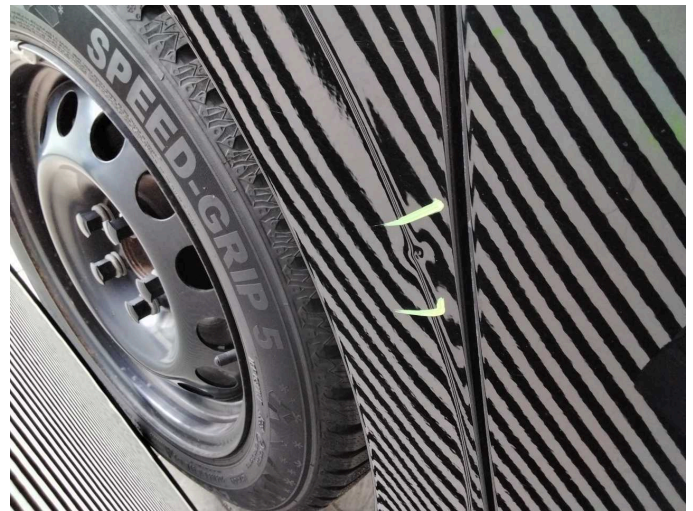
Damage 5: Side panel - rear right side: Side panel - dent(s) - Smooth repair work

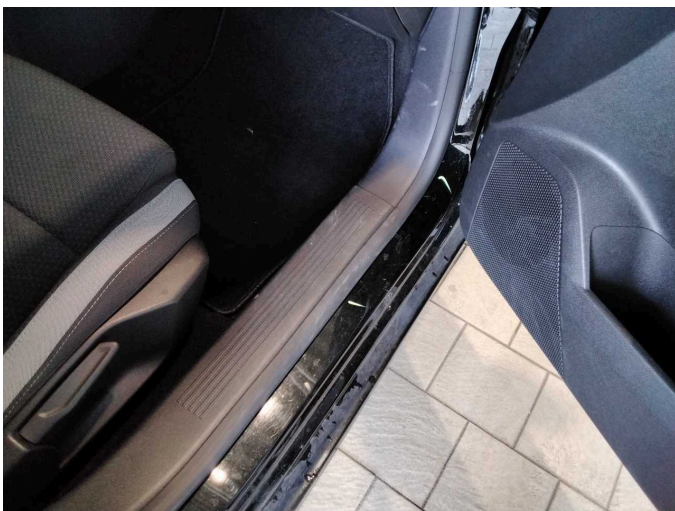
Damage 6: Sill - right side: Sill - Scratch(es) - Smart repair

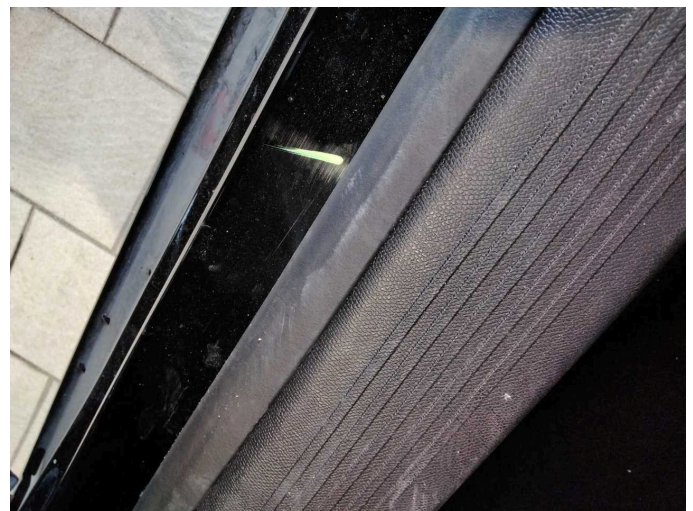
Damage 6: Sill - right side: Sill - Scratch(es) - Smart repair

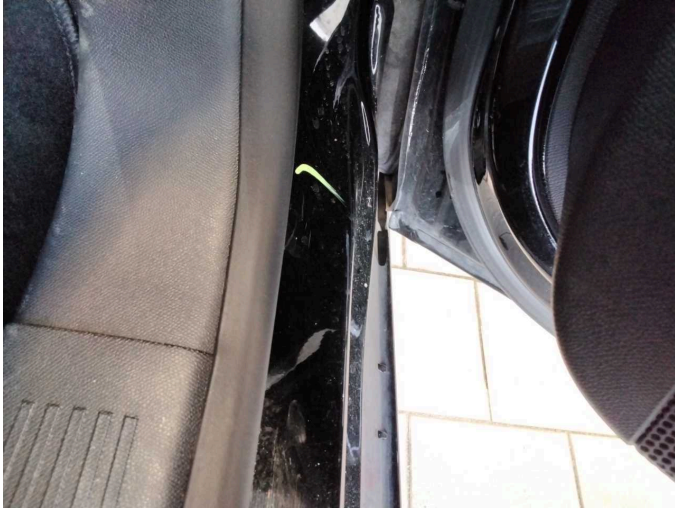
Damage 6: Sill - right side: Sill - Scratch(es) - Smart repair

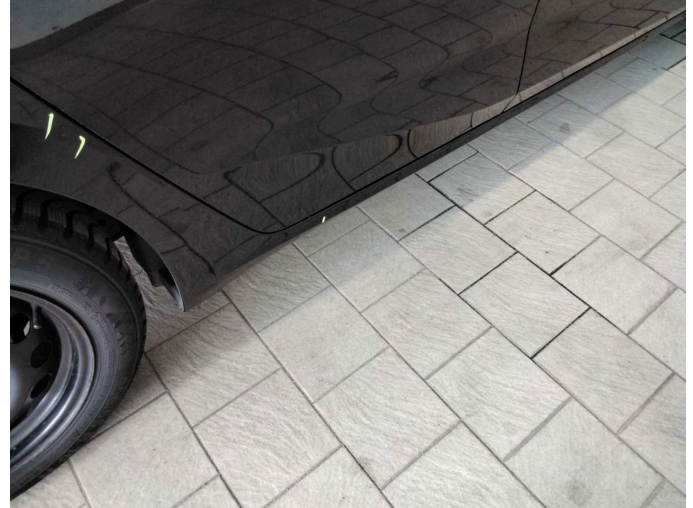
Damage 7: Sill - right side: Sill - Scratch(es) - Smart repair

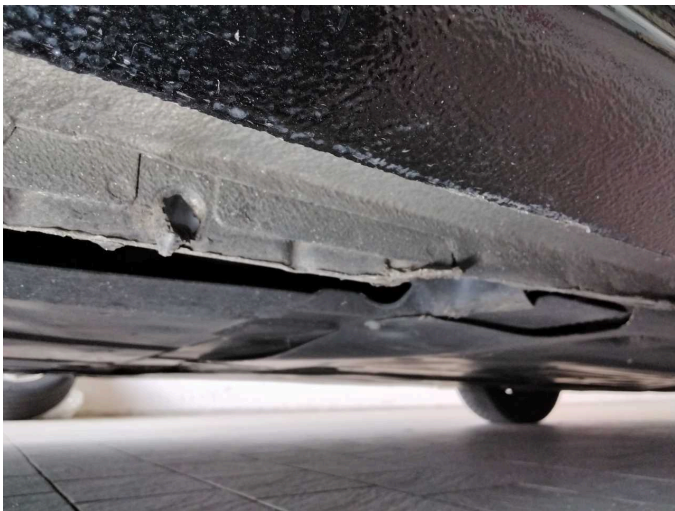
Damage 7: Sill - right side: Sill - Scratch(es) - Smart repair

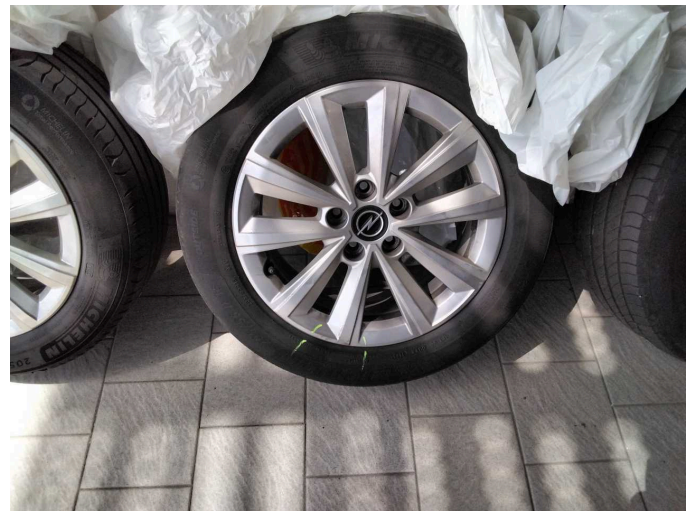
Damage 8: 2nd wheel set: 1 alloy rim - Scratch(es) - Loss in value

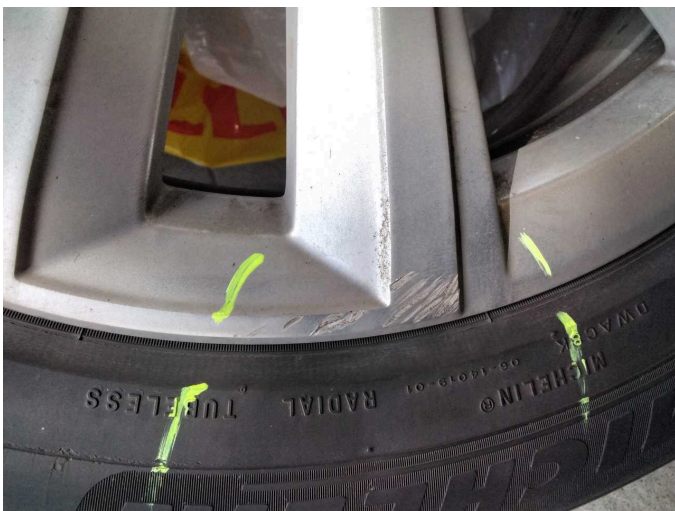
Damage 8: 2nd wheel set: 1 alloy rim - Scratch(es) - Loss in value

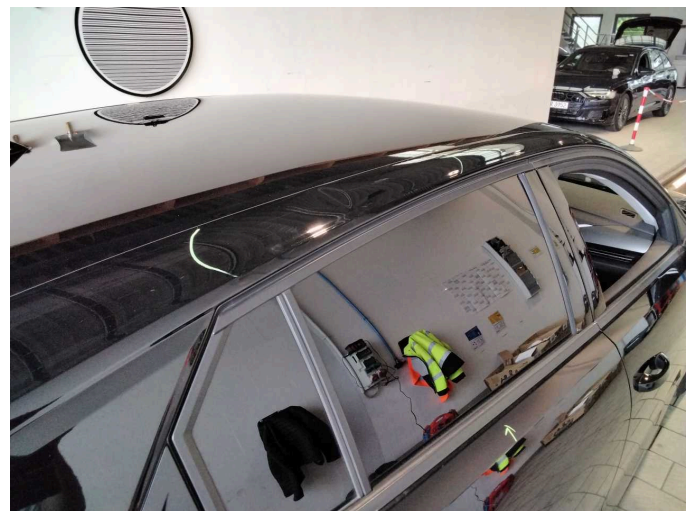
Damage 9: Roof: Roof rail - right side - Dent / paintcoat damage - Repair and paint

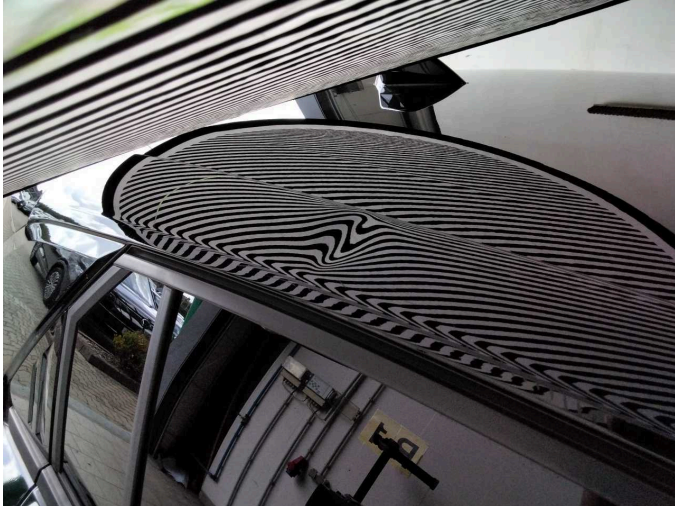
Damage 9: Roof: Roof rail - right side - Dent / paintcoat damage - Repair and paint

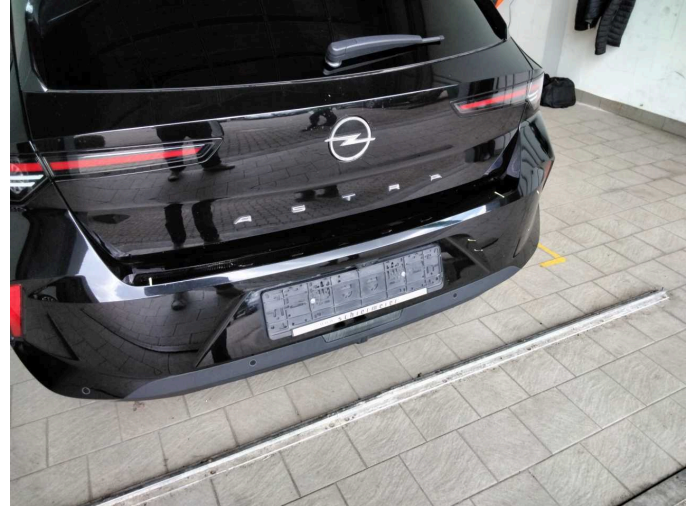
Damage 10: Rear bumper: Rear bumper - Scratch(es) - Paint

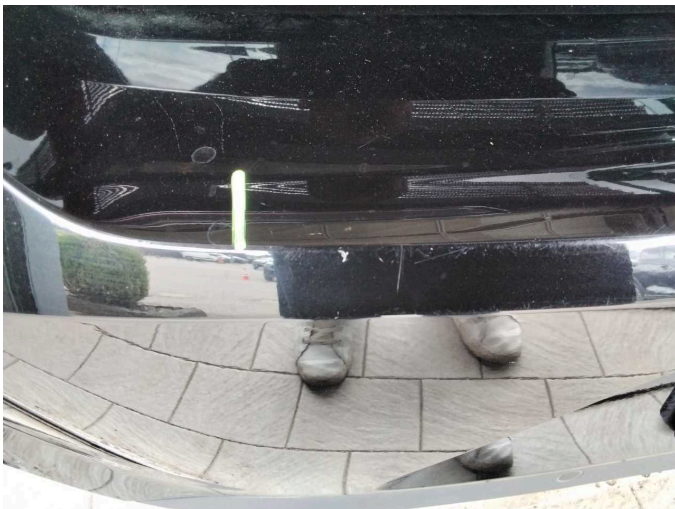
Damage 10: Rear bumper: Rear bumper - Scratch(es) - Paint

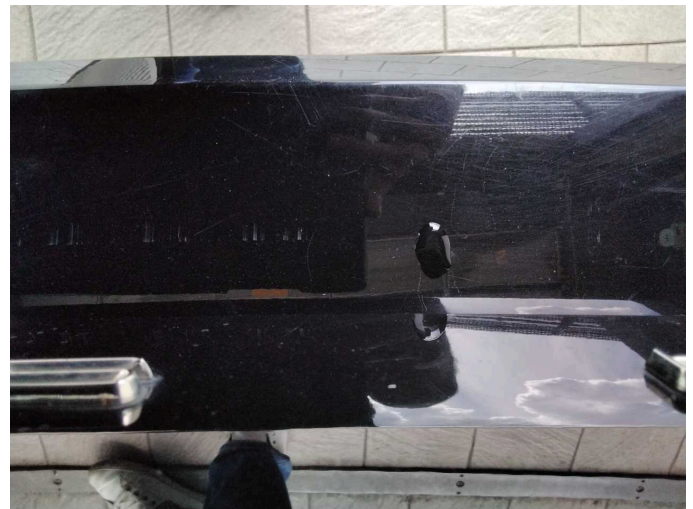
Damage 10: Rear bumper: Rear bumper - Scratch(es) - Paint

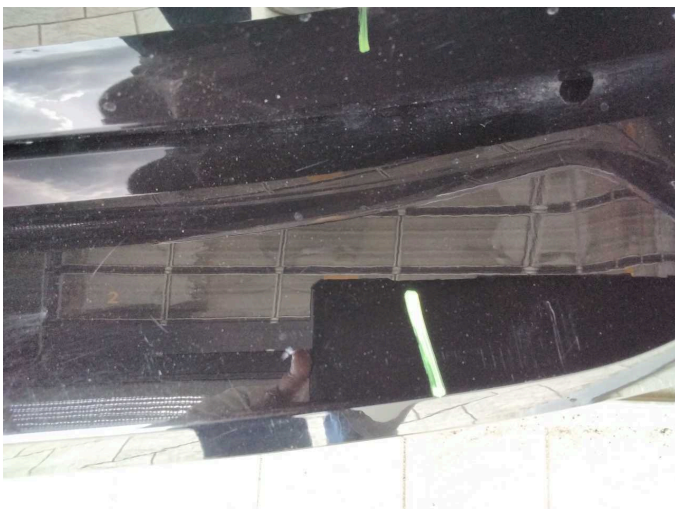
Damage 10: Rear bumper: Rear bumper - Scratch(es) - Paint

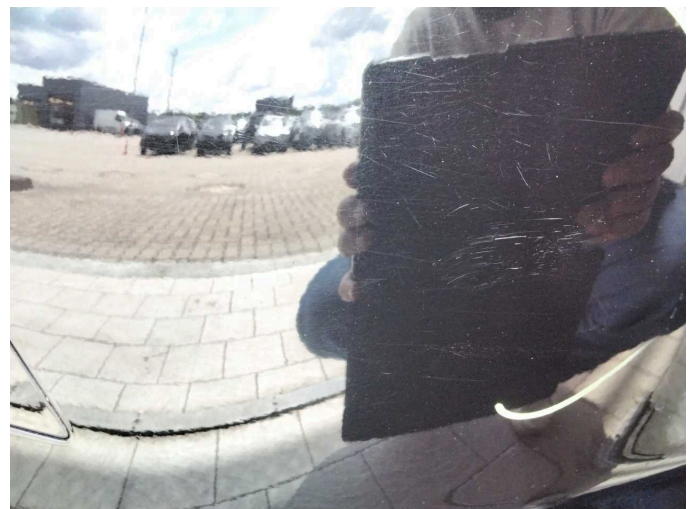
Damage 10: Rear bumper: Rear bumper - Scratch(es) - Paint

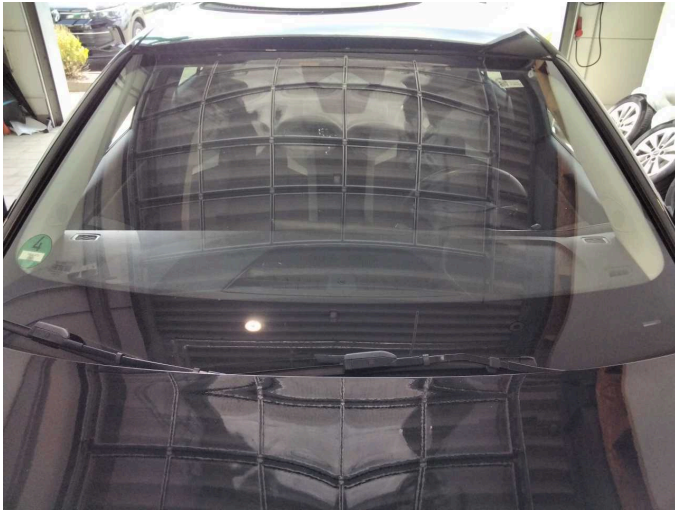
Wear and tear 1: Vehicle glazing: Windscreen - Stone chips - No deduction

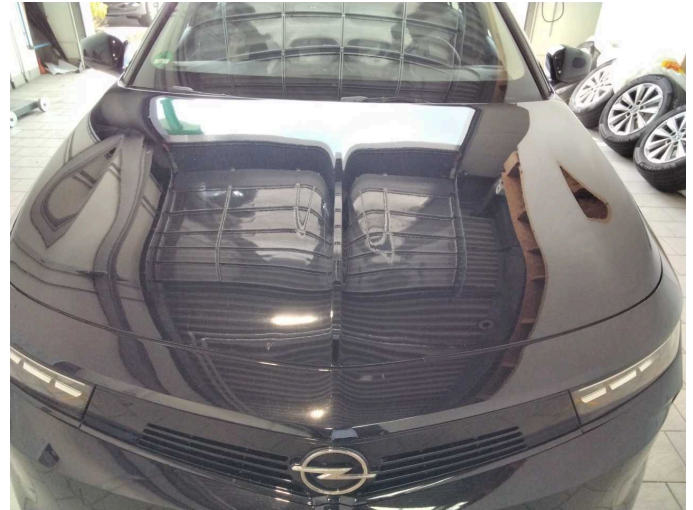
Wear and tear 2: Bonnet: Bonnet - Stone chips - No deduction

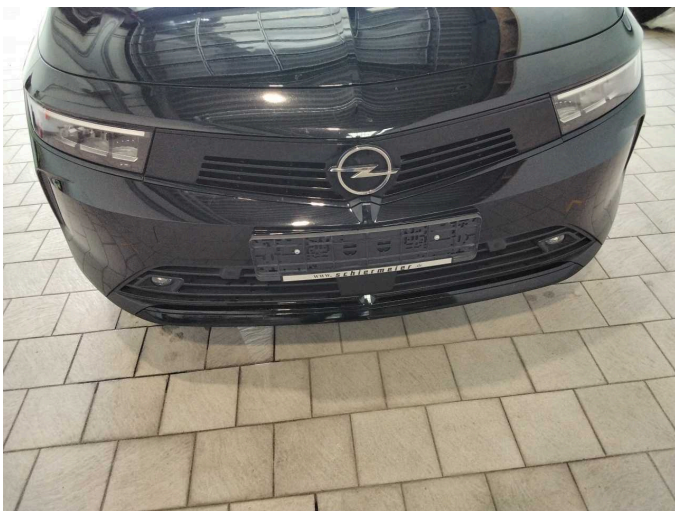
Wear and tear 3: Front bumper: Front bumper - Stone chips - No deduction

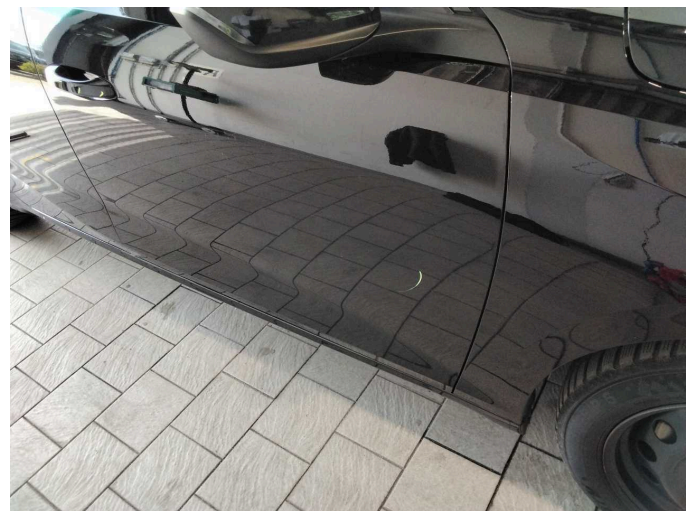
Wear and tear 4: Door - front right side: Door - dent(s) - No deduction

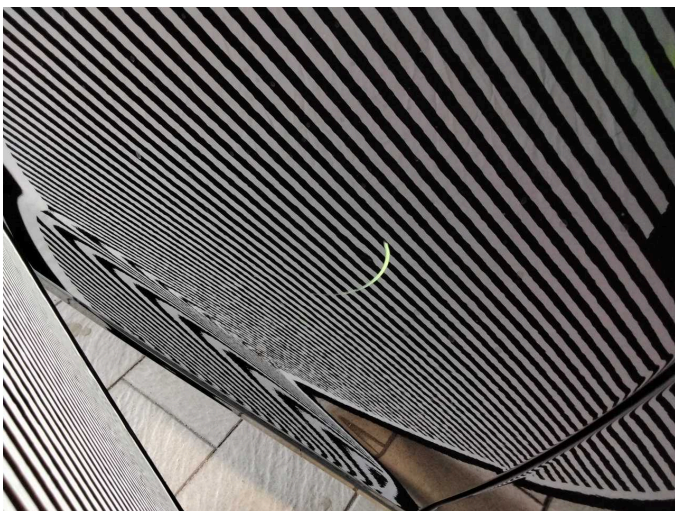
Wear and tear 4: Door - front right side: Door - dent(s) - No deduction
