Expertise

Protocol number: 46495242  
Order No. / Reference: 26294509  
Inspection date: 10 Jul 2026

Manufacturer: Mercedes-Benz  
VIN: W1VVLBEZ4T4564790

Model: Vito 116 CDI Lang HA PRO Kasten

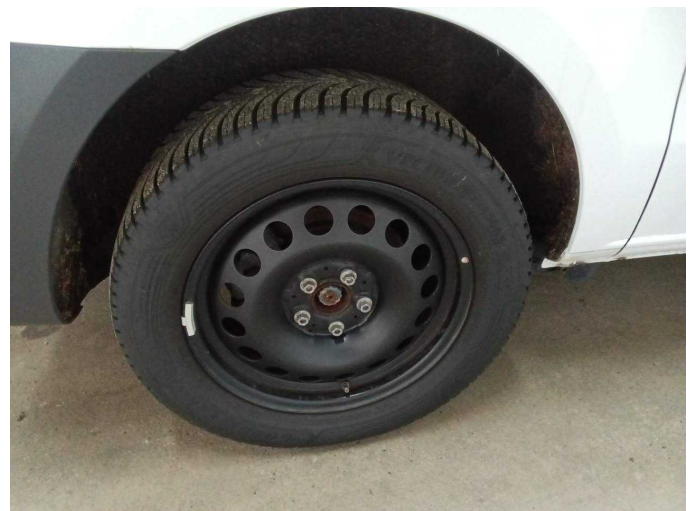
| No. | Component group | Description |
|---|---|---|
| 1 | Wheel / tyres | Wheel cover - rear right side - Missing - Replace |

Damage 1: Wheel / tyres: Wheel cover - rear right side - Missing - Replace

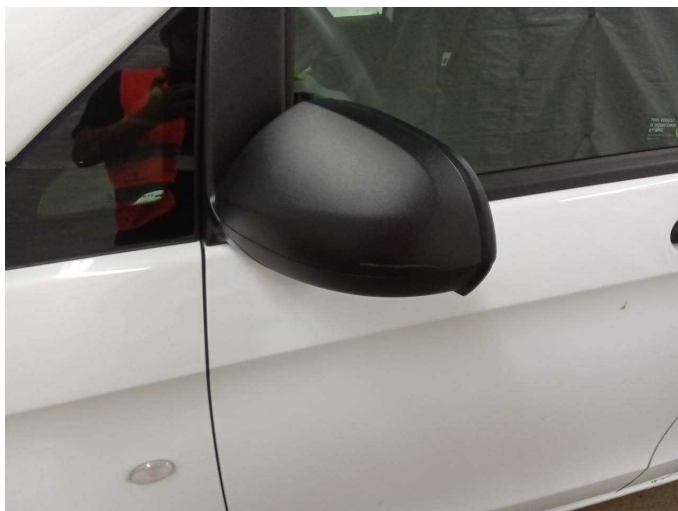
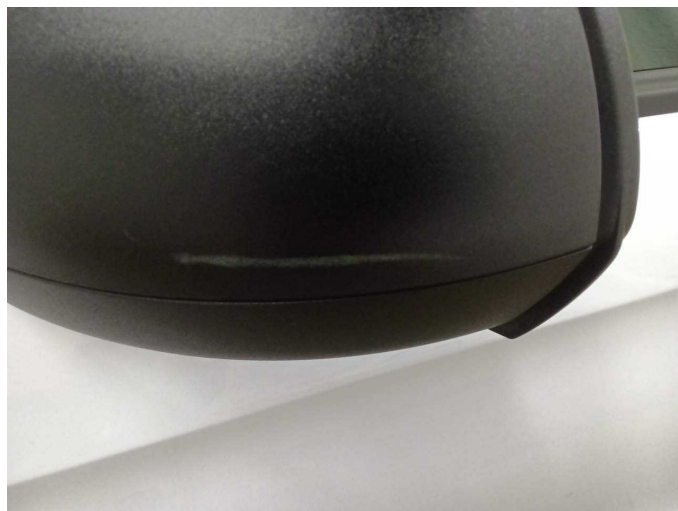
| No. | Component group | Description |
|---|---|---|
| 2 | Wing mirror - left side | Cap - Scratch(es) - Loss in value |

**Damage 2:** Wing mirror - left side: Cap - Scratch(es) - Loss in value
