Expertise

Protocol number: 46479144  
Order No. / Reference: 26535239  
Inspection date: 13 Jul 2026

Manufacturer: Ford

Model: Transit Custom 320 L2H1 VA Trend

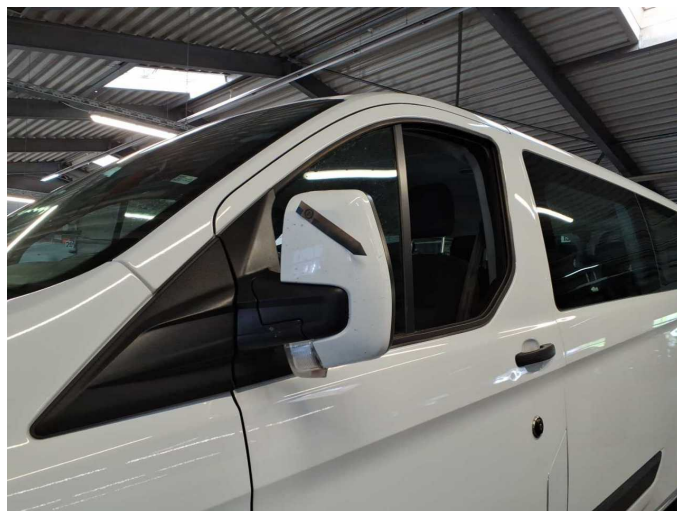
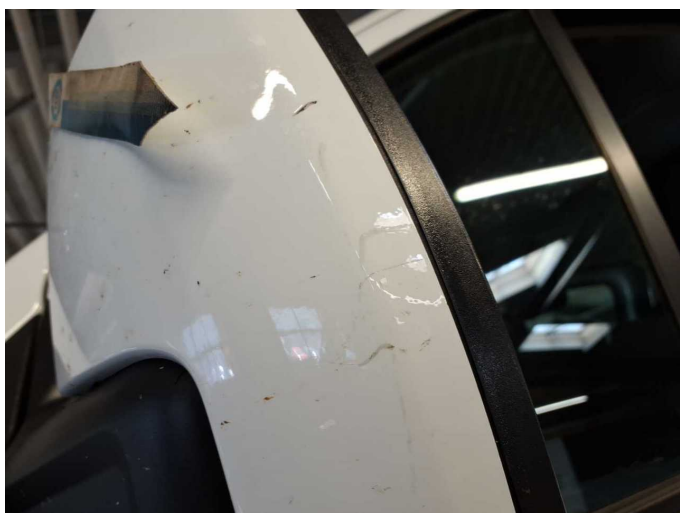
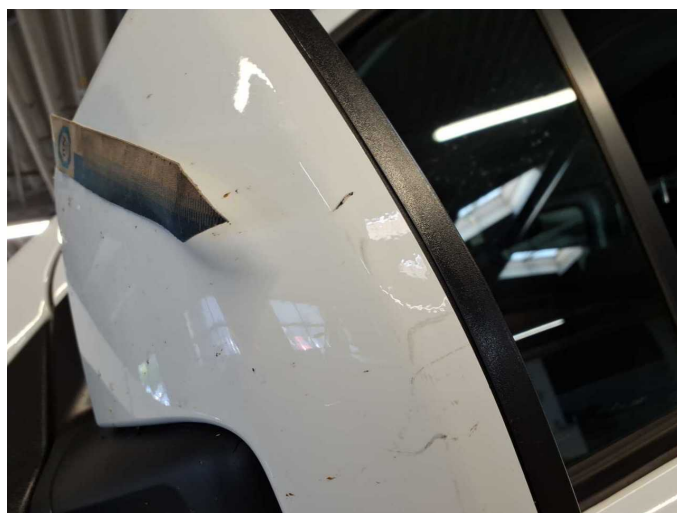
| No. | Component group | Description |
|---|---|---|
| 1 | Wing mirror - left side | Cap - Scratch(es) - Smart repair |

**Damage 1:** Wing mirror - left side: Cap - Scratch(es) - Smart repair

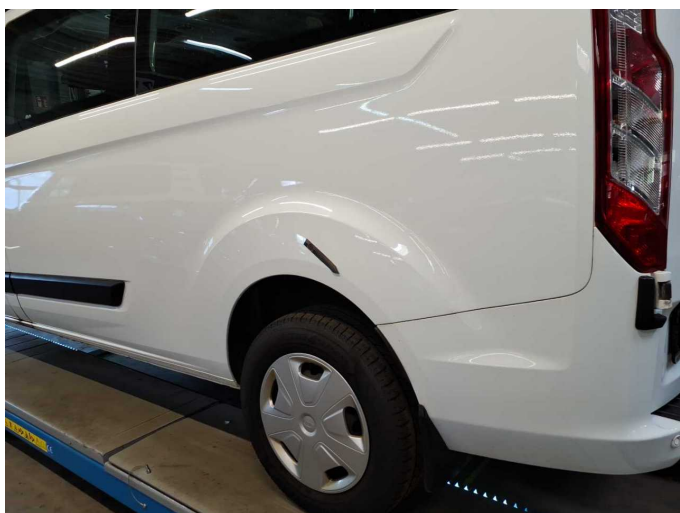
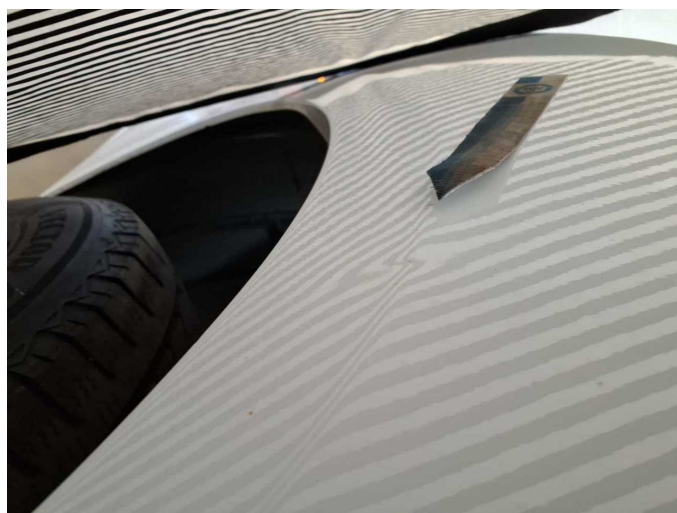
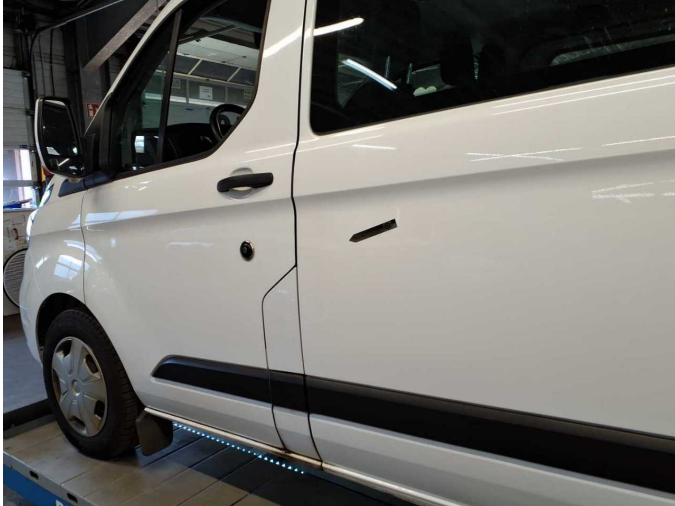
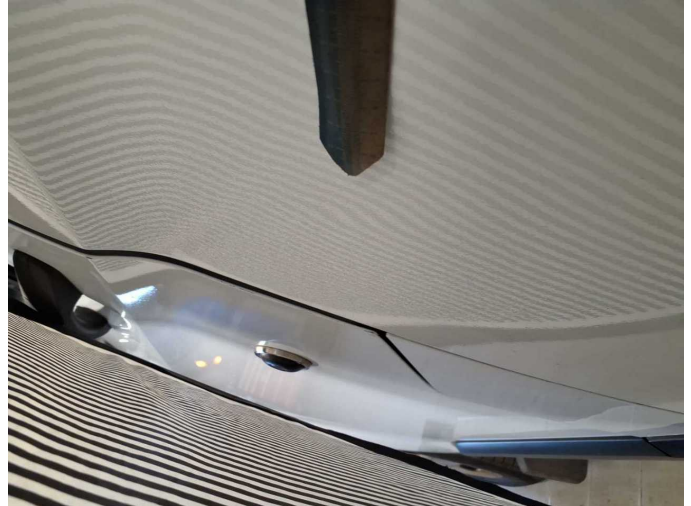
| No. | Component group | Description |
|---|---|---|
| 2 | Side panel - rear left side | Side panel - dent(s) - Smooth repair work |

**Damage 2:** Side panel - rear left side: Side panel - dent(s) - Smooth repair work

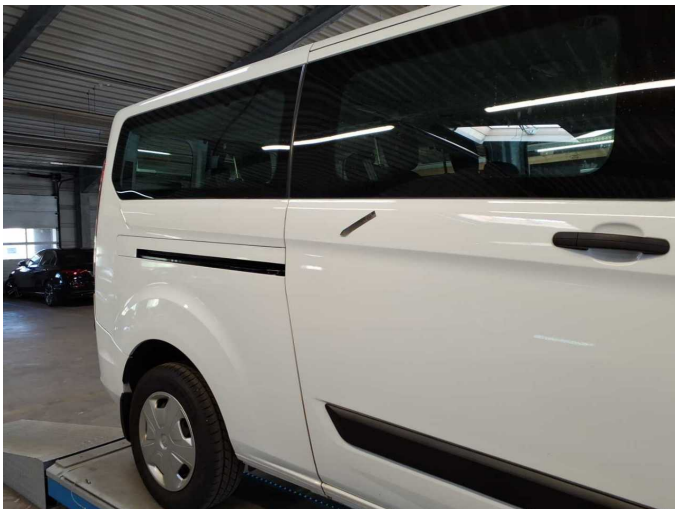
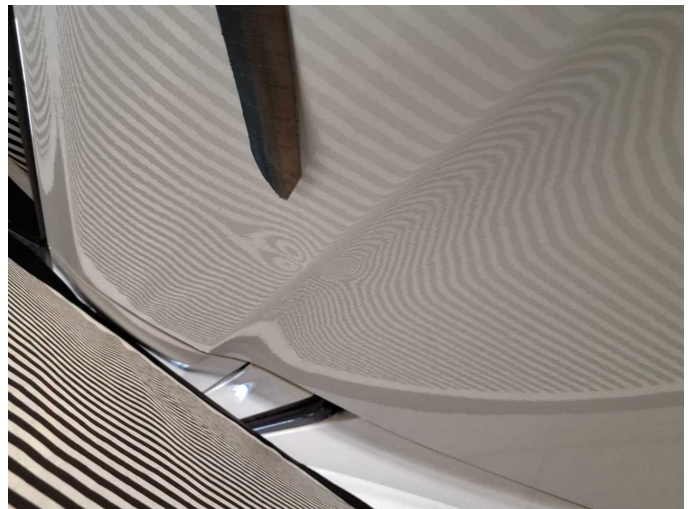
| No. | Component group | Description |
|---|---|---|
| 3 | Sliding door, right | Sliding door with glass panel - dent(s) - Smooth repair work |

**Damage 3:** Sliding door, right: Sliding door with glass panel - dent(s) - Smooth repair work

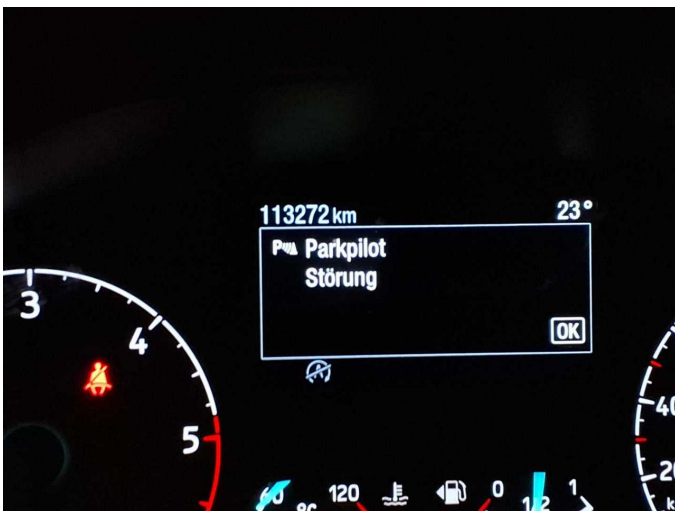
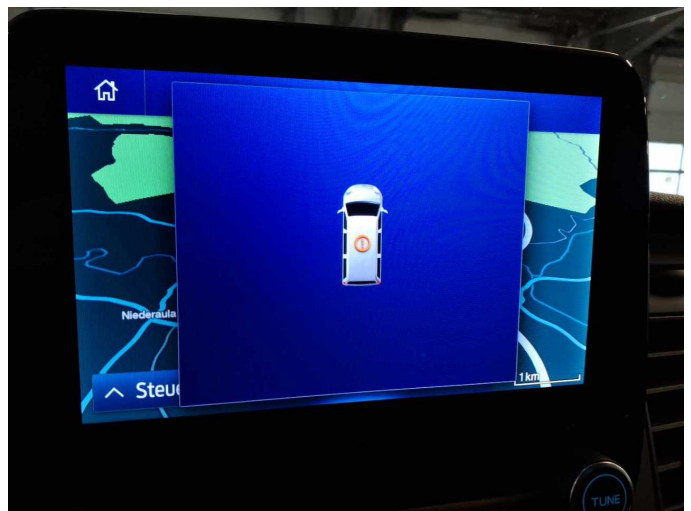
| No. | Component group | Description |
|---|---|---|
| 4 | Electronic systems | Parking assistance - Functional / admissibility - Perform diagnosis |

**Damage 4:** Electronic systems: Parking assistance - Functional / admissibility - Perform diagnosis

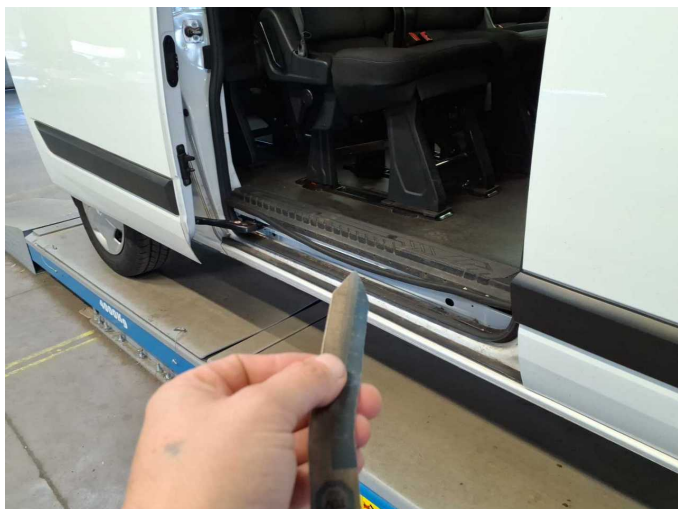
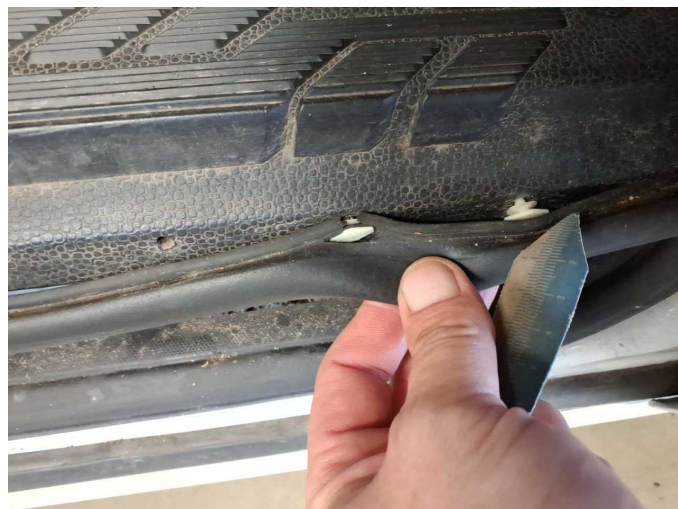
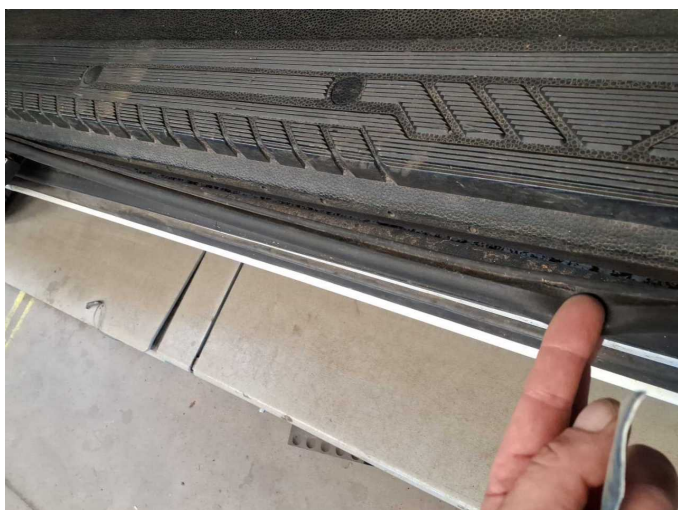
| No. | Component group | Description |
|---|---|---|
| 5 | Side panel - rear right side | Sill (Gummi) - Broken / torn - Replace |

**Damage 5:** Side panel - rear right side: Sill (Gummi) - Broken / torn - Replace

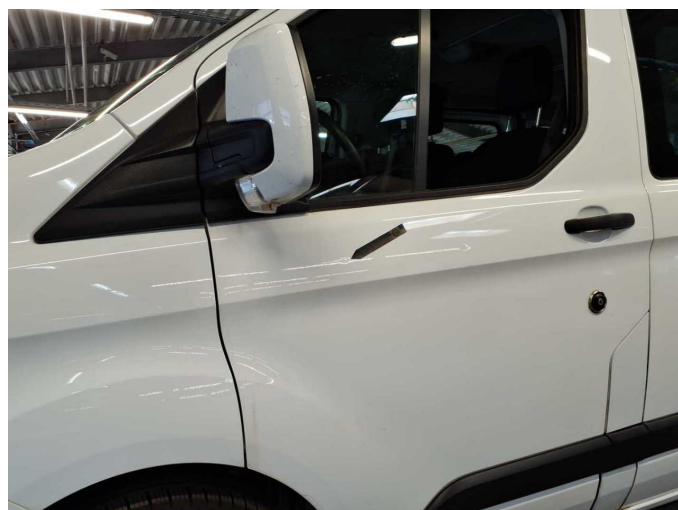
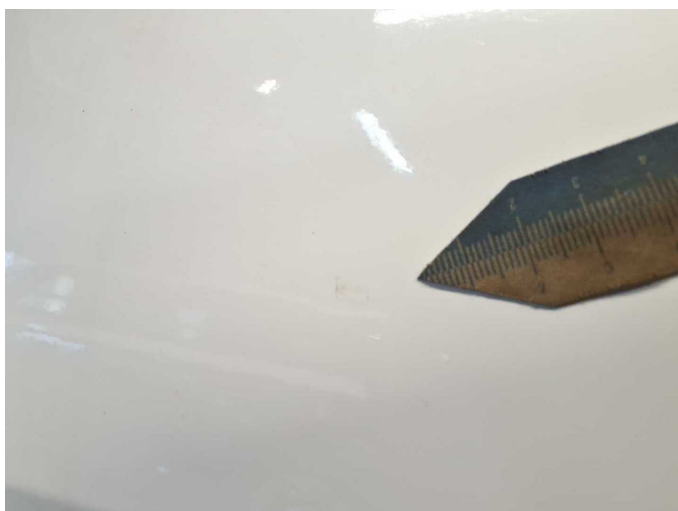
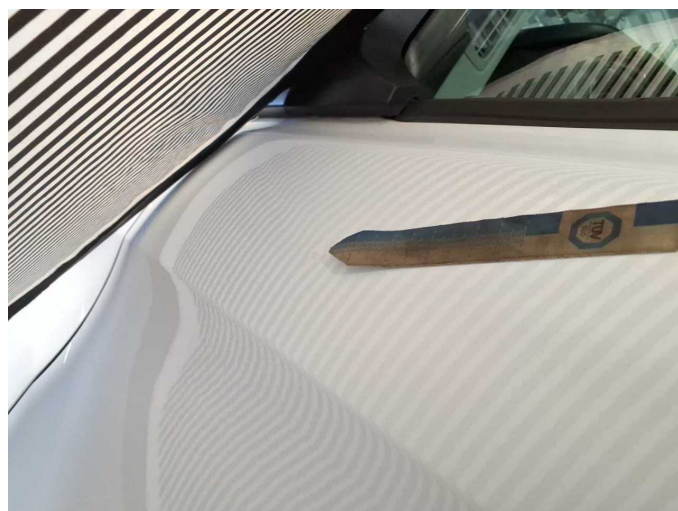
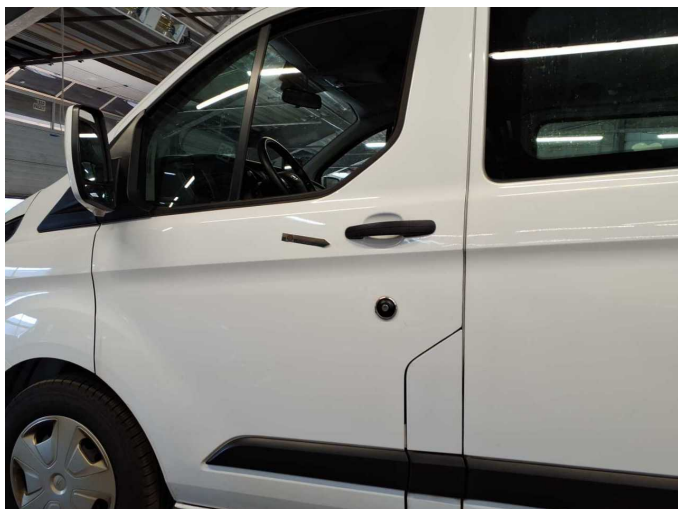
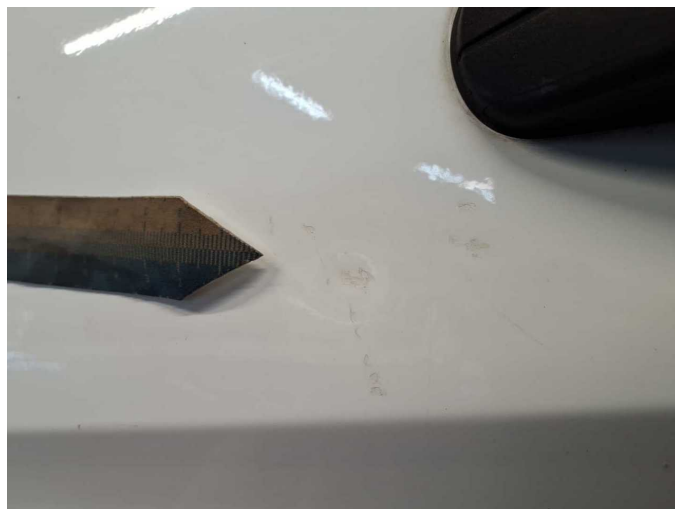
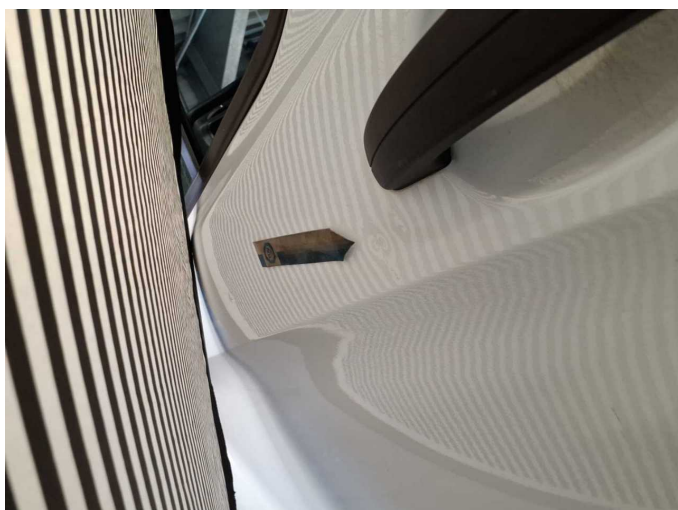
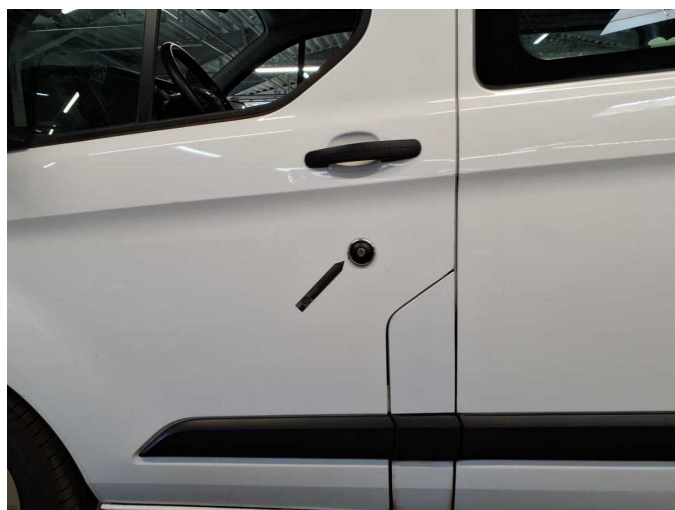
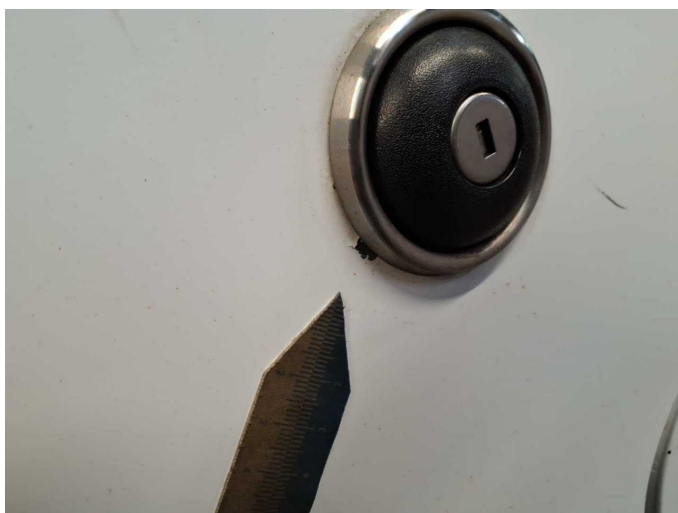
| No. | Component group | Description |
|---|---|---|
| 6 | Door - front left side | Door - Dent / paintcoat damage - Smart repair |

**Damage 6:** Door - front left side: Door - Dent / paintcoat damage - Smart repair

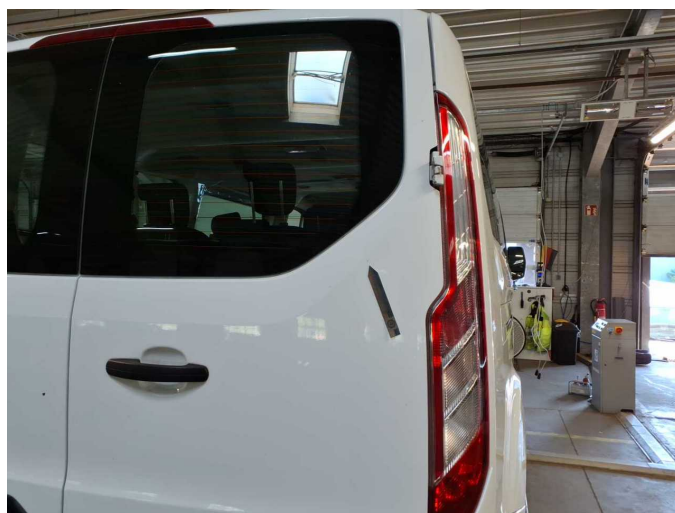
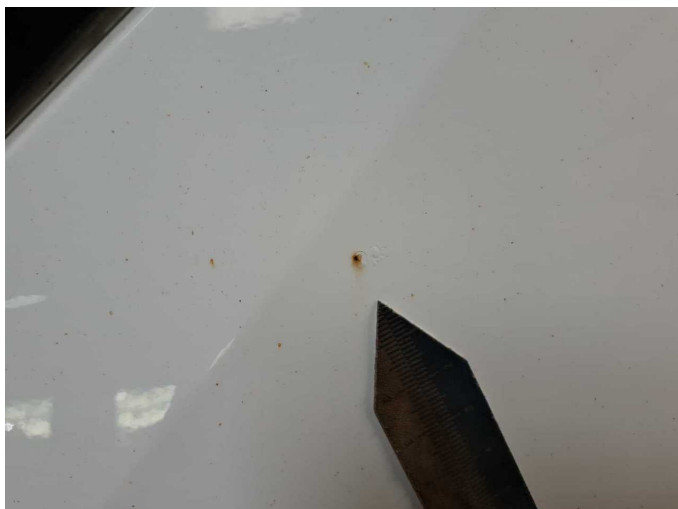
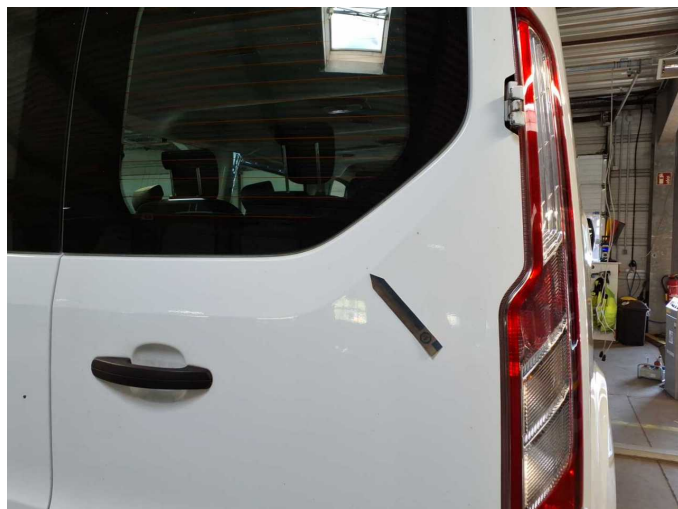
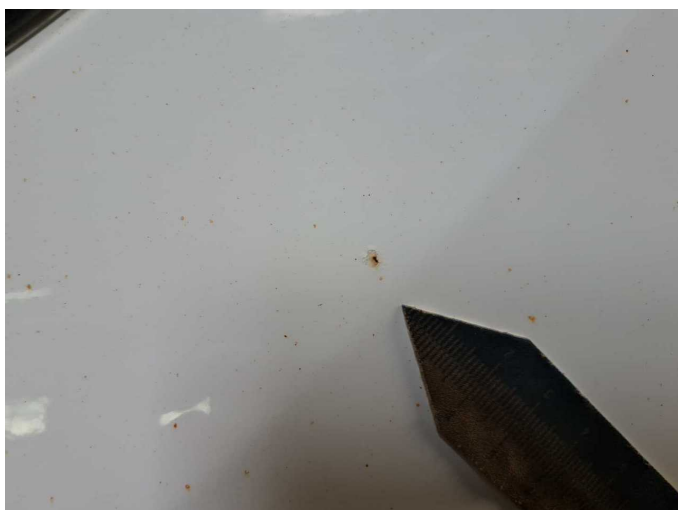
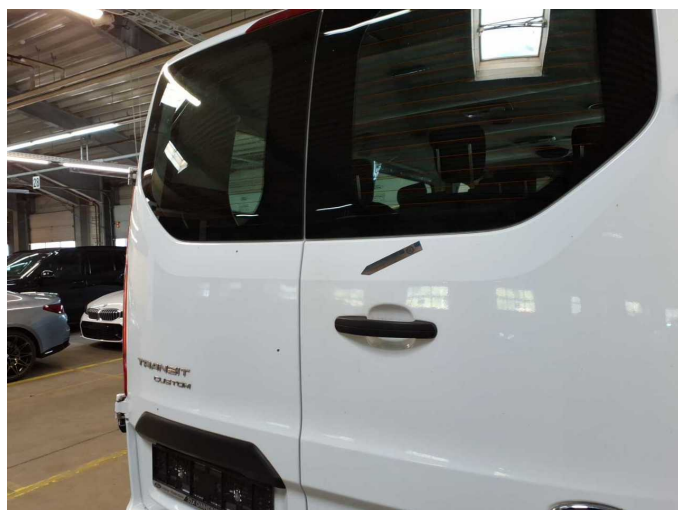
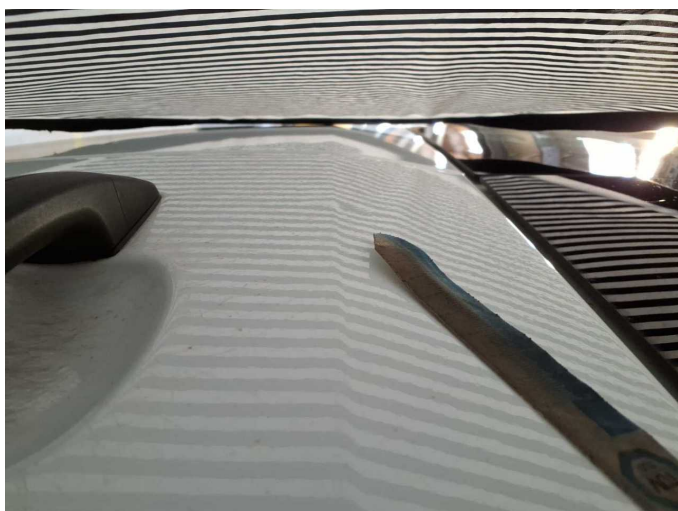
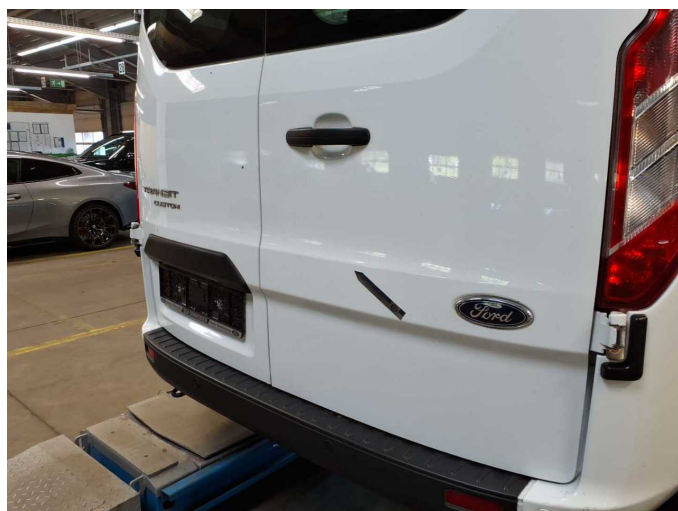
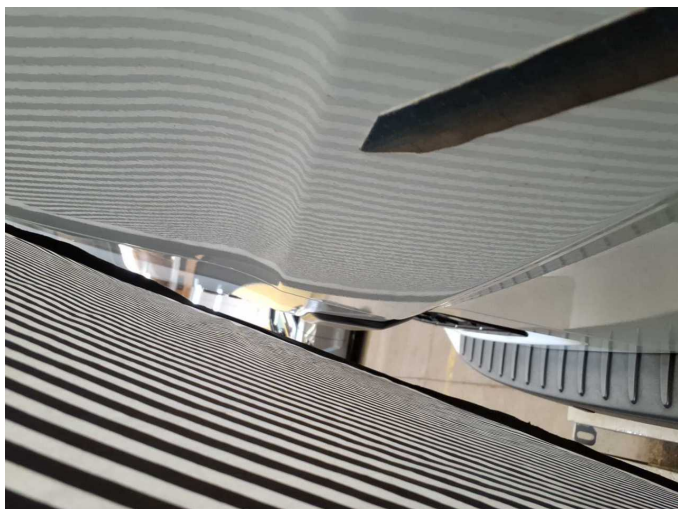
| No. | Component group | Description |
|---|---|---|
| 7 | Boot lid / rear door | Rear door - right side (Dellen) - Corrosion - Repair and paint |

**Damage 7:** Boot lid / rear door: Rear door - right side (Dellen) - Corrosion - Repair and paint

**Damage 7:** Boot lid / rear door: Rear door - right side (Dellen) - Corrosion  
- Repair and paint

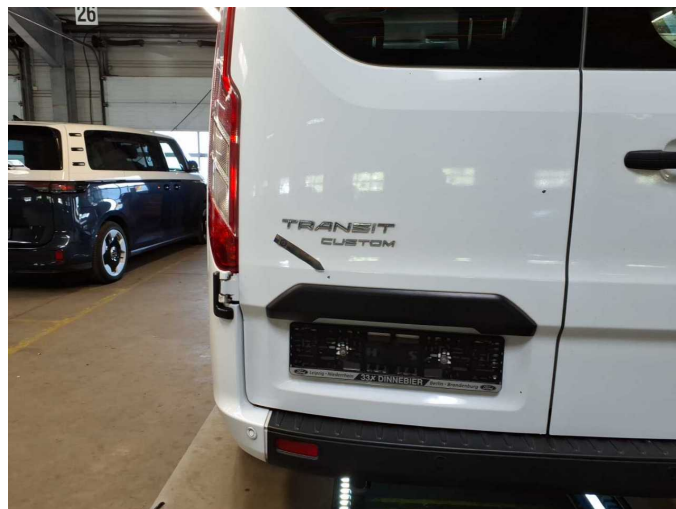
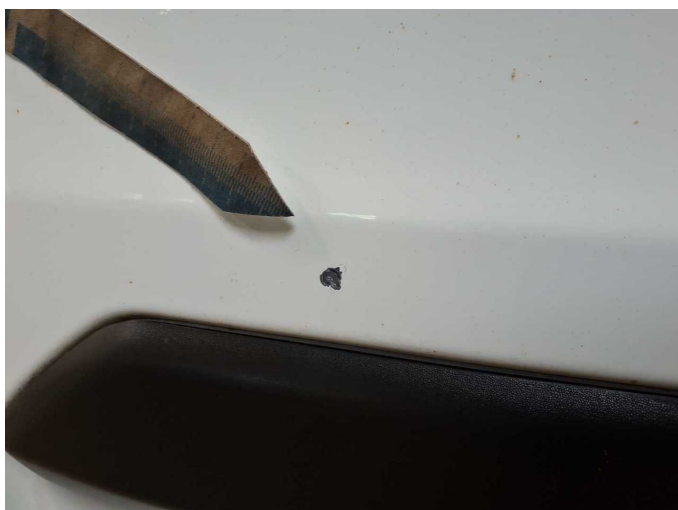
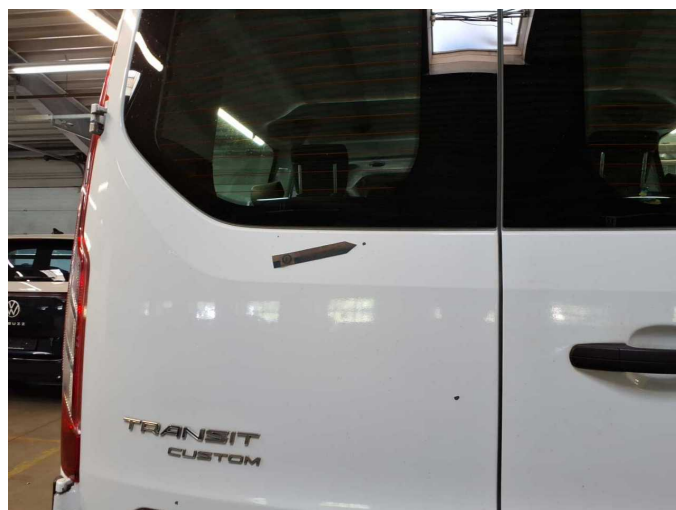
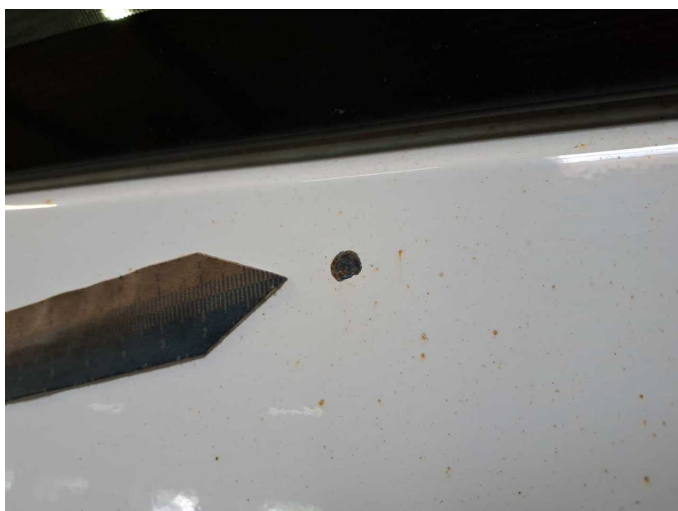
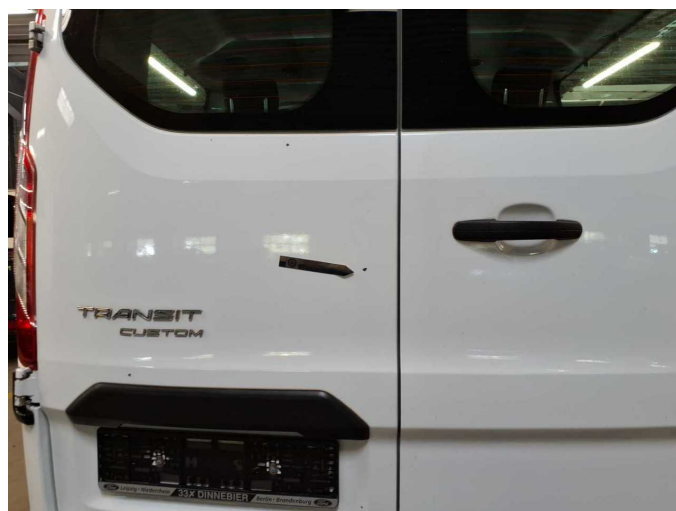
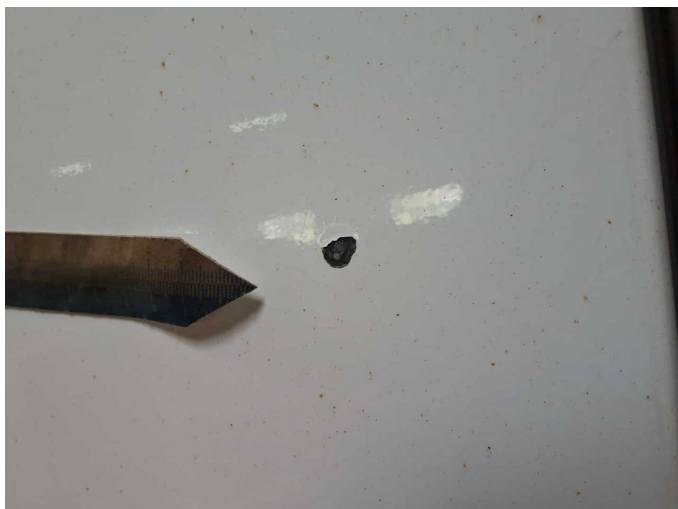
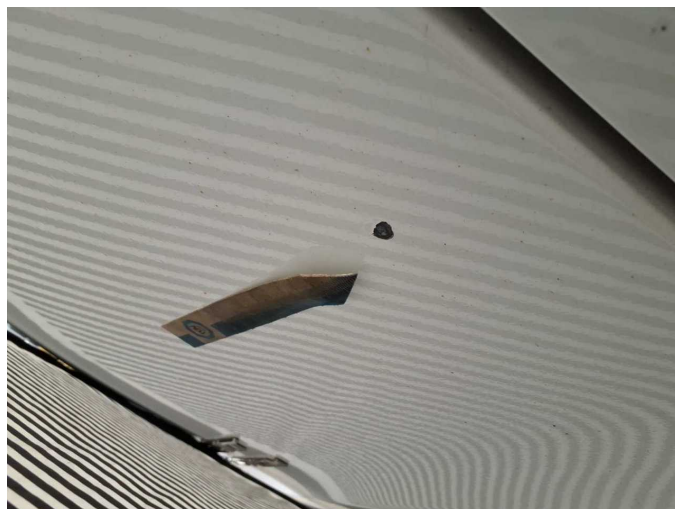
| No. | Component group | Description |
|---|---|---|
| 8 | Boot lid / rear door | Rear door - left side (Korrosion) - Scratch(es) - Paint |

**Damage 8:** Boot lid / rear door: Rear door - left side (Korrosion) -  
Scratch(es) - Paint

**Damage 8:** Boot lid / rear door: Rear door - left side (Korrosion) - Scratch(es) - Paint

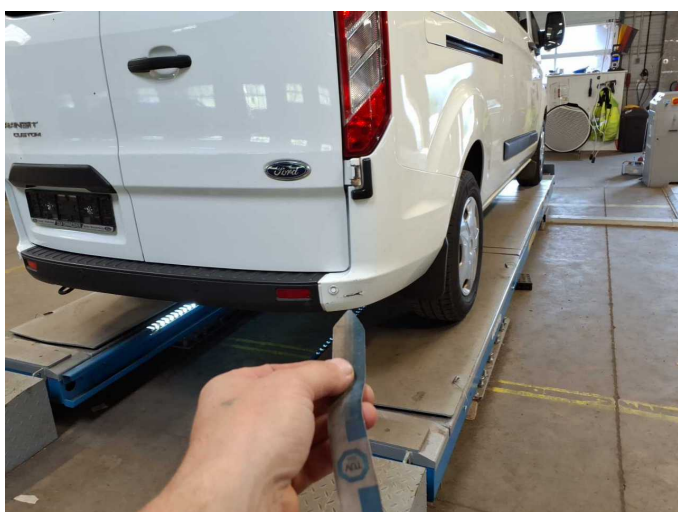
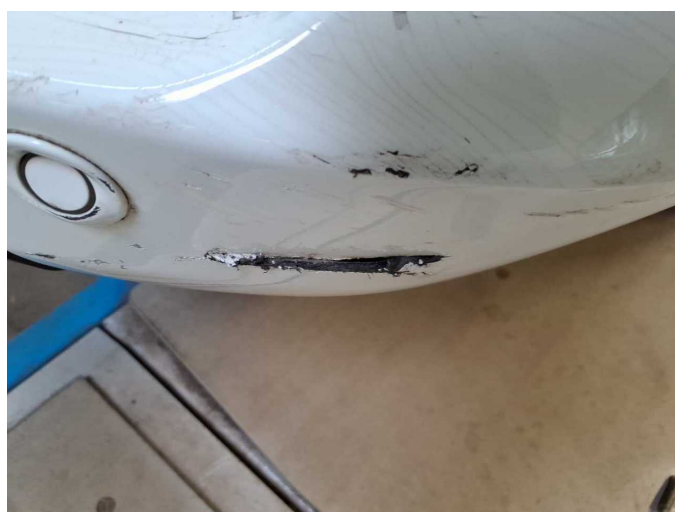
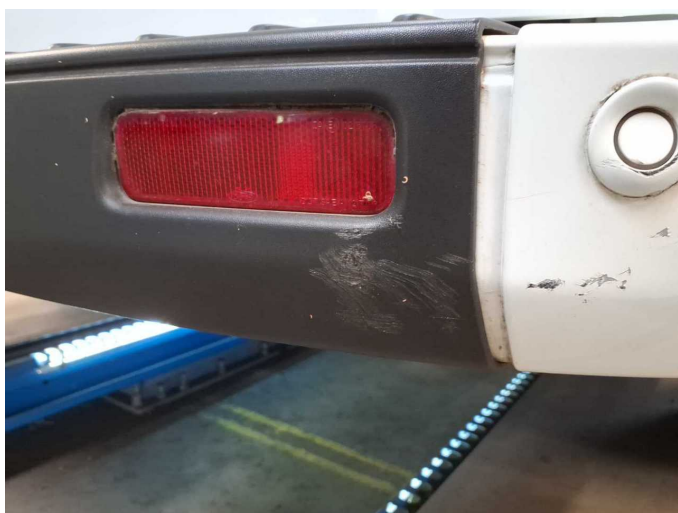
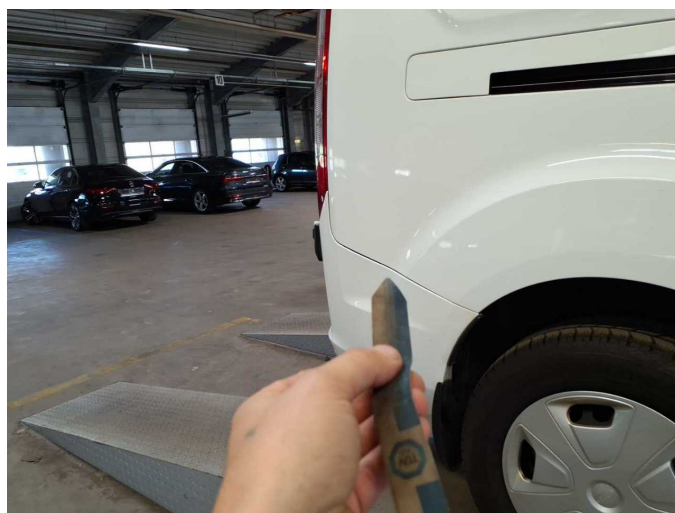
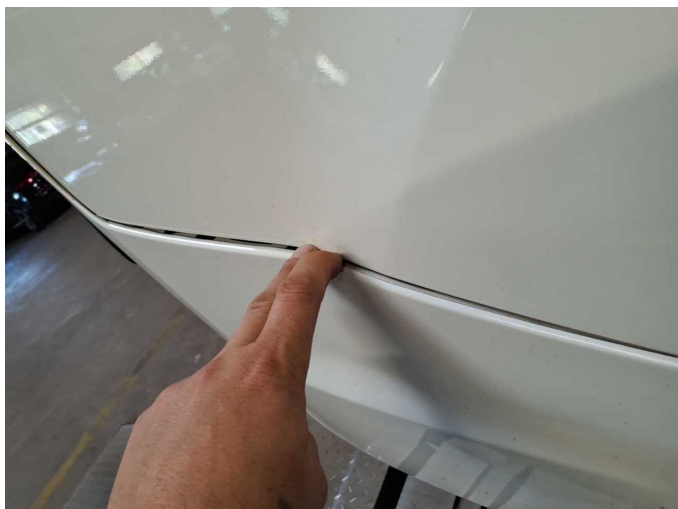
| No. | Component group | Description |
|---|---|---|
| 9 | Rear bumper | Rear bumper - Damaged - Replace |

**Damage 9:** Rear bumper: Rear bumper - Damaged - Replace

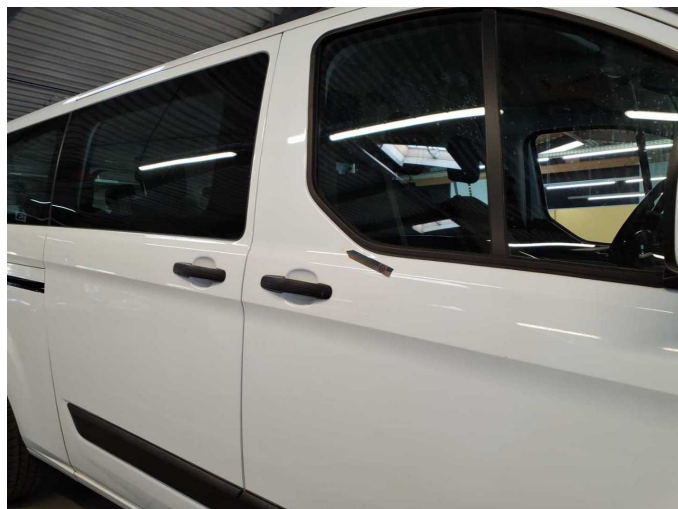
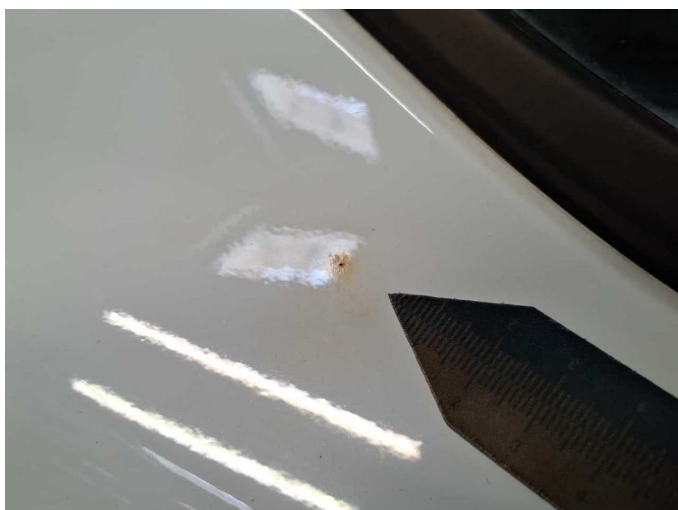
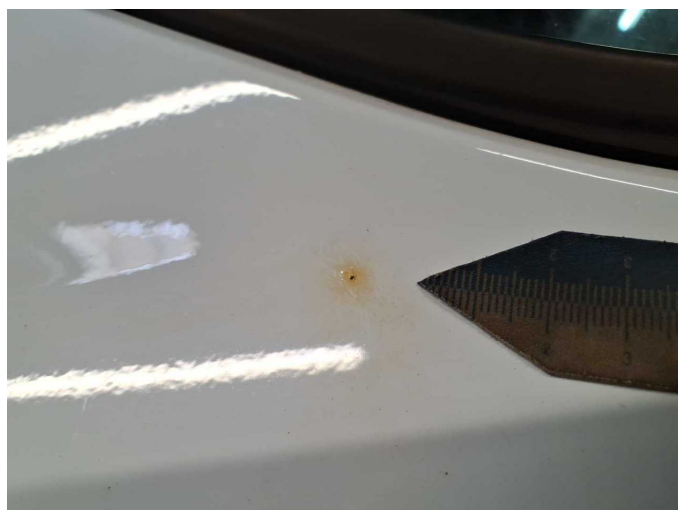
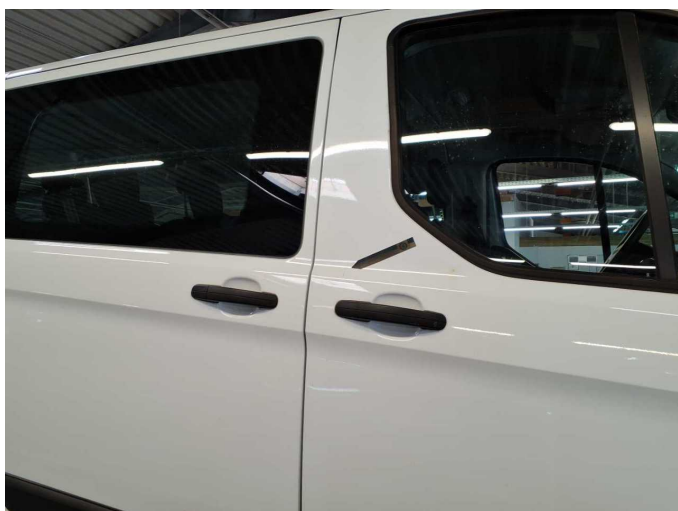
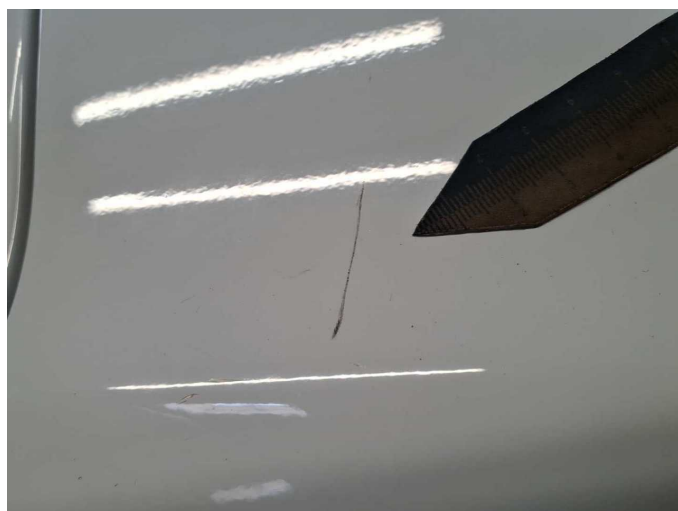
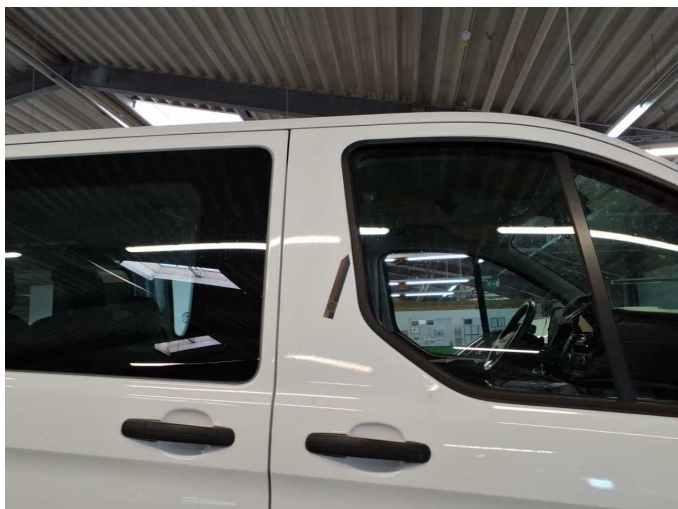
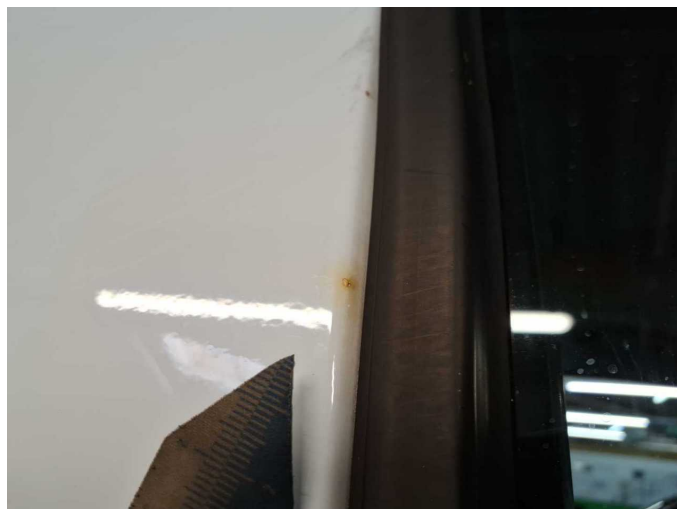
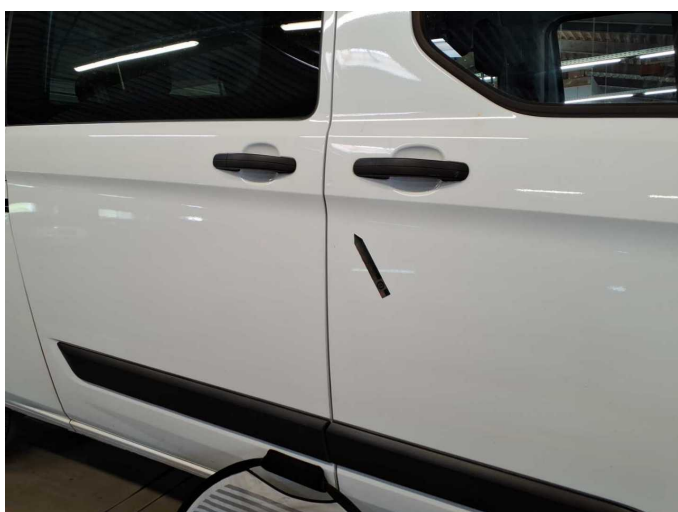
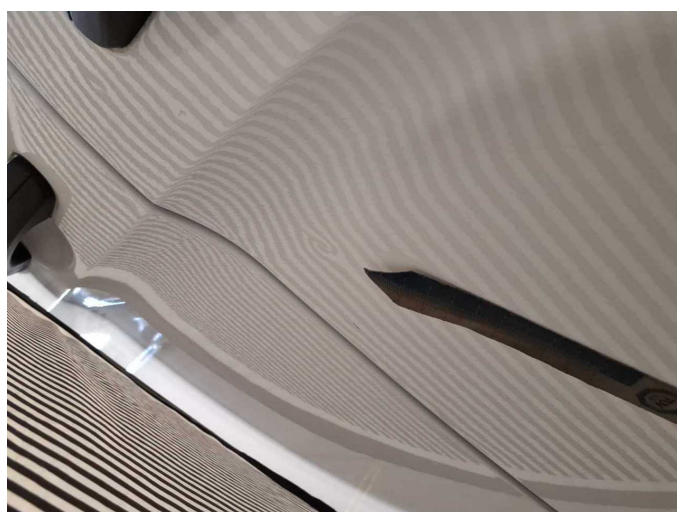
| No. | Component group | Description |
|---|---|---|
| 10 | Door - front right side | Door (Kratzer, Dellen) - Corrosion - Repair and paint |

**Damage 10:** Door - front right side: Door (Kratzer, Dellen) - Corrosion - Repair and paint

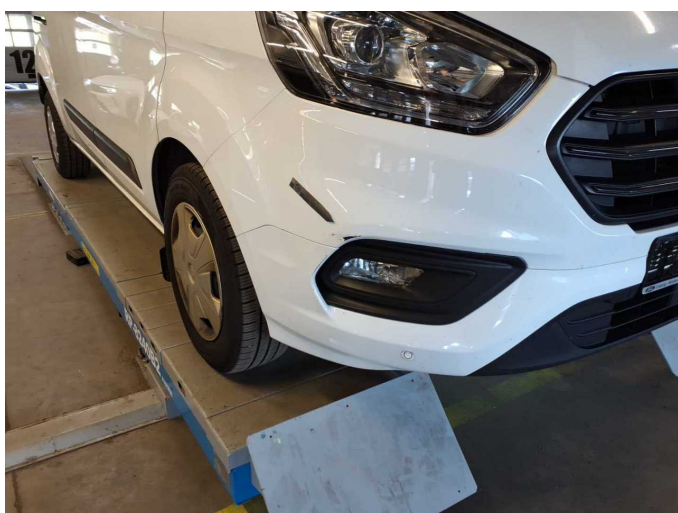
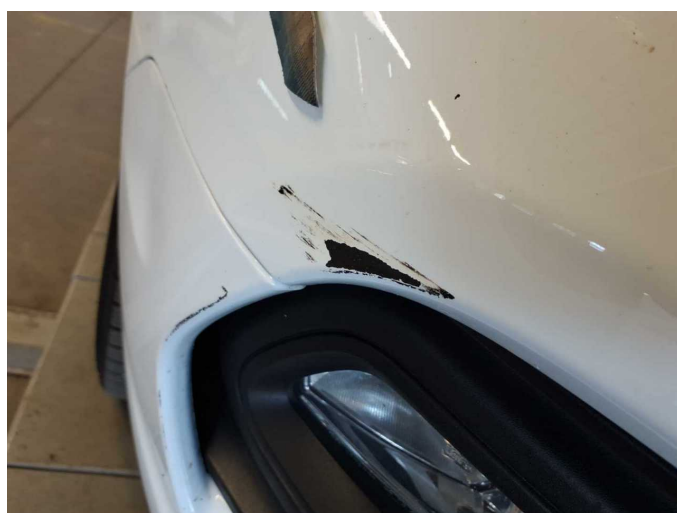
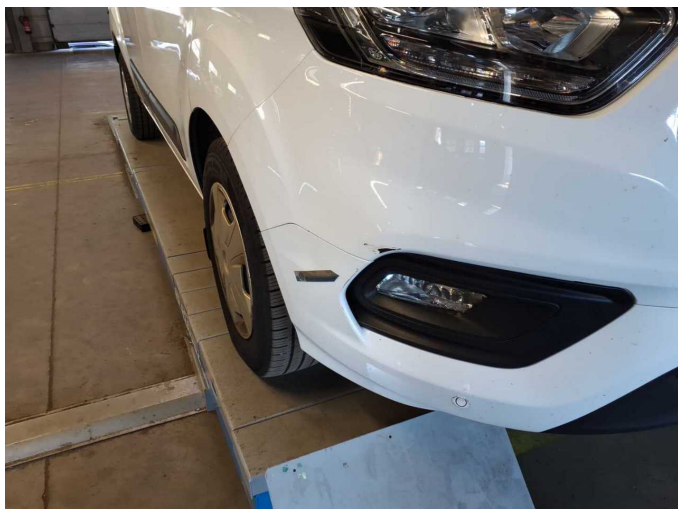
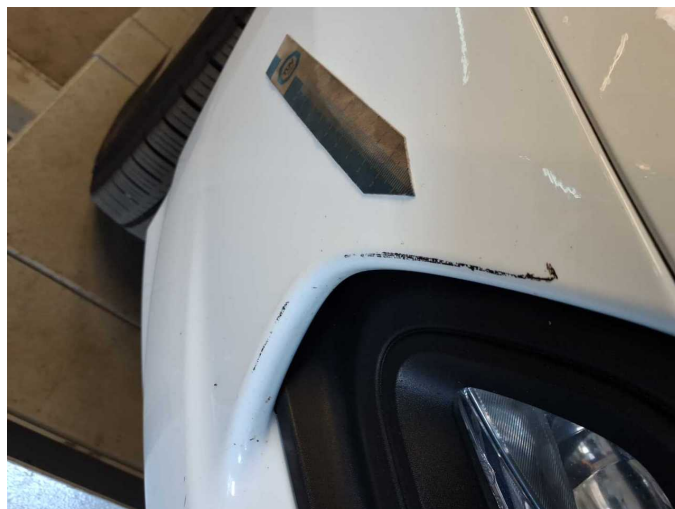
| No. | Component group | Description |
|---|---|---|
| 11 | Front bumper | Front bumper - Scratch(es) - Paint |

**Damage 11:** Front bumper: Front bumper - Scratch(es) - Paint

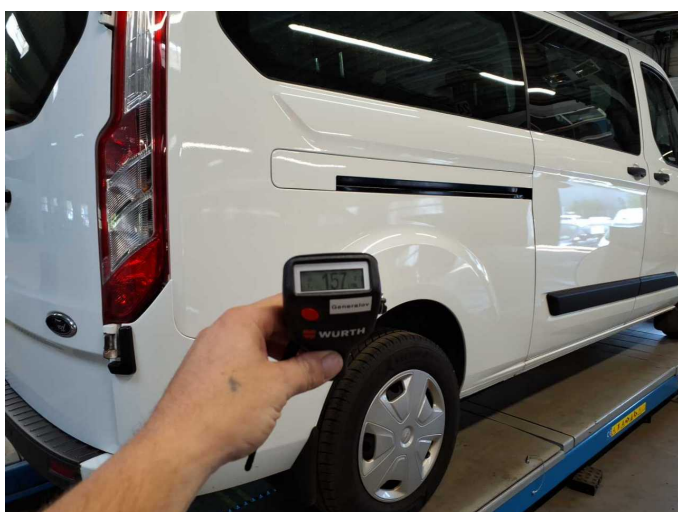
| No. | Repainting |
|---|---|
| 1 | Side panel - rear right side, Professionally carried out, Invoice of repair done Non-existent |

| Side panel - rear right side | 157 µm |

**Repainting 1:** Side panel - rear right side
