Opel Vivaro:

Vinnnumber:	VXEVFAHKKLZ048947	Versionname:	Vivaro 2.0D 90kW GBDC L3H1 Innovation HP
First Registrationdate:	22/07/2020	Fiscalpower:	
Expertise Mileage:	183459	Power Kw:	90
Bodytype:		Body colour:	White Jade basis lak
Gearbox:	MAN 6 VIT	Paint type:	Opaque
Transmission:		Type of rims (mounted):	Aluminium
Fueltype:	Diesel	Parking lot:	889
Number of seats:	5		
Type of rims (mounted):	Aluminium		
Maintenance needed:	Yes

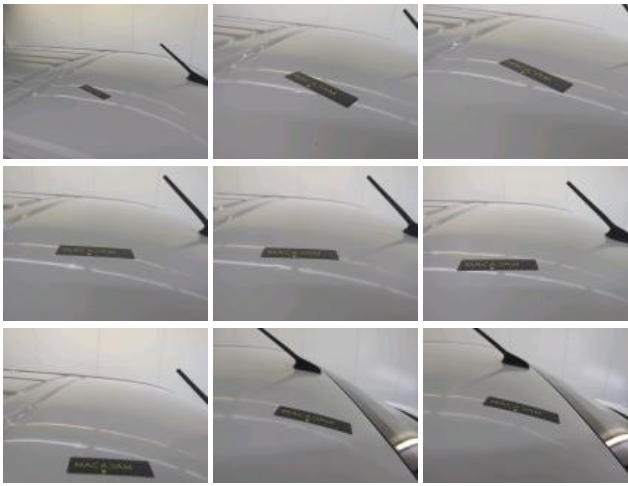
Roof, Hail damage, Paintless dent repair (hail)
