Expertise

Protocol number: 46567351  
Order No. / Reference: 26630118  
Inspection date: 16 Jul 2026

Manufacturer: Ford

Model: Focus Turnier 1.5 EcoBlue Start-Stopp-System Aut. TITANIUM

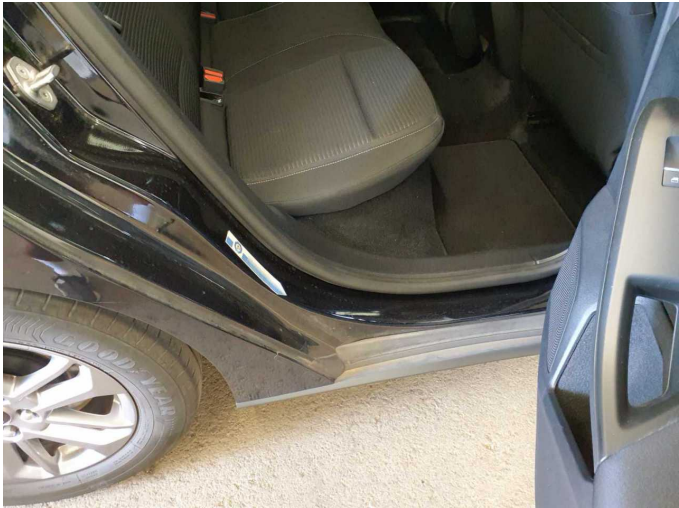
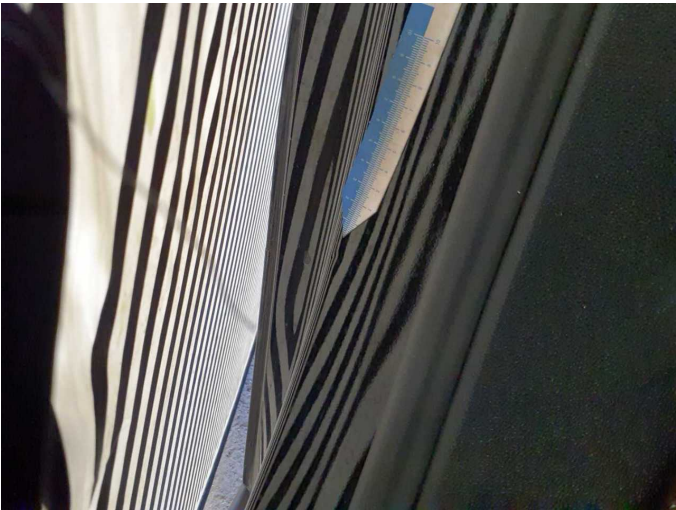
| No. | Component group | Description |
|---|---|---|
| 1 | Side panel - rear right side | Sill - dent(s) - Smart repair |

Damage 1: Side panel - rear right side: Sill - dent(s) - Smart repair

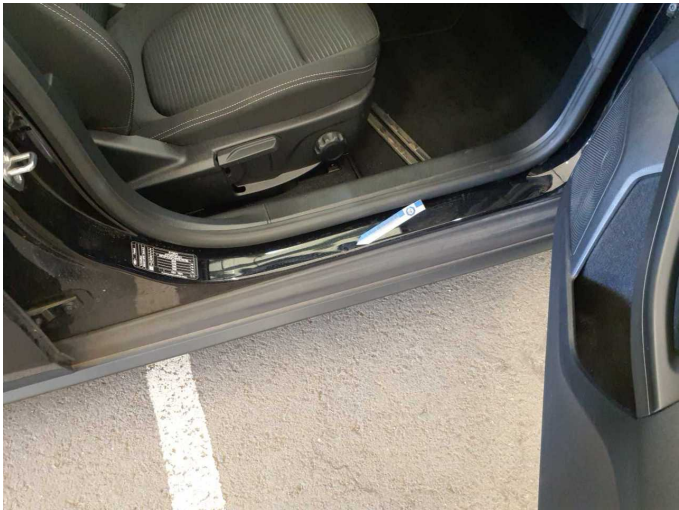
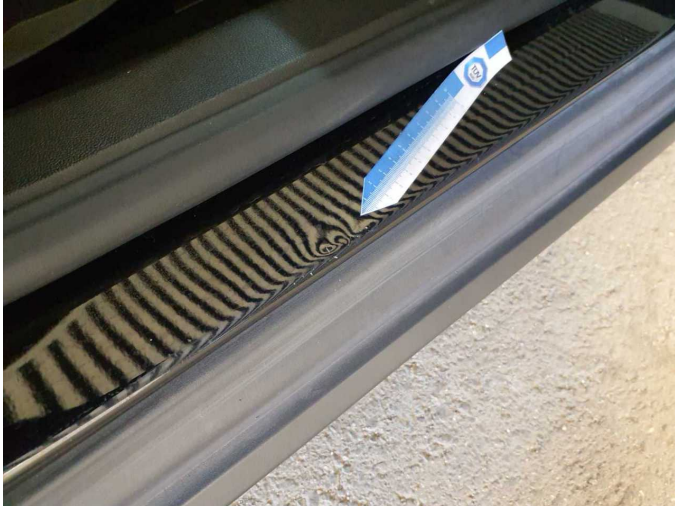
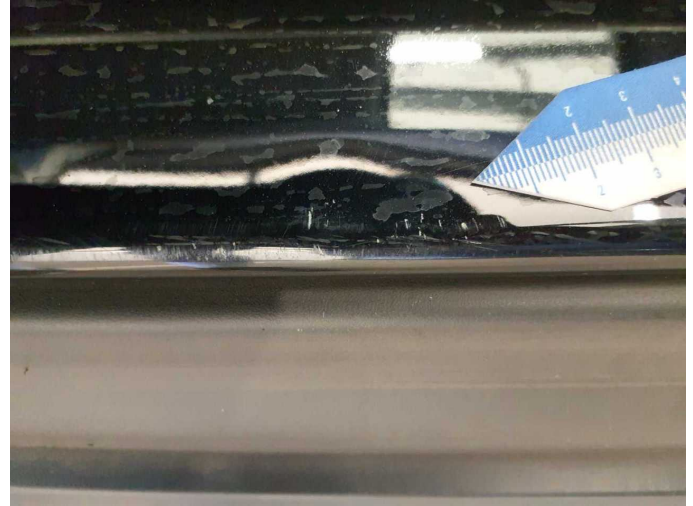
| No. | Component group | Description |
|---|---|---|
| 2 | Sill - right side | Sill - Dent / paintcoat damage - Smart repair |

Damage 2: Sill - right side: Sill - Dent / paintcoat damage - Smart repair

**Damage 2:** Sill - right side: Sill - Dent / paintcoat damage - Smart repair

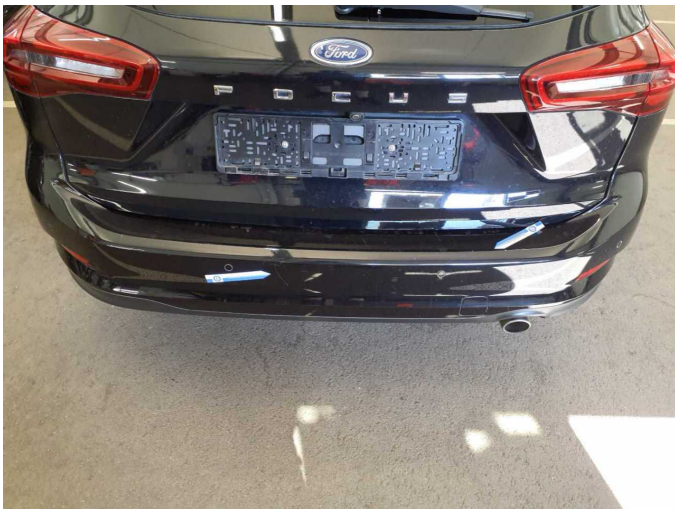
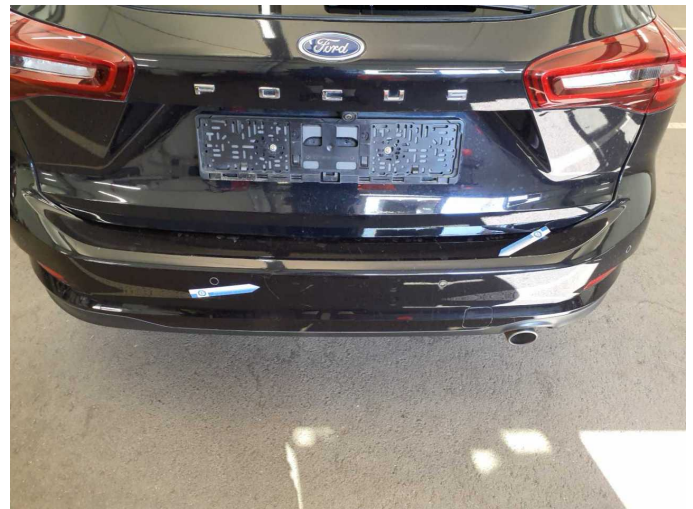
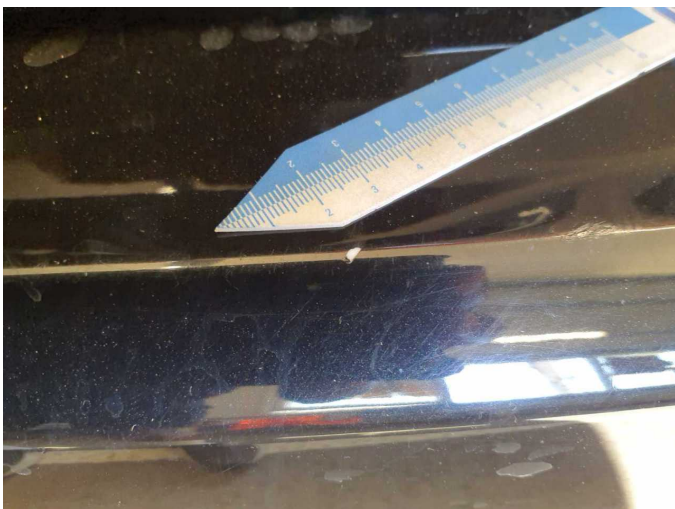
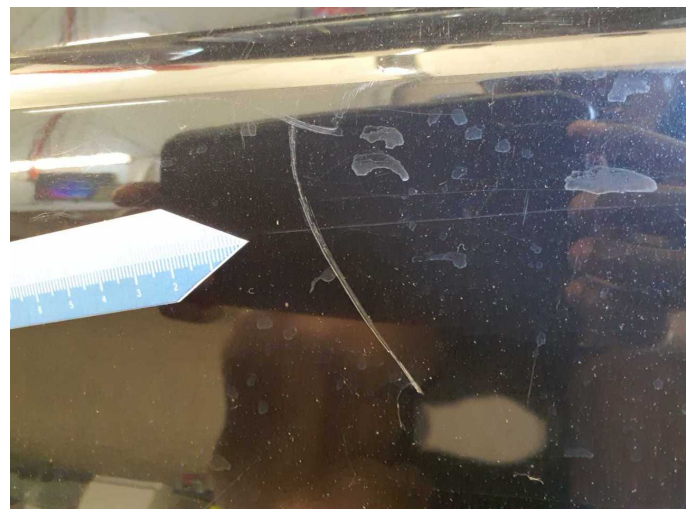
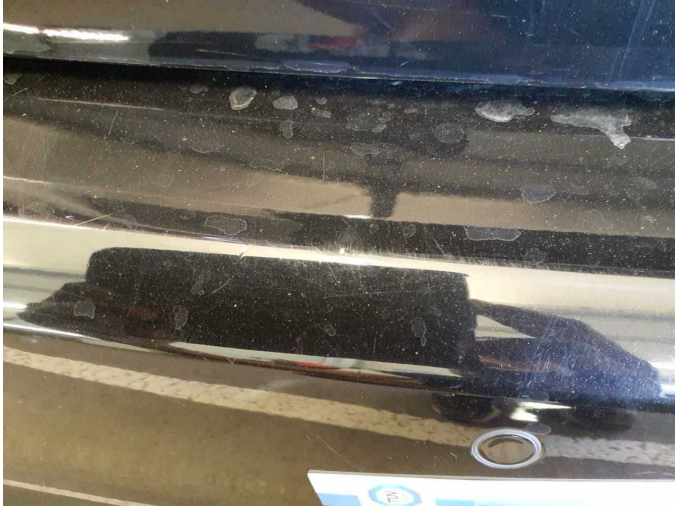
| No. | Component group | Description |
|---|---|---|
| 3 | Rear bumper | Rear bumper - Scratch(es) - Smart repair |

**Damage 3:** Rear bumper: Rear bumper - Scratch(es) - Smart repair

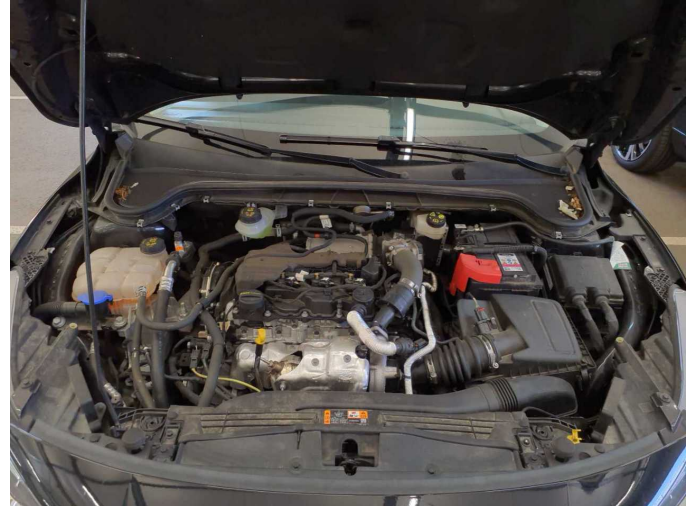
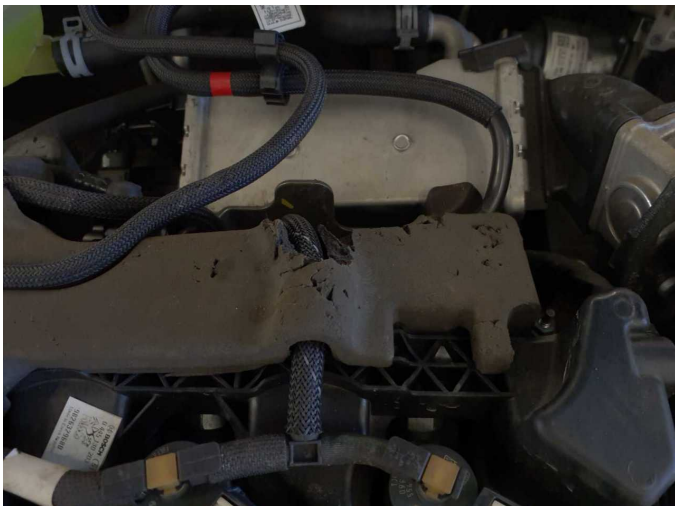
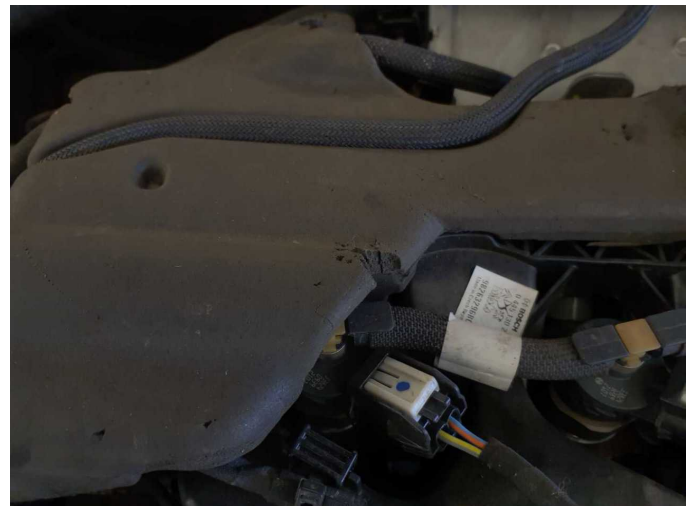
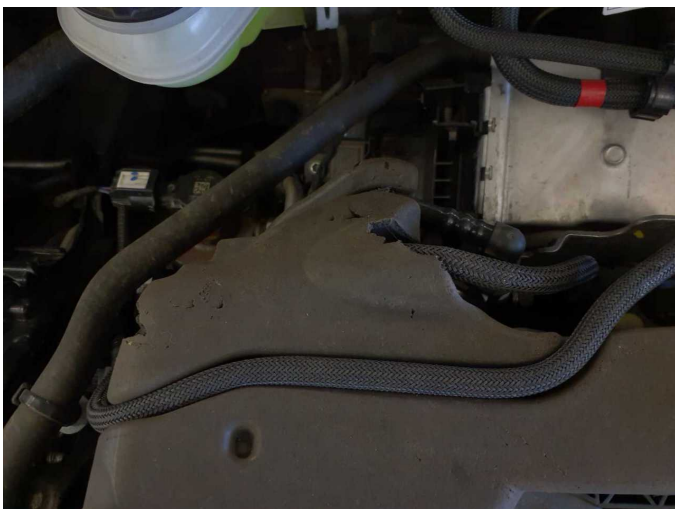
| No. | Component group | Description |
|---|---|---|
| 4 | Engine | Engine cover - Damage caused by marten / rodent - Replace |

**Damage 4:** Engine: Engine cover - Damage caused by marten / rodent - Replace

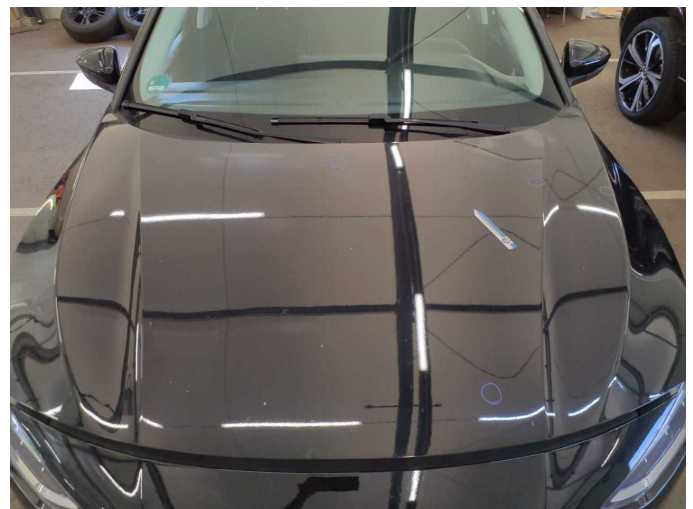
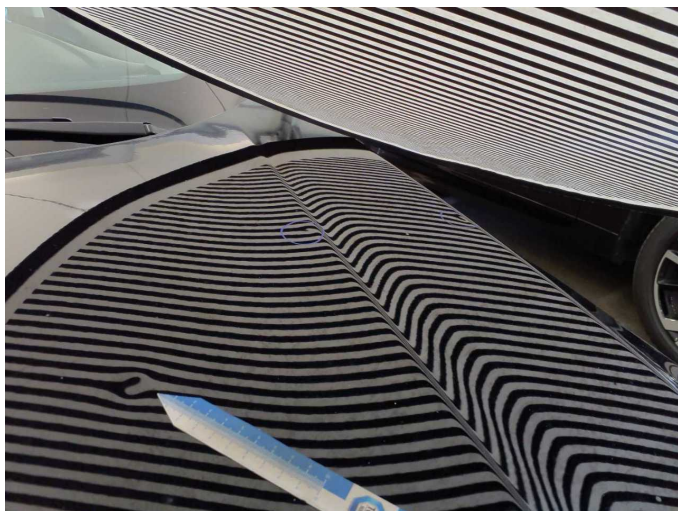
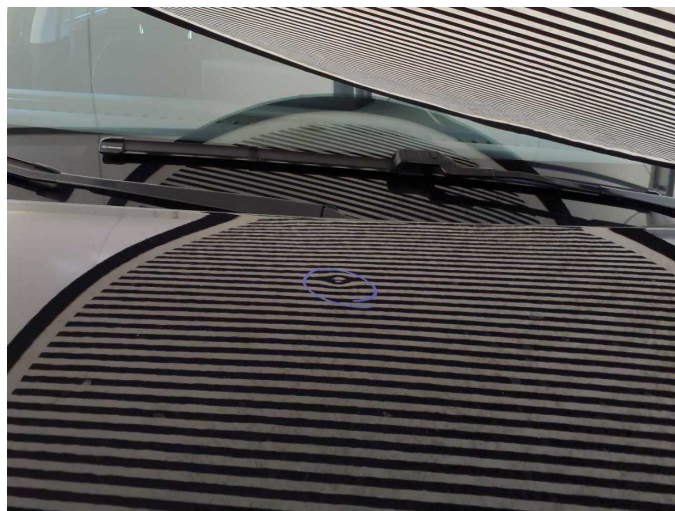
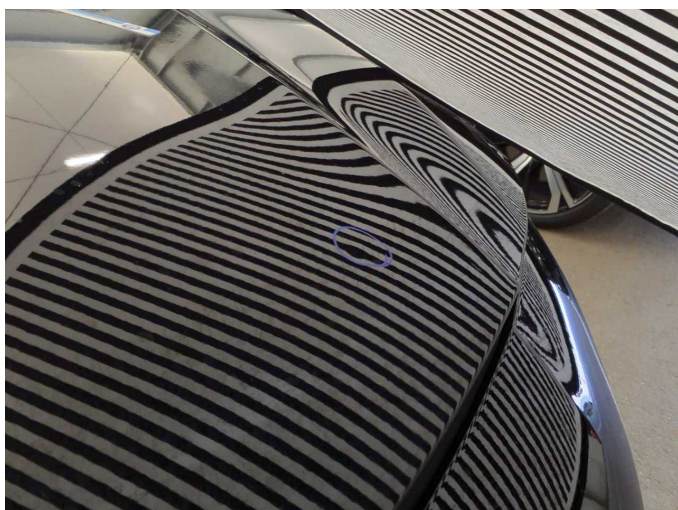
| No. | Component group | Description |
|---|---|---|
| 5 | Bonnet | Bonnet - dent(s) - Smart repair |

**Damage 5:** Bonnet: Bonnet - dent(s) - Smart repair

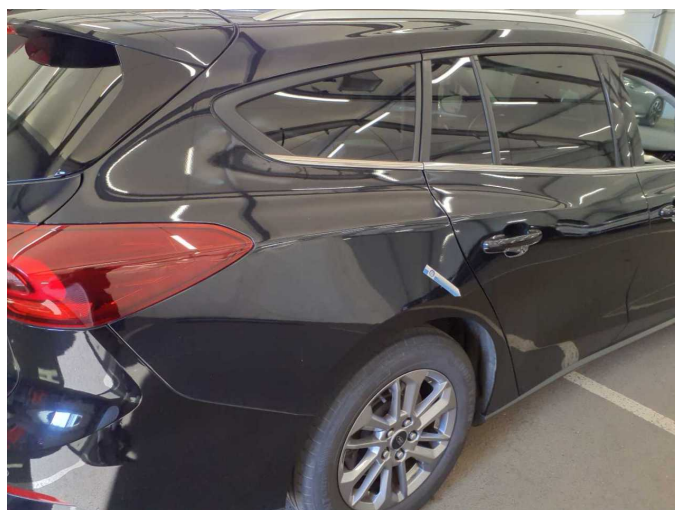
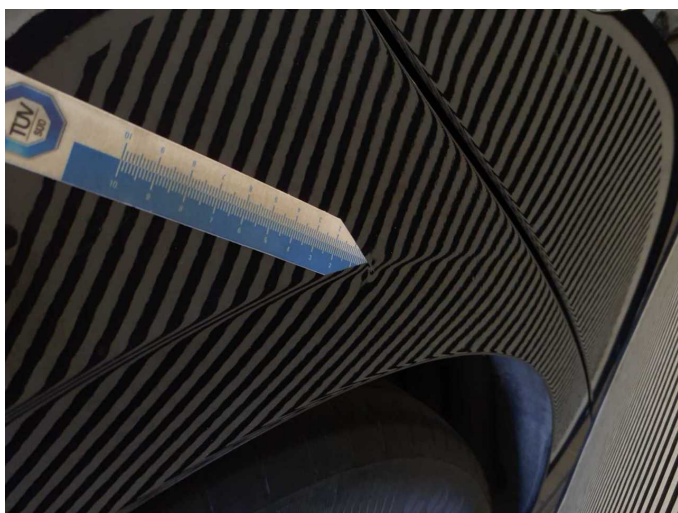
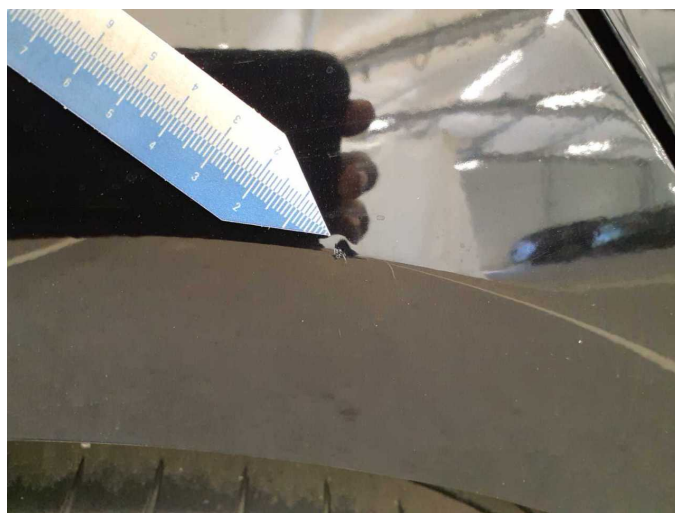
| No. | Component group | Description |
|---|---|---|
| 6 | Side panel - rear right side | Side panel - Dent / paintcoat damage - Smart repair |

**Damage 6:** Side panel - rear right side: Side panel - Dent / paintcoat damage - Smart repair

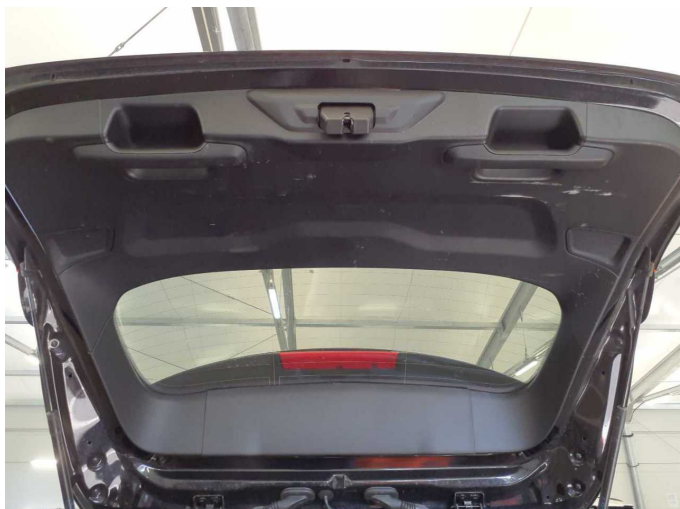
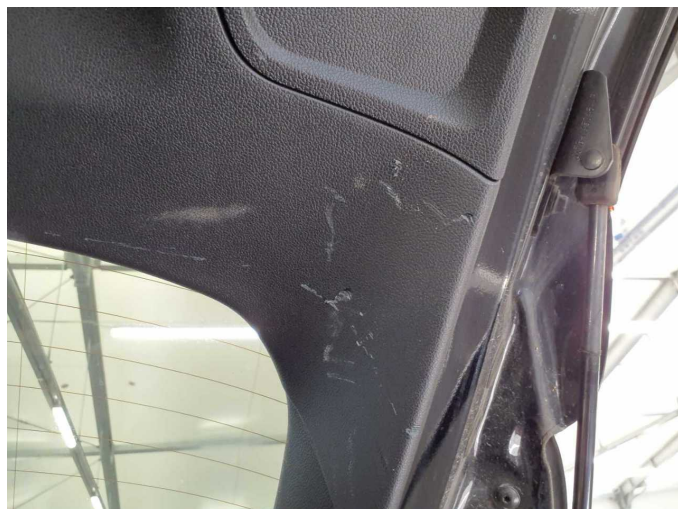
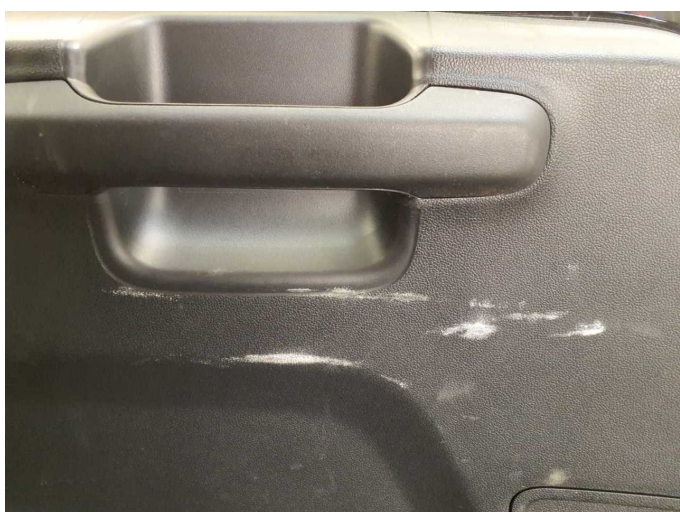
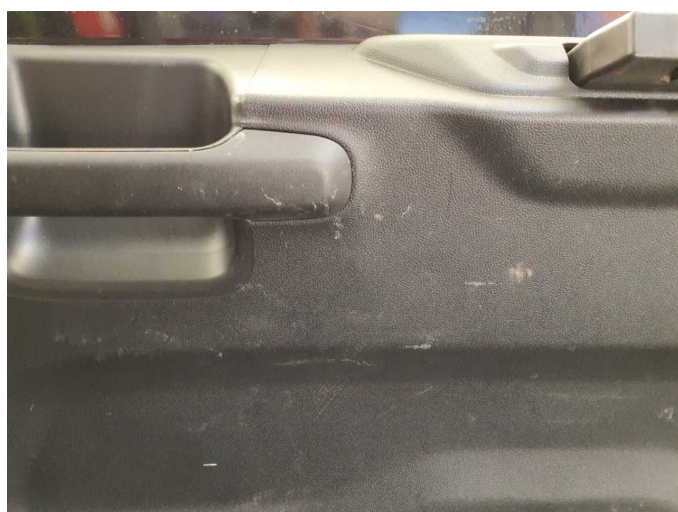
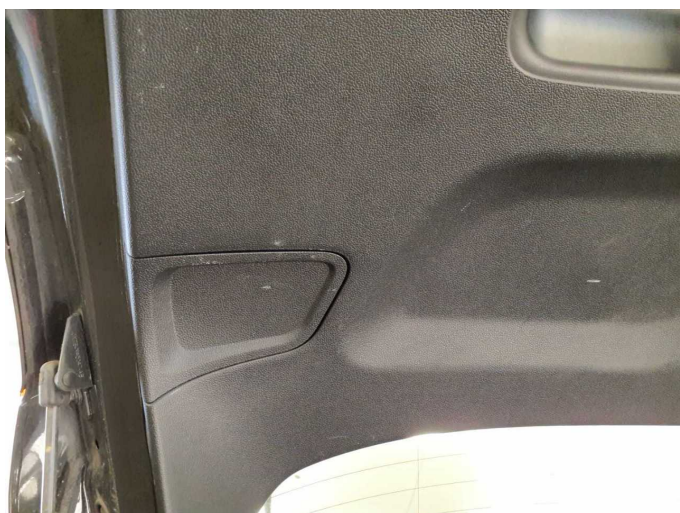
| No. | Component group | Description |
|---|---|---|
| 1 | Trim / covers | Boot lid - interior trim - Scratch(es) - No deduction |

**Wear and tear 1:** Trim / covers: Boot lid - interior trim - Scratch(es) - No deduction

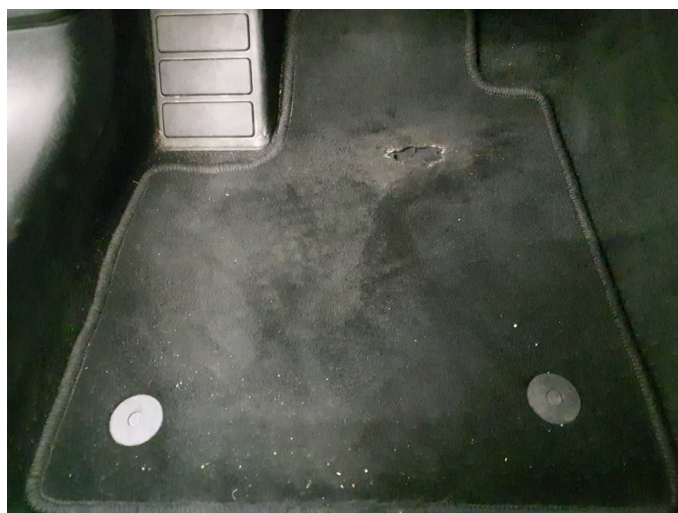
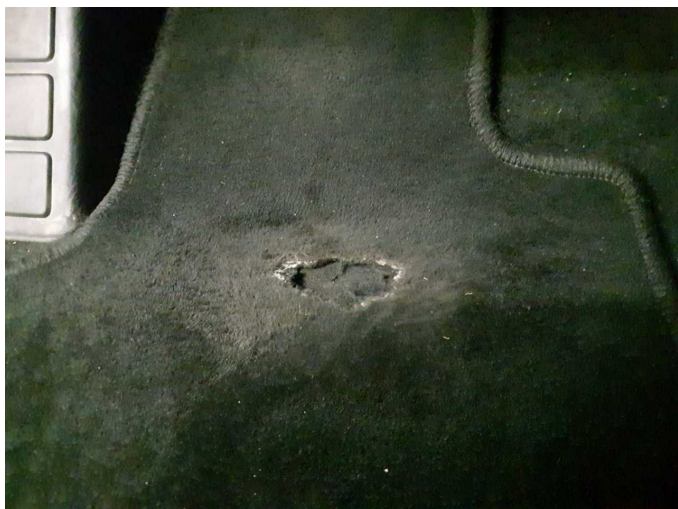
| No. | Component group | Description |
|---|---|---|
| 2 | Trim / covers | Floor mats - Holes - No deduction |

**Wear and tear 2:** Trim / covers: Floor mats - Holes - No deduction
