Expertise

Protocol number: 45492332
Order No. / Reference: 26373722
Inspection date: 18 May 2026

Model: Superb Combi 2.0 TDI DSG Style

VIN: TMBJH7NP6P7033064

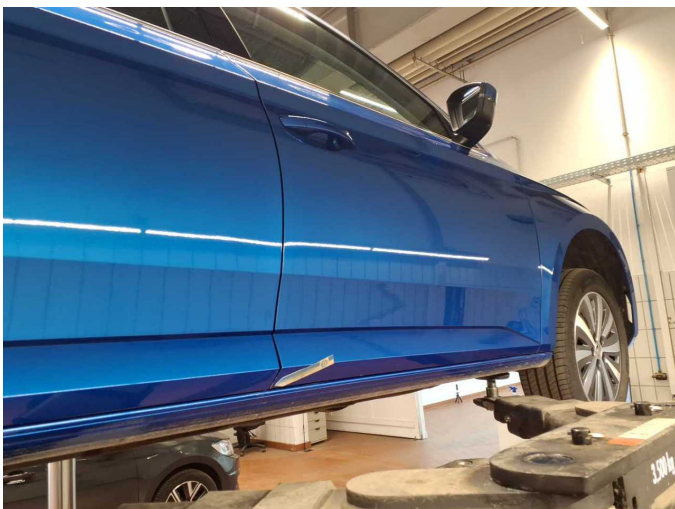
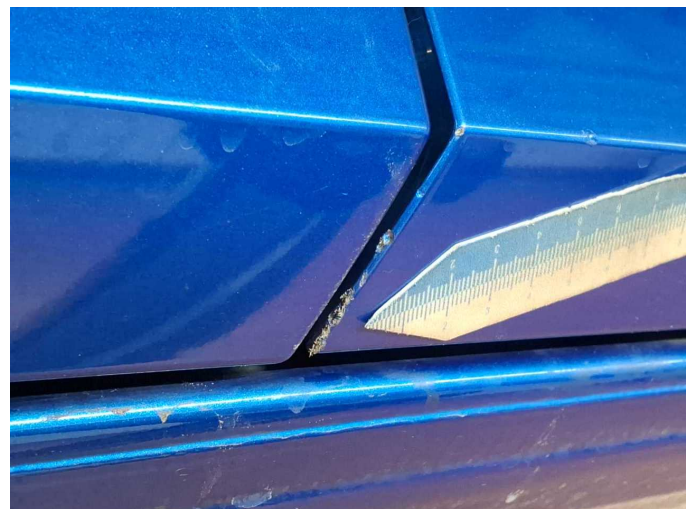
Damage 1: Door - front right side: Brightware - lower - Scratch(es) - Smart repair

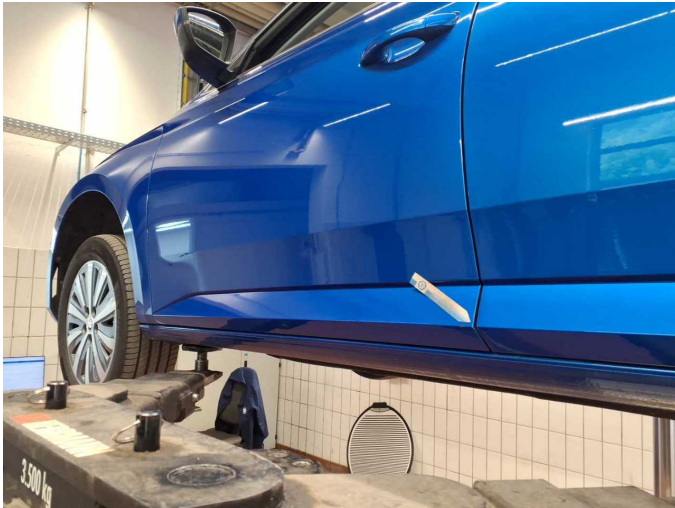
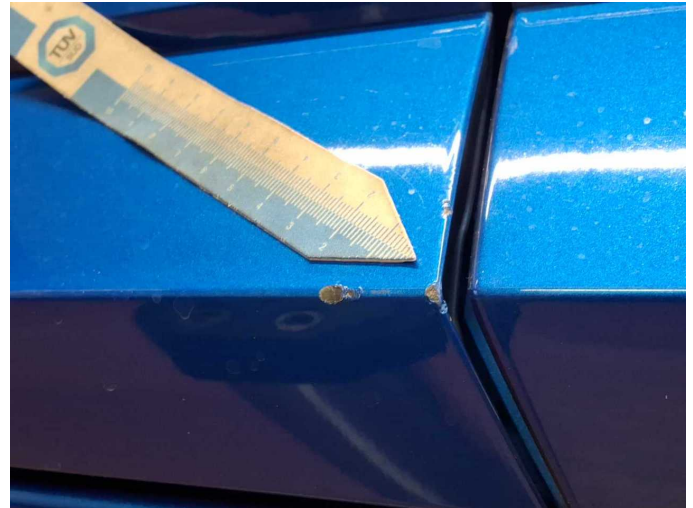
Damage 2: Door - front left side: Brightware - lower - Scratch(es) - Smart repair

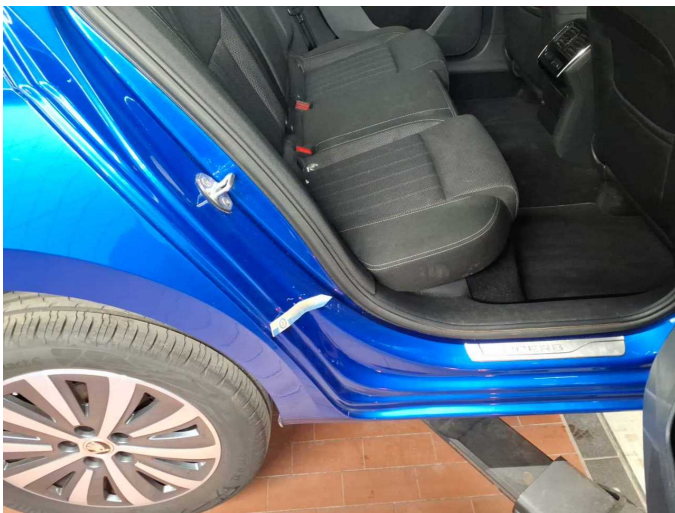
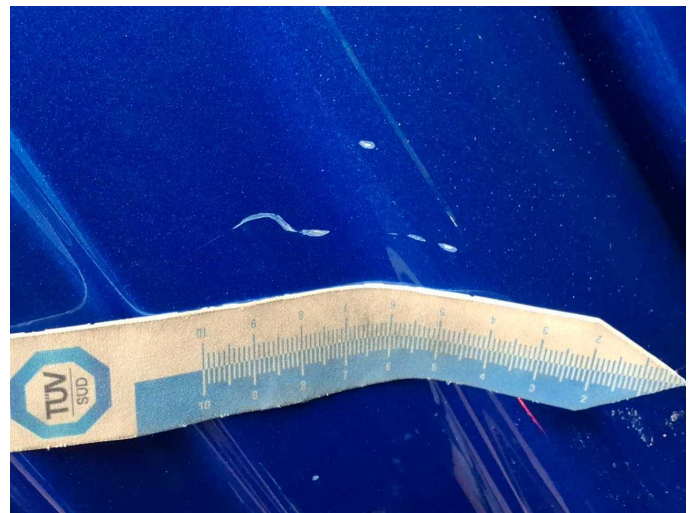
Damage 3: Side panel - rear right side: Sill - Scratch(es) - Smart repair

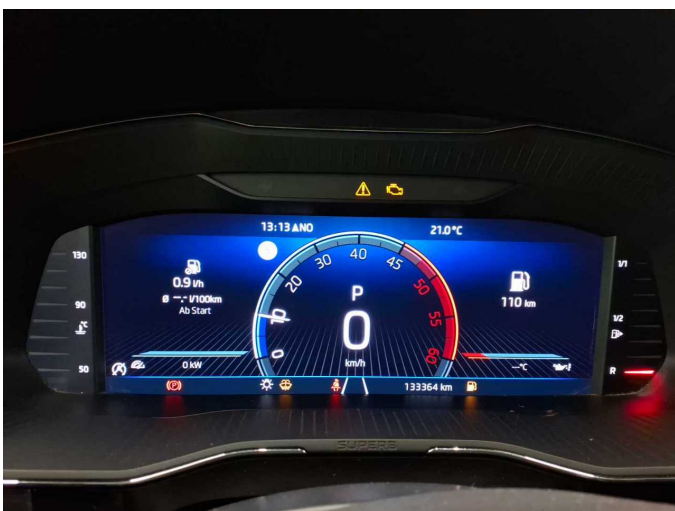
Damage 5: Instrument panel: Indicator light (Motor) - Electrical fault - Perform diagnosis

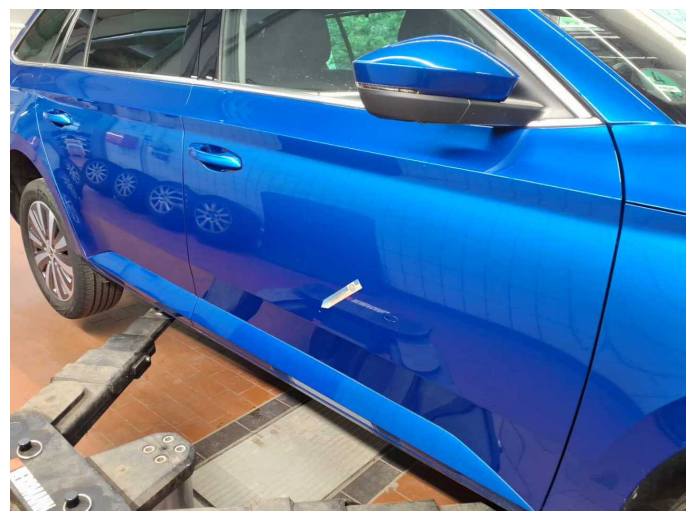
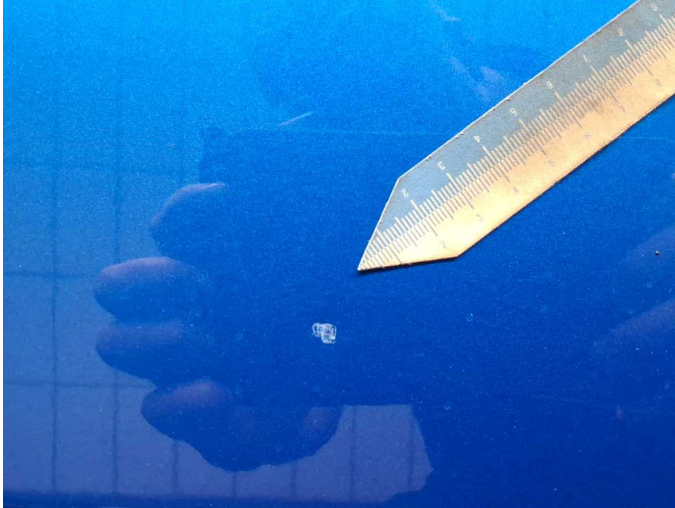
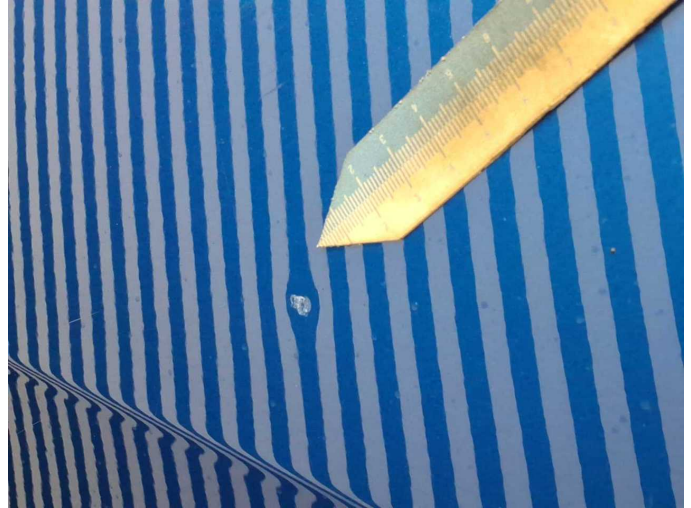
Damage 6: Door - front right side: Door - Dent / paintcoat damage - Repair and paint

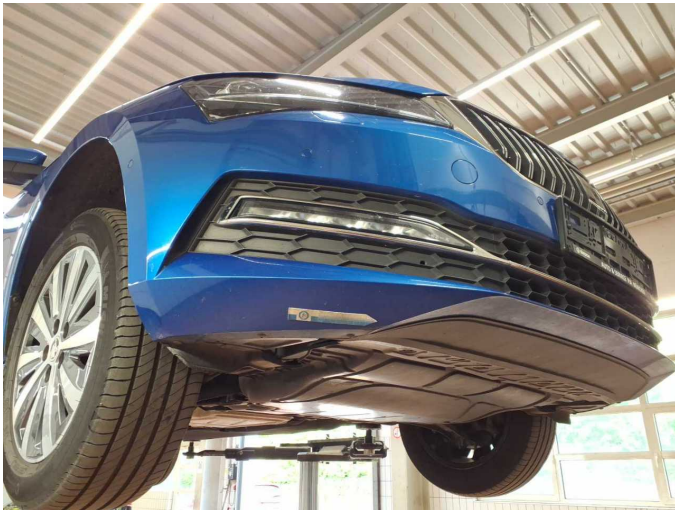
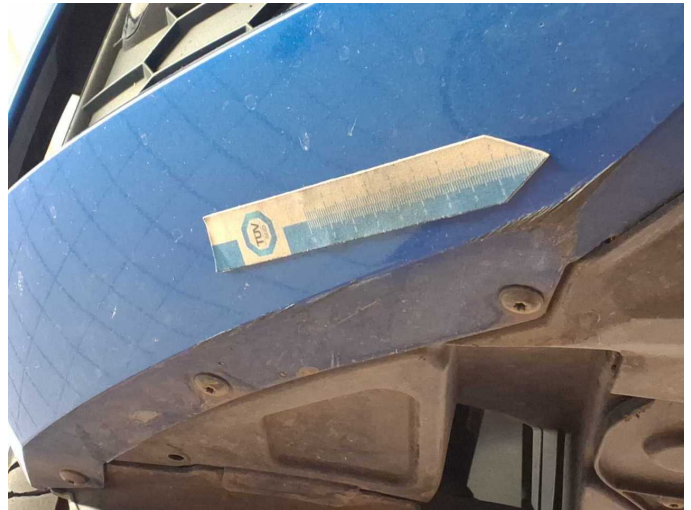
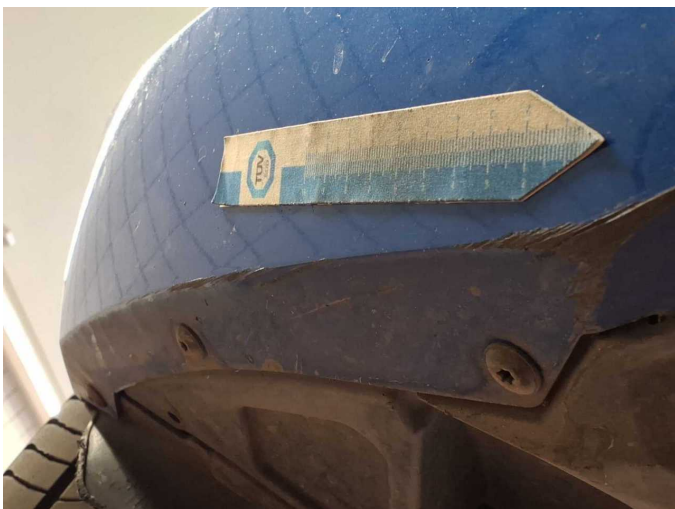
Damage 7: Front bumper: Front bumper - Scratched - Paint

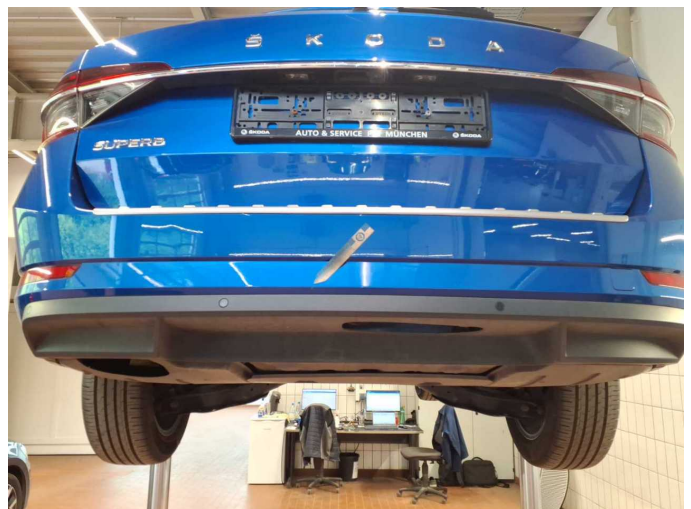
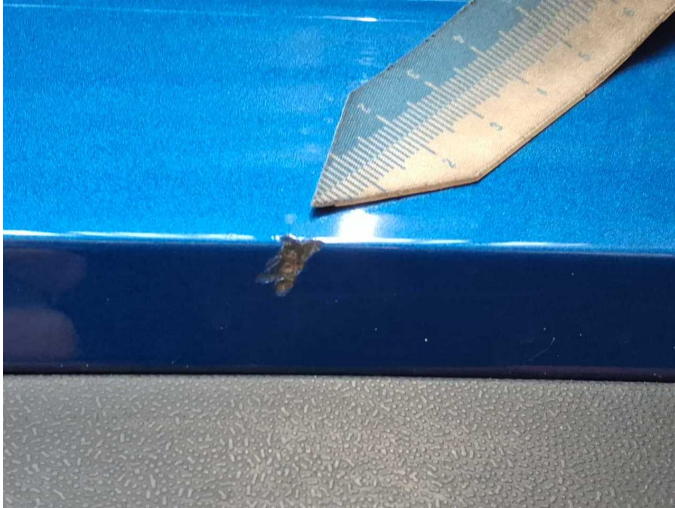
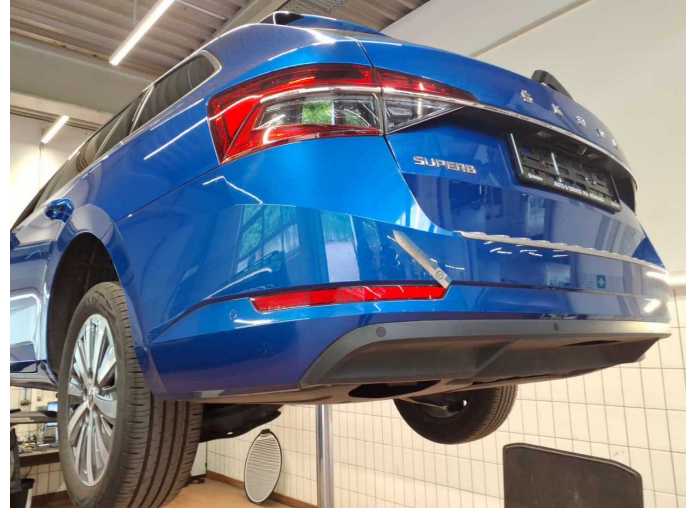
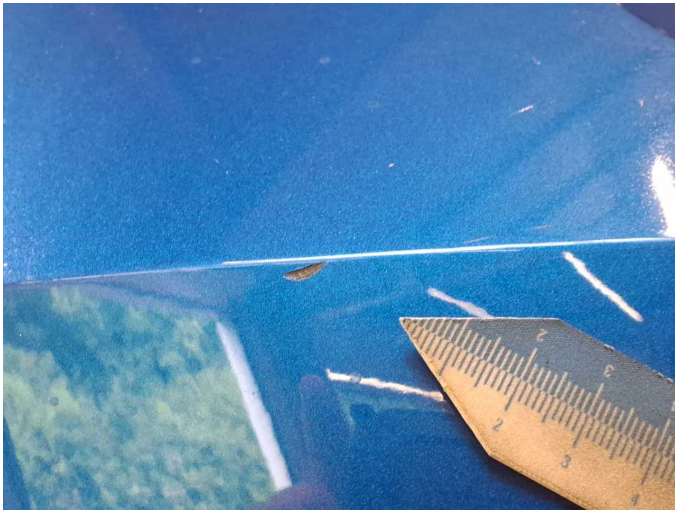
Damage 8: Rear bumper: Rear bumper - Scratch(es) - Repair and paint

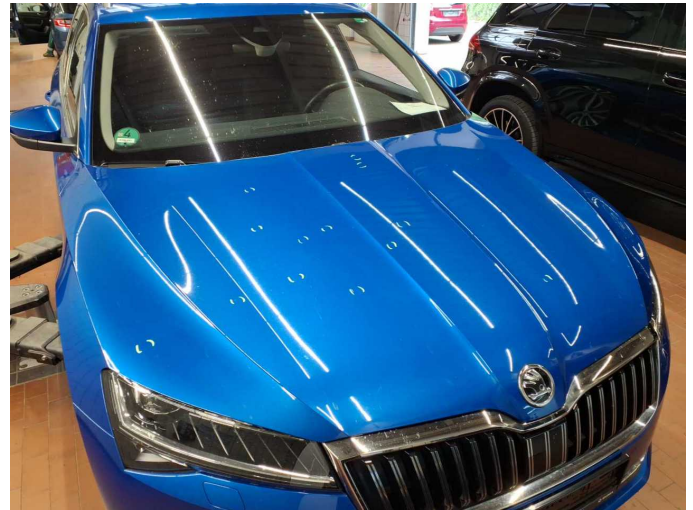
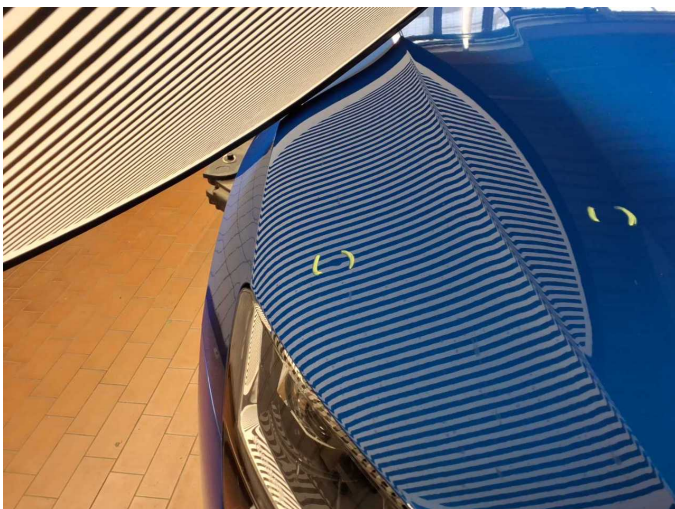
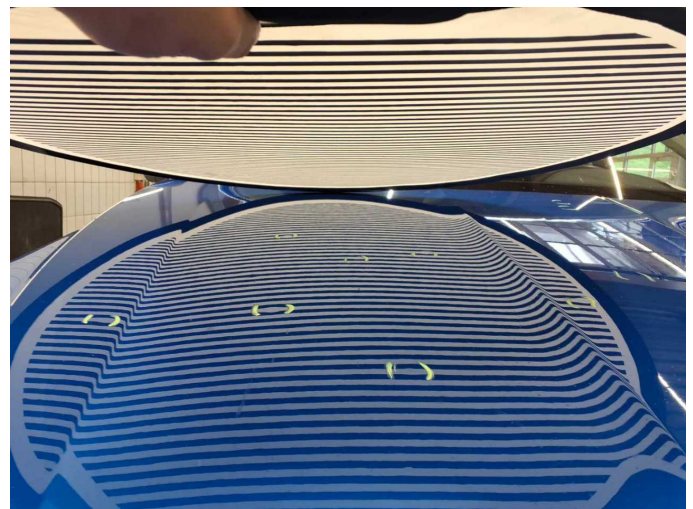
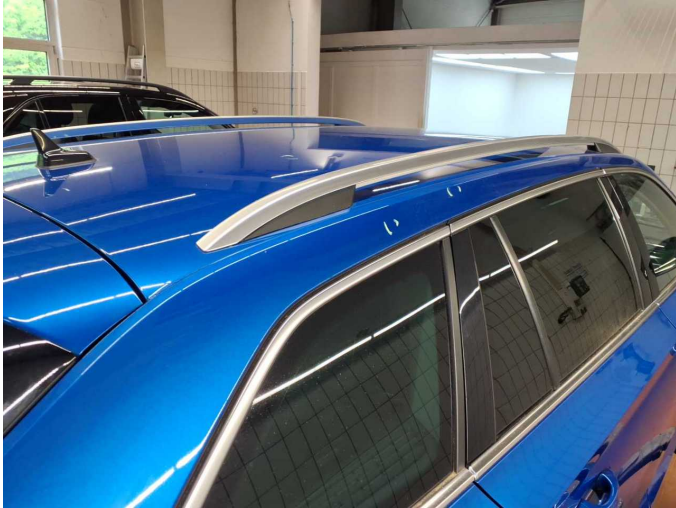
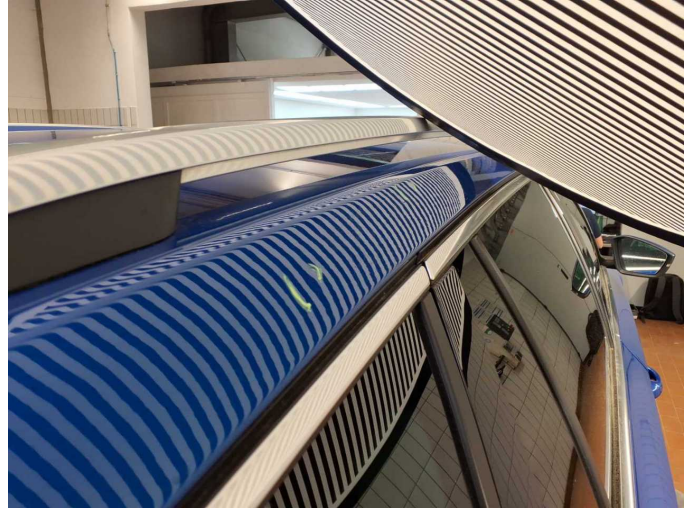
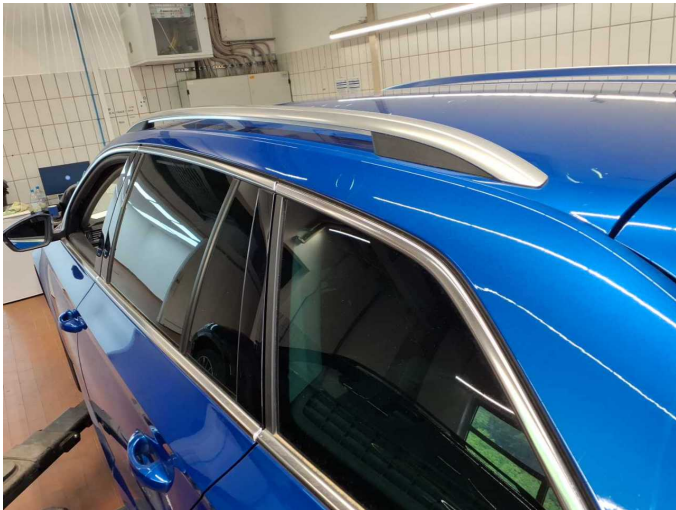
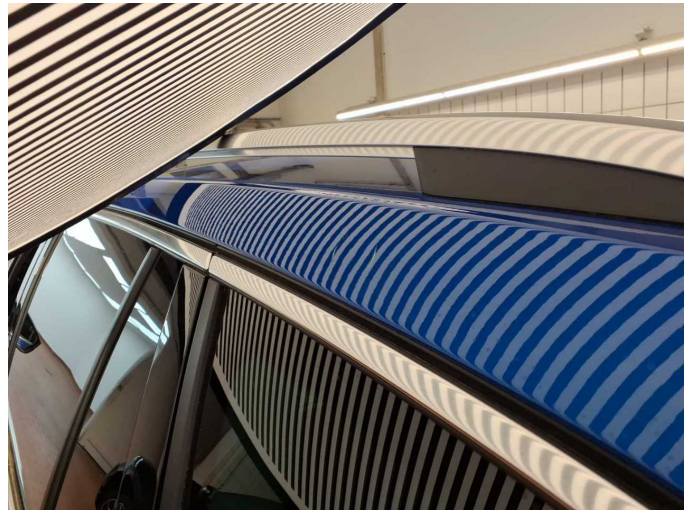
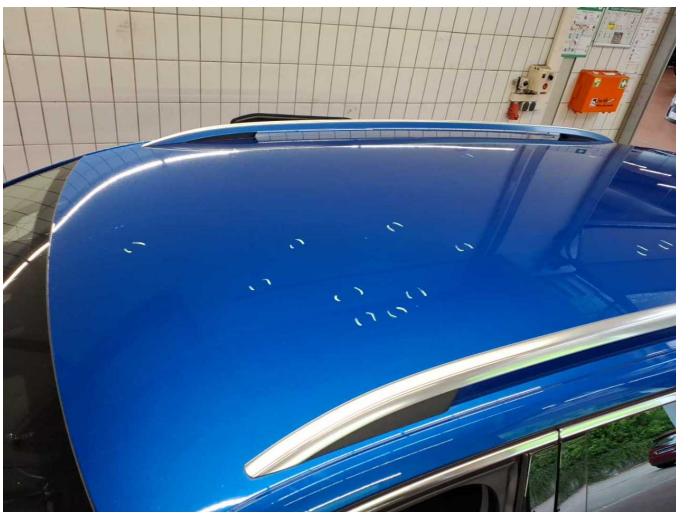
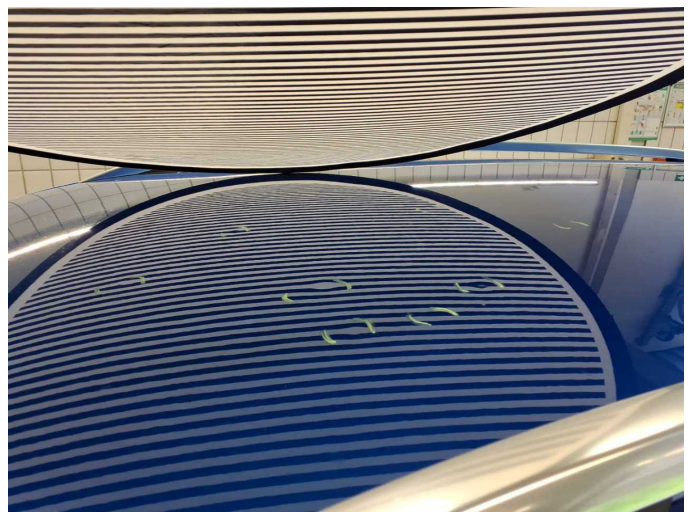
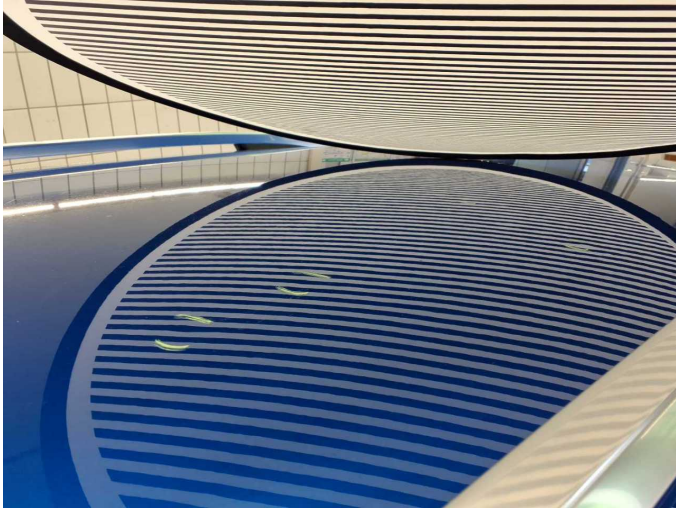
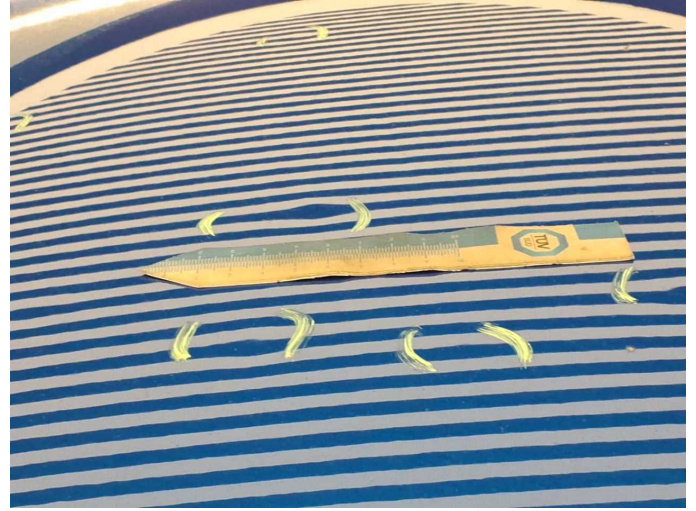
Damage 9: Body: Body - Damage by hail - repair according to calculation

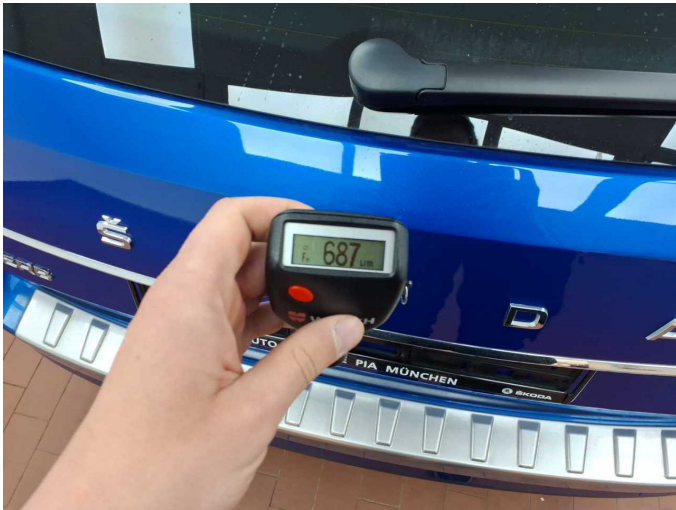
Repainting 1: Boot lid / rear door

No.	Repainting
1	Boot lid / rear door, Professionally carried out, Invoice of repair done Non-existent

687 µm
