Protocol number: 46236947
Order No. / Reference: 26542352
Inspection date: 22 Jun 2026

Manufacturer: Volkswagen

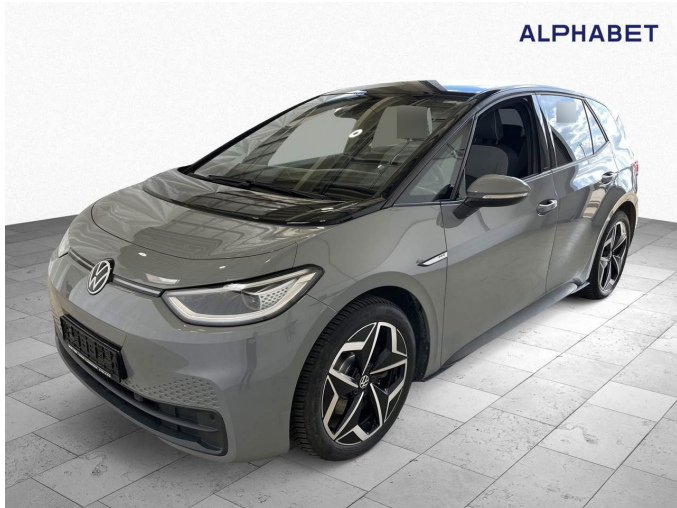
Figure 1: Diagonal front (left)

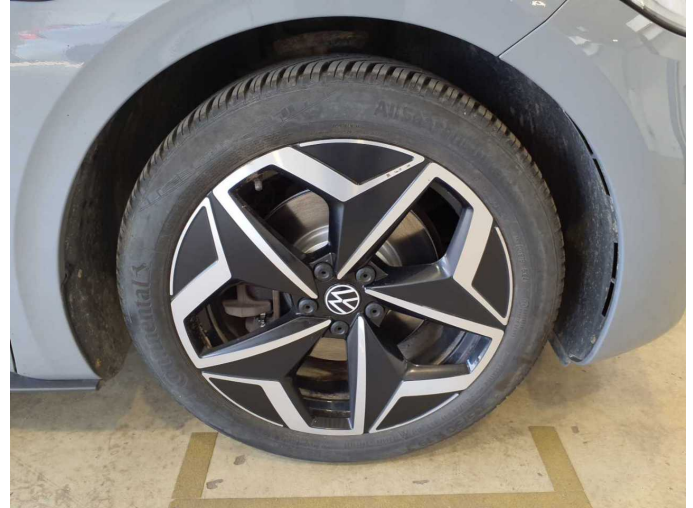
Damage 2: Wheel / tyres: Alloy rim - front right side - Scratch(es) - Loss in value

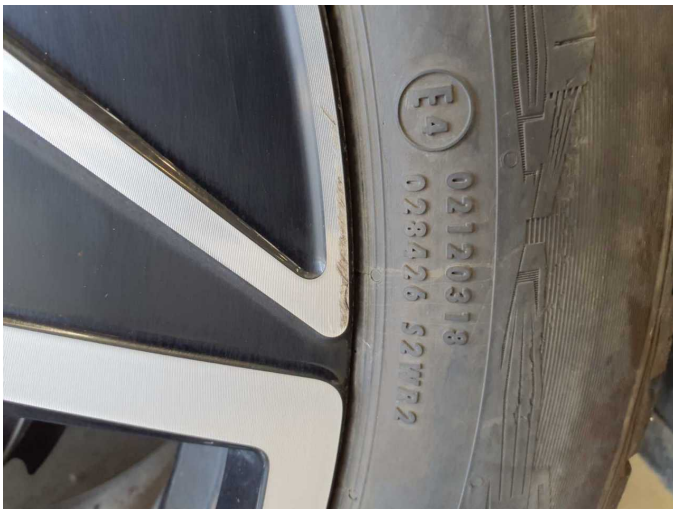
Damage 2: Wheel / tyres: Alloy rim - front right side - Scratch(es) - Loss in value

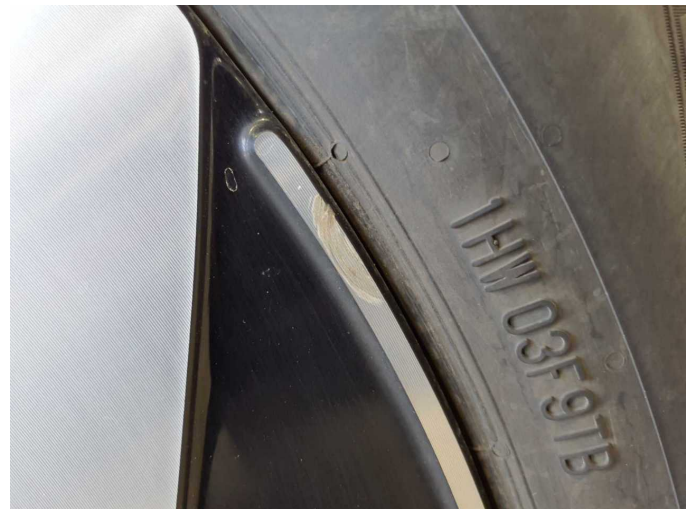
Damage 2: Wheel / tyres: Alloy rim - front right side - Scratch(es) - Loss in value

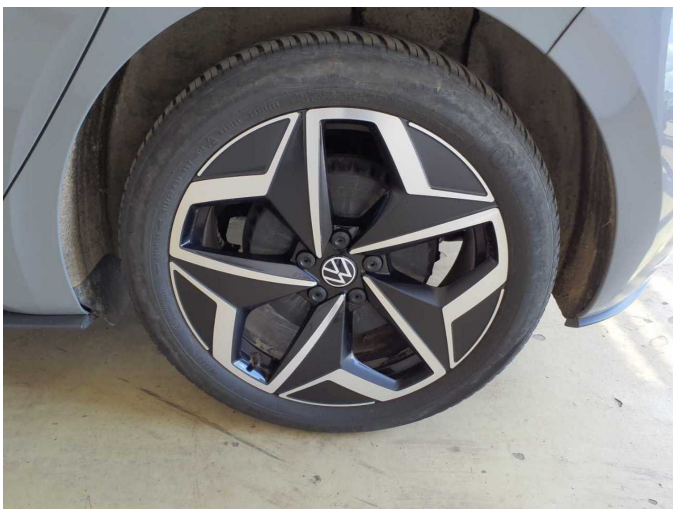
Damage 4: Wheel / tyres: Tyre - right - Worn - Replace

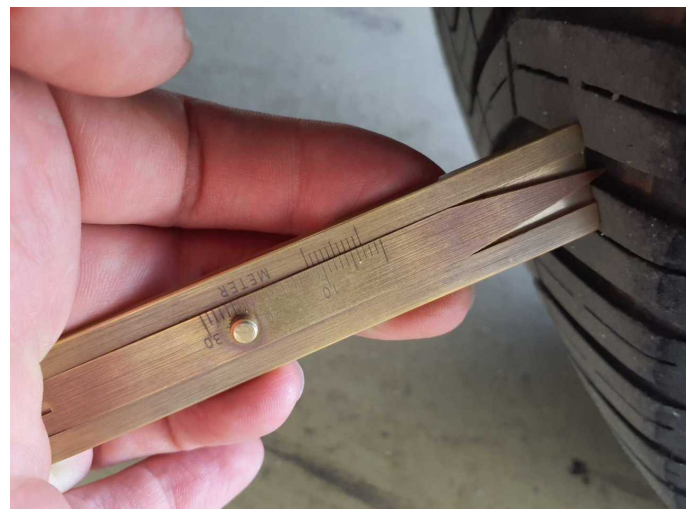
Damage 4: Wheel / tyres: Tyre - right - Worn - Replace

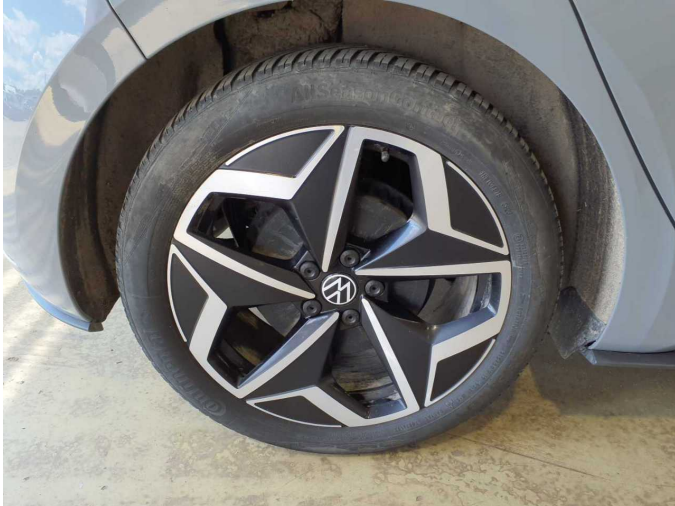
Damage 4: Wheel / tyres: Tyre - right - Worn - Replace

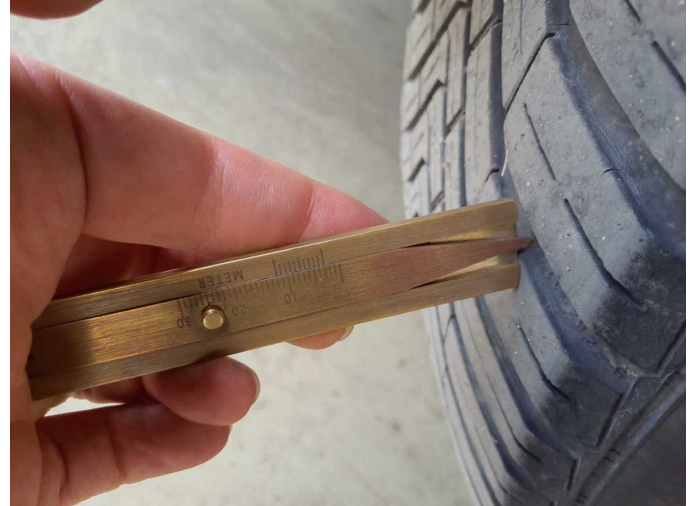
Damage 4: Wheel / tyres: Tyre - right - Worn - Replace

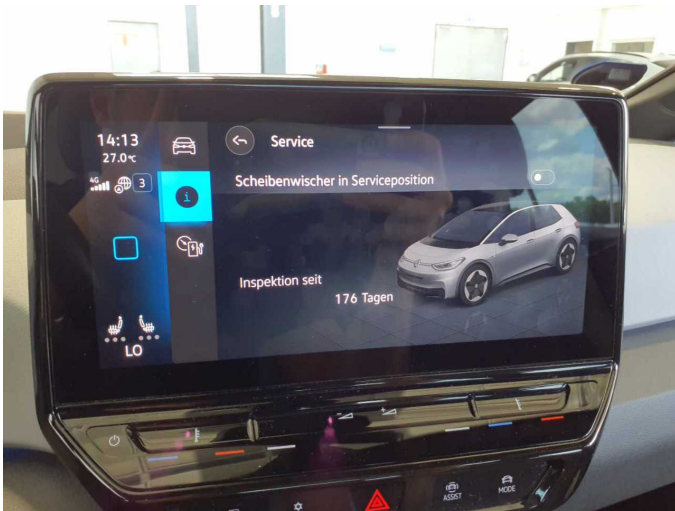
Damage 5: Misc.: Inspection / maintenance - Due - Replace

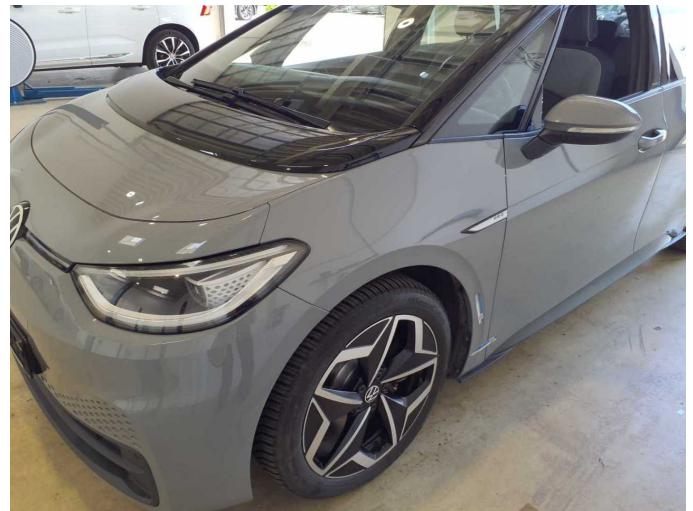
Damage 6: Mudguard - left side: Mudguard - left side - Deformed - Repair and paint

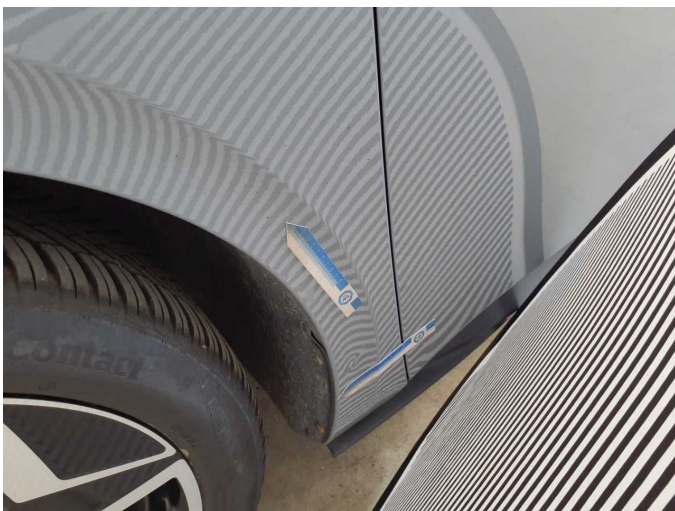
Damage 6: Mudguard - left side: Mudguard - left side - Deformed - Repair and paint

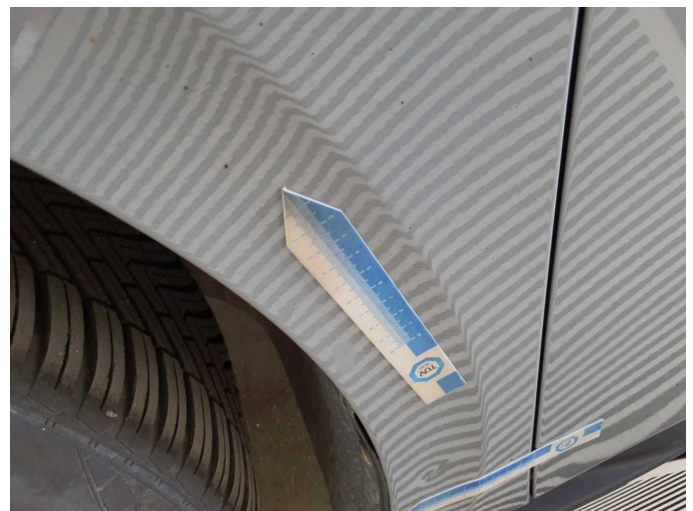
Damage 6: Mudguard - left side: Mudguard - left side - Deformed - Repair and paint

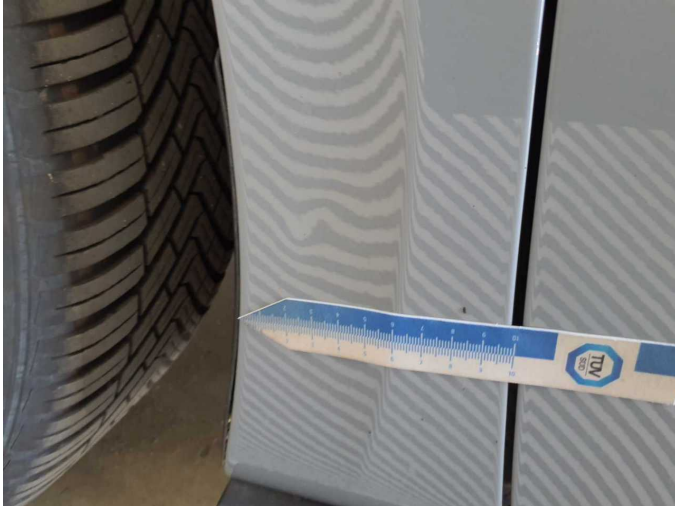
Damage 6: Mudguard - left side: Mudguard - left side - Deformed - Repair and paint

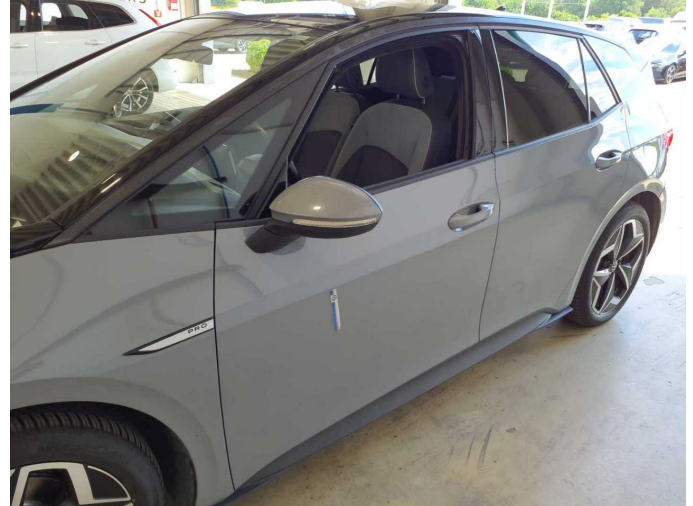
Damage 7: Door - front left side: Door - Dent / paintcoat damage - Repair and paint

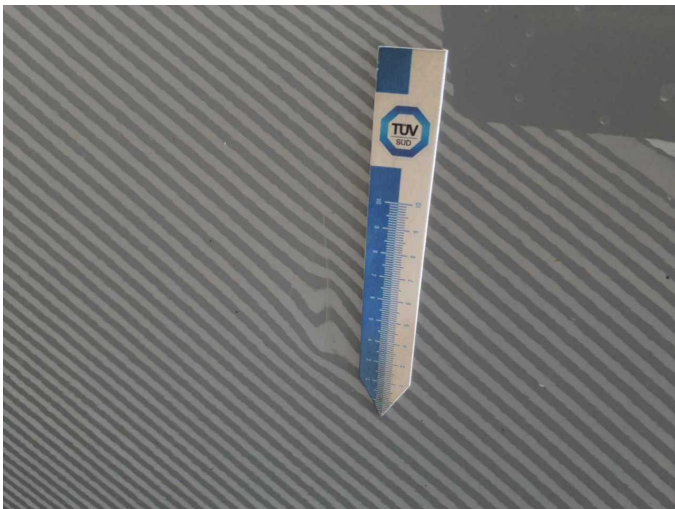
Damage 7: Door - front left side: Door - Dent / paintcoat damage - Repair and paint

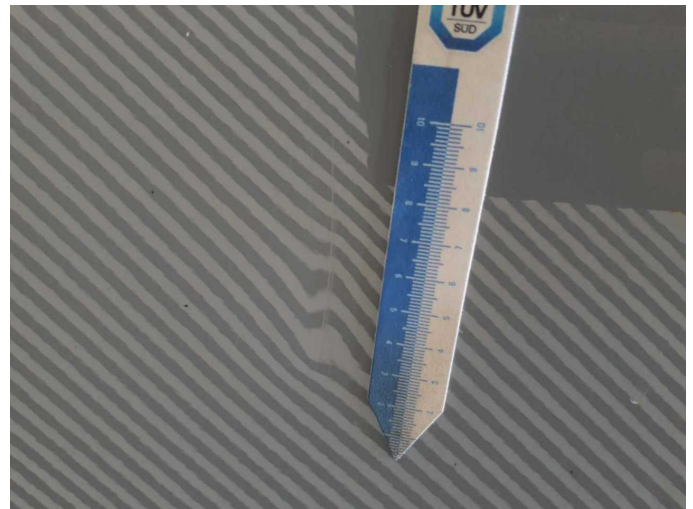
Damage 7: Door - front left side: Door - Dent / paintcoat damage - Repair and paint

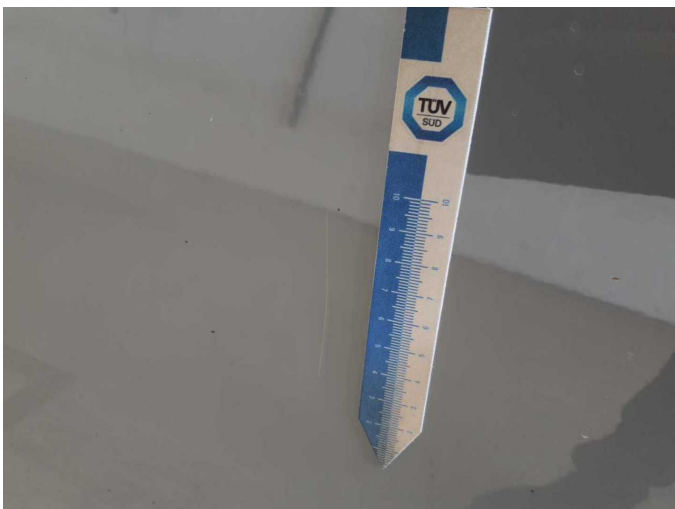
Damage 7: Door - front left side: Door - Dent / paintcoat damage - Repair and paint

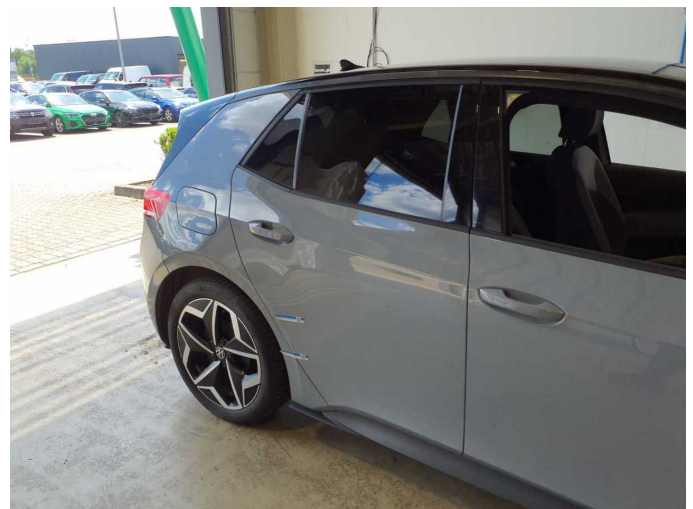
Accident 1: Side right
