Expertise

Protocol number: 46001012
Order No. / Reference: 26310325
Inspection date: 17 Jun 2026

Model: Focus Turnier 1.0 EcoBoost Hybrid TITANIUM EDITION

VIN: WF0PXXGCHPSJ80644

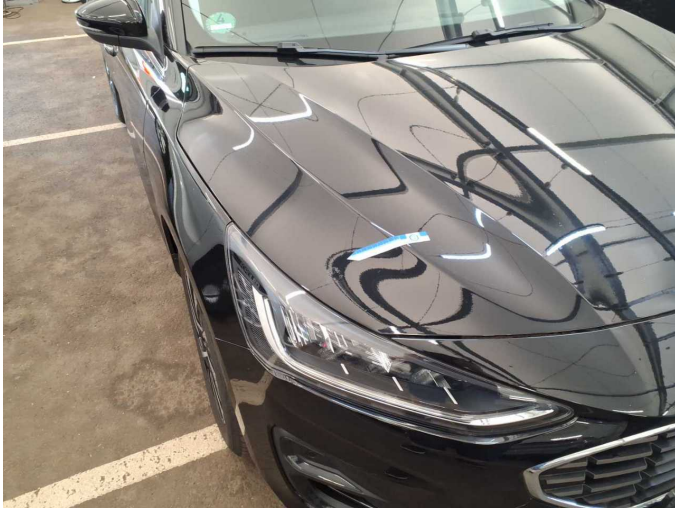
| No. | Component group | Description |
|---|---|---|
| 1 | Bonnet | Bonnet (Ätzungen, Vogelkot) - Paint defect - Smart repair |

Damage 1: Bonnet: Bonnet (Ätzungen, Vogelkot) - Paint defect - Smart repair

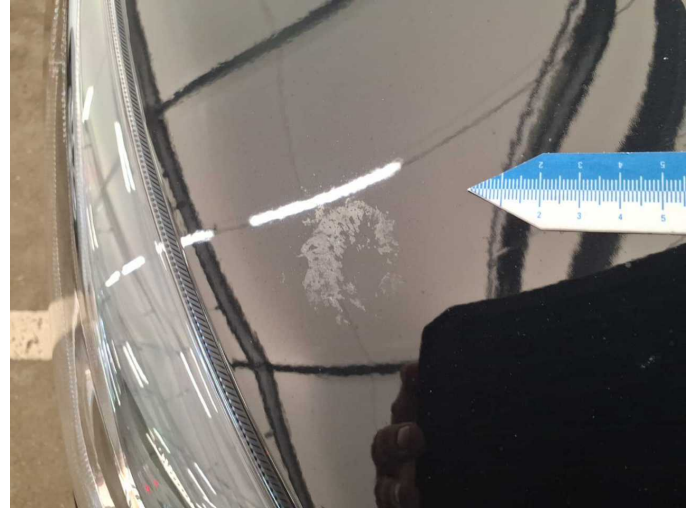
Damage 1: Bonnet: Bonnet (Ätzungen, Vogelkot) - Paint defect - Smart repair

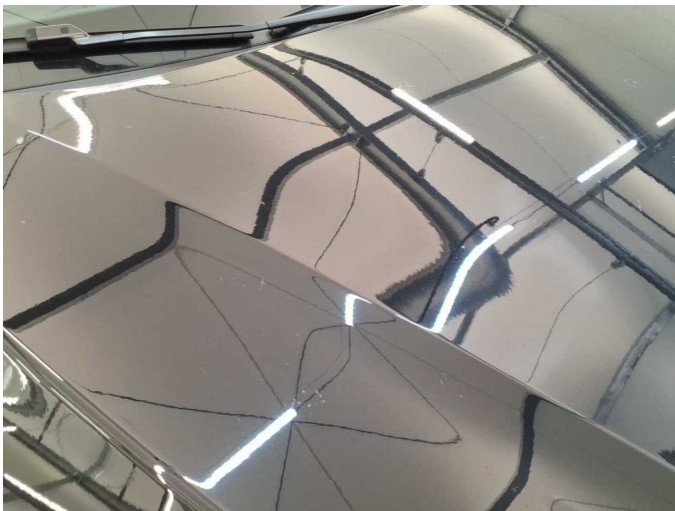
Damage 1: Bonnet: Bonnet (Ätzungen, Vogelkot) - Paint defect - Smart repair

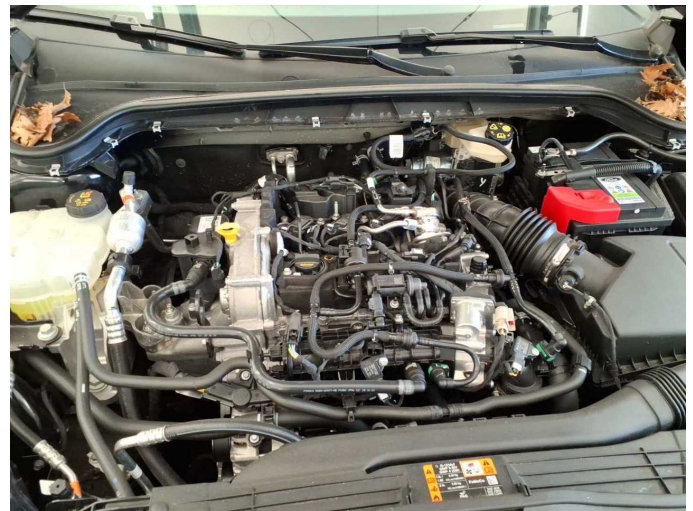
Engine - Engine cover

Missing part 1: Engine: Engine cover - Missing - Replace
