Expertise

Protocol number: 46285253
Order No. / Reference: 26543375
Inspection date: 24 Jun 2026

Manufacturer: Ford

Model: Transit Connect 230 L2 S&S Trend

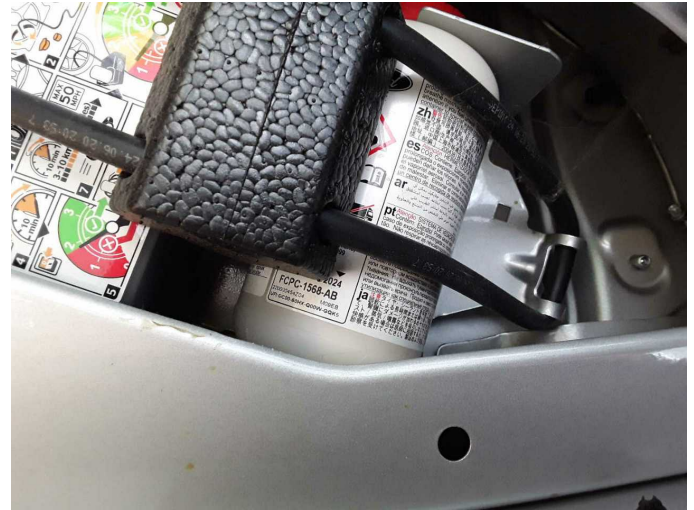
Damage 1: Equipment: Tirefit filler - Expired - Replace

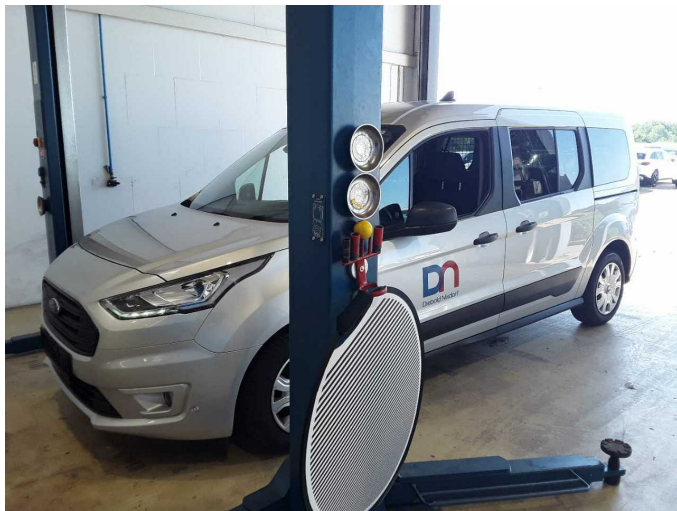
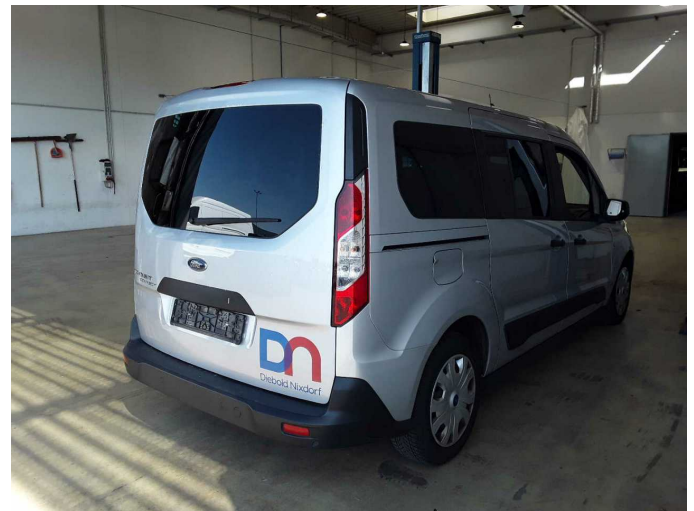
Damage 2: Body: Body - Glued / labelled - De-glove / neutralise

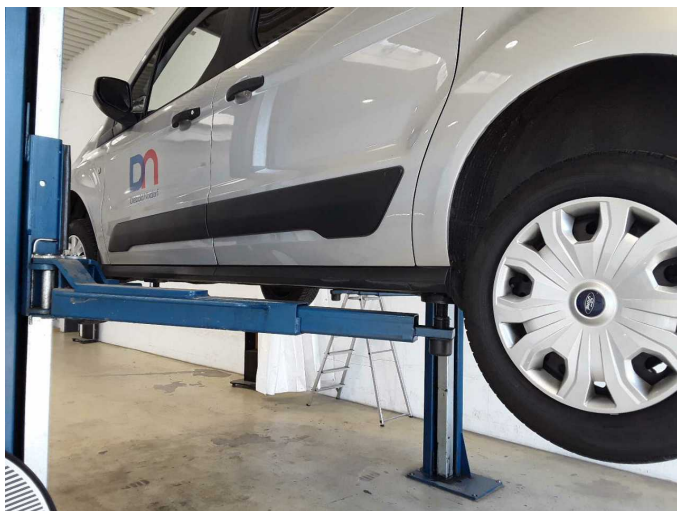
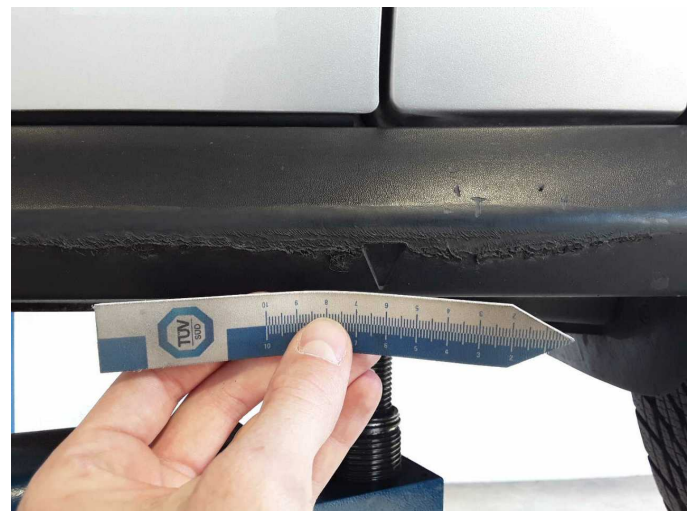
Damage 3: Sill - left side: Trim - Scratch(es) - Replace

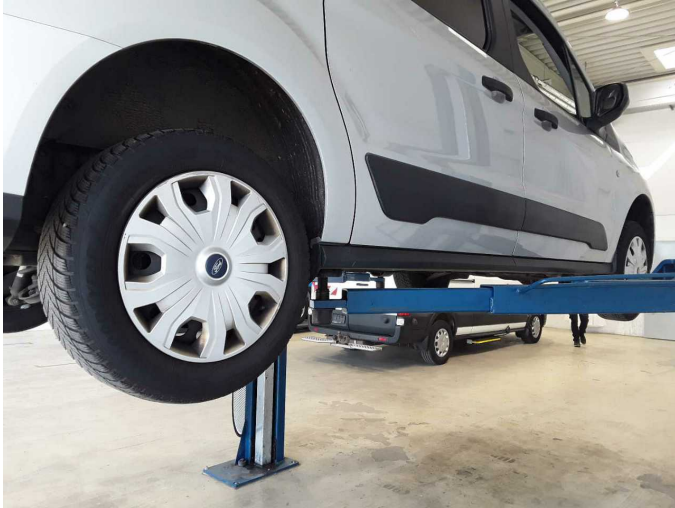
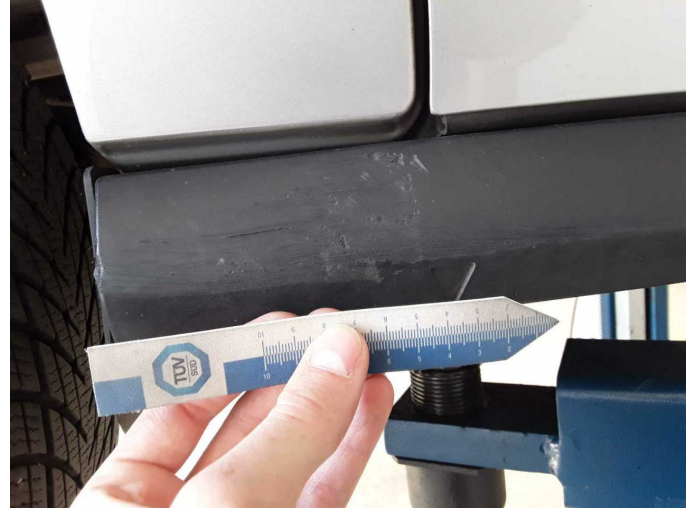
Damage 4: Sill - right side: Trim - Scratch(es) - Replace

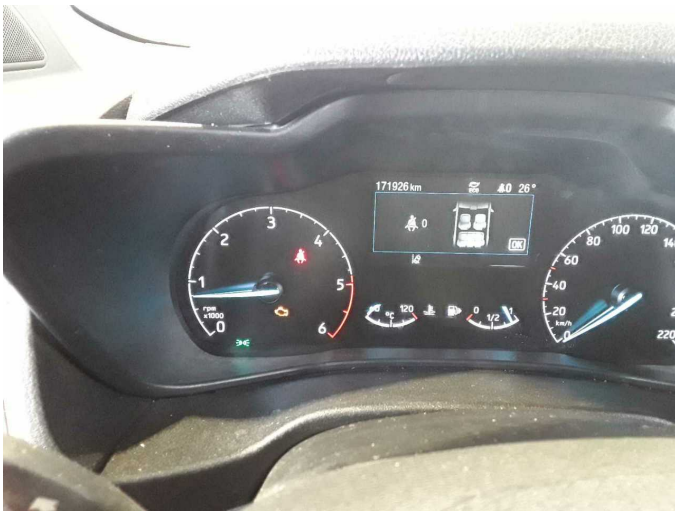
Damage 5: Instrument panel: Indicator light (Motorkontrolle) - on - Perform diagnosis

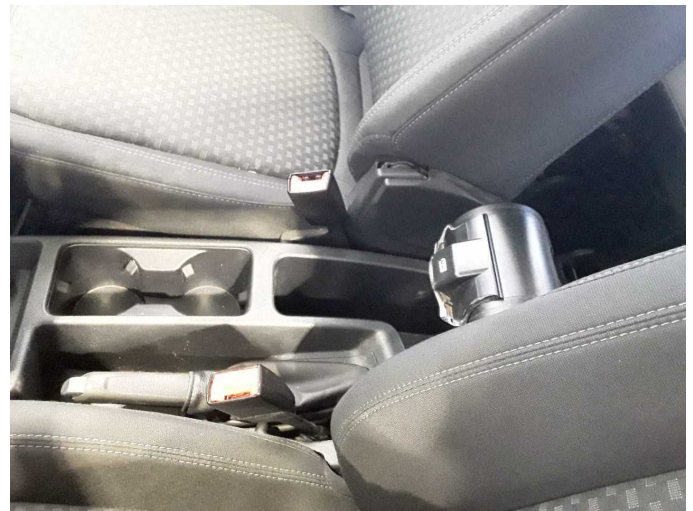
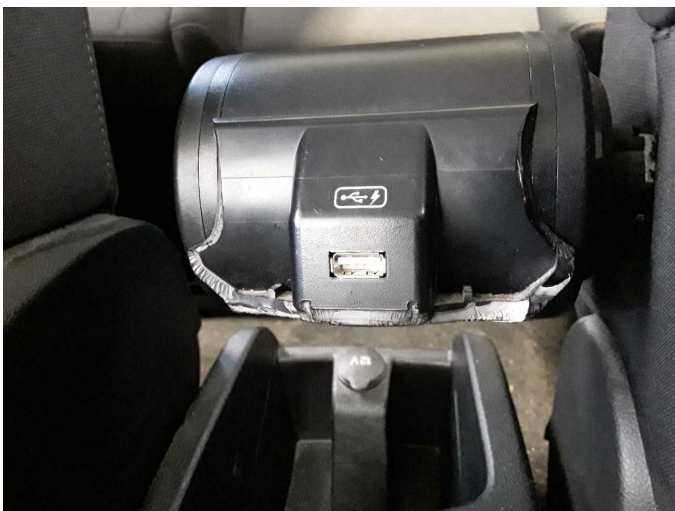
Damage 6: Seat - front: armrests - Broken / torn - Replace

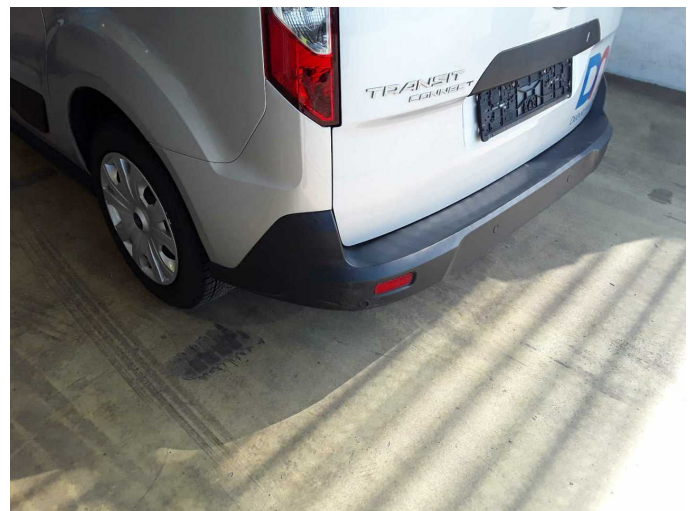
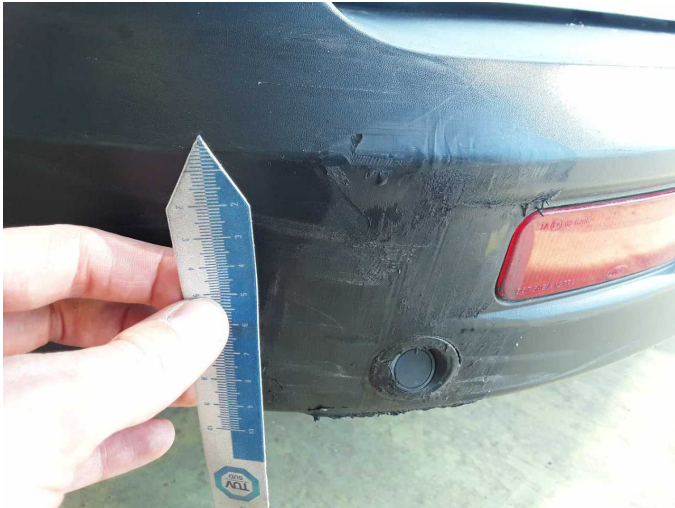
Damage 7: Rear bumper: Rear bumper (unpainted) - Scratched - Replace

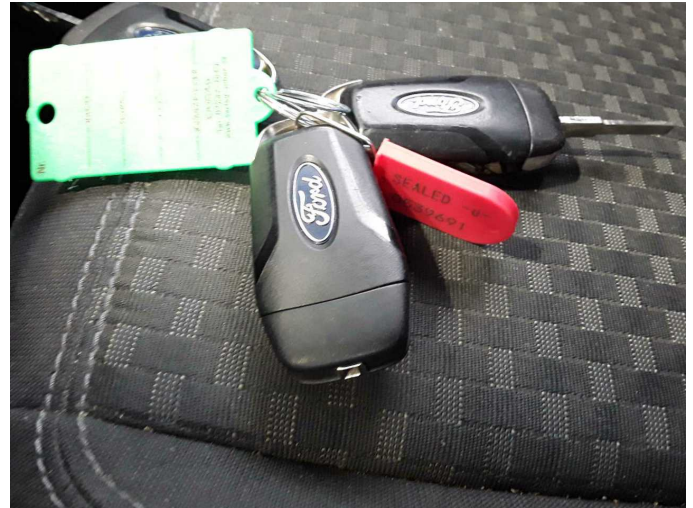
Damage 8: Equipment: Vehicle key (Schlüsselbart fehlt) - Differs from the original configuration - Replace

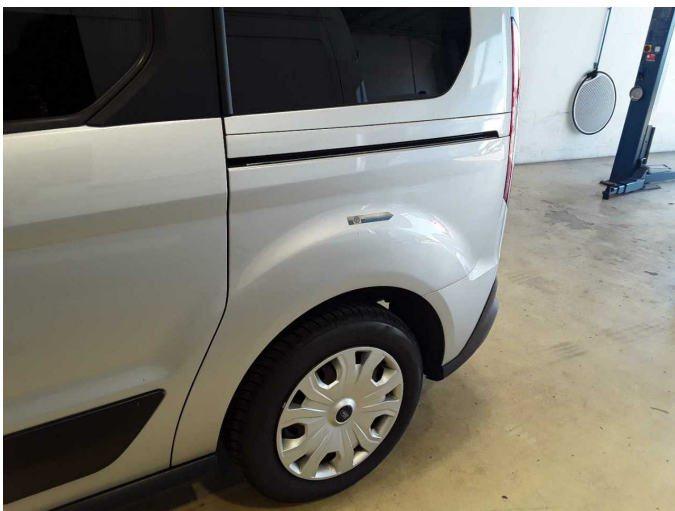
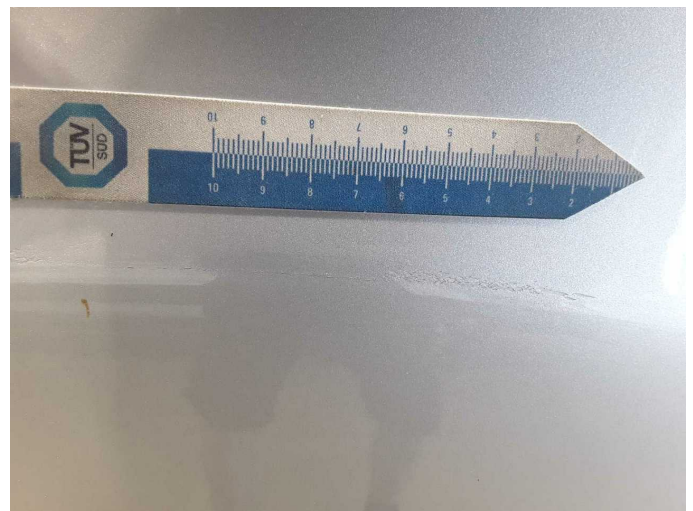
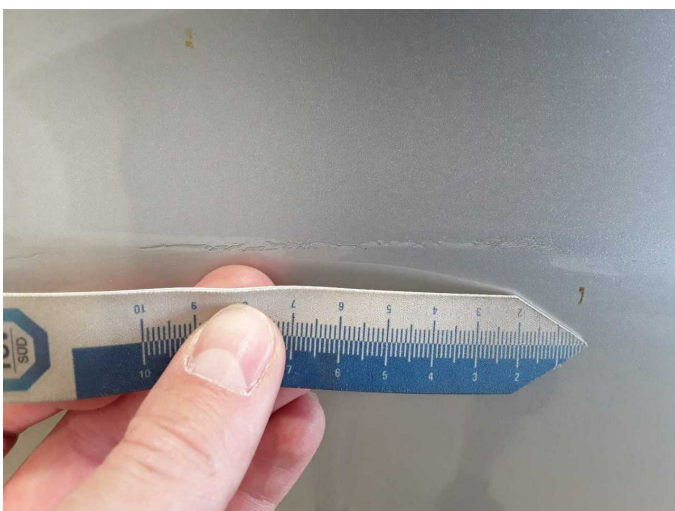
Damage 9: Side panel - rear left side: Side panel (Spachtel eingefallen) - Unprofessionally repaired - Paint

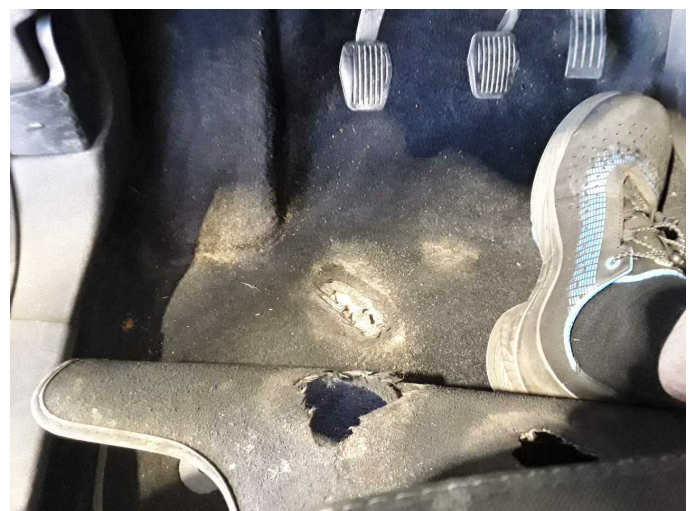
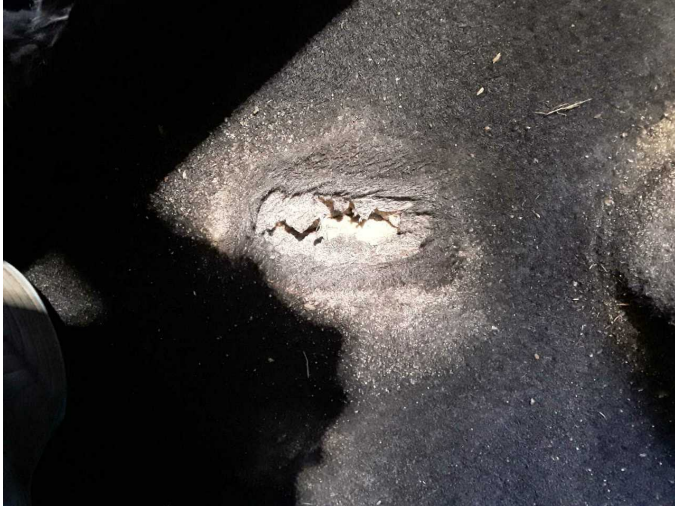
Damage 10: Trim / covers: Carpet - front left side - Worn - Replace

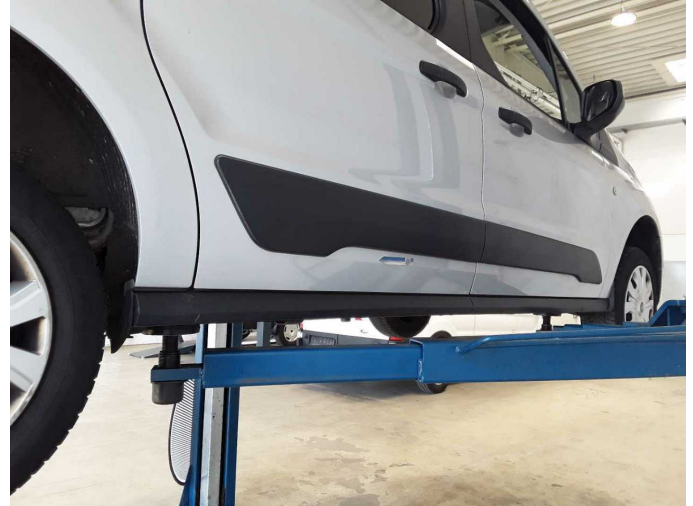
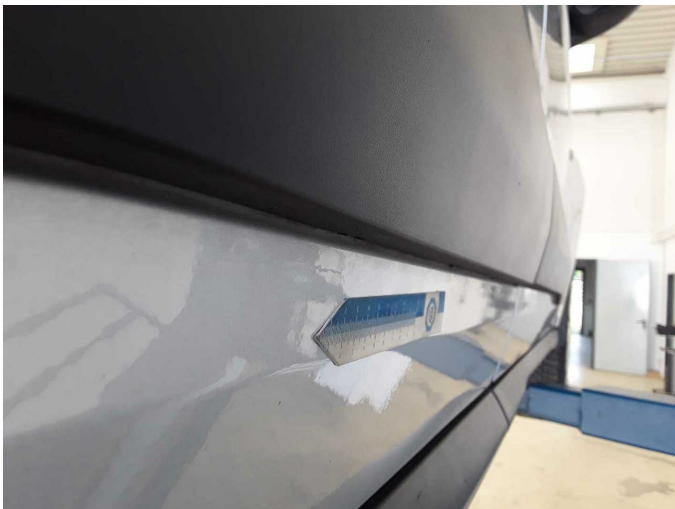
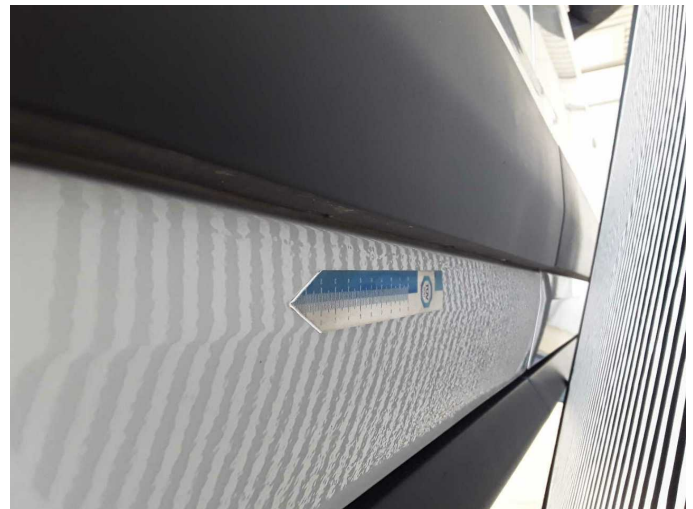
Damage 11: Sliding door, right: Sliding door (Läufer) - Unprofessionally repaired - Paint

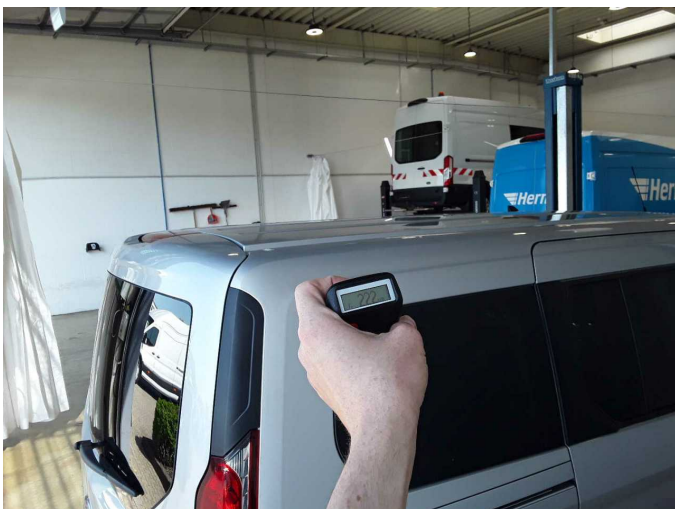
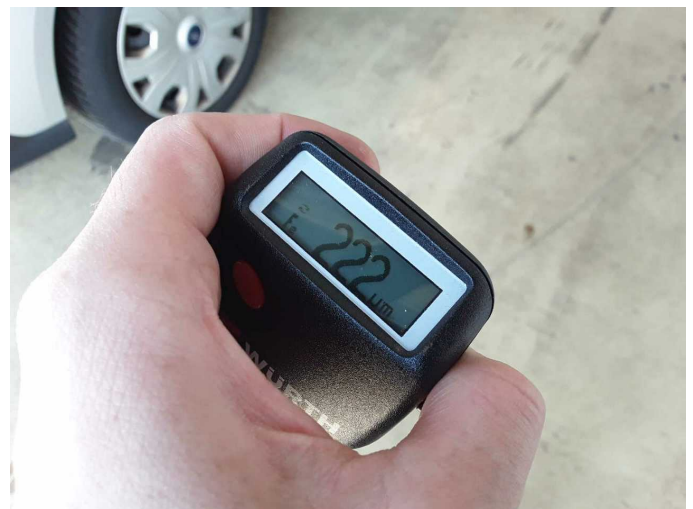
Repainting 1: Roof

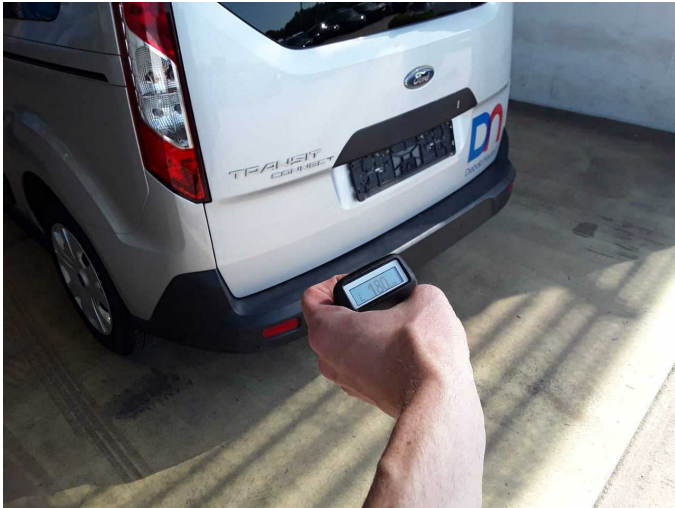
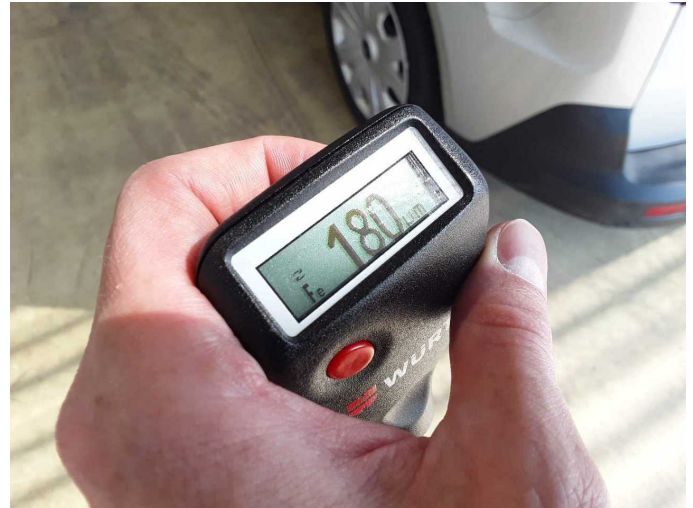
Repainting 2: Boot lid / rear door

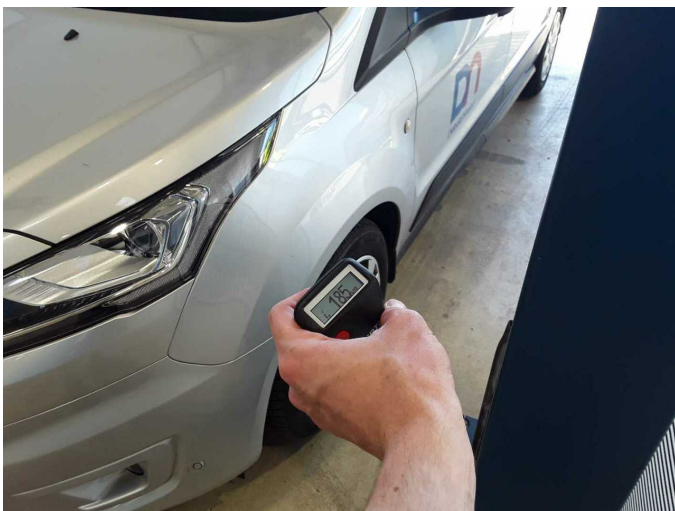
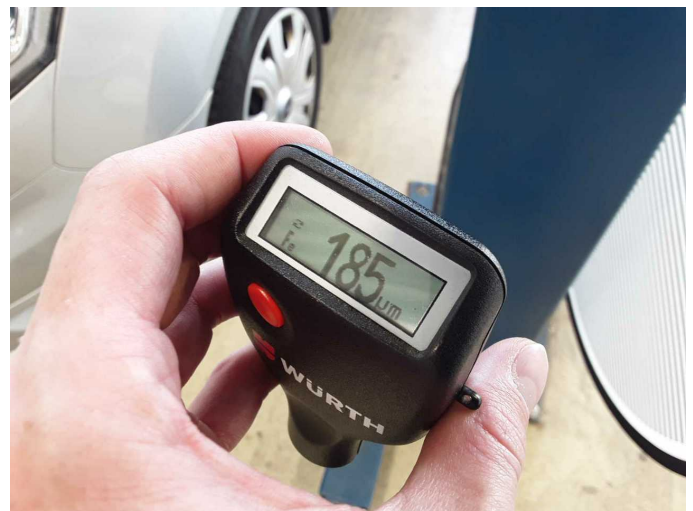
Repainting 3: Mudguard - left side

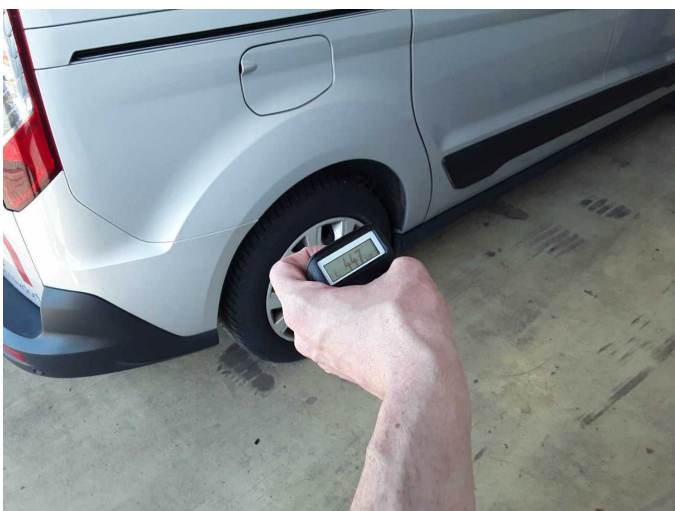
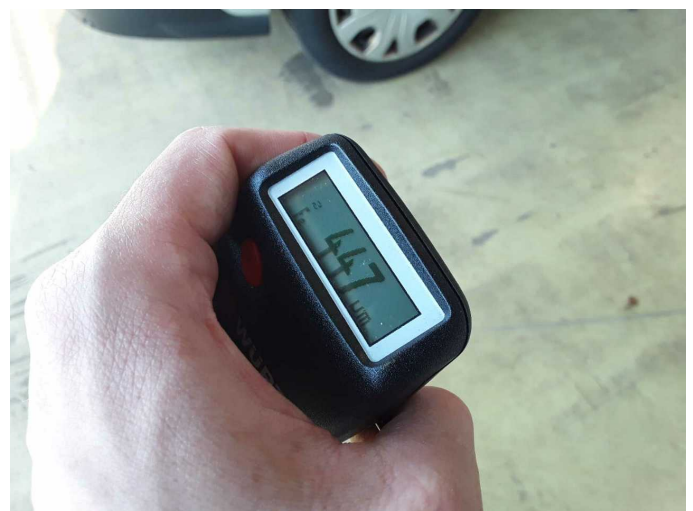
Repainting 4: Side panel - rear right side

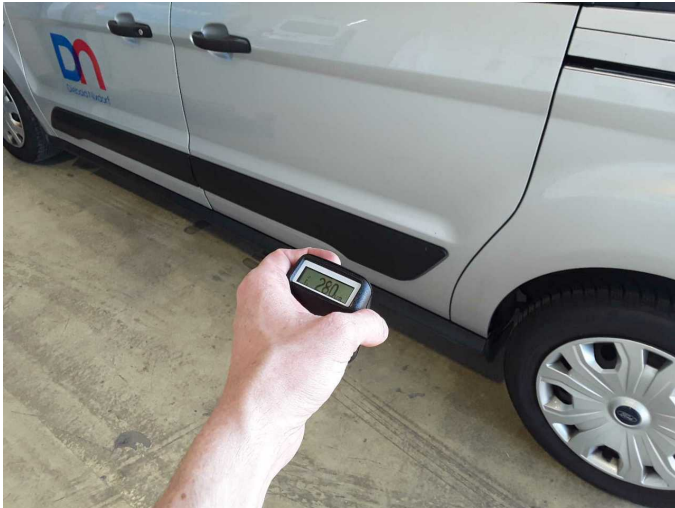
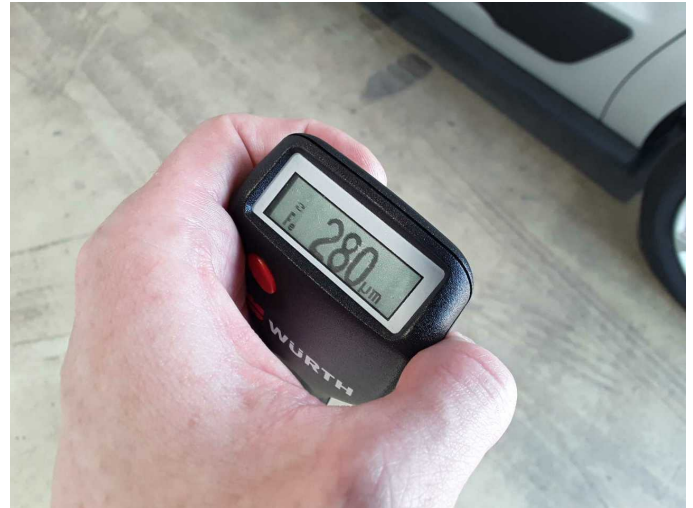
Repainting 5: Door - rear left side

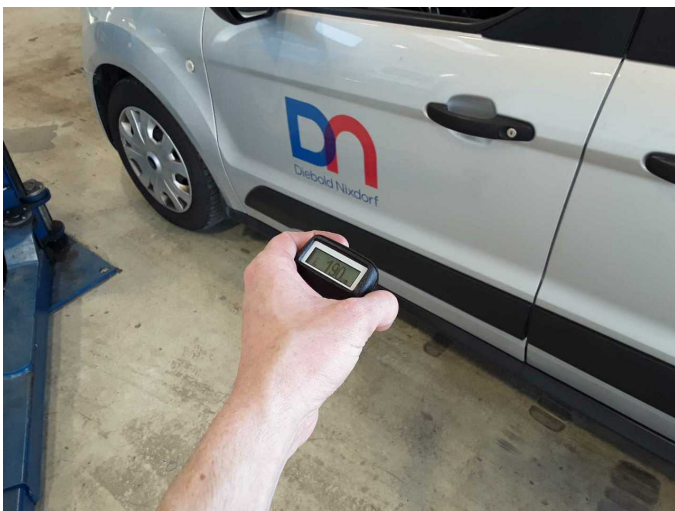
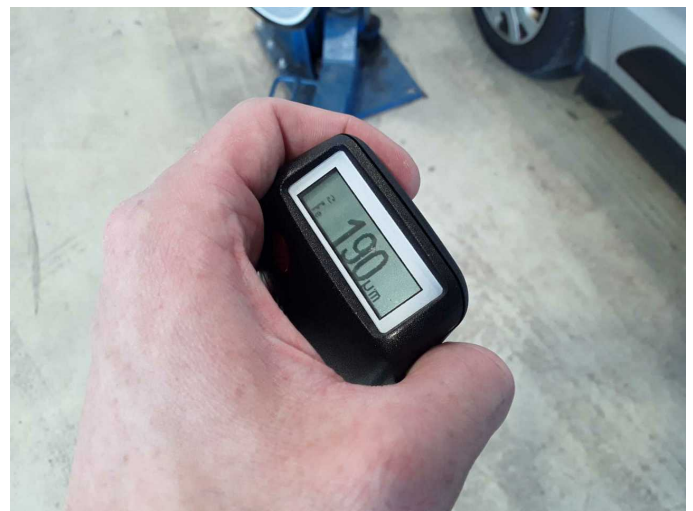
Repainting 6: Door - front left side

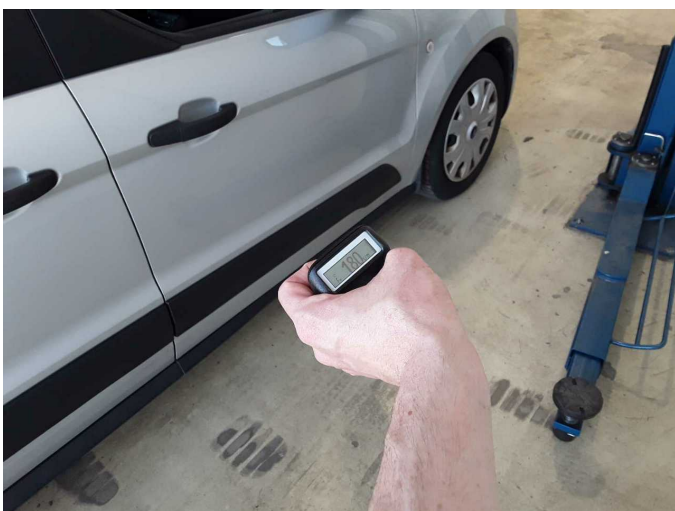
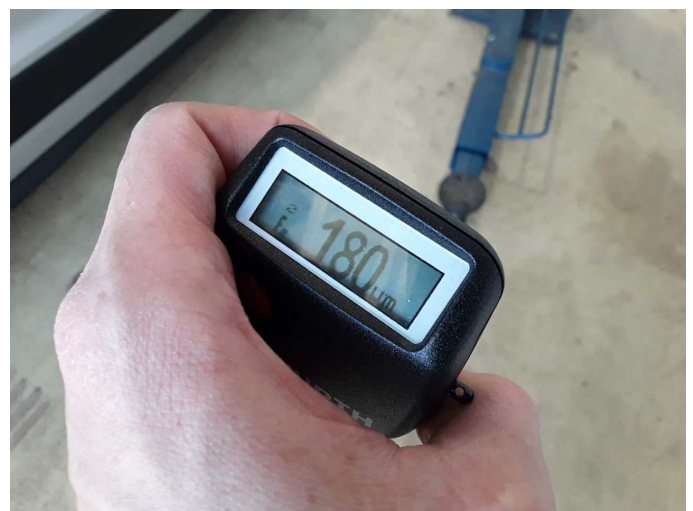
Repainting 7: Door - front right side

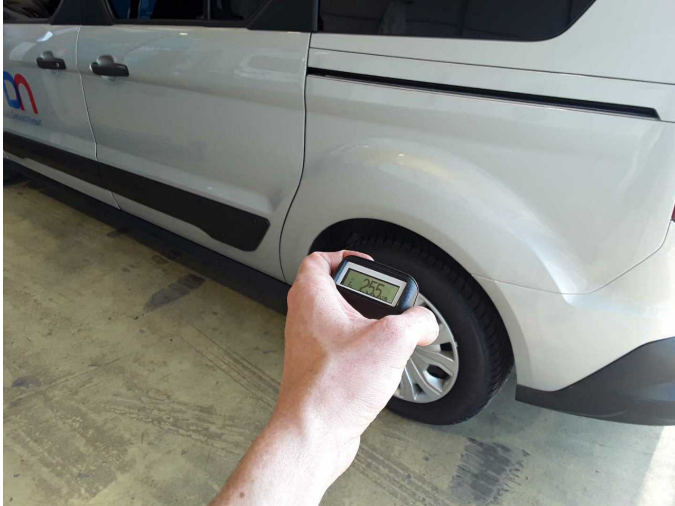
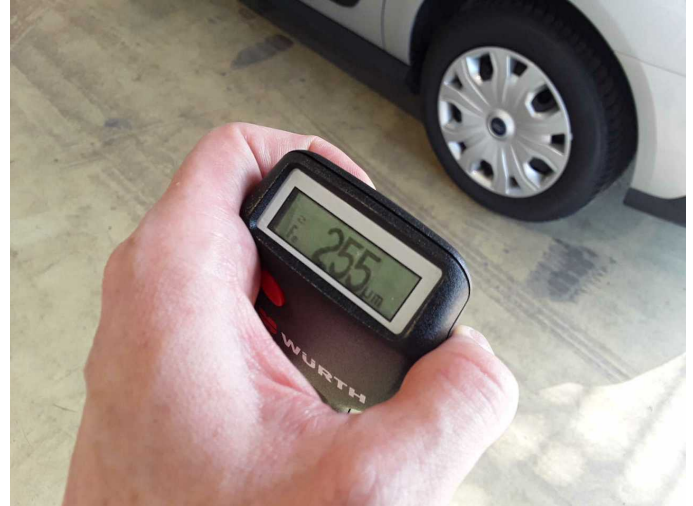
Repainting 8: Side panel - rear left side

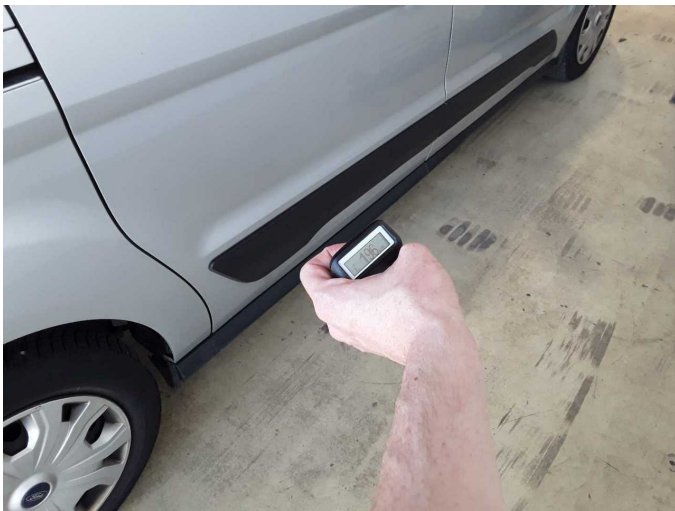
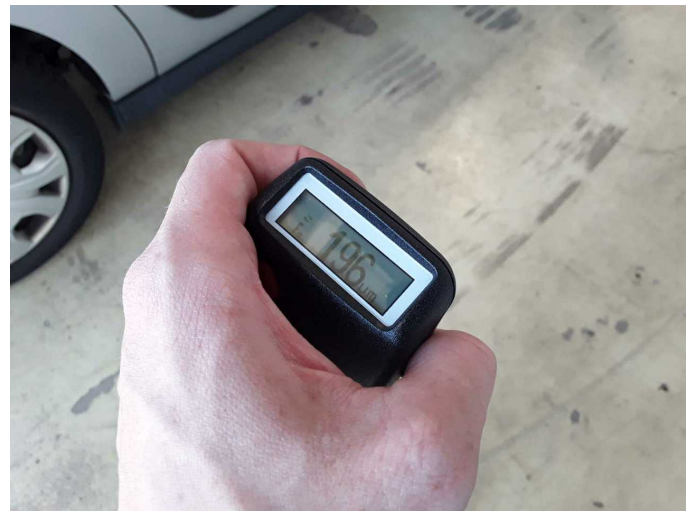
Repainting 9: Door - rear right side
