Expertise

Protocol number: 46291022
Order No. / Reference: 26154508
Inspection date: 22 Jun 2026

Model: Vito 116 CDI Tourer Extralang Aut. PRO

VIN: W1VVLGFZ4T4567944

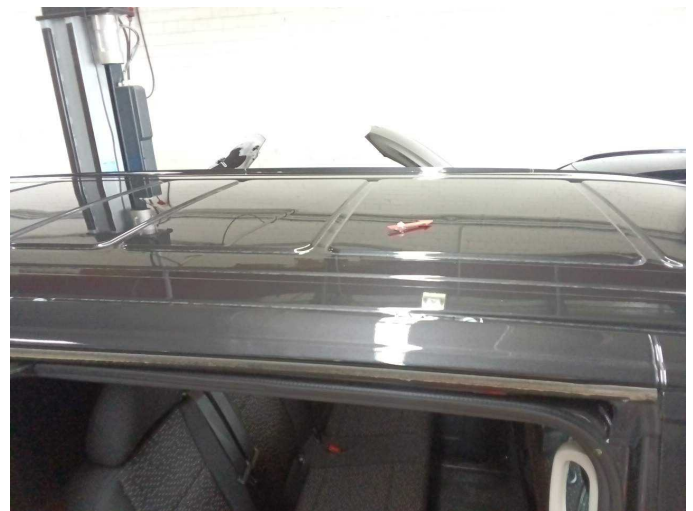
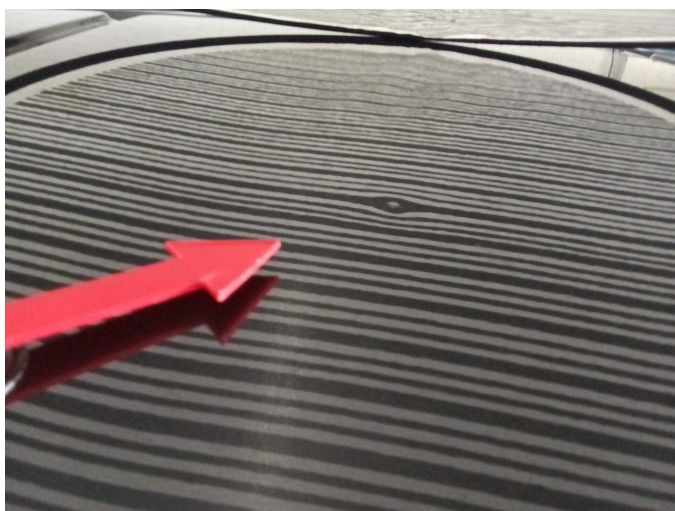
Damage 1: Roof: Roof - dent(s) - Smooth repair work

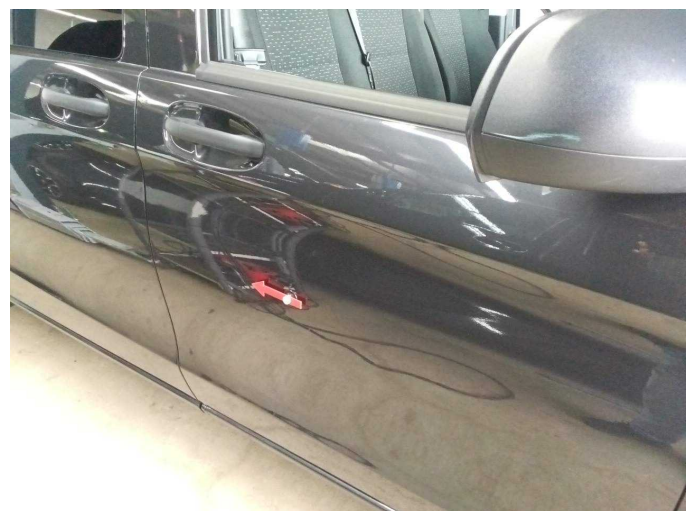
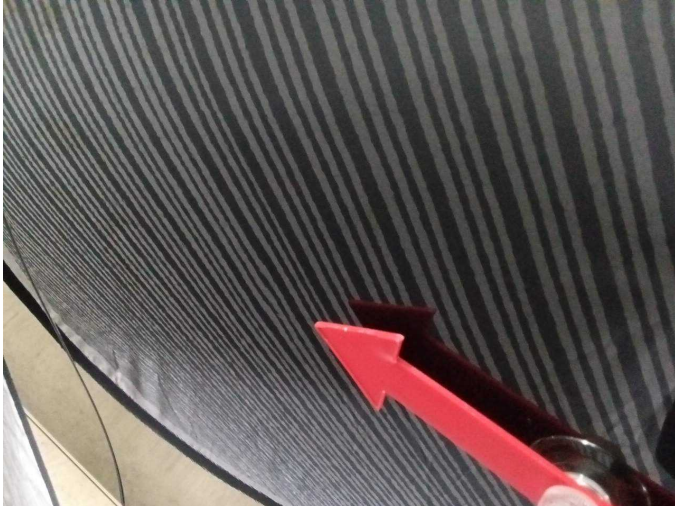
Damage 2: Door - front right side: Door - dent(s) - Smooth repair work

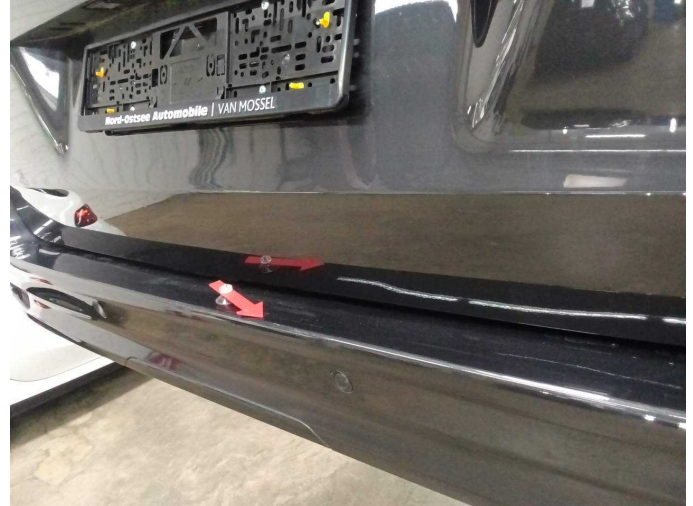
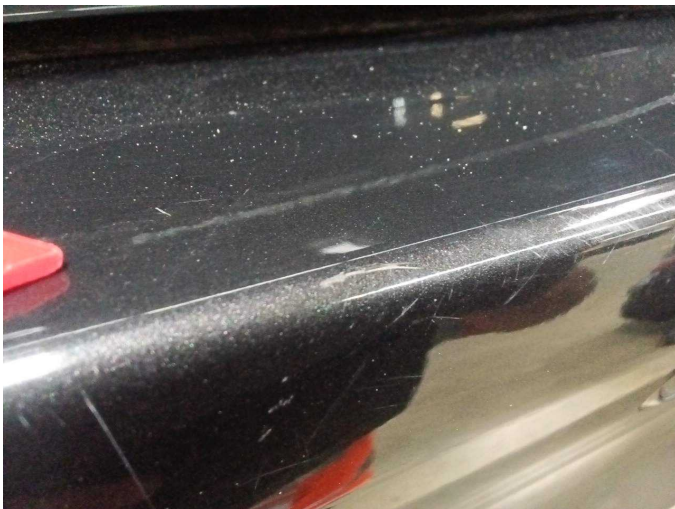
Damage 3: Rear bumper: Rear bumper - Scratch(es) - Smart repair

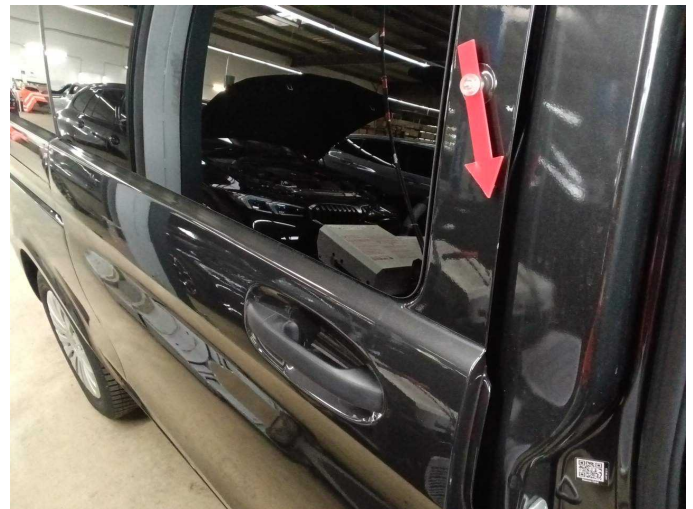
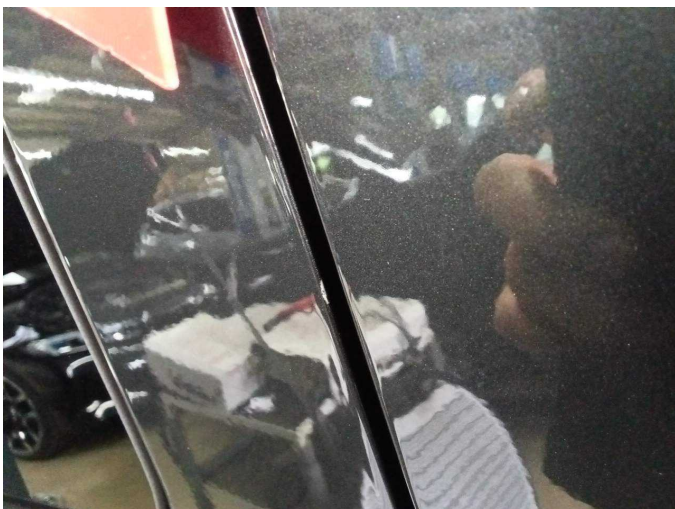
Damage 4: Sliding door, right: Sliding door - Scratch(es) - Smart repair

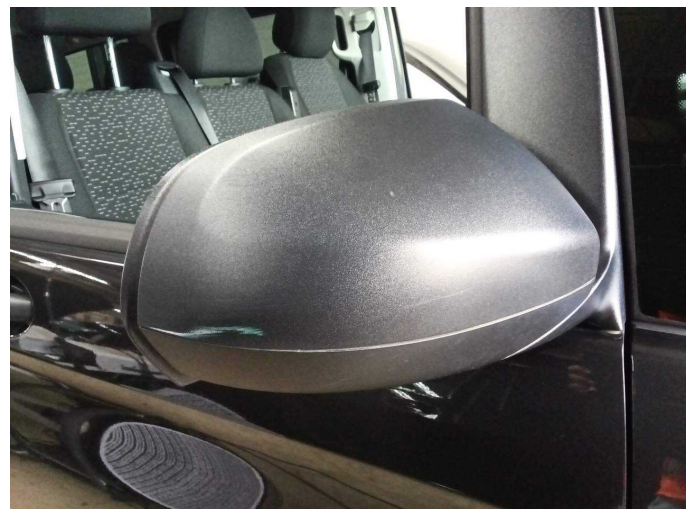
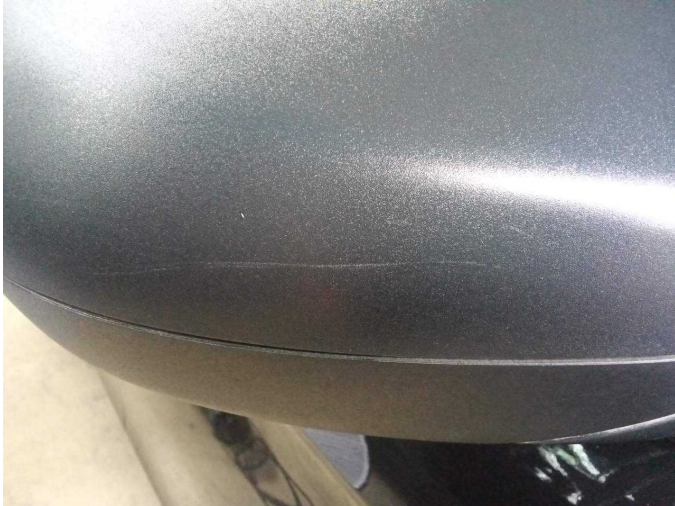
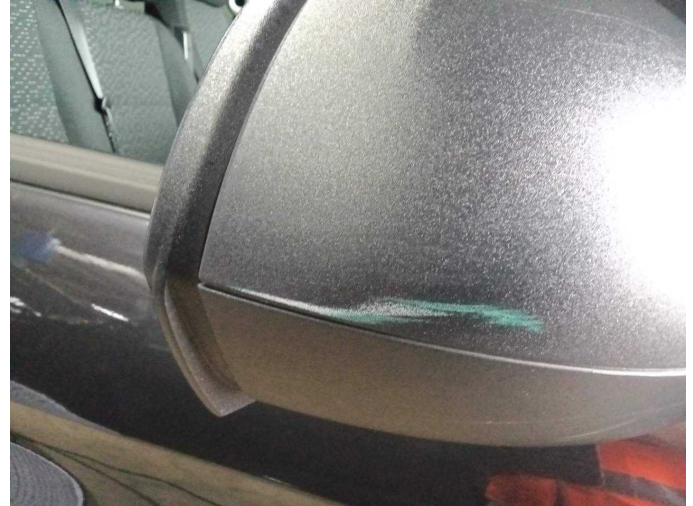
Damage 5: Wing mirror - right side: Mirror housing - Scratch(es) - Replace

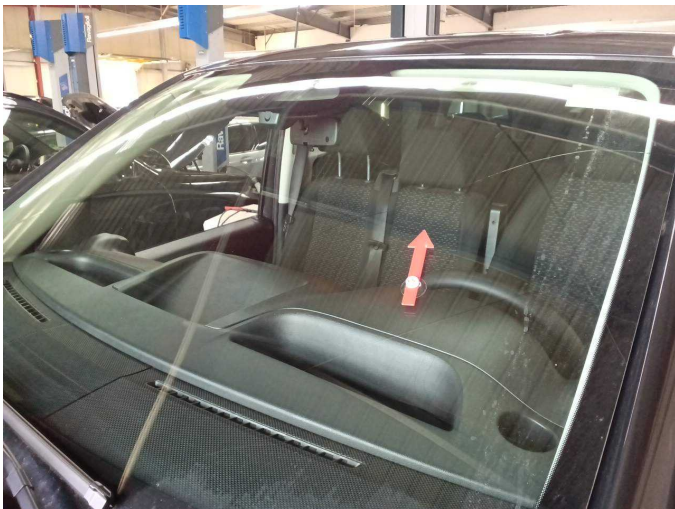
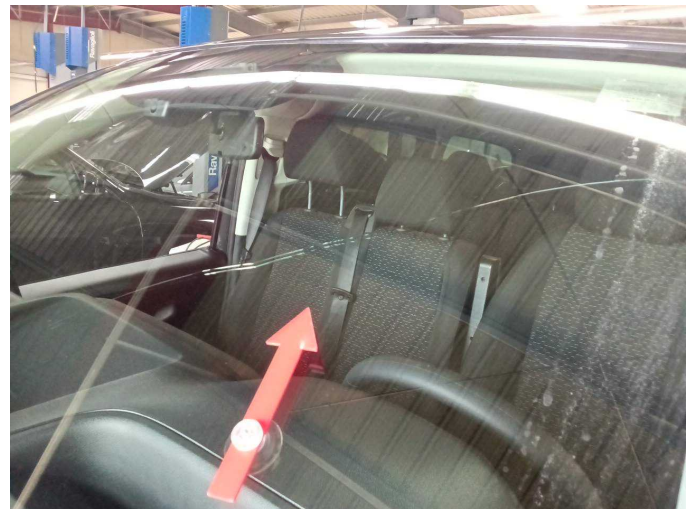
Damage 6: Vehicle glazing: Windscreen (Gerissen) - Stone chips - Replace

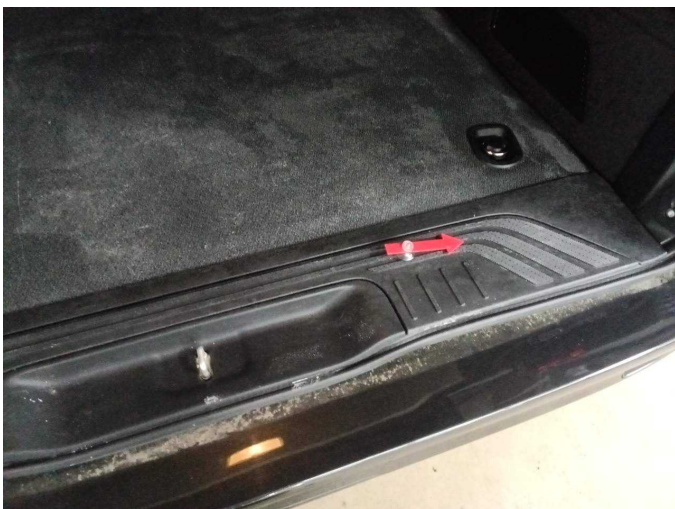
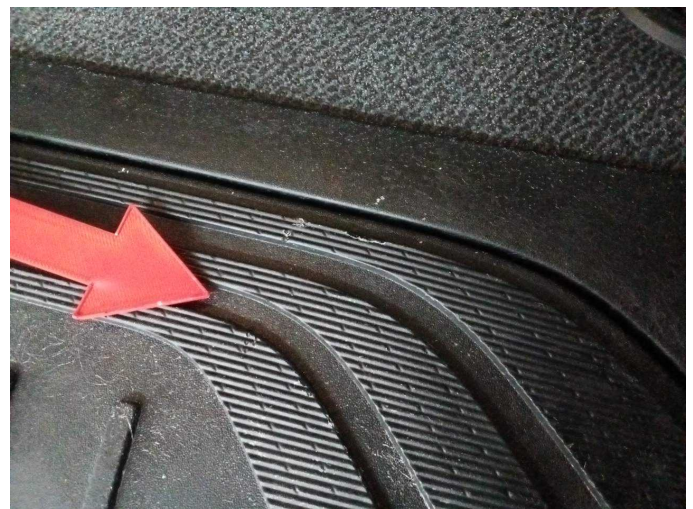
Wear and tear 1: Trim / covers: Boot lining - Scratch(es) - No deduction

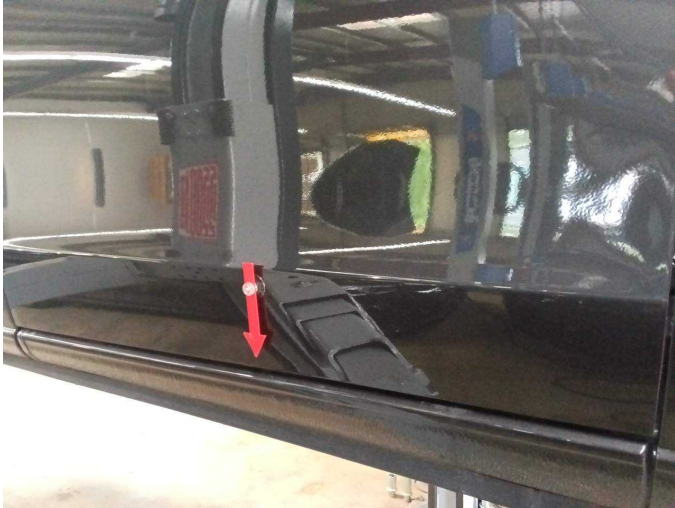
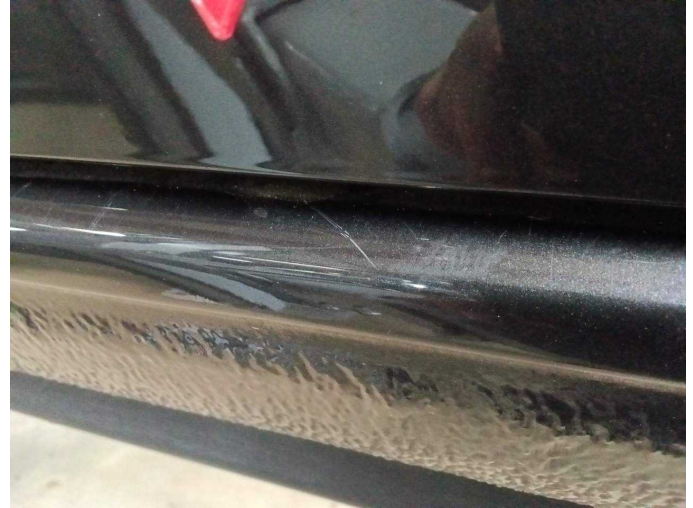
Wear and tear 2: Sill - right side: Sill - Scratch(es) - No deduction

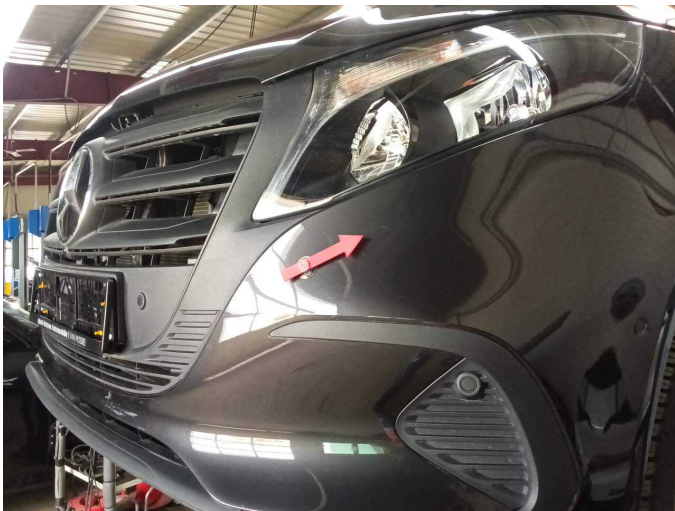
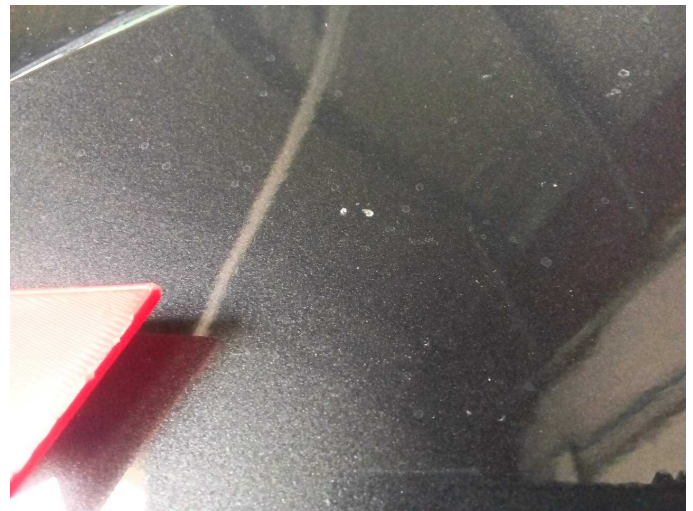
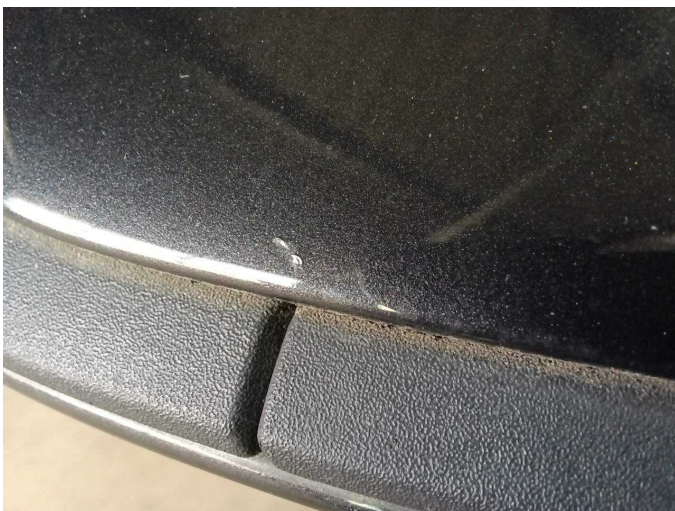
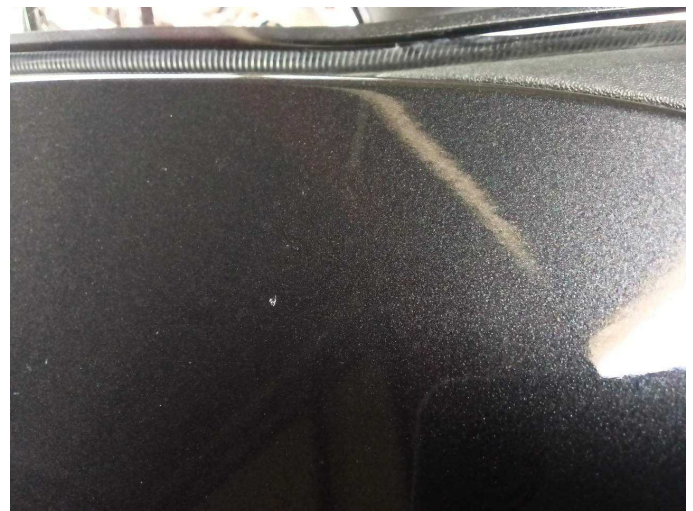
Wear and tear 3: Front bumper: Front bumper - Stone chips - No deduction

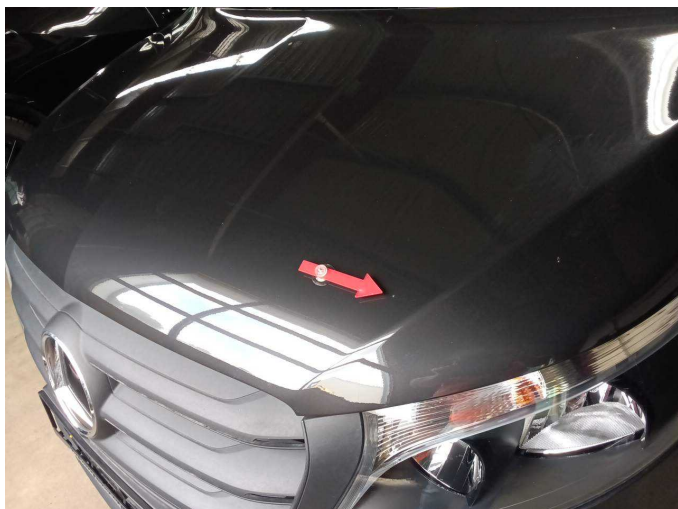
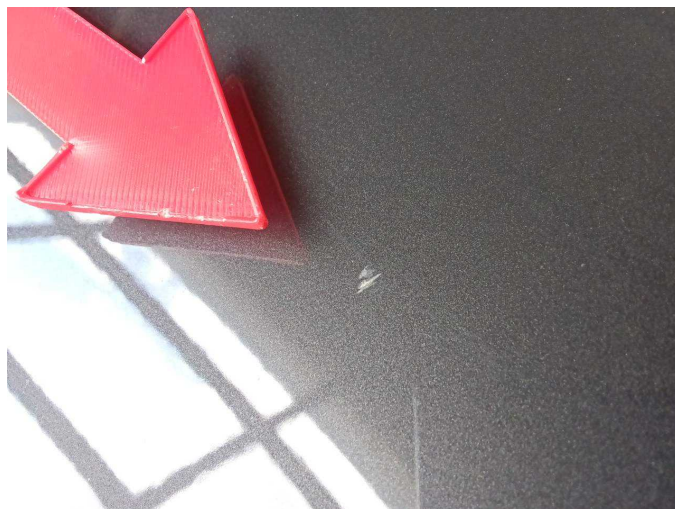
Wear and tear 4: Bonnet: Bonnet - Stone chips - No deduction

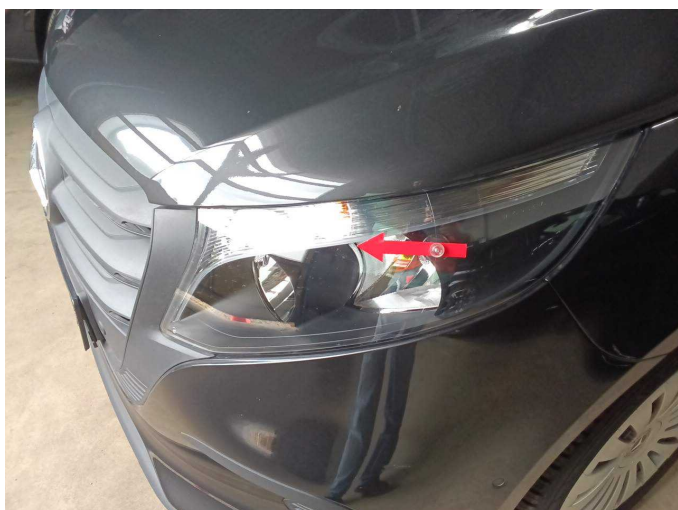
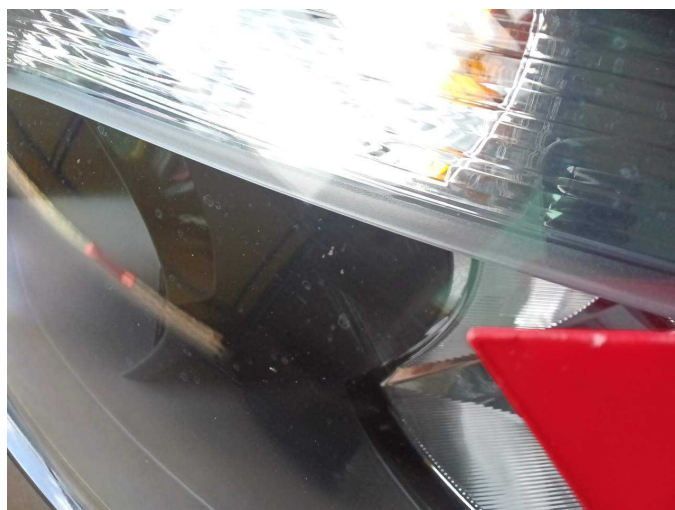
Wear and tear 5: Headlight: Headlight - left side - Stone chips - No deduction
