Expertise

Protocol number: 46460485  
Order No. / Reference: 26577733  
Inspection date: 10 Jul 2026

Model: Zafira Life 2.0 D M Aut. Tourer

VIN: VXEEVHZ7NZ010644

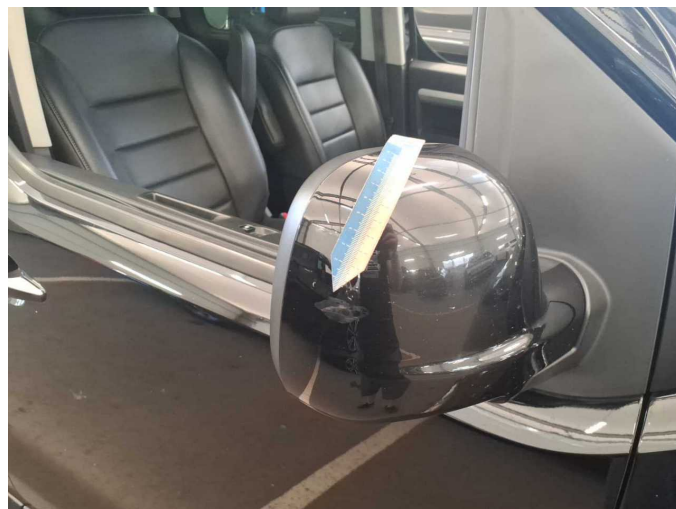
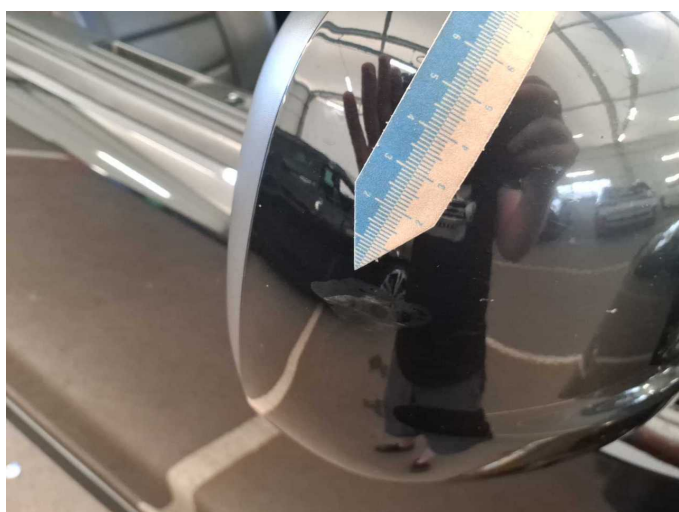
| No. | Component group | Description |
|---|---|---|
| 1 | Wing mirror - right side | Cap - Scratch(es) - Smart repair |

**Damage 1:** Wing mirror - right side: Cap - Scratch(es) - Smart repair

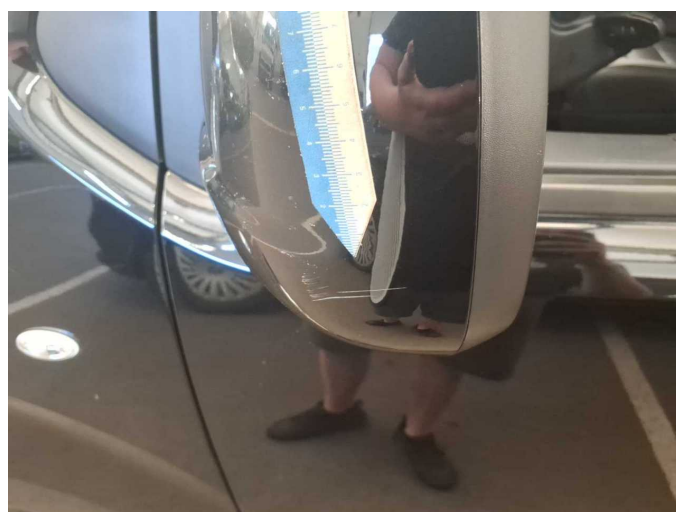
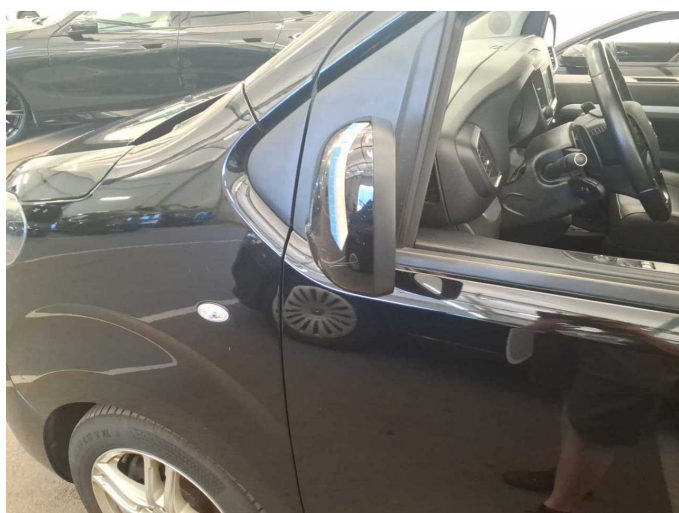
| No. | Component group | Description |
|---|---|---|
| 2 | Wing mirror - left side | Cap - Scratch(es) - Smart repair |

**Damage 2:** Wing mirror - left side: Cap - Scratch(es) - Smart repair

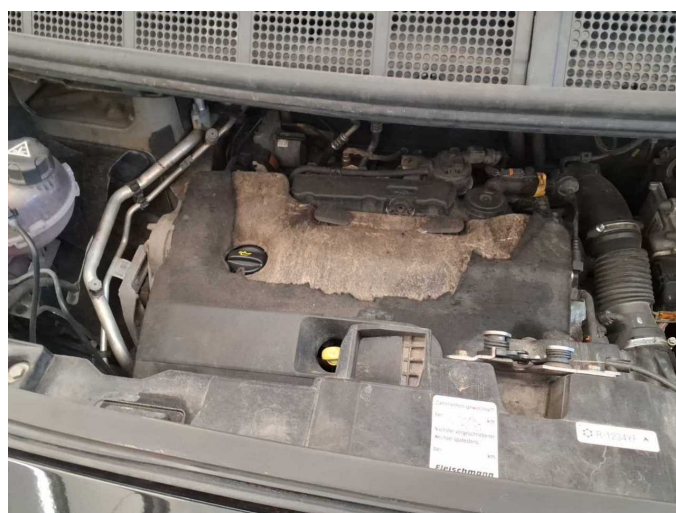
| No. | Component group | Description |
|---|---|---|
| 3 | Engine | Engine cover - Damage caused by marten / rodent - Replace |

**Damage 3:** Engine: Engine cover - Damage caused by marten / rodent - Replace

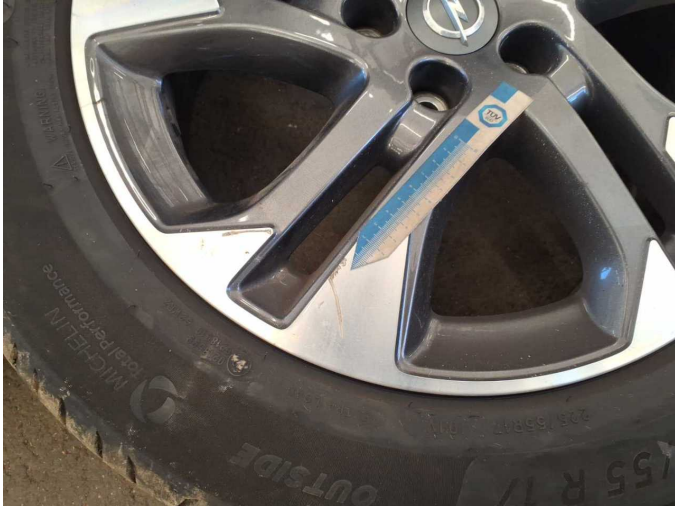
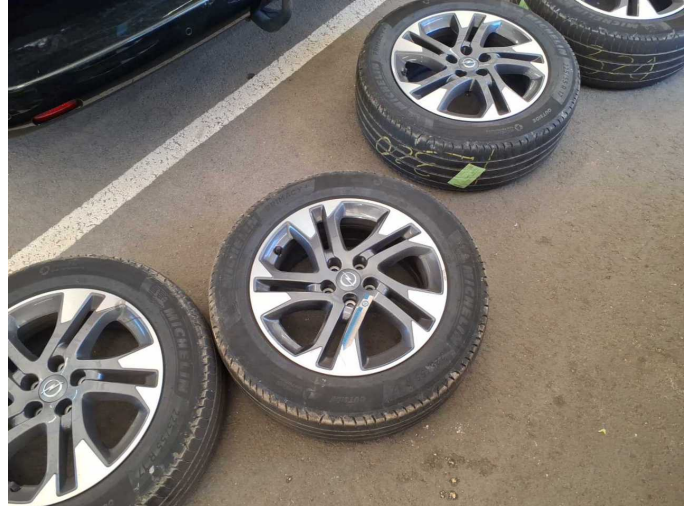
| No. | Component group | Description |
|---|---|---|
| 4 | 2nd wheel set | 1 alloy rim - Scratch(es) - Loss in value |

**Damage 4:** 2nd wheel set: 1 alloy rim - Scratch(es) - Loss in value

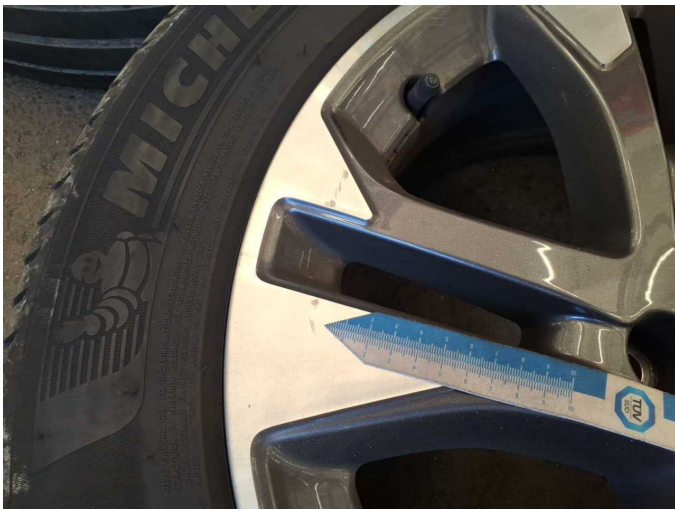
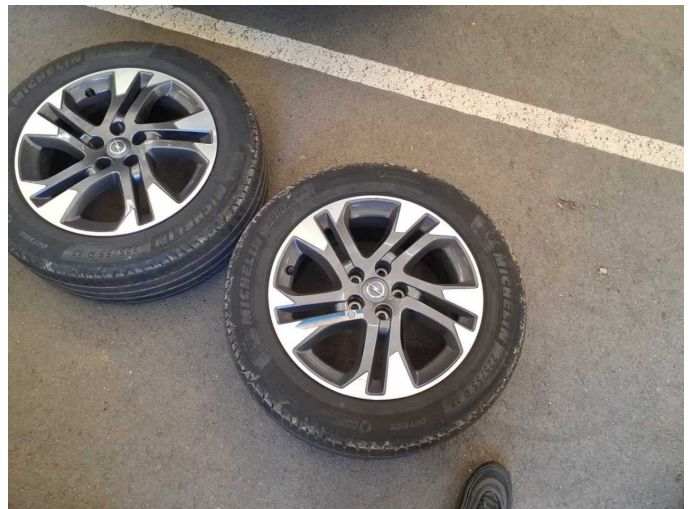
| No. | Component group | Description |
|---|---|---|
| 5 | 2nd wheel set | 1 alloy rim - Scratch(es) - Loss in value |

**Damage 5:** 2nd wheel set: 1 alloy rim - Scratch(es) - Loss in value

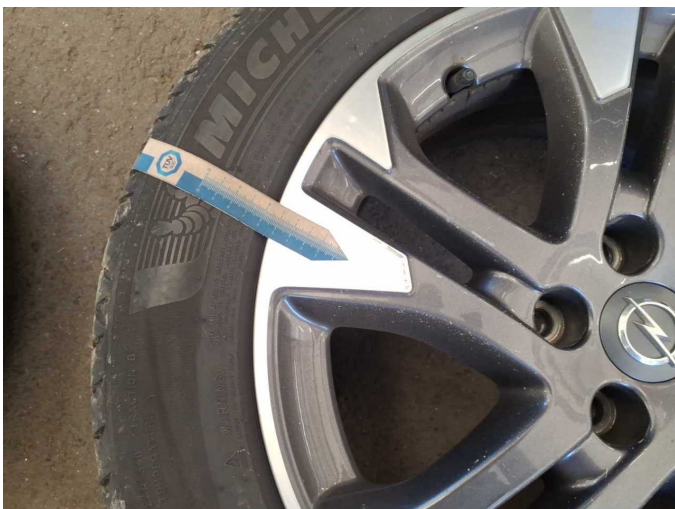
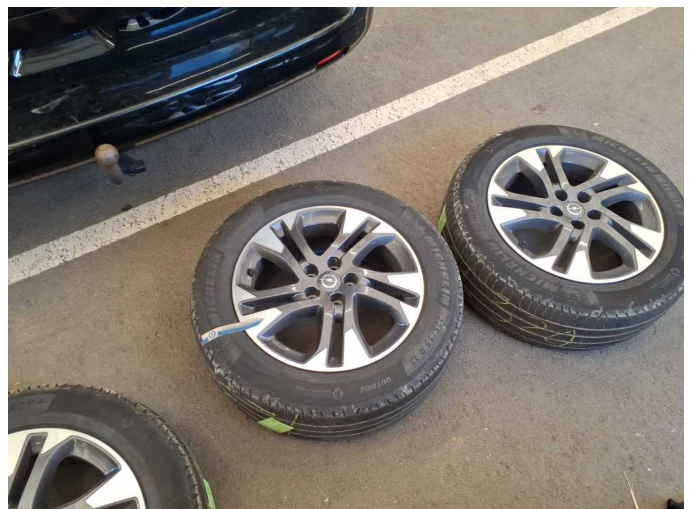
| No. | Component group | Description |
|---|---|---|
| 6 | 2nd wheel set | 1 alloy rim - Scratch(es) - Loss in value |

**Damage 6:** 2nd wheel set: 1 alloy rim - Scratch(es) - Loss in value

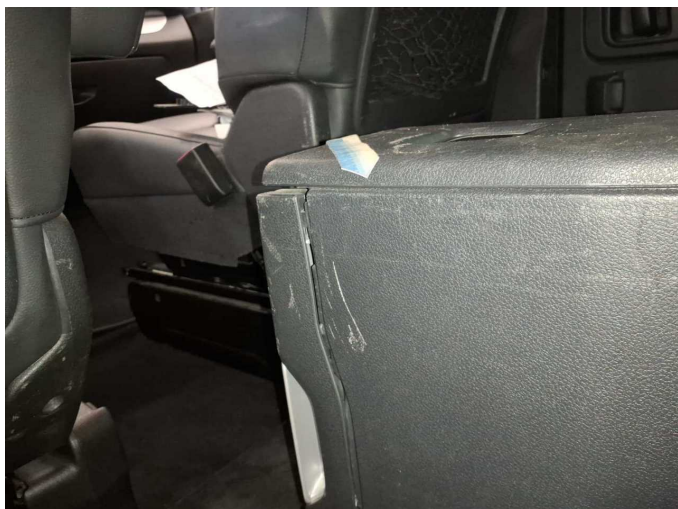
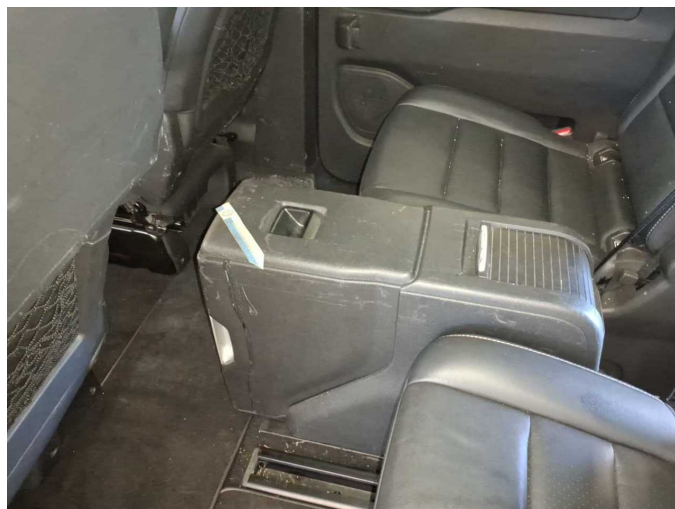
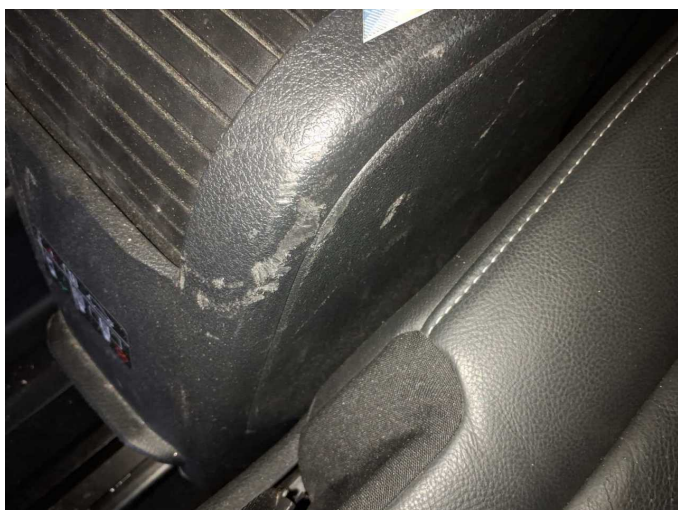
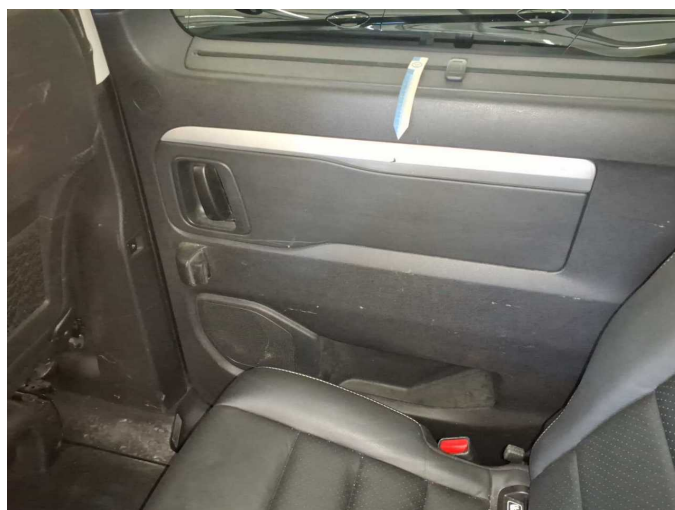
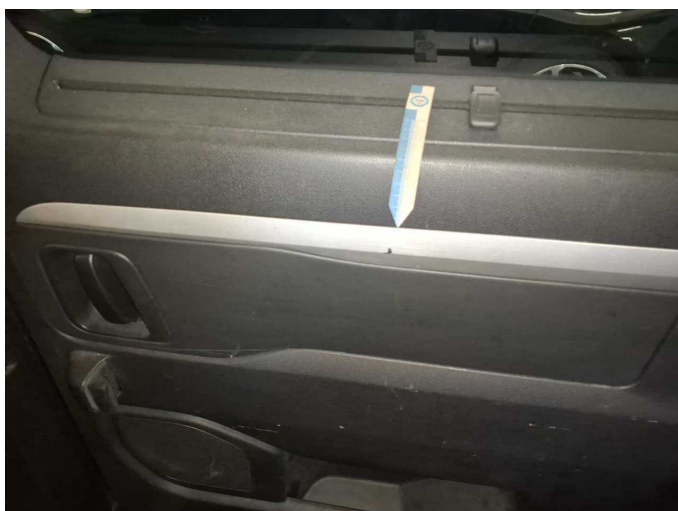
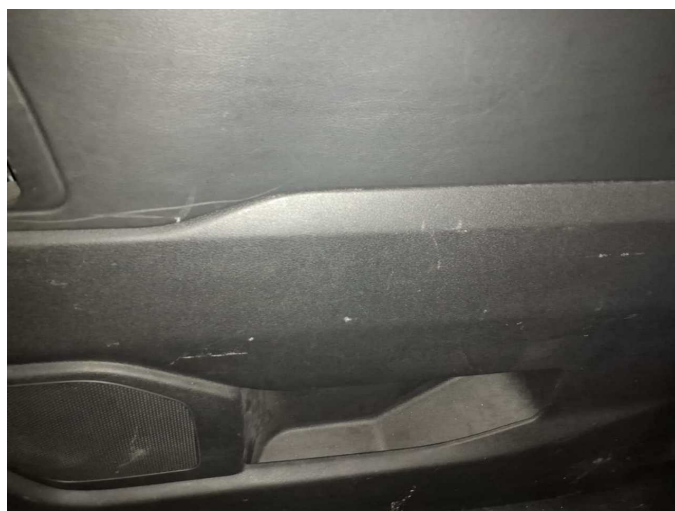
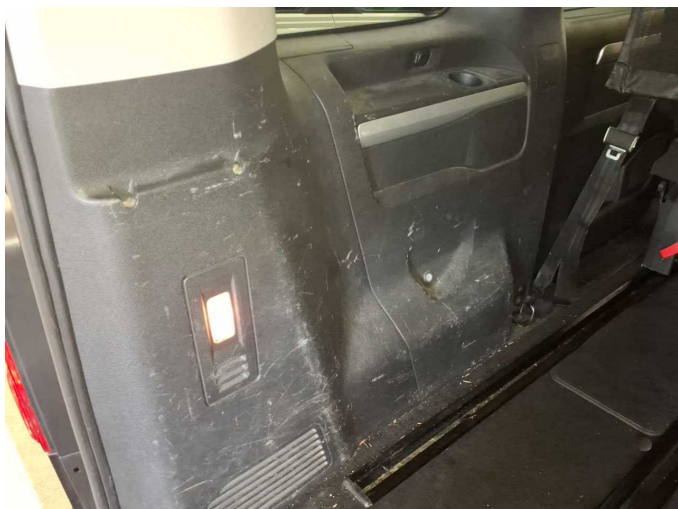
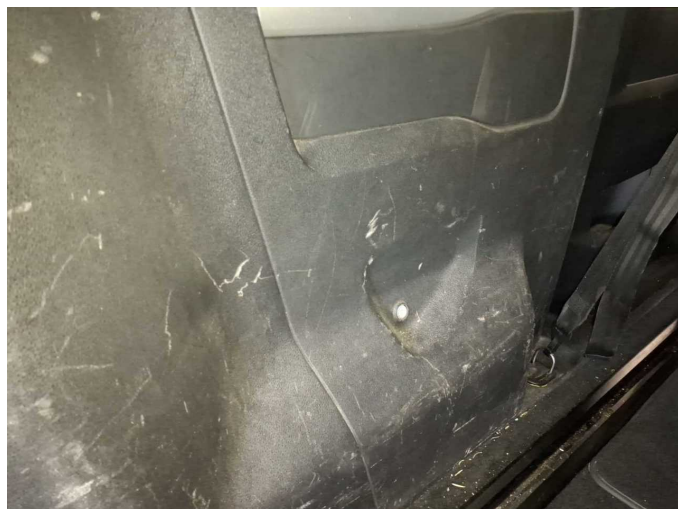
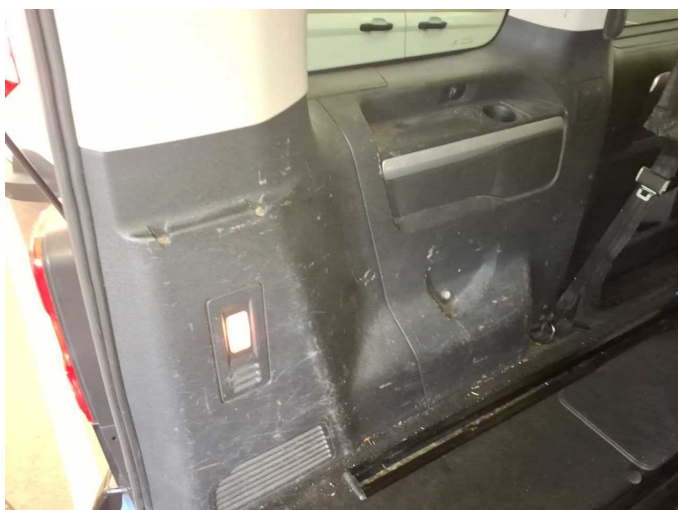
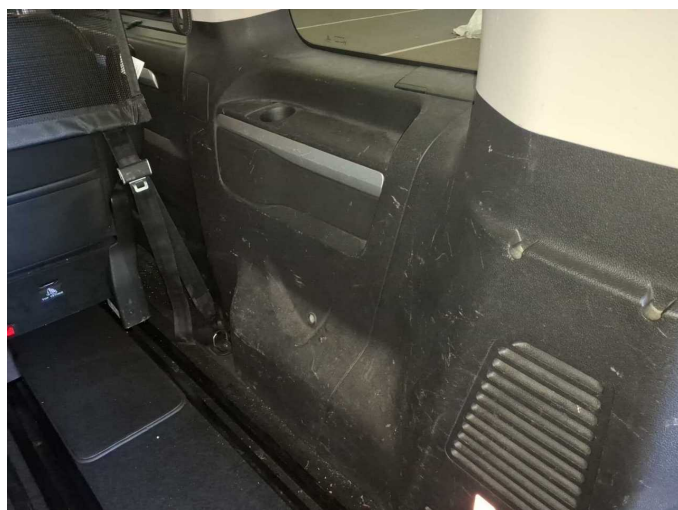
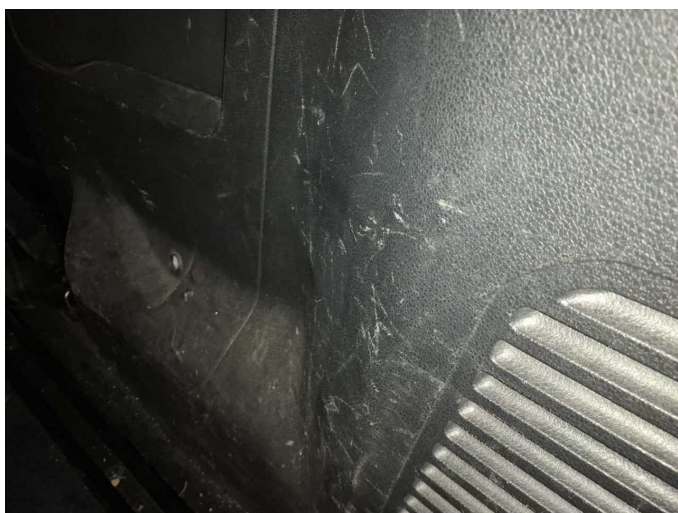
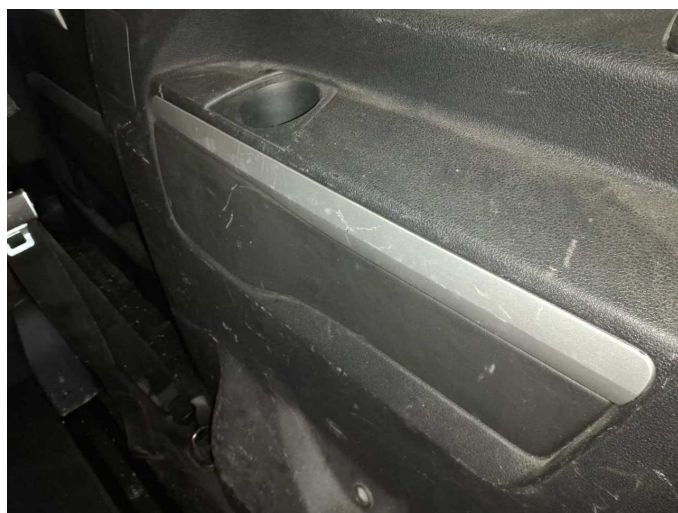
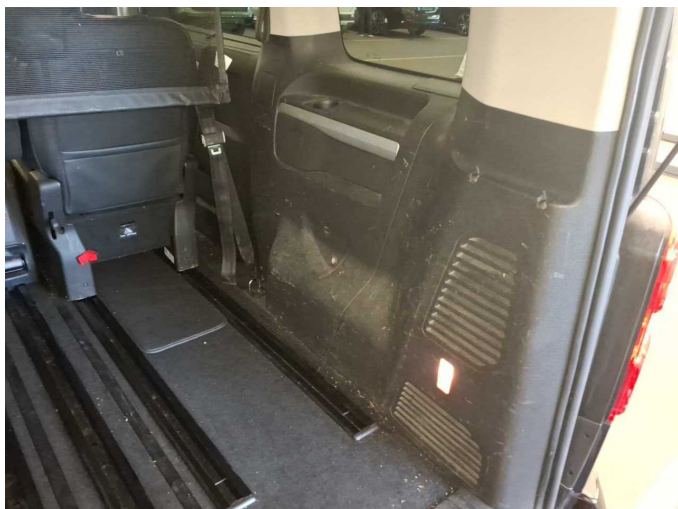
| No. | Component group | Description |
|---|---|---|
| 7 | Interior | Interior - Scratched - Loss in value |

**Damage 7:** Interior: Interior - Scratched - Loss in value

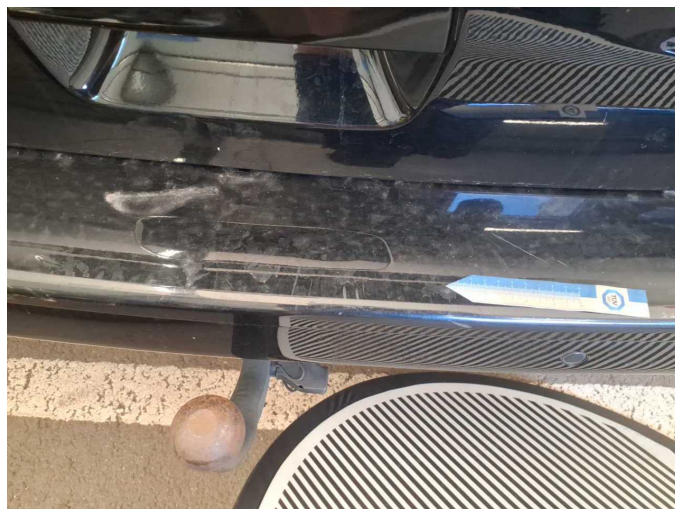
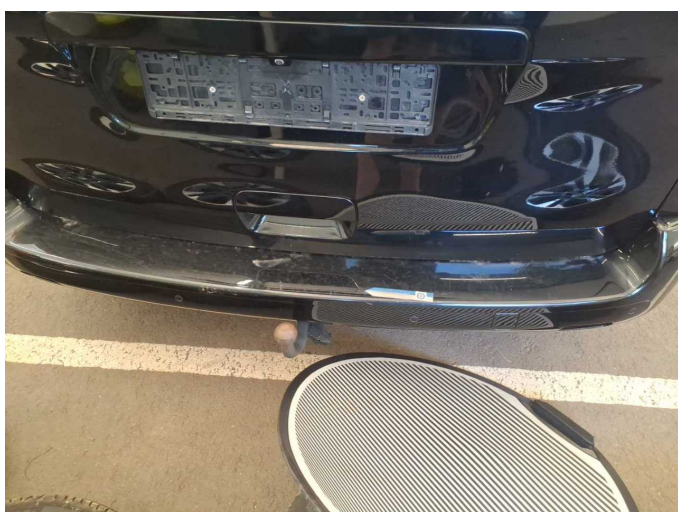
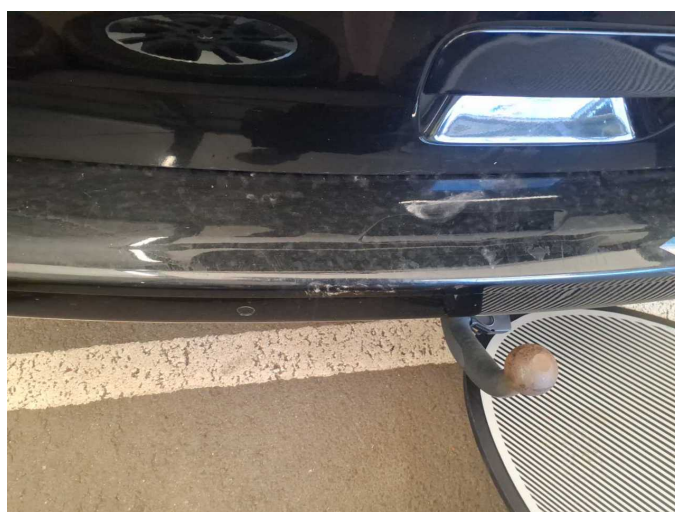
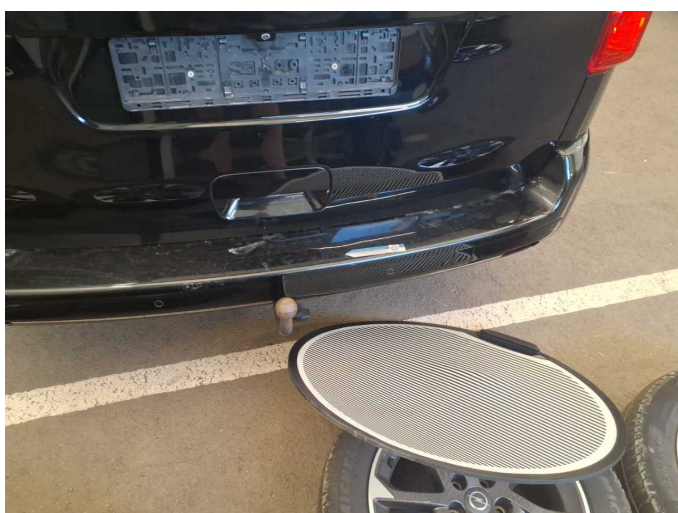
| No. | Component group | Description |
|---|---|---|
| 8 | Rear bumper | Rear bumper - Scratched - Repair and paint |

**Damage 8:** Rear bumper: Rear bumper - Scratched - Repair and paint

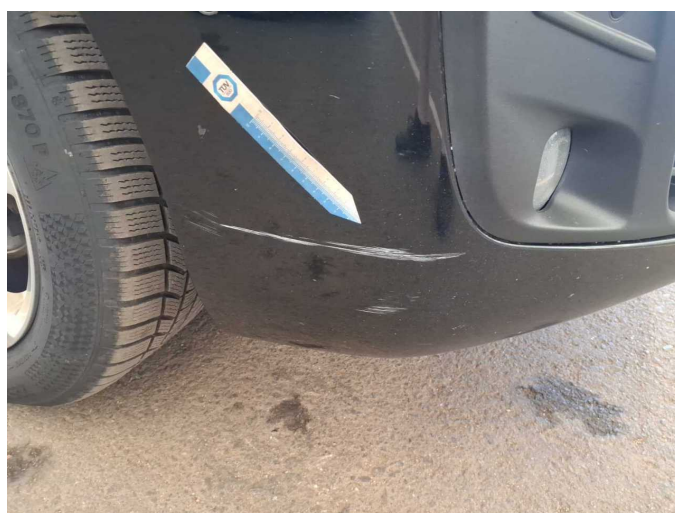
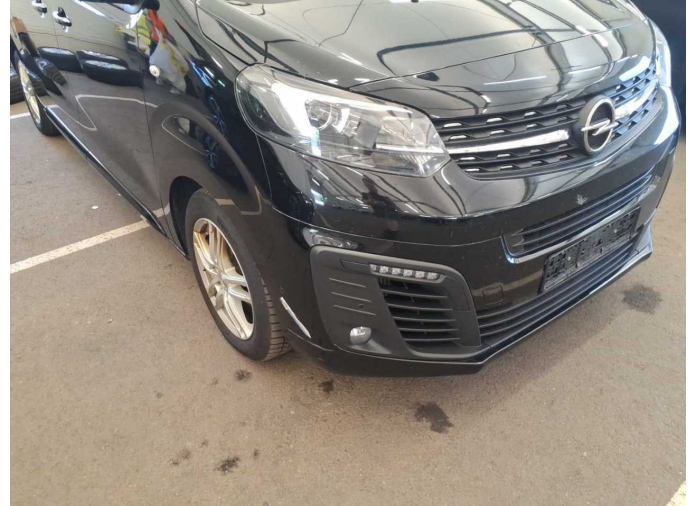
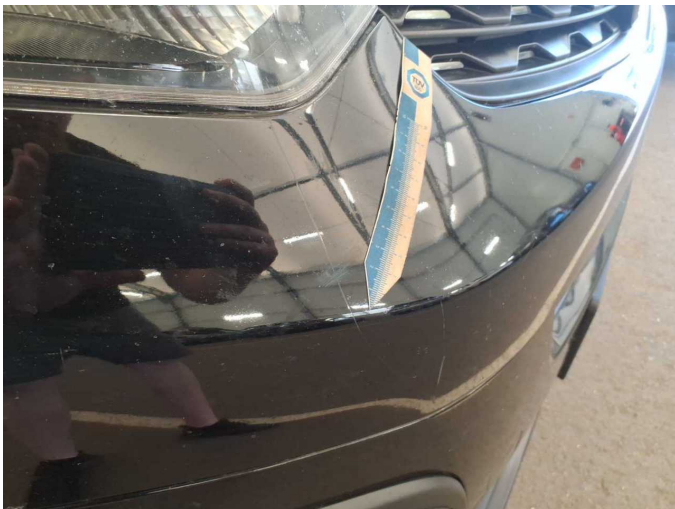
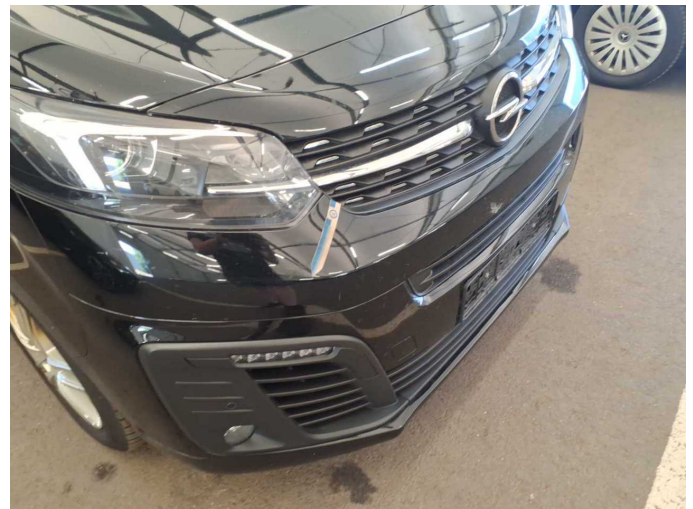
| No. | Component group | Description |
|---|---|---|
| 9 | Front bumper | Front bumper - Scratched - Repair and paint |

**Damage 9:** Front bumper: Front bumper - Scratched - Repair and paint

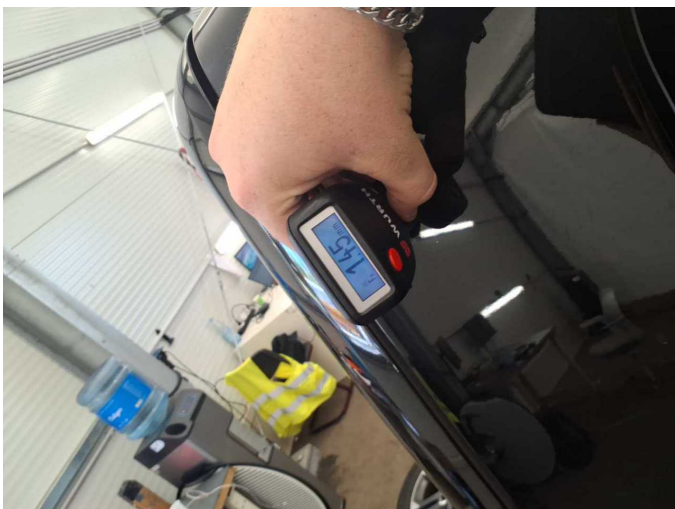
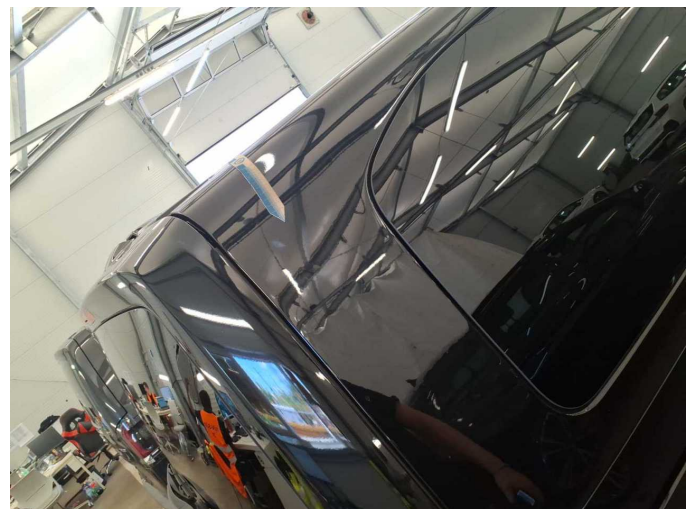
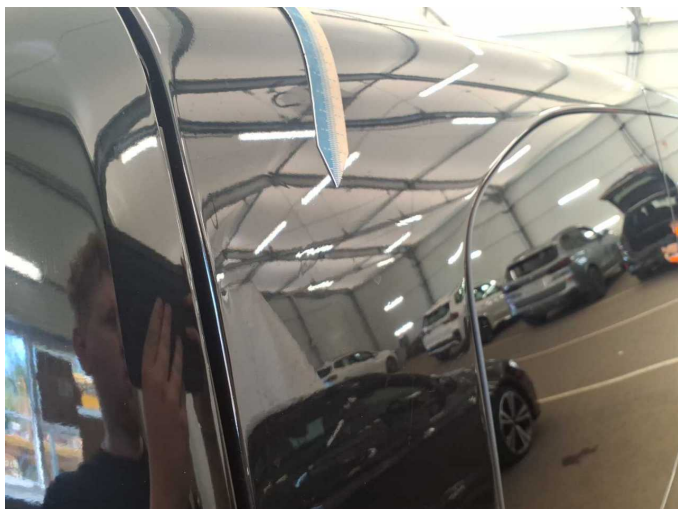
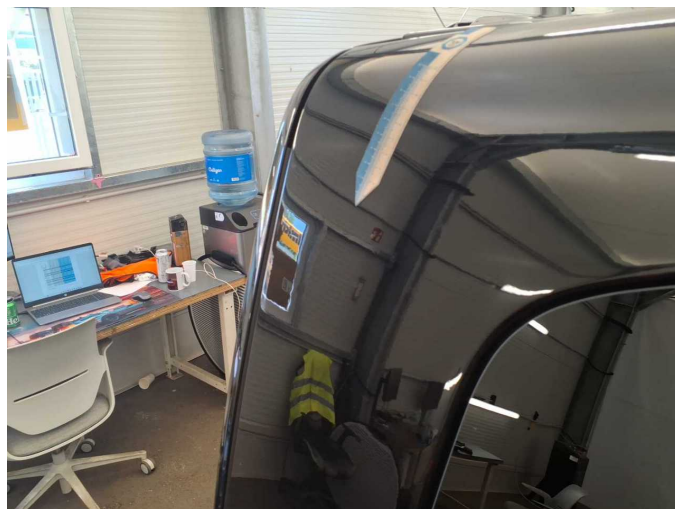
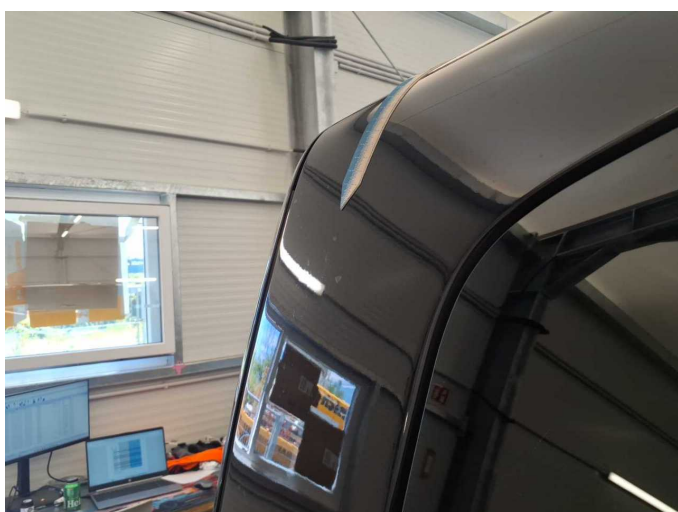
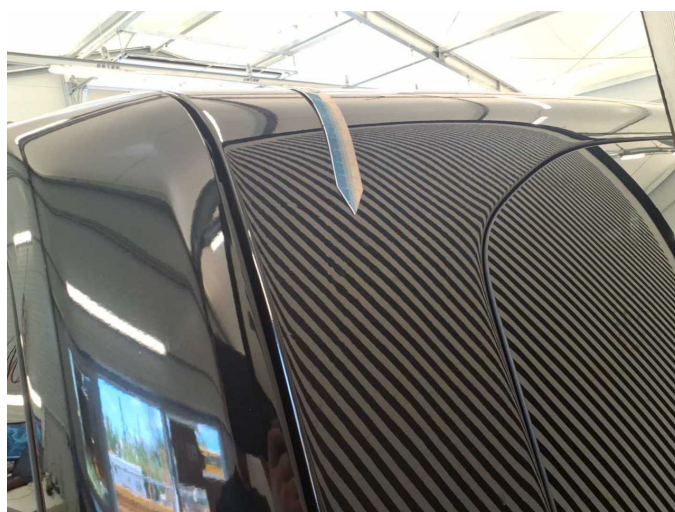
| No. | Component group | Description |
|---|---|---|
| 10 | Side panel - rear right side | Side panel (wellig) - Unprofessionally repaired - Repair and paint |

| No. | Repainting |
|---|---|
| 1 | Side panel - rear right side, Unprofessionally carried out, Invoice of repair done Non-existent |

| Side panel - rear right side | 1,430<br>µm |

**Damage 10:** Side panel - rear right side: Side panel (wellig) - Unprofessionally repaired - Repair and paint

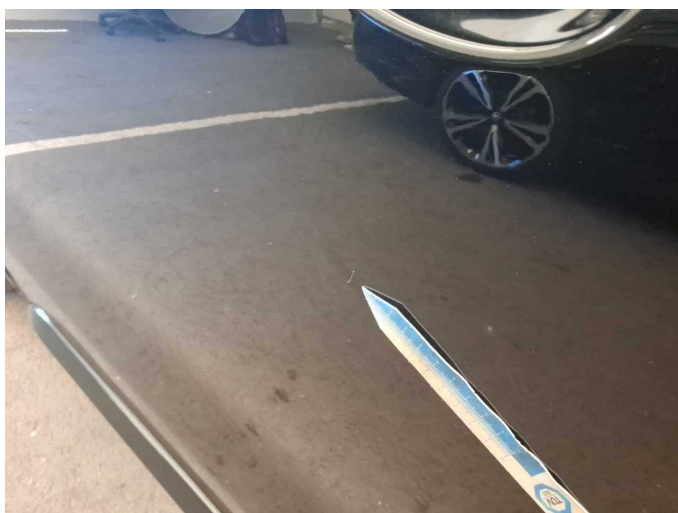
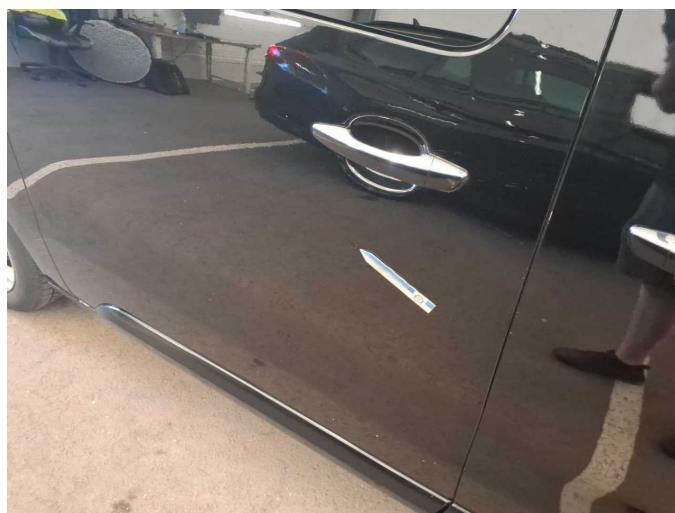
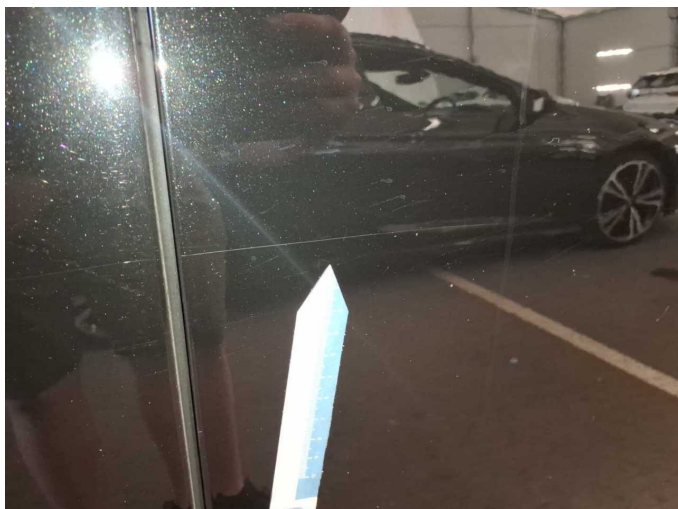
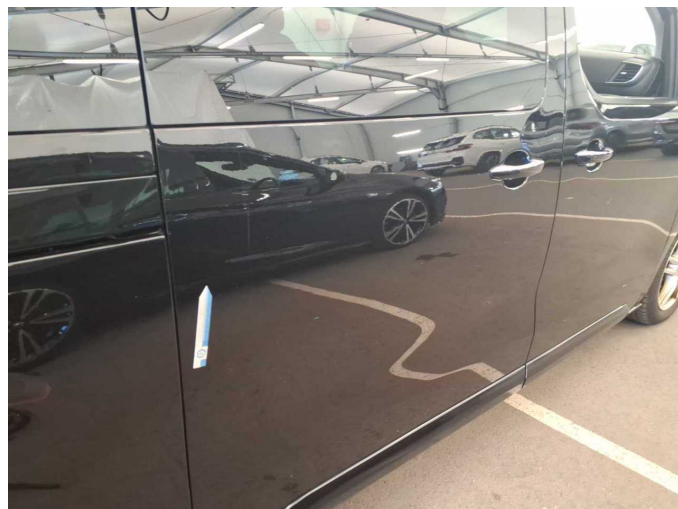
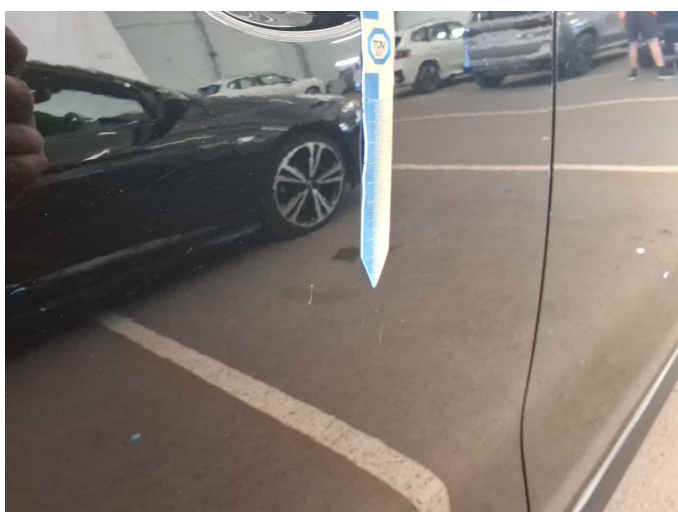
| No. | Component group | Description |
|---|---|---|
| 11 | Door - rear right side | Door - Scratch(es) - Paint |

**Damage 11:** Door - rear right side: Door - Scratch(es) - Paint

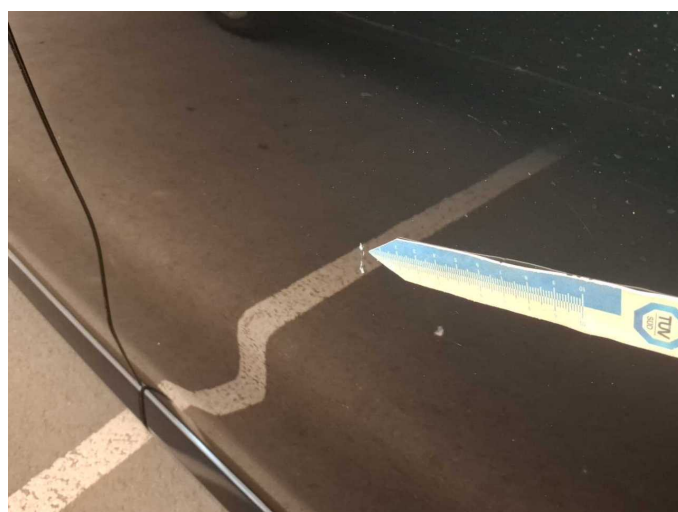
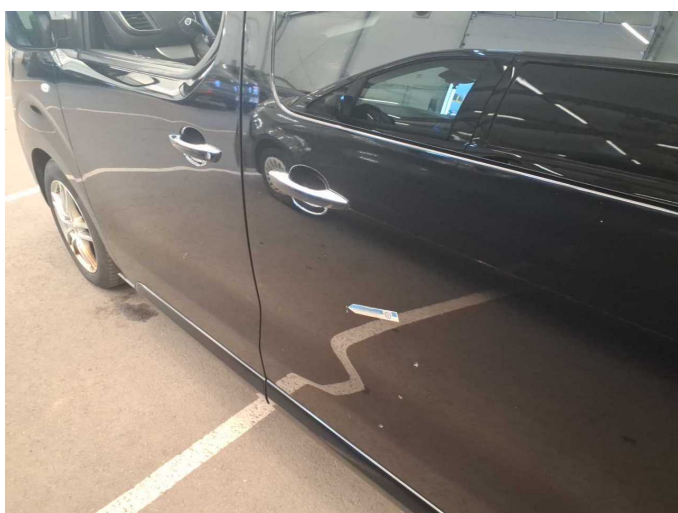
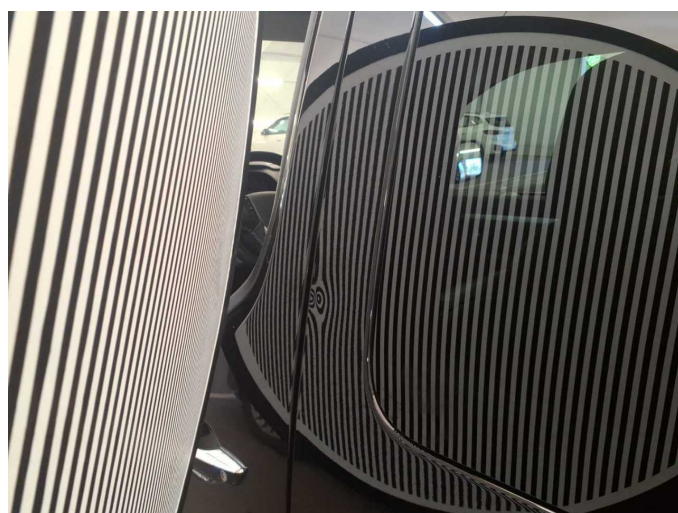
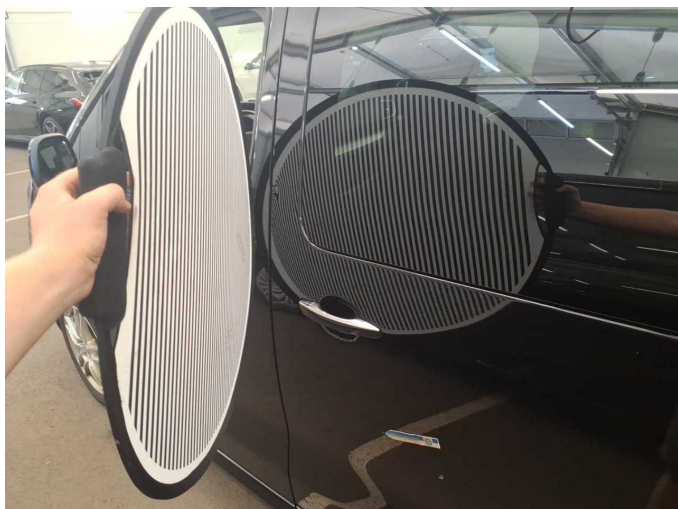
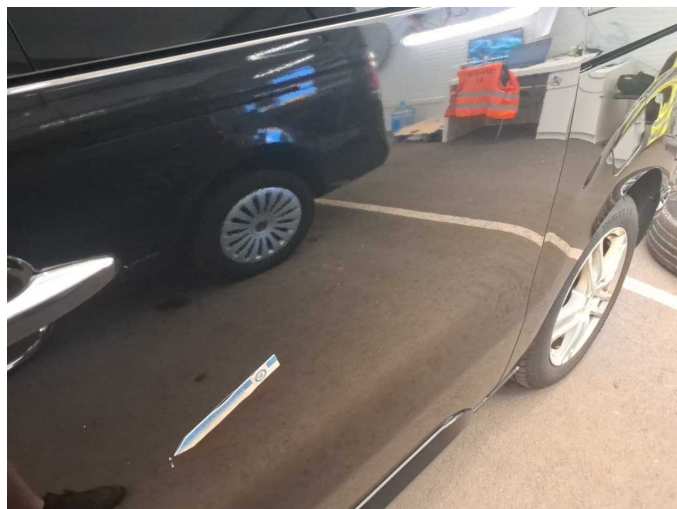
| No. | Component group | Description |
|---|---|---|
| 12 | Door - rear left side | Door - Dent / paintcoat damage - Repair and paint |

**Damage 12:** Door - rear left side: Door - Dent / paintcoat damage - Repair and paint

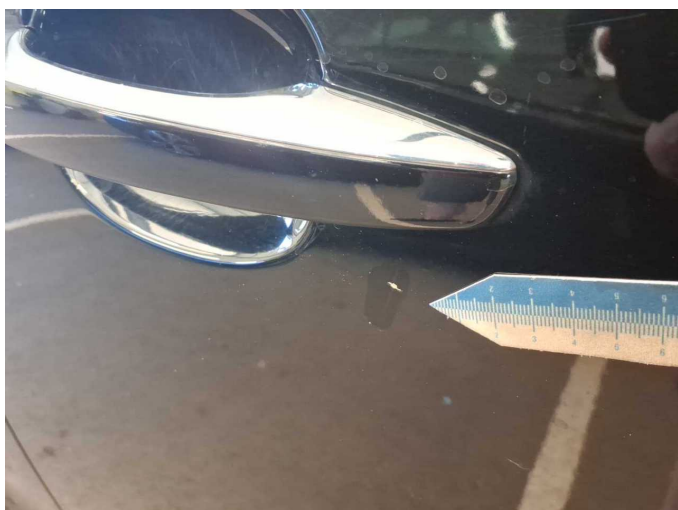
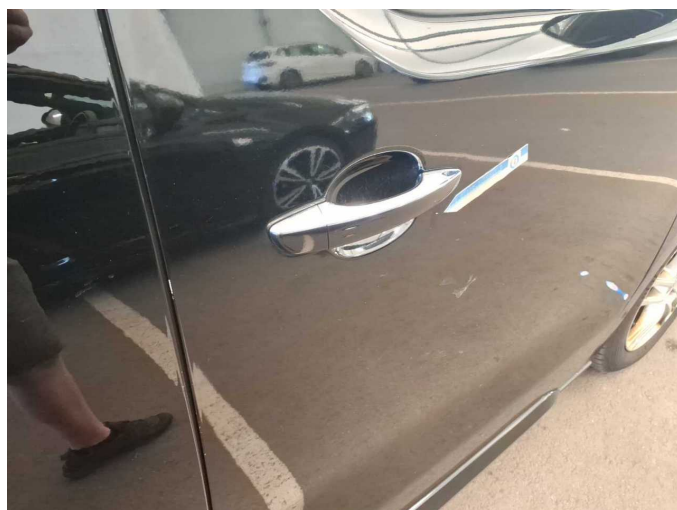
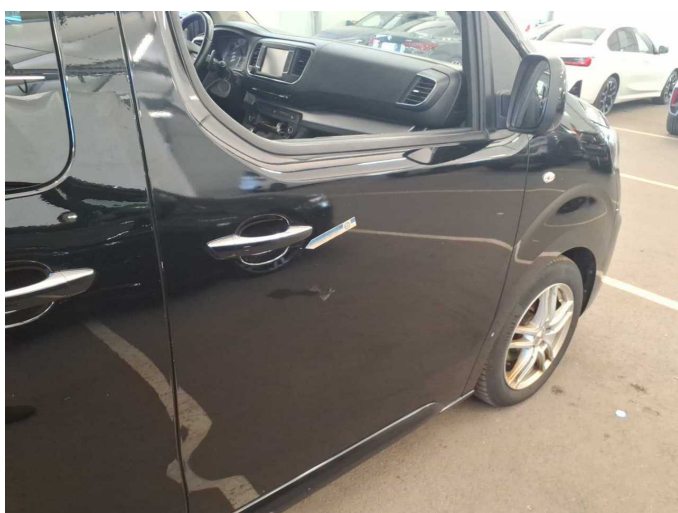
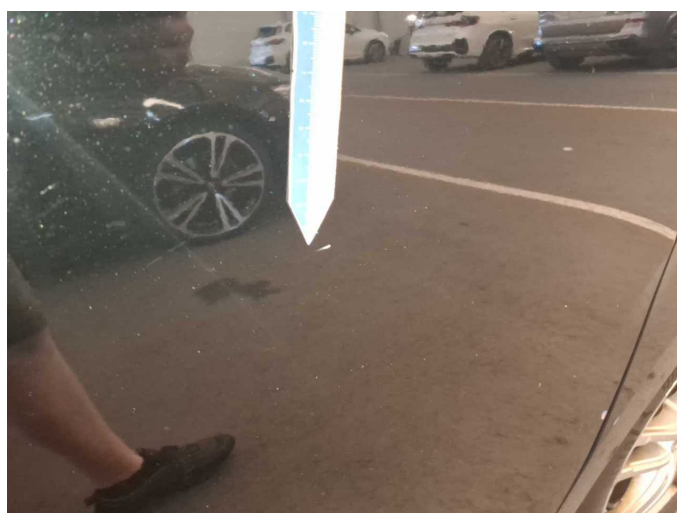
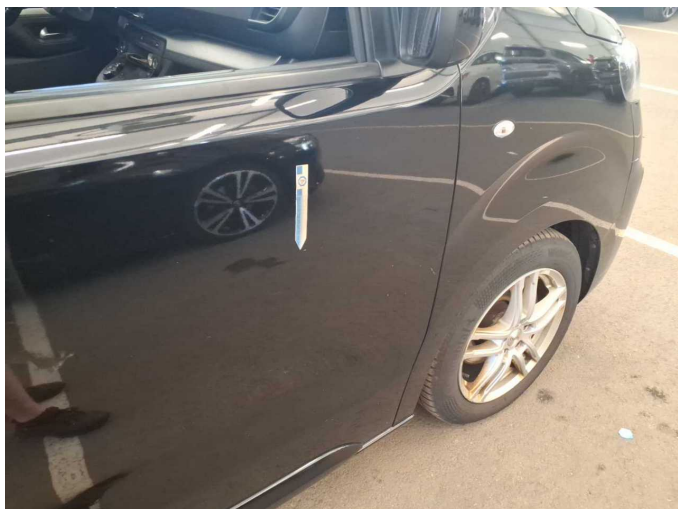
| No. | Component group | Description |
|---|---|---|
| 13 | Door - front right side | Door - Scratch(es) - Paint |

**Damage 13:** Door - front right side: Door - Scratch(es) - Paint

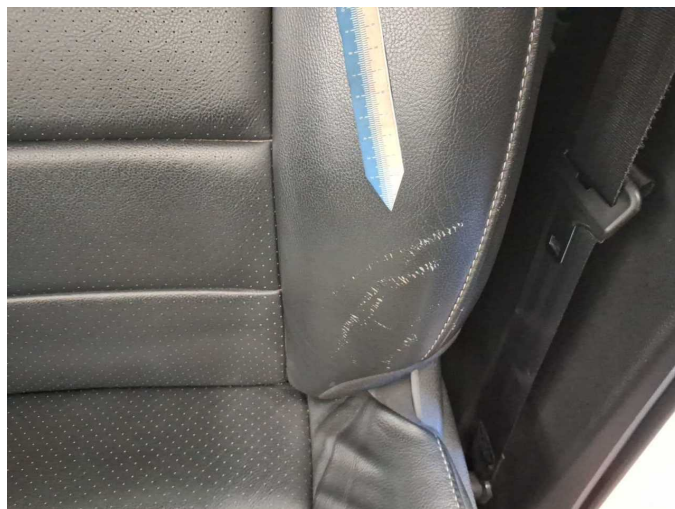
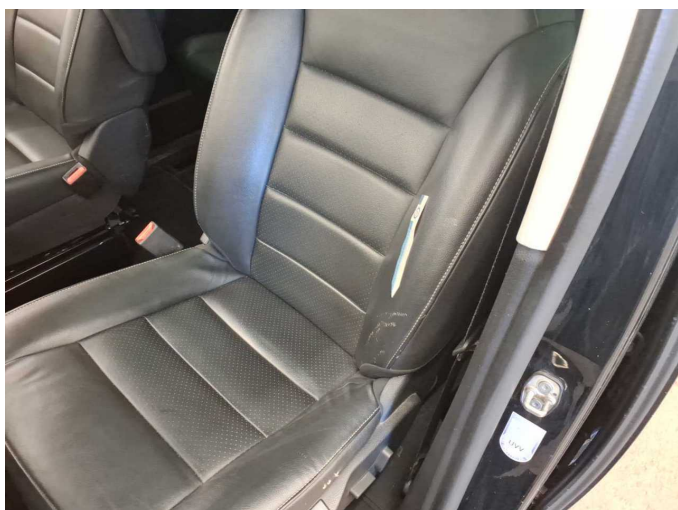
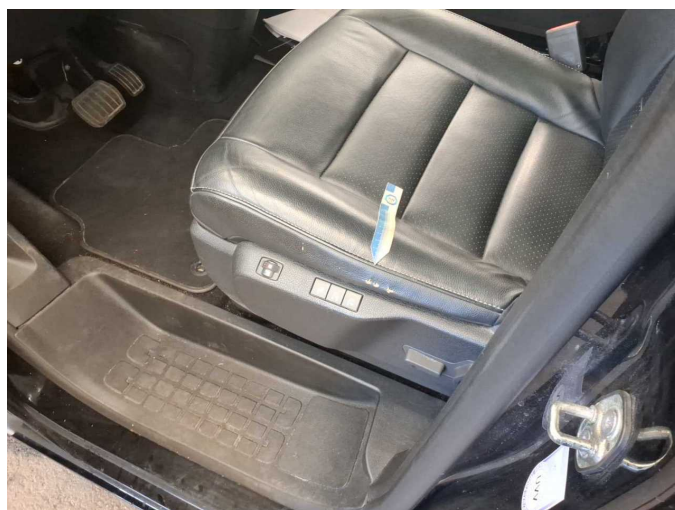
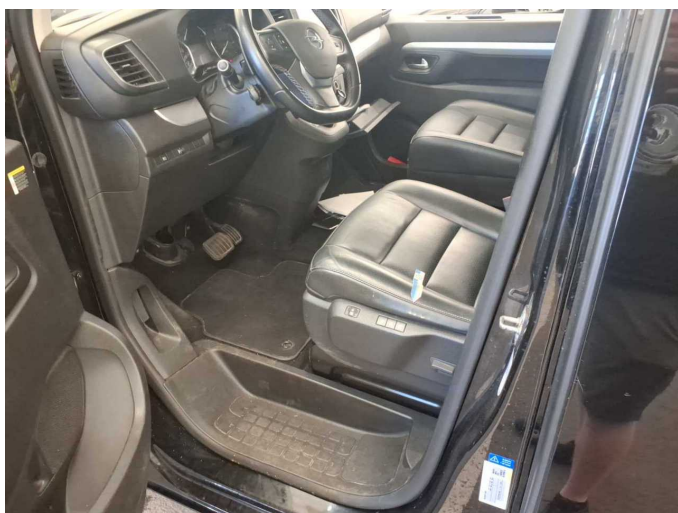
| No. | Component group | Description |
|---|---|---|
| 15 | Seat - front | Seat cover - left side - Broken / torn - Replace |

**Damage 15:** Seat - front: Seat cover - left side - Broken / torn - Replace

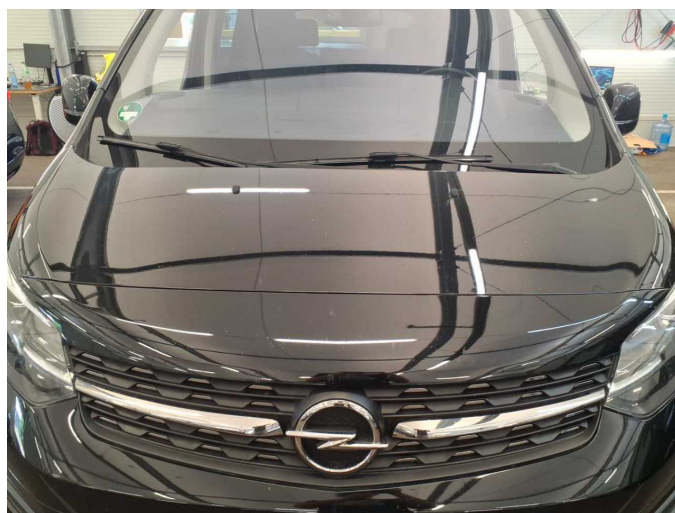
| No. | Component group | Description |
|---|---|---|
| 1 | Bonnet | Bonnet - Stone chips - No deduction |

**Wear and tear 1:** Bonnet: Bonnet - Stone chips - No deduction

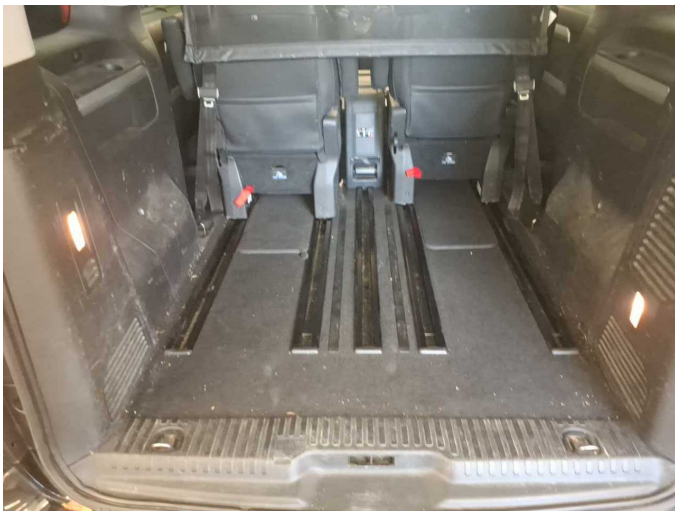
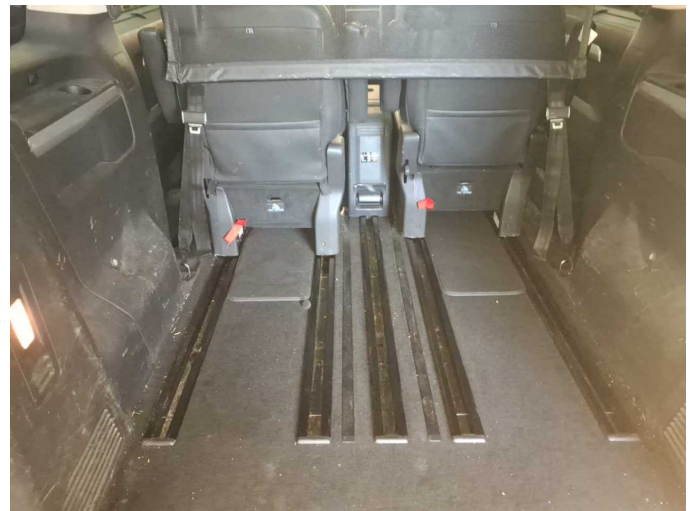
**Missing part 1:** Rear of vehicle: Key trailer hitch - Missing - Replace

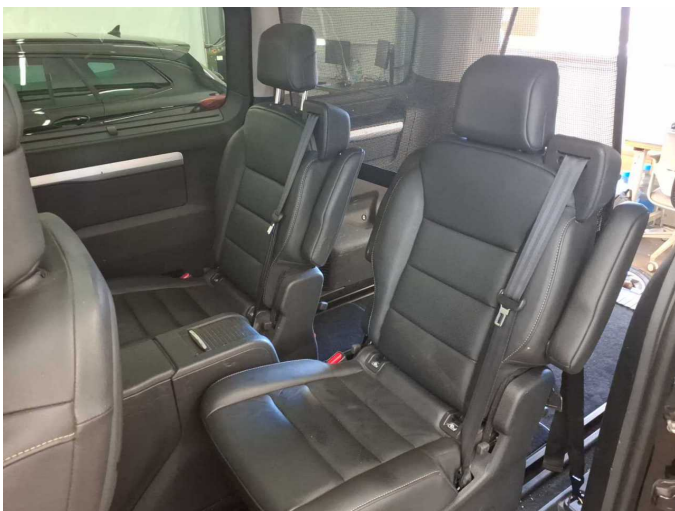
**Missing part 2:** Equipment: Tirefit complete - Missing - Replace

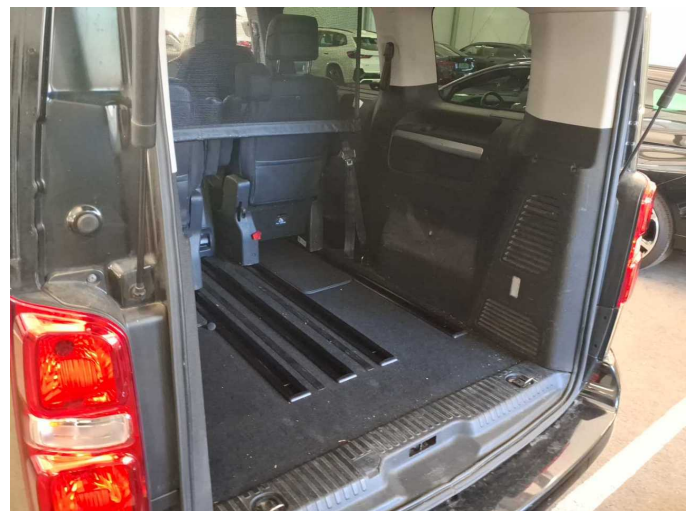
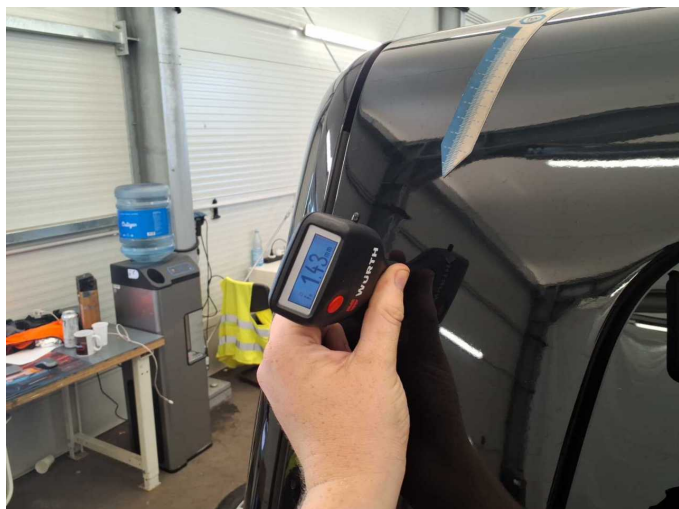
**Missing part 3:** Interior: Rear shelf - Missing - Replace
